Detection of illicit discharge from stormwater system outfalls in Plainfield, VT

August - October 2013

**Friends of the Winooski River
P.O. Box 777
Montpelier, VT 05601**

**Stone Environmental
535 Stone Cutters Way
Montpelier, VT 05602**

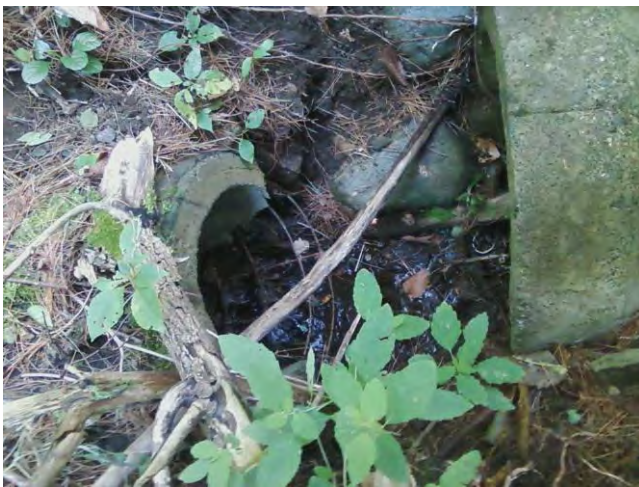
Plainfield outfall P-O-090 (Towne Avenue/Martin Meadow Road)

Description: 12-inch concrete. Drains Towne Avenue and swale along Robert Lane; empties into the Winooski River.

Damage: Concrete outfall pipe is broken in two about 4 feet from the end. The concrete at the break has eroded away and the metal reinforcement is visible and rusting. The flow is running through this break and no longer reaches the end of the pipe.

Erosion description: Significant erosion channel below outfall. Close to the Winooski River.

- Track down the source of the illicit discharge into the catch basin at the intersection of Towne Avenue/Martin Meadow Road
- Repair outfalls P-O-090 and P-O-130, and, if necessary, P-O-120, P-O-160, and P-O-190.

- Retrofit outfalls P-O-060, P-O-080, and P-O-090 to address the erosion below them.
- Encourage the community and property owner about ways to reduce stormwater flow, especially in areas drained by outfalls with erosion and sediment problems. Methods for reducing stormwater runoff involve increasing stormwater infiltration on individual properties. Infiltration may be enhanced by reducing bare and paved areas, converting lawn to perennial gardens or woody shrubs and trees, redirecting gutters away from bare or paved areas and toward vegetation, and disconnecting gutters from the stormwater system.

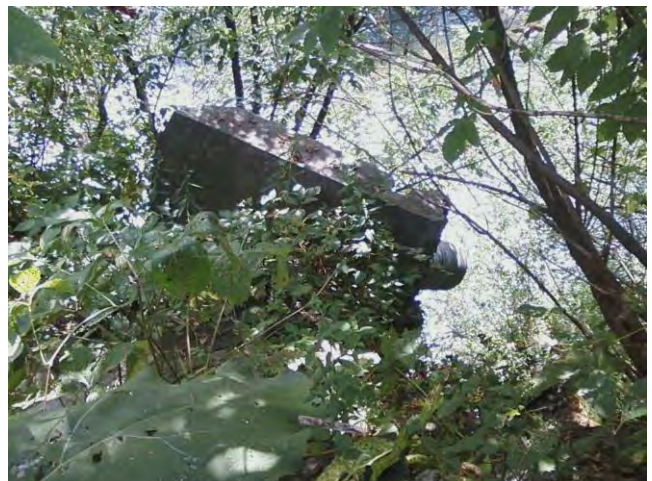
Plainfield outfall P-O-120 (south of Main Street Extension/Route 2)

Description: Approximately 16-inch corrugated metal pipe. Drains Main Street west of the blinking light and empties into the Winooski River. Inaccessible.

Damage: Pipe and concrete header appear to be detached from the storm line. This outfall could only be observed from the top of the bank, however, and a close inspection was not made.

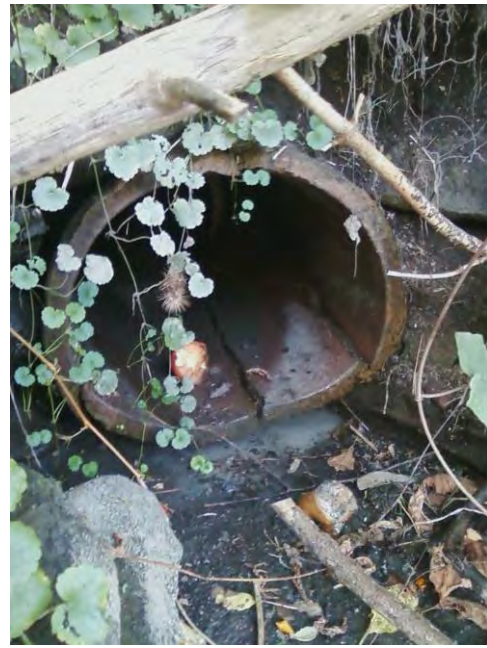
Plainfield outfall P-O-130 (north of Main Street Extension/Mill Street)

Description: 12-inch ceramic outfall. Drains most of Main Street extension and empties into the Winooski River.

Damage: Outfall pipe is cracked longitudinally at the bottom in at least three places, perhaps due to the weight of the soil above. Discharge flows through these cracks and does not make it to the end of pipe.

Reason for flag: On 8/23/13 suds were observed in the river below this outfall when the first visit was made. The discharge at this time was slightly turbid. In order to determine where the source of potential pollutants was, the catch basin immediately upstream was inspected (see below).

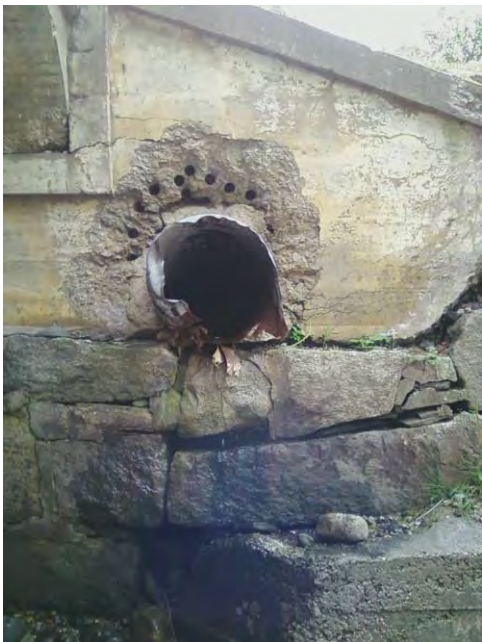
Plainfield outfall P-O-160 (southwest edge of Mill Street Bridge @ Great Brook)

Description: 18-inch corrugated metal. Drains Barre Hill Road and the west side of upper Mill Street empties into Great Brook.

Damage: Corrugated metal outfall is corroded at the bottom and slightly bent at the mouth so that a moderate amount of debris collects at the end, obstructing the flow to some extent.

Sediment description: Outfall contains sediment and is probably transporting a moderate amount of sediment into Great Brook.

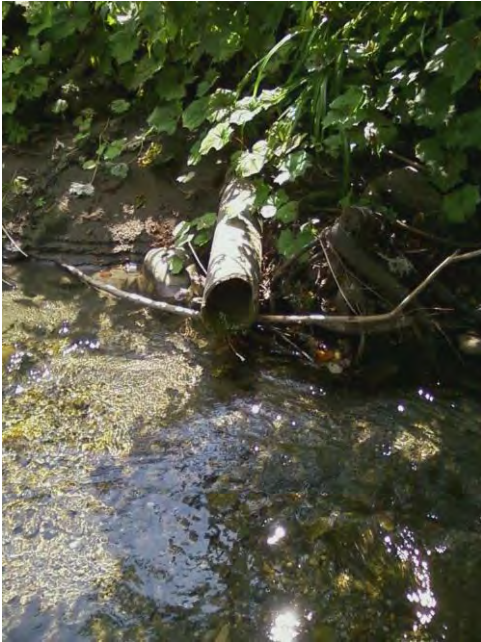
Plainfield outfall P-O-190 (Recreation Field Road)

Description: 8-inch asbestos cement. Drains apartment house parking and lower Recreation Fields Road and empties into Great Brook.

Damage: Pipe is cracking.

Sediment description: Outfall contains sediment and is probably transporting some sediment into Great Brook.

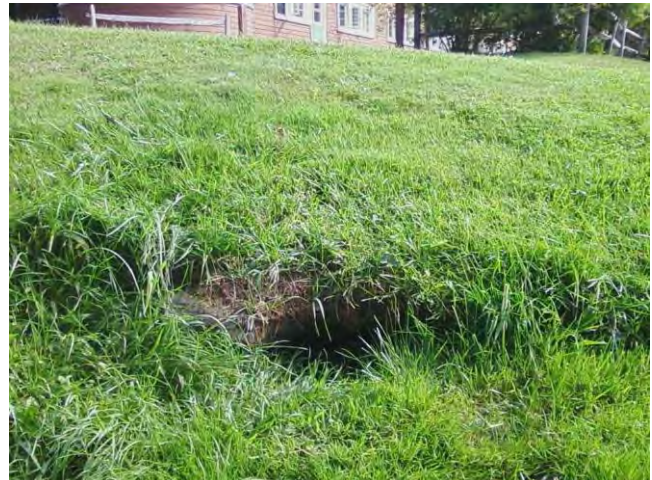
Plainfield outfall P-O-070 (Pitkin Road, Goddard campus)

Description: 12-inch corrugated metal pipe. Drains Pitkin Road and empties into grassy area below the road.

Obstruction: Outfall and the drop inlet that drains into it are full of sediment. Bottom of outfall pipe outlet is below the soil surface.

Three outfalls were partially blocked with sediment. The most severely obstructed outfall was P-O-070, on the Goddard College campus, and should be cleared out, especially if drainage in this area becomes a problem. An outfall along Route 2 (P-O-080) was also about 25% full of sediment, and should be cleaned out. Cleaning out these pipes, however, will probably only serve to temporarily solve these problems. A more permanent solution would involve reducing stormwater flow and erosion above these outfalls.

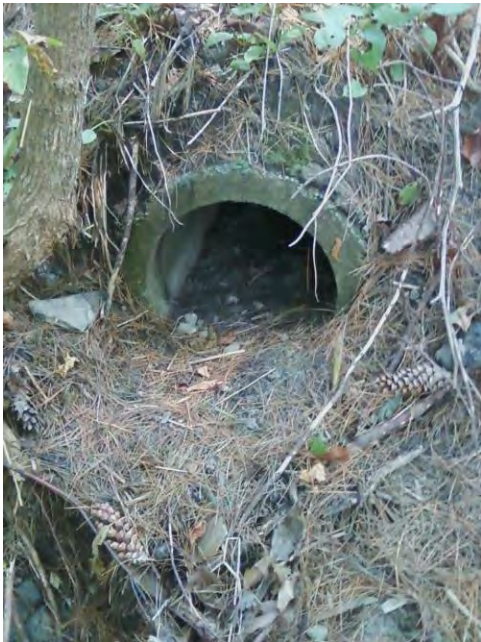
Plainfield outfall P-O-080 (Routes 2 and 214)

Description: 12-inch concrete. Difficult to access.

Obstruction: Outfall is $\sim\frac{1}{4}$ -full of sediment.

Erosion description: Significant erosion channel below outfall.

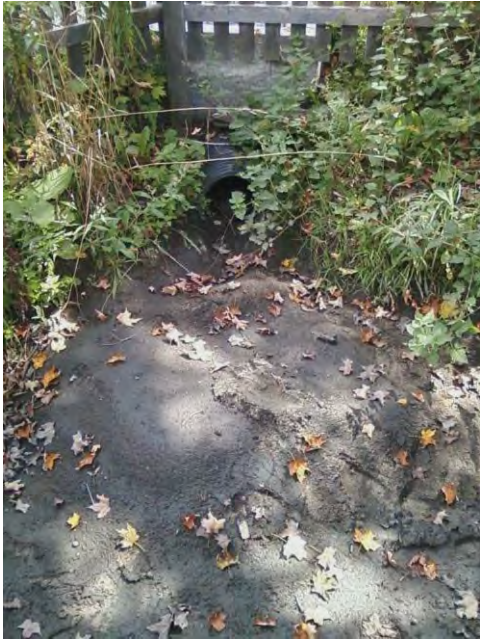
Plainfield outfall P-O-150 (Mill Street parking lot)

Description: 10-inch corrugated black plastic. Fed by a drop inlet off of Mill Street, drains into rain garden (and from there down the slope to the Winooski River.)

Obstruction: sediment Outfall is $\frac{1}{4}$ -full of sediment; brings into the rain garden.

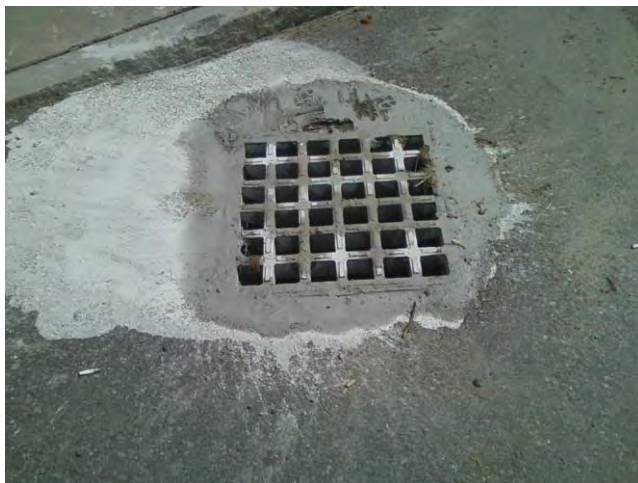
Plainfield catch basin P-CB-140

Reason for flag: This catch basin was observed to be full of what appeared to be grey dry wall mud, plaster, or concrete when inspected on 8/23/13. Since renovations were being done inside Positive Pie, inquiries were made as to whether any of the contractors were disposing of waste material into the catch basin. One of the contractors admitted that he had been dumping materials into this catch basin and agreed to stop.

Follow-up: On 9/6/13, this catch basin was revisited and appeared to be clear of the grey material.

- Educate the community, businesses, and contractors about illegal dumping into catch basins.

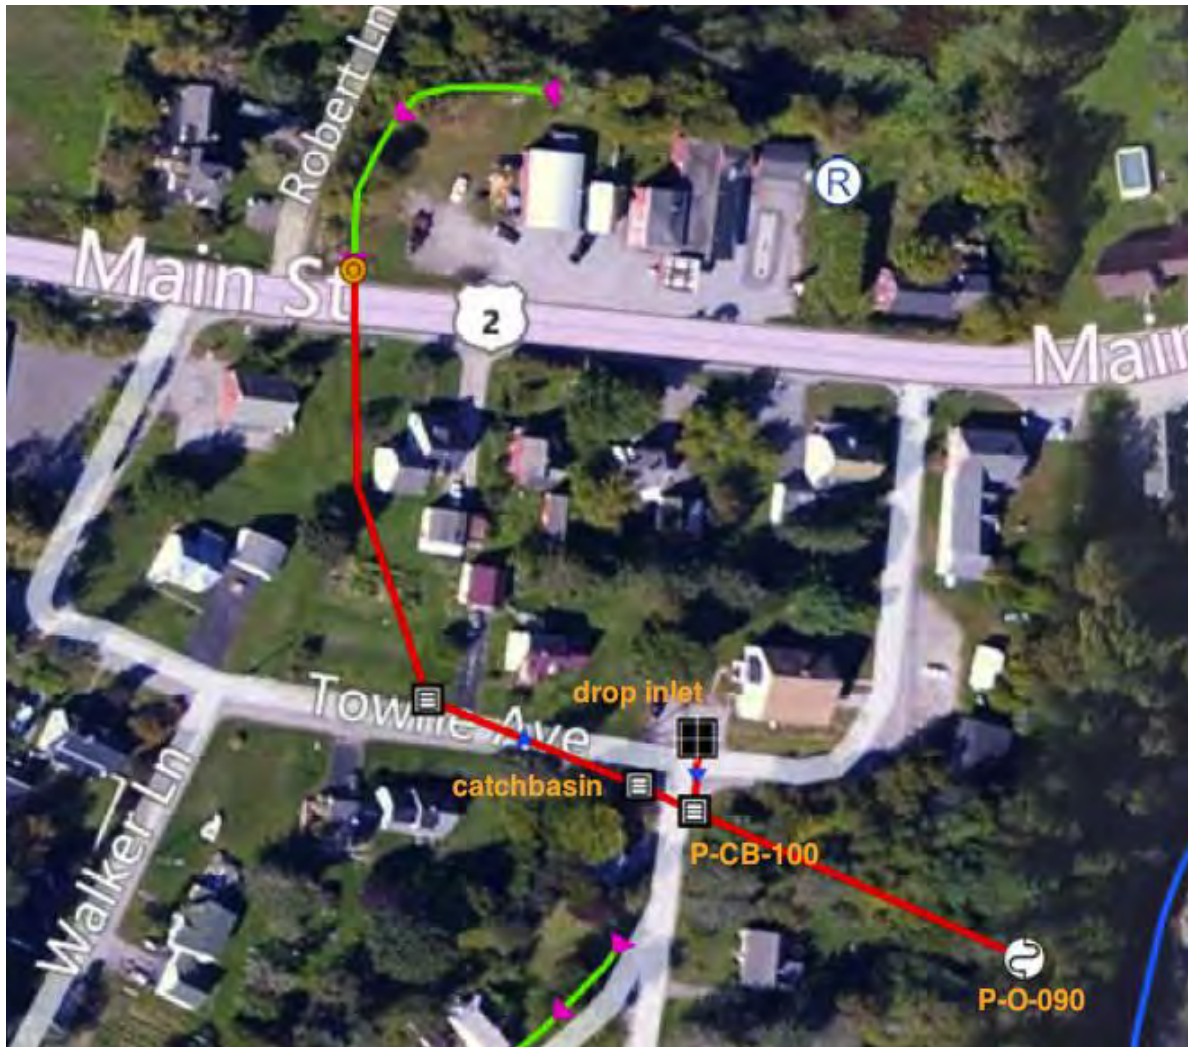
The stormwater system line that drains into problem outfall P-O-090. This outfall was flowing in dry weather and tested positive for optical brighteners, an indicator of gray water or raw sewage. An unmapped connection to the catch basin (P-CB-100) directly up the line from P-O-090 was found during this study and is suspected to be the source of the flow. The drop inlet across Towne Ave from P-CB-100 and the catch basin on the other corner were observed to be dry.
