**CHARACTERIZATION OF OUTFALLS
ON THE WINOOSKI RIVER
IN MONTPELIER**

FINAL REPORT – AUGUST 31ST, 2001

Friends of the Winooski River

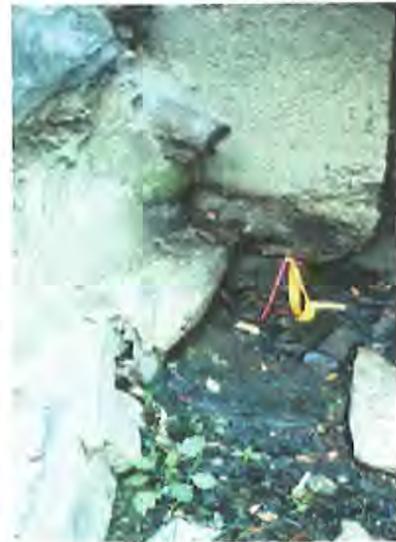
Outfall NB-JT-01

Located in the foundation wall of the old Chittenden Bank building (below Mail Boxes Etc.) just upstream of the Rialto Bridge on the west bank (right bank when facing downstream). A 6-inch diameter ceramic pipe was discharging a small quantity of foul-smelling liquid. The eroded base of the building foundation below the pipe was also seeping the liquid, creating a plum of gray water in the North Branch.

In September 2000, a sample of the discharge was taken to Spectrum Laboratories and found to contain >160,000 E. coli colonies/100 mL.

MDPW Action: In September 2000, this finding was brought to the attention of MDPW. MDPW contacted the building landlord, who supposedly took corrective action. However, the problem was apparent when the site was revisited in August 2001 (right); a second sample taken at that time had E. coli concentrations exceeding 160,000 colonies/100 mL. MDPW agreed to investigate the problem further and take corrective action. FWR will monitor progress in correcting this problem.

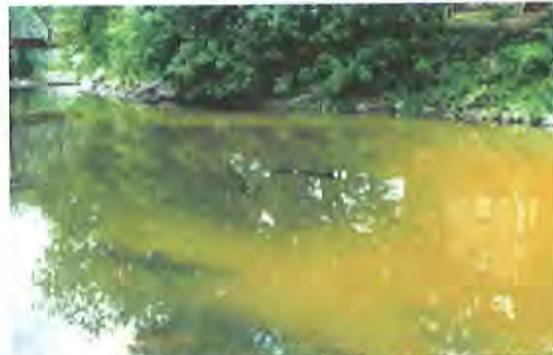
Outfall NB-MW-16

When outfall NB-MW-16 was revisited in August 2001, the pipe was discharging a steady flow of dirty water that formed a sediment plume in the North Branch. The repair on a burst water main on Main Street was the obvious source of the pollution (right).

A large hole had been excavated where the break had occurred and City water was flowing out of a disconnected section of pipe and mixing with soil in the bottom of the hole. A pump and hose was being used to transfer this muddy water to the nearest stormdrain that in turn discharged in the North Branch at the outfall in question.

MDPW Action: When discussing this outfall with MDPW it was learned that a sewer siphon approximately 20-feet downstream has the potential to overflow into the North Branch. The proximity of this discharge may account for the foul odor. The siphon overflows when its carrying capacity is exceeded, or if sediment is allowed to accumulate in the siphon. Accordingly, this and other siphons in Montpelier are scheduled for weekly inspections and monthly cleaning. The situation should improve as CSO separation work continues, allowing previous separations to come 'on-line'. This will be a matter for FWR to monitor in the future.

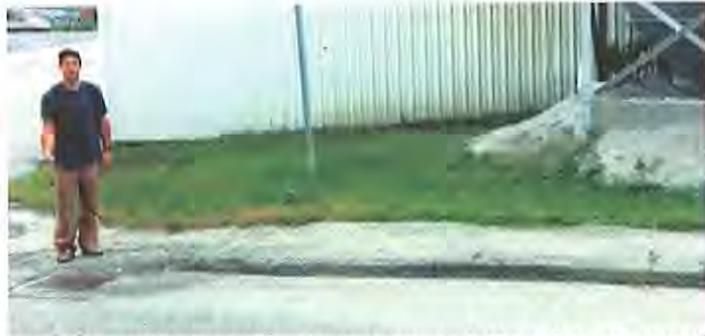
Another potential problem noted in the course of this study is a large quantity of granite dust located approximately 10 feet from a storm drain at the intersection of Granite Street and Barre Street (below).

In the spring it was observed that the dust was washing over the ice and snow into the storm drain.

MDPW Action: Steve Gray will send a letter to the proprietor asking that the dust be contained in

a more substantial receiving box and that the dust accumulation be removed periodically to prevent overspill.

- FWR understands the City will discuss the granite dust runoff problem at the corner of Barre Street and Granite Street with the building's owner or manager.

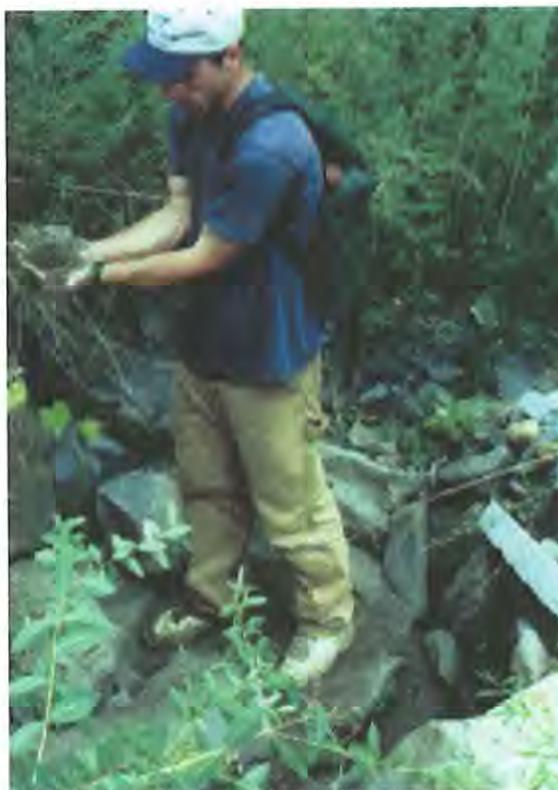
The survey results provide evidence that the design, location, and disrepair of many outfalls is the cause of considerable bank and streambed erosion, resulting in sediment loading to the river. Because sediment is the most pervasive water quality problem in the Winooski River watershed and a major cause of impairment in the river segment under study, this is a significant finding. In addition, bank erosion, often in combination with bed erosion, can lead to the undermining of the outfalls, leading to their collapse, resulting in turn in more sediment loading and costly repairs. There were, however, examples of well designed outfalls, including one with a rock-lined sediment basin (right) below the Granite Street Bridge.

- Those outfalls in danger of failure from severe bank erosion should be stabilized by the City of Montpelier. A combination of rock riprap and vegetation planting would be effective in most situations.
- Bed erosion should be prevented by redesigning the oufall or the installation of a rock-lined basin, which may also help to intercept sediment from runoff.
