Detecting and Eliminating Illicit Discharges in Rutland County to Improve Water Quality

Final Report

March 31, 2014

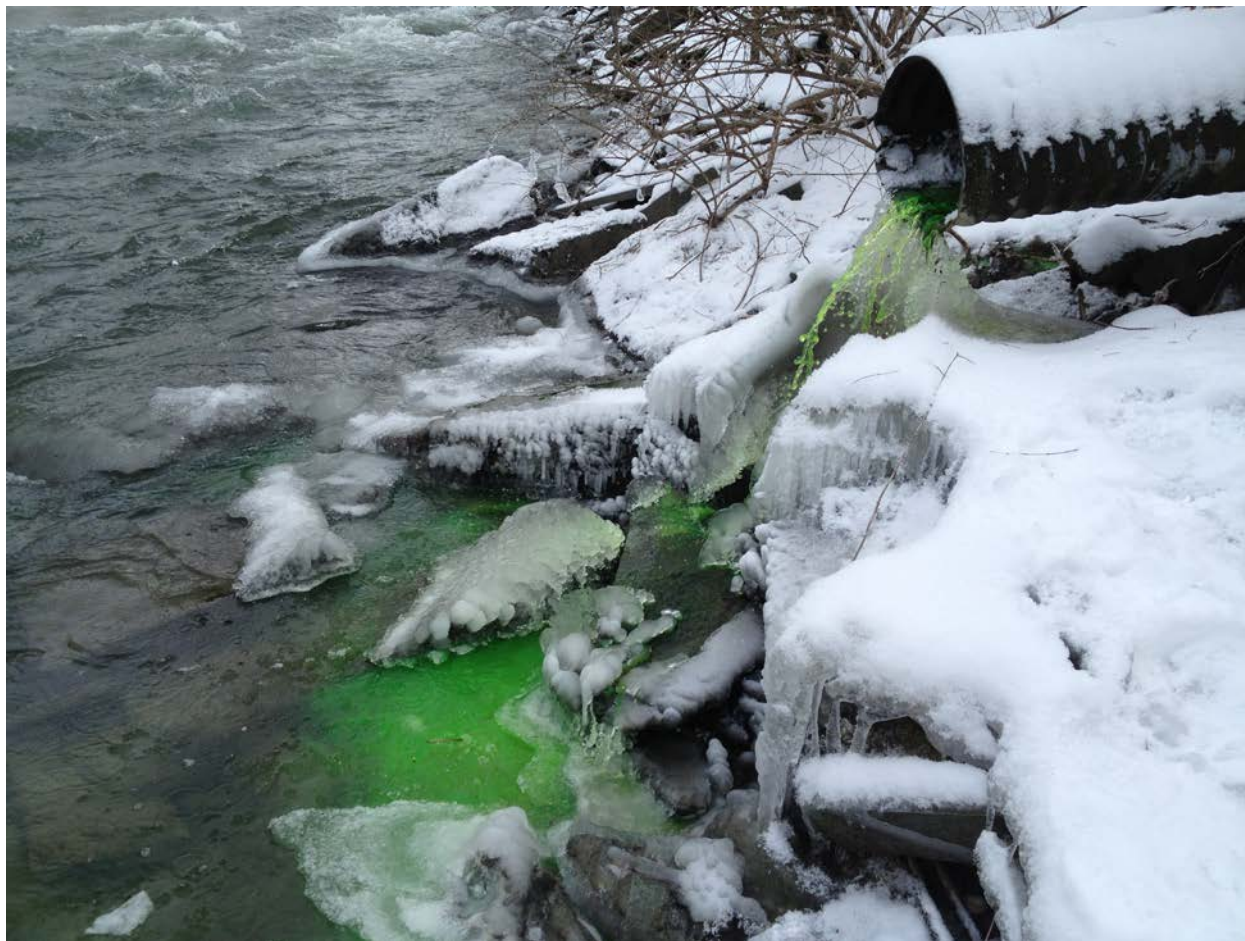
Dye flushed down a toilet in Fair Haven discharges to the Castleton River at outfall FH280, confirming presence of a sanitary wastewater connection

Notwithstanding these challenges, on January 21, 2014, Dave Braun and Ryan Sleeper met Bud Panoushek, Fair Haven Highway Superintendent, to dye test houses on Prospect Street. The first house tested, 12 Prospect Street, was found to have an illicit connection to system FH280. Dye added to the toilet in this house appeared in the sanitary sewer as expected but was also seen at the outfall (see cover photograph). This result suggests a badly leaking house sewer lateral. Two houses further up Prospect Street (#18 and #22) were also tested and no dye was observed at the outfall, which indicates that both house laterals as well as the sewer main on Prospect Street are not leaking. No one was home at the only other occupied house on this block, #24 Prospect Street, but this house is over 1000 feet from the FH280 line crossing. Therefore, we believe we have identified the only illicit connection to the FH280 system. **The Town of Fair Haven has agreed to take the lead in working with the property owner at 12 Prospect Street to address the leaking sewer lateral. Stone Environmental wrote a letter to the Town Manager, Herb Durfee, detailing these findings for the town to use in pursuing resolution of this matter.**

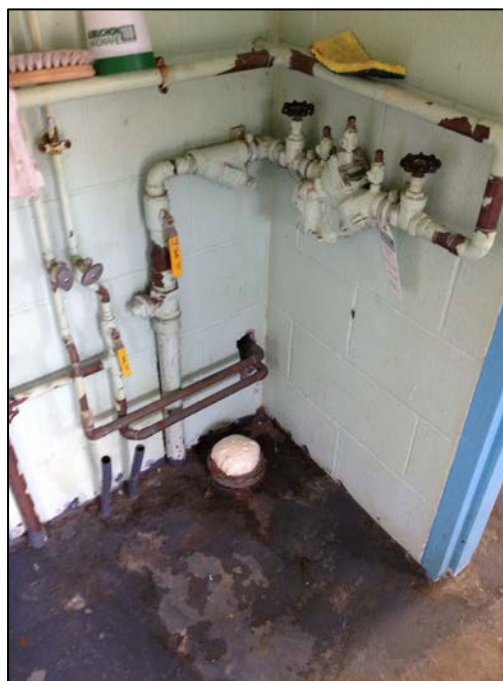
Figure 2. Sealed utility sink drain

During the initial investigation in this system, a utility sink in the wastewater treatment plant lab room was found to be improperly connected to the catchbasin in the parking lot. Shortly after this discovery, prior to August 27, 2013, the Town of Fair Haven removed the sink and sealed the drain (Figure 2). There do not appear to be any other direct connections to the system.

It is not certain that this sink was the source of optical brightener initially detected at the outfall. It is also possible that oil or small amounts of wastewater present on vehicles and on the road surface wash into catchbasin CB-A during rain events, although the pavement appears relatively clean. **The likelier explanation, however, is that materials washed down the sink resulted in positive optical brightener readings, and that elimination of the sink has corrected this problem. No further action is planned.**

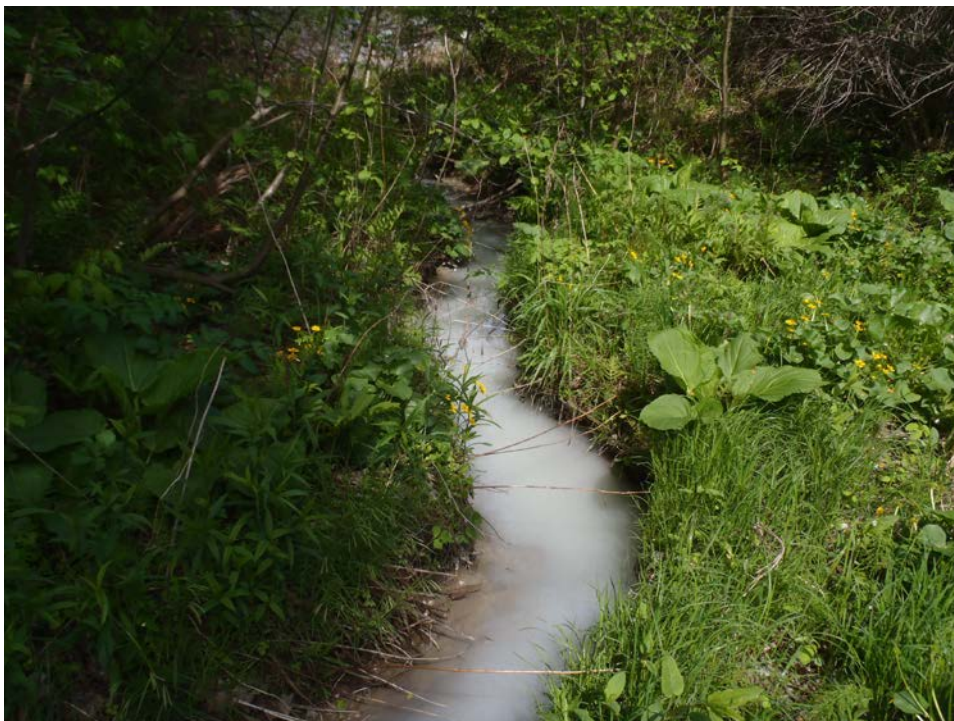
Figure 3. Small stream receiving discharge from Vermont Structural Slate property

East of the village along River Street a pipe was found discharging highly turbid water. The water had a cloudy, white appearance, similar to skim milk (Figure 3). If allowed to settle, a layer of white sediment formed on the bottom of the sample bottle. The pipe is on the north side of the Vermont Structural Slate property. We did not investigate the source because it clearly originates on private property.

When this issue was raised with Vermont DEC, Patrick Lowkes (Enforcement Division) and others clarified that DEC was already aware of the issue and was working with the facility through the MSGP process. According to Mr. Lowkes, the discharge consists of quarry hole water that is pumped periodically. **DEC is handling this issue and no action**

by the municipality is necessary.

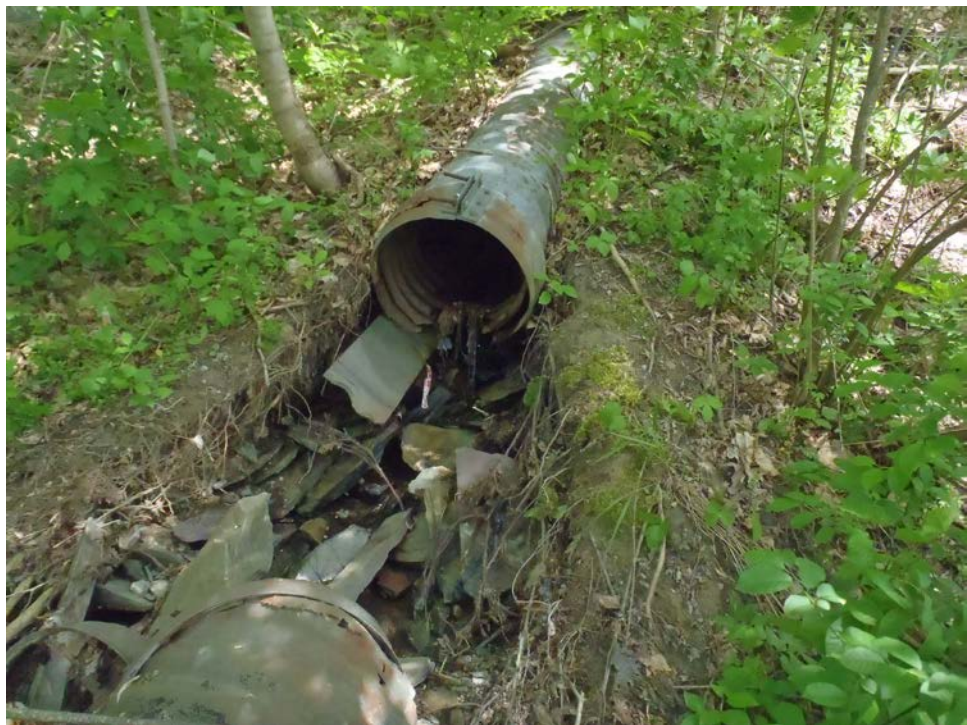
Figure 4. Outfall PY140

The PY140 outfall is an 18-in. diameter corrugated steel pipe (Figure 4). This system drains a series of catchbasins on Wilson Avenue, York Street, and College Street North (Appendix C, Map 5). During our initial visit on June 19, 2013 the outfall was flowing and the discharge was clear with no odor.

Water quality data for this outfall are presented in Table 10. Optical brightener was detected in a pad set at the outfall on the initial visit, although fluorescence was weak. Monitoring pads set throughout the system on July 25, 2013 indicated presence of optical brightener only at the outfall and in a catchbasin CB-C on Branch A, although fluorescence in the

catchbasin was weak. There do not appear to be any inappropriate connections in catchbasin CB-C on Branch A and we suspect this detection was a false positive reading, possibly resulting from motor oil.

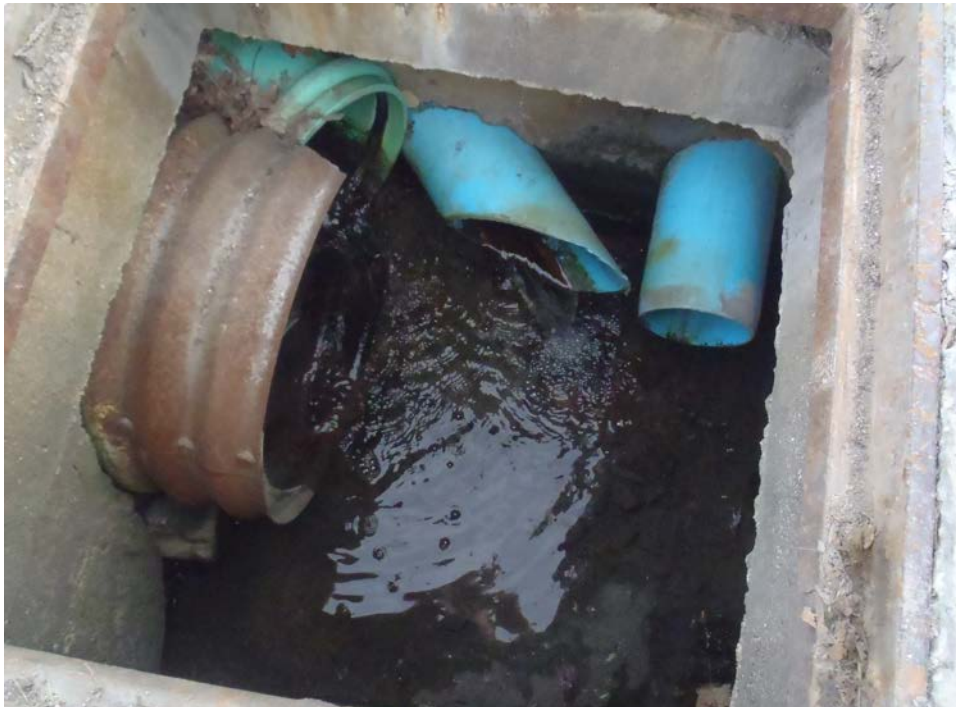
Figure 5. Catchbasin CB-J in System PR240.

because it is buried in rubble; therefore the first up-pipe catchbasin (CB-J) was assessed. On this date, pipes B and C in catchbasin CB-J were flowing, while pipe A (the main line draining Holden Avenue) and pipe D (from CB-I) were not flowing. Pipes B and C were tested for optical brightener, which was detected at pipe B only (Table 12).

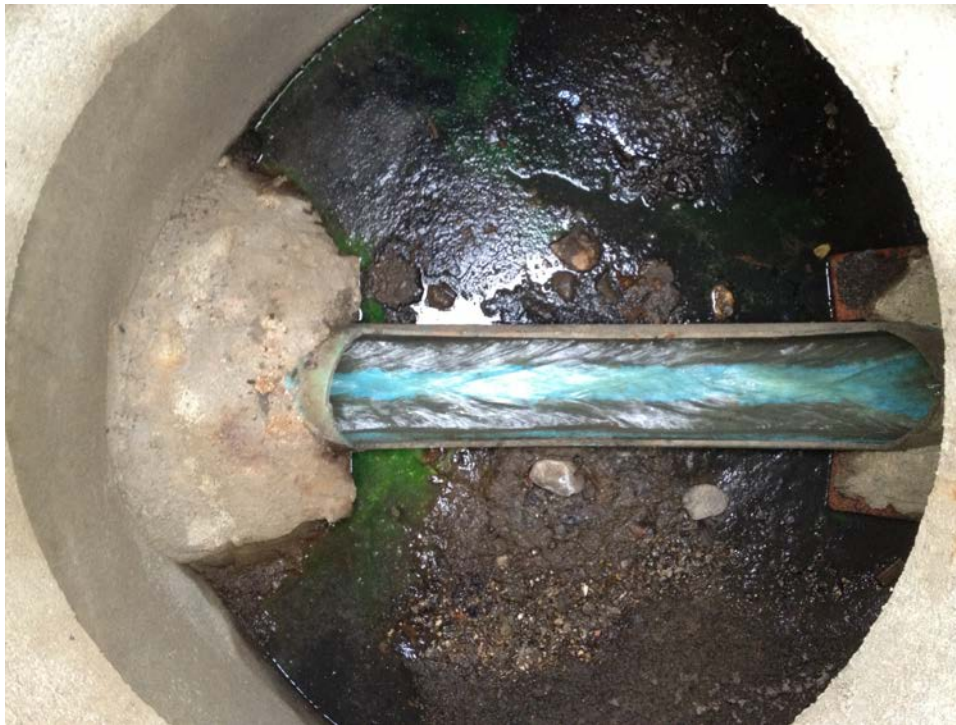
Figure 6. Sanitary manhole on Holden Avenue in Proctor

In the sanitary sewer manhole (Figure 6) opened to observe the dye tests at #3 and #11 Holden Avenue, dye was observed within the open PVC channel spanning the structure and also on the floor of the manhole. The dye appeared to flow onto the floor of the manhole from beneath the incoming PVC pipe (on left in Figure 6). It also appears that wastewater pools on the floor of the structure. This wastewater may be migrating from the manhole (and possibly other points along the vitrified clay line) to the stormline between MH-Q to CB-K. Given the substantial increase in flow along pipe A from MH-Q to CB-K, the shallow depth of the pipe, and the wastewater leak into the manhole beneath the PVC pipe, we strongly suspect that wastewater is migrating from the sewer line to the stormline on Holden Avenue.

According to Mr. Blow, the Town of Proctor has allocated funds to slip-line the sanitary sewer on Holden Avenue if warranted.

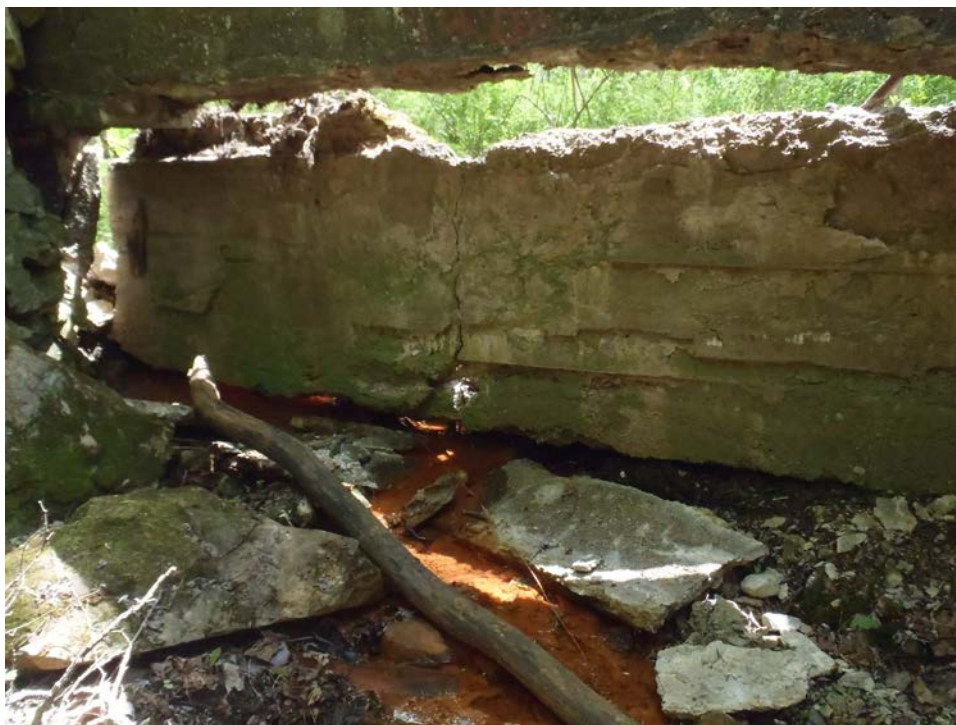
Figure 7. Seep in area of former mill building in Wallingford

The WA040 system consists of the remains of an abandoned combined sewer line (Appendix C, Map 10). No known structures drain via this abandoned line. The mapped outfall does not exist; however there is a large concrete structure in the vicinity of the mapped outfall that appears to have been a water control structure for an old mill (Figure 7).

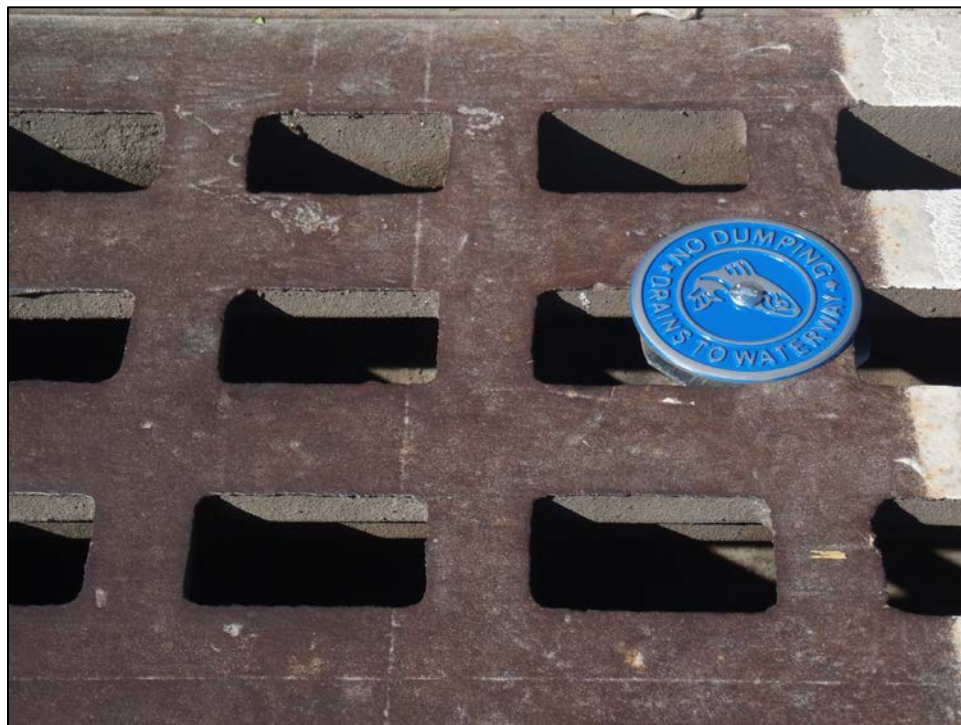
Figure 8. Catchbasin grate (CB-B) with "No Dumping" placard

Optical brightener was detected at the outfall in April, 2013. Monitoring pads set at the outfall and CB-B on May 15, 2013 both indicated that optical brightener was present. Further inspection of the system on August 21, 2013 revealed no irregularities throughout the system. However, suspecting Stewart's employees were dumping mop water into catchbasin CB-B, Dave Braun spoke with the Stewart's store manager about advising employees not to dispose of mop water in the catchbasins. On a subsequent visit on September 5, 2013, Dave Braun spoke with an employee who said she had recently dumped mop water into catchbasin CB-B and had not gotten the message from the store manager. **In communication with the Town of West Rutland and the store manager, Stone installed a metal marker on the catchbasin grate to remind Stewarts' employees not to discharge wastes to the basin (Figure 8). No further action is planned.**
