TOWN OF SPRINGFIELD, VERMONT

Illicit Discharge Detection and Elimination Study

January 2013

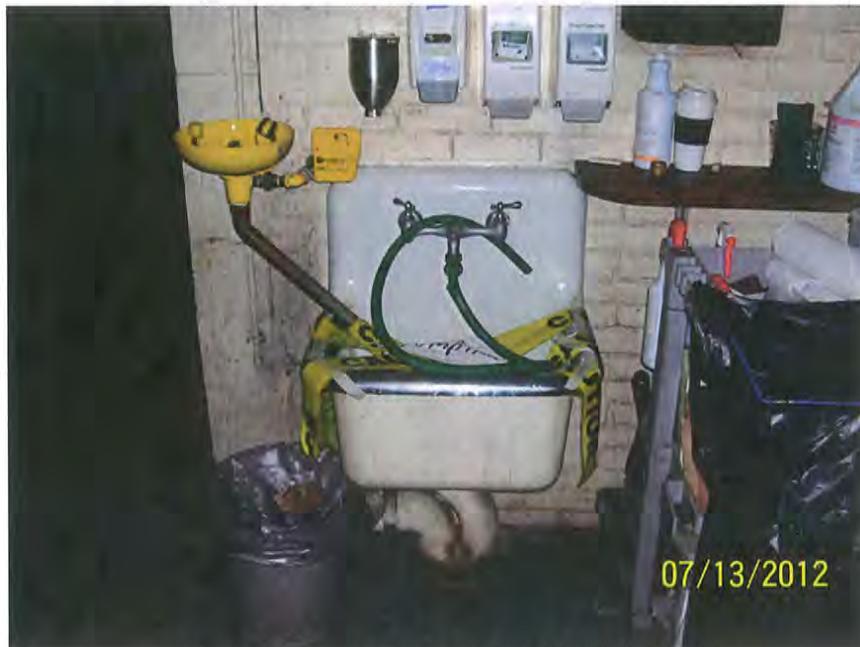
Figure 3.1: Sink Connected to Outfall

The Town of Springfield dye tested within the Jones Center Building to confirm the source of the illicit discharge. Through the dye testing, it was determined that a sink, seen in Figure 3.1 and a floor drain were connected to this outfall. The Town, informed the property owner of the identified problem. The property owner subsequently had the drain pipe rerouted to the building sewer to eliminate the illicit connection. This repair was made by the property owner at a cost of \$1,200.

A floor and sink drain that was discharging directly to the Black River has been disconnected and rerouted to the building sewer. The approximate repair cost was approximately \$1,200.

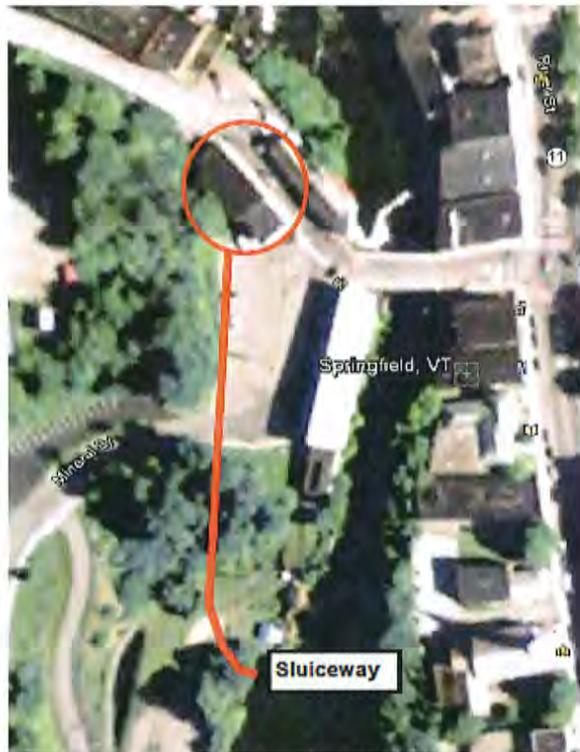
Figure 3.2: Sluiceway

The Town's Public Works Department believes that this tunnel was once the bypass of an old penstock that was upstream on Park Street. Visual inspection of the tunnel showed that the tunnel turns and continues toward Park Street, supporting this claim. The Town dye tested an apartment building at 24 Park Street to see if the sewer system was connected into the sluiceway. The dye test confirmed that the sewer in 24 Park Street is connected to the sluiceway. The Town confirmed through remote camera that the catch basins in the parking lot south of 24 Park street are also connected to the sluiceway. It is believed that the sluiceway is located to the west of the parking lot, as shown in Figure 3.2. Based on the slow movement of the dye through the sluiceway, obstructions and accumulated debris slow the water and hold back the evidence of paper products at the discharge point in the river. The Town informed the property owner about the sewer connection and is working with the property owner to address this issue.

A+E completed a survey to verify that the building sewer could be rerouted into the sewer line on Park Street. A preliminary design for the new sewer service was completed and shown on Figure No. 12 in Appendix A. In Spring 2013, the Town is planning to coordinate with the property owner to construct the new sewer building service from the Park Street sewer main. The cost to construct the new service is estimated at \$11,000. The Town needs to confirm prior to the repair that the roof drains are not tied into the sewer service. After the repair, it is recommended that the Town resample the sluiceway to confirm that the illicit discharge has been eliminated.

The Town should follow-up with the property owner on Park Street in order to connect the wastewater discharge from this apartment building to the Town sewer main on Park Street. A+E has prepared a design for this wastewater disconnection (Appendix A, Figure 12). The cost estimate to construct this repair is approximately \$11,000.

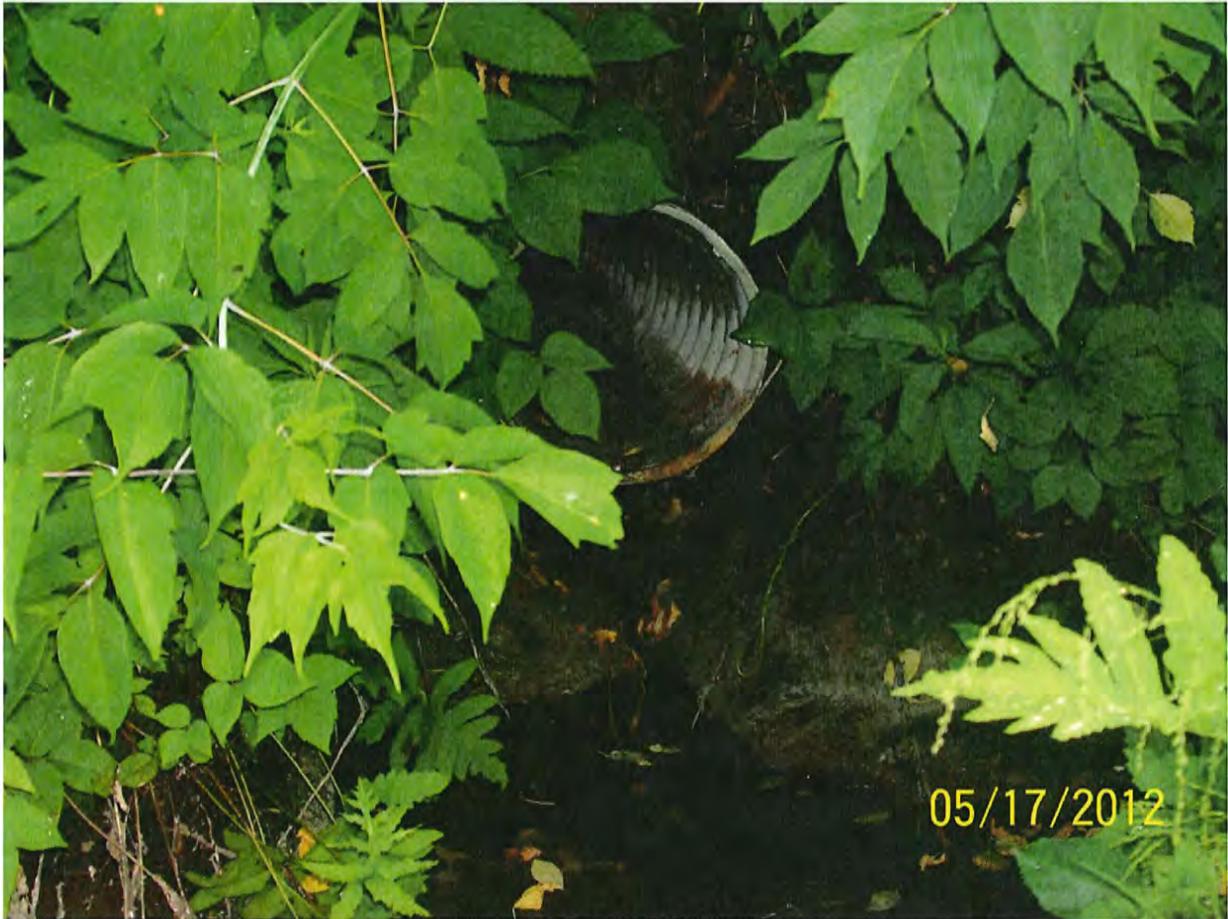
Figure 3.3: Outfall 2006

Outfall 2006 is a 24-inch diameter corrugated metal pipe located behind the insurance agency adjacent to the Family Dollar. During the initial assessment, no dry weather flow was observed, but paper products were noted below the outfall with an odor of wastewater, as shown in Figure 3.3. OB results came back positive from the initial assessment. Table 3.4 summarizes the water quality results for Outfall 2006.

A+E and the Town of Springfield traced the outfall back to the first catch basin to identify potential sources. At the first catch basin in front of the insurance agency, an overflow pipe from the insurance agency's pump station was found connected into the catch basin. A discussion with the property owner confirmed the existence of the overflow pipe. The Town sent a letter to the property owner about this violation and the property owner agreed to cut and cap the overflow pipe. The letter can be found in Appendix E. This repair cost the property owner approximately \$500.

A pump station overflow was illegally connected into a catch basin and discharging directly into the Black River. The Town sent a letter to the property owner about this violation. The property owner cut and capped the overflow pipe to the catch basin. The approximate repair cost was approximately \$500.

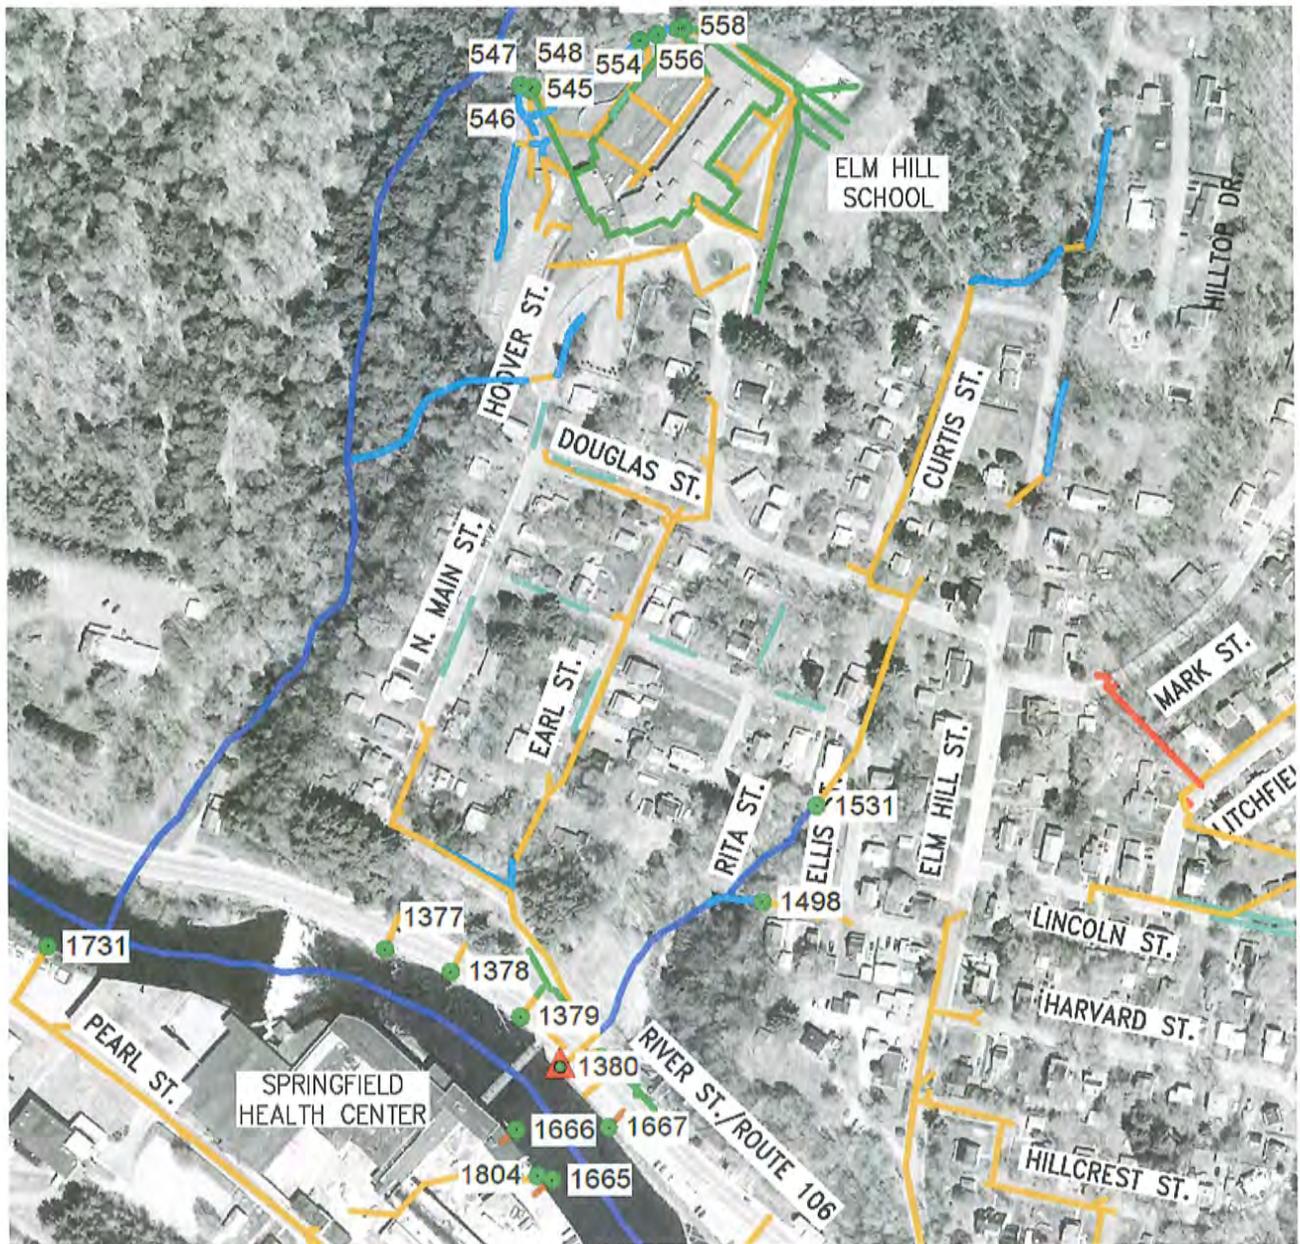
Figure 3.4: Mary Street Ravine

The Mary Street ravine was walked to locate any possible sources of illicit discharges and none were found. One possible intermittent source for the positive OB test may be car washing in this residential neighborhood near the Mary Street catch basin above Outfall 1531.

The cause of the positive OB test at Outfall 1380 could not be determined. The Town should on occasion inspect the Mary Street Ravine to determine whether an intermittent illicit discharge is occurring.

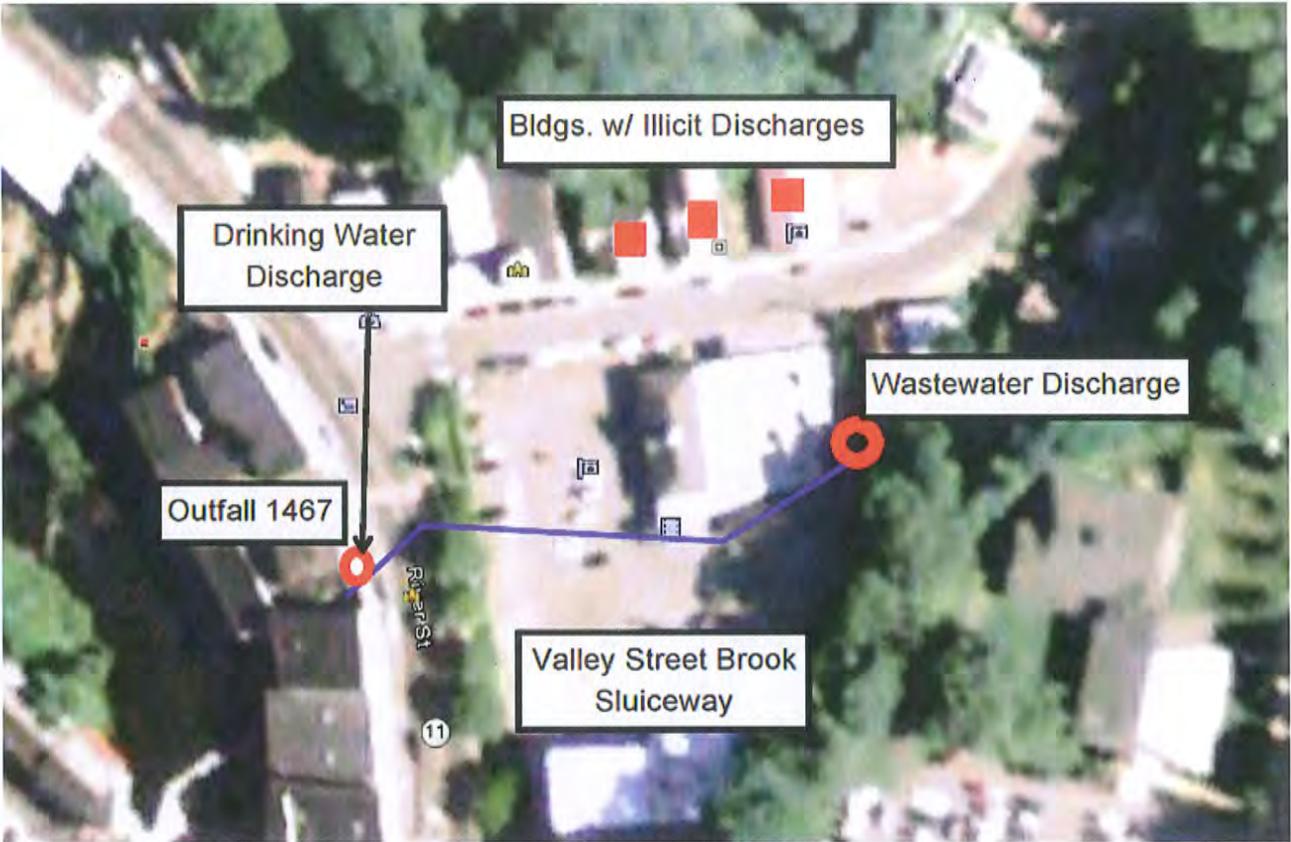
Figure 3.5: Valley Street Brook

After the Initial Assessment, the Town investigated the Valley Street Sluiceway looking for a petroleum source. During the follow-up inspection, the flows were extremely low and the Town found a protruding pipe into the brook buried by rocks and debris. The Town dye tested the catch basin on Valley Street and surrounding buildings to identify the source of the discharge pipe. Based on the investigation it was found that three buildings on Valley Street discharged wastewater directly into the brook. The location of the three buildings and discharge are highlighted in Figure 3.5. The existing sewer system runs underneath the Valley Street Brook northeast of the People's United Bank. There is no existing sewer line that runs down Valley Street to the intersection of Main Street. A+E completed a survey to verify existing field conditions on Valley Street, including ground elevations, existing infrastructure, and building sewer elevations. A preliminary design for a new sewer on Valley Street to intercept the building services was completed and is shown on Figure No. 11 in Appendix A. The preliminary construction cost for this project is estimated at \$120,000. Refer to Appendix F for a breakdown of the cost estimate.

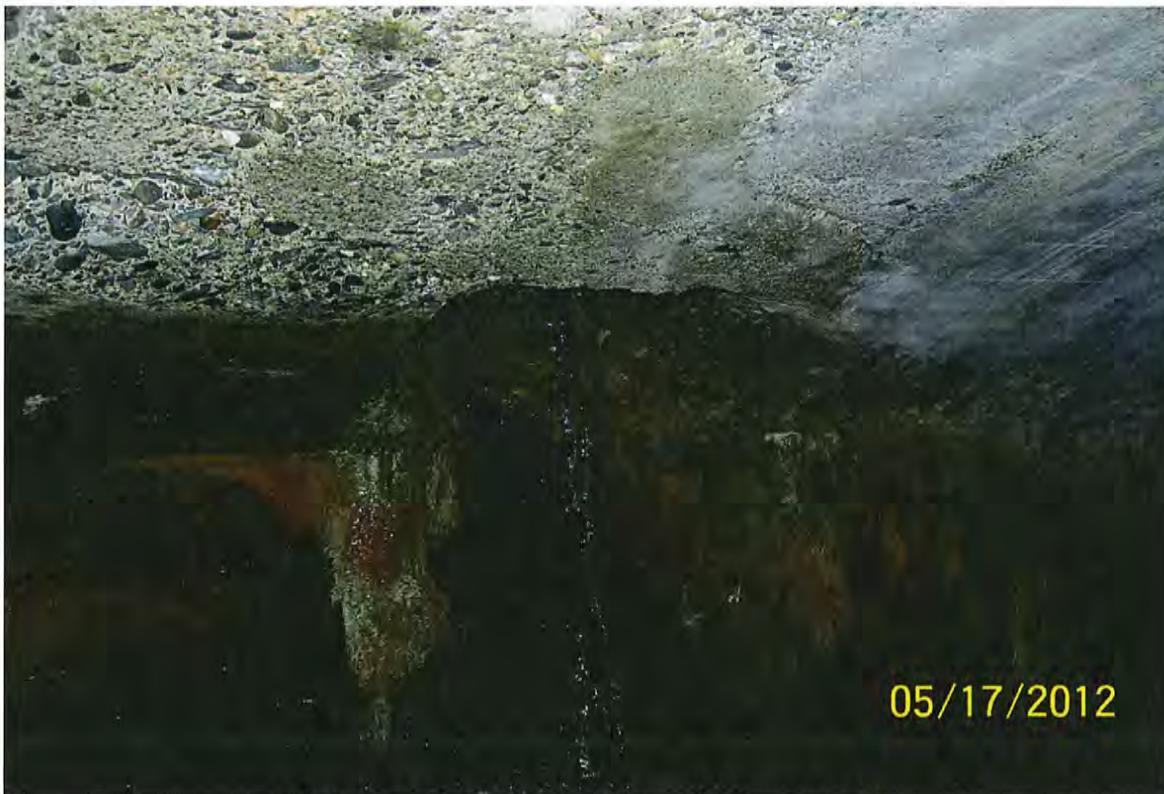
Figure 3.6: Valley Street Brook Water Break

In the Valley Street Sluiceway (Outfall 1467) a 6-inch corrugated metal pipe discharges below Main Street into the Valley Street Brook. During inspection of the sluiceway, the underdrain pipe had a steady flow of water discharging into the brook, estimated at 50 gpm. A photo of the chlorinated water discharging into the Valley Street Brook is provided in Figure 3.6. The chlorine concentration of this flow was 0.5 mg/L. To determine if the source was Town water, the fountain on Main Street was tested for chlorine as well, and yielded the same results. The Town, with the aid of EJ Prescott, located two (2) separate water leaks. The first was on Valley Street in front of the Springfield United Methodist Church. The source of the leak was an old abandoned 1" corporation

stop that had not been shut off and was releasing approximately 50 gpm of treated Town water. The other leak was a small crack found in the water main at the intersection of Main Street and Valley Street. Both leaks were promptly fixed by the Town of Springfield Public Works Department. The cost for this repair was approximately \$1,700.

A 6" underdrain was discharging treated drinking water directly into Valley Street Brook sluiceway. The Town, with the aid of E.J. Prescott, located water line breaks. The leaks were promptly fixed by the Town and it was confirmed that the discharge to Valley Brook ceased. The Town of Springfield Public Works Department fixed these breaks at a cost of approximately \$1,700.

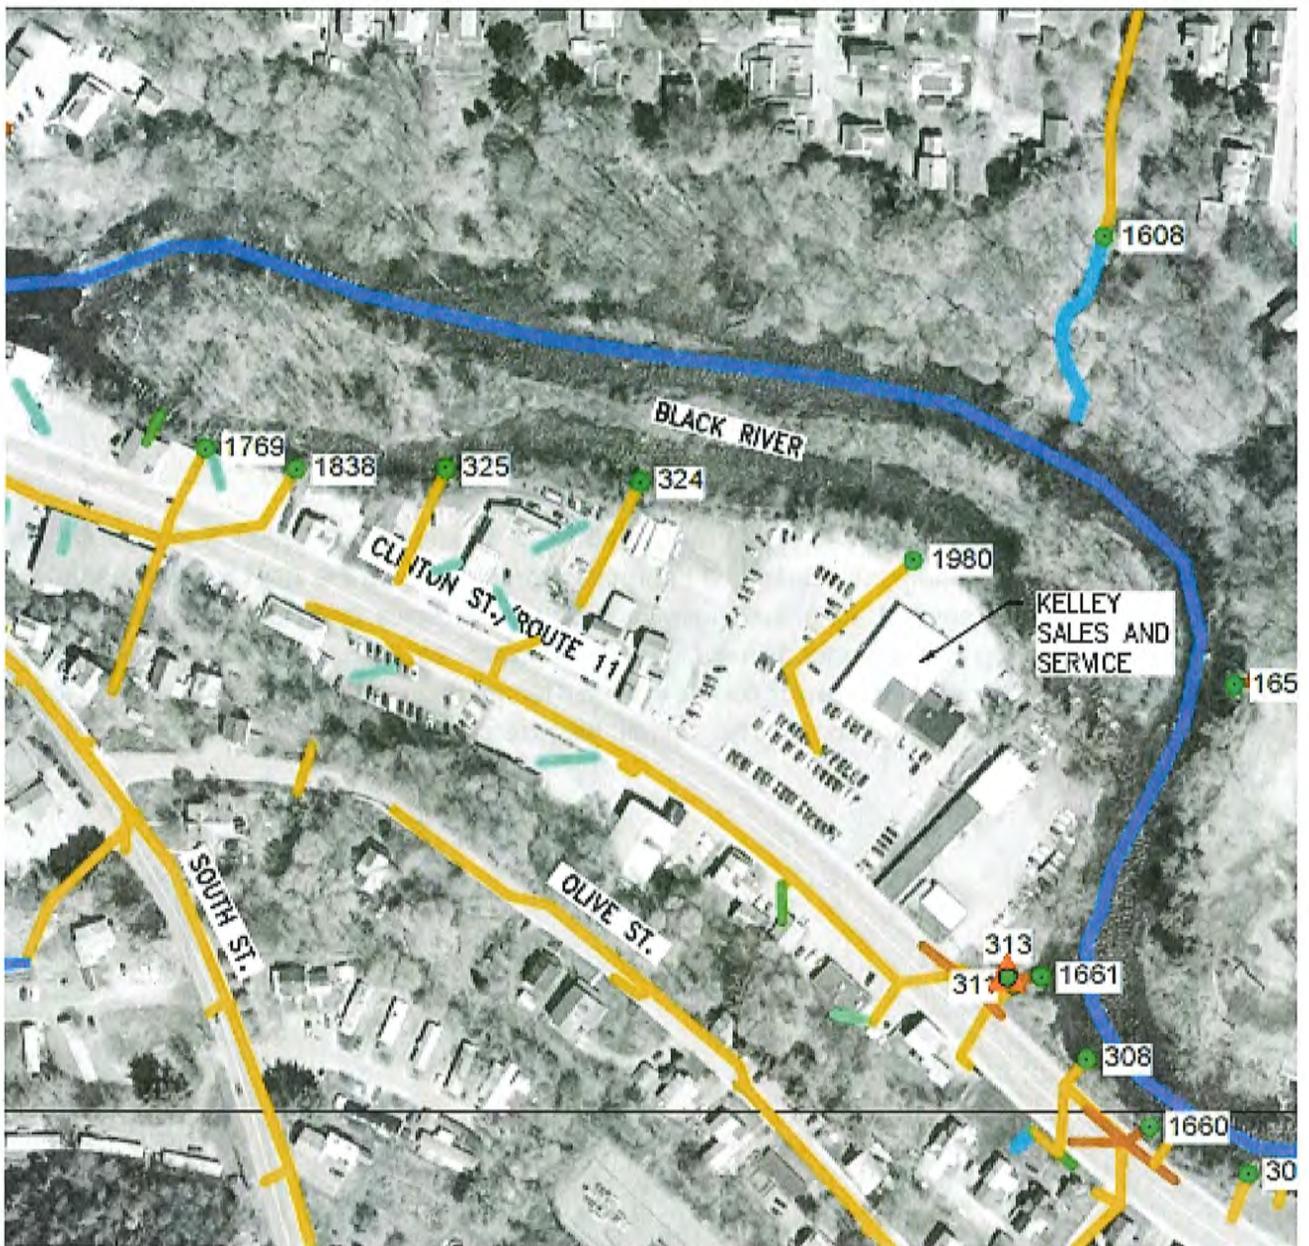
Figure 3.7: Outfall 313 Collection System

Figure 3.7 shows the collection system for Outfall 313. It extends up Clinton Street past numerous existing and past gas stations. Based on information provided from the ANR Environmental Interest Locator, there are several sites that have had petroleum spills and site cases along this area previously. During the advanced investigation, all catch basins connected to this outfall were inspected to identify any sources of contamination. No additional evidence of petroleum leaks was found during this investigation. The outfall was referred to DEC Site Manager for further investigation.

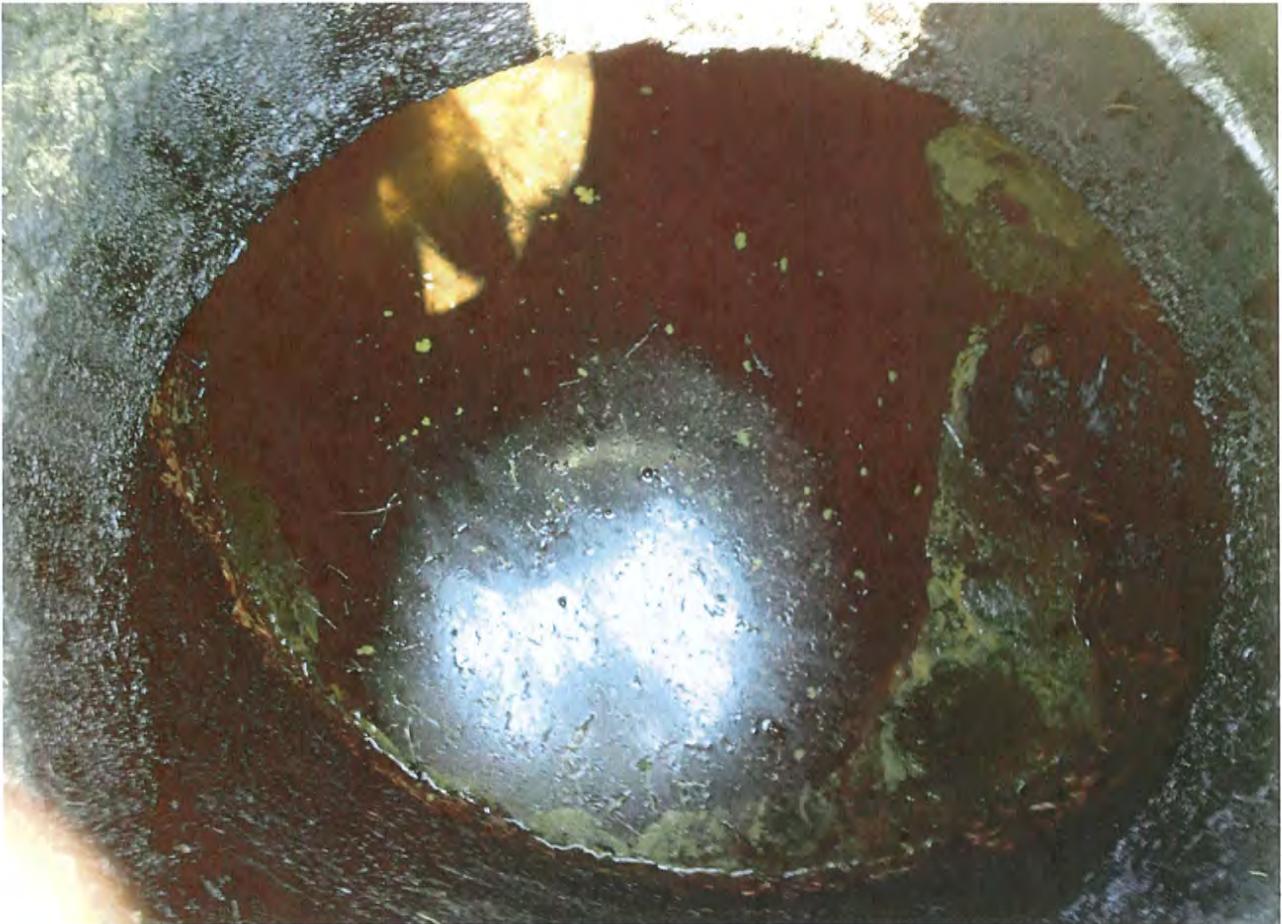
Figure 3.8: Heating Oil in Manhole near Riverside Middle School

Outfall 2004 is a 12-inch corrugated HDPE pipe from the Riverside Middle School which discharges into the Black River. During the Initial Assessment there was a petroleum odor as well as a visible sheen in the river. The Town informed us that the Middle School had problems with heating oil spills in the past. An upstream manhole was opened and heating oil was visible on the inside as seen in Figure 3.8. The manhole has snouts installed to limit the amount of floating oil that discharges to the river. This site was referred to DEC Site Manager for follow-up.

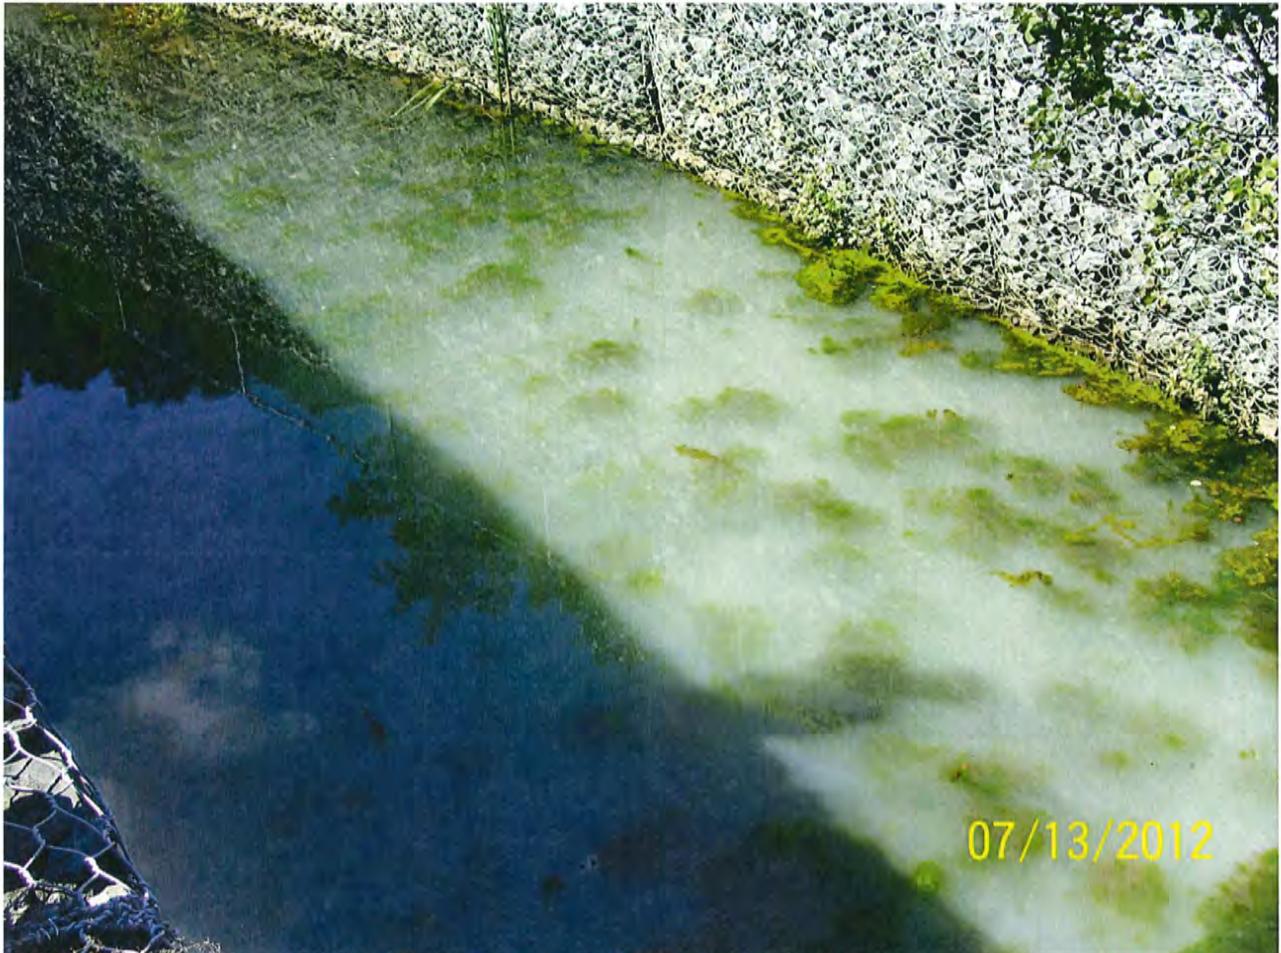
Figure 3.9: State Building Retention Pond

Outfall 376 is an 18-inch diameter corrugated HDPE outfall that discharges from a retention pond at the State Office Building into the Black River. During the inspection the water in the retention pond was found to be turbid and cloudy as seen in Figure 3.9. After discussion with a maintenance worker at the State Building, it was determined that latex paint had been washed into a nearby catch basin earlier that day. The water in the detention pond cleared over the next several hours.
