Illicit Discharge Detection  
and Elimination in  
Richmond, Waterbury,  
Moretown, and Waitsfield

FINAL REPORT

February 25, 2011

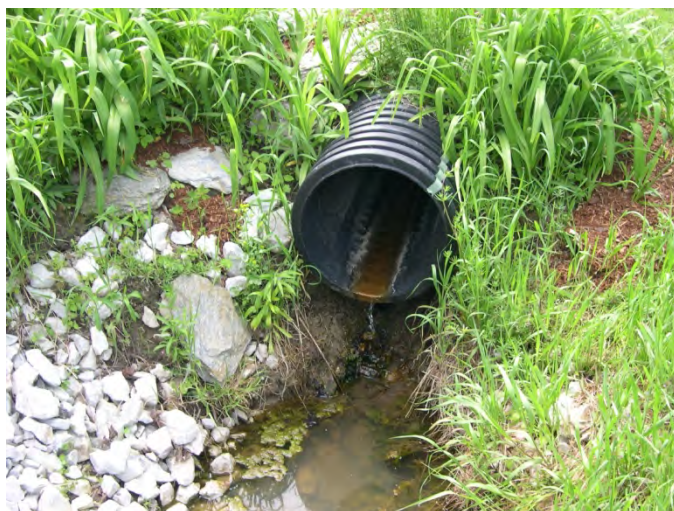
**Outfall RI-003 from the Richmond Town Garage**

Outfall RI-003 is the discharge point for the storm sewer at the Richmond town garage (see Figure 2). As illustrated in the photograph below, this outfall is an 18-inch diameter corrugated black plastic pipe with a persistent trickle of flow in dry weather. This system was investigated in detail after optical brightener was detected and exceedingly high specific conductance (6,280  $\mu\text{S}/\text{cm}$ ) was measured in the initial assessment. Suds and some iron staining were observed at the outfall. Analytical data collected at this outfall are summarized in Table 4; the data in bold face are concerning.

Subsequent to the July 1, 2010 investigation, we suspected two problems contributing to poor water quality at the RI-003 outfall: seepage of petroleum and possibly metals contaminated groundwater to the structures on the backside of the garage and also a wastewater source arising somewhere on the property. The Richmond Town Garage is a listed contaminated site due to historic petroleum releases (from failed fuel tanks and purportedly a waste dumping area). Road salt has also been stored on the property. We attributed the high specific conductance values to salt and/or metals contamination of groundwater arising from these past uses.

have on petroleum contamination of the storm sewer is unknown, but it should improve water quality over the long term. The town garage is a recognized contaminated site and the responsibility of the Town of Richmond (with oversight by the DEC Sites Management Section). The only recommendation we make is that outfall RI-003 be tested periodically to confirm reduction in petroleum contamination. Therefore, the outfall is included on the Watch List in Table 3

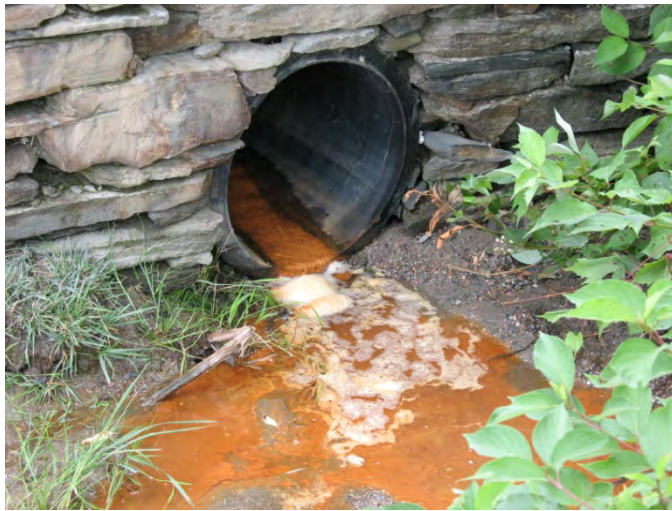
### Outfall WB-470

Two flowing pipes, WB-460 and WB-470, were assessed at the Ben and Jerry's factory property on July 8, 2010 (see Figure 6). The photograph below was taken at WB-470, where flow enters the stormwater pond. During the initial assessment on July 8, 2010, the ammonia concentration and the specific conductance were elevated at outfall WB-460 and the fluoride and specific conductance were elevated at outfall WB-470. These data are included in Appendix B and summarized in Table 9; the data in bold face are concerning. Iron staining was observed at both outfalls. Optical brightener was not detected at either outfall. Follow-up sampling on July 28, 2010 at WB-460 yielded a higher ammonia concentration (1.0 mg/L), high specific conductance, and fluoride. At WB-470, ammonia, specific conductance, and fluoride were somewhat lower than on July 8. *E. coli* and total phosphorus concentrations were very low at both outfalls on July 28, 2010.

Note that the flow appears orange due to the presence of iron oxide

During the meeting we inspected the storm drainage system in several locations. There were no dry weather stormwater flows to the structures in question. Both structures were flowing as a result of groundwater seepage into the grass swales. There were orange particles of iron oxide on the surface of the water in both swales. This is common where groundwater lacking oxygen surfaces causing dissolved ferrous iron to form iron oxide (rust). No foam or foul odors were observed. The pulsing flow observed previously at WB-460 was diminished, but closer inspection indicated that it is simply a result of the outfall pipe hydraulics, due to some corrugation or misaligned pipe joint. The inflow to the pipe was not pulsing.

Based on the statements and testing of Mr. Thompson and on our observations, we do not believe that there is an illicit discharge problem at the facility. The iron staining is a likely consequence of groundwater discharge from the fill slope; the pulsing flow was simply a misleading observation; the low ammonia levels may result from decomposition of organic nitrogen under reducing conditions in the saturated swales; and the fluoride may result from use of municipal drinking water for cleaning the Scoop Shop patio and other public areas. The foam observed on July 8 at WB-470 is a little more puzzling; however, organic acids leached from vegetation can cause foaming in natural waters and perhaps that is all that is occurring here.

While a reasonable explanation may be found for all the observations and water quality results, it is prudent to repeat sampling periodically to rule out the possibility that we have missed something significant. Both WB-460 and WB-470 are included on the Watch List in Table 3.

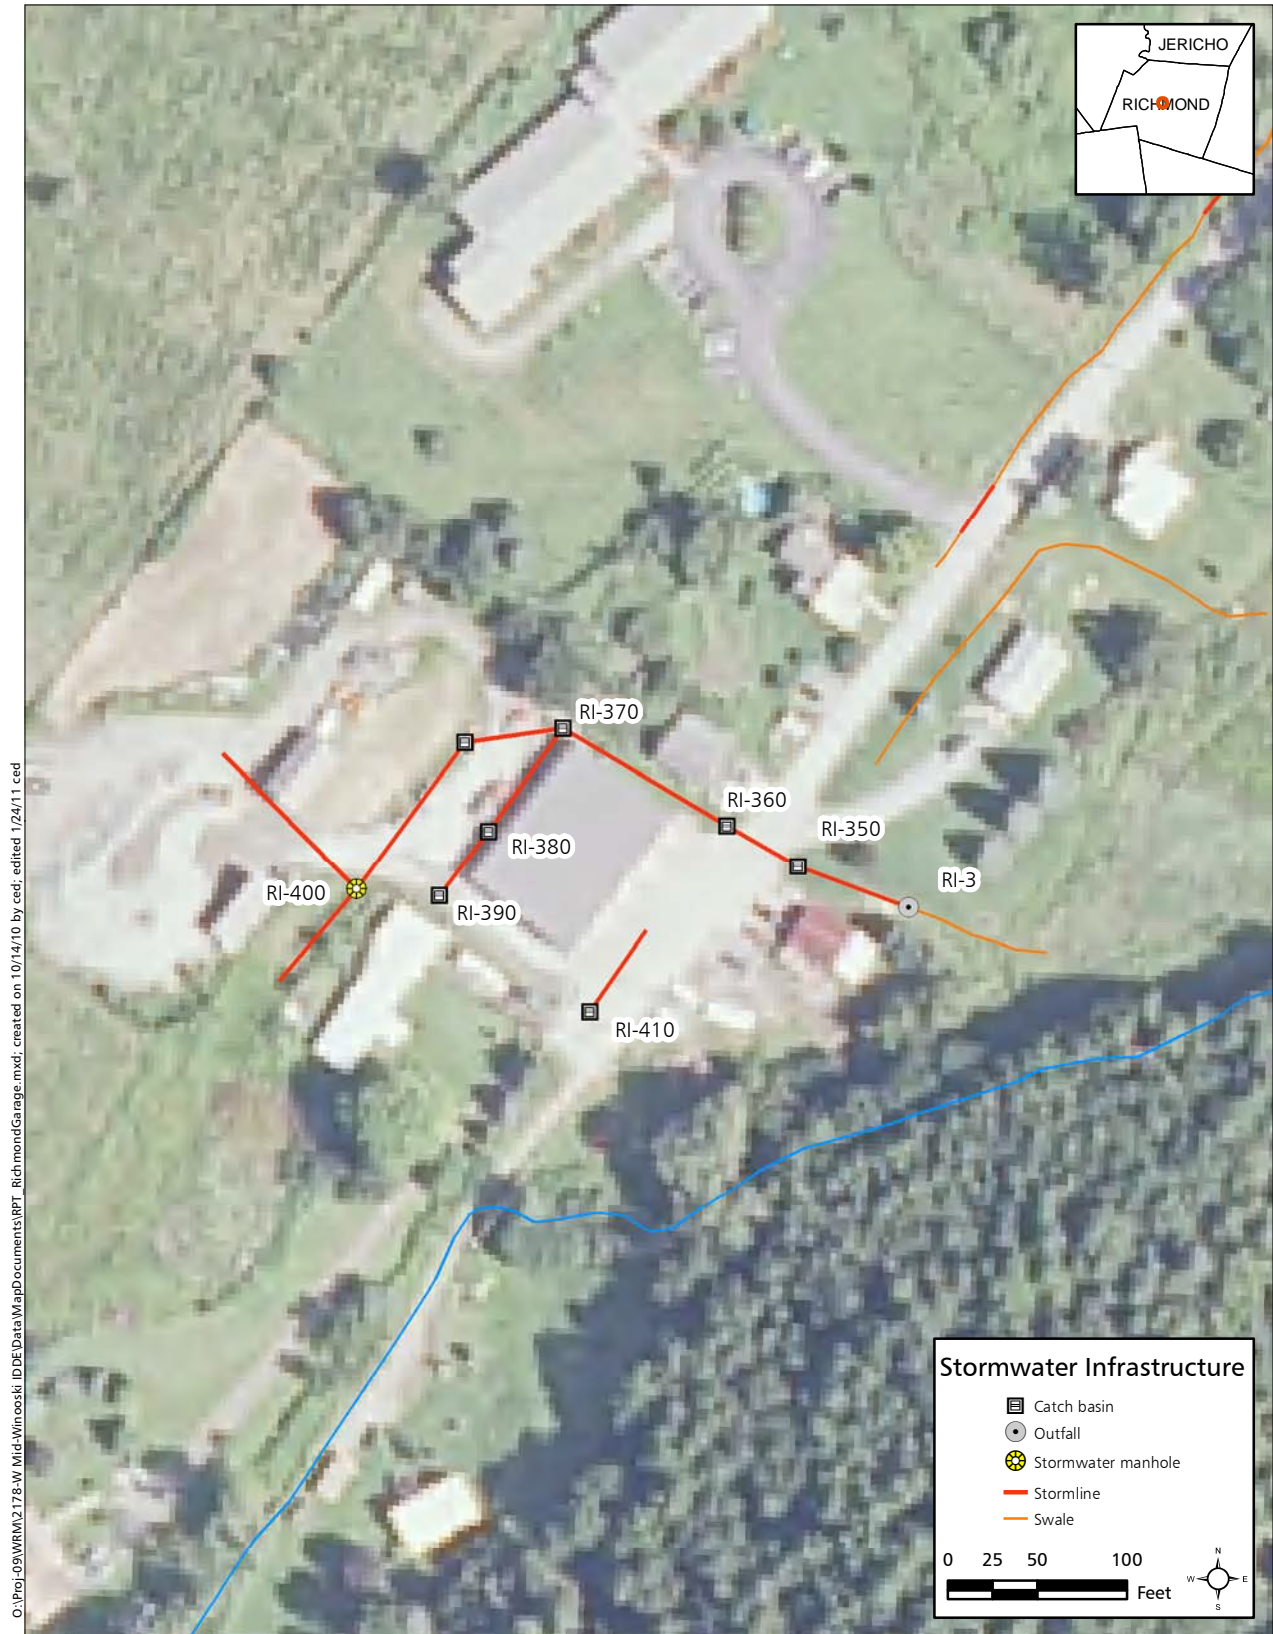
**Figure 2. Richmond Town Garage Illicit Discharge Assessment**  
Mid-Winooski IDDE

total phosphorus concentration was not high and a laboratory error invalidated the *E. coli* result. Monitoring pads were placed in all the structures shown in Figure 2. The test results were positive for manhole RI-400 and all catchbasins except RI-380, RI-390, and RI-410. Sediments in manhole RI-400 appeared coated with petroleum and likely metal oxides. Water samples collected in catchbasins RI-370 and RI-380 had exceedingly high specific conductance and apparently elevated fluoride. On July 1, 2010 *E. coli* sampling at the outfall was repeated, and the level was found to be moderately high (862 MPN/100 mL).

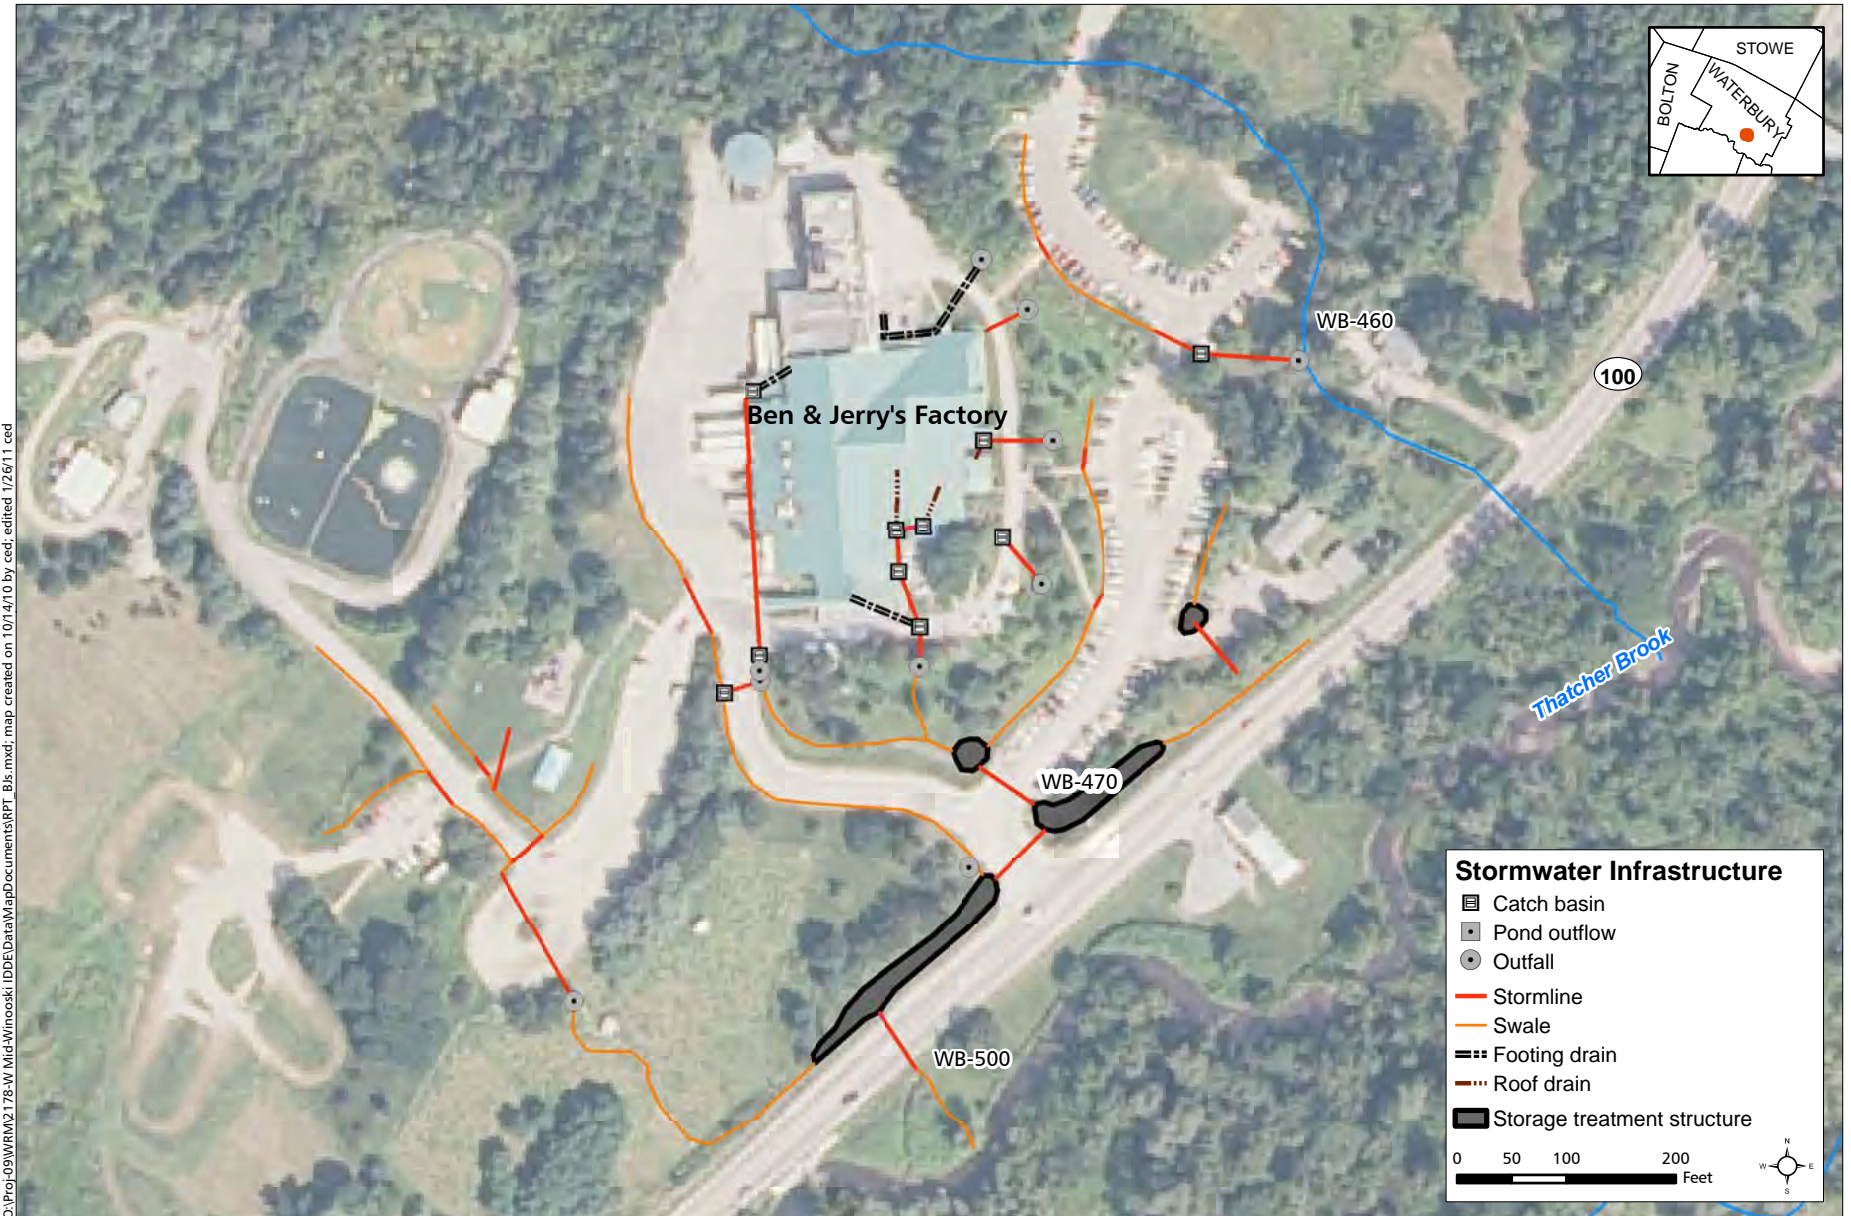
**Figure 6. Ben & Jerry's Stormwater System Illicit Discharge Assessment**  
Mid-Winooski IDDE

Thompson, the patio area is pressure washed daily, using no detergents. Below these pipe outlets, grass swales collect runoff and convey it to several structures, including WB-460 and WB-470. Mr. Thompson further described how within the preceding two weeks, after learning of the preliminary findings, he had placed dye in all sumps in the facility and in a catchbasin in the parking lot beneath the trash compactor to ascertain whether any of these drains were connected to the stormwater systems. No dye was found issuing from the storm drain outlets and therefore he concluded there were no inappropriate connections within the facility.

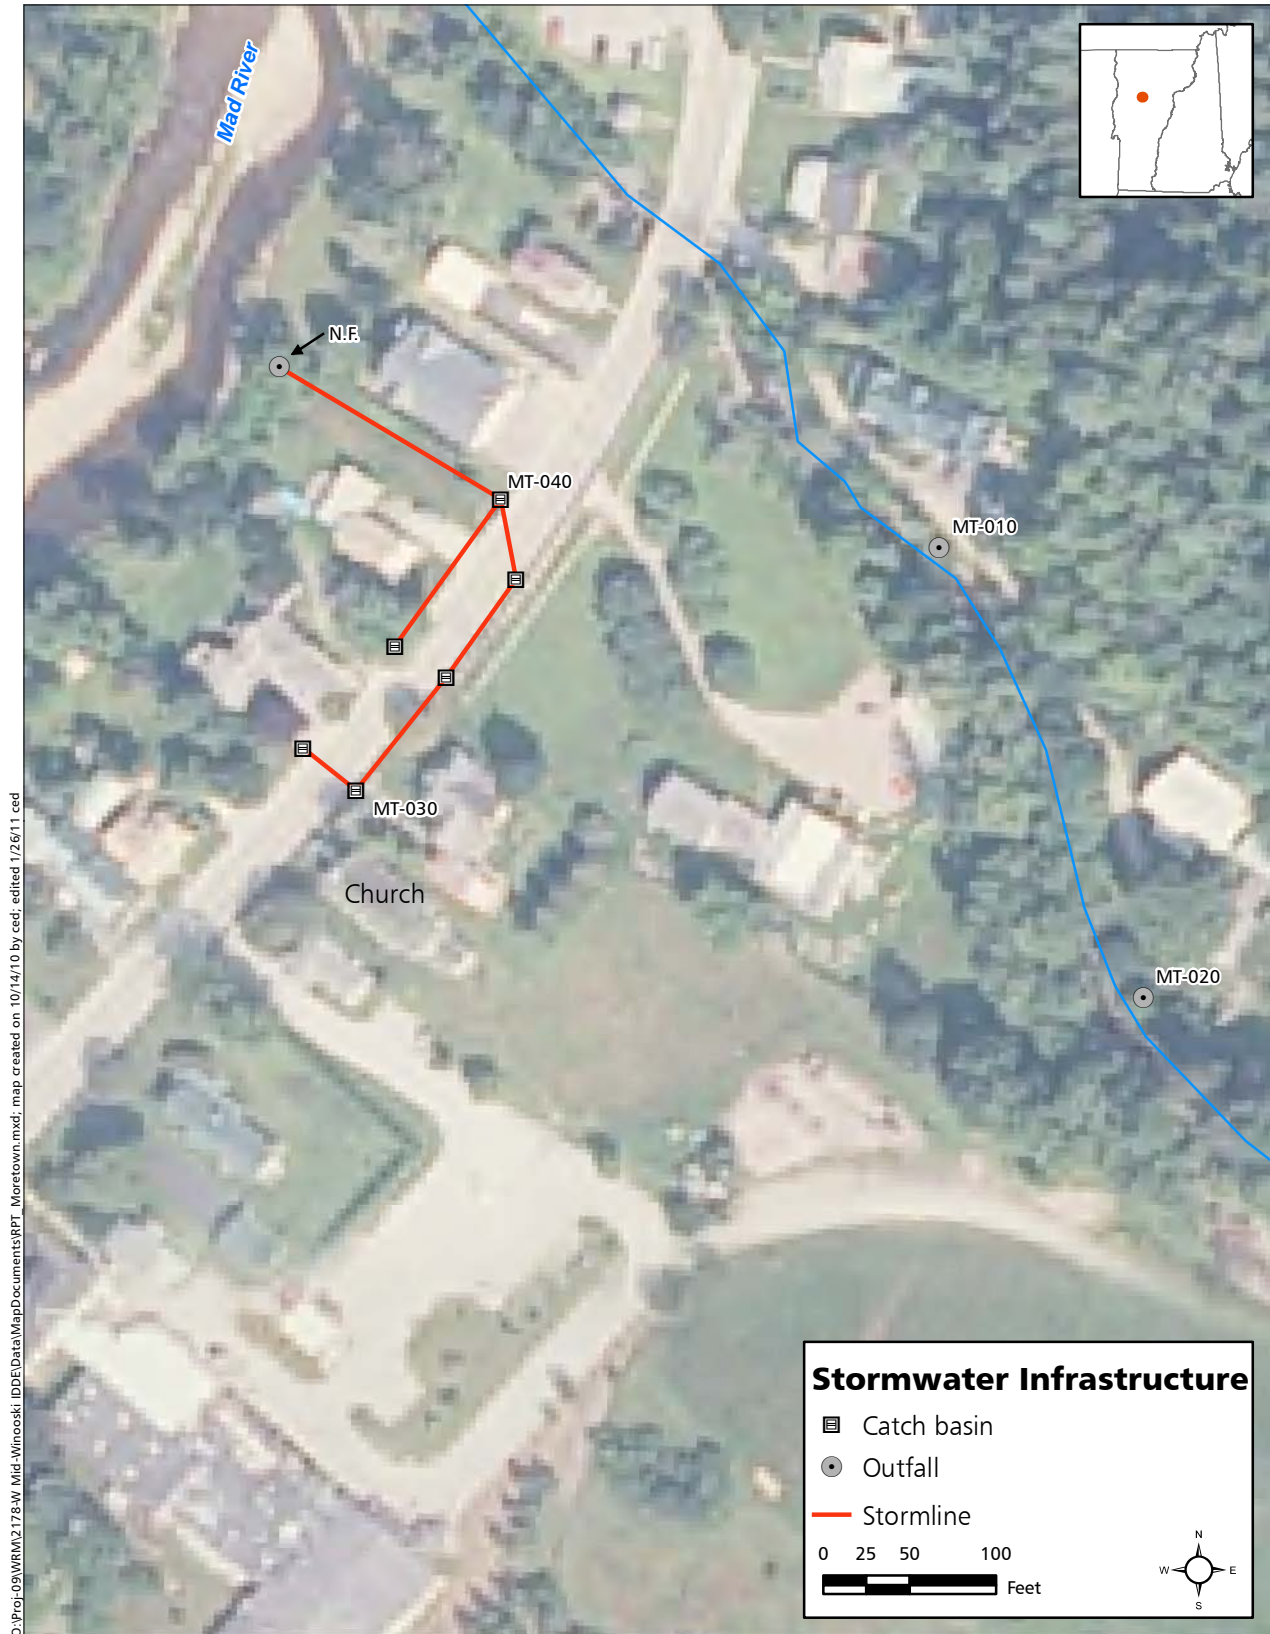
**Figure 7. Moretown Illicit Discharge Assessment**  
 Mid-Winooski IDDE

The only potential problem identified in Moretown was a pipe discharging in the area of MT-030 that appears to be the outlet for a sump pump located in the church building (see Figure 7), although this was not confirmed. This pipe was not flowing when observed. Therefore, the only recommendation FWR and FMR will make in the final letter to Moretown is to advise the town to check in the church building for any improper plumbing connections to this pipe.
