Illicit Discharge Detection and Elimination in Six Missisquoi River Basin Communities

FINAL REPORT

Project ID 082219-W

March 20, 2011

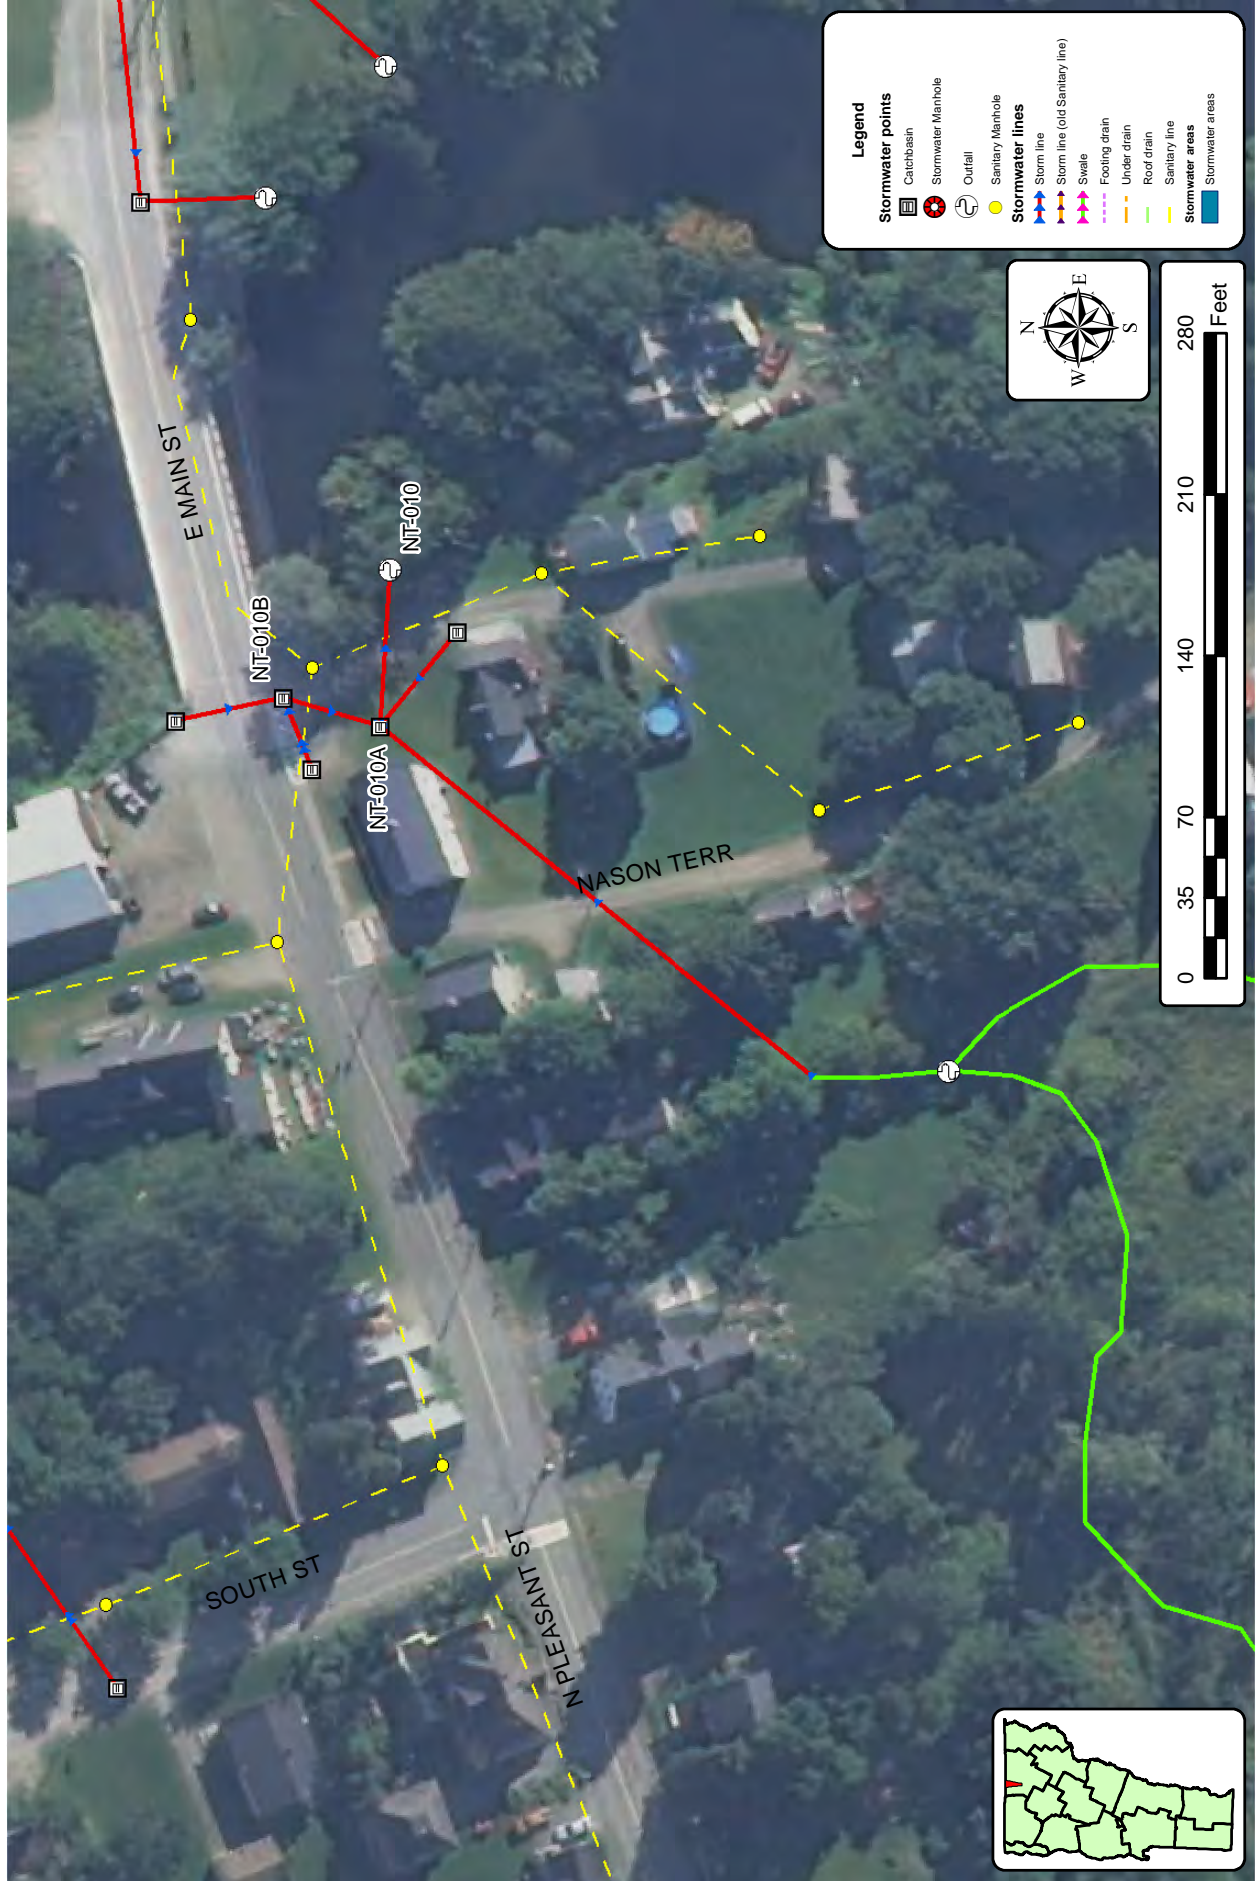
Figure 4. Stormwater drainage system discharging at outfall NT-010
 North Troy, VT

Outfall NT-010 (Figure 4) had a low total phosphorus concentration (0.087 mg/L) and an elevated *E. coli* level (720 MPN/100 mL) in grab samples collected on August 20, 2009. On the three dates we investigated the NT-010 system (6/24/09, 8/20/09, and 9/18/09), most of the flow was contributed by a stream that runs along the backside of properties on Pleasant Street. This stream flows through a culvert into a catch basin (NT-010A) on Nason Terrace, into which a storm sewer on North Pleasant Street also drains. When observed on August 20 and September 18, the storm sewer pipe was trickling, while the next catch basin (NT-010B) up the stormline was dry. The combined flow then passes under Nason Terrace to the outfall. To determine whether the contamination present at the outfall originated in the stream or in the North Pleasant Street storm sewer, we intended to sample both flows at the Nason Terrace catch basin, but, unfortunately, the catch basin grate was stuck fast.

On December 16, 2009, we attempted to find sources of washwater or sanitary wastewater entering the NT-010 system using a smoke blower and theater smoke. Wayne Graham of the Vermont Rural Water Association installed the blower over the catch basin immediately up from the outfall pipe (NT-010A) and we observed building vents for signs of smoke, which would indicate connection between the storm sewer and the building sewer. No smoke was observed issuing from any building vent. Based on Mr. Mayhew's description, there are two or three houses that could possibly have an inappropriate connection to this system. We attempted to inspect interior plumbing; however no one was home at the

houses in this area. We therefore recommended that Mr. Mayhew inspect building sewer connections at #137 Nason Terrace, #364 Pleasant Street, and any other potentially connected buildings when possible and require correction of any improper connections.

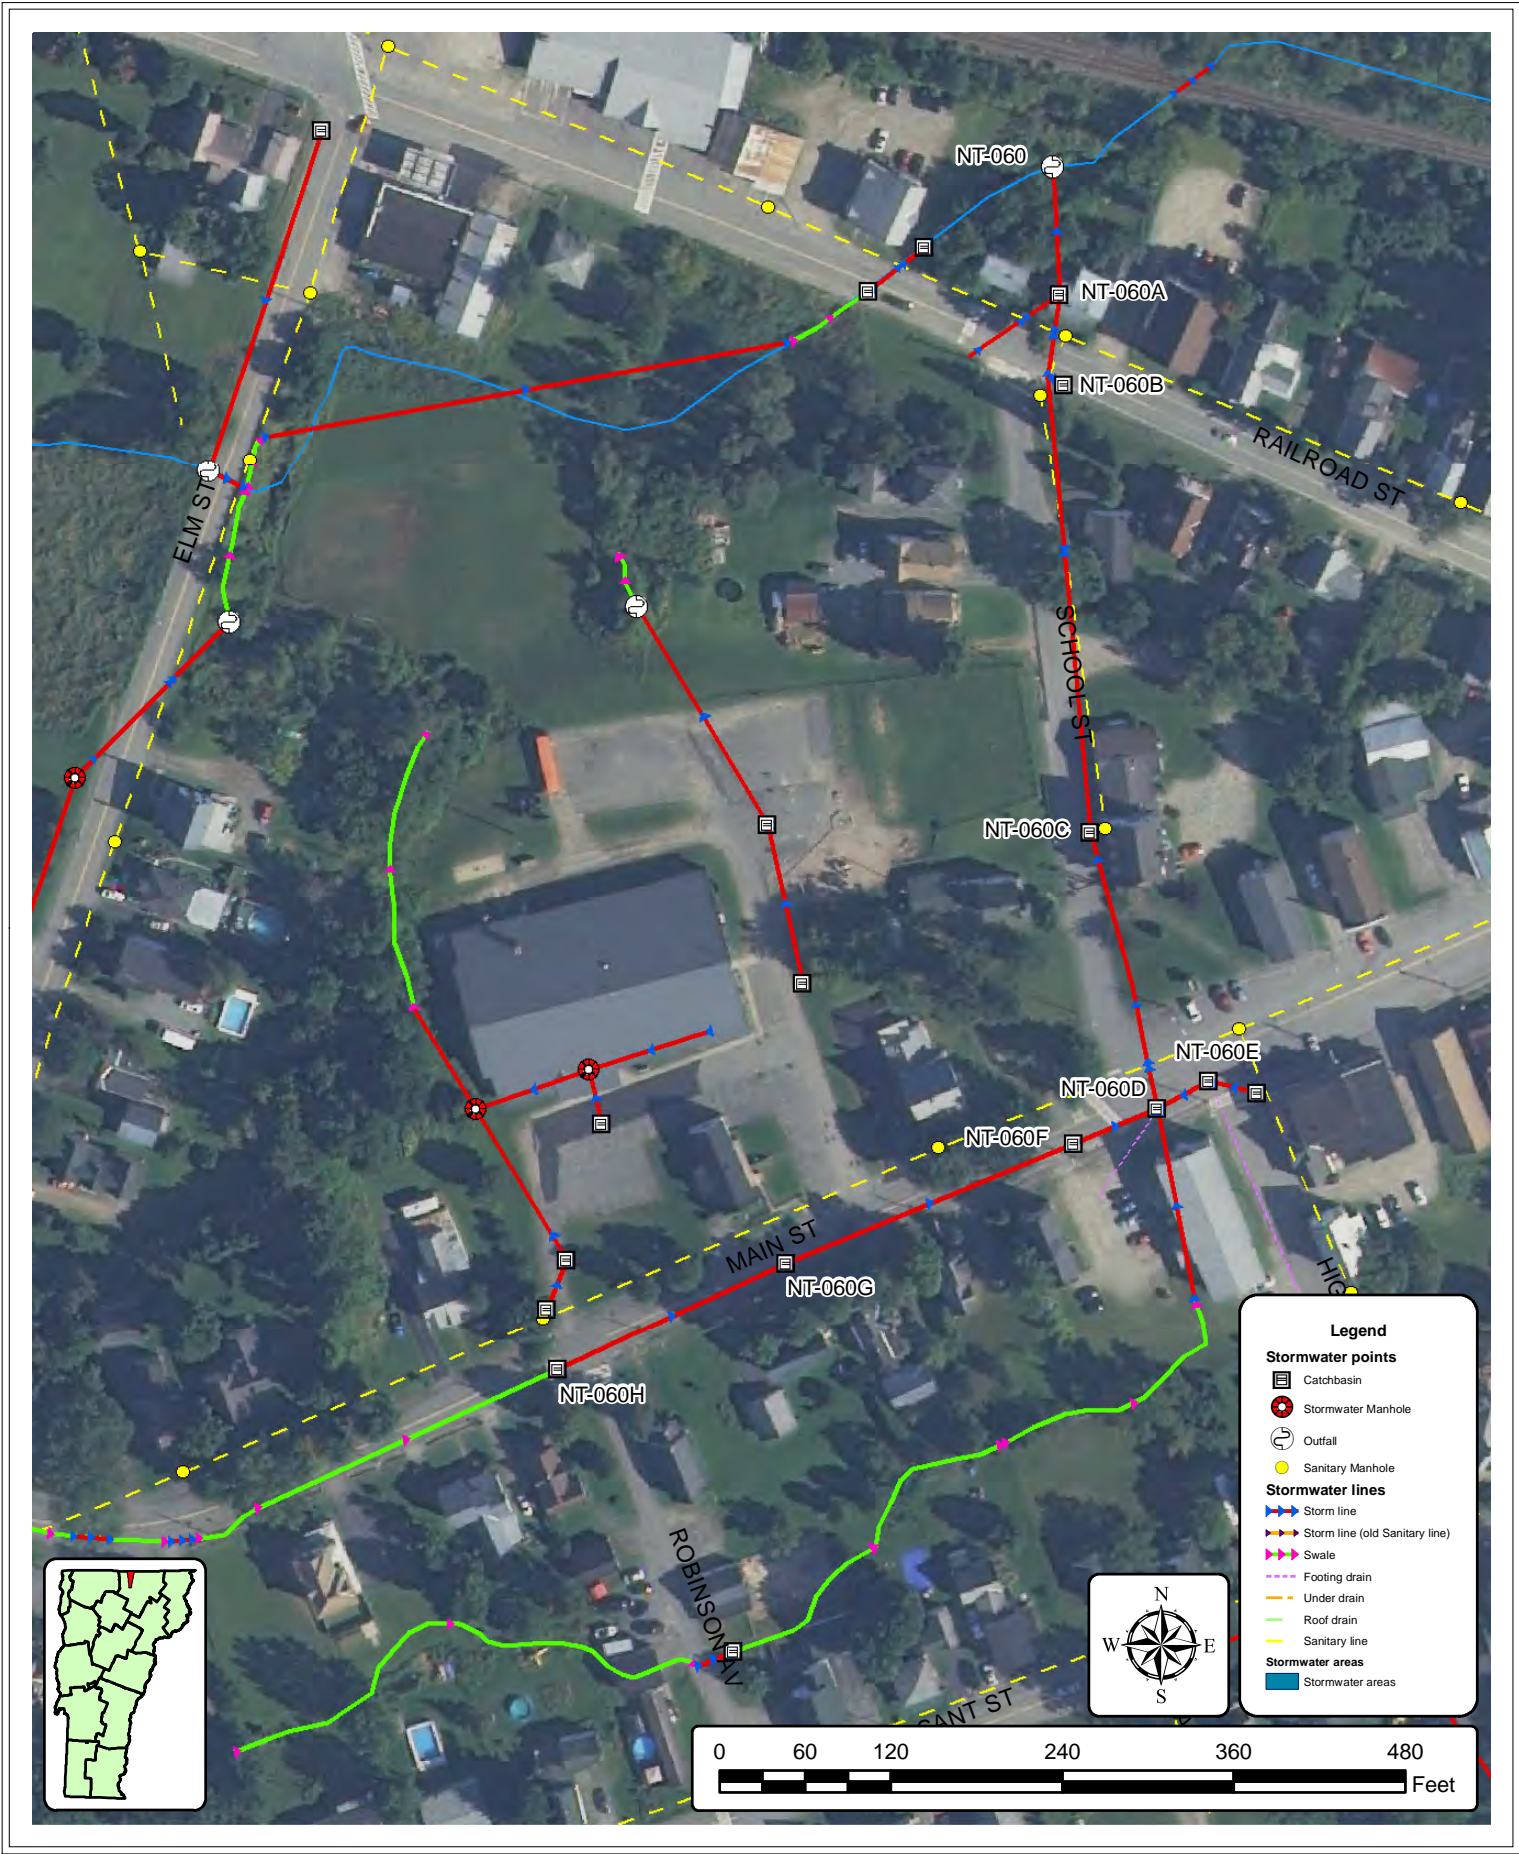
Figure 5. Stormwater drainage system discharging at outfall NT-060 North Troy, VT

Outfall NT-060 (Figure 5) had a low concentration of total phosphorus (0.045 mg/L) and *E. coli* (140 MPN/100 mL) in grab samples collected on August 20, 2009. On August 20, optical brightener monitoring pads were set in every accessible structure in the storm sewer discharging at outfall NT-060. Optical brighteners were detected up the stormline on School Street and Main Street up to and including the catch basin identified as NT-060G, near #129 Main Street. Up the stormline beyond this point no optical brightener was detected. We revisited catch basin NT-060G on September 18, 2009 and noted a septic odor, but could not collect a water sample because this is an irregular structure with a narrow diameter drop inlet pipe.

On December 16, 2009 we attempted to find sources of washwater or sanitary wastewater entering the NT-060 system by smoke testing. No smoke was observed issuing from any building vent. Smoke was observed seeping through the cracked foundation of an abandoned house, which suggests a connected floor drain; however, this house has not been occupied for many years, so it is not the source of the contamination. The church building does not have laundry facilities, ruling out this building as the source of contamination. Because smoke testing was not definitive, we entered houses to inspect plumbing connections, where residents were at home. We inspected three houses near the NT-060G catch basin and found an inappropriate connection from a laundry machine to the storm sewer in one of them, #49 Robinson Road. At this home, we also found an open sanitary line in the basement. Since this inspection, Mr. Mayhew obtained a small grant for the elderly homeowner through Gilman Housing to enable the plumbing correction, which he believes has been completed.

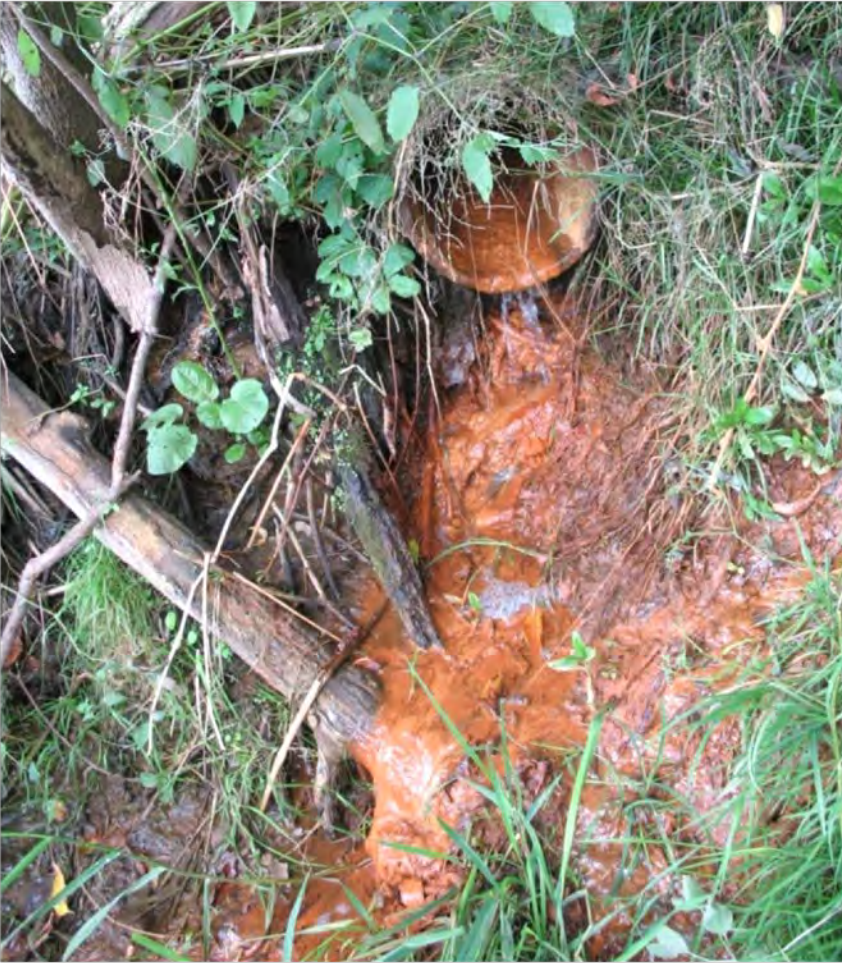
Figure 7. Pipe RF-010X, September 17, 2009

Pipes RF-010X and RF-010Z and the groundwater seeps show orange (iron) staining (Figure 7) and elevated ammonia and detergent levels (Table 5). A wastewater leak intercepted by relic pipes was suspected. A possible source is a 6-inch diameter force main that runs from a pump station behind the TD Bank building to a manhole on Main Street, in front of the Sunoco gas station. Because there are no connected stormwater inlets to pipes RF-010X and RF-010Z or to the seeps, there was no way to perform bracket sampling to isolate the problems.

It is not possible to smoke test a flowing force main; therefore on December 16, 2009 we attempted to test for connection between the force main and the cluster of contaminated pipes by adding dye to the pump station wet well. Dye was not observed at the bank within approximately 20 minutes of addition. Chief operator Rich Mackay of Simon’s Operating Service returned the following day, added more dye, and did not observe dye on the bank over the course of the day. This suggests either an indirect pathway from the force main to the streambank or an alternate source of contamination, possibly the Main Street sewer line.

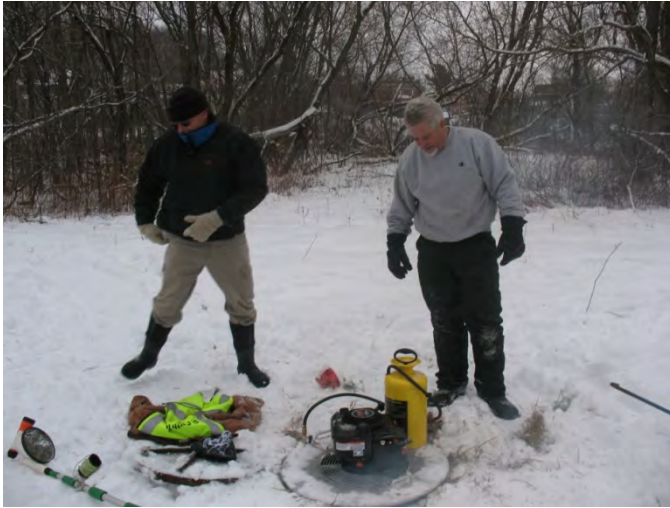
Figure 9. Smoke testing at sewer manhole SMH#9-A (near Willow Street)

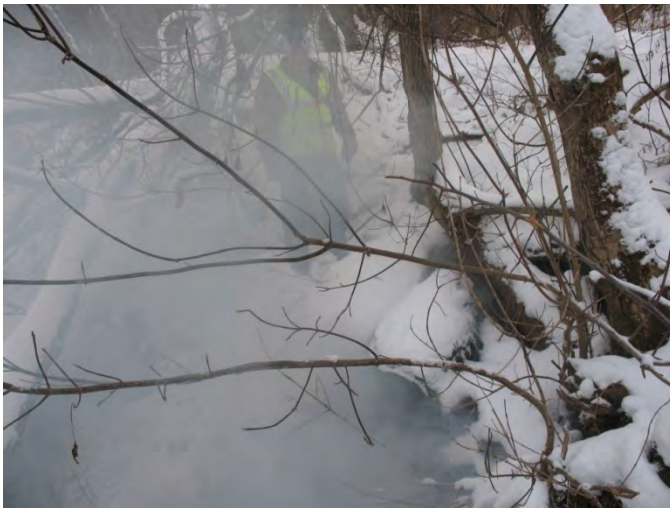
RF-045 and RF-050 were investigated on two occasions after the initial assessment. On December 16, 2009, Dave Braun, Wayne Graham of Vermont Rural Water Association, and Rich Mackay of Simon Operating Service (a contractor responsible for operation of the wastewater treatment plant) smoke tested the sanitary sewer line in the vicinity of RF-045 and RF-050, at the manhole labeled SMH#9-A on town sewer maps (Figure 9). Both RF-045 and RF-050 were flowing during dry (winter) conditions. Almost immediately smoke issued from outfall RF-045 in great quantity (Figure 10). This indicates a

Figure 10. Smoke from outfall RF-045

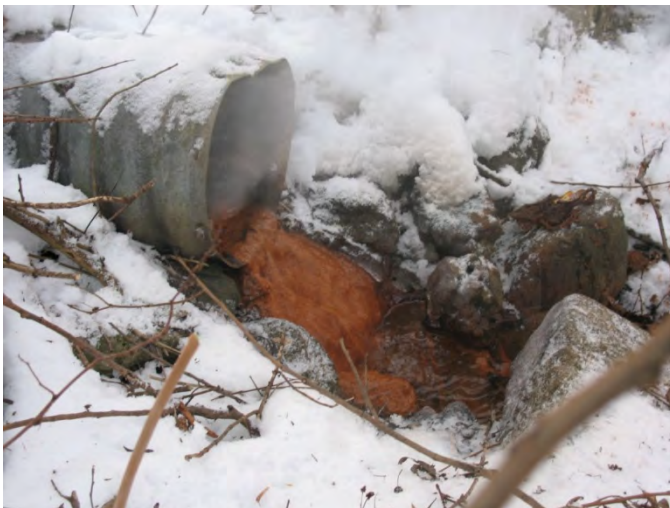
Figure 11. Smoke from outfall RF-050

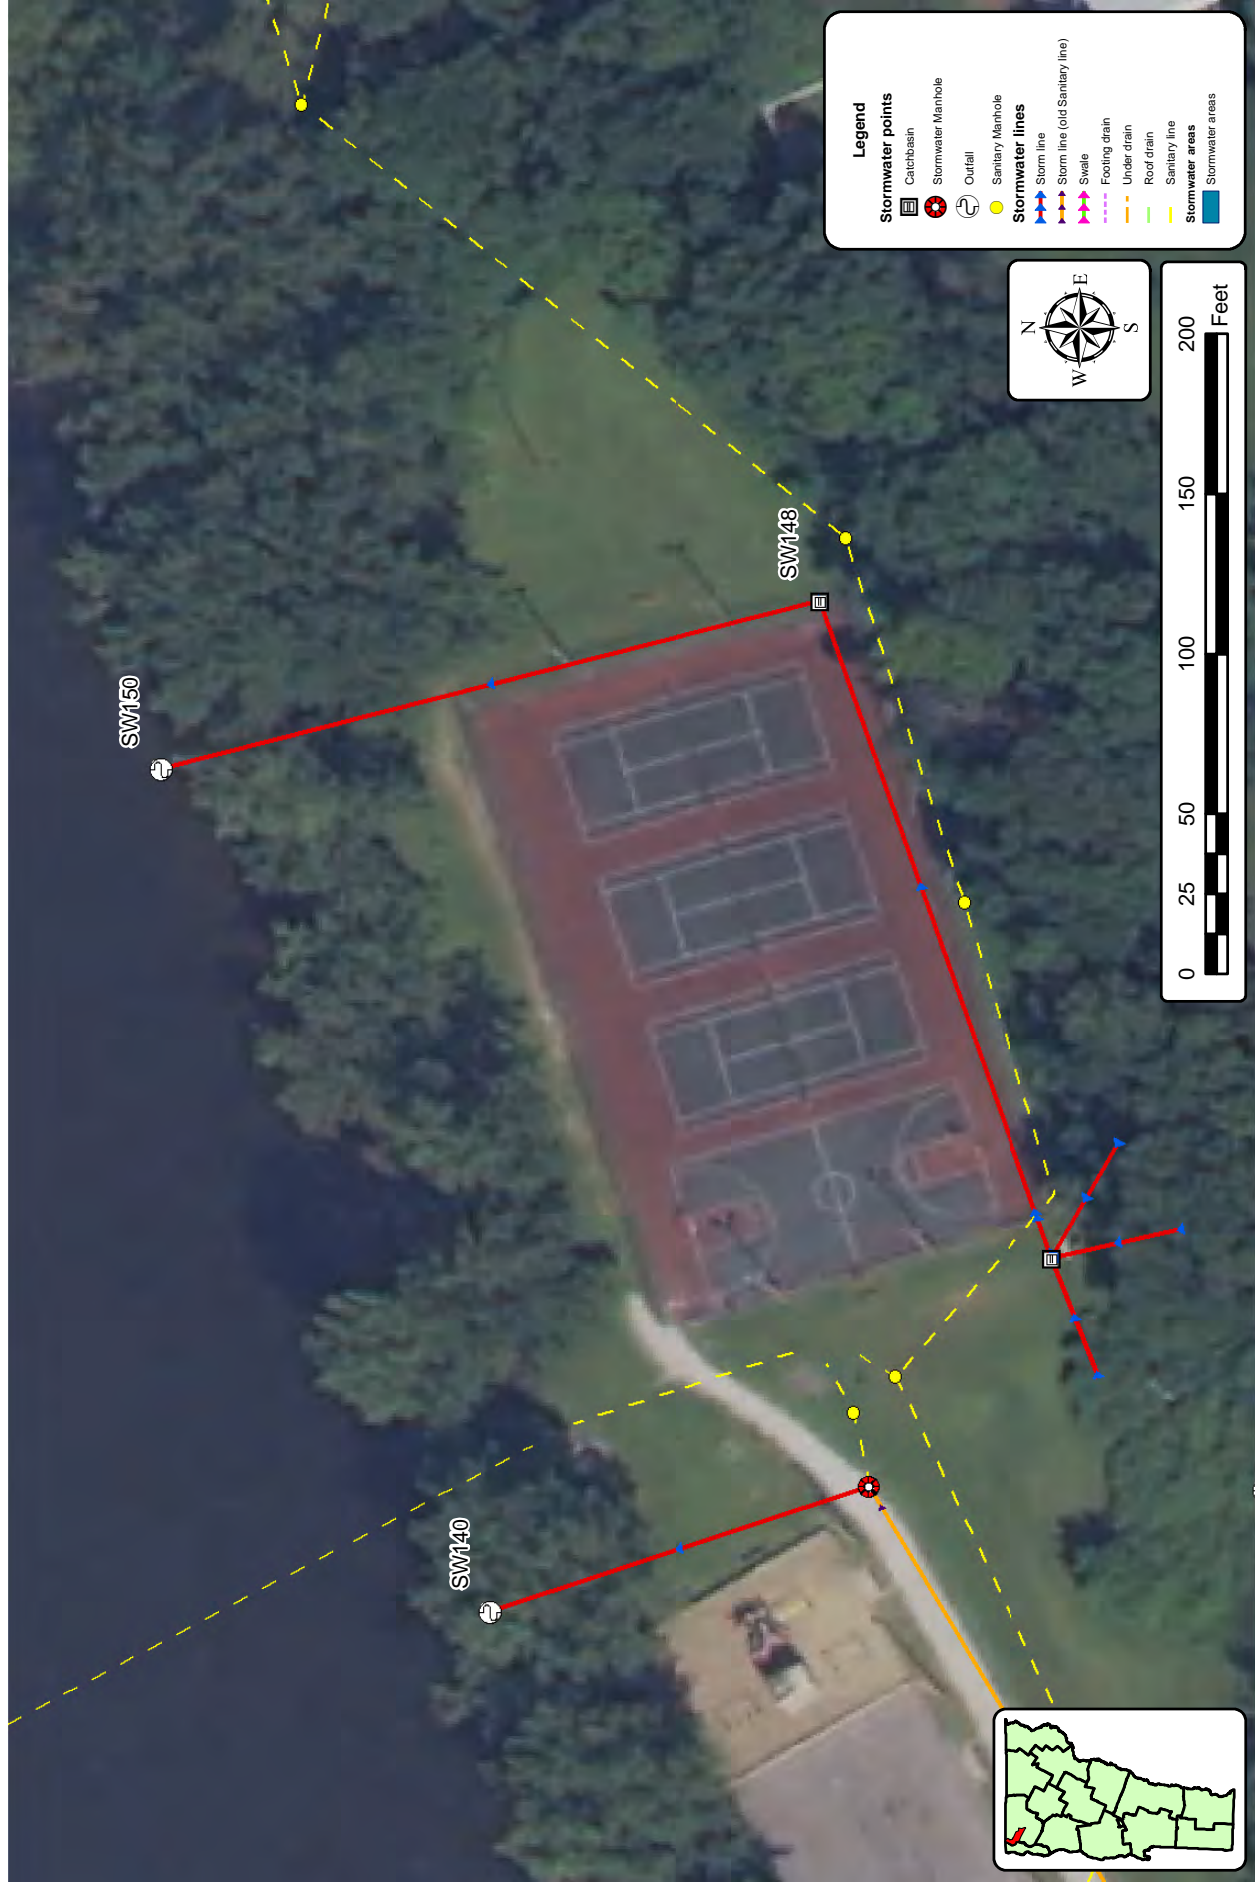
Figure 14. Stormwater drainage system discharging at outfall SW-150
Swanton, VT

SW-150 is an 8-inch diameter PVC outfall pipe discharging to the Missisquoi River immediately north of the tennis courts in Marble Mill Park (Figure 14). There is extensive iron staining and precipitate in this pipe. The only water quality data that suggests potential contamination of this storm sewer was detection of optical brightener, although fluorescence was weak. The water quality data and investigation activities are described in Table 9.

We do not know the source of the optical brightener apparently entering this stormline between the most down-pipe catch basin (SW-148) and the outfall. It is possible that petroleum contaminated groundwater intercepted by the stormdrain caused a false positive result for optical brightener.
