Re: Jay Peak Resort
Revised 2014 Water Quality Remediation Plan ("WQRP")

**Water Quality Remediation Plan
2014 Update**

JAY PEAK RESORT
Jay, Vermont

Revised: January 16, 2015

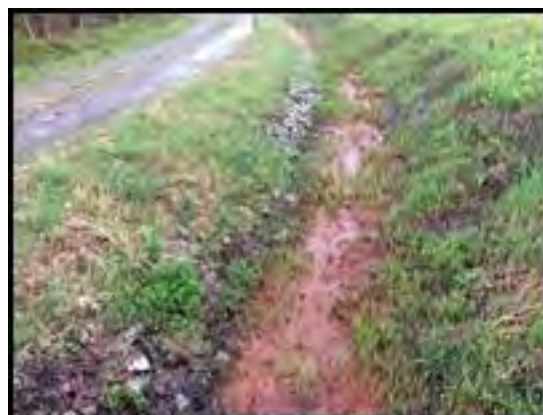
Updated inspection - similar conditions (05/22/2014)

Unique ID	1002		
Subwatershed	Jay Branch		
Geographic Coordinates	-72.505; 44.939		
Location Description	Hotel Jay / Jay Peak Access Road		
Type of Problem	Untreated Impervious		
Remedial Action Description	Vegetate informal parking spaces that occur adjacent to the roadway and parking lots. Install wattles to capture sediment each fall. Remove sand, mulch and reseed as necessary each spring.		
Discharges to Stormwater BMP	Yes	Associated Stormwater BMP	Hotel Jay Basin
Seasonal Discharge	All		
Reduction Potential (est.)	Lower		
Remediation Cost (est.)	Lower		
Identification Date	04/28/2014		
Proposed Implementation	2014		
Implementation Completed	2014 (complete); Provide maintenance annually as needed.		
Follow-up Inspection Date(s)	05/22/2014		
Follow-up Inspection Notes	Sand removed and area mulched as of 5/22/2014. Disturbed areas vegetated as of 08/20/2014.

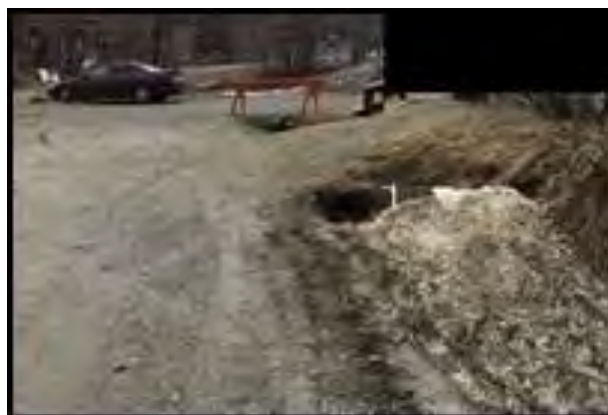
Snow storage in untreated area (04/28/2014)

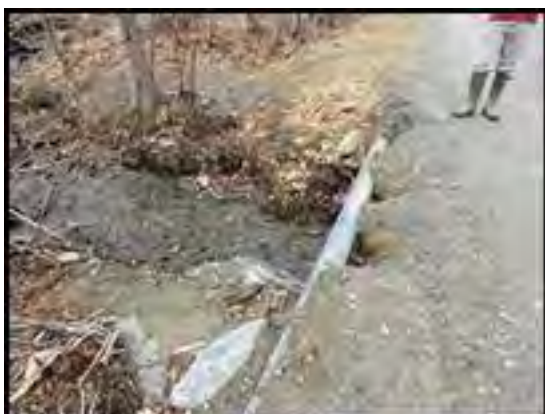
Unique ID	1015		
Subwatershed	Jay Branch		
Geographic Coordinates	-72.508; 44.939		
Location Description	Work Road to Snowmaking Pond		
Type of Problem	Culvert / Bridge Improvement		
Remedial Action Description	Armor upstream face of roadway embankment and place rip-rap on edge of road at snowmaking pipes; extend culvert beneath pipes if possible. Evaluate culvert size when replacement is required.		
Discharges to Stormwater BMP	No	Associated Stormwater BMP	
Seasonal Discharge	All		
Reduction Potential (est.)	Lower		
Remediation Cost (est.)	Moderate		
Identification Date	04/24/2012		
Proposed Implementation	2014		
Implementation Completed	2014		
Follow-up Inspection Date(s)	07/09/2014		
Follow-up Inspection Notes	Culvert headwall reconstructed and roadway shoulder stabilized as of 08/20/2014.

Work road culvert crossing (04/24/2012)

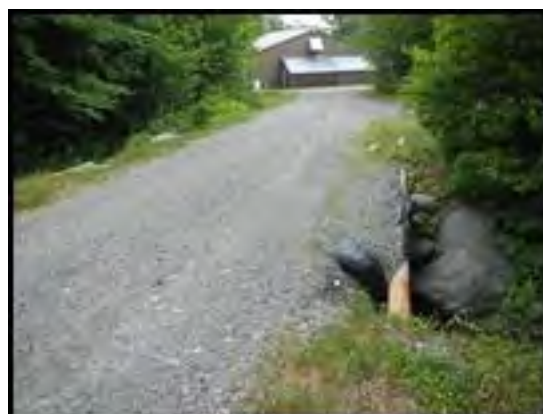
Conditions present during 2014 inspection (07/09/2014)

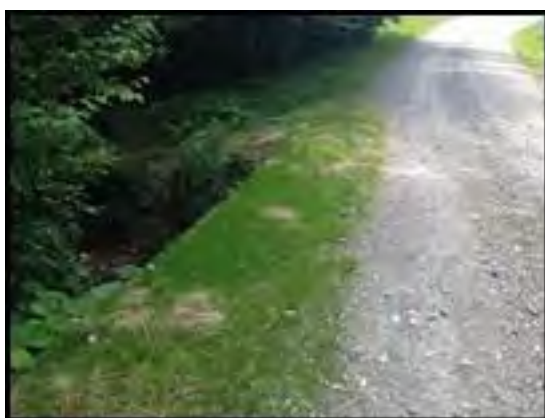
Culvert crossing following stabilization (08/20/2014)

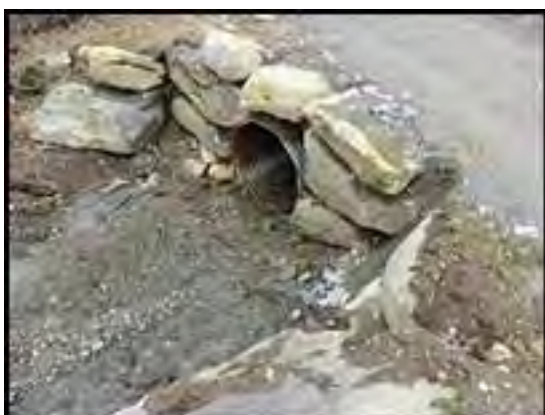
Unique ID	1016		
Subwatershed	Jay Branch		
Geographic Coordinates	-72.508; 44.940		
Location Description	West Bowl Road upgradient from Chair Barn		
Type of Problem	Culvert / Bridge Improvement		
Remedial Action Description	Culvert constricts bankfull channel width, may be causing downstream erosion. Replace with a wider span structure.		
Discharges to Stormwater BMP	No	Associated Stormwater BMP	
Seasonal Discharge	All		
Reduction Potential (est.)	Lower		
Remediation Cost (est.)	Moderate		
Identification Date	04/24/2012		
Proposed Implementation	Monitor and Assess		
Implementation Completed			
Follow-up Inspection Date(s)	07/09/2014		
Follow-up Inspection Notes	Minimal amount of erosion/sedimentation observed as of 07/09/2014; continue to monitor.

West Bowl Road culvert crossing (04/24/2012)

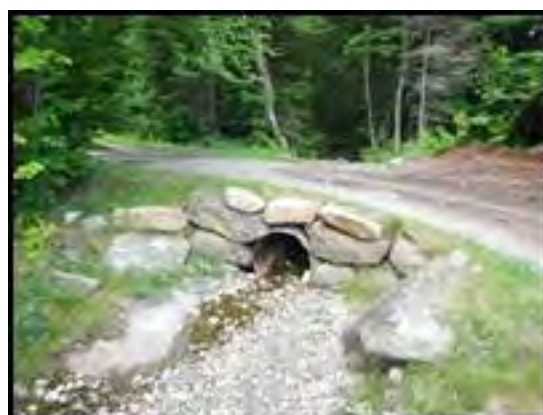
Stable conditions observed, monitor (07/09/2014)

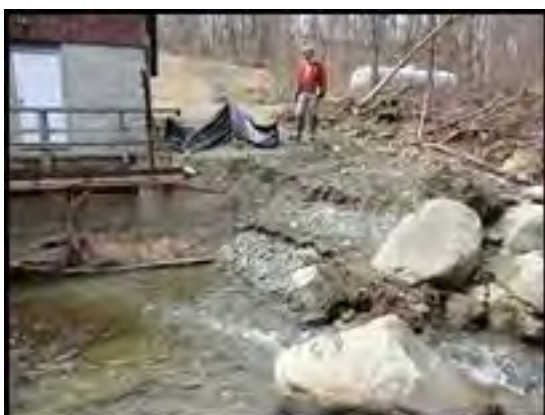
Unique ID	1017		
Subwatershed	Jay Branch		
Geographic Coordinates	-72.507; 44.940		
Location Description	Snowmaking Intake at Jay Branch		
Type of Problem	Bank Stabilization		
Remedial Action Description	Remove sediment from snowmaking intake, stabilize area and install additional plant material.		
Discharges to Stormwater BMP	No	Associated Stormwater BMP	
Seasonal Discharge	All		
Reduction Potential (est.)	Lower		
Remediation Cost (est.)	Moderate		
Identification Date	04/24/2012		
Proposed Implementation	November 1, 2015		
Implementation Completed	2014 (partial) - slumping bank has been armored; additional plantings to be installed by November 1, 2015.		
Follow-up Inspection Date(s)	07/09/2014		
Follow-up Inspection Notes	Some improvement in vegetative cover observed as of 07/09/2014.

Exposed sediment at snowmaking intake (04/24/2012)

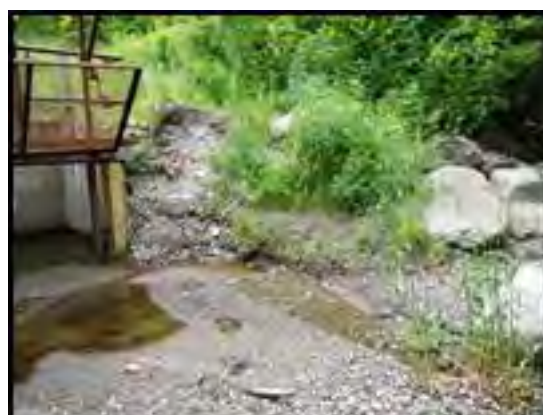
Conditions present during 2014 inspection (07/09/2014)

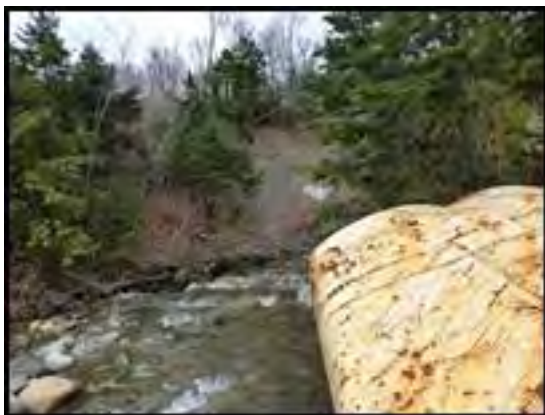
Unique ID	1018		
Subwatershed	Jay Branch		
Geographic Coordinates	-72.501; 44.941		
Location Description	Golf Course at Jay Branch		
Type of Problem	Bank Stabilization		
Remedial Action Description	Mass bank failure not associated with site development; install monitoring measures to evaluate site as potential source of sediment in the watershed.		
Discharges to Stormwater BMP	No	Associated Stormwater BMP	
Seasonal Discharge	All		
Reduction Potential (est.)	Moderate		
Remediation Cost (est.)	Higher		
Identification Date	04/24/2012		
Proposed Implementation	Monitor and assess		
Implementation Completed			
Follow-up Inspection Date(s)	04/28/2014		
Follow-up Inspection Notes	Erosion appears to be continuing when inspected on 04/28/2014.

Jay Branch slope failure (04/24/2012)

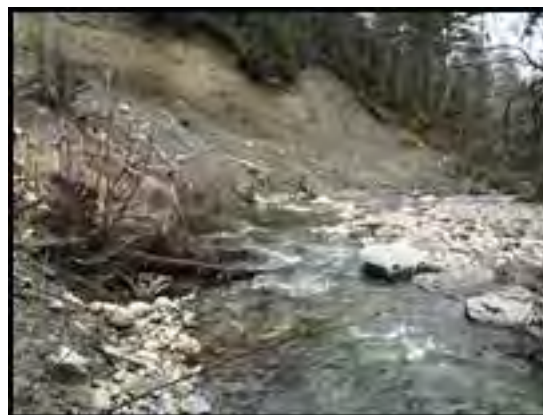
Jay Branch slope failure (04/28/2014)

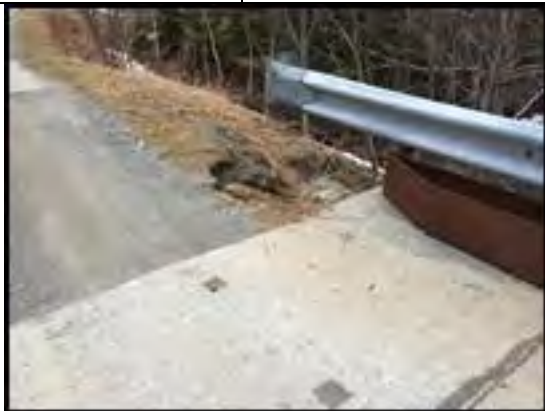
Unique ID	1019		
Subwatershed	Jay Branch		
Geographic Coordinates	-72.502; 44.940		
Location Description	Golf Course		
Type of Problem	Untreated Impervious		
Remedial Action Description	Repair cart path erosion at Golf Course Bridge over Jay Branch; stabilize approaches to reduce erosion and sediment discharge. Repair erosion at Hole 18 Bridge over Jay Branch; pave approaches to reduce sediment		
Discharges to Stormwater BMP	No	Associated Stormwater BMP	
Seasonal Discharge	All		
Reduction Potential (est.)	Lower		
Remediation Cost (est.)	Lower		
Identification Date	04/28/2014		
Proposed Implementation	2014		
Implementation Completed	2014 (complete)		
Follow-up Inspection Date(s)	04/28/2014		
Follow-up Inspection Notes	Cartpath regraded and shoulders vegetated as of 08/08/2014.

Eroded bridge approaches over Jay Branch (04/28/2014)

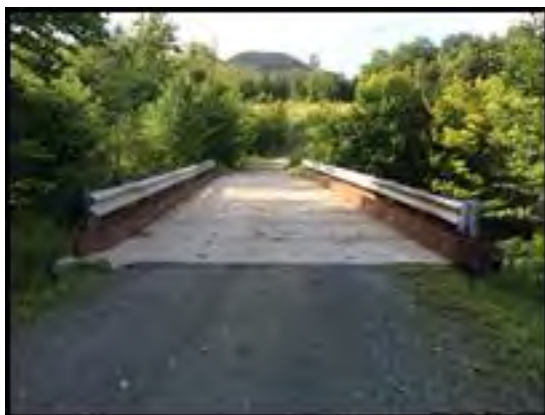
Repaired bridge approach (08/07/2014)

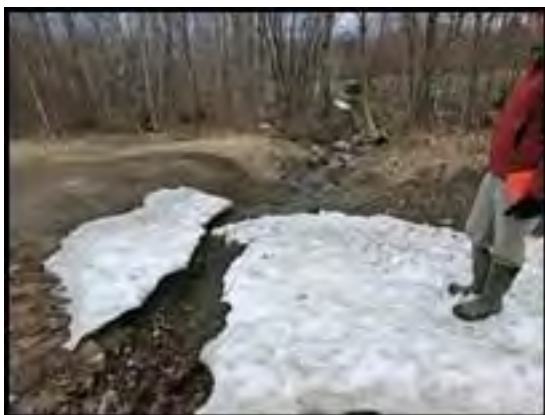
Unique ID	2001		
Subwatershed	Tributary 9		
Geographic Coordinates	-72.508; 44.933		
Location Description	Phase II Tributary at Queen's Highway		
Type of Problem	Bank Stabilization		
Remedial Action Description	Stabilize waterbar and upgrade or eliminate work road crossing.		
Discharges to Stormwater BMP	No	Associated Stormwater BMP	
Seasonal Discharge	Summer		
Reduction Potential (est.)	Lower		
Remediation Cost (est.)	Higher		
Identification Date	04/24/2012		
Proposed Implementation	2014		
Implementation Completed	2014 (complete)		
Follow-up Inspection Date(s)	05/22/2014		
Follow-up Inspection Notes	Waterbar regraded and stabilized as of 07/09/2014; work road eliminated in this area as of 08/20/2014.

Phase II Trib. crossing at Queen's Highway (04/24/2012)

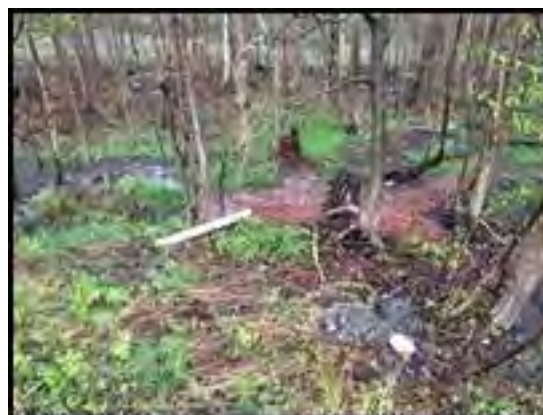
Staining only visible near outlet (05/22/2014)

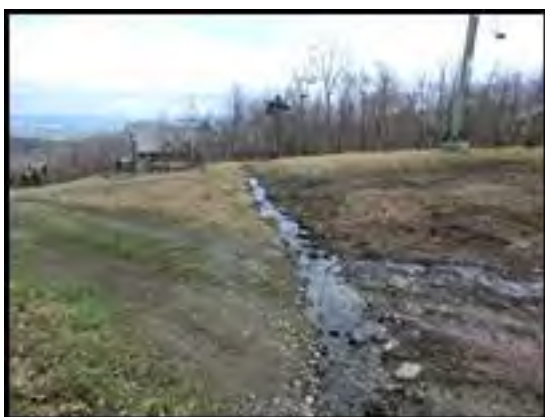
Unique ID	2003		
Subwatershed	Tributary 9		
Geographic Coordinates	-72.507; 44.933		
Location Description	Phase II Trib at Raccoon Run		
Type of Problem	Bank Stabilization		
Remedial Action Description	Stabilize waterbar and upgrade or eliminate work road crossing.		
Discharges to Stormwater BMP	No	Associated Stormwater BMP	
Seasonal Discharge	Summer		
Reduction Potential (est.)	Moderate		
Remediation Cost (est.)	Lower		
Identification Date	04/24/2012		
Proposed Implementation	2014		
Implementation Completed	2014 (complete)		
Follow-up Inspection Date(s)	05/22/2014		
Follow-up Inspection Notes	Work road eliminated and repaired waterbar vegetation establishment in progress as of 08/20/2014.

Phase II Trib. crossing at Raccoon Run (04/24/2012)

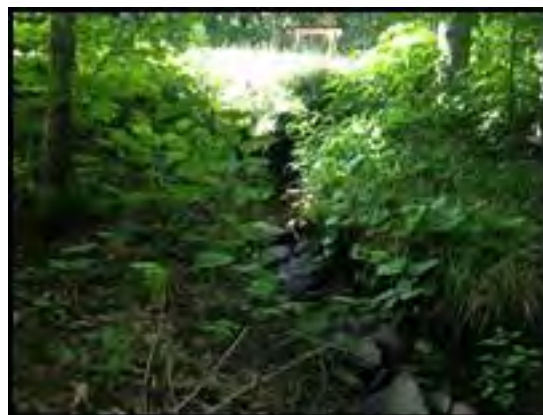
Same area with well-established vegetation (08/19/2014)

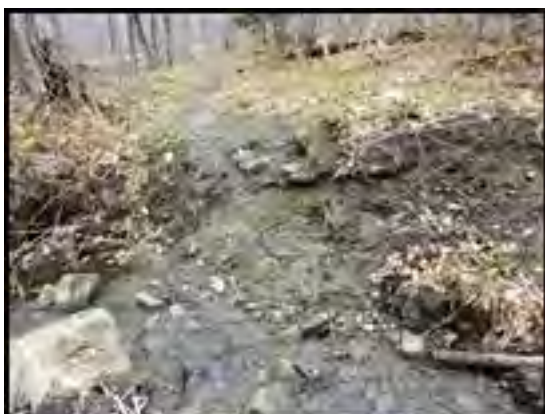
Unique ID	2008		
Subwatershed	Tributary 9		
Geographic Coordinates	-72.502; 44.935		
Location Description	Phase II Tributary at South Village Road		
Type of Problem	Bank Stabilization		
Remedial Action Description	Outlet repair, stream bank stabilization. Continue to monitor following completion of 2013 remedial activities and stormwater certifications.		
Discharges to Stormwater BMP	No	Associated Stormwater BMP	
Seasonal Discharge	All		
Reduction Potential (est.)	Moderate		
Remediation Cost (est.)	Moderate		
Identification Date	04/24/2012		
Proposed Implementation	Monitor and assess		
Implementation Completed			
Follow-up Inspection Date(s)	04/24/2012		
Follow-up Inspection Notes

Phase II Tributary erosion (04/24/2012)

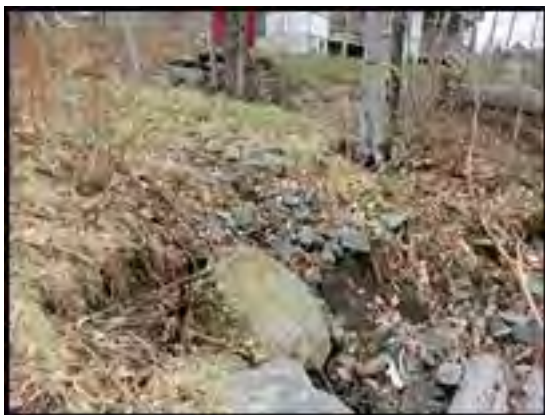
Unique ID	2009		
Subwatershed	Tributary 9		
Geographic Coordinates	-72.502; 44.935		
Location Description	Phase II Tributary at South Village Road		
Type of Problem	Bank Stabilization		
Remedial Action Description	Outlet repair, stream bank stabilization. Continue to monitor following completion of 2013 remedial activities and stormwater certifications.		
Discharges to Stormwater BMP	No	Associated Stormwater BMP	
Seasonal Discharge	All		
Reduction Potential (est.)	Moderate		
Remediation Cost (est.)	Moderate		
Identification Date	04/24/2012		
Proposed Implementation	Monitor and assess		
Implementation Completed			
Follow-up Inspection Date(s)	04/24/2012		
Follow-up Inspection Notes	Slumping / erosion appears to have arrested, good vegetation growth observed as of 08/07/2014.

Phase II Tributary erosion (04/24/2012)

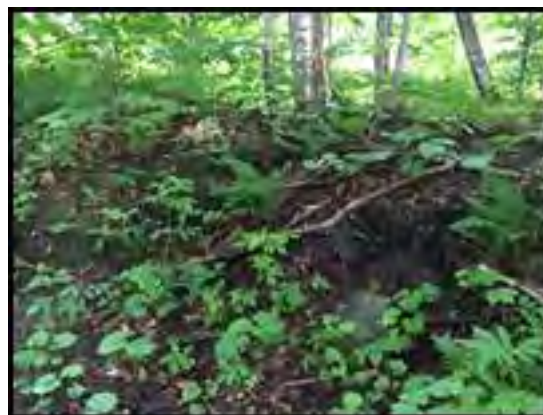
Improved vegetative growth in area (08/07/2014)

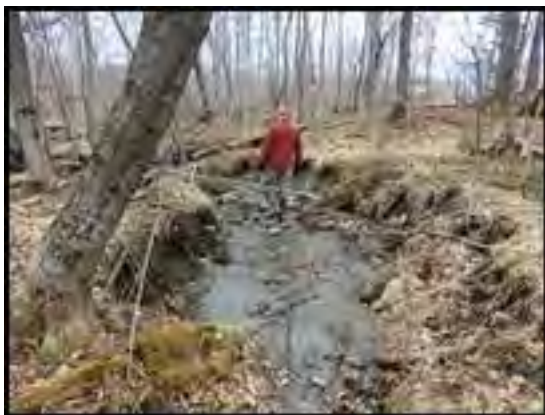
Unique ID	2010		
Subwatershed	Tributary 9		
Geographic Coordinates	-72.501; 44.935		
Location Description	Phase II Tributary at South Village Road		
Type of Problem	Bank Stabilization		
Remedial Action Description	Outlet repair, stream bank stabilization. Continue to monitor following completion of 2013 remedial activities and stormwater certifications.		
Discharges to Stormwater BMP	No	Associated Stormwater BMP	
Seasonal Discharge	All		
Reduction Potential (est.)	Moderate		
Remediation Cost (est.)	Moderate		
Identification Date	04/24/2012		
Proposed Implementation	Monitor and assess		
Implementation Completed			
Follow-up Inspection Date(s)	04/24/2012		
Follow-up Inspection Notes	Slumping / erosion appears to have arrested, good vegetation growth observed as of 08/07/2014.

Phase II Tributary erosion (04/24/2012)

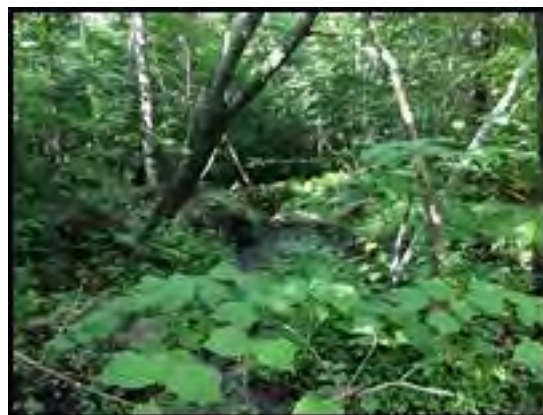
Improved vegetative growth in area (08/07/2014)

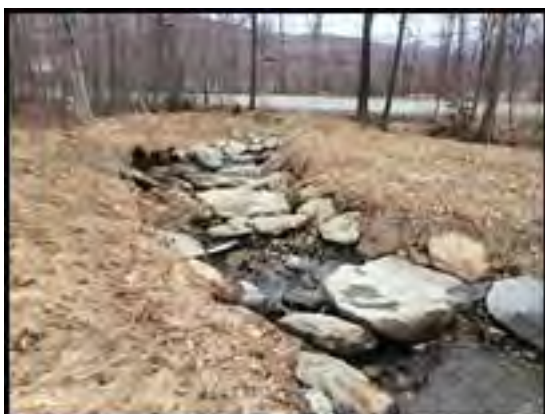
Unique ID	2013		
Subwatershed	Tributary 9		
Geographic Coordinates	-72.500; 44.936		
Location Description	Phase II Tributary at North Village Road		
Type of Problem	Bank Stabilization		
Remedial Action Description	Repair erosion along Phase II Tributary Restoration Area; Incorporate wider gradation of particle sizes in addition to rock steps. Install woody vegetation.		
Discharges to Stormwater BMP	No	Associated Stormwater BMP	
Seasonal Discharge	All		
Reduction Potential (est.)	Moderate		
Remediation Cost (est.)	Lower		
Identification Date	04/28/2014		
Proposed Implementation	November 1, 2015		
Implementation Completed	Bank stabilization completed 2014; Additional plantings to be installed by November 1, 2015.		
Follow-up Inspection Date(s)	04/28/2014; 07/09/2014; 07/31/2014		
Follow-up Inspection Notes	Implementation of remedial action observed on 07/09/2014; Plantings replaced as of 7/31/2014.

Phase II Trib. erosion in restoration area (04/28/2014)

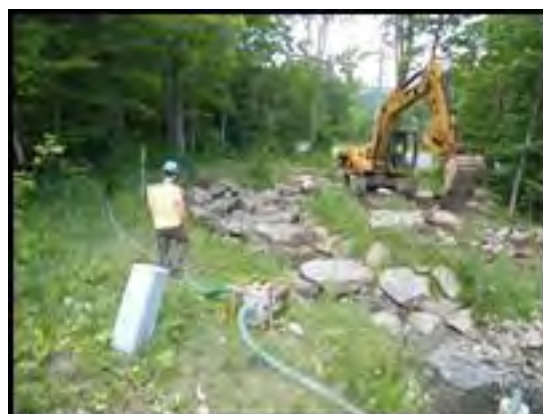
Contractor repairing restoration reach (07/09/2014)

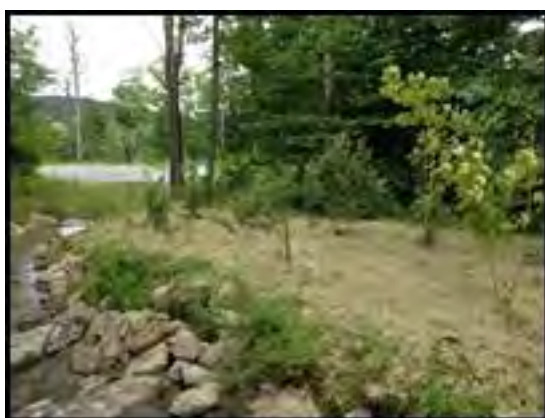
Vegetation installed after stream repairs (07/29/2014)

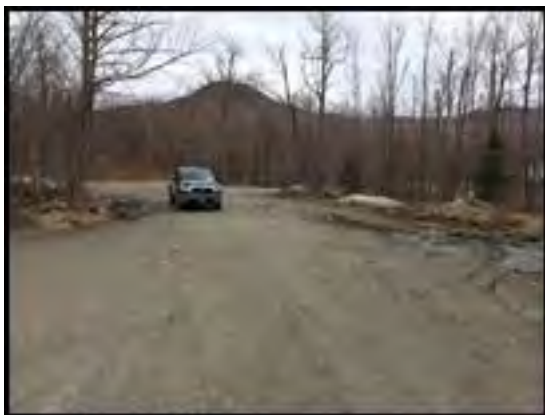
Unique ID	2014		
Subwatershed	Tributary 9		
Geographic Coordinates	-72.500; 44.937		
Location Description	Phase I Tributary at North Village Road		
Type of Problem	Untreated Impervious		
Remedial Action Description	Improve stormwater management along roadway adjacent to Phase 1 Tributary.		
Discharges to Stormwater BMP	No	Associated Stormwater BMP	
Seasonal Discharge	All		
Reduction Potential (est.)	Moderate		
Remediation Cost (est.)	Moderate		
Identification Date	04/28/2014		
Proposed Implementation	2014		
Implementation Completed	2014 (complete)		
Follow-up Inspection Date(s)	04/28/2014		
Follow-up Inspection Notes	Roadway superelevated to direct flow away from stream, rock shoulder installed, settling basin installed in ditchline as of 08/07/2014.

Untreated impervious near Phase I Trib. (04/28/2014)

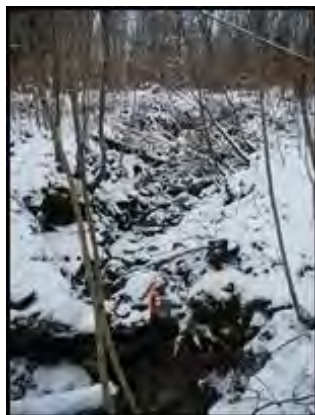
Unique ID	3001		
Subwatershed	South Mtn Branch		
Geographic Coordinates	-72.495; 44.933		
Location Description	North of Snowline Lodge		
Type of Problem	Bank Stabilization		
Remedial Action Description	Downcutting in overhead power line corridor has resulted in downstream sediment transport and has exposed a stretch of abandoned sanitary sewer line.		
Discharges to Stormwater BMP	No	Associated Stormwater BMP	
Seasonal Discharge	All		
Reduction Potential (est.)	Moderate		
Remediation Cost (est.)	Moderate		
Identification Date	11/08/2012		
Proposed Implementation	Monitor and assess		
Implementation Completed			
Follow-up Inspection Date(s)	11/08/2012		
Follow-up Inspection Notes

Downcutting at abandoned utility crossing (11/08/2012)

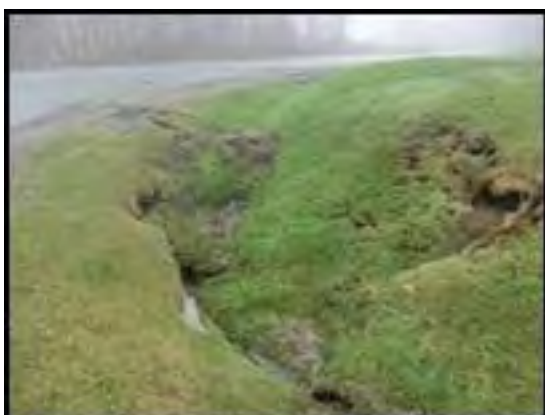
Unique ID	3002		
Subwatershed	South Mtn Branch		
Geographic Coordinates	-72.500; 44.929		
Location Description	Stateside Road Culvert at Route 242		
Type of Problem	Bank Stabilization		
Remedial Action Description	Improve drainage, and prevent road side slope erosion, through repair of ditch.		
Discharges to Stormwater BMP	No	Associated Stormwater BMP	
Seasonal Discharge	All		
Reduction Potential (est.)	Lower		
Remediation Cost (est.)	Lower		
Identification Date	05/02/2012		
Proposed Implementation	2014		
Implementation Completed	2014 (complete)		
Follow-up Inspection Date(s)	04/28/2014; 05/22/2014		
Follow-up Inspection Notes	Slope and ditchline regraded and stabilized as of 08/14/2014.

Slumped banks and clogged culvert inlet (05/02/2012)

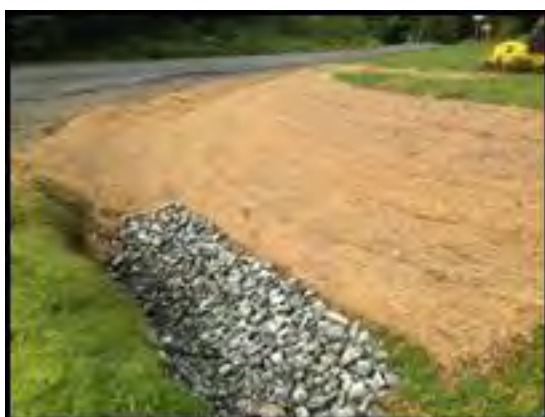
Repaired bank and ditchline (08/14/2014)

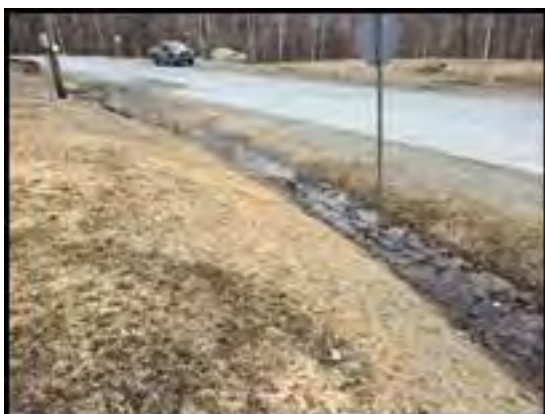
Unique ID	3005		
Subwatershed	South Mtn Branch		
Geographic Coordinates	-72.500; 44.930		
Location Description	Jay Peak Road		
Type of Problem	Untreated Impervious		
Remedial Action Description	Adjust local grading during repaving operations to direct more impervious area to treatment; add check dams in drainage swales.		
Discharges to Stormwater BMP	No	Associated Stormwater BMP	
Seasonal Discharge	All		
Reduction Potential (est.)	Lower		
Remediation Cost (est.)	Moderate		
Identification Date	04/28/2014		
Proposed Implementation	November 1, 2015		
Implementation Completed			
Follow-up Inspection Date(s)	04/28/2014; 06/25/2014		
Follow-up Inspection Notes	Exposed soils have been mulched and check dams added to ditches as of 06/25/2014.

Jay Peak Road at Rt. 242 (04/28/2014)

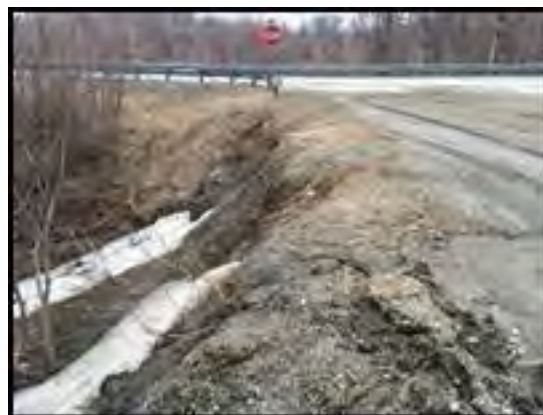
Sediment entering Trib. 3 at Rt. 242 (04/28/2014)

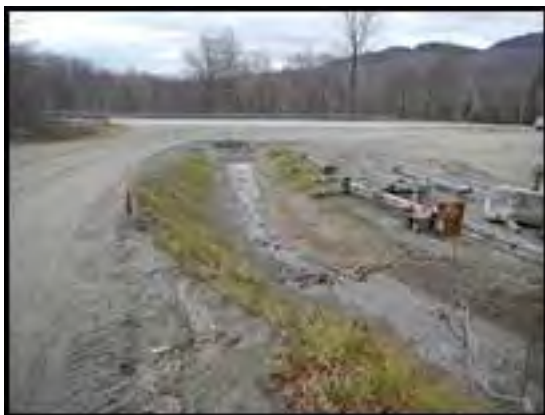
Unique ID	3008		
Subwatershed	South Mtn Branch		
Geographic Coordinates	-72.502; 44.928		
Location Description	Route 242 Parking Lot		
Type of Problem	Untreated Impervious		
Remedial Action Description	Relocate parking lot entrance away from VT Rt. 242, replace with dedicated entrance off Stateside Road; reduce the width of Stateside Road at Route 242 intersection.		
Discharges to Stormwater BMP	No	Associated Stormwater BMP	
Seasonal Discharge	All		
Reduction Potential (est.)	Moderate		
Remediation Cost (est.)	Moderate		
Identification Date	11/01/2012		
Proposed Implementation	November 1, 2015		
Implementation Completed			
Follow-up Inspection Date(s)	11/01/2012; 04/28/2014		
Follow-up Inspection Notes	Similar conditions present as of 07/09/2014; improvements expected when Route 242 lot regraded.. Meeting scheduled with VTrans on 7/28/2014

Rt. 242 Parking Lot at Stateside Road (11/01/2012)

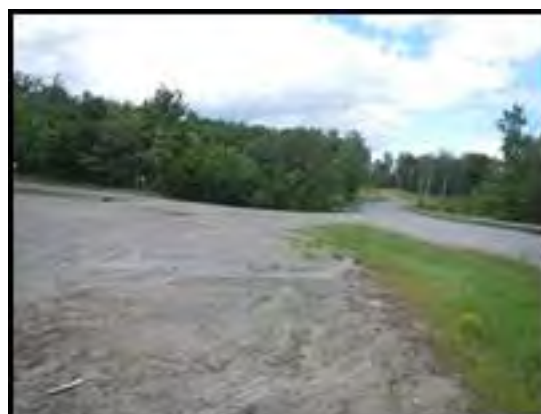
Improved vegetation during summer months (07/09/2014)

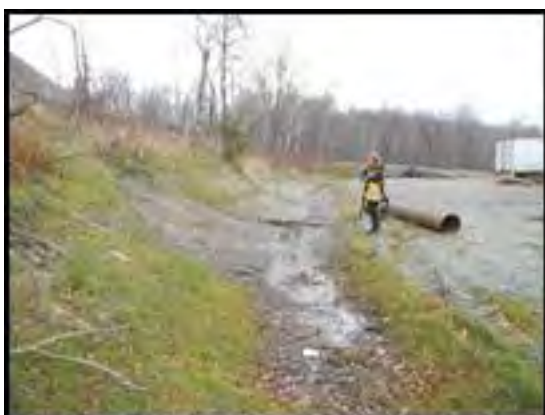
Unique ID	3010		
Subwatershed	South Mtn Branch		
Geographic Coordinates	-72.502; 44.928		
Location Description	Stateside Road		
Type of Problem	STP Issues/Concerns		
Remedial Action Description	Slope failure above treatment swale, receiving runoff from sand pile and clogging outlet.		
Discharges to Stormwater BMP	No	Associated Stormwater BMP	
Seasonal Discharge	All		
Reduction Potential (est.)	Higher		
Remediation Cost (est.)	Lower		
Identification Date	11/01/2012		
Proposed Implementation	2014		
Implementation Completed	2014 (complete)		
Follow-up Inspection Date(s)	05/22/2014		
Follow-up Inspection Notes	Swale stabilized as of 05/22/2014; Route 242 lot regraded October 2014

Slope erosion at Rt. 242 Parking Lot (11/01/2012)

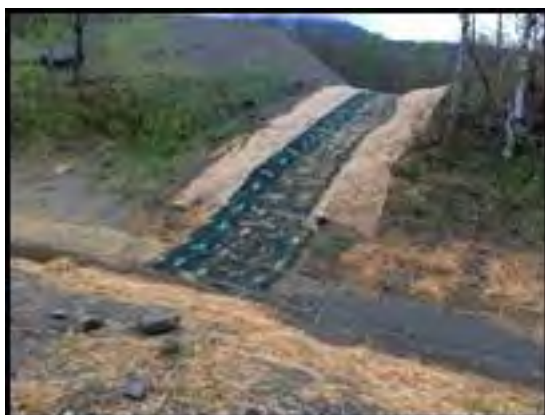
Gully repaired with RECP (05/22/2014)

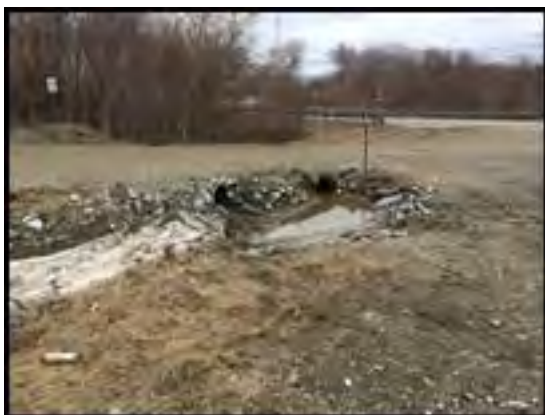
Unique ID	3011		
Subwatershed	South Mtn Branch		
Geographic Coordinates	-72.502; 44.928		
Location Description	Route 242 Parking Lot		
Type of Problem	Untreated Impervious		
Remedial Action Description	Regrade parking lot to direct flows away from VT Rt. 242 and into an enhanced stormwater treatment swale.		
Discharges to Stormwater BMP	No	Associated Stormwater BMP	
Seasonal Discharge	All		
Reduction Potential (est.)	Higher		
Remediation Cost (est.)	Higher		
Identification Date	04/28/2014		
Proposed Implementation	2014		
Implementation Completed	2014 (complete)		
Follow-up Inspection Date(s)	05/22/2014		
Follow-up Inspection Notes	Swale stabilized as of 05/22/2014; Route 242 lot regraded and Stateside Road culvert replaced October 2014

Discharge from Rt. 242 Parking Lot (04/28/2014)

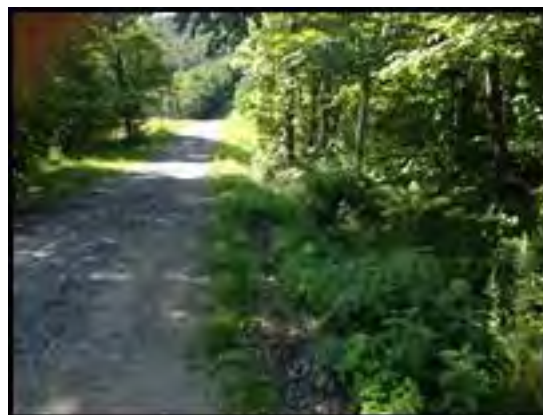
Summer conditions along access road (08/20/2014)

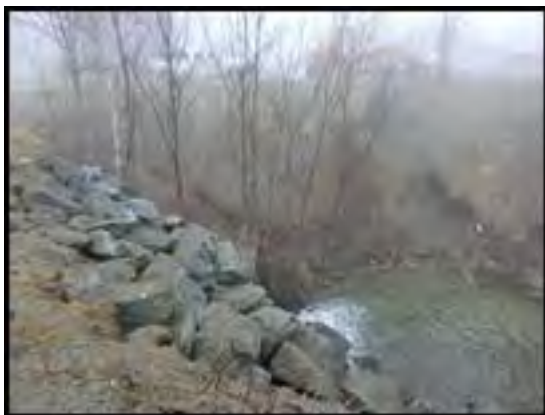
Unique ID	3016		
Subwatershed	South Mtn Branch		
Geographic Coordinates	-72.503; 44.929		
Location Description	Tributary 3 downstream from Stateside Road culvert		
Type of Problem	Bank Stabilization		
Remedial Action Description	Berm installed along top of slope in 2012, preventing runoff down face of slope. Vegetation is becoming established. Continue to monitor.		
Discharges to Stormwater BMP	No	Associated Stormwater BMP	
Seasonal Discharge	All		
Reduction Potential (est.)	Moderate		
Remediation Cost (est.)	Moderate		
Identification Date	11/08/2012		
Proposed Implementation	2014		
Implementation Completed	2014		
Follow-up Inspection Date(s)	05/02/2014; 11/01/2012; 04/28/2014; 07/09/2014		
Follow-up Inspection Notes	Berm added 2013, reducing over bank flows (04/28/2014); vegetation growth suggests bank erosion has slowed in this area (07/09/2014). Continue to monitor and respond if conditions change.

Trib. 3 slope failure at maintenance area (11/08/2012)

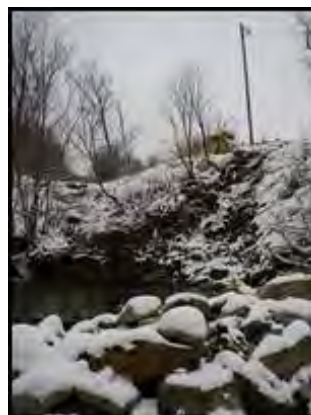
Trib. 3 slope failure at maintenance area (05/02/2012)

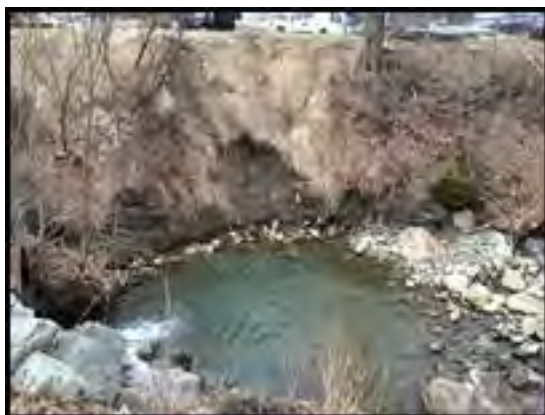
Trib. 3 slope failure at maintenance area (04/28/2014)

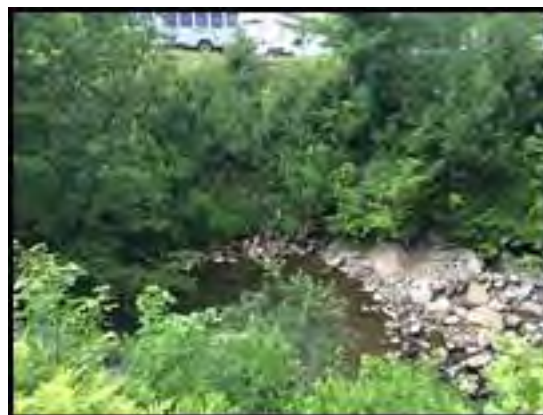
Vegetated growth on bank (07/09/2014)

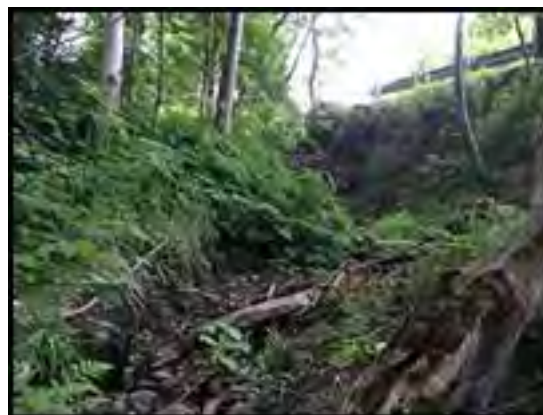
Conditions present during 2014 inspection (07/09/2014)

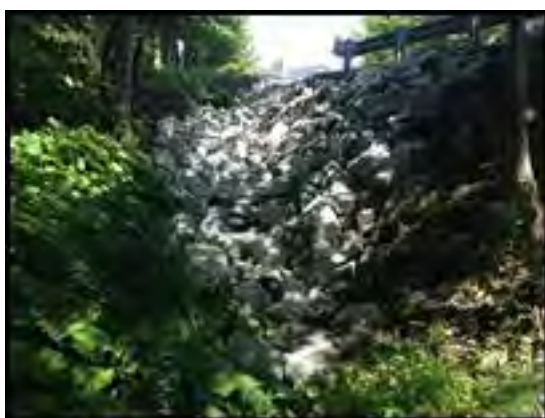
Area stabilized with rock rip rap (08/19/2014)

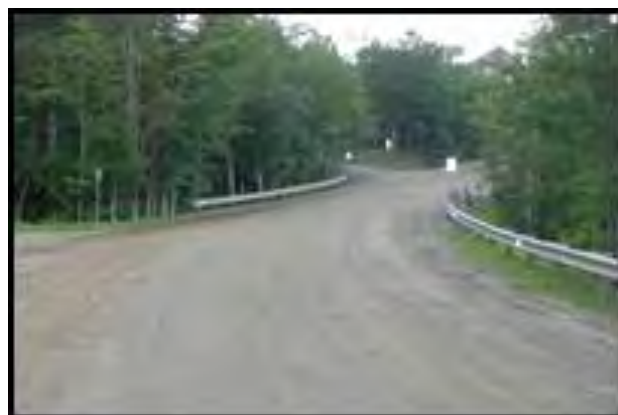
Stateside Road at Tributary 3 culvert (07/09/2014)

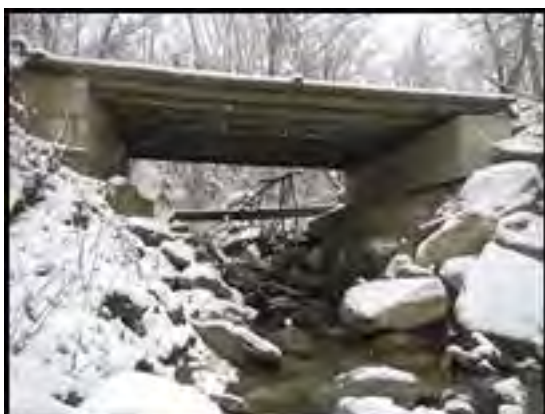
Unique ID	3022		
Subwatershed	South Mtn Branch		
Geographic Coordinates	-72.505; 44.928		
Location Description	Timber Bridge crossing near First Aid / Ski Patrol		
Type of Problem	Culvert / Bridge Improvement		
Remedial Action Description	Decrease bank erosion and flood velocity through channel constriction by increasing structure span; wider structure will be used when bridge is replaced. Coordinate with River Management Engineer.		
Discharges to Stormwater BMP	No	Associated Stormwater BMP	
Seasonal Discharge	All		
Reduction Potential (est.)	Moderate		
Remediation Cost (est.)	Moderate		
Identification Date	11/08/2012		
Proposed Implementation	Monitor and assess		
Implementation Completed			
Follow-up Inspection Date(s)	11/08/2012		
Follow-up Inspection Notes	Chris Brunelle, VT DEC River Management Engineer, conducted site visit in October 2014

Channel constriction near Ski Patrol (11/08/2012)

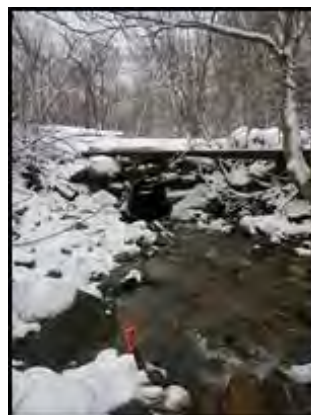
Tributary 3 at Hell's Crossing culvert (11/08/2012)

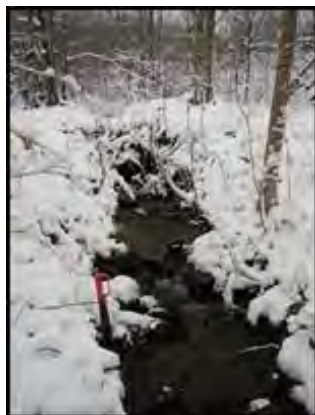
Unique ID	3024		
Subwatershed	South Mtn Branch		
Geographic Coordinates	-72.504; 44.928		
Location Description	Culverted Stream Crossing		
Type of Problem	Culvert / Bridge Improvement		
Remedial Action Description	Incised and widening stream 2010/2012-SC-C1 at culvert SMB-15. Replace culvert and stabilize affected channel. Coordinate with River Management Engineer.		
Discharges to Stormwater BMP	No	Associated Stormwater BMP	
Seasonal Discharge	All		
Reduction Potential (est.)	Moderate		
Remediation Cost (est.)	Moderate		
Identification Date	11/08/2012		
Proposed Implementation	Monitor and assess		
Implementation Completed			
Follow-up Inspection Date(s)	11/08/2012		
Follow-up Inspection Notes	Chris Brunelle, VT DEC River Management Engineer, conducted site visit in October 2014

Incised stream at culvert SMB-15 (11/08/2012)

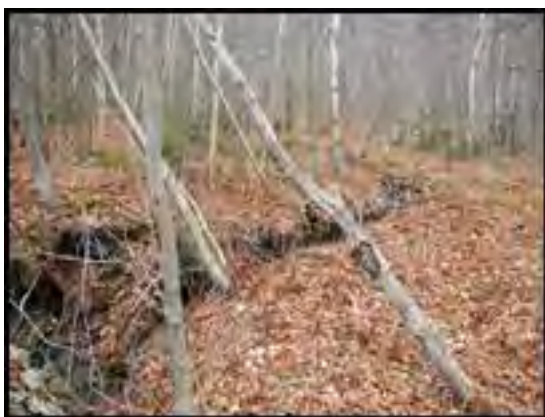
Unique ID	3025		
Subwatershed	South Mtn Branch		
Geographic Coordinates	-72.502; 44.926		
Location Description	2011-TB/SC-C25		
Type of Problem	Bank Stabilization		
Remedial Action Description	Naturally occurring avulsion has active headcut and will likely contribute sediments to downstream resources in the future. Outside of development area		
Discharges to Stormwater BMP	No	Associated Stormwater BMP	
Seasonal Discharge	All		
Reduction Potential (est.)	Moderate		
Remediation Cost (est.)	Moderate		
Identification Date	11/01/2012		
Proposed Implementation	Monitor and assess		
Implementation Completed			
Follow-up Inspection Date(s)	11/01/2012		
Follow-up Inspection Notes

Headcut in channel 2011-TB/SC-C25 (11/01/2012)

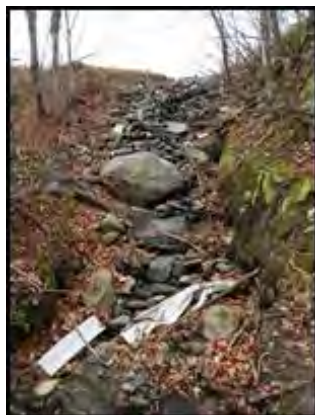
Unique ID	3026		
Subwatershed	South Mtn Branch		
Geographic Coordinates	-72.502; 44.928		
Location Description	VT-242 Parking Lot		
Type of Problem	Culvert / Bridge Improvement		
Remedial Action Description	Culvert outfall partially blocked, potentially causing localized flooding in Rt. 242 parking lot. Culvert will be replaced in conjunction with Rt. 242 lot improvements.		
Discharges to Stormwater BMP	No	Associated Stormwater BMP	
Seasonal Discharge	All		
Reduction Potential (est.)	Lower		
Remediation Cost (est.)	Lower		
Identification Date	11/01/2012		
Proposed Implementation	2014		
Implementation Completed	2014 (complete)		
Follow-up Inspection Date(s)	11/01/2012; 05/22/2014		
Follow-up Inspection Notes	On-going improvements at parking lot have reduced impact to culvert outfall. Outfall channel is stable. Continue to monitor.

Stateside Road outfall to Tributary 3 (11/01/2012)

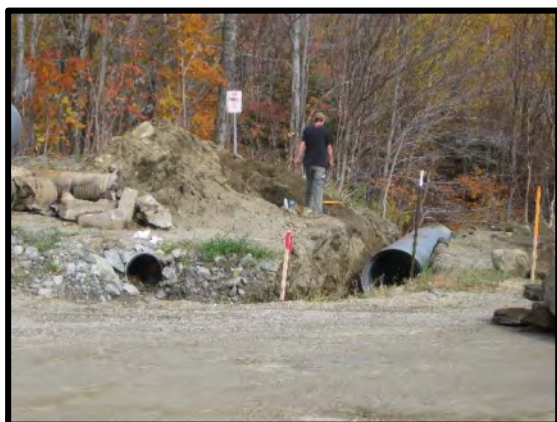
Stateside Road culvert replacement (10/14/2014)

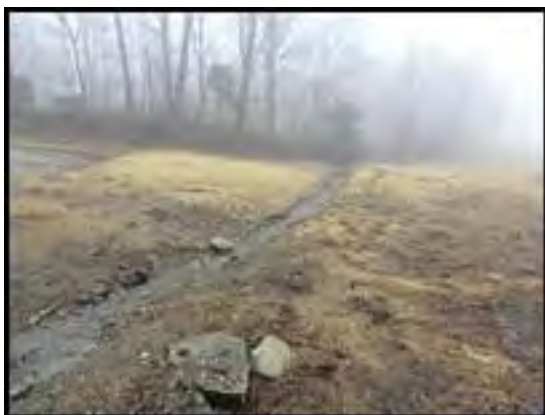
Unique ID	3027		
Subwatershed	South Mtn Branch		
Geographic Coordinates	-72.507; 44.929		
Location Description	Powerliner Ski Trail Waterbar		
Type of Problem	Bank Stabilization		
Remedial Action Description	Stabilize waterbar and add sediment sump to capture sediment before discharge to stream.		
Discharges to Stormwater BMP	No	Associated Stormwater BMP	
Seasonal Discharge	All		
Reduction Potential (est.)	Lower		
Remediation Cost (est.)	Moderate		
Identification Date	05/02/2012		
Proposed Implementation	2014		
Implementation Completed	2014 (complete)		
Follow-up Inspection Date(s)	05/02/2012		
Follow-up Inspection Notes	Waterbar regraded and stabilized as of 08/20/2014.

Powerliner Ski Trail Waterbar (05/02/2012)

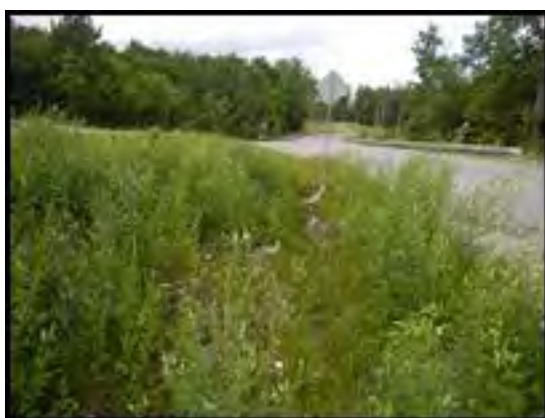
Summer conditions of Route 242 swales (07/09/2014)

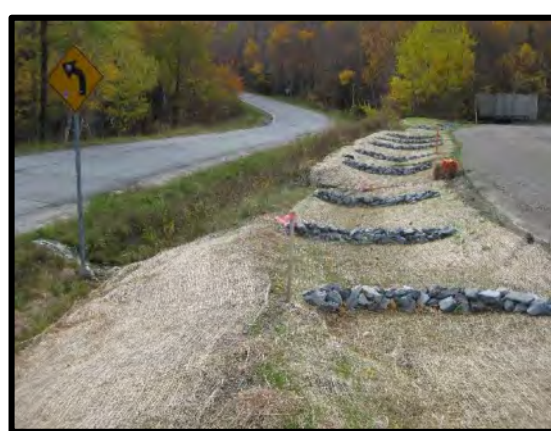
Improved swale along Route 242 parking lot (10/14/2014)
