Re: FERC project #P-14308-001—VT  
Vermont Tissue Mill Dam Hydroelectric Project  
Carbon Zero, LLC

*Re: Vermont Tissue Project-FERC# P-14308-001*  
*1. Amendment to prescribed bypass flows*

## VT Tissue Hydro – Secondary Channel Flow Assessment and Report

Rod Wentworth, December 9, 2015

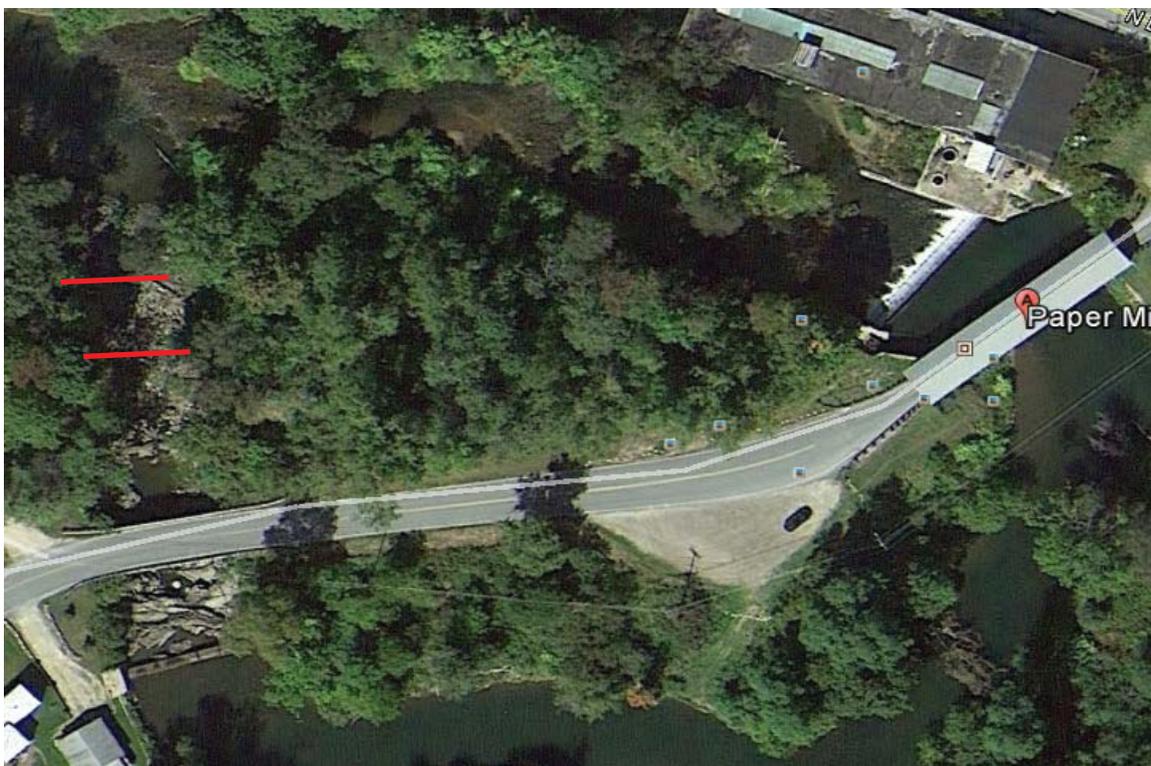
The secondary bypass is about 250 feet long. The approximate transect locations are shown in the image as red lines. Transect 1 is the more upstream of the two. The distance between the two transects was about 60 feet.

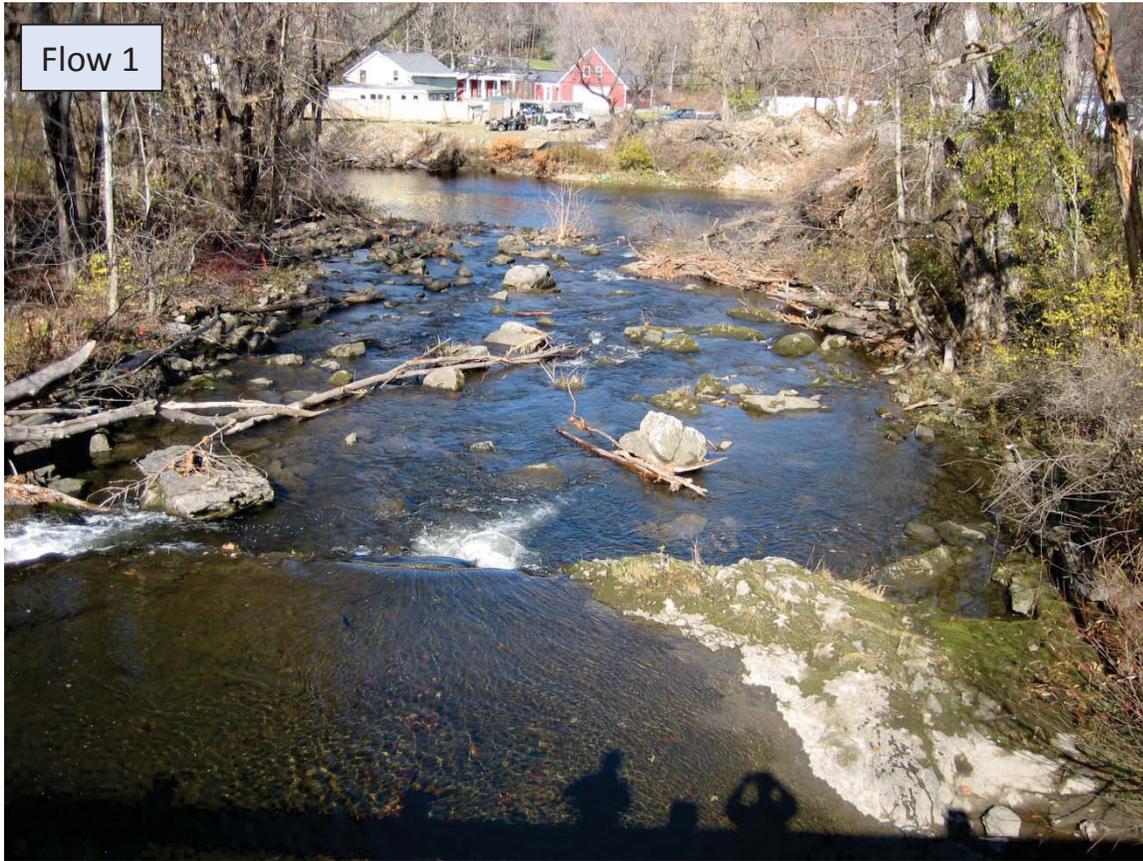
Flow 1

In summary, Flows #1 and #2 looked very good. Both Flow #3 and #4 looked good; Flow #4 was shallower but still met the assessment criteria. Flow #5 exhibited several unacceptable conditions as described. The flow requirement for the secondary bypass channel can be revised to 15 cfs.

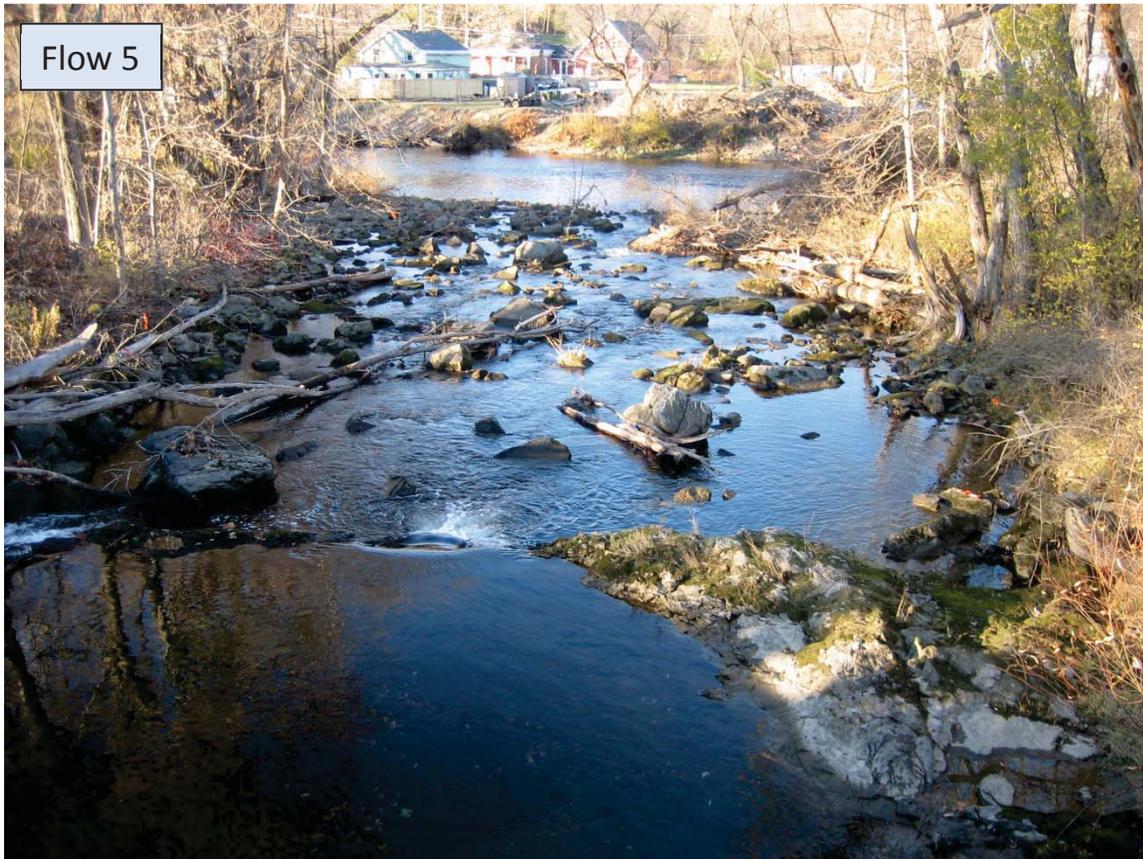
Flow 5

There are two large tongues of faster whitewater in the bypass, where the falls enters the pool just upstream of the bridge and at the outlet of pool. These tongues provide cover for fish but also create areas of fast water near slow water that can serve as feeding lanes for fish. In addition, the quantity of water entering the pool influences the water velocity and circulation in the pool and as a result its habitat value. Flow #1 provides velocities that are suitable for juvenile and adult trout. The quality of the habitat in the pool decreased somewhat with each assessment flow. Flow #4 was judged to still provide high quality habitat but was just barely still acceptable. Flow #5 clearly was not acceptable. The pool was too quiescent and lost the broken or rippled water surface found at higher flows. This type of water surface provides cover for fish. The diversity of velocity conditions was inadequate at Flow #5.

The water exiting the pool provided an attractive tongue of water that was too diminished at Flow #5. A similar condition exists where water passes over ledge near transect 2.

Water depths in the bypass decreased with each successive flow assessed. In comparing the Flow #1 and Flow #5 photos, the bypass is shrinking to shrinking. A rocky area near the confluence with the main channel (left side) is essentially dewatered at Flow #5, and an area between the two transects (right side) was reduced to a depth of about two inches. This area showed a noticeable decrease in depth beginning with Flow #3.
