Vermont Geological Survey Open File Report VG2019-5

# Landslide Inventory of Orange County, Vermont

George Springston Norwich University Department of Earth and Environmental Sciences 108 Harmon Drive, Northfield, VT 05663 802-485-2734; gsprings@norwich.edu December 2019

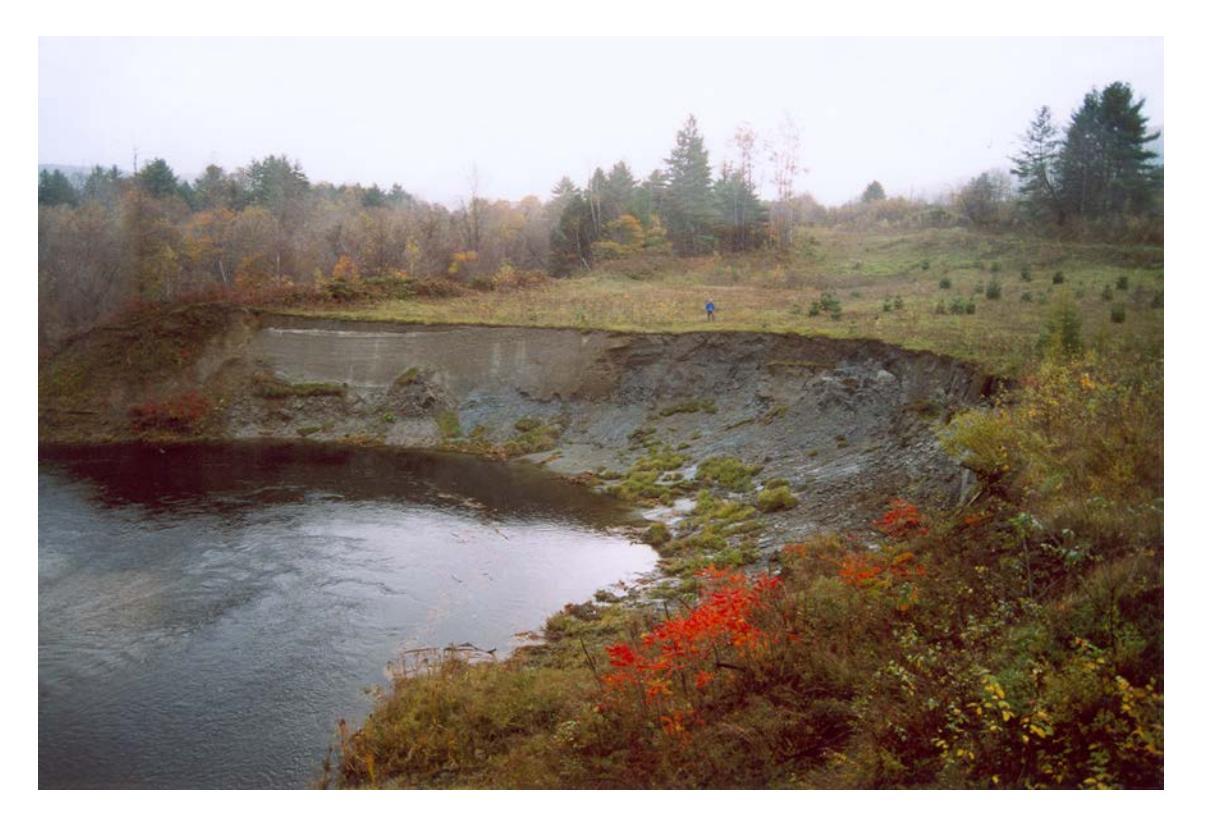
On the cover: Active landslide on the Third Branch of the White River at the Randolph Landfill, October, 2003. Photo by George Springston.

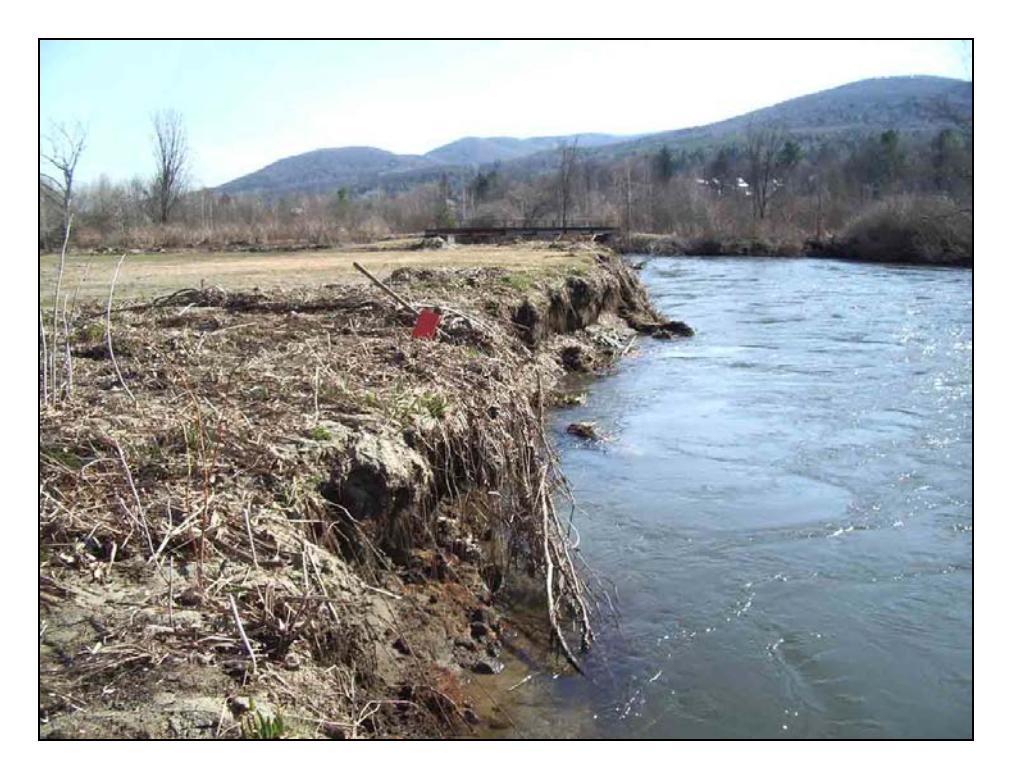
Eroding banks are common along many of the streams in the county but are not included in this inventory. Eroding banks are formed by the same mechanisms as landslides, but a cutoff has been set at about 4 meters in height, with eroding banks being below that height and landslides above it. A typical example is shown in Figure 5. Although the distinction may seem arbitrary, it is commonly the case that eroding banks are forming on the sides of low terraces that are themselves subject to inundation flooding. In contrast, landslides are generally high enough that they are not going to have their tops flooded (at least during normal floods of short recurrence intervals). Thus, the landslide hazard may be more of a fluvial erosion hazard than an inundation hazard.

Figure 5. Eroding bank of the Dog River, Northfield, Vermont. Shovel and notebook for scale. Flow is away from observer. Sandy alluvium has been undercut during recent high flows and is in the process of collapsing. Photo by George Springston, April, 2007.

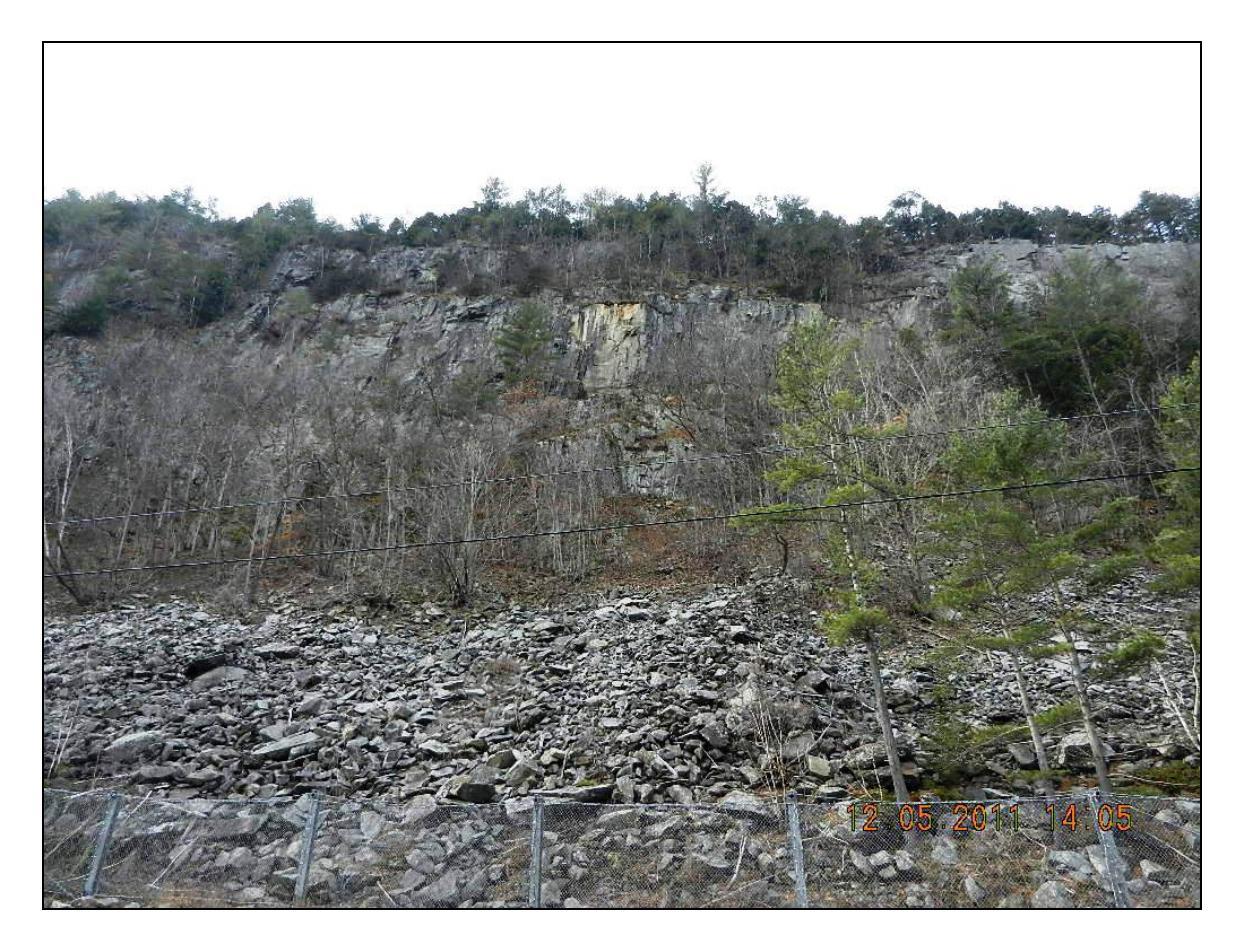
A talus deposit is a fan or apron of fallen rock at the base of a cliff. Talus deposits are mapped in order to indicate the presence of unstable rock slopes that are prone to failure. In Orange County extensive talus deposits are present at the bases of the tall, steep cliffs in and near Fairlee near the Connecticut River (Figure 6). These are shown on Figure 2 and Plate 1.

Figure 6. Looking up from U.S Rt. 5 in Fairlee at extensive talus deposit at base of cliff. The heavy steel fence has been constructed to reduce the likelihood of falling rocks reaching the highway. Photo courtesy of Ethan Thomas, VTrans.

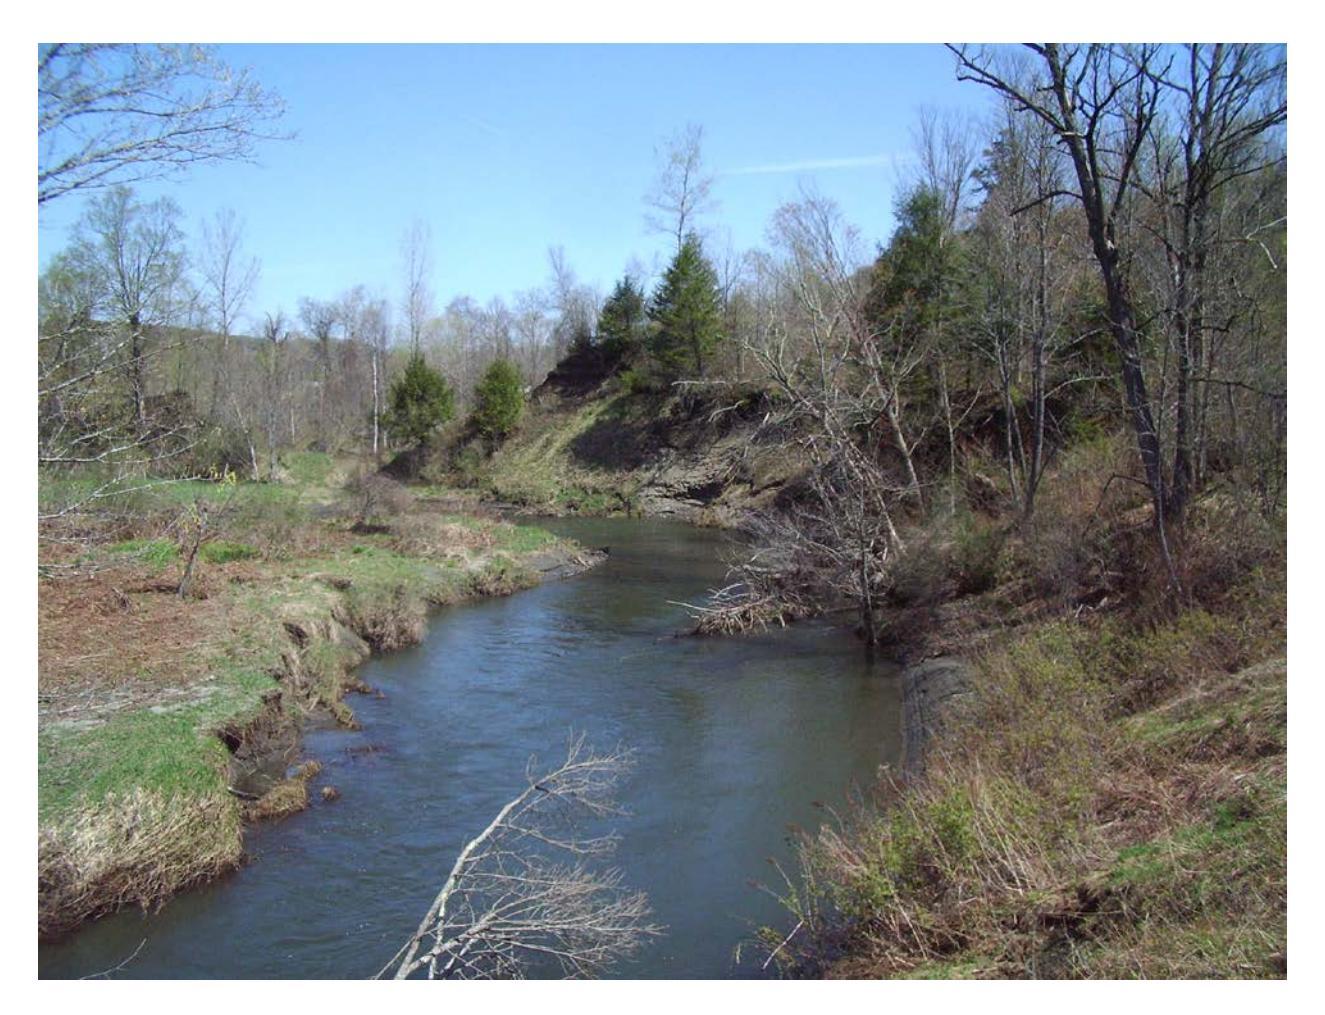
A typical streamside landslide is shown in Figures 7 and 8. This site is on the east side of the Second Branch of the White River in East Randolph. The landslide exposes an alluvial terrace deposit of sand and gravel overlying glaciolacustrine silt and silty clay interpreted to have been deposited in glacial Lake Hitchcock. The landslide appears to have been driven largely by toe erosion.

Figure 7. Landslide in alluvial terrace deposits overlying lacustrine silt-clay deposits on Second Branch of White River in East Randolph. Photo by George Springston, 2006.

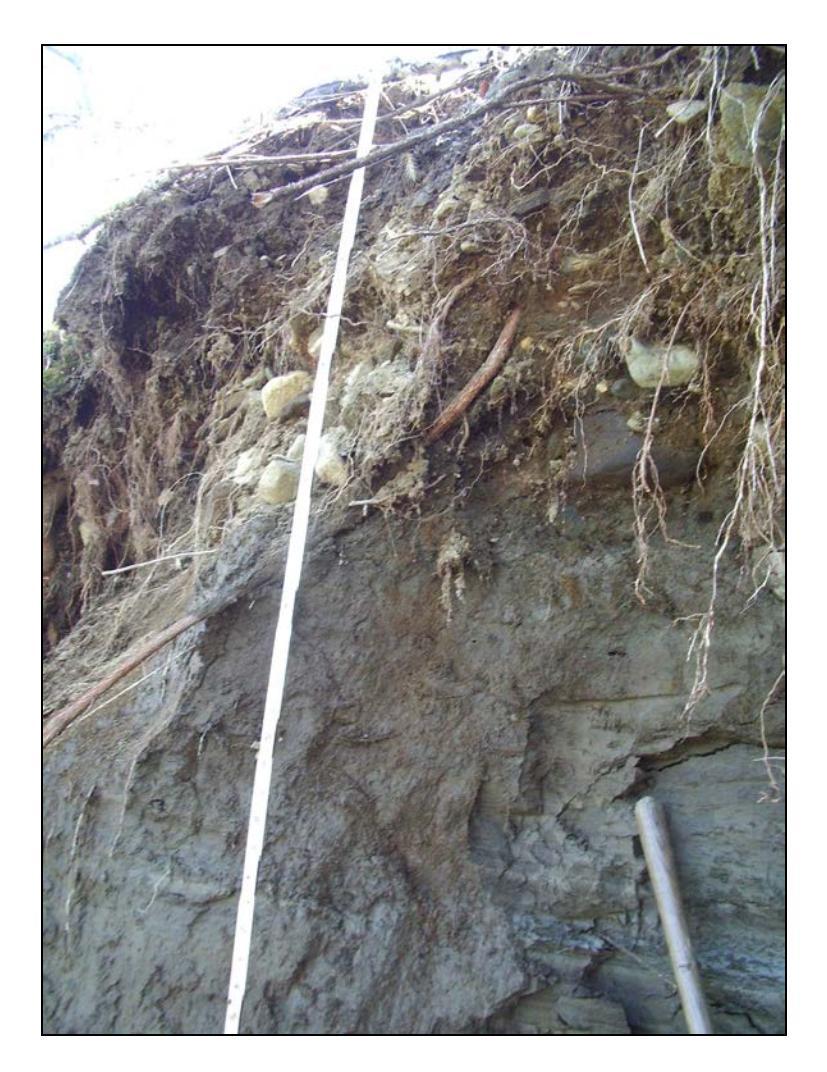
Figure 8. Close-up view of alluvial sand and gravel overlying grey lacustrine silt and silty clay in landslide scar shown in Figure 7. Photo by George Springston, 2006.

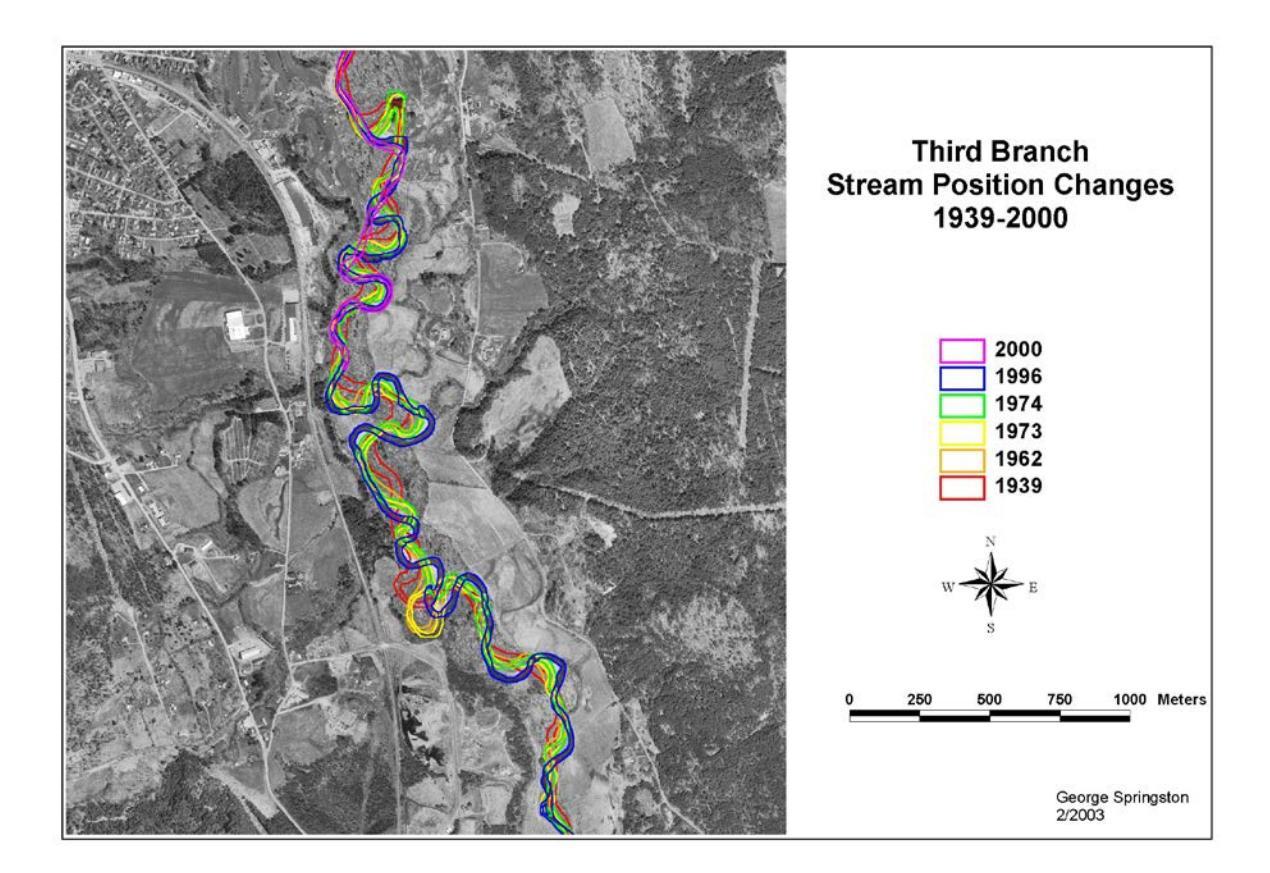
The Third Branch of the White River between Braintree and Bethel shows abundant evidence of rapid stream migration, which appears to be at least partly due to thick deposits of highly erodible glaciolacustrine silt and silty clay deposits (Figure 9). From the 1990s through the spring of 2007 a meander bend of the Third Branch at the Randolph Landfill underwent particularly rapid migration, with the top of the bank retreating up to 30 feet over the course of two years (Figures 10 and 11). In the spring of 2007 a neck cut-off of the bend in the river occurred, leaving the former meander bend as an abandoned oxbow (see final panorama in Figure 11).

Figure 9. Planform changes along the Third Branch of the White River in southern Randolph from 1939 to 2000. Extensive landslides and bank erosion are associated with these dramatic channel shifts.

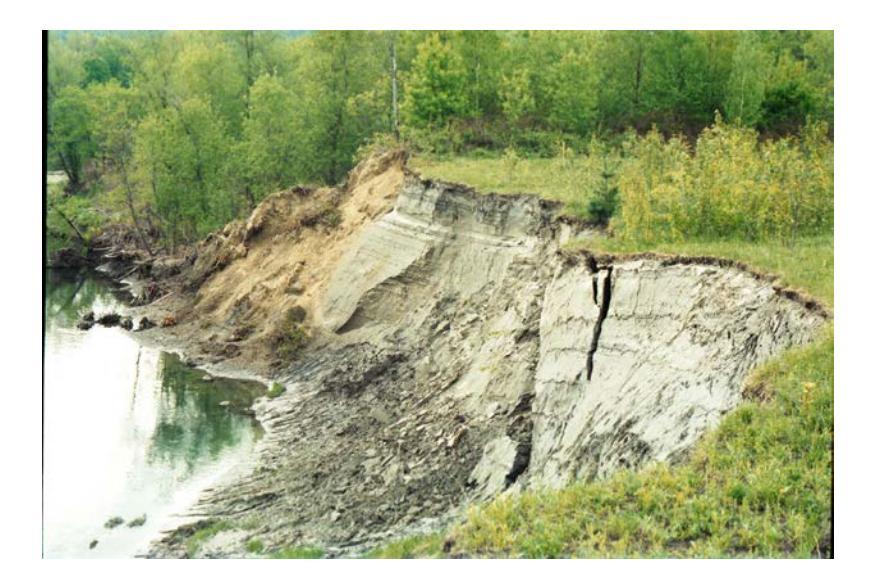
Figure 10. Landslide in fine-grained deposits of glacial Lake Hitchcock on the Third Branch of the White River at the Randolph Landfill. Photo by George Springston, 2004. The slope is about 9 meters (29 feet) high.

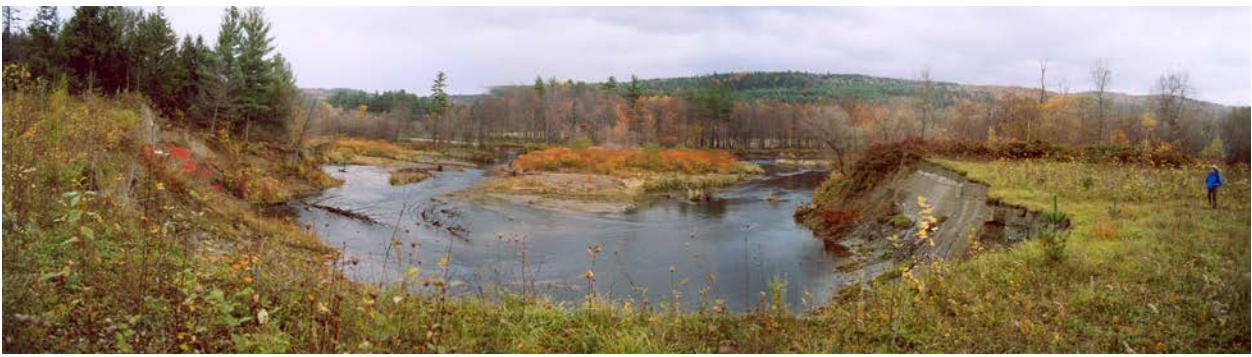
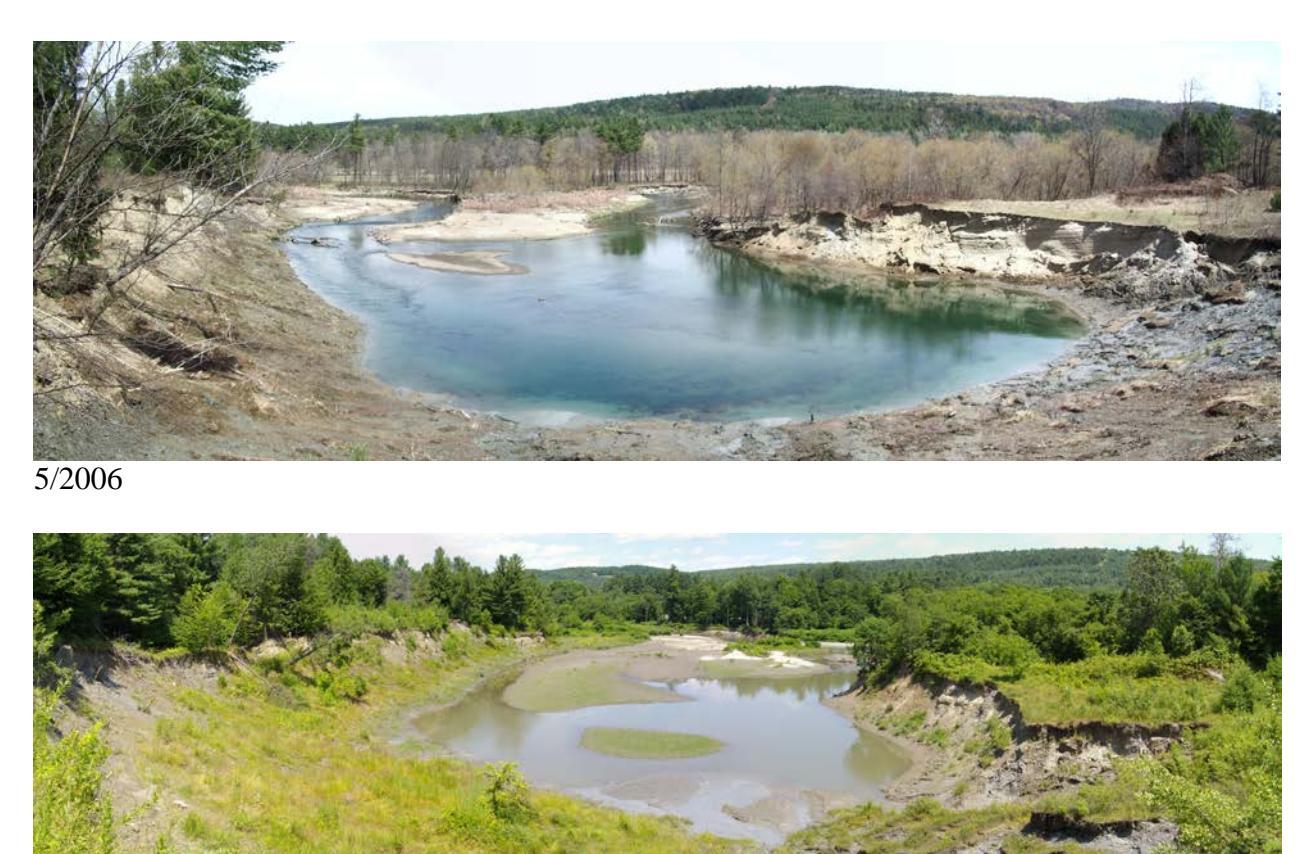
Figure 11. Panoramas showing changes from 2003 to 2007 at a rapidly elongating meander bend of the Third Branch at the Randolph Landfill. In the spring of 2007 the neck of the meander (seen in the background) had cut off and the channel became an abandoned oxbow as shown in the final photo taken in July of 2007.

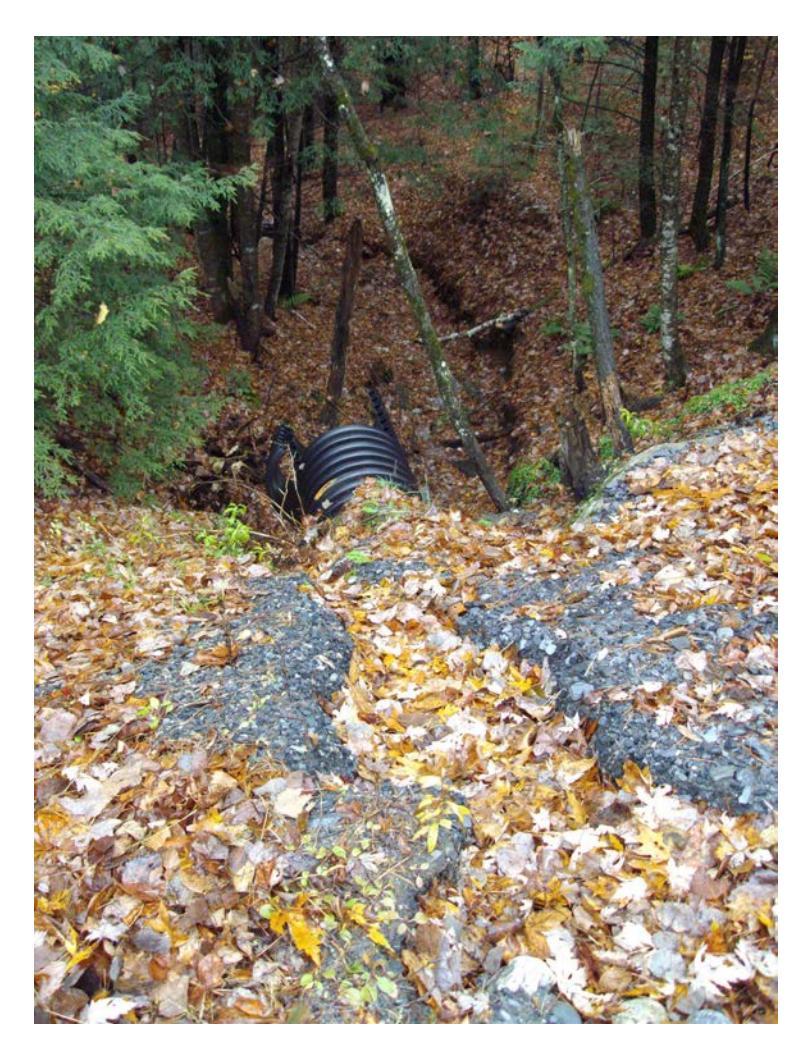
A typical unstable gully is shown in Figures 12 and 13. The gully is part of a landslidegully complex on the southwest bank of the Ompompanoosuc River in Thetford that has eroded into about 20 feet of loose, coarse-sandy boulder cobble gravel overlying 11 feet of dense finesand to silt-matrix till over bedrock. The culvert outfall shown in Figure 12 drains onto the slope. In this particular case it appears that road runoff has contributed significantly to the formation of the gully.

Figure 12. Looking down at a typical unstable gully near the Ompompanoosuc River in Thetford.

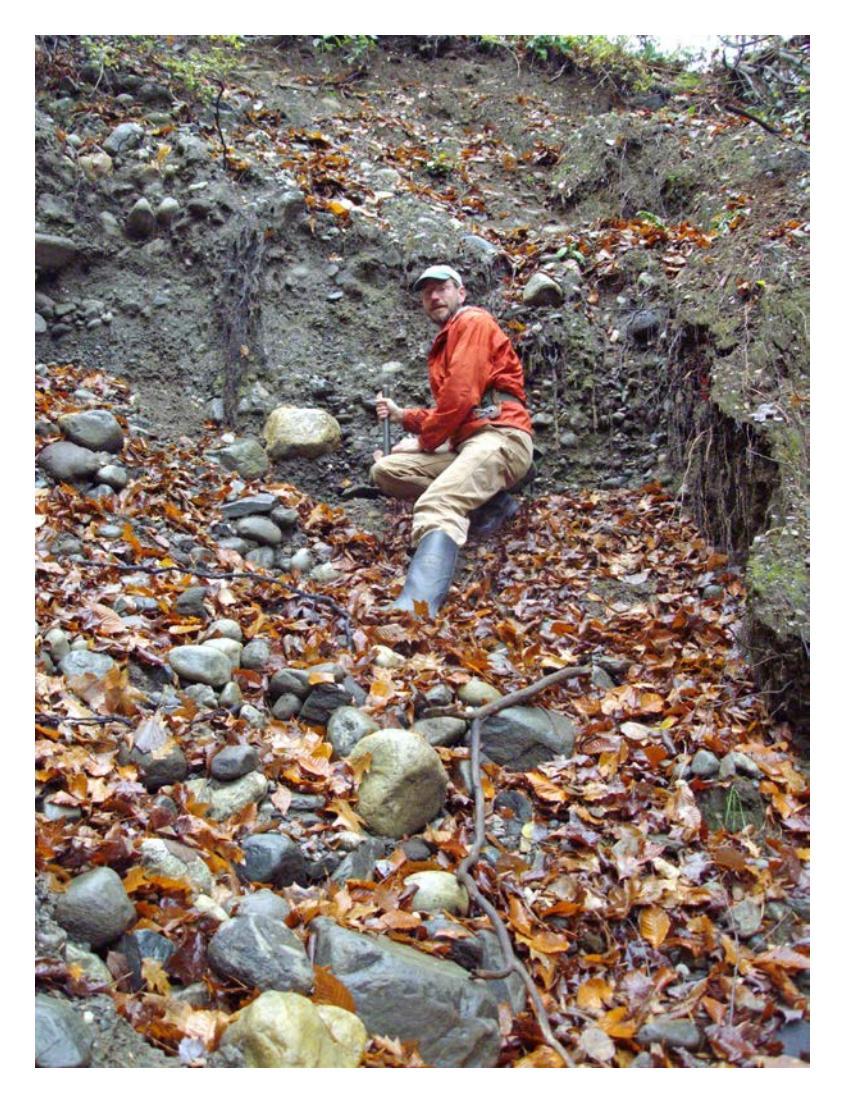
Figure 13. Looking up the center of the gully at highly erodible gravel deposit.

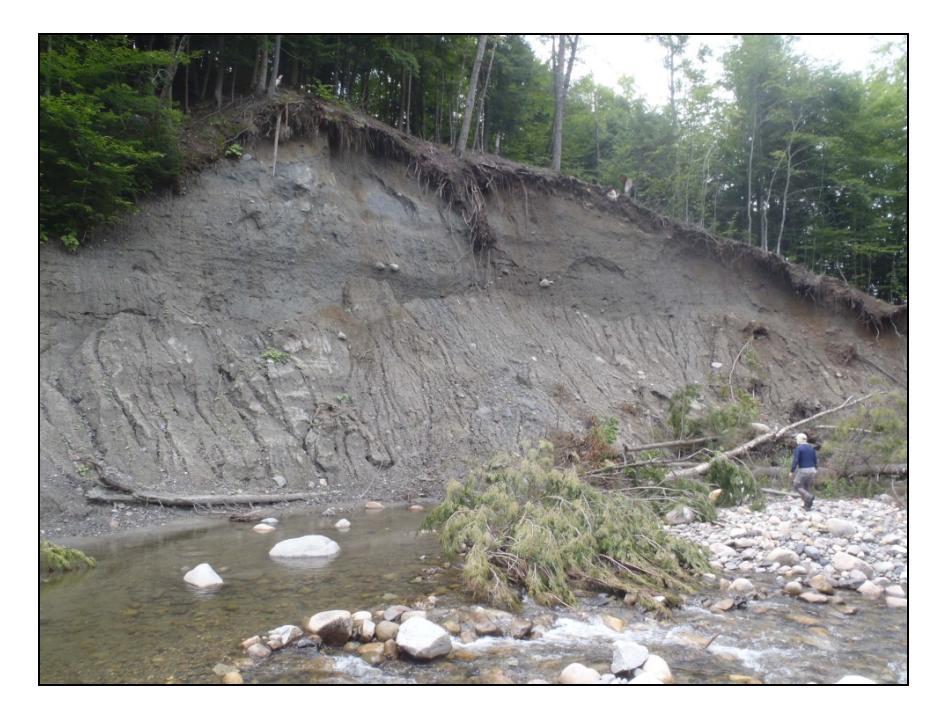
Many of the landslides in Orange County originate in glacial till deposits. A typical landslide in till is shown in Figure 14. Observations of the landslides here and elsewhere in Vermont suggest the following as a common sequence of events on till-dominated slopes in response to catastrophic flood events (Springston and Thomas, 2018). Note that the events described below will not always take place in a sequence of discrete steps. For example, a translational slide on the upper part of a landslide may be occurring at the same time that the base is being undercut by flood waters. The model is illustrated in Figure 15.

Figure 14. A typical large landslide in till. From the Great Brook watershed in Plainfield, Vermont. Photo taken in 2013 by George Springston.
