Winhall River Watershed Corridor Plan

Winhall, Jamaica, & Londonderry, Vermont
October 27, 2014

Prepared by:
Bear Creek Environmental, LLC
149 State Street, Suite 3
Montpelier, Vermont 05602

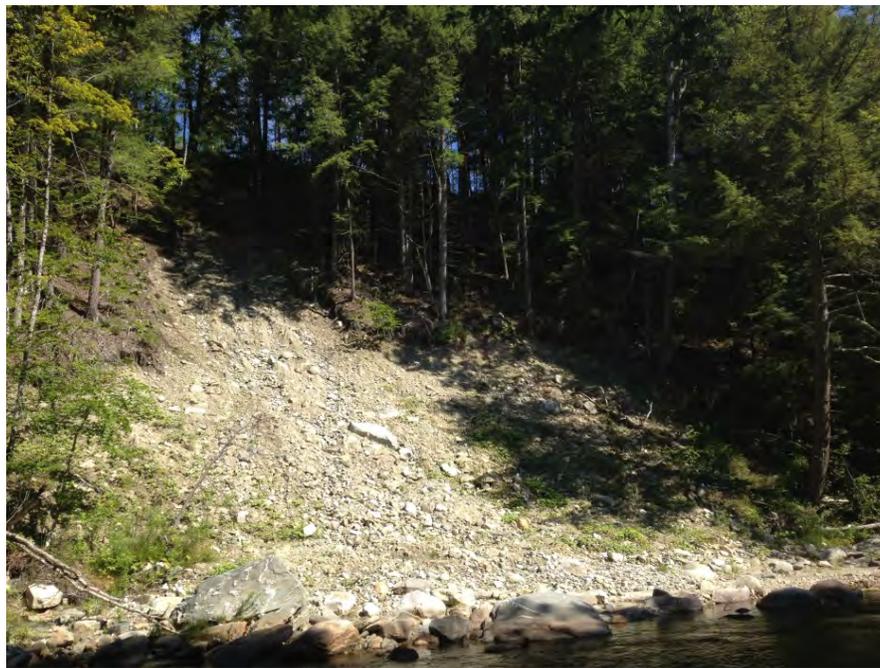
Figure 5.4. One of many mass failures present in T11.01-A.

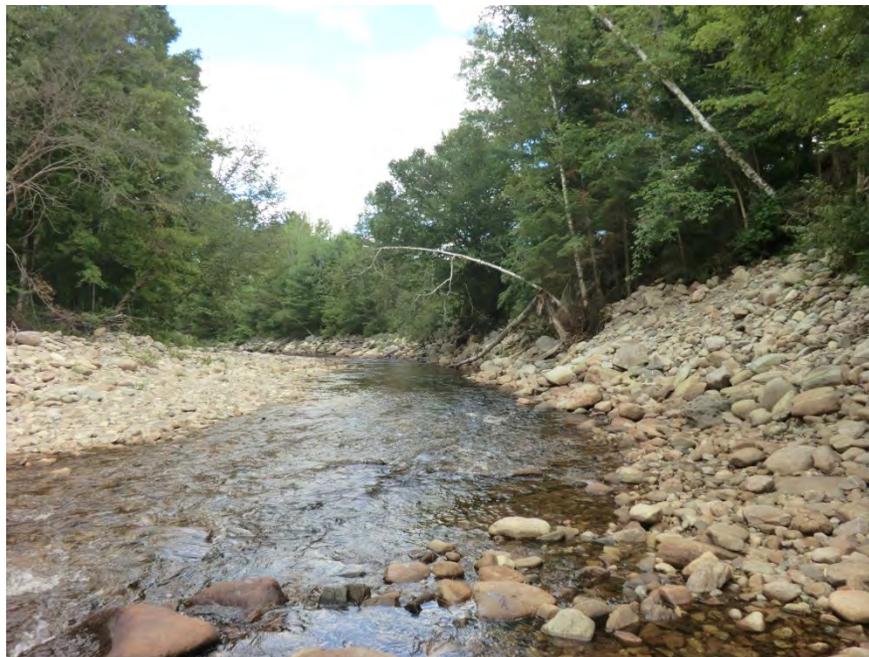
Figure 5.7. T11.03-A was windrowed extensively post-Irene.

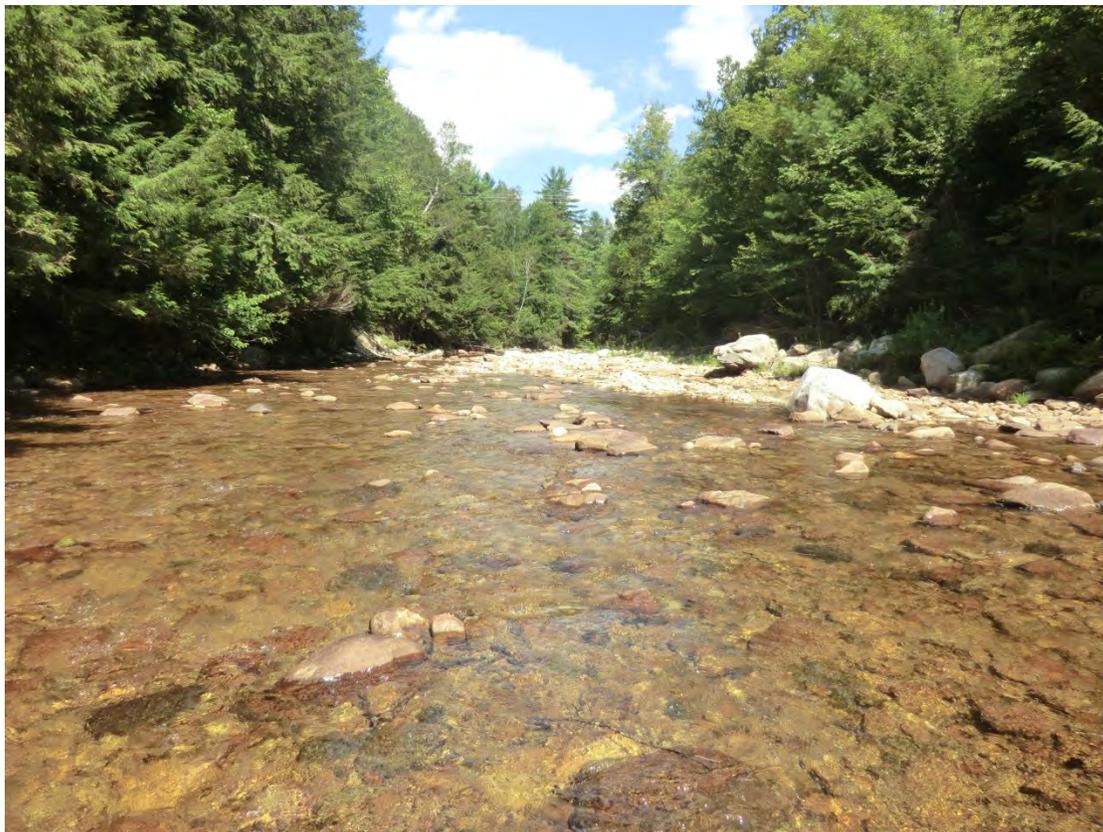
Figure 5.8. A featureless plane bed channel dominates in T11.03-B.

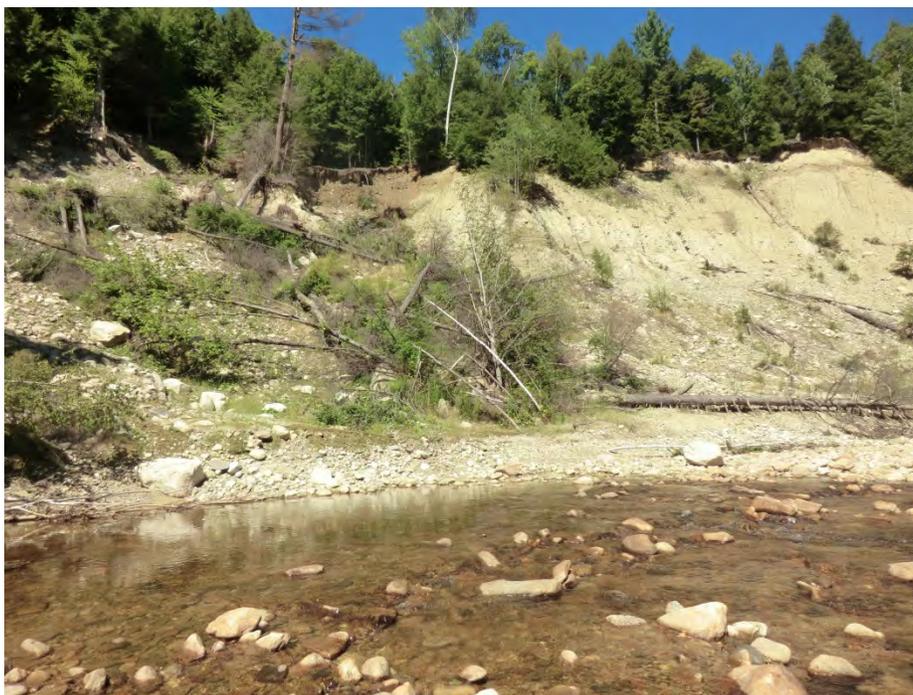
Figure 5.10. One of seven large mass failures in T11.04.

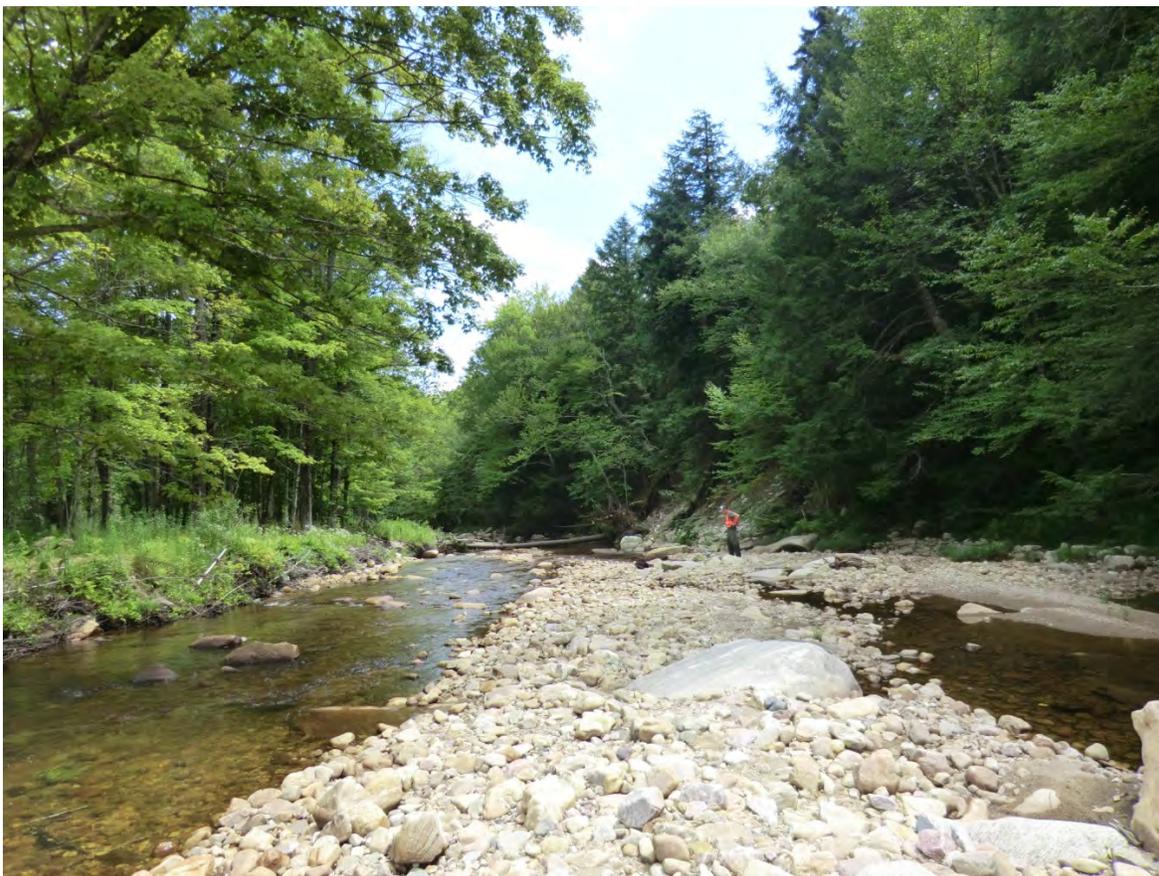
Figure 5.12. T11.05-B is undergoing major aggradation, but has good floodplain access.

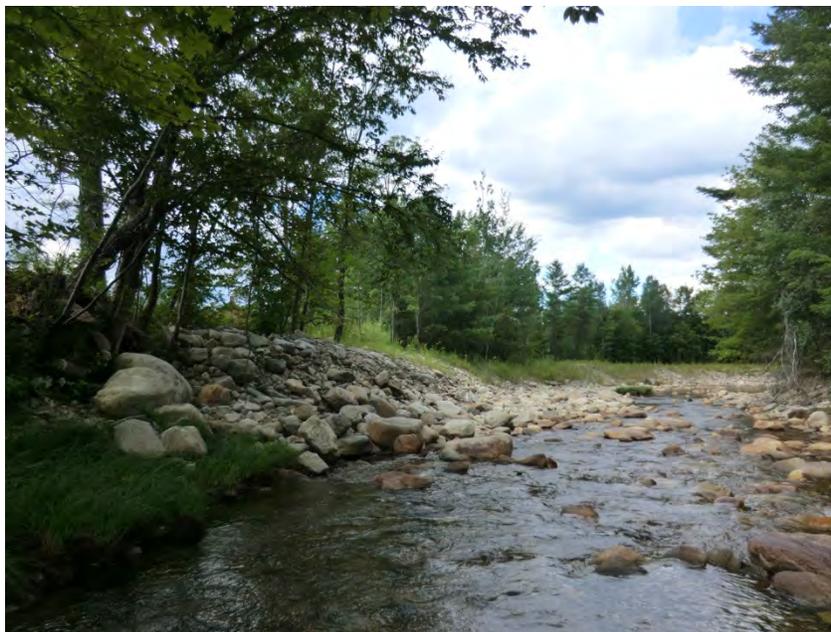
Figure 5.13. T11.06-A was windrowed extensively during post-TSI channel work and has lost its bedform.

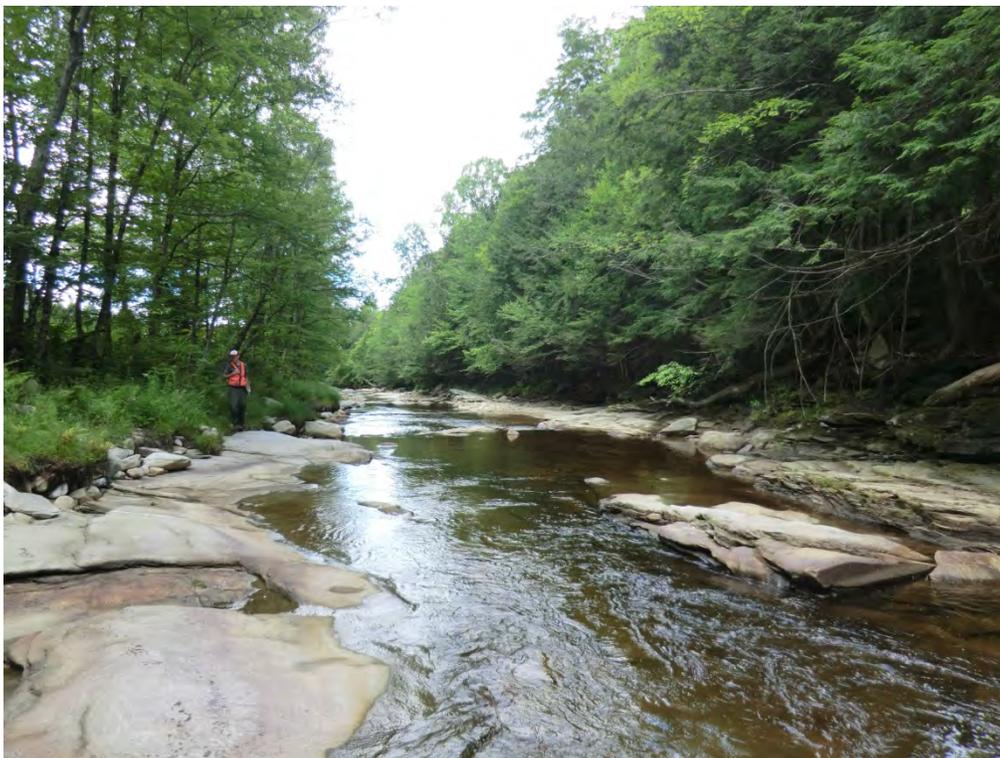
Figure 5.14. The stream channel in T11.06-B has incised to bedrock and lost its riffle-pool bedform.

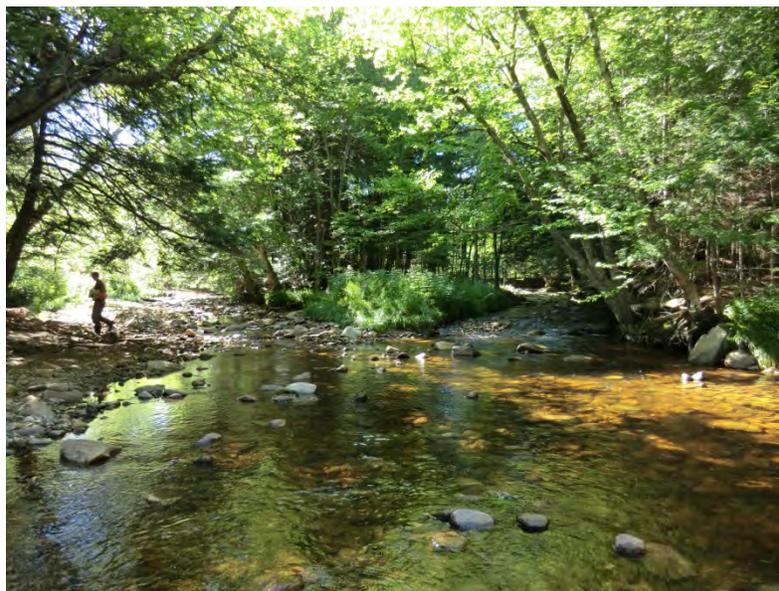
Figure 5.17. Braiding is common in T11.08-A due to the presence of an alluvial fan.

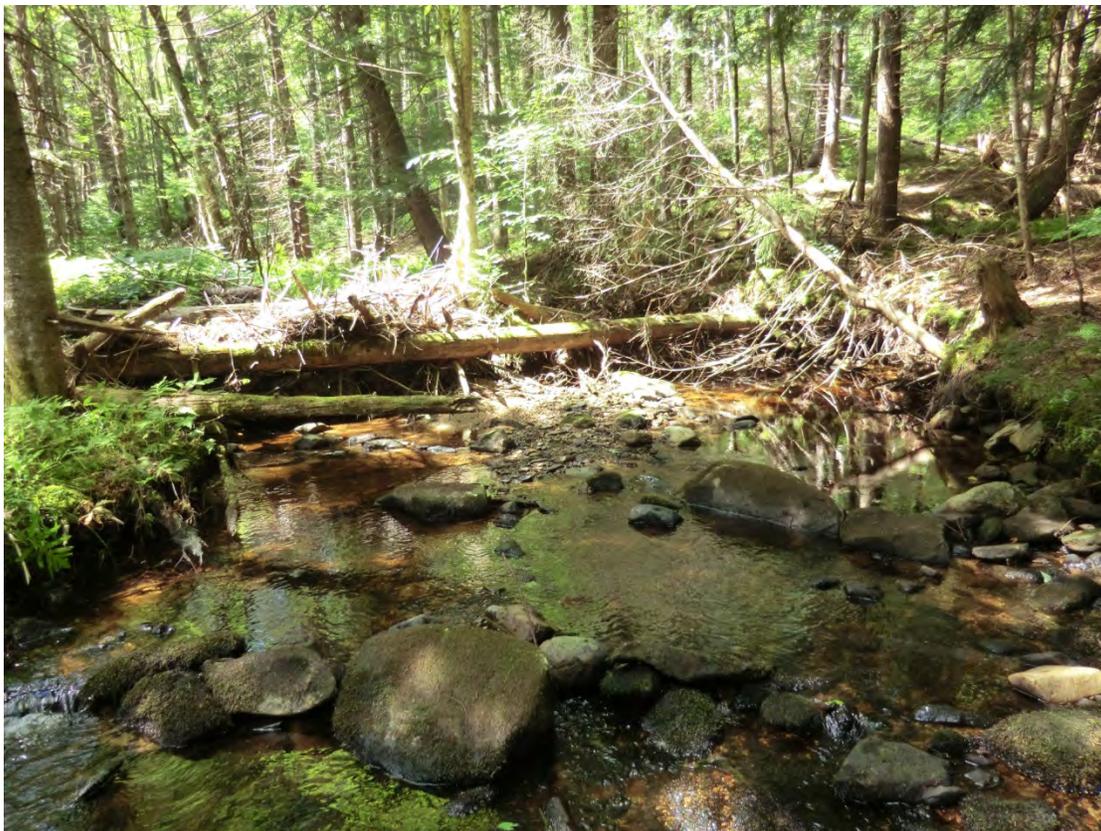
Figure 5.23. Debris jams are common in T11.S3.01-D and are causing planform adjustment.

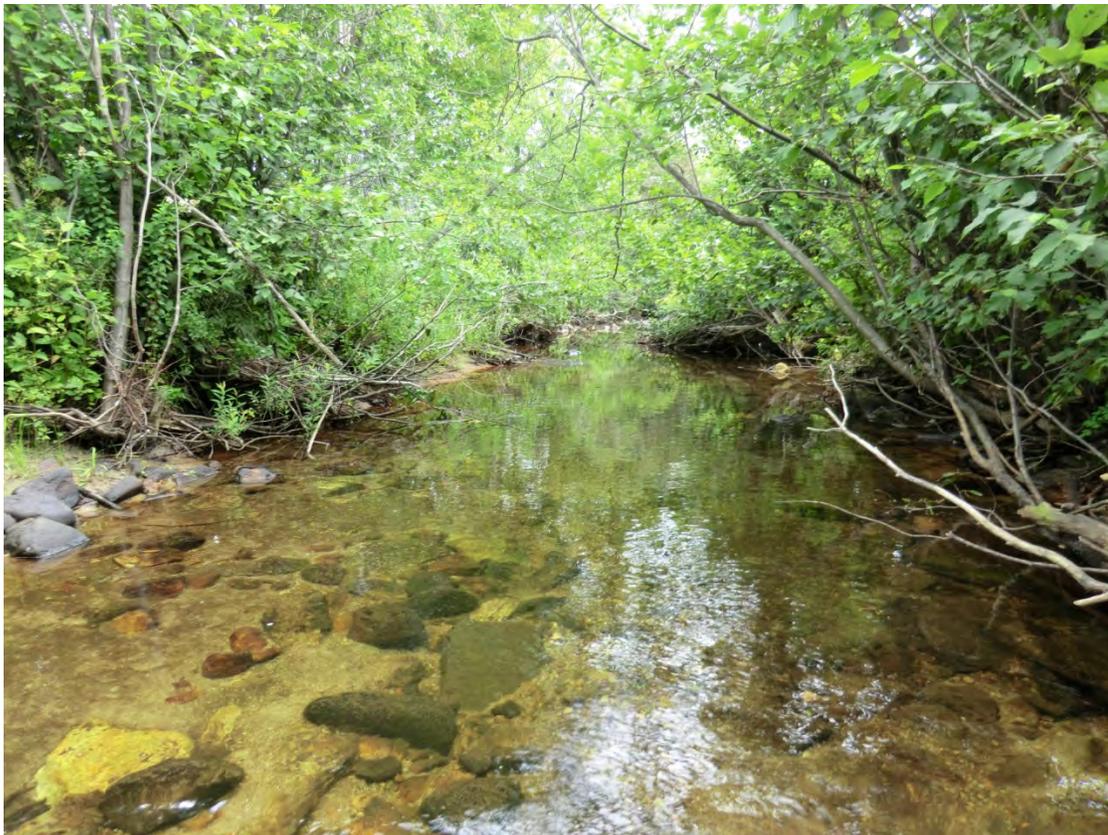
Figure 5.25. T11.S4.01-A has a reference riffle-pool bedform but has likely been converted to plane bed due to channel straightening.

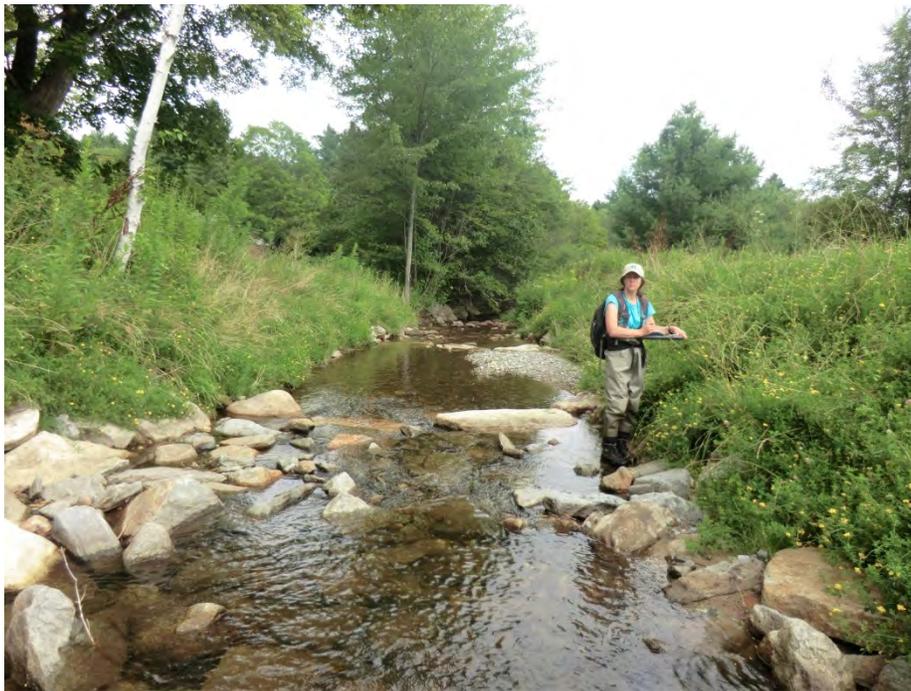
Figure 5.28. A riffle-pool bedform has been converted to featureless plane bed in T11.S4.02-A.

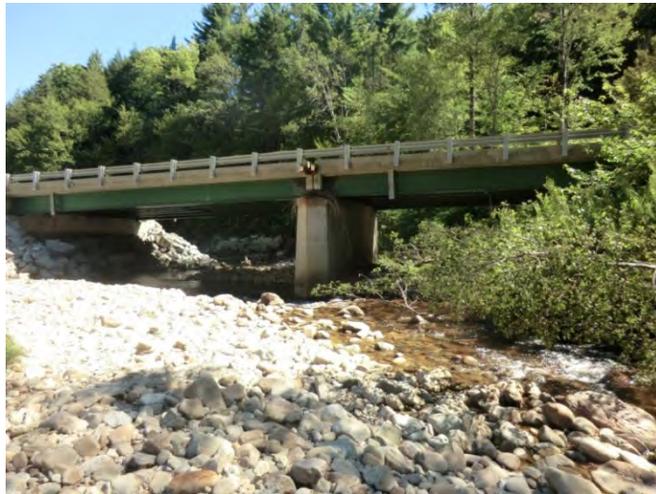
Figure 5.30. Rt. 30 bridge with aggradation and alignment problems in T11.04.

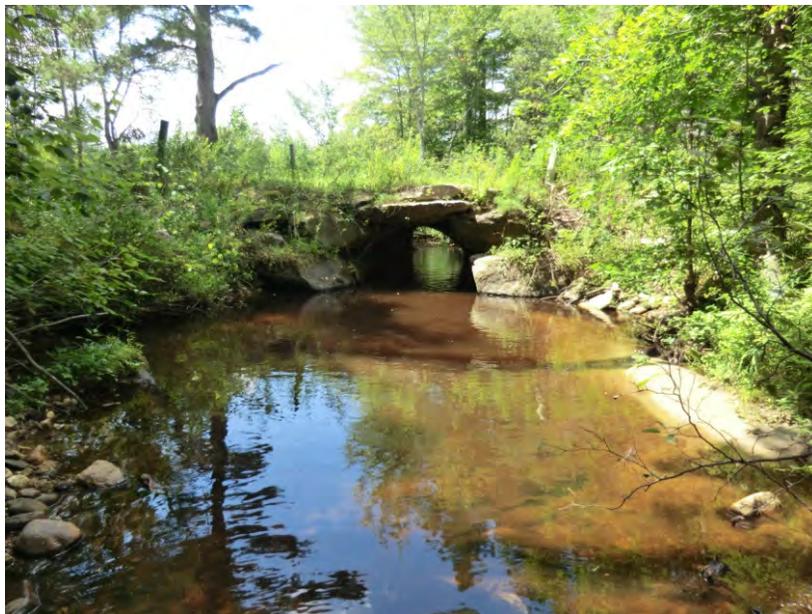
Figure 5.33. A culvert under River Road in T11.S3.01-A is very undersized.

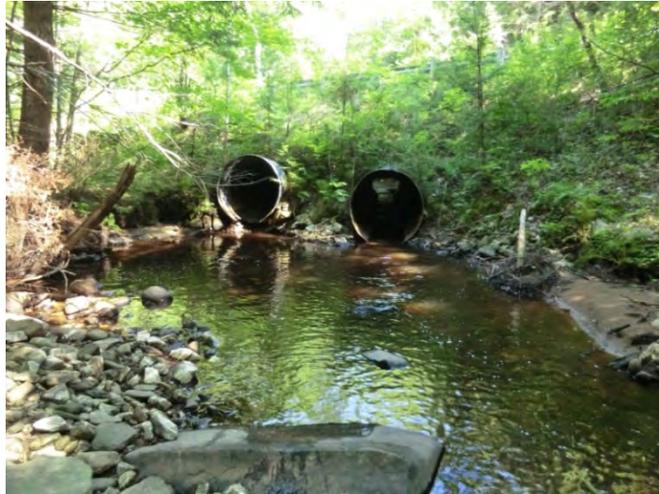
Figure 5.34. One culvert captures all baseflow and the other is rusting out at Raspberry Hill in T11.S3.01-B.

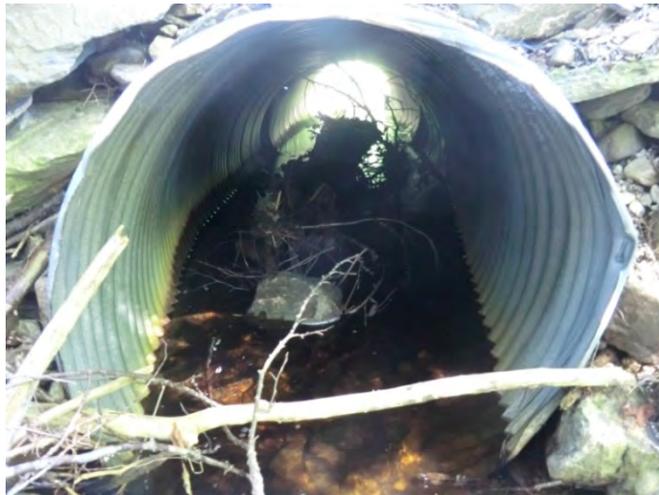
Figure 5.35. The culvert on Red Brook under Cranberry Hill Rd is full of woody debris.

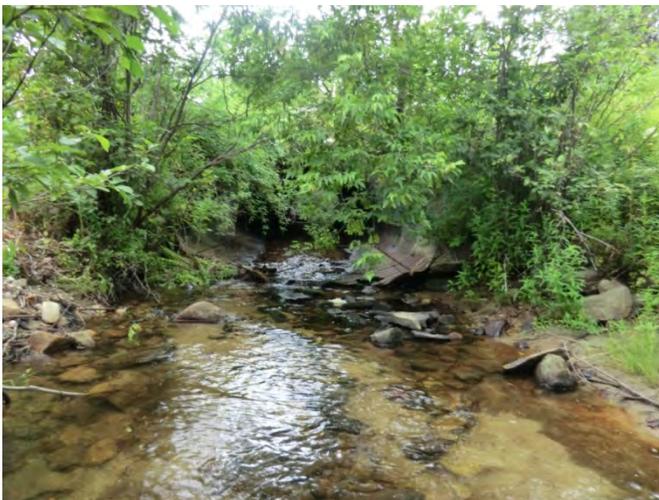
Figure 5.37. The bottom of the culvert under Rt. 30 in T11.S4.01-B is rusting out.

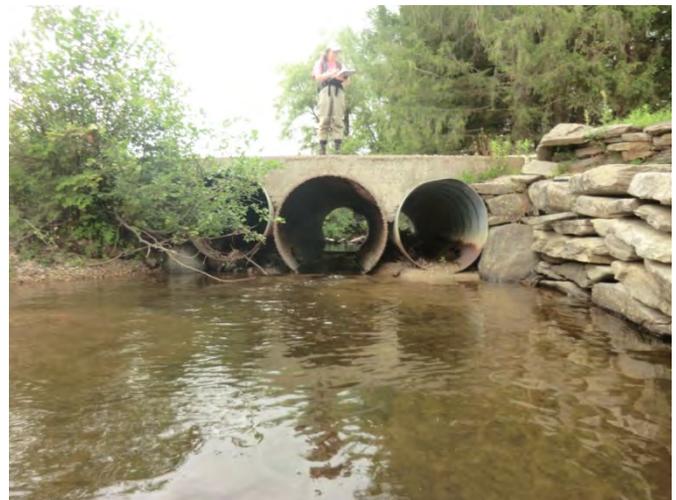
Figure 5.38. One of three culverts under Stratton View Rd in T11.S4.01-B is rusted out.

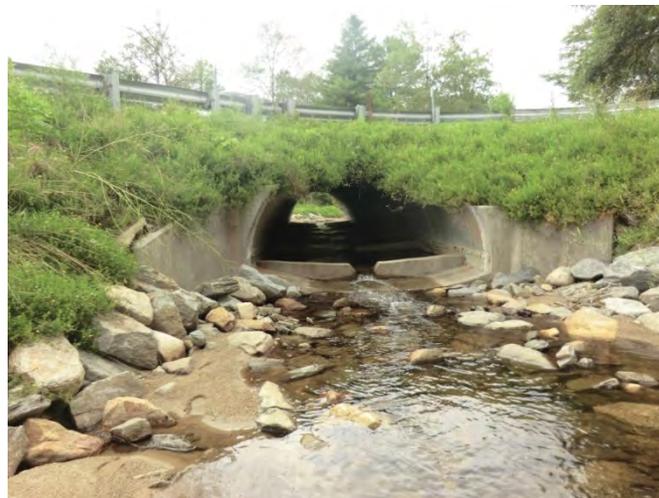
Lastly, a culvert under Rt. 30 in segment T11.S4.02-A has been recommended for replacement with a low priority (Figure 5.39). The culvert is undersized, but is in good condition. Baffles are present throughout the structure and there is a drop of 0.4 feet at the outlet. The structure's alignment with the channel is poor. Deposition is present above the structure and scour below.

Figure 5.39. The culvert under Rt. 30 has a small drop at the outlet and baffles throughout.
