**Rock River Watershed
Stream Geomorphic Assessment
Phase 2 Report
May, 2007**

Table of Contents

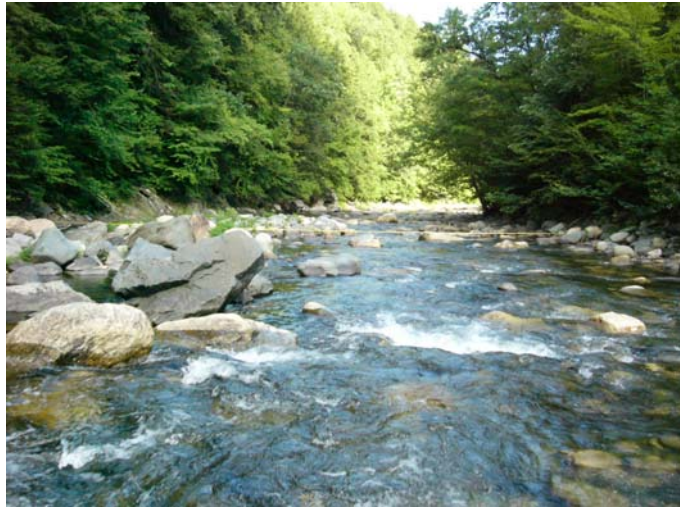
This reach is located at the confluence of the Rock River and the West River in a naturally semi-confined valley. The reach is dominated by series of ledge outcrops that create deep pools with steep riffles in between them. It is both a Bc by reference and currently a Bc type channel although it is moderately entrenched and very incised. The right bank has an old road bed running along its entire length that is a public right of way that facilitates access by swimmers and is likely a recently abandoned floodplain feature. This road is found on the 1893 and 1935 USGS

topographic maps but is not shown on the 1954 edition. There are six steep riffles at the upstream end of the reach which may be related to the historic dam on T08.03. When it was removed it is likely a large amount of sediment was released, causing the previously sediment starved (and thus incised) river to now be aggrading. Reference channel width is 78' and current channel width is 115'.

This reach is in "Fair" geomorphic condition, is highly sensitive and in channel evolution stage IV-F; aggrading with historic widening and degradation. The habitat condition was rated good.

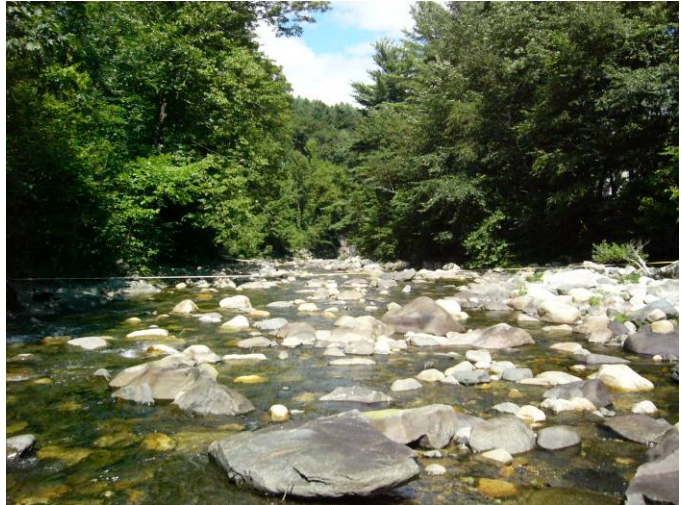
This reach is located downstream of the village of Williamsville in a semi-confined valley and it is naturally straight. There is a gravel town road along the entire right bank, which used to connect to the road in T2.01, and the left corridor is almost entirely mowed meadow though the stream bank is vegetated along both banks. There are no channel or floodplain constrictions and no grade controls that span the entire channel. However, there is ledge across the right channel in the upstream section of the reach where the stream accesses a left bank channel during high water. Reference channel width is 77' and current channel width is 96'.

T2.02 is a C plane bed stream type by reference but is currently an F plane bed channel type that is in stage IV of the F-stage channel evolution process. It is aggrading with historic degradation and widening and is in fair geomorphic condition. The habitat condition was rated good.

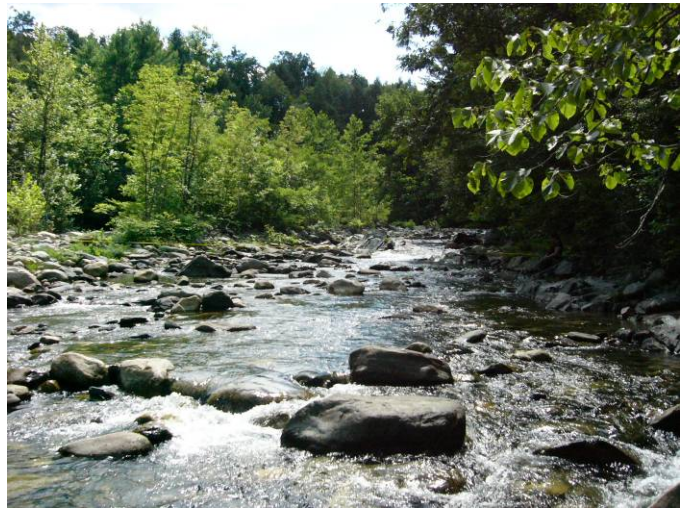
This reach is in the village of Williamsville and has a popular public swimming area in the pools created by the channel spanning grade control. It is located in a narrowly confined valley that has been altered by human land use. There is a road the entire length of the left corridor with development along most of it. The reach is dominated by ledge with an over-widened section that has two parallel flood channels. Local residents report that the main flow has been in the left channel for at least the past 30 years and the river accesses both flood channels during high flow events. All of this is down stream of channel spanning grade control that had a wooden dam on it until it was “dismantled naturally after being declared unnecessary in the 1980’s” (Phase 1 SGA Report). Reference channel width for this reach is 76' and it is currently 96'.

There is one bridge in this reach that is flood prone area constriction with deposition above and below it. The left bank is dominated by the Dover Road and village development while the right bank is relatively undeveloped.

T2.03 is an F stream type in stage IV of the F-stage channel evolution process. The Phase 1 assessment identified this as a C riffle pool stream type. It is extremely sensitive and is in fair geomorphic condition. The habitat was condition was rated good.

Passive river management is recommended for this reach that will naturally narrow and re-build its floodplain as it continues to adjust to the removal of the dam. Community outreach is recommended to help residents and swimmers understand the fluvial processes at work in their part of the river.

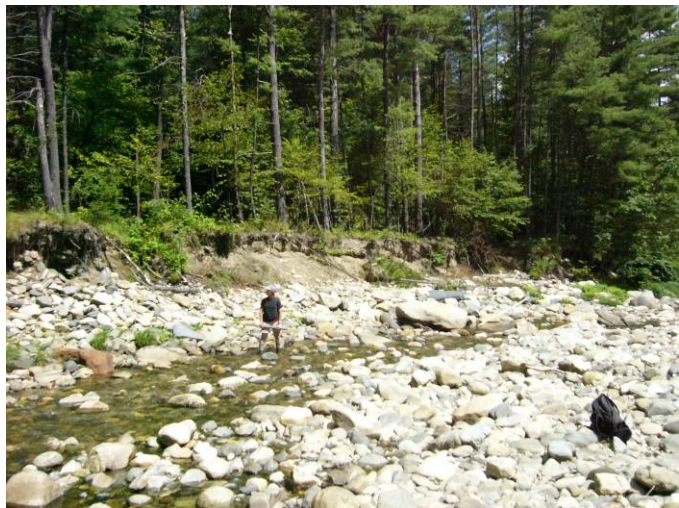
This reach was segmented due to channel dimension, substrate size, and planform and slope. It is located in a narrow valley due to human caused changes to the valley width (it is up against the road). This segment is eroding on the left bank for the entire length and has rip rap along one third of right bank where the road is closest to the channel. There was an active logging operation along the top of the left bank, a steep riffle in the down stream portion of the reach and a very large mid-channel bar dominating the mid section of the reach. There are no channel constrictions in this segment. Reference channel width is 67' and current channel width is 128'.

The stream is currently an F plane bed, though it is a C type stream by reference. It is in stage IV of the F-stage channel evolution model, currently experiencing planform adjustment. It is extremely sensitive and is in fair geomorphic condition. Habitat was rated in fair condition. The

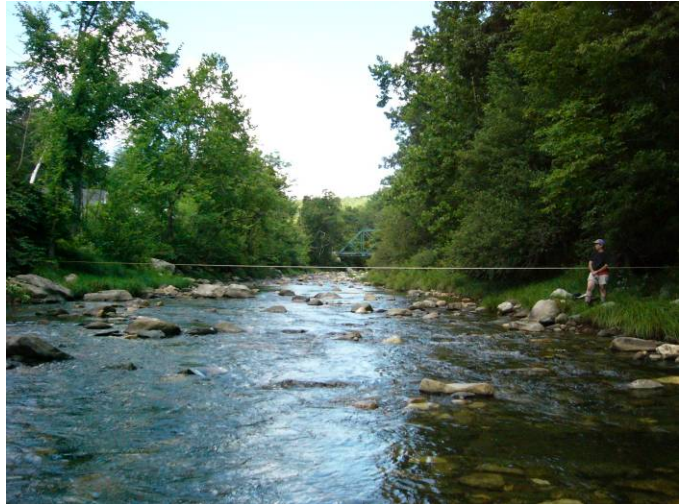
The segment is a C riffle pool stream type currently and by reference. It is in good geomorphic condition and is in stage I of the F-stage channel evolution model with minor degradation and widening as the dominant adjustment processes. Stream sensitivity is moderate and the habitat condition was rated good.

The left bank of this segment is critical as floodplain that it accesses during high flow events and it should be conserved.

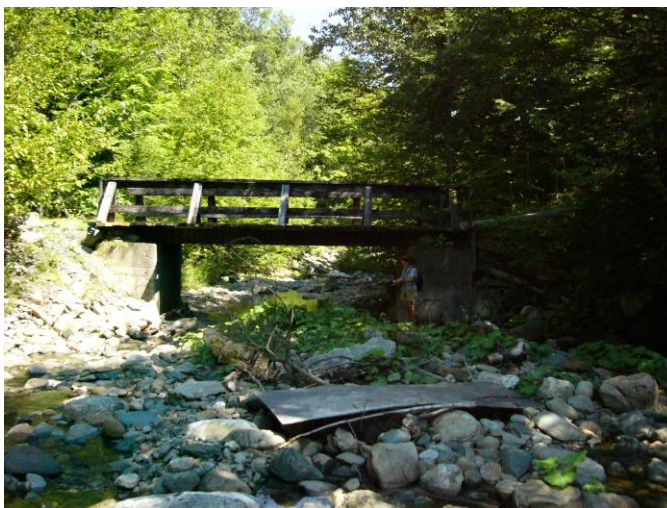
This reach runs from East Dover upstream to Goose City and is located in a naturally narrowly confined valley that also has a road in it. There are numerous mid, point, side and diagonal bars as well as two islands and seven flood chutes throughout this reach. It is 17% bermed. The road is in the river corridor for almost half of its length. There are three bridges in this reach, one of which is a minor (< 1') channel constriction, and the other two are floodplain constrictions. There are three mass failures and two steep riffles. This is the first reach on the main stem with a large amount of woody debris (19 pieces).

There are numerous seasonal camps in the corridor, one of which was being accessed by a new ford while we were surveying the stream. Reference channel width is 26' and current channel width is 31'.

This reach is a B plane bed by reference but is currently moderately entrenched and very incised, making it an F plane bed. It has undergone historic degradation and is presently in planform adjustment. The geomorphic condition is fair and it is in stage IV of the F-stage channel evolution process. The habitat condition is also fair.

This reach would benefit from the establishment of a Fluvial Erosion Hazard Zone (FEH) to prevent further encroachments into the corridor and from working with landowners and the town to implement best management practices as new camps and year round residences are built.

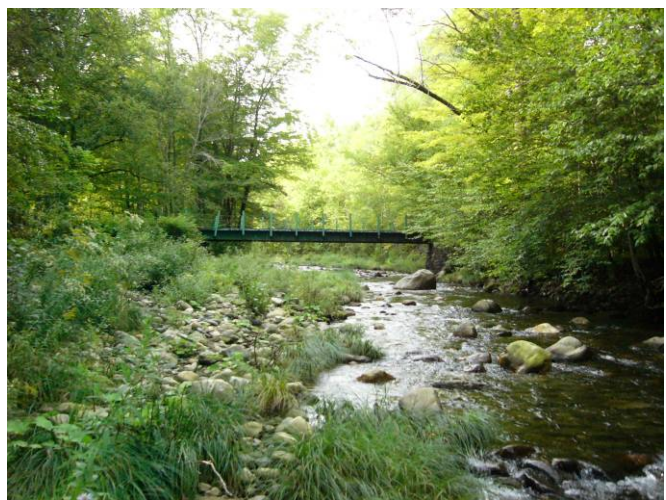
This reach is located along Augerhole Road from Lahar Road upstream to just after Adam's Brook joins the Marlboro Branch. It is a half a mile long and in a very broad valley type, though the valley narrows in the middle of the reach. There is 1,600' of berming and 780' of erosion along the reach. There is one bridge at the downstream end of the reach that is both a channel and floodplain constriction. The reference channel width is 38' and the current channel width is 56'.

The reach is C riffle pool both by reference and currently. It is in stage IV of the F-stage channel evolution process and is in good

geomorphic condition with minor planform being the dominant adjustment process. The habitat was also rated in good condition.

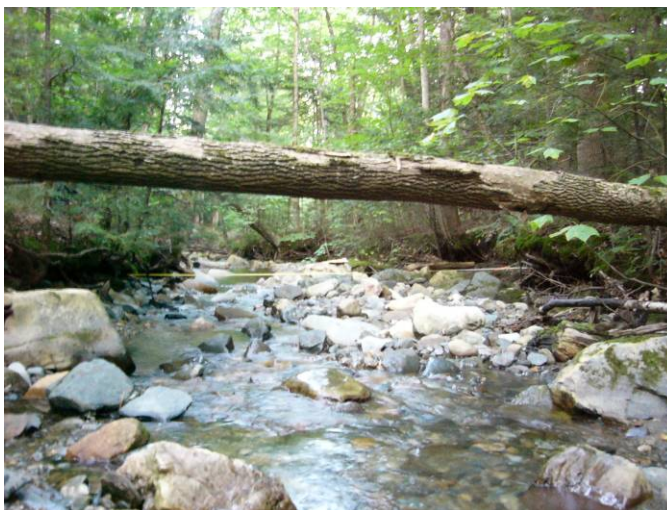
There are six structures in this reach, only one of which is not a channel constriction. They all have deposition above them and

all but one has deposition below and it has scour below. There are 12 mid channel, 22 point and 55 side bars in this reach alone and 22 pieces of large woody debris. This segment has 1,200' of erosion on both the right and left banks. There are three channel spanning natural grade controls in this segment as well. It is 21% rip-rapped along the left bank. The reference channel width is 15' and the current channel width is 18'.
