STORMWATER MANAGEMENT PLAN FOR SWANTON TOWN AND VILLAGE

FINAL REPORT

Stone Project ID 112475-W
February 21, 2013

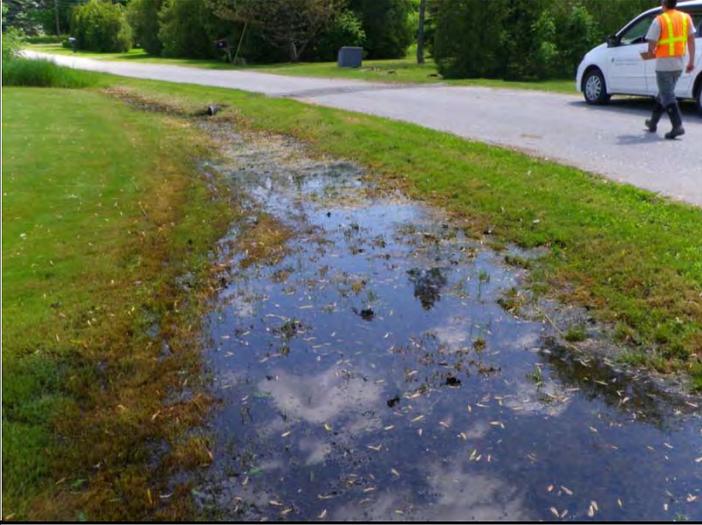
Photo 1. Ponding on North side of road	Photo 2. Drainage ditch coming from neighborhood

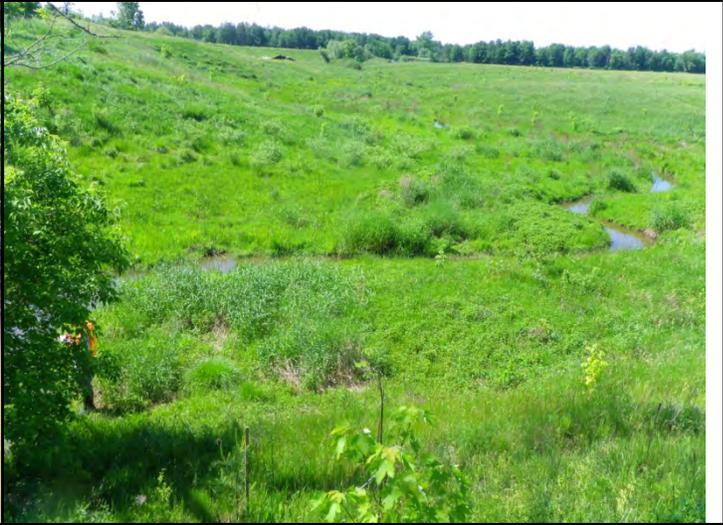
Photo 4. Floodplain leading to culvert (C2)

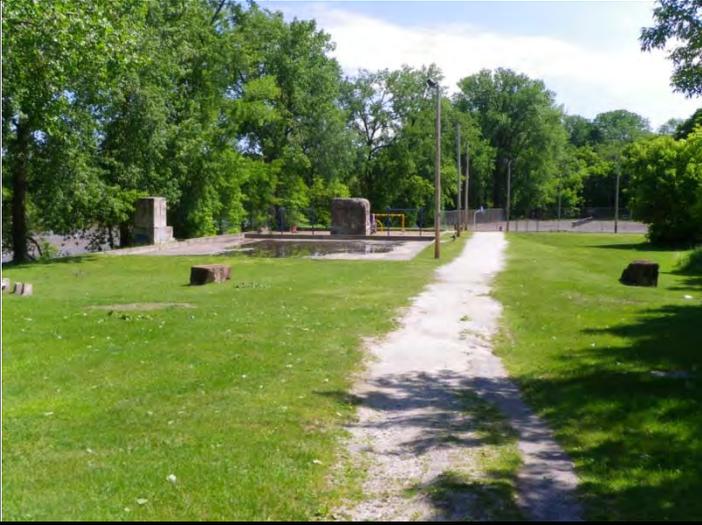
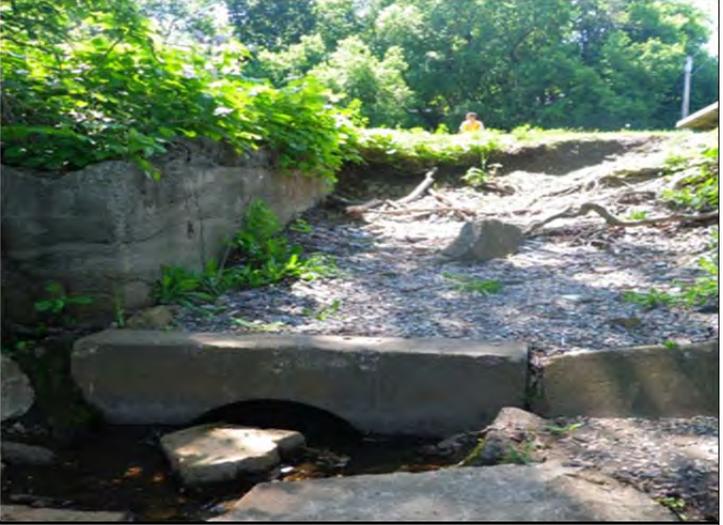
Photo 1. Erosion in access road/path	Photo 2. Washout and outfall, in park near river

Description of Observed Conditions:
Erosion present in road/path to the park, runoff coming from parking lot above. Signs of standing water areas along southern end of park before the tennis courts. Washout area leading from park to rivers edge, with concrete outfall at the bottom. Outfall serves as storm water runoff from streets/village above the park. 4" of water flowing from drains.
The Village is currently working with NWRPC and VT DEC to implement a comprehensive treatment solution.

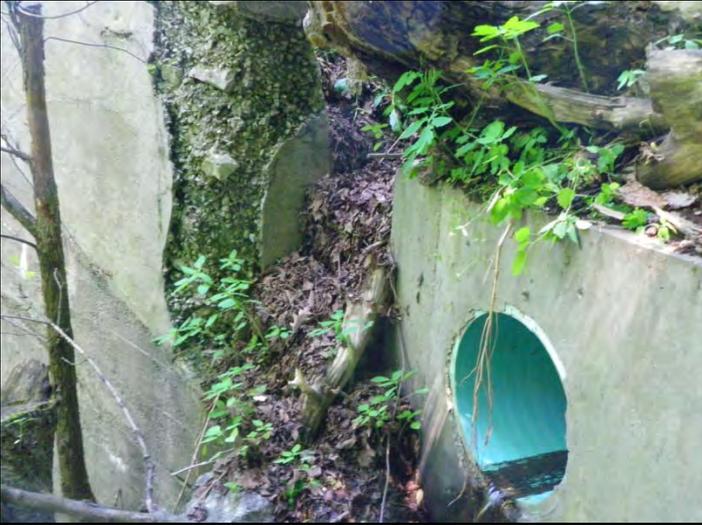
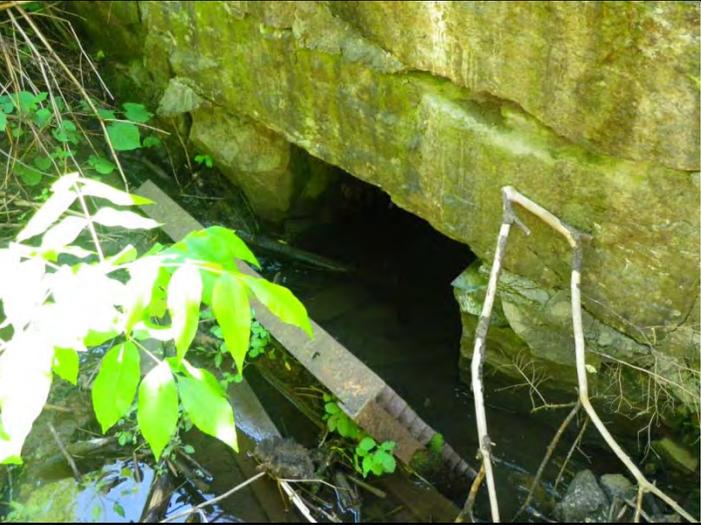
Photo 1. Stormwater pipe outfall into ravine	Photo 2. Box culvert running under Grand Ave.

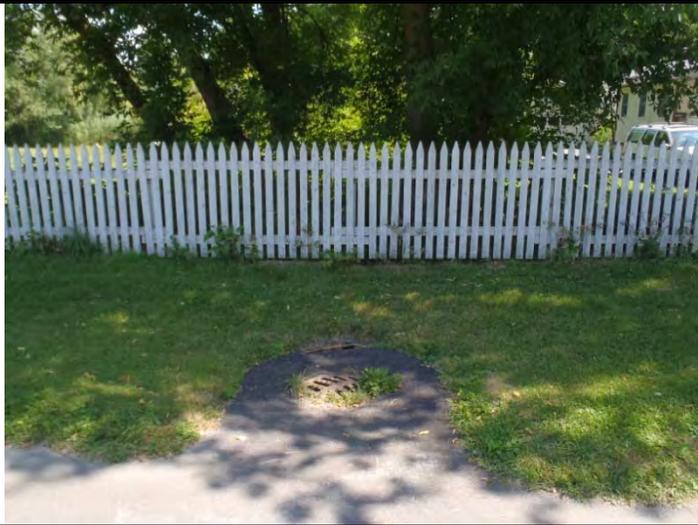
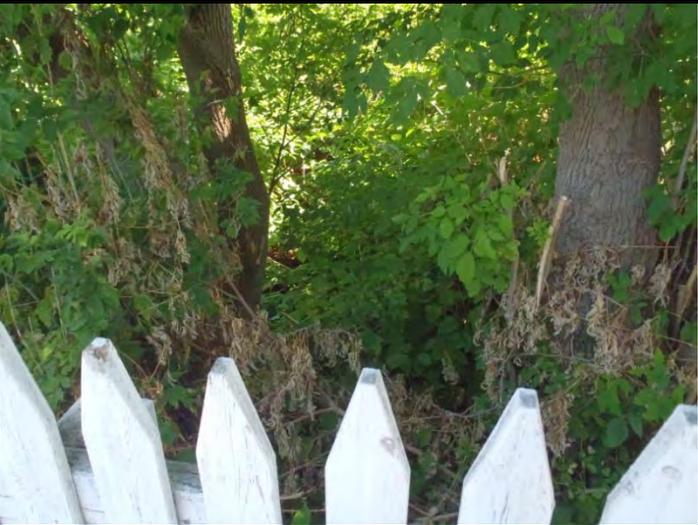
Photo 1. Stream from Greenwich, looking east	Photo 2. Stream below bridge/culvert

Description of Observed Conditions:
The stream appears to begin in the vicinity of First and Liberty Streets, and runs coincident with a stormline through the Village. Further investigation is needed to determine the extent of the system and any potential for retrofits or daylighting.

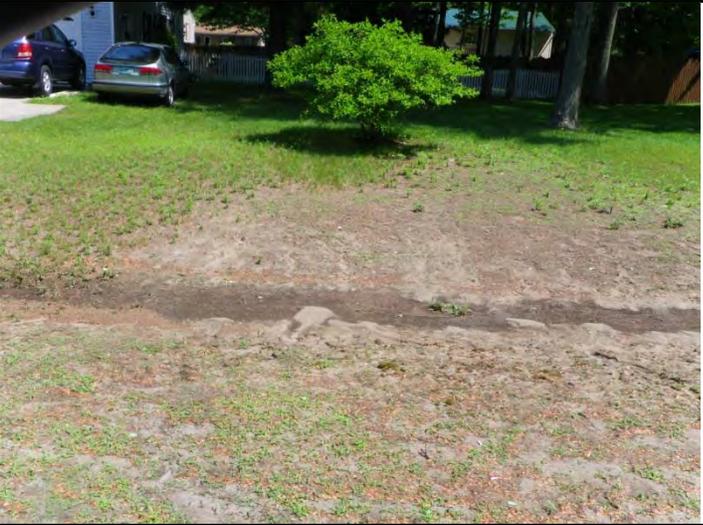
Photo 1. Catch basin (in background) seem to be working and flowing throughout neighborhood	Photo 2. Evidence of ponding water and localized erosion

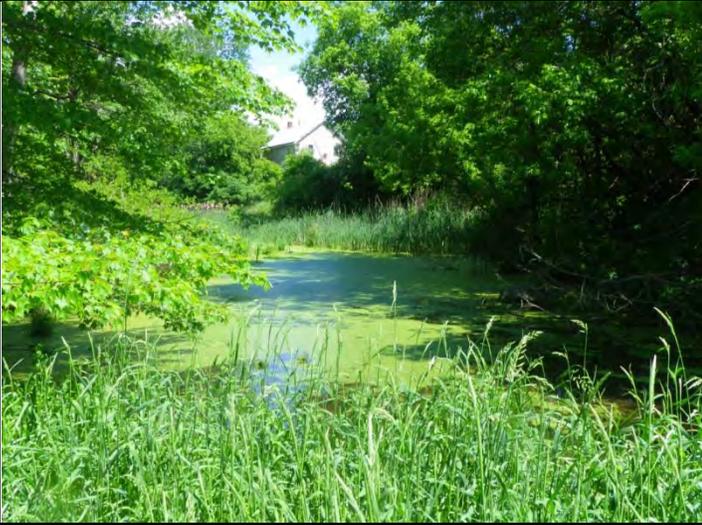
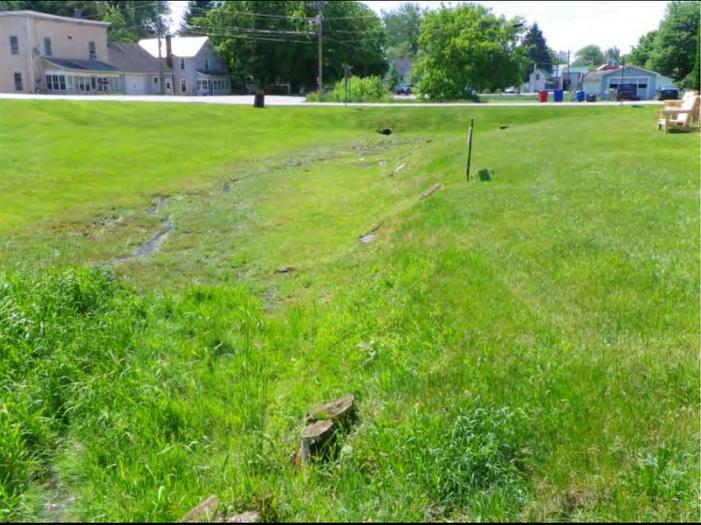
Photo 1. Existing pond	Photo 2. Swale between pond and culvert

Description of Observed Conditions:
 Existing retention pond north of 6 Brooklyn St (Photo 1). Water from pond extends parallel Rt. 78 into swale before reaching culvert under Brooklyn St. Sufficient room between retention pond and beginning of swale to extend pond and improve treatment. Retrofits could provide additional treatment for stormwater flows before outfall onto Goose Point. Landowner interest/willingness is unknown.

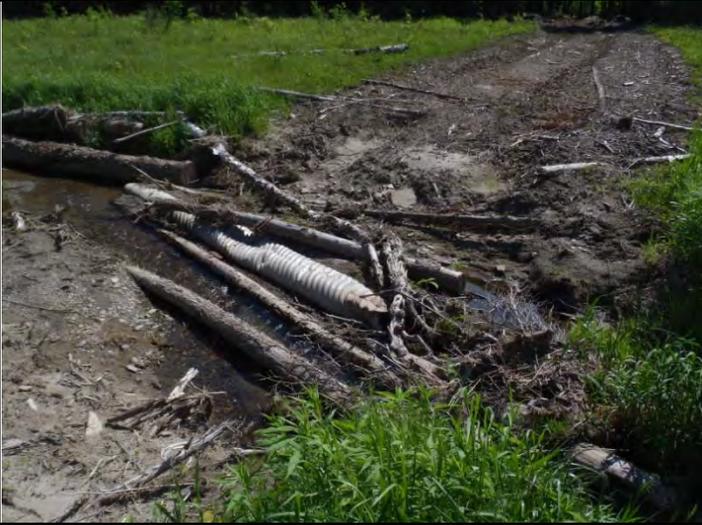
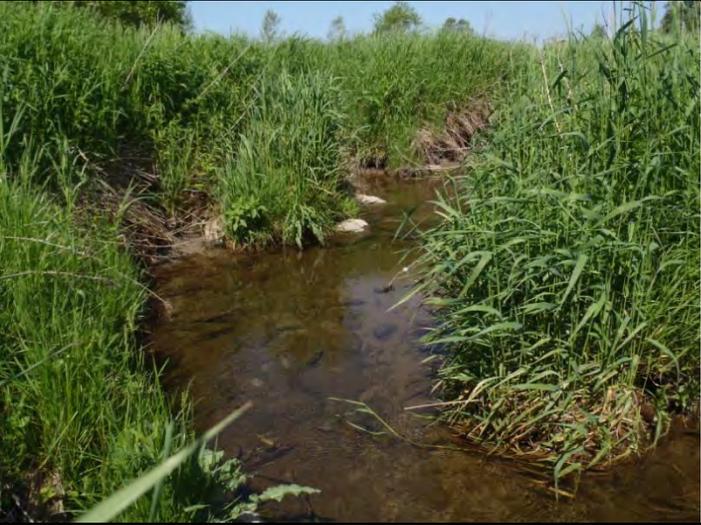
Photo 1. Destroyed Culvert	Photo 2. Bank undercutting downstream

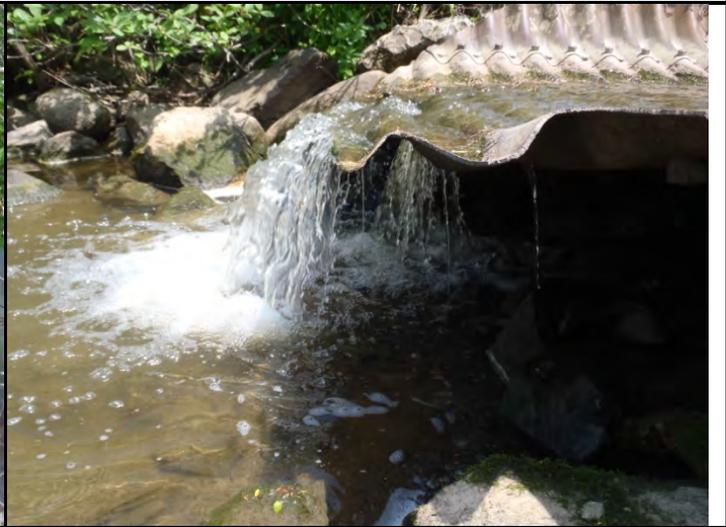
Photo 6. Outfall waterfall C3

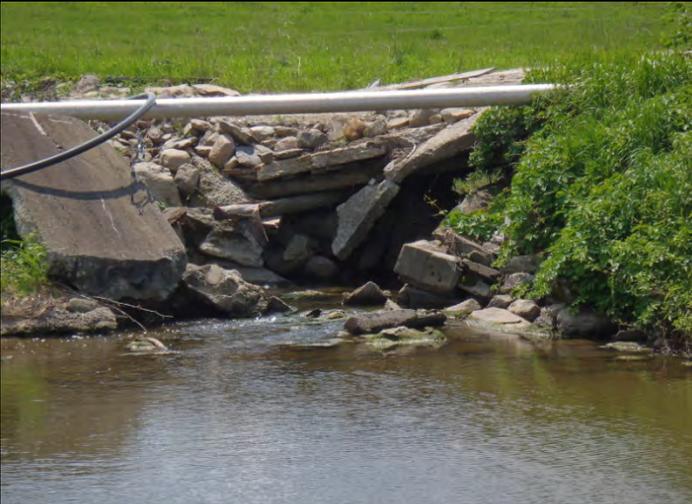
Photo 5. Extensive damage C4

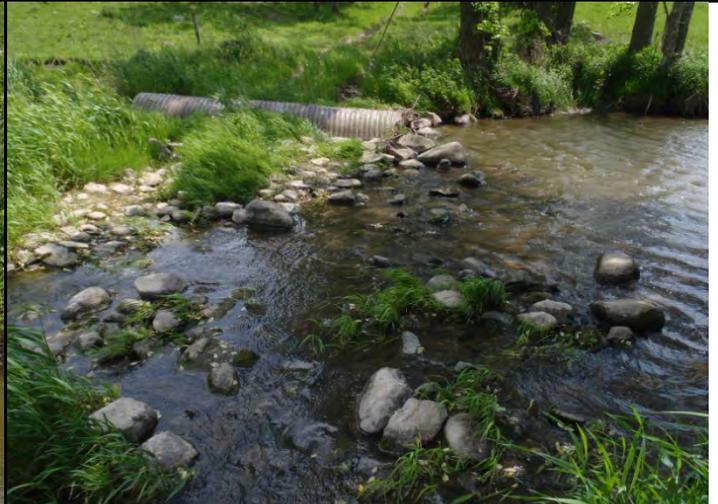
Photo 6. Brook bypassing culvert C5

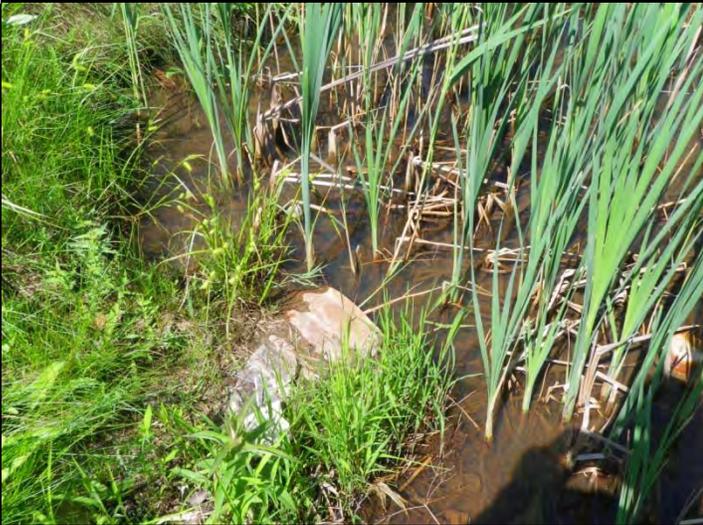
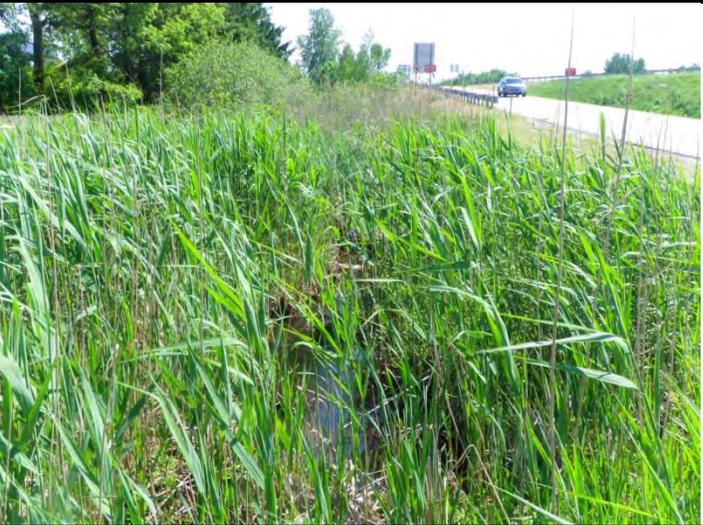
Photo 1. Partially clogged culvert	Photo 2. Reach R3S2.01 of Missisquoi

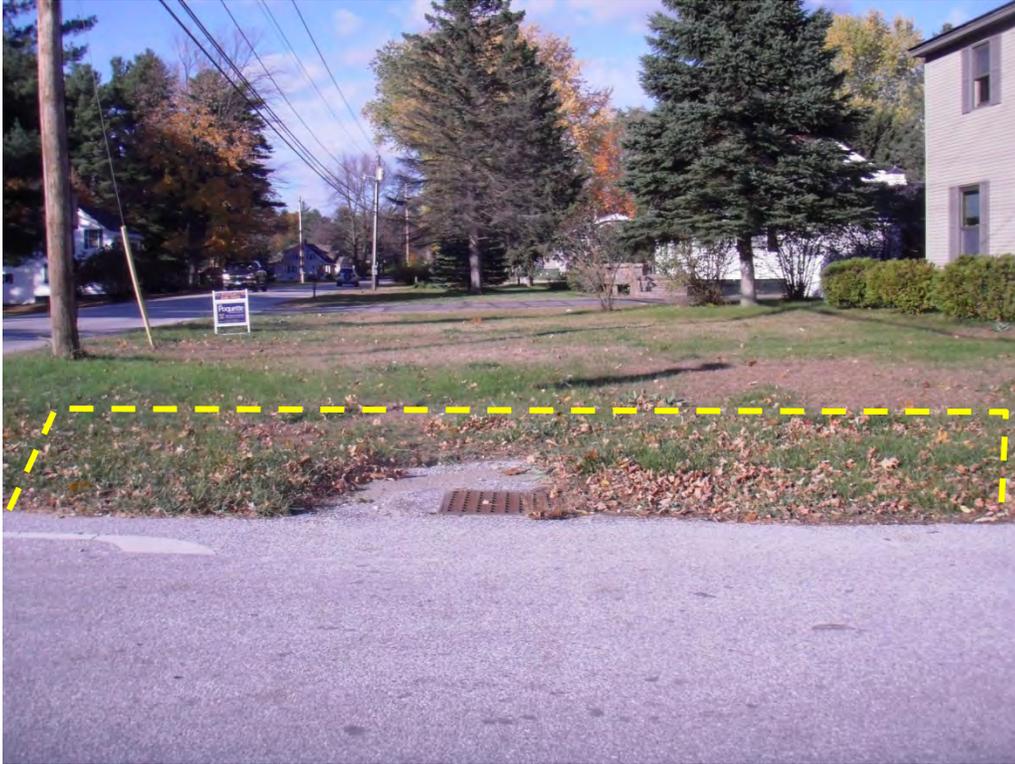
Figure 22. Catch basin on the corner of Thibault Pkwy and Spring St. could be retrofitted with an STP, such as a rain garden.

A catch basin adjacent to Thibault Parkway could be retrofitted and utilized as part of an STP, such as a simple rain garden. Site conditions, including Windsor loamy fine sand (HSG A) and a deep water table, would enable detention and infiltration of a significant portion of stormwater runoff from 0.04 acres of impervious surface draining to the existing catch basin.

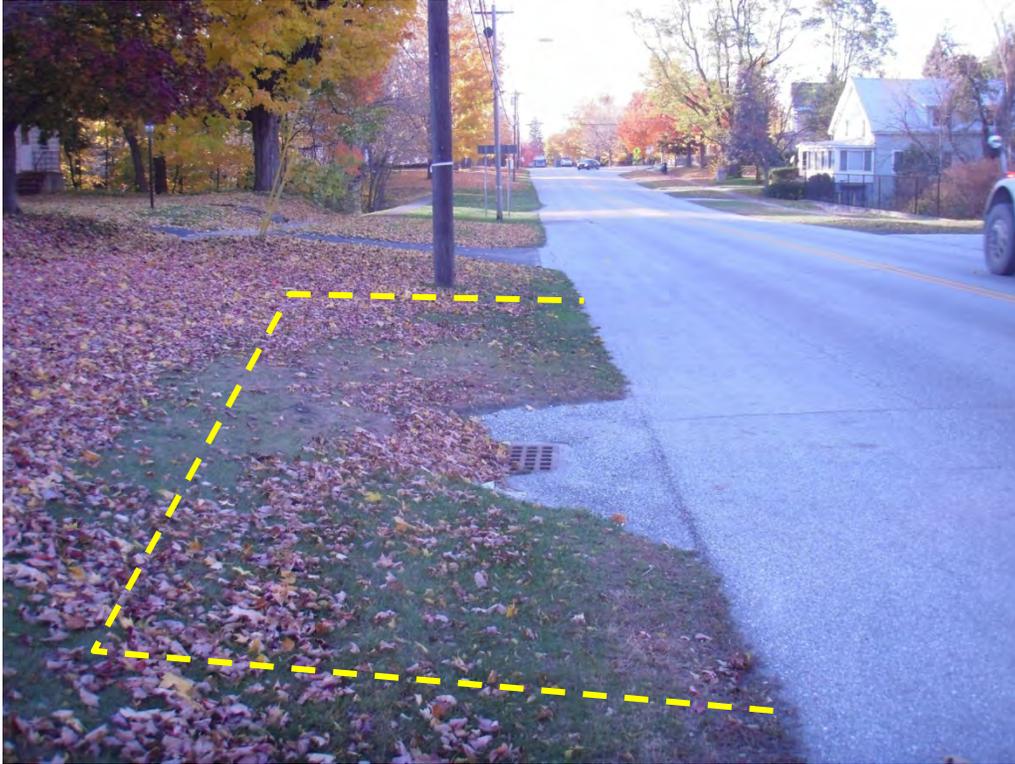
Figure 26. Catch basin on north side of Grand Ave. that could be modified as part of an STP.

Given the well-drained soils and position of existing catch basins, stormwater from this section of Grand Ave., could be treated with an infiltration-based STP (see Figure 26 and Figure 27). Water would infiltrate the underlying soils, or otherwise be slowly released with sediment removal occurring through settling and filtration.
