Lake Watershed Action Plans

Alison Marchione

Vermont Department of Environmental Conservation

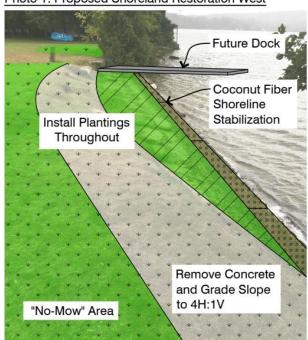
Photo 1: Proposed Shoreland Restoration West

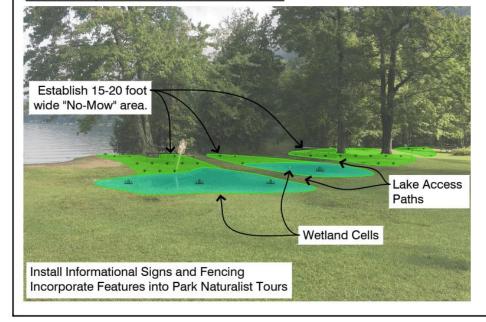
Photo 2: Proposed Shoreland Restoration East

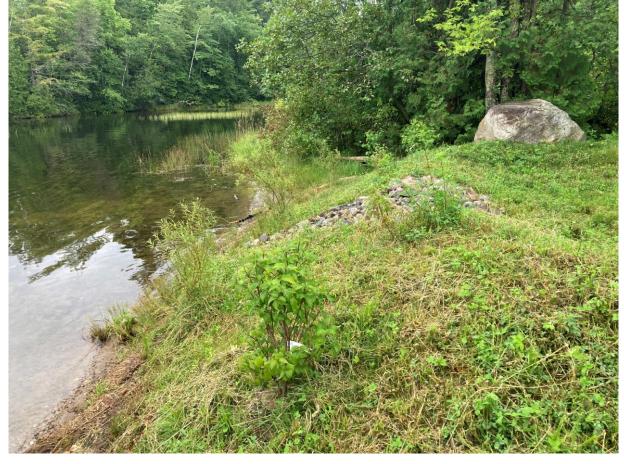
Keewaydin Boy's Camp Implemented TC-6

- Trespassers were using private land to access the lake, aggravating a storm water erosion problem.
- The landowner voluntarily fenced off the shoreline and filled the eroded section with stone.

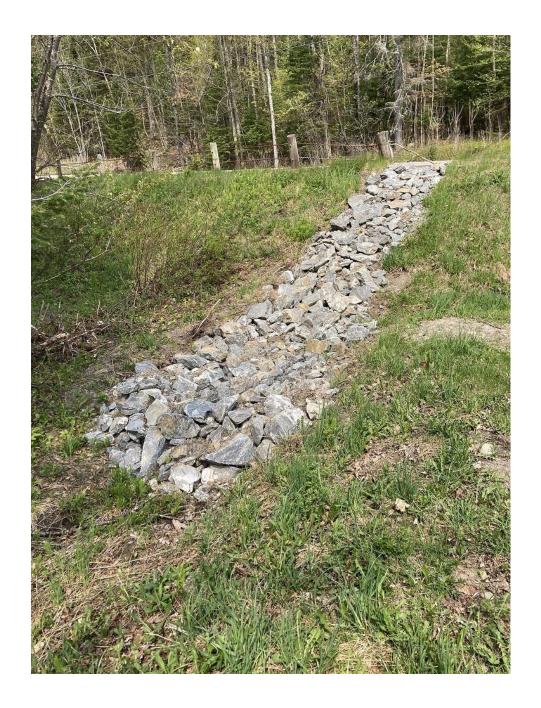
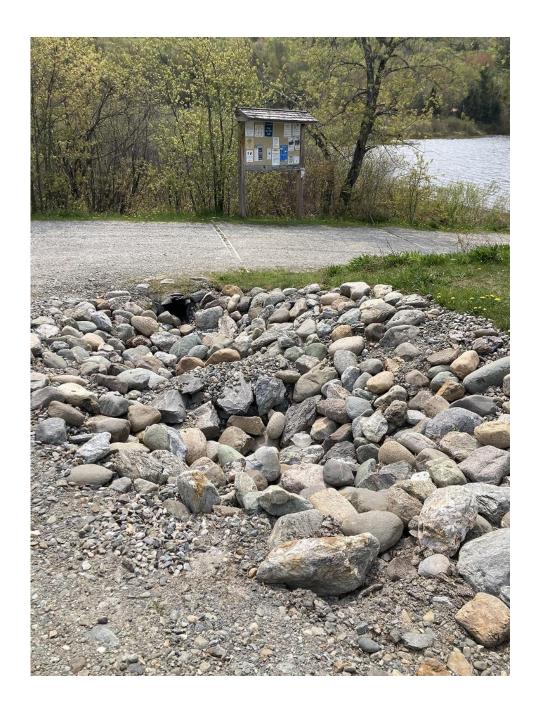
- Vermont Fish and Wildlife Boat Launch
- Concentrated runoff from route 100 causing erosion in the parking area and driveway
- Sediment load was exacerbated by plowing
- Open top culvert and some rock installed in 2019 helped but not enough
- Suggested a sediment trap above the culvert inlet
- No mow area on the grass slope

Site Description: Concentrated runoff off Route 100 is causing rill erosion near the cross-culvert inlet conveying water to the adjacent wetland, and directly to the lake. The recent addition of water bars has helped intercept flow from Route 100, but opportunities remain to improve infiltration and sediment retention on-site. The sediment load at the site may be exacerbated by accumulation of gravel in the winter from plowing. See concept design in Appendix E for updated scope and cost opinion.

Photo 1: Cross-culvert inlet in June 2019.

Photo 2: Cross-culvert inlet in August 2019.

BMP Description: Improve the Route 100 eastern road shoulder to remove a small berm and allow sheet flow over the vegetated slope. This will reduce the volume of runoff reaching the fishing access property. Consider installing a small sediment trap above the culvert inlet, treating runoff from the upper tier of parking lot. Implement "no mow" areas on the grass slope and install native plantings in this area.

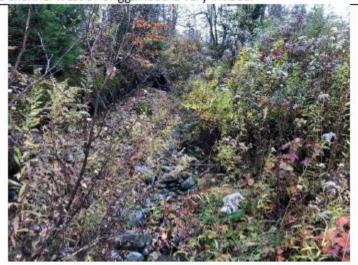
- Private Residence on Griggs Road
- Incised channel coming from road runoff via stone lined ditch and culvert creating a gully
- Gully runs into tributary for the lake
- Need to stabilize the channel laterally and vertically

Site Description: This channel takes runoff from the stone-lined ditch on the east side of Griggs Road. Runoff from the roadway comes down the ditch, under the road via culvert, and wraps around the east side of the house. The channel west of Griggs Road is very incised.

Photo 1: Gully on the north side of Griggs Road.

BMP Description: Evaluate options for stabilizing the channel west of Griggs Road that leads to a tributary to the Lake. Work with the owner to understand property constraints for stabilizing the channel laterally and vertically.

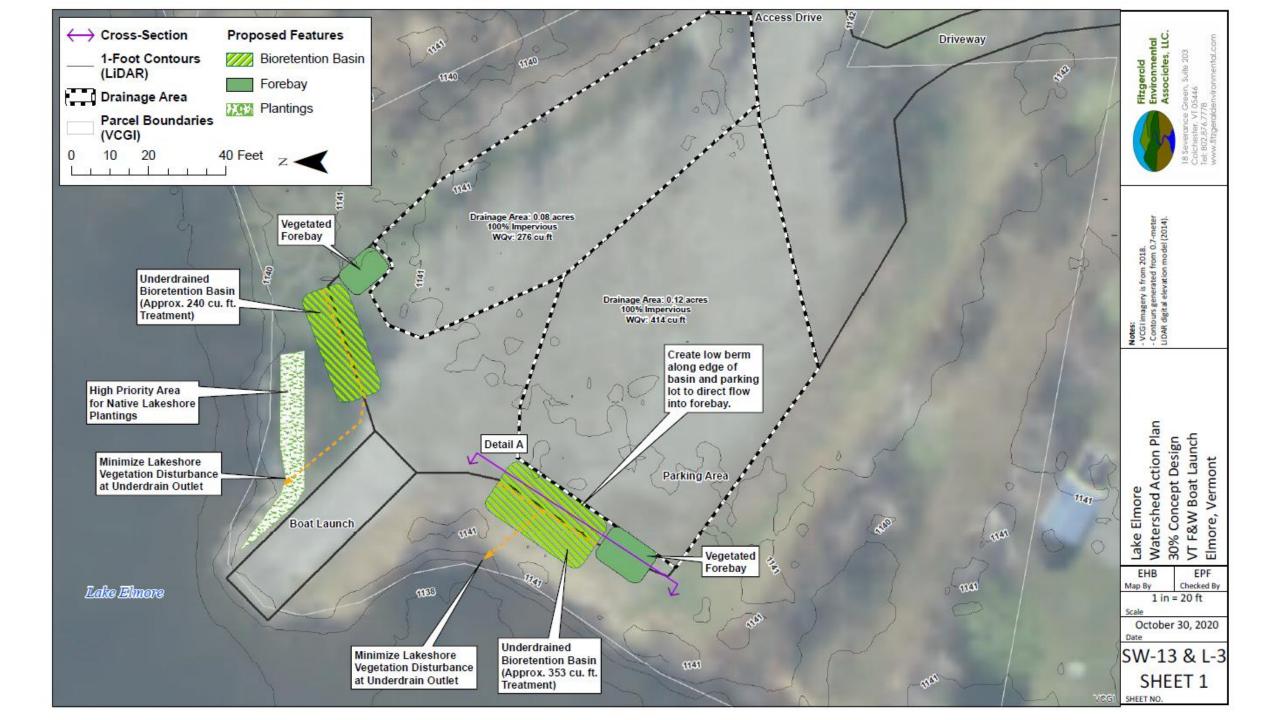
- Grass mowed down to the shoreline
- Eroding due to wave action
- Stabilize with native plantings and no mow areas
- Enhance lakeshore natural communities with native vegetation, providing habitat and shade in the littoral zone

Site Description: Wave action is eroding the lakeshore in a mowed grass area at the boat launch. See Concept design in Appendix F for updated scope and cost opinion.

Photo 1: Lakeshore property with opportunities to establish native vegetation.

BMP Description: Stabilize lakeshore with native plantings and implement "no mow" areas along the lakeshore.
