Vermont Geological Survey Open File Report VG2017-7

Landslide Inventory of Washington County, Central Vermont

2017

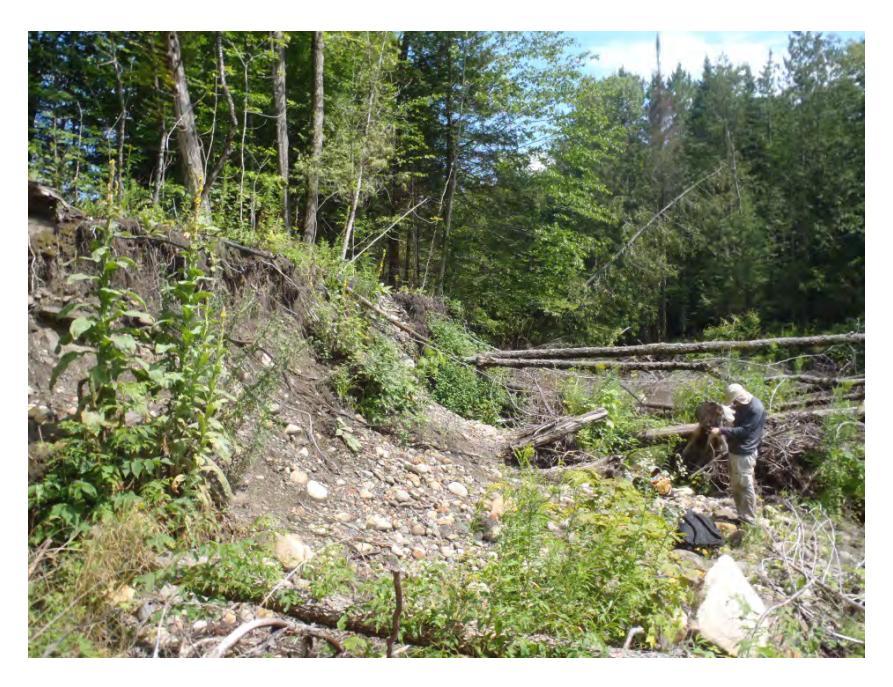
Figure 4a. Site GB-1023 looking downstream. Typical exposure of coarse-grained stream terrace deposits on outside of bend. Material failed during high stream flows of 2011, primarily by singe-grain detachment. Photo taken July 29, 2013.

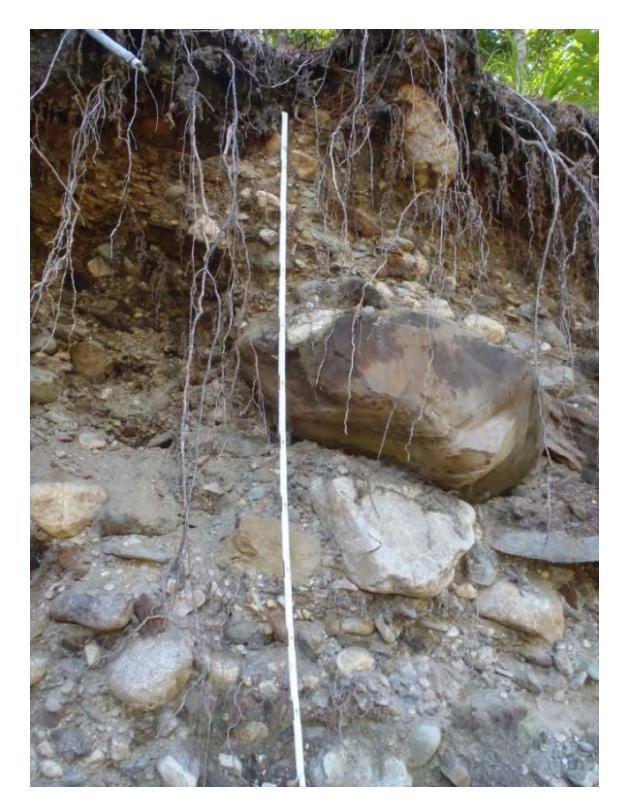
Figure 4b. Close-up of stream terrace deposits at Site GB-1027. Boulder-cobble-pebble gravel in lower part is overlain by sandy pebble-cobble gravel. Similar to material at GB-1023 but coarser-grained. Photo taken July 29, 2013.

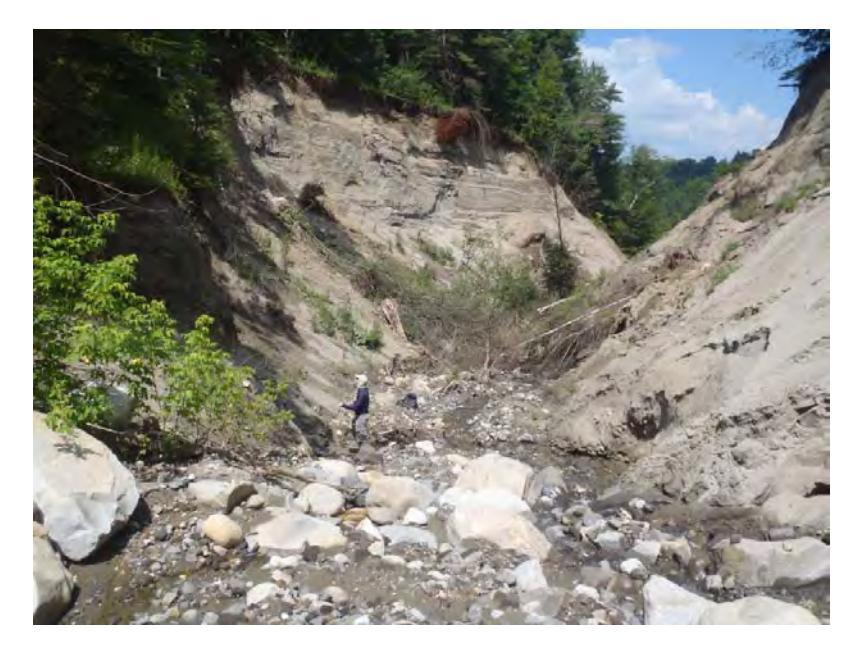
Figure 5a. Site GB-1010, a large, active gully in the Great Brook watershed, Plainfield. Looking down gully on July 16, 2013. This is part of the large MacLaren-Fowler gully system, which has developed in ice-contact sands.

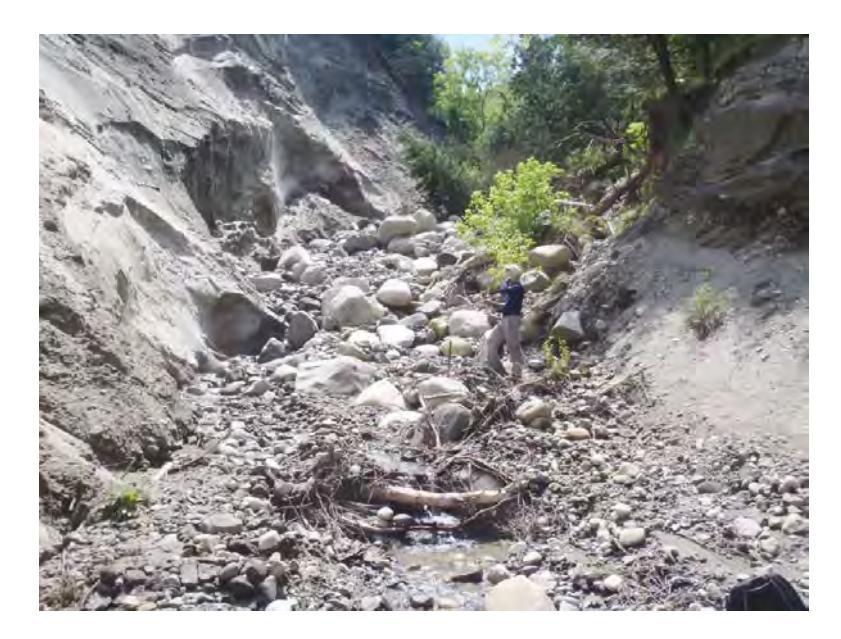
Figure 5b. Site GB-1010, looking upstream. Headcuts are actively incising the valley bottom, the bases of the slopes are being undercut, and the side walls are continuously collapsing into the gully bottom. Some of the boulders in the channel have fallen in from gravel lenses within the ice-contact deposits exposed in the side walls while others have probably washed down from till exposures near the head of the gully.

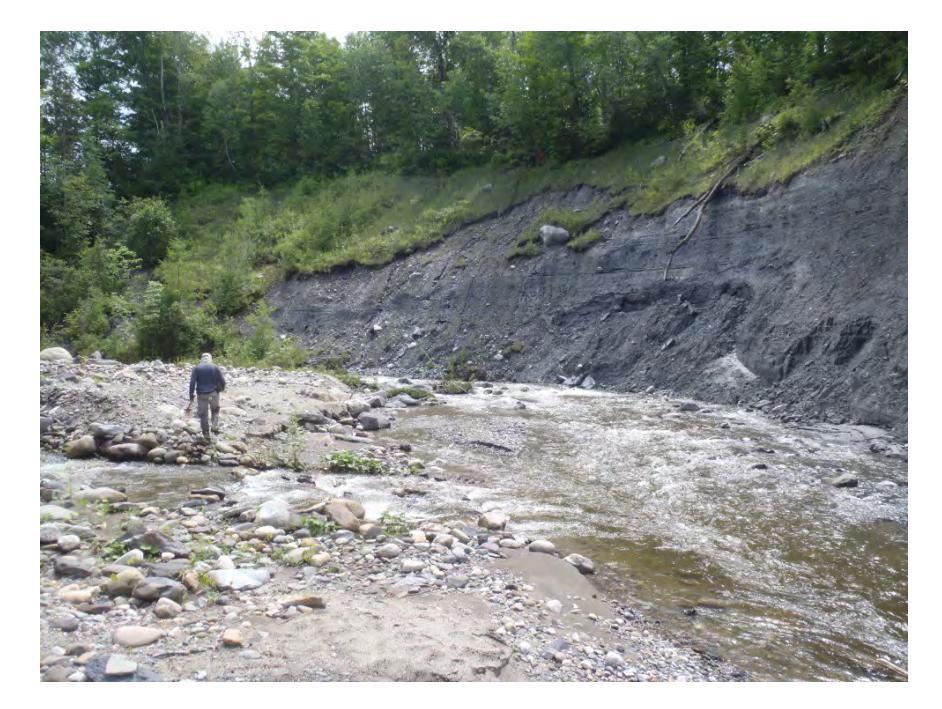
Figure 6. Site GB-3 on July 11, 2013. The waters have receded and the fresh toe deposits have partially collapsed.

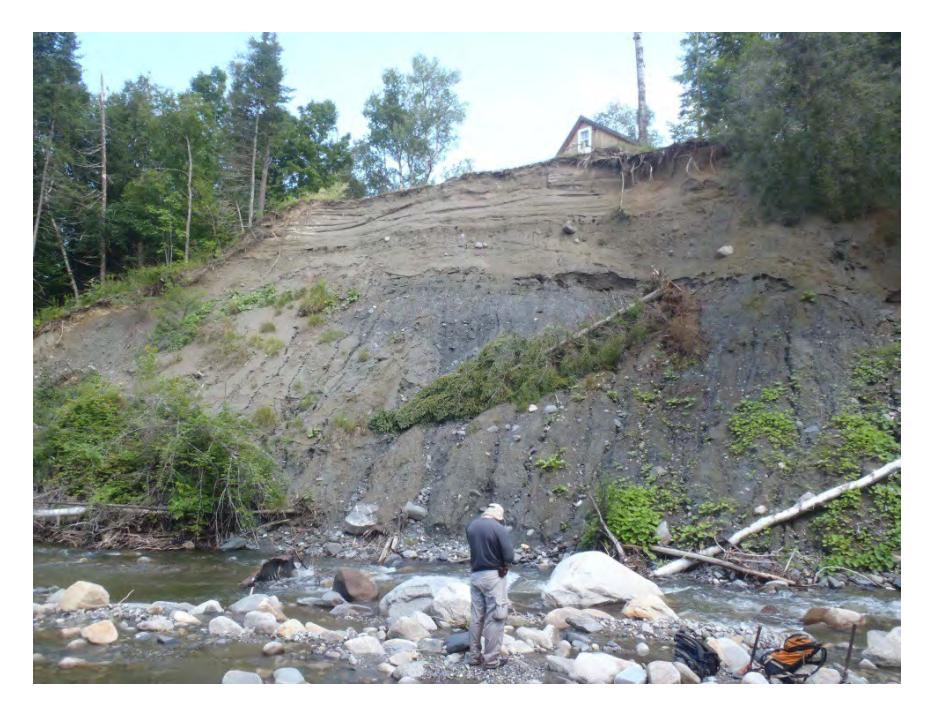
Figure 7a. Site GB-1025 on Great Brook in Plainfield. Active landslide on right bank. Lacustrine sand, silt, and silty clay over dense gray till. Note roof of garage visible just beyond top of landslide. Photo taken July 29, 2013.

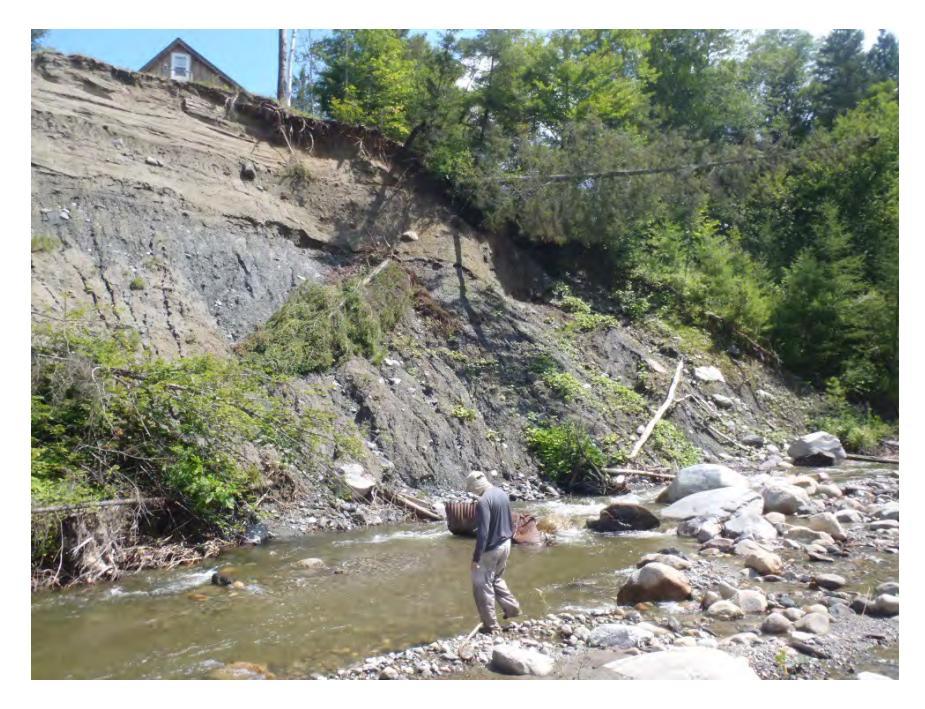
Figure 7b. Site GB-1025 looking downstream and across. Note trees toppling over at top. Photo taken July 29, 2013. A garage is visible at the top of the slope. The property has recently been purchased by the Town of Plainfield through a FEMA buyout and the buildings have been removed.
