Bedrock Structural Control in the Waterbury Dam Area

Author: Jon Kim

Citation:
Kim, Jonathan, J., 2007, Bedrock Structural Control in the Waterbury Dam Area, Vermont Geological Survey Technical Report VGTR 2007-2, 1 plate.

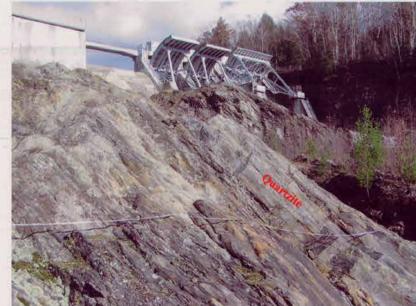
North-northeast striking, moderately east dipping S1/S2 foliation just west of dam spillway. Roughly equivalent perspective to looking at Face A on 3D block diagram. Quartzites shown in blue on 3D block diagram.

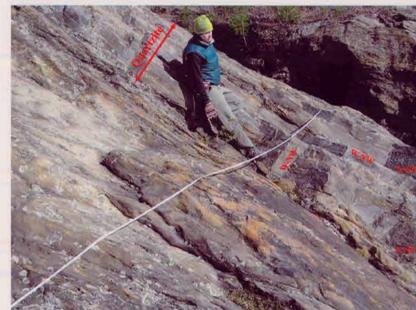
~10' thick gray quartzite layer in rusty-weathering Hazens Notch Formation schist. Note two sets of fractures in quartzite: north-northeast and west-northwest trending. Fractures are more abundant in the brittle quartzite.

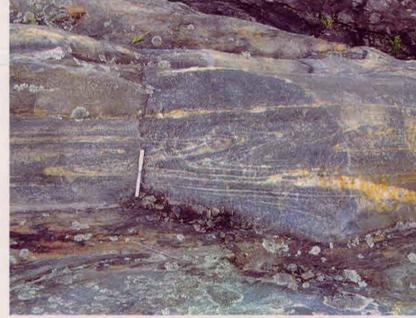
F2 fold in gray quartzite. View in photo is looking at Face C in 3D block diagram.

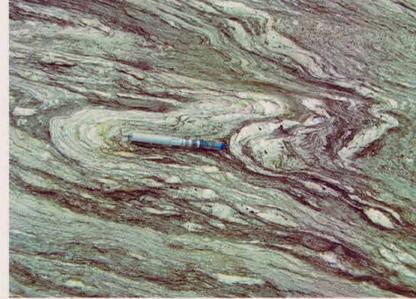
F3 fold in Hazens Notch Formation schist. View in photo is looking at Face C in 3D block diagram. Fold plunges into the ground and that perspective can be seen in Face A.

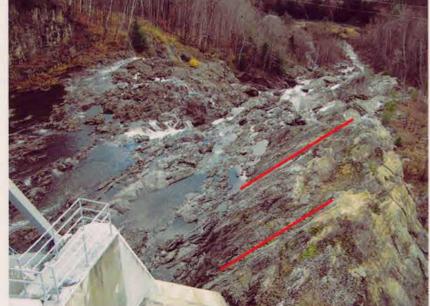
This view looking south at the spillway for the Waterbury Dam shows that the present river flow is dominantly controlled by the north-northeast trending, moderately east dipping S1/S2 foliation (parallel to red line) in the Hazens Notch Formation schist.

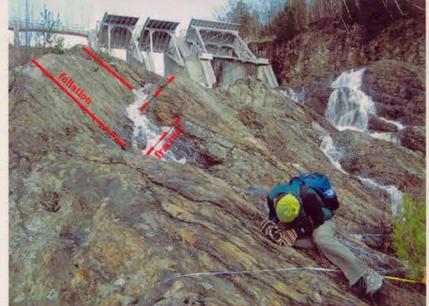
A closer view of the spillway looking to the north shows that water flows not only along the strike of the S1/S2 foliation, but also across this foliation along north-north east trending moderately west dipping fractures.

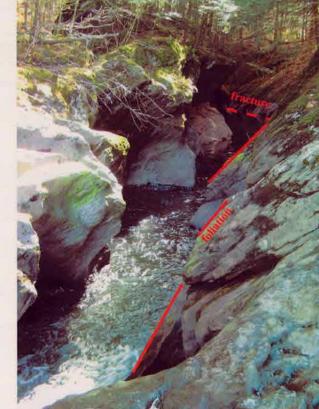
The lower Little River gorge just downstream (south) of the U.S. Geological Survey stream gauging station is likely a smaller scale analogue for the gorge beneath the Waterbury Dam. The river dominantly flows along the S1/S2 foliation, but is offset by fractures that step the gorge to one side. The foliation is also deflected by F3 folds. Note half potholes on left (east) side of gorge

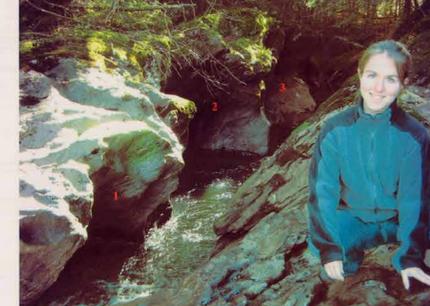
Three coalesced half potholes located along the foliation defined gorge. These potholes likely formed during glacial retreat as large volumes of meltwater carrying sand, silt, clay, and boulders eroded the bedrock surface. The S1/S2 foliation provided a plane of weakness along which trains of potholes could form. As a pothole's enlarged, it eventually impinged on neighboring potholes and formed the coalescing scalloped shape. Some linear pothole zones would presumably step downward along the foliation as they deepened. Some potholes are inclined with the foliation.

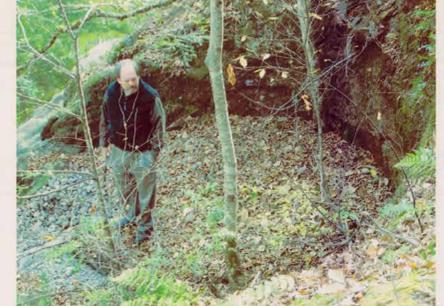
Stranded pothole west of and above existing water level in lower Little River gorge.
