APPENDICES

APPENDIX A: LETTER TO VILLAGE OF ENOSBURG FALLS

SEI No. 082119-W RE: Enosburg Falls IDDE results to date

APPENDIX B: CAMERA INSPECTION REPORTS FOR

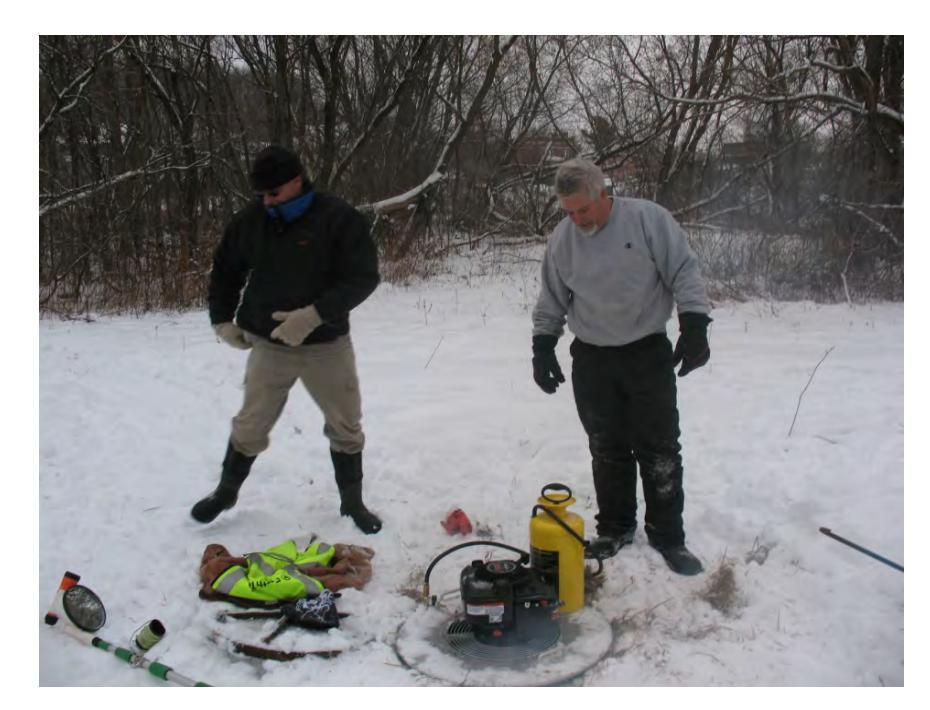
temporarily and restarted the smoke test to see if this stopped the flow of smoke from RF-045 or RF-050, but this did not appear to make any difference. We do not know if the overflow pipe in this manhole is an active sewer overflow, but its presence explains neither the contaminated dry weather flows nor the smoke observed at outfalls RF-045 and RF-050.

Figure 1. Smoke testing at sewer manhole SMH#9-A (near Willow Street)

- A connection has been confirmed between the sanitary sewer and outfall pipes RF-045 and RF-050. We suspect a leak in the sanitary sewer in the vicinity of the stormsewer pipe crossing. We recommend further discussions with the Vermont Rural Water Association to locate the connection(s), followed by repairs. Camera inspection may be the best next step.
- 2. The possibility that an undocumented sanitary sewer overflow pipe may exist in manhole SMH#9-A should be further investigated.
- 3. Because dye testing was inconclusive, further investigation of the cluster of contaminated pipes discharging to the river bank between the Sunoco station and TD Bank should be performed. We recommend as a next step smoke testing pipes RF-10X and RF-10Z.

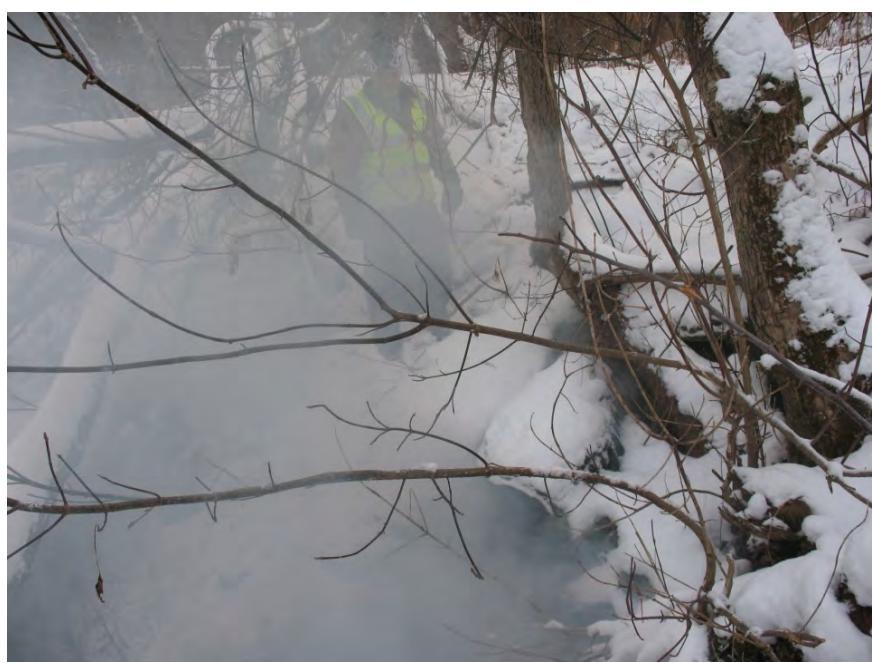
Figure 2. Smoke from outfall RF-045

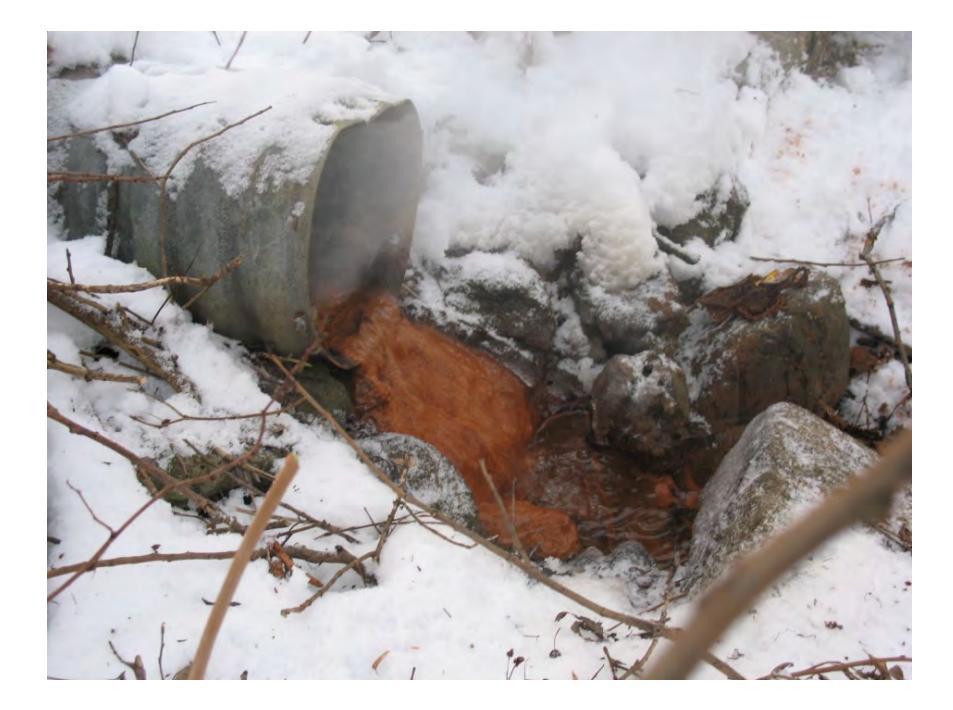
Figure 3. Smoke from outfall RF-050

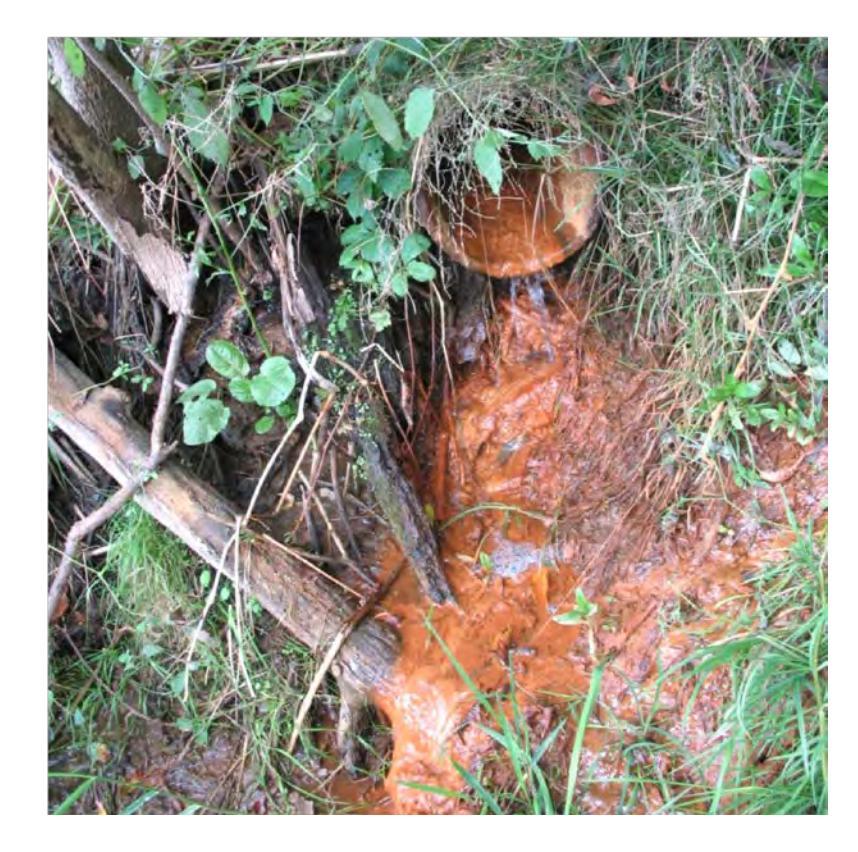
It was late in the day when we began investigating the source of contamination at the river bank between the Sunoco station and TD Bank. Outfalls RF-010X and RF-010Z were flowing. A third pipe, a 4-inch diameter iron pipe, was also flowing. These three pipes are marked by orange-stained deposits. The legitimate stormsewer outfall (RF-010Y), which is not stained with orange deposits, was not flowing. We previously found no contamination at outfall RF-010Y. Figure 4 shows flow from outfall RF-010X.

Figure 4. Outfall RF-010X, September 17, 2009.
