Lake Morey

Lake and Watershed Action Plan (LWAP)

Fairlee, Vermont

March 19, 2024

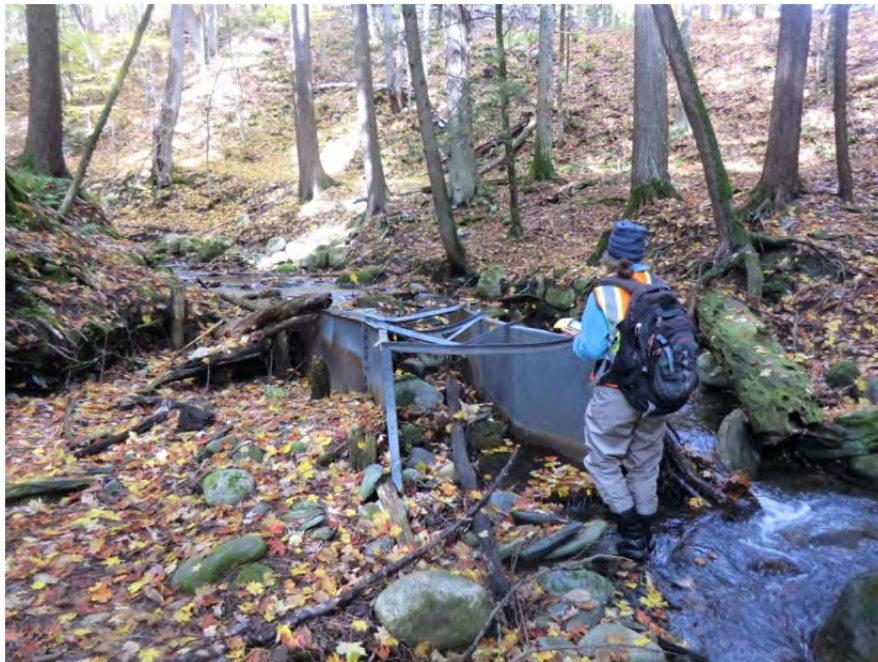
Figure 22. Remnants of Parshall Flume Stream Gauging Structure

Glenn Falls Brook: Above approximately 500 feet in elevation, the channel of Glen Falls Brook is quite steep and contains ledge and waterfalls. The watershed is forested upstream of lake Morey Road. A parshall flume, likely used to measure stream flow as part of DEC’s studies in the mid-1980s, was noted to still be in the channel at elevation 475 feet, where the slope of the channel starts to drop (Figure 22). The centerline of stream channel was mapped in the field using a submeter GPS unit, as it differs significantly from the channel location shown on the VHD. The section of channel downstream of Lake Morey Road appears to be an alluvial fan, where the slope flattens, gravel is deposited, and the stream channel would be naturally braided. This section of stream has been heavily managed in the past in different single thread channels. Just upstream of the inlet to Lake Morey, the channel is a losing stream as it decreases in flow as it travels through the gravel deposits below Lake Morey Road. A beaver dam break in the upper watershed took place in May 2016, resulting in a significant release of woody debris and water in the lower reach of the brook and the west side of Lake Morey (Valley News, 5/27/2016).

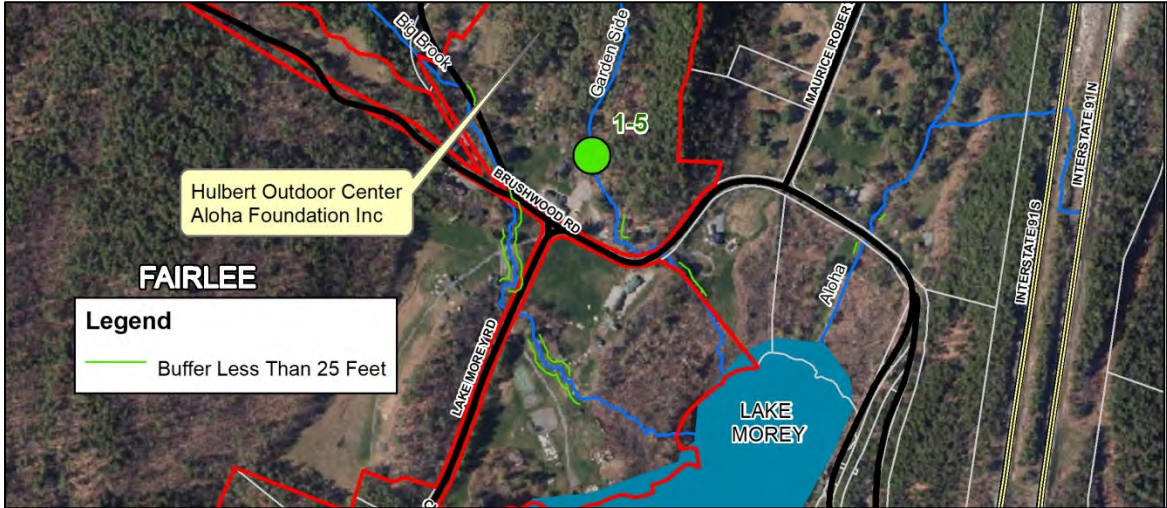
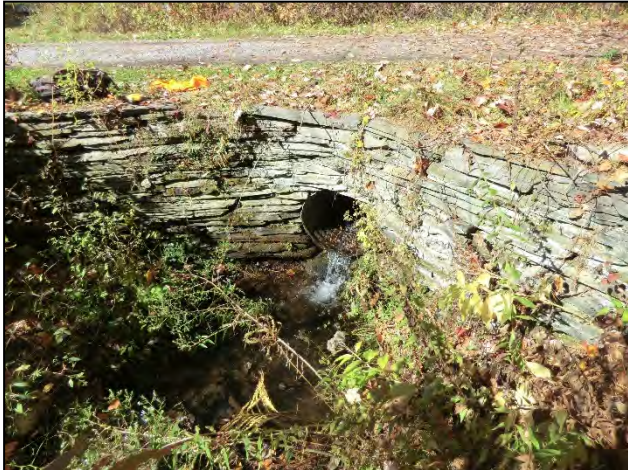
| Stream Name: Garden Side Brook | |

| Site Description: Replace culvert that is perched 0.8 feet to increase geomorphic compatibility and potentially improve fish passage. Drainage area of Garden Side Brook at this area is 0.25 square miles. | |
| Site Design Considerations: Private Road and funding sources are unknown. This stream has a small drainage area and it is unknown whether fish utilize this brook. The stream is likely intermittent given the small drainage area. | |

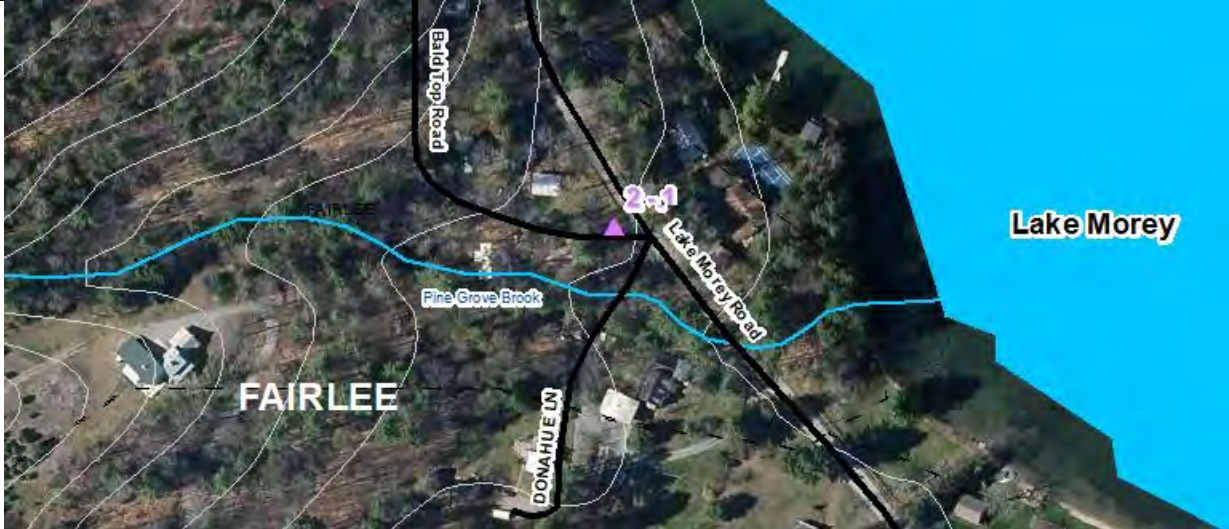
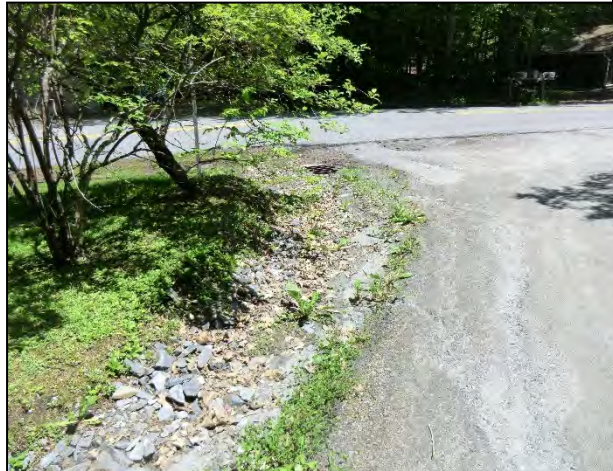
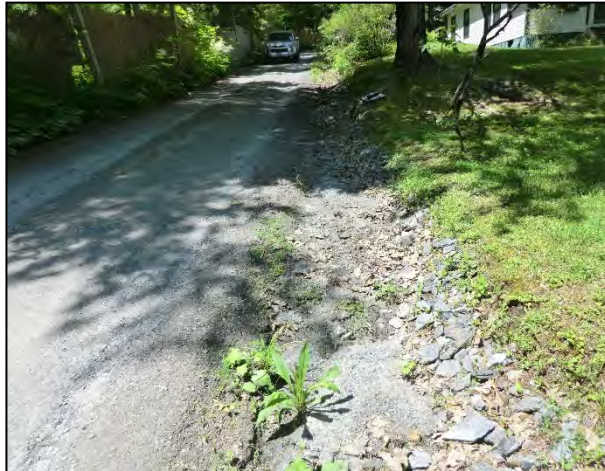
| Site Location: Bald Top Road – Lower end of Bald Top Road above intersection with Lake Morey Road | |

| Site Description: Roadside ditches are steep. The rock lined ditch leads to a drop inlet at intersection of Bald Top Road and Lake Morey Road. | |

| Site Design Considerations: The roadway is steep. Raise the road and grade toward the rock lined ditch. Grading of the road will help reduce sediment input by reducing riling. | |

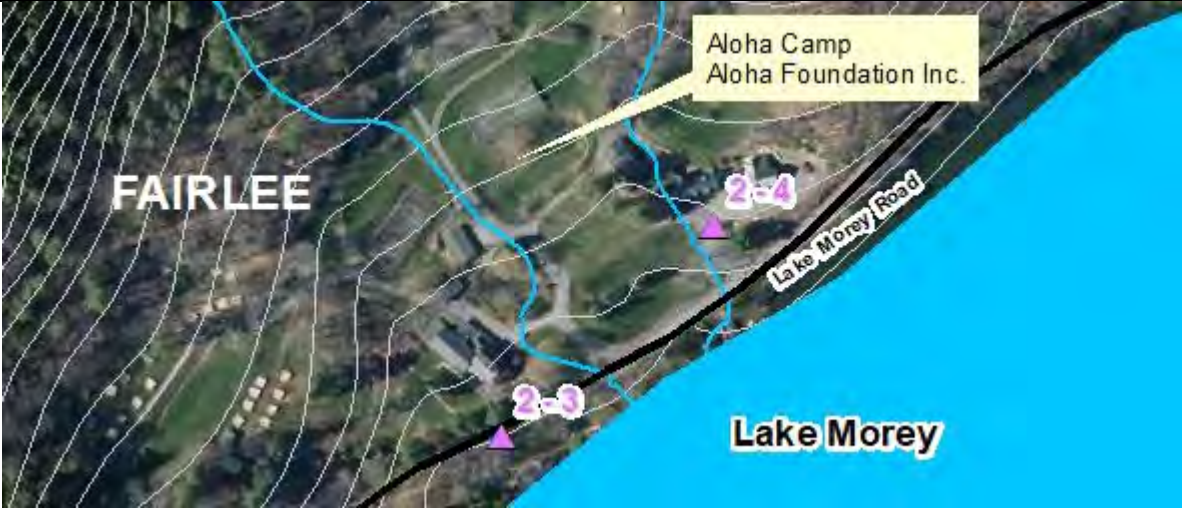
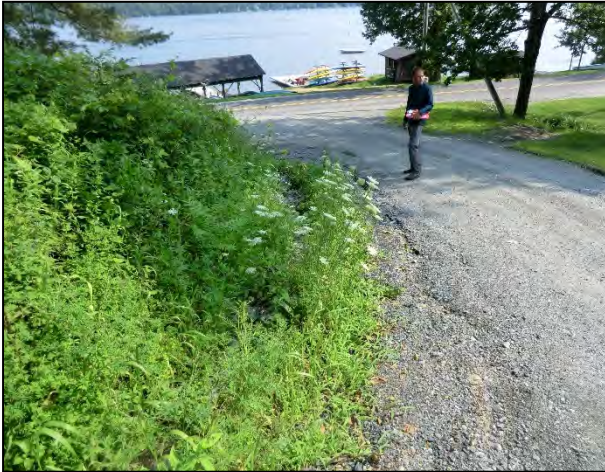
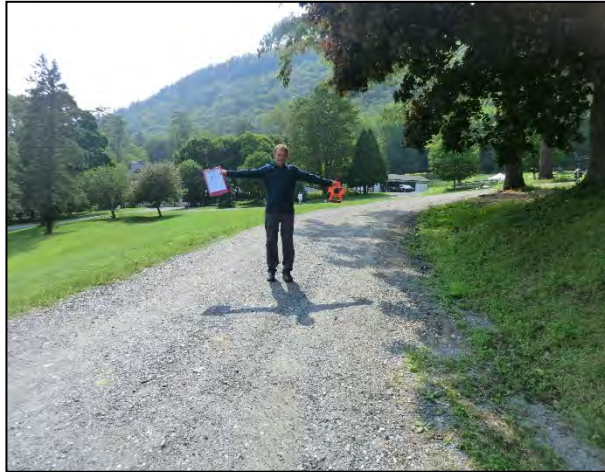
| Site Location: North of Lake Morey Road (approximately 0.65 miles southwest of intersection of Lake Morey Road and Cliff Mull Lane) | |

| Site Description: Stormwater runoff is causing erosion of the northeastern access drive of the Aloha Camp. | |

| Site Design Considerations: The northeastern access drive is steep and is in close proximity to Lake Morey. The access drive could be improved by adding a cross culvert at the upper end to reduce concentration of stormwater runoff. Rock lining the ditch along the drive and regrading the parking lot should also result in reduced erosion and sedimentation. | |

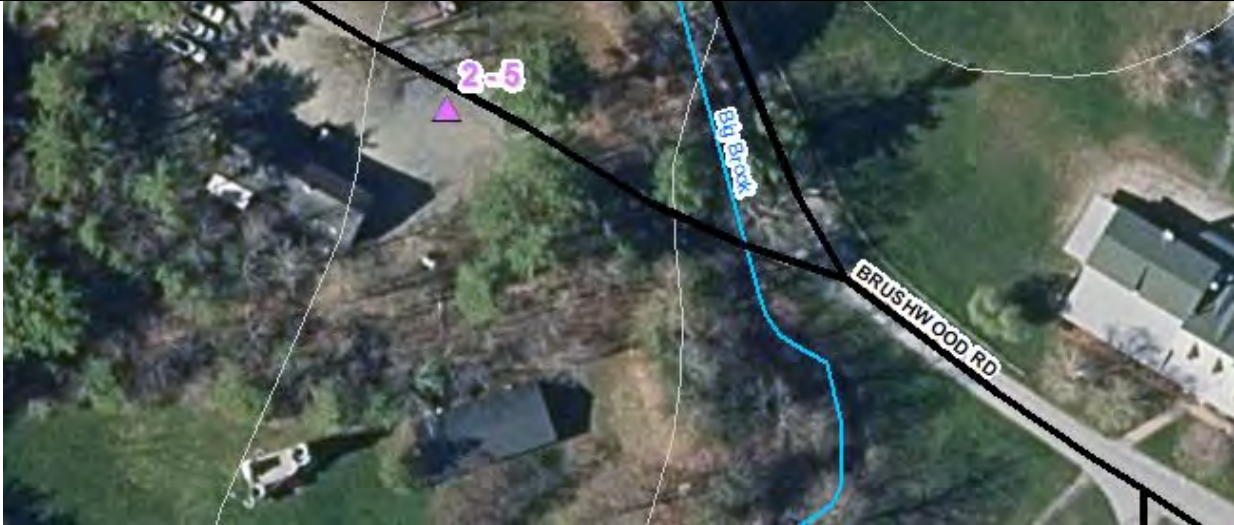
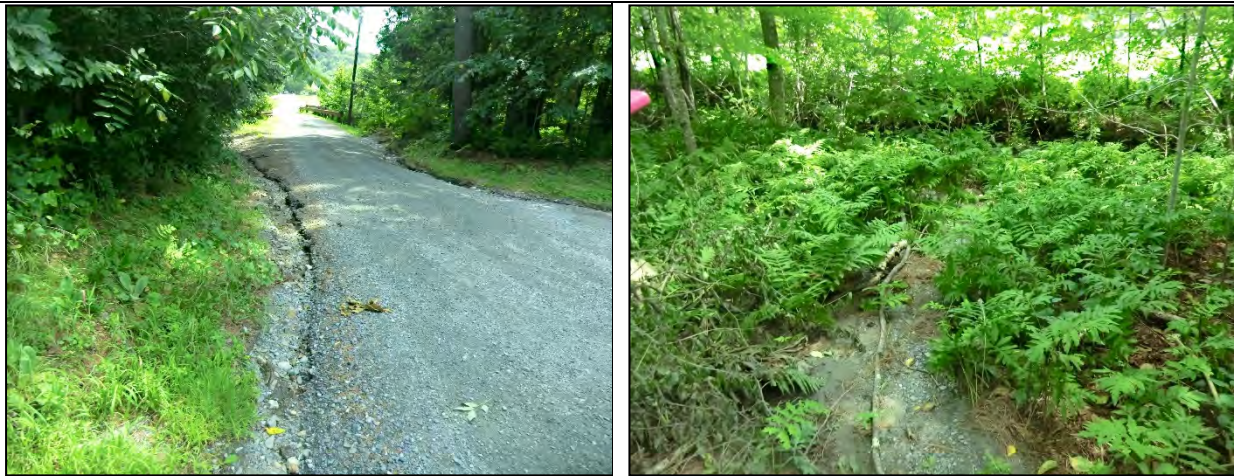
Site Location: On Brushwood Road about 0.1 miles northwest of intersection of Brushwood Road and Lake Morey Road in vicinity of parking log for the shop at Holbrook Outdoor Center

Site Description: Stormwater runoff is causing erosion of the shop parking lot at the Holbrook Outdoor Center and Brushwood Road leading to sediment accumulation in close proximity to Big Brook

Site Design Considerations: Brushwood Road is steep and transitions to a trail upslope of the shop parking lot. The Aloha foundation has already taken steps to reduce concentration of stormwater by installing a water bar at the base of the trail. Additional stormwater improvements, such as stone lining the ditches along Brushwood Road and or constructing a small sediment basin, could reduce sediment reaching Big Brook.

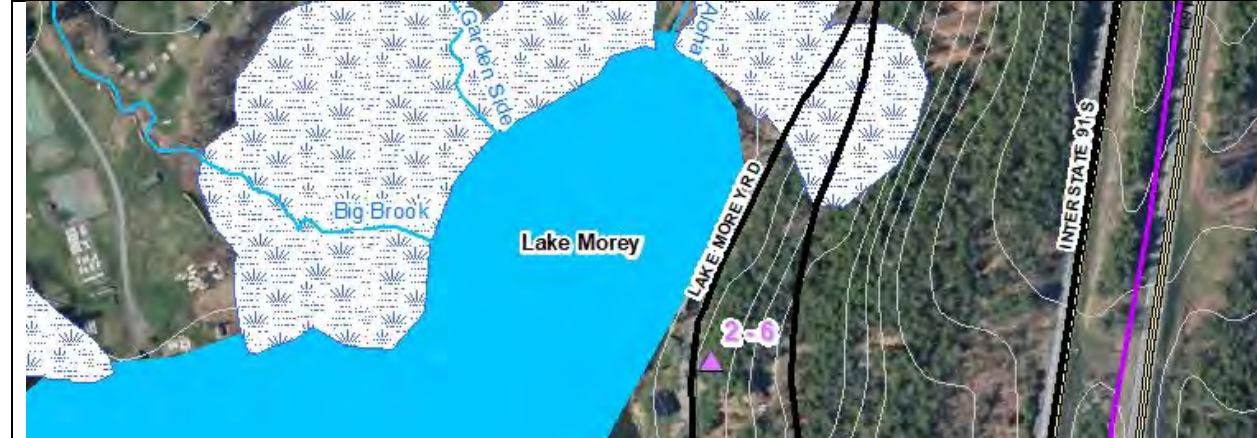
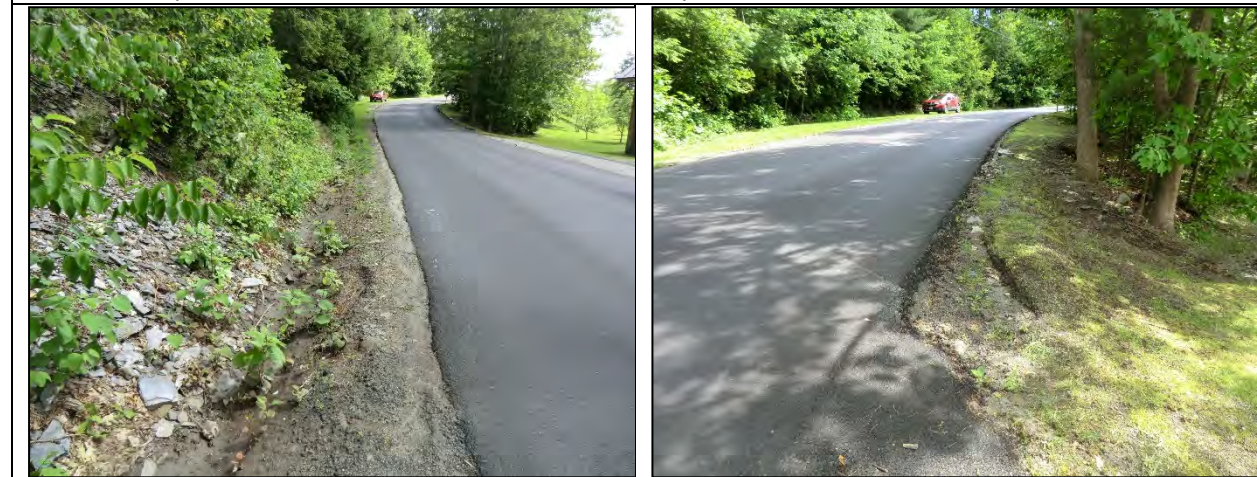
Site Location: On Lake Morey Road about 0.35 miles south of intersection of Maurice Roberts Memorial Highway and Lake Morey Road

Site Description: Stormwater runoff is causing erosion of the roadside on Lake Morey Road and sediment deposition in roadside ditches and a downslope lawn

Site Design Considerations: The sediment from the roadside erosion is accumulating in the roadside ditches and on an adjacent lawn, which is located in close proximity to Lake Morey. Currently, the sediment is being trapped and does not appear to be reaching Lake Morey. Roadside improvements may be warranted to prevent sediment from traveling towards Lake Morey at some point in the future.

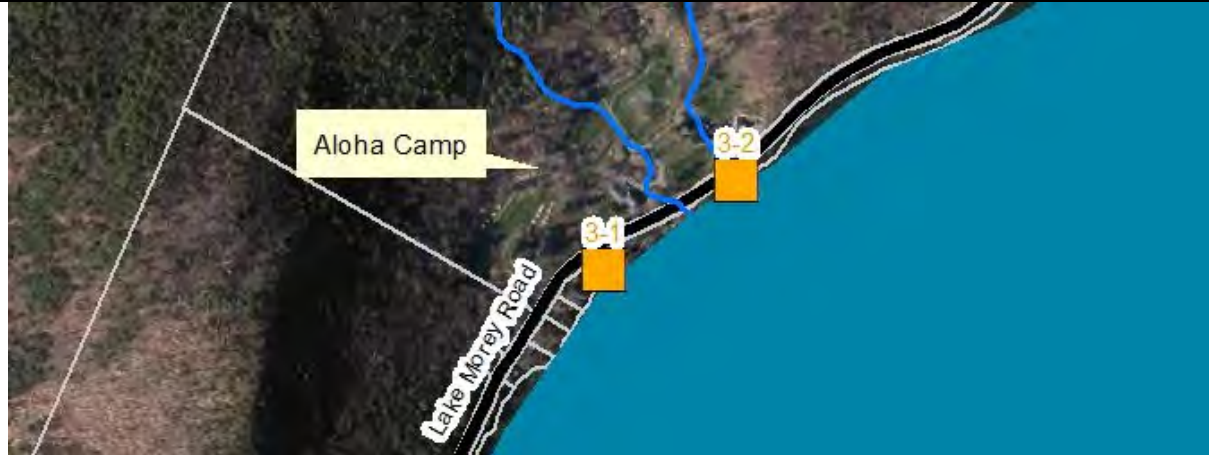
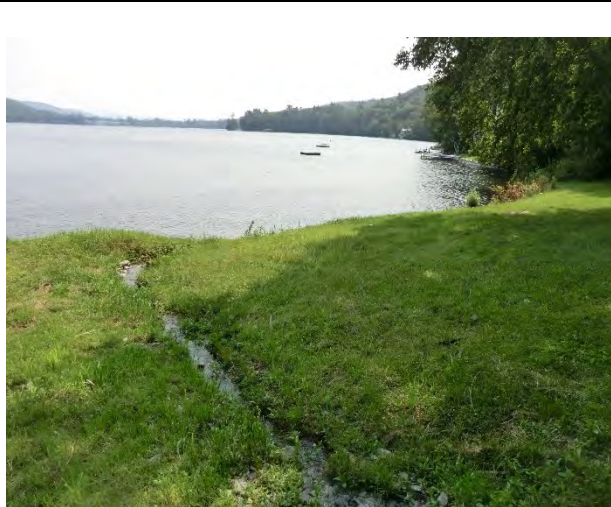
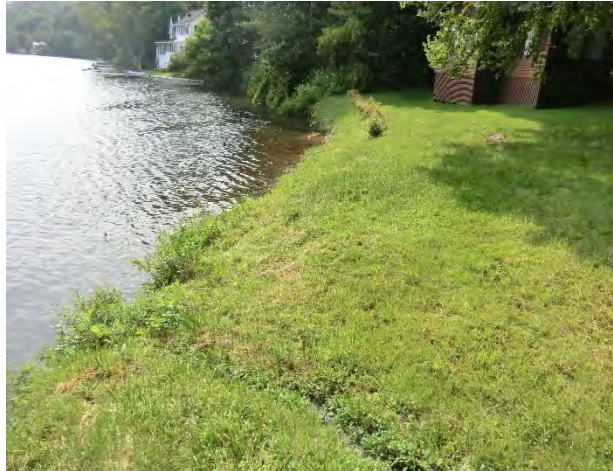
| Site Location: Fairlee, VT (43.927328, -72.156242) | |

| Site Description: The area adjacent to Lake Morey is lacking a vegetated buffer. Some blueberry bushes have already been planted at the eastern edge of this area along the shoreline. The buffer could be improved by expanding the area of plantings or by creating a no mow zone. | |

| Site Design Considerations: This area to the south (photo right) of culvert outlet channel is not being actively used by campers and could be converted to buffer. The area is very wet due to outflow from a culvert and natural seepage from the adjacent slope. Plants that are adapted to wet soils would do best in this location. | |

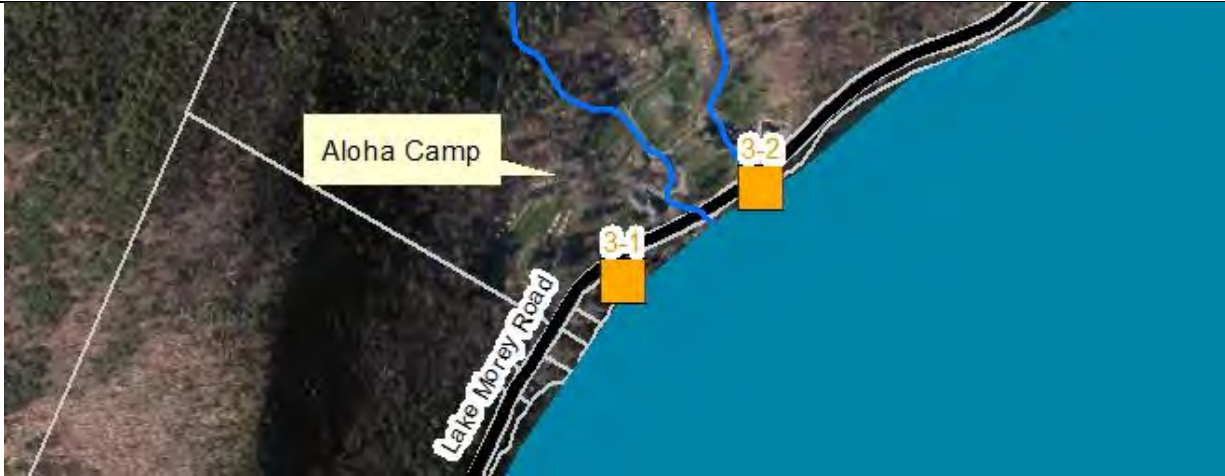
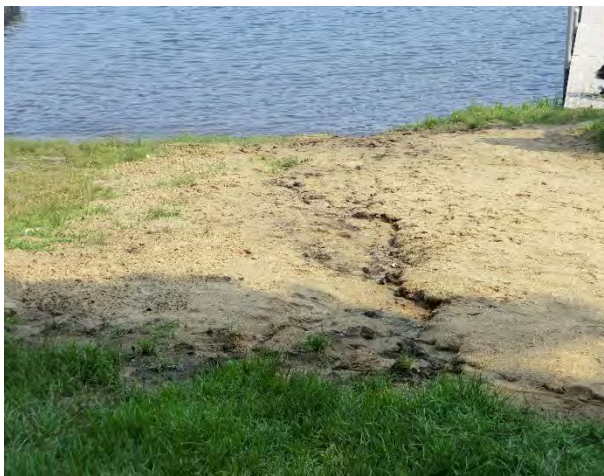
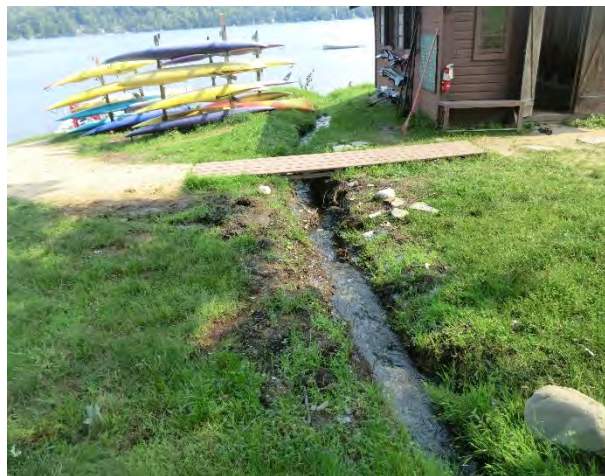
| <p>Site Description: The sandy beach in the vicinity of the Aloha Camp's boathouse is eroding. Groundwater from the hillside and a small stream are contributing to the erosion. Install a French drain to intercept the groundwater and enlarge and naturalize the channel to reduce surface water flow onto the beach.</p> | |
| Site Design Considerations: This area is heavily used by campers. | |

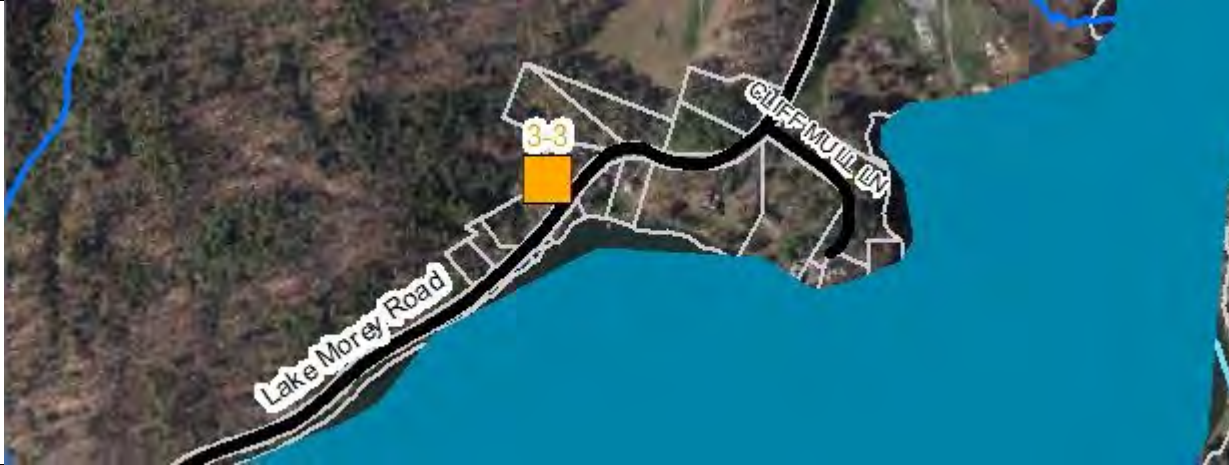
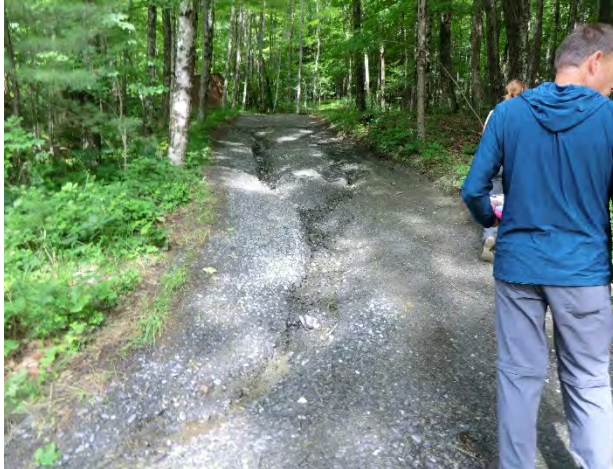
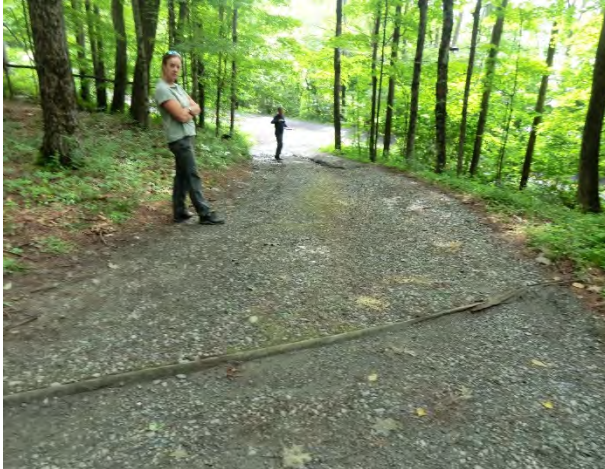
| <p>Site Description: A private driveway is eroding and potentially contributing sediment and phosphorus to Lake Morey. There are some existing wooden water bars. Reduce the concentration of stormwater runoff by installing three water bars at locations 25' (new), 55' (replacement), and 90' (new) above Lake Morey Road. Cut and ditch east side of driveway within 25' of road to route seepage to driveway culvert. Grade outlet of lowest water bar to drain to roadside ditch.</p> | |
| <p>Site Design Considerations: Groundwater seeps on the upslope side of the driveway are contributing water during non-storm events.</p> | |

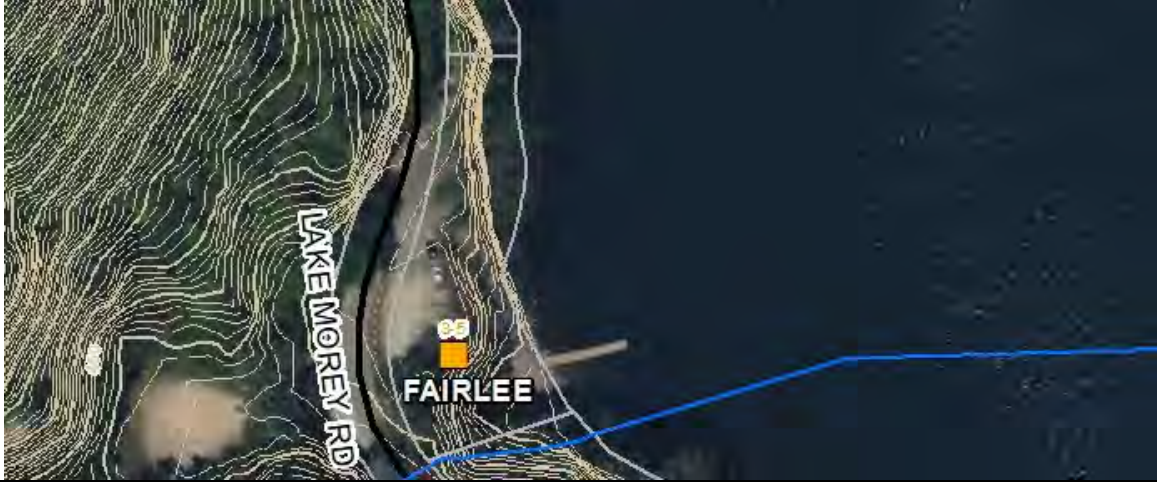
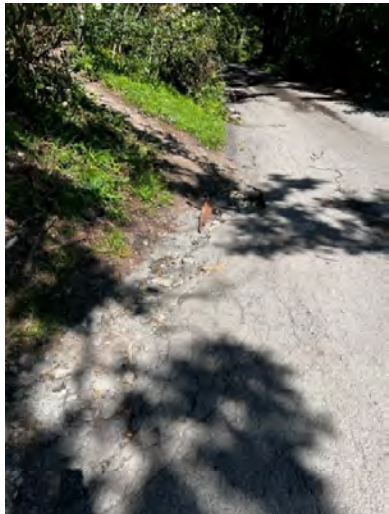
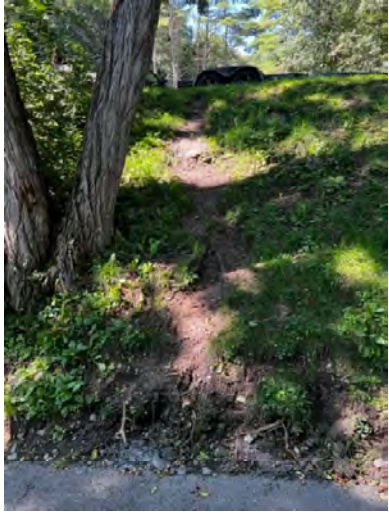
| Site Description: The access road and lower launch area need to be repaved to prevent erosion. The steep access path is eroding and could be fenced off. | | |
| Site Design Considerations: There is no room for stormwater treatment. The site is steep. | | |
