Maidstone Lake Watershed Action Plan

2021-1221

Sam Mayne & Heather Johnson
Essex County Natural Resources
Conservation District
5396 VT-105
Brunswick / VT 05905

Peter Lazorchak, P.E. / *Senior Water Resources Engineer*
Alex Huizenga, EIT / *Water Resources Engineer*
Stone Environmental, Inc.
535 Stone Cutters Way
Montpelier / VT 05602
plazorchak@stone-env.com
ahuizenga@stone-env.com

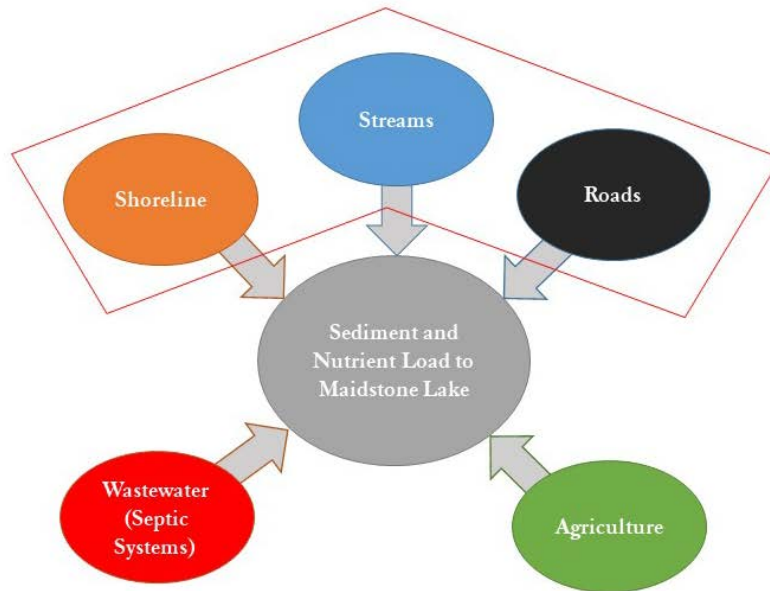
Figure 2: Contributing sources of sediment and phosphorus to Maidstone Lake.

Additional concerns around Maidstone Lake include erosion and degradation of streams from logging operations, road/ditch erosion, lakeshore encroachment and erosion, lakeshore clearing on private properties, soil erosion, and nutrient loading. This watershed assessment focused on the shoreland, tributary, and roadway sources of sediment and nutrients as well as any other serious sources of stormwater runoff in the watershed as shown in Figure 2.

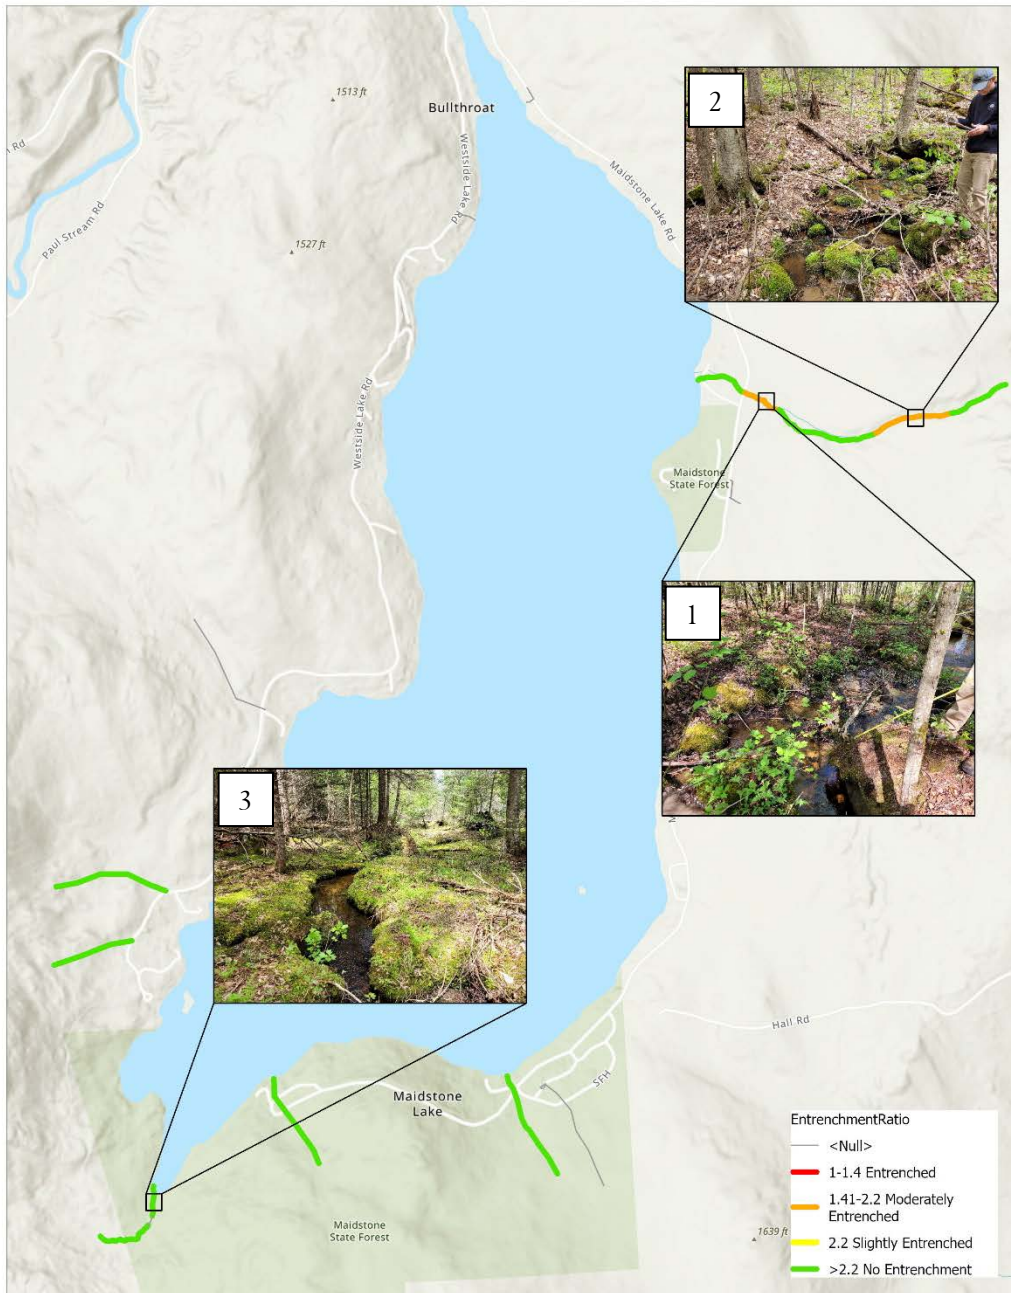
Figure 5: Maidstone Lake Stream Entrenchment

Entrenchment ratios for the assessed reaches at Maidstone Lake ranged from 1.7 to 46, with the majority of reaches showing high floodplain connectivity. The lowest entrenchment ratios were recorded in the longest assessed stream on the eastern side of Maidstone Lake. The downstream reach, with an entrenchment ratio of 1.71, has been altered due to the culverted road crossing and the parking area to the north. As shown in photograph 1 in Figure 5, however, there is very little sign of erosion or bank instability in this area. The upstream reach, entrenchment ratio equal to 2.1, may have been altered from legacy forestry activities but also shows very little sign of erosion or bank instability as shown in photograph 2.

In general, the streams assessed were in good condition with great floodplain connectivity and almost no identifiable channel and bank erosion, particularly in the upper parts of the watershed. Very few projects were identified from the stream walks and tended to be along the lower sections of the tributaries where impacts from road crossings and clearing on private property were present. Figure 5 shows a map of the assessed streams and the measured entrenchment ratio. Only the unnamed stream north of the Maidstone Lake public beach measured in the “Moderately Entrenched” category. This is possibly due to historic logging operations, however, the stream showed little to no signs of bank erosion and only minimal disturbance to its natural flow pattern.

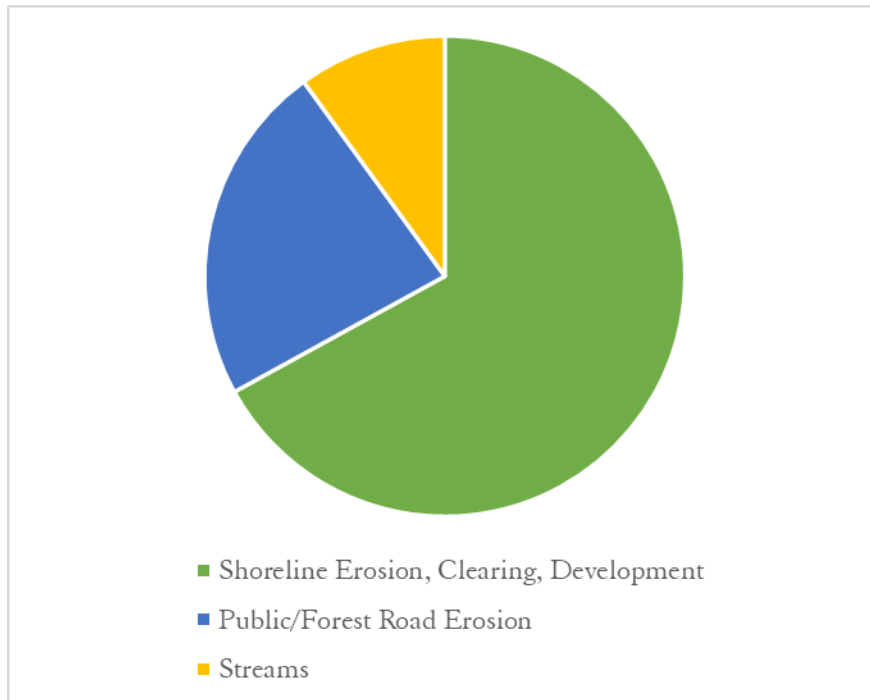
Figure 6: Relative contributions of sediment and nutrient loads to Maidstone Lake.

Based on the quantity and spatial spread of the project types as well as their relative contributing drainage areas and loading potentials, the relative load from each of the project types (roadways, shoreline, and streams) were estimated. The majority of the projects identified during field investigations at Maidstone Lake were shoreline related including shoreline erosion, long stretches of cleared lawns and shoreline, as well as buildings and driveways with direct runoff to the lake. Therefore, it was estimated that approximately 2/3 of the total sediment and nutrient load to Maidstone Lake is from shoreline activities. Municipal and forest roads were the next largest contributor and were estimated to make up less than a quarter of the total load, while streams were estimated at 10% of the total load. Figure 6 illustrates the estimated sediment and nutrient contributions to Maidstone Lake.
