Lake Watershed Action Plan Phase 1 at Shadow Lake in Glover, Vermont Final Report

March 2024

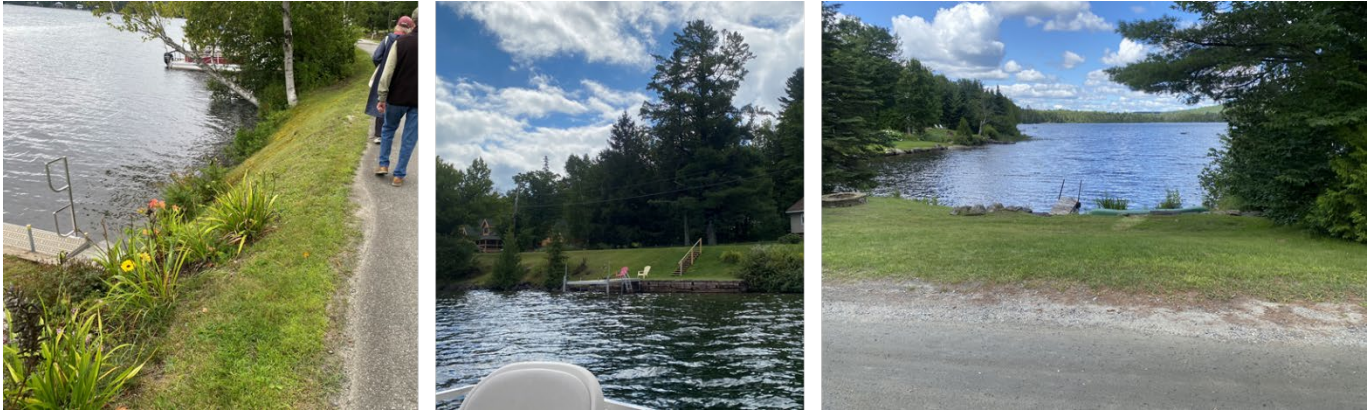
Figure 14. Lakeshores lacking robust native buffers can contribute higher nutrient loads to the lake. This can result in shorelines becoming more unstable as turf grass has very shallow roots that do not stabilize the shoreline well.

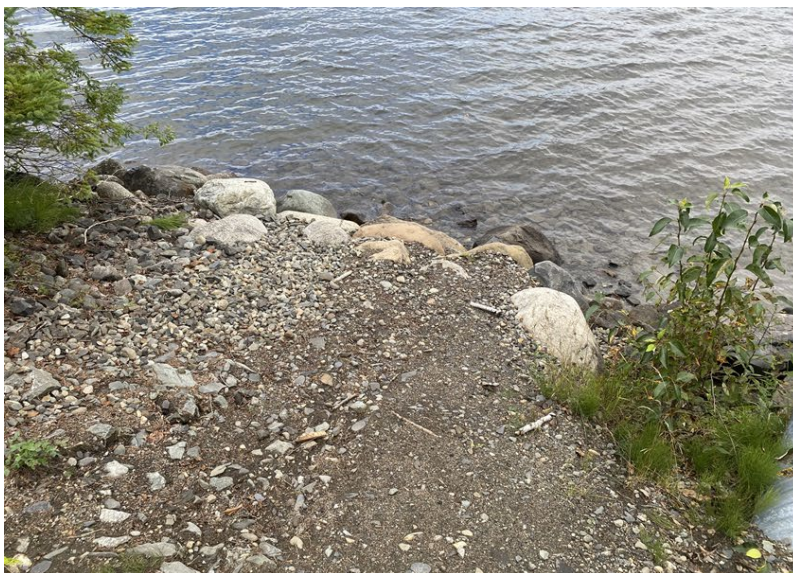
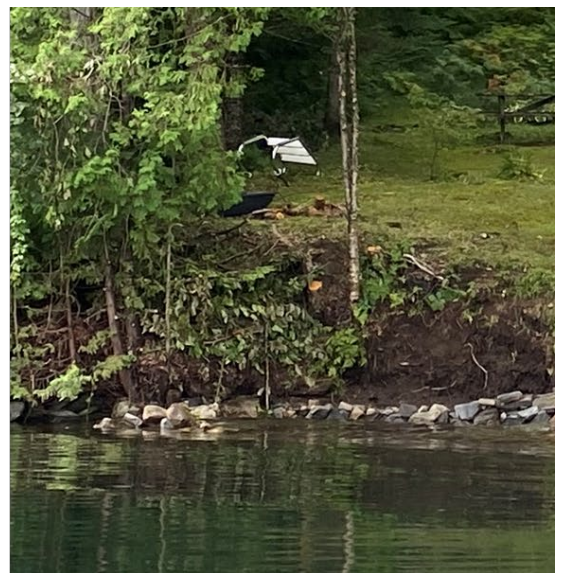
Figure 15. Bare soils, especially on steep slopes, are especially prone to erosion.

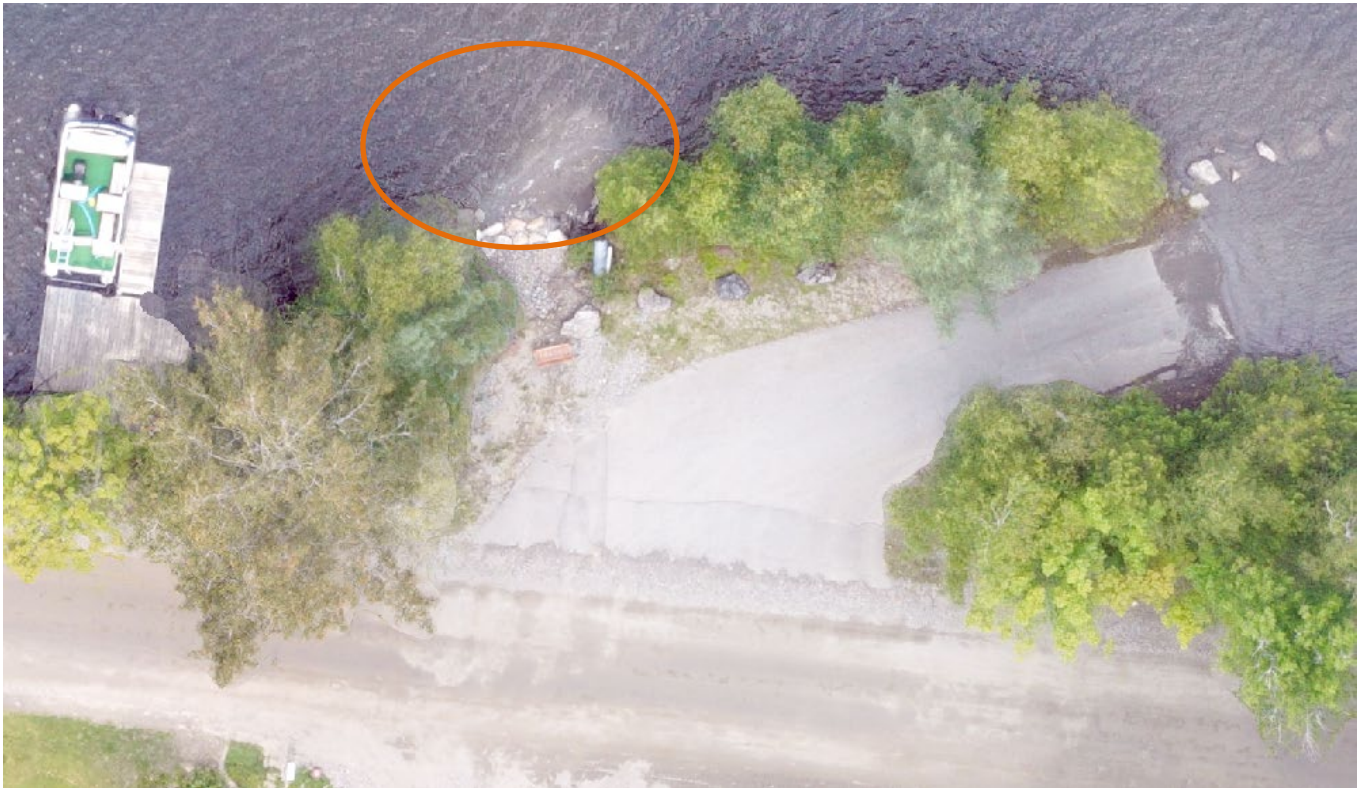
The Fish and Wildlife Access area is one example where stormwater is flowing over a sparsely vegetated and eroding shoreline and depositing sediment into Shadow Lake (Figure 16 and Figure 17, upper). It is recommended that this area be stabilized with native vegetation (Figure 17, lower). A stable footpath could be included to provide access to the existing bench that overlooks the lake, preserving use and preserving and improving aesthetic appeal. This retrofit would stabilize the area and reduce sedimentation to the lake. As this site is a public area with simple access, this would be a fairly straightforward practice to implement by the Shadow Lake community.

Figure 16. Sediment deposition can be observed adjacent to the boat launch area (see area highlighted by an orange circle).

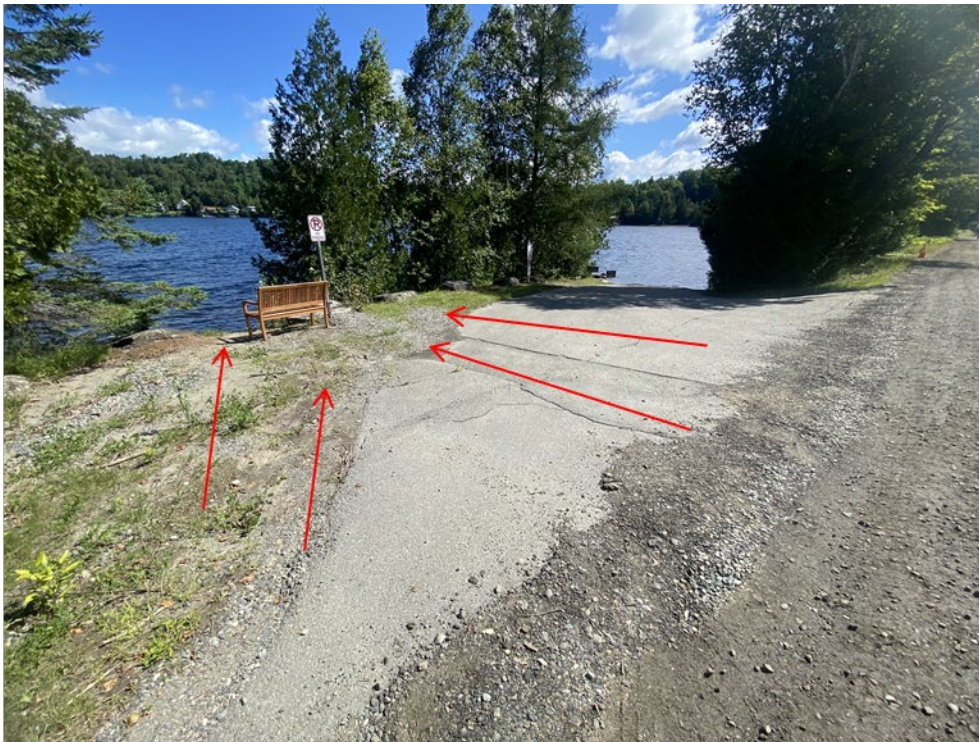
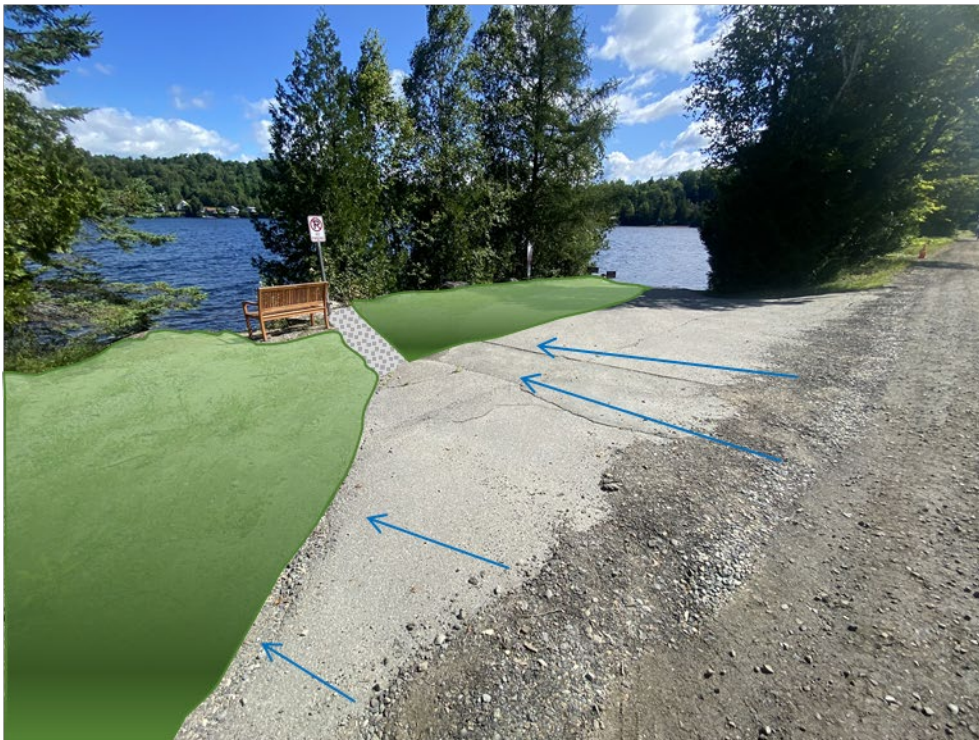
Figure 17. Currently, stormwater flows pass over loose sparsely vegetated shoreline before entering Shadow Lake (upper). It is recommended that this area is vegetated with native species per the [VT Bioengineering Manual](#) (VT DEC, 2022) to stabilize the shoreline and filter stormwater (conceptual retrofit is shown overlaid in lower photo).

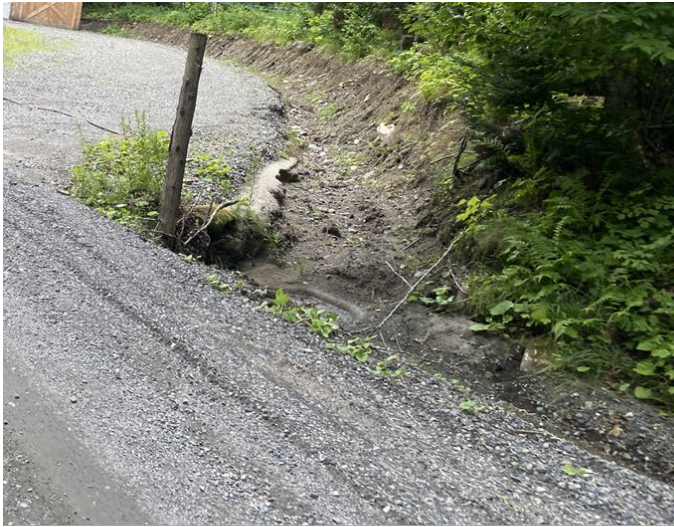
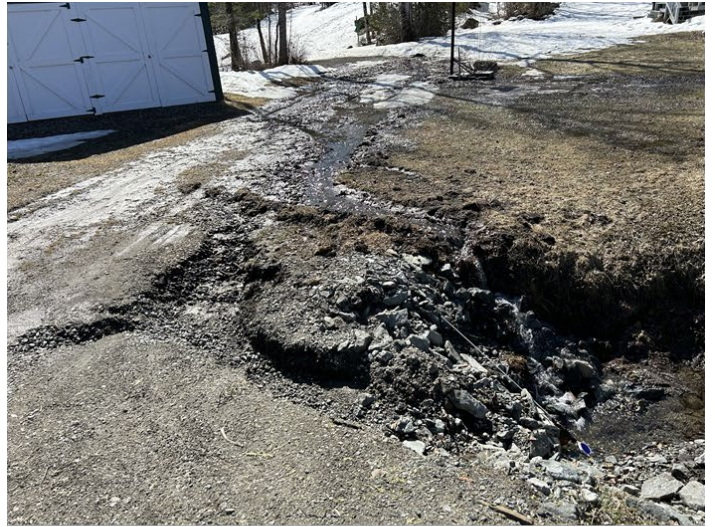
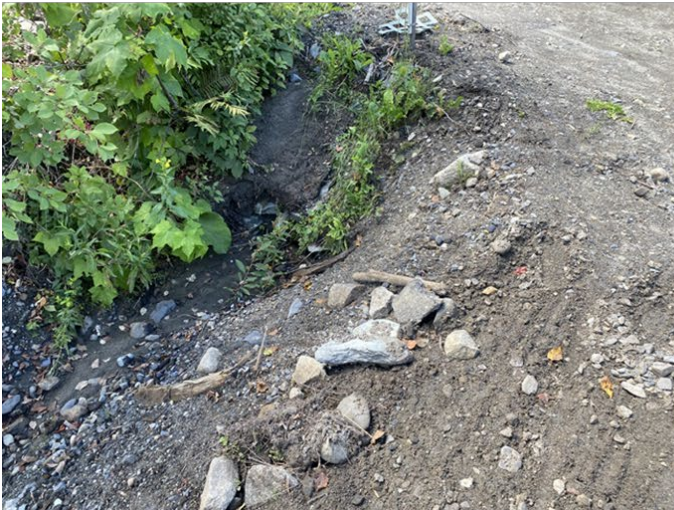
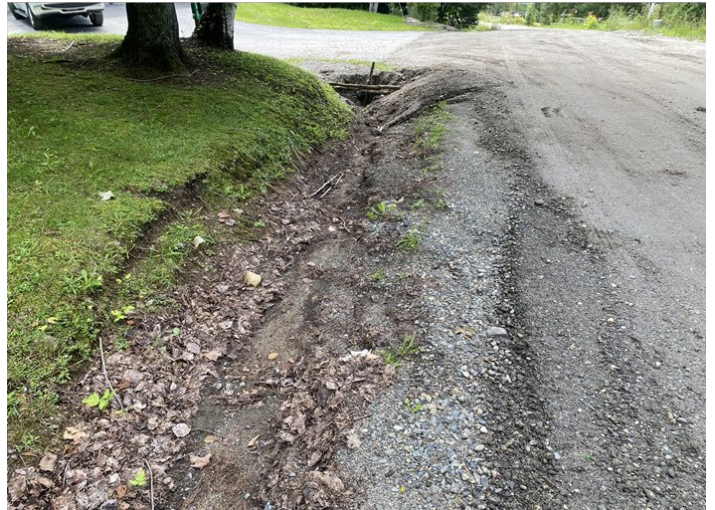
In general, several common types of issues were identified. One common situation included areas where there were unstable ditches that lack stone or vegetative stabilization often coupled with uncompacted ditch slopes and road edges leading to significant sediment transport (Figure 20). Absent or undersized culverts have resulted in erosion and sediment transport, especially during high flow events. These conditions were observed in several locations (Figure 21). Culverts that are not regularly cleaned out, especially in areas where there are these unstable road shoulders, can become clogged over time and limit the transportation capacity of these culverts (Figure 22). As these clogged culverts cannot properly convey stormwater, significant infrastructure damage can result, and these failures can also be associated with sediment loading.

Figure 20. Common issues observed in the watershed were unstable ditches and uncompacted ditch slopes leading to sediment transport.

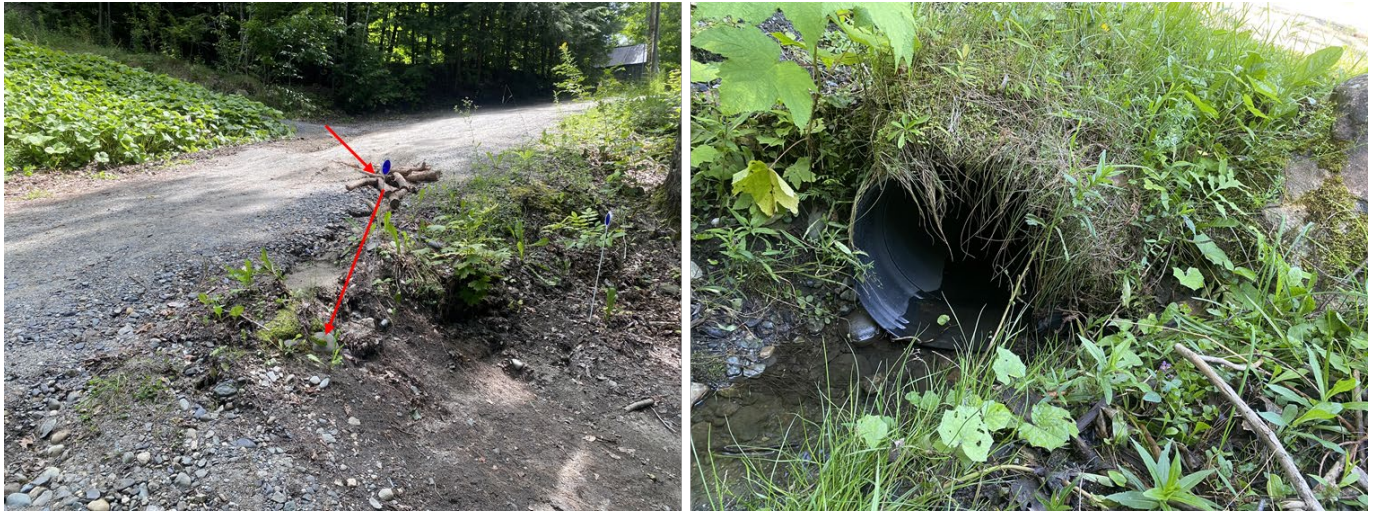
Figure 21. Absent (left; see flow paths across road highlighted with red arrows) and undersized (right) culverts have resulted in erosion during larger storm events.

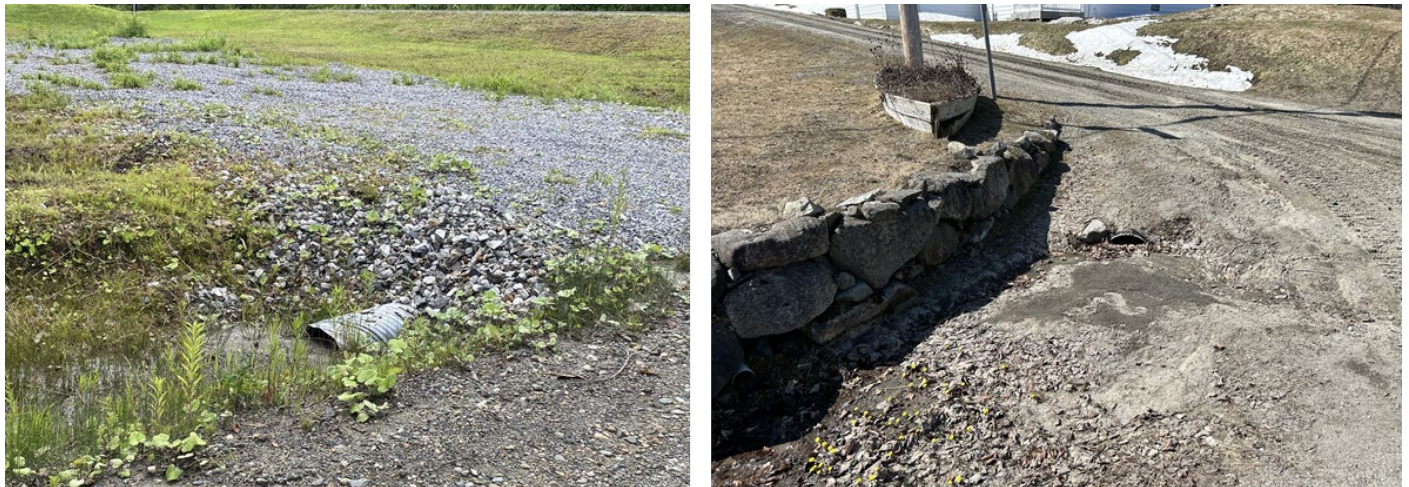
Figure 22. Clogged culverts cannot transport stormwater effectively and can lead to scour and flooding damage in adjacent areas and the transport of sediment to Shadow Lake.

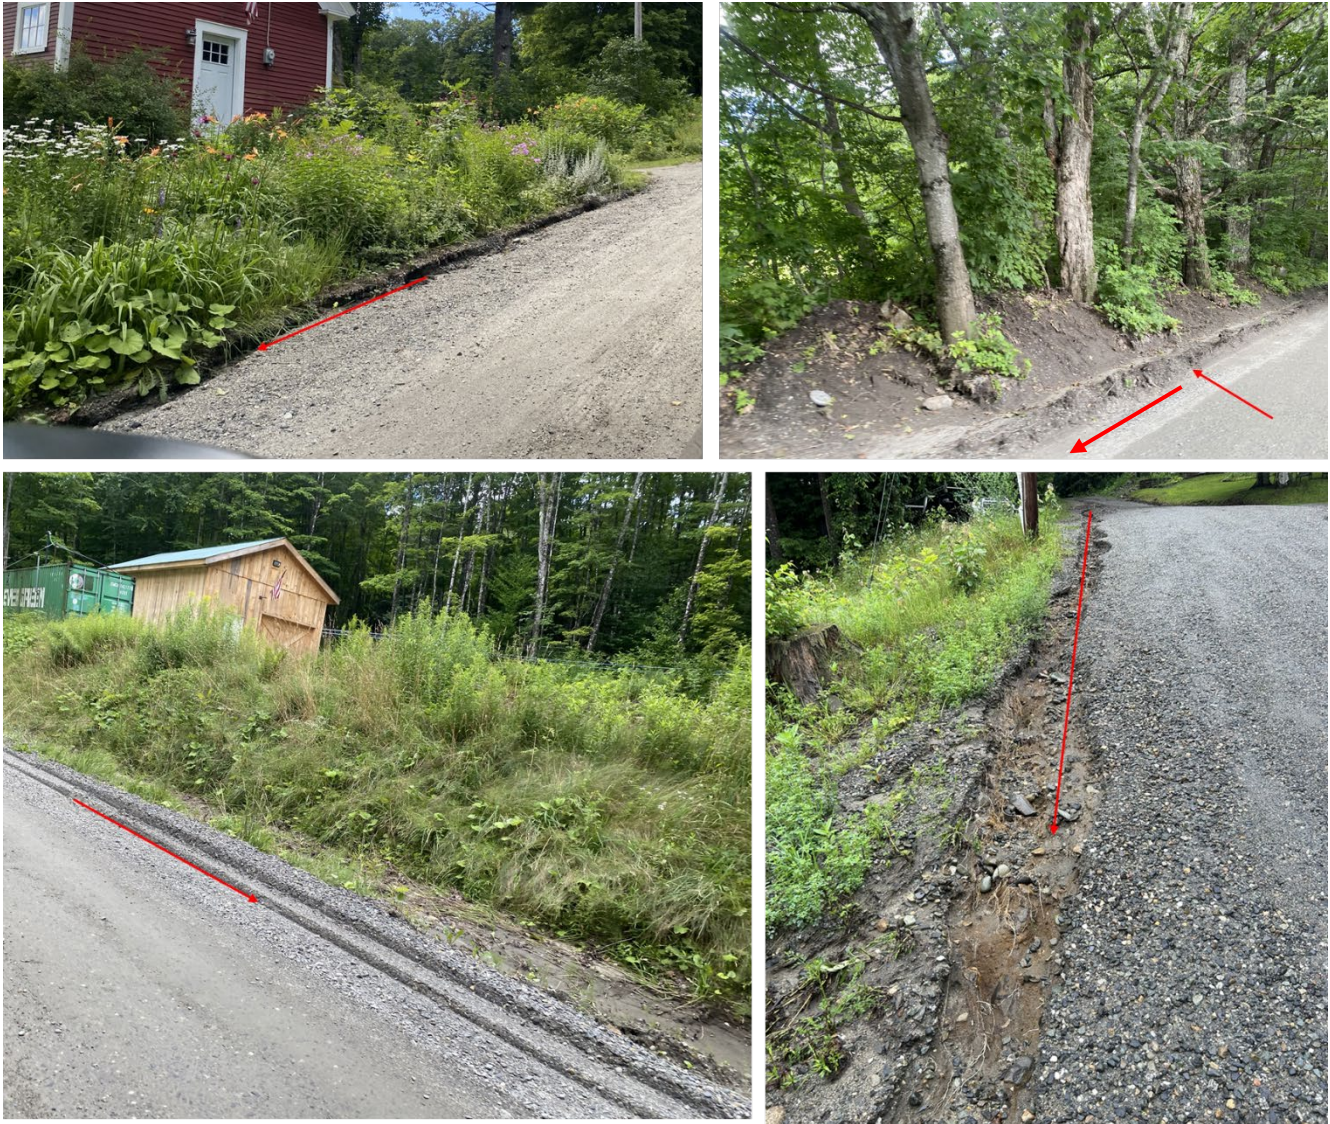
Figure 24. Improper grading and the creation of grader berms that restrict flow to the road result in erosion and sediment transport. Red arrows show the direction of flow.

Unpaved roads should be graded to shed water to vegetated areas to stable conveyances like vegetated or stone lined ditches. All grader berms (piles of material that are pushed to the edge of the road by the grader and limit or fully prevent water from leaving the road) should be removed. Several areas where grader berms prevent water from shedding off the road and instead redirect water down the road were observed in the watershed (Figure 24). Additionally, areas where roads and driveways were graded so that water is directed down the transportation surface or left ungraded for so long that tire tracks have caused ruts in the surface were observed in multiple locations (Figure 23). These lead to similar erosion and scour issues as the grader berms because water cannot leave the road or driveway surface.

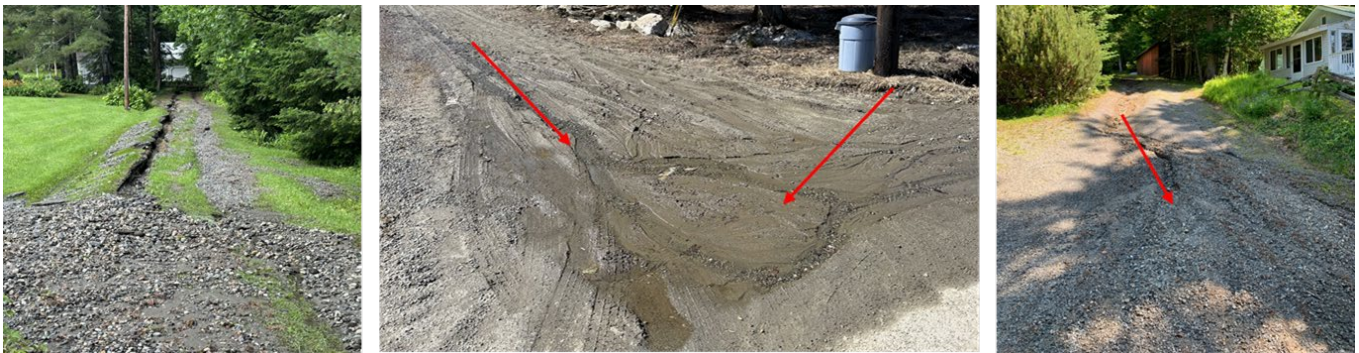
Figure 23. Several unpaved driveways in the watershed are graded so that water runs down the center of the driveway rather than shedding water off of the driveways to green areas, resulting in erosion and sediment transport especially during larger storm events. Red arrows show the direction of flow.

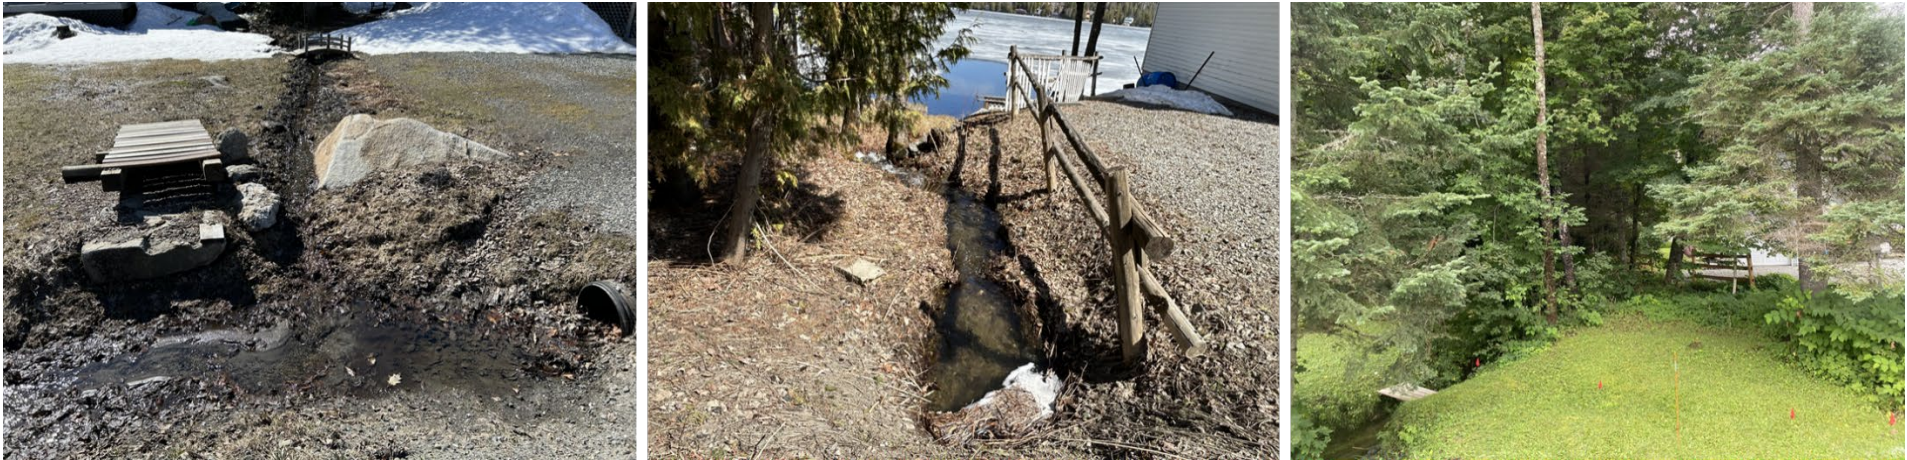
Figure 28. Several stretches of stream within the watershed lack a robust riparian buffer.

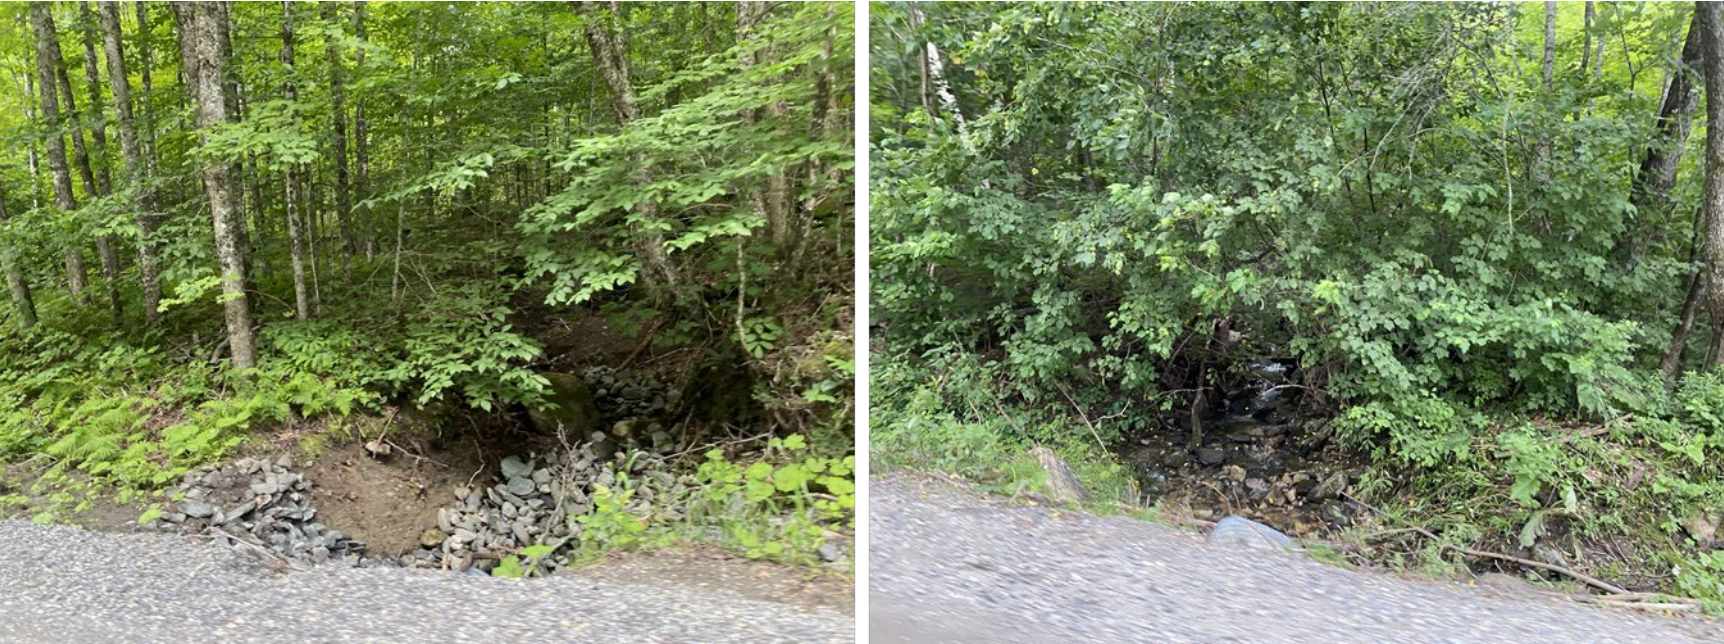
Figure 29. Unstable stream banks and direct connections between roadside ditches and streams are recurring problems in the watershed.

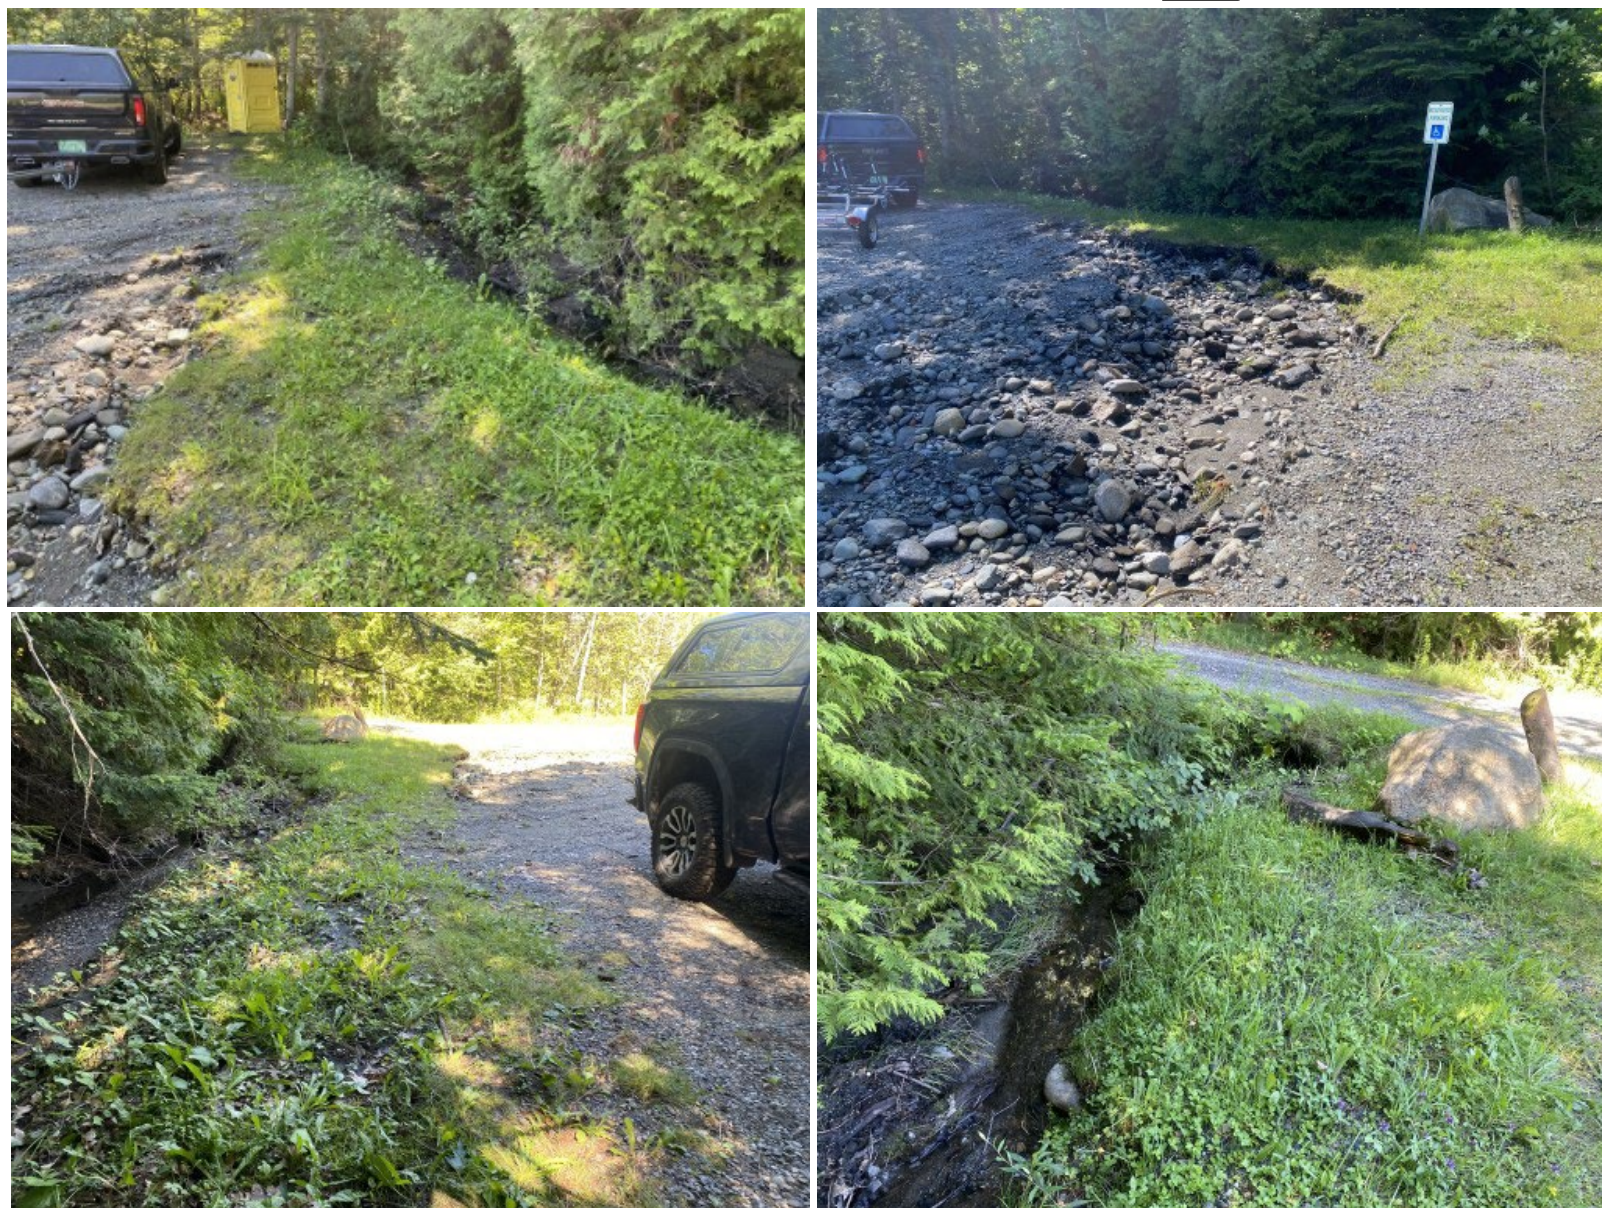
One area where several of these issues was observed was the Fish and Wildlife Access area. This area lacks a vegetated riparian buffer, has an undersized culvert that restricts flows, and has a straightened stream channel that decreases stream roughness and sinuosity and thus increases stream velocity and erosive power (see Figure 30 and Figure 31). Culverts should be sized to adequately pass at least a 10-year storm event. The recommended minimum diameter of stream culverts is the bankfull width of that stream (in sensitive areas, this recommendation is increased to 1.2 times bankfull width). The bankfull width, not to be confused with the water level at any given time as this can fluctuate greatly, is a measure of how wide a stream is when it is passing channel forming stream flows. These flows occur regularly (generally annually or semiannually) and maintain the shape of that stream channel. See Figure 27 for a diagram showing the concept of bankfull width.

Figure 30. The Fish and Wildlife Access parking area abuts a tributary that has been artificially straightened and lacks a robust riparian buffer (upper left and lower left) and has an undersized culvert (bottom right) that contributed to the stream jumping its banks during the July 2023 storm, which caused significant damage and sediment transport (top right).

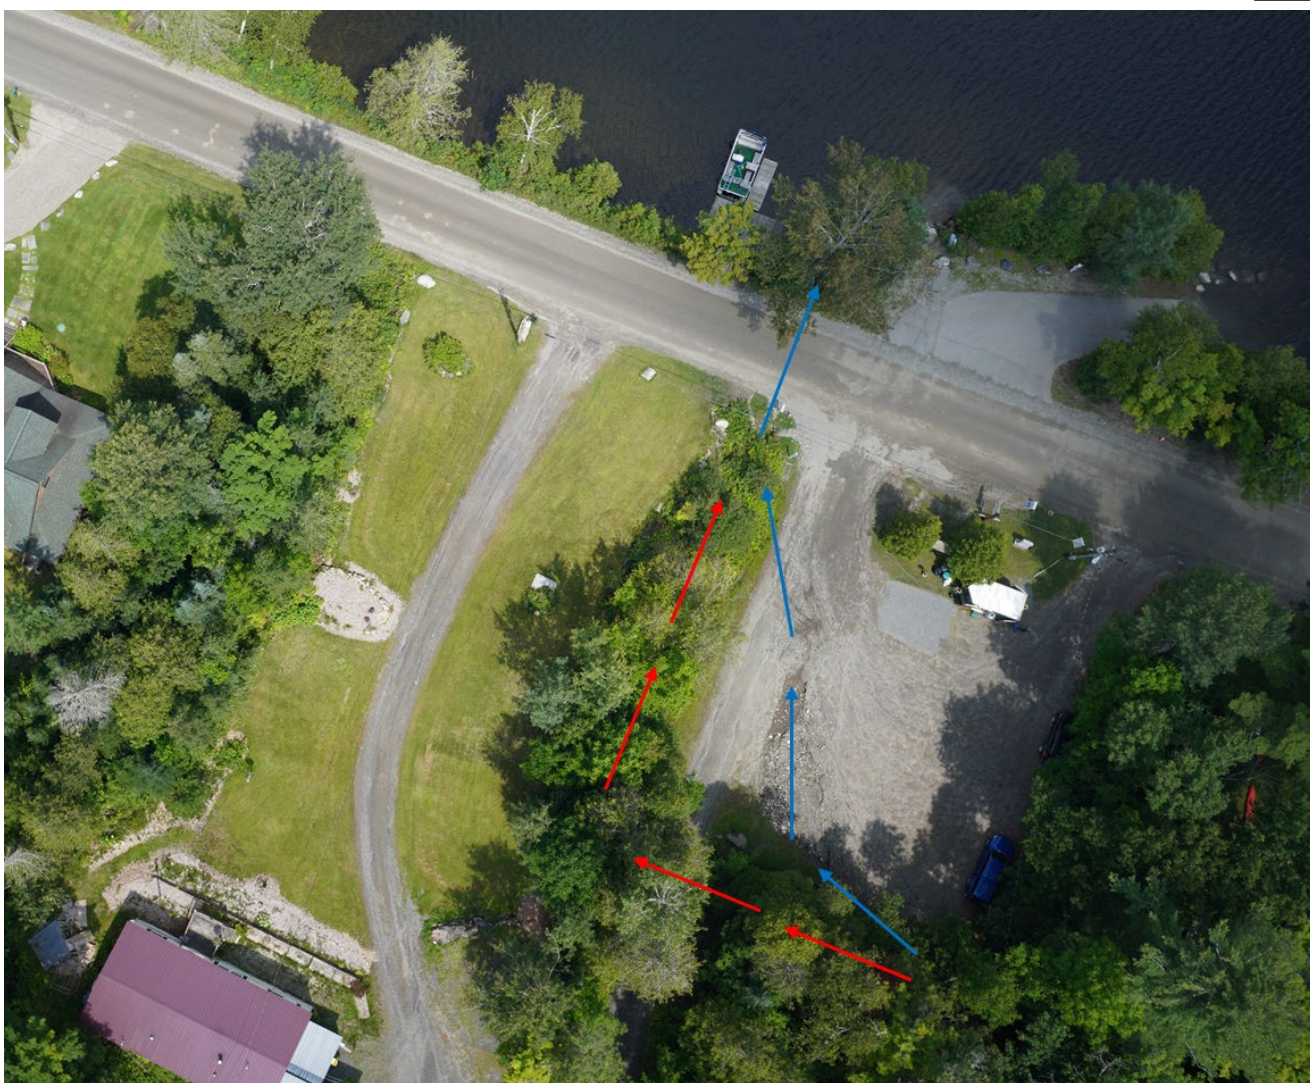
Figure 31. The tributary along the Fish and Wildlife Access area (shown with red arrows) jumped its banks and flowed through the parking area during the July 2023 storm (blue arrows).

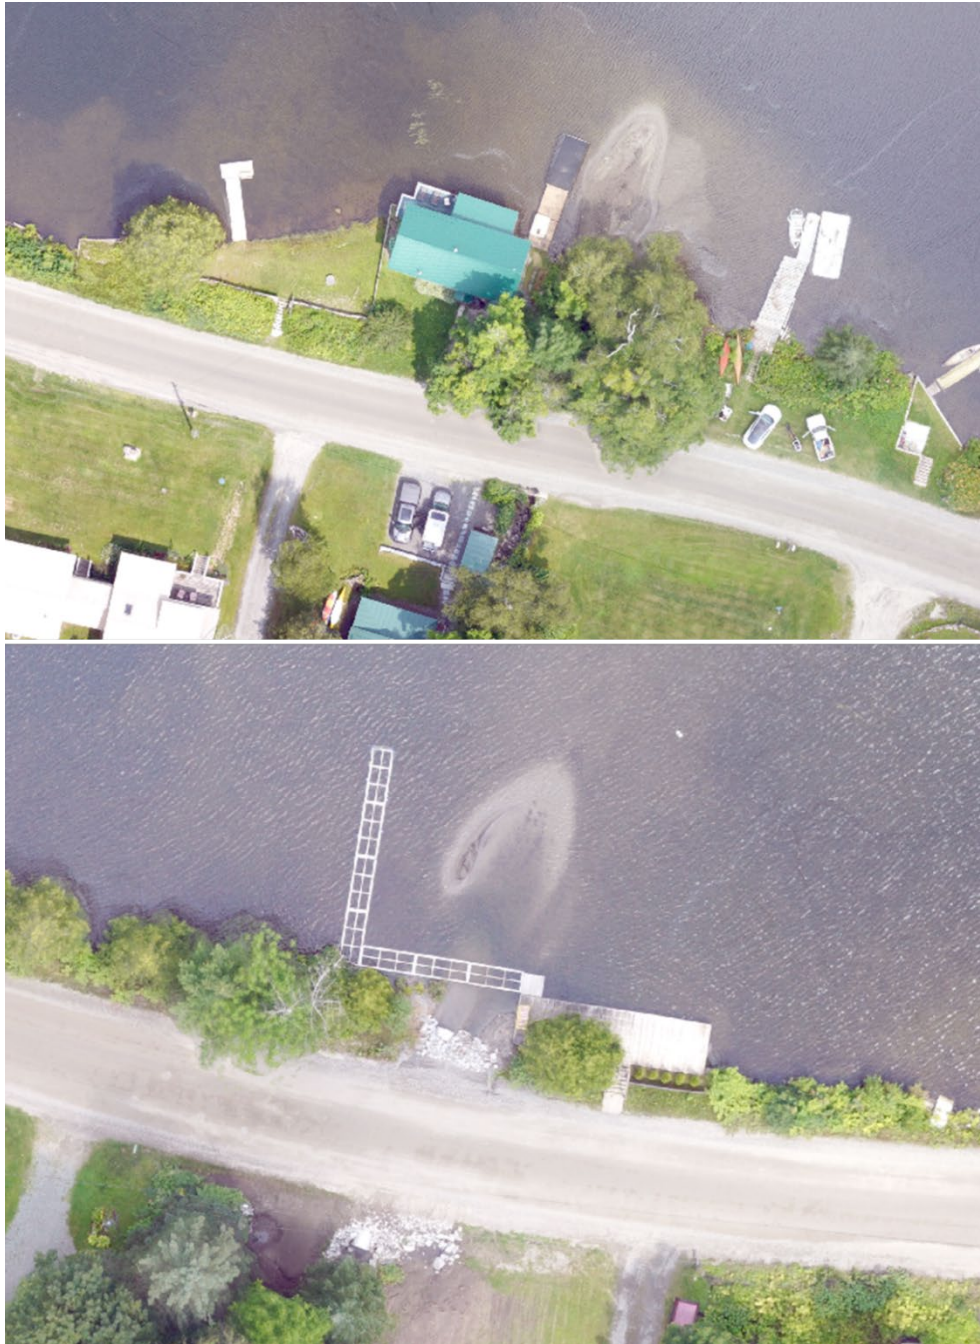
Following the July 2023 storm event, the stream network in the Shadow Lake watershed transported significant sediment that was then deposited in the lake. UAS-collected imagery shows large depositional areas at several stream culvert outlets (Figure 35). While this was an extreme event with much larger than normal stream volumes and velocities, some deposition at these culvert outlets was already observed, which indicates that providing additional floodplain access, increasing stormwater storage within the watershed, reducing and slowing stormwater flows to the stream network, and stabilizing erosion in the watershed are all important in reducing sediment loading to the lake.

Figure 35. Significant sediment was deposited in Shadow Lake from stream culverts following the July 2023 storm event.
