AUTHORIZATION TO CONDUCT NEXT FLOOD MEASURES

Project Number: NFM-06-23-2016

1. This project authorizes scour protection repairs to the Randell Road crossing of Shepard Brook; to be completed as described in the documents submitted to this office on 11/16/2016; prepared by J.A. McDonald Inc.

Bridge Repair

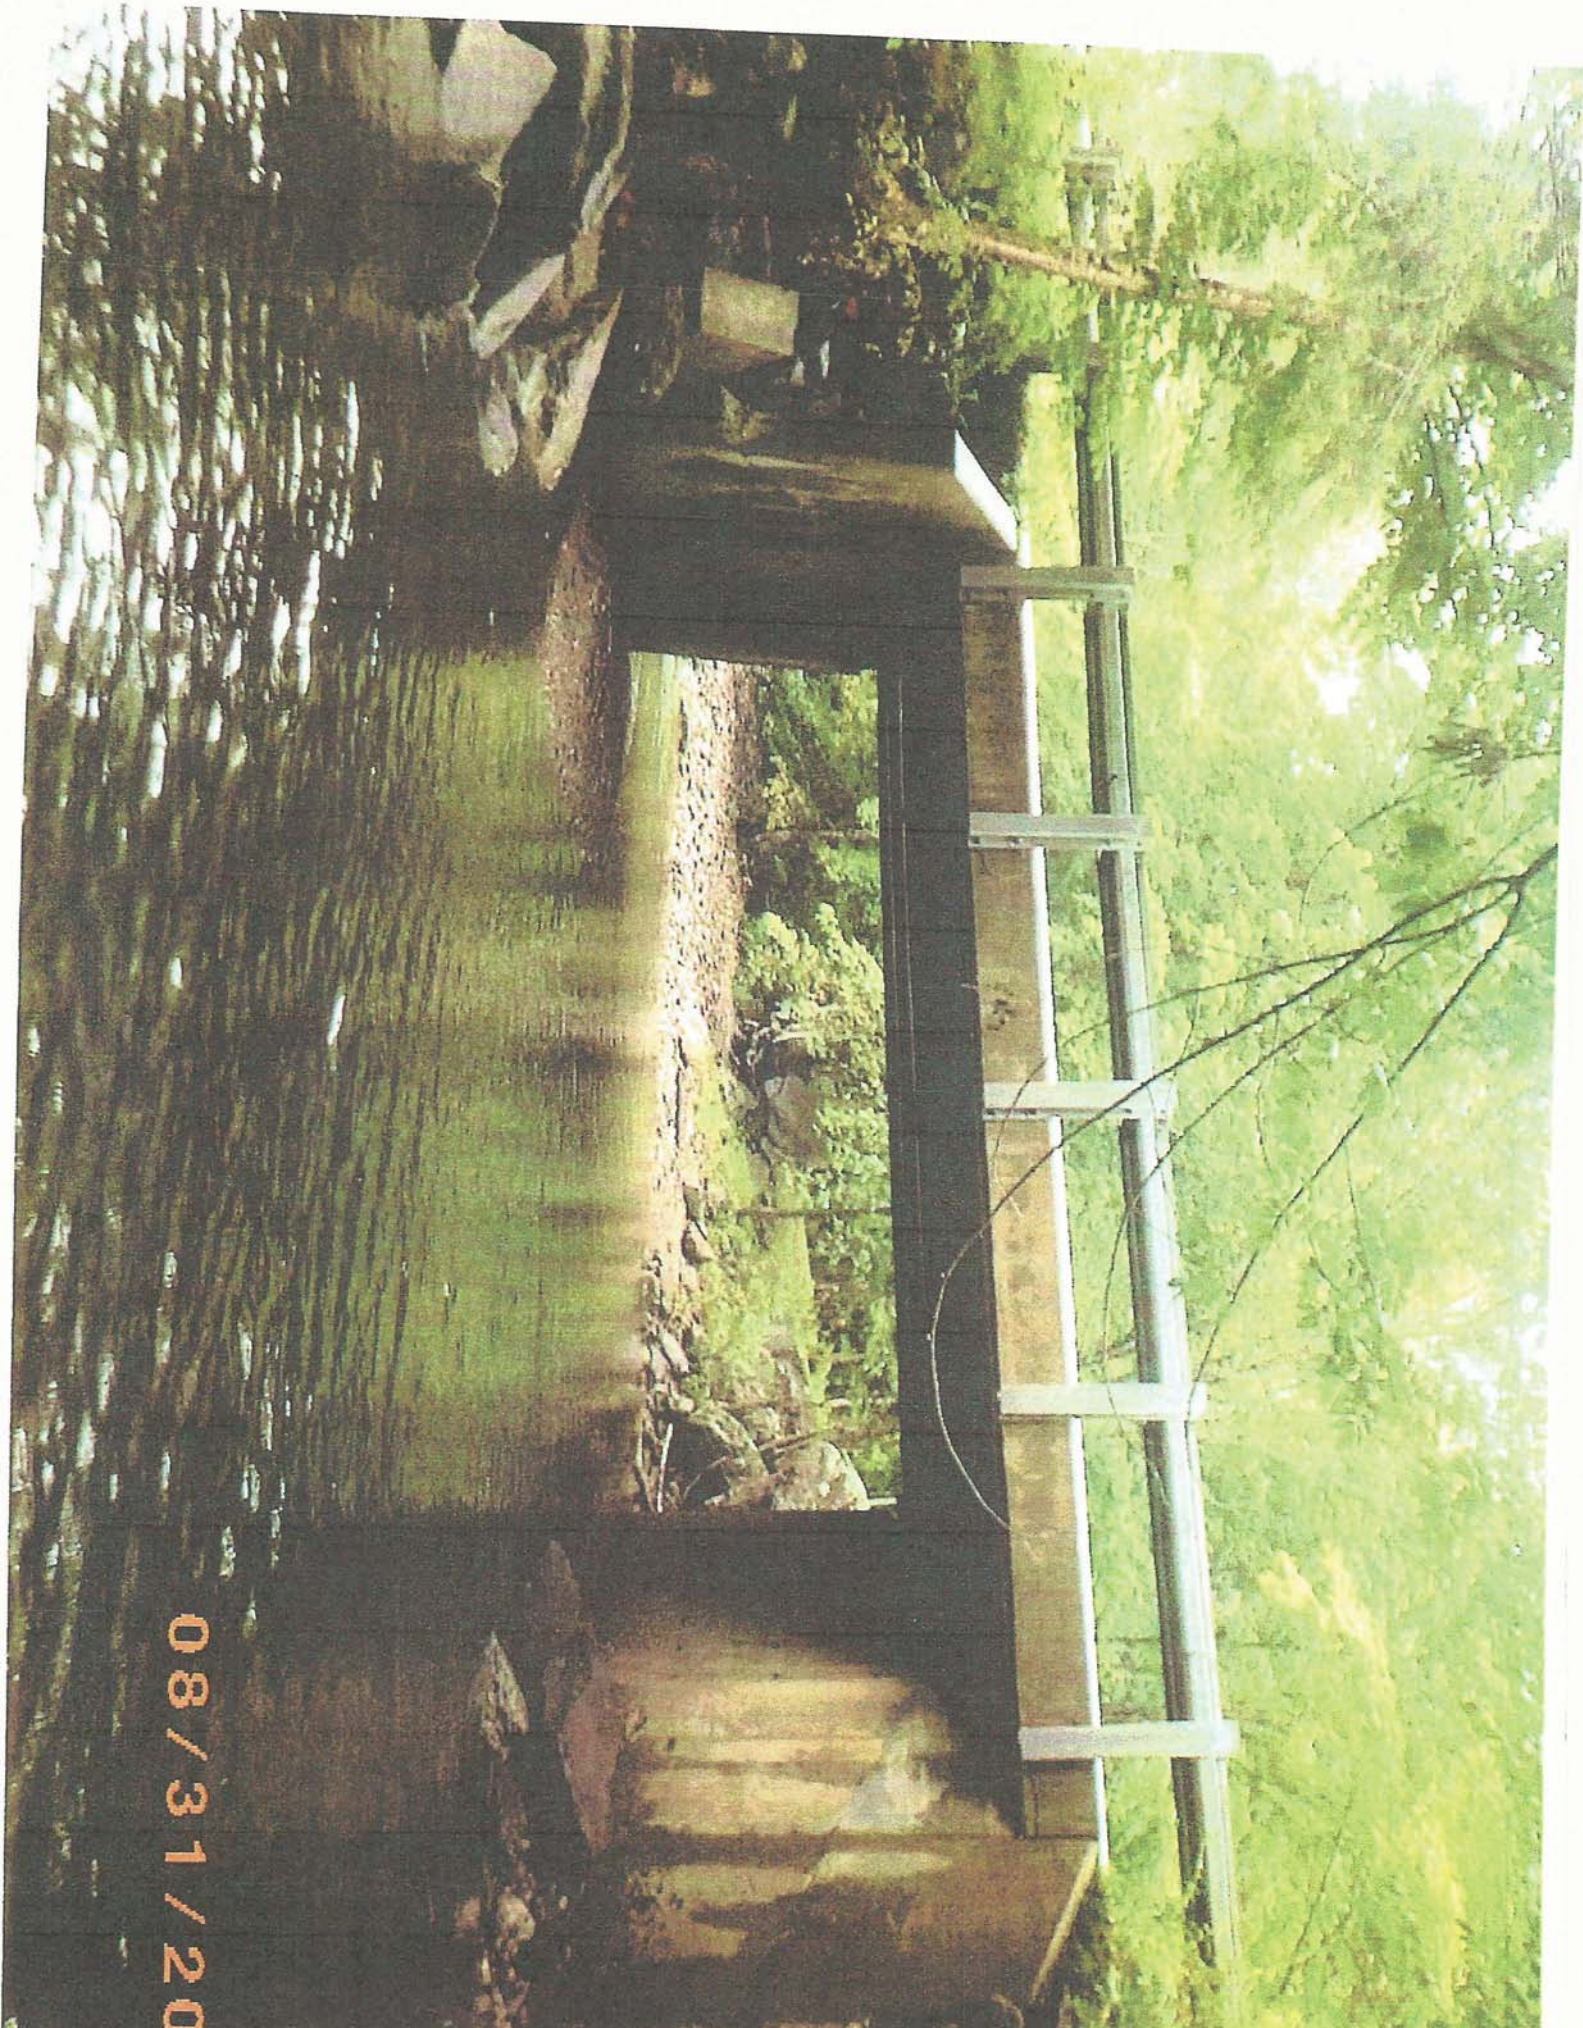
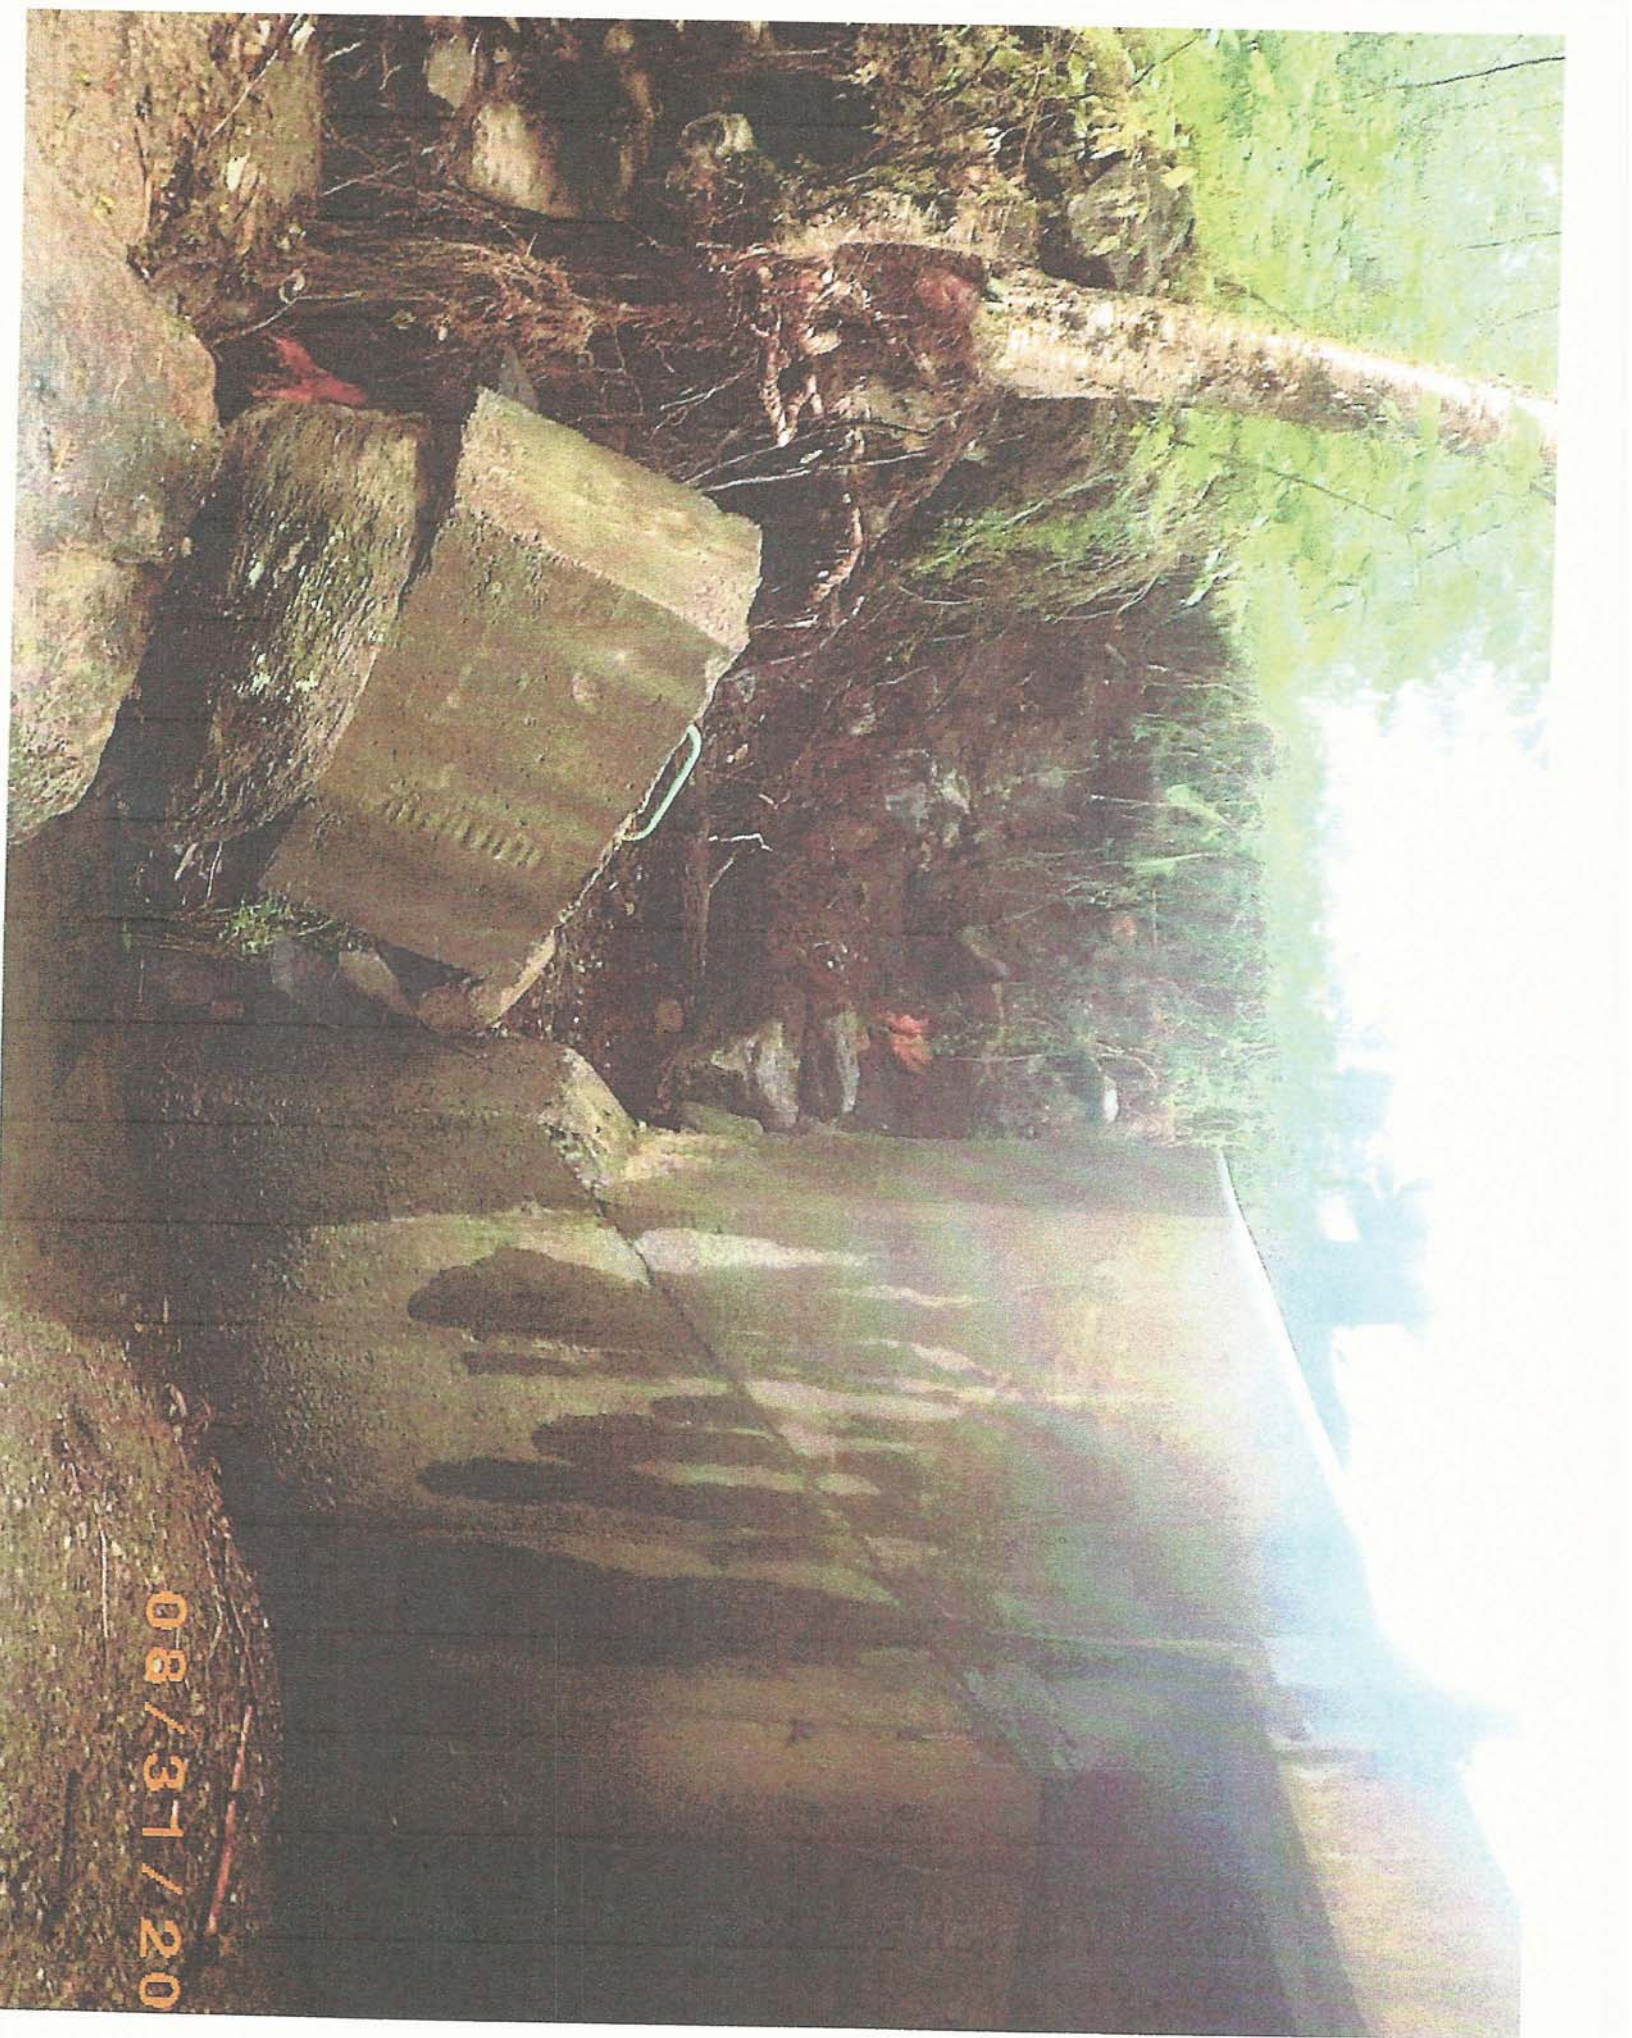
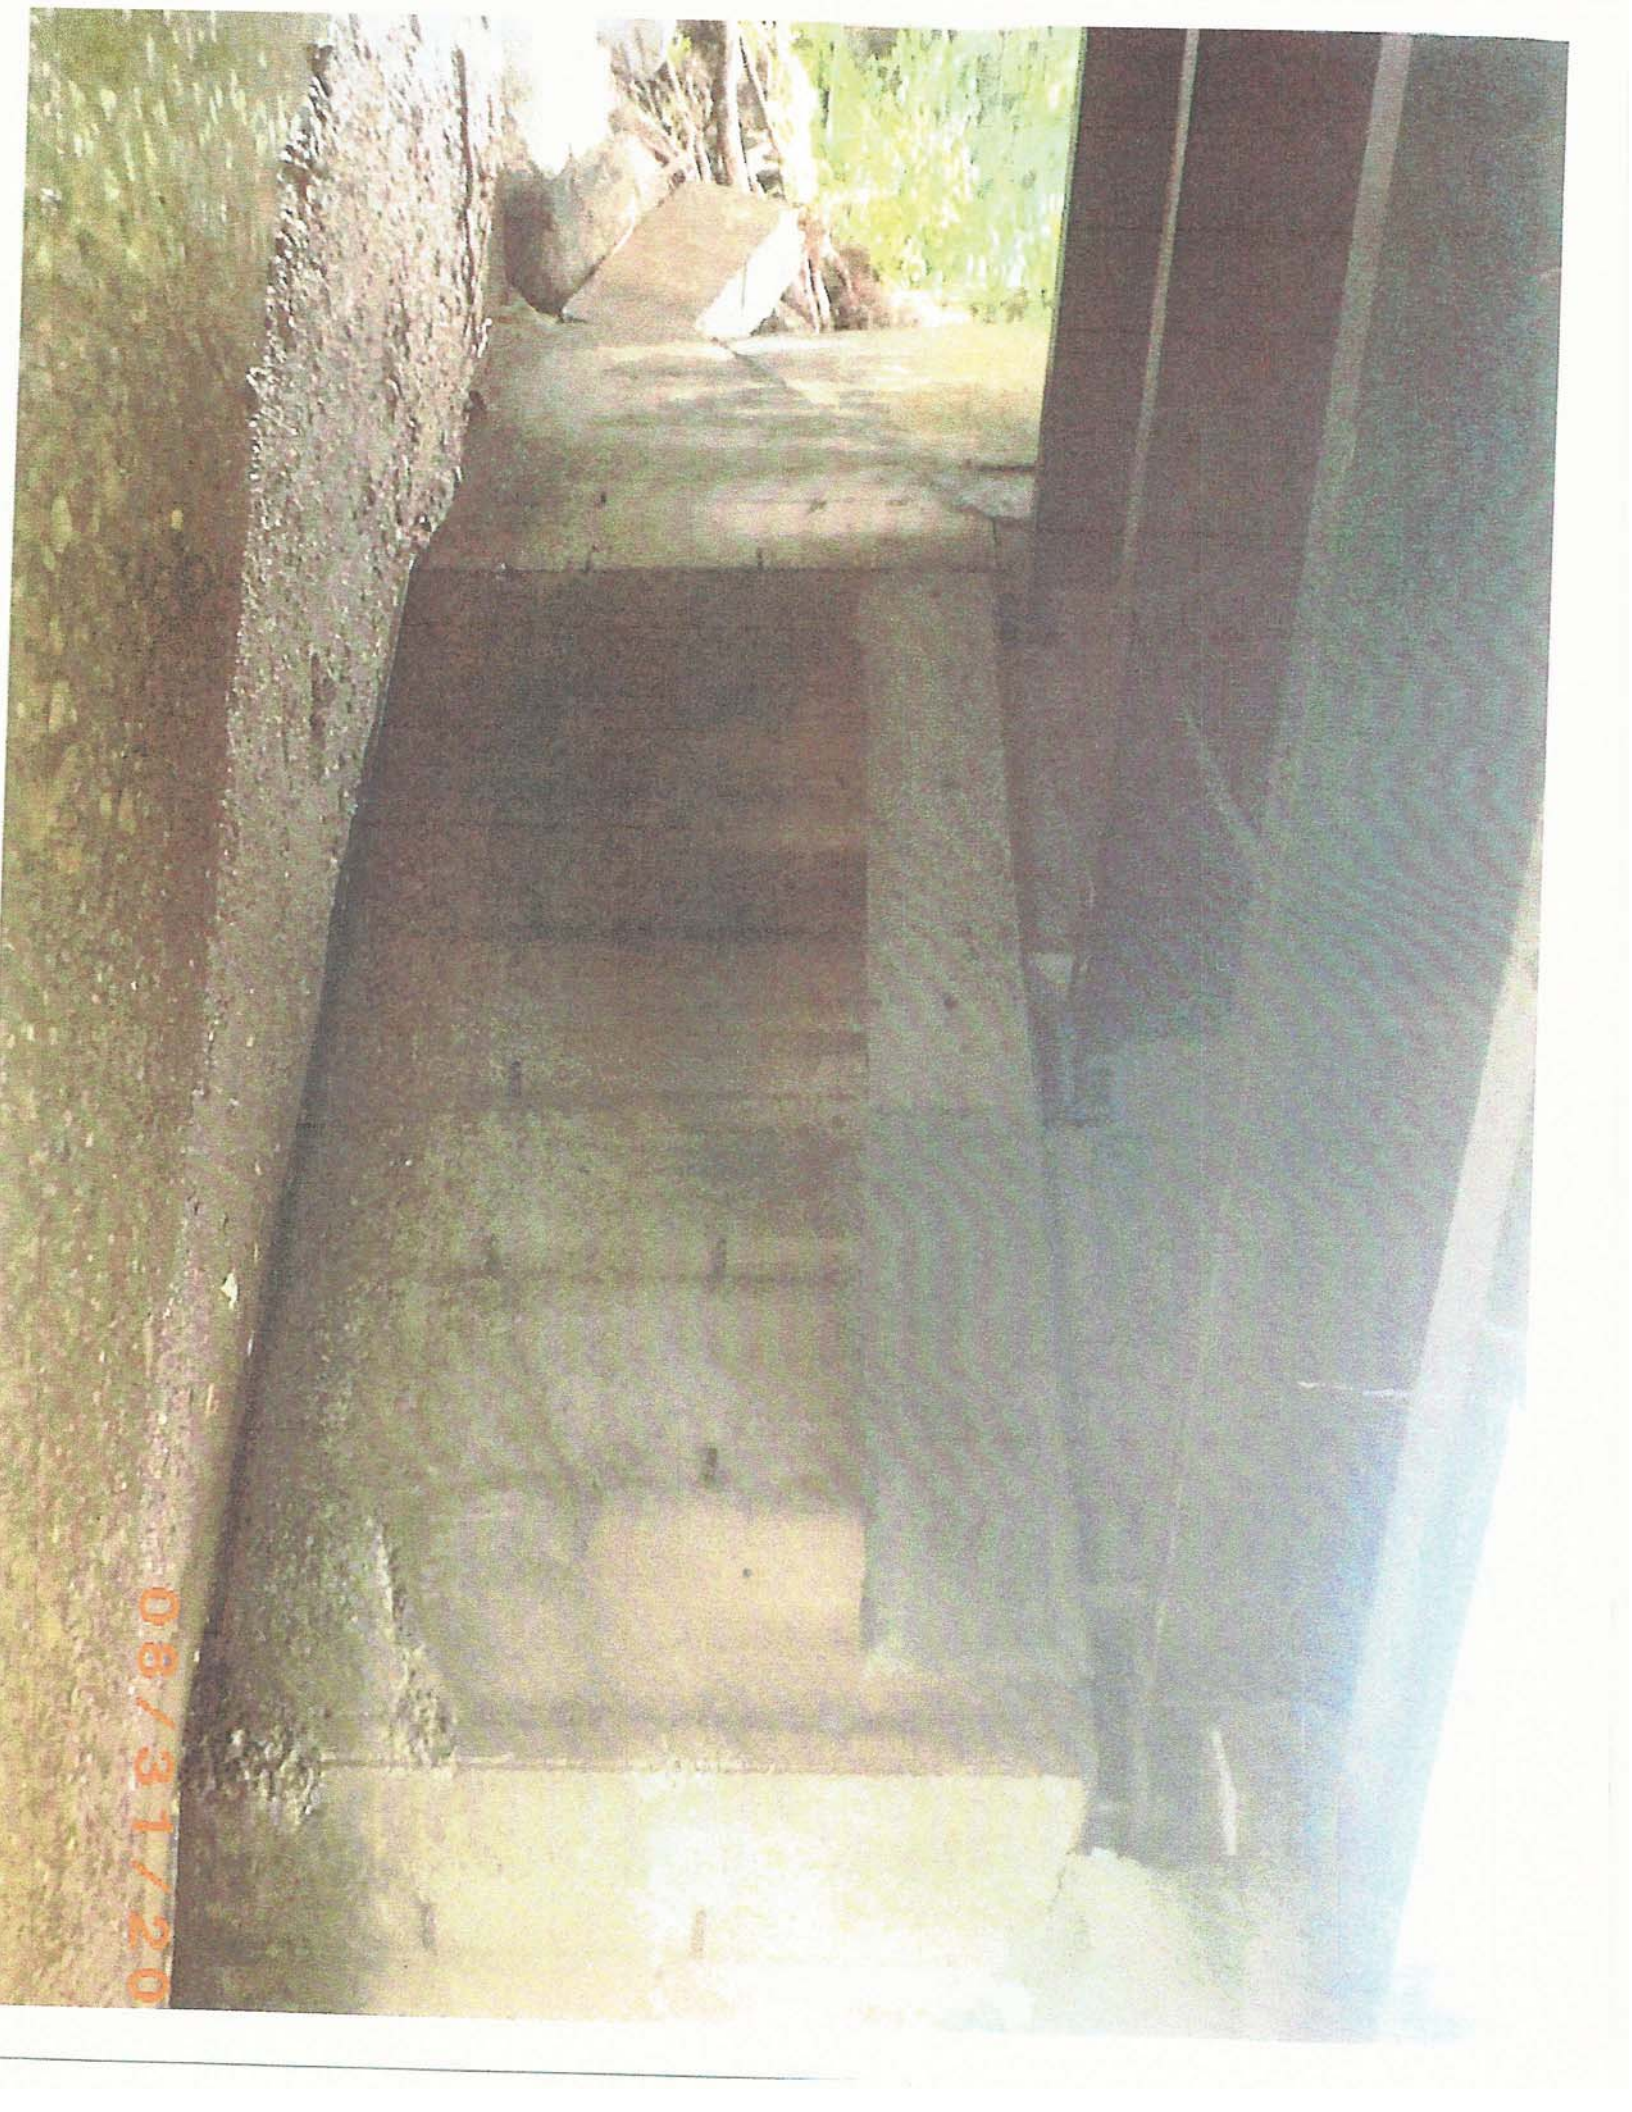
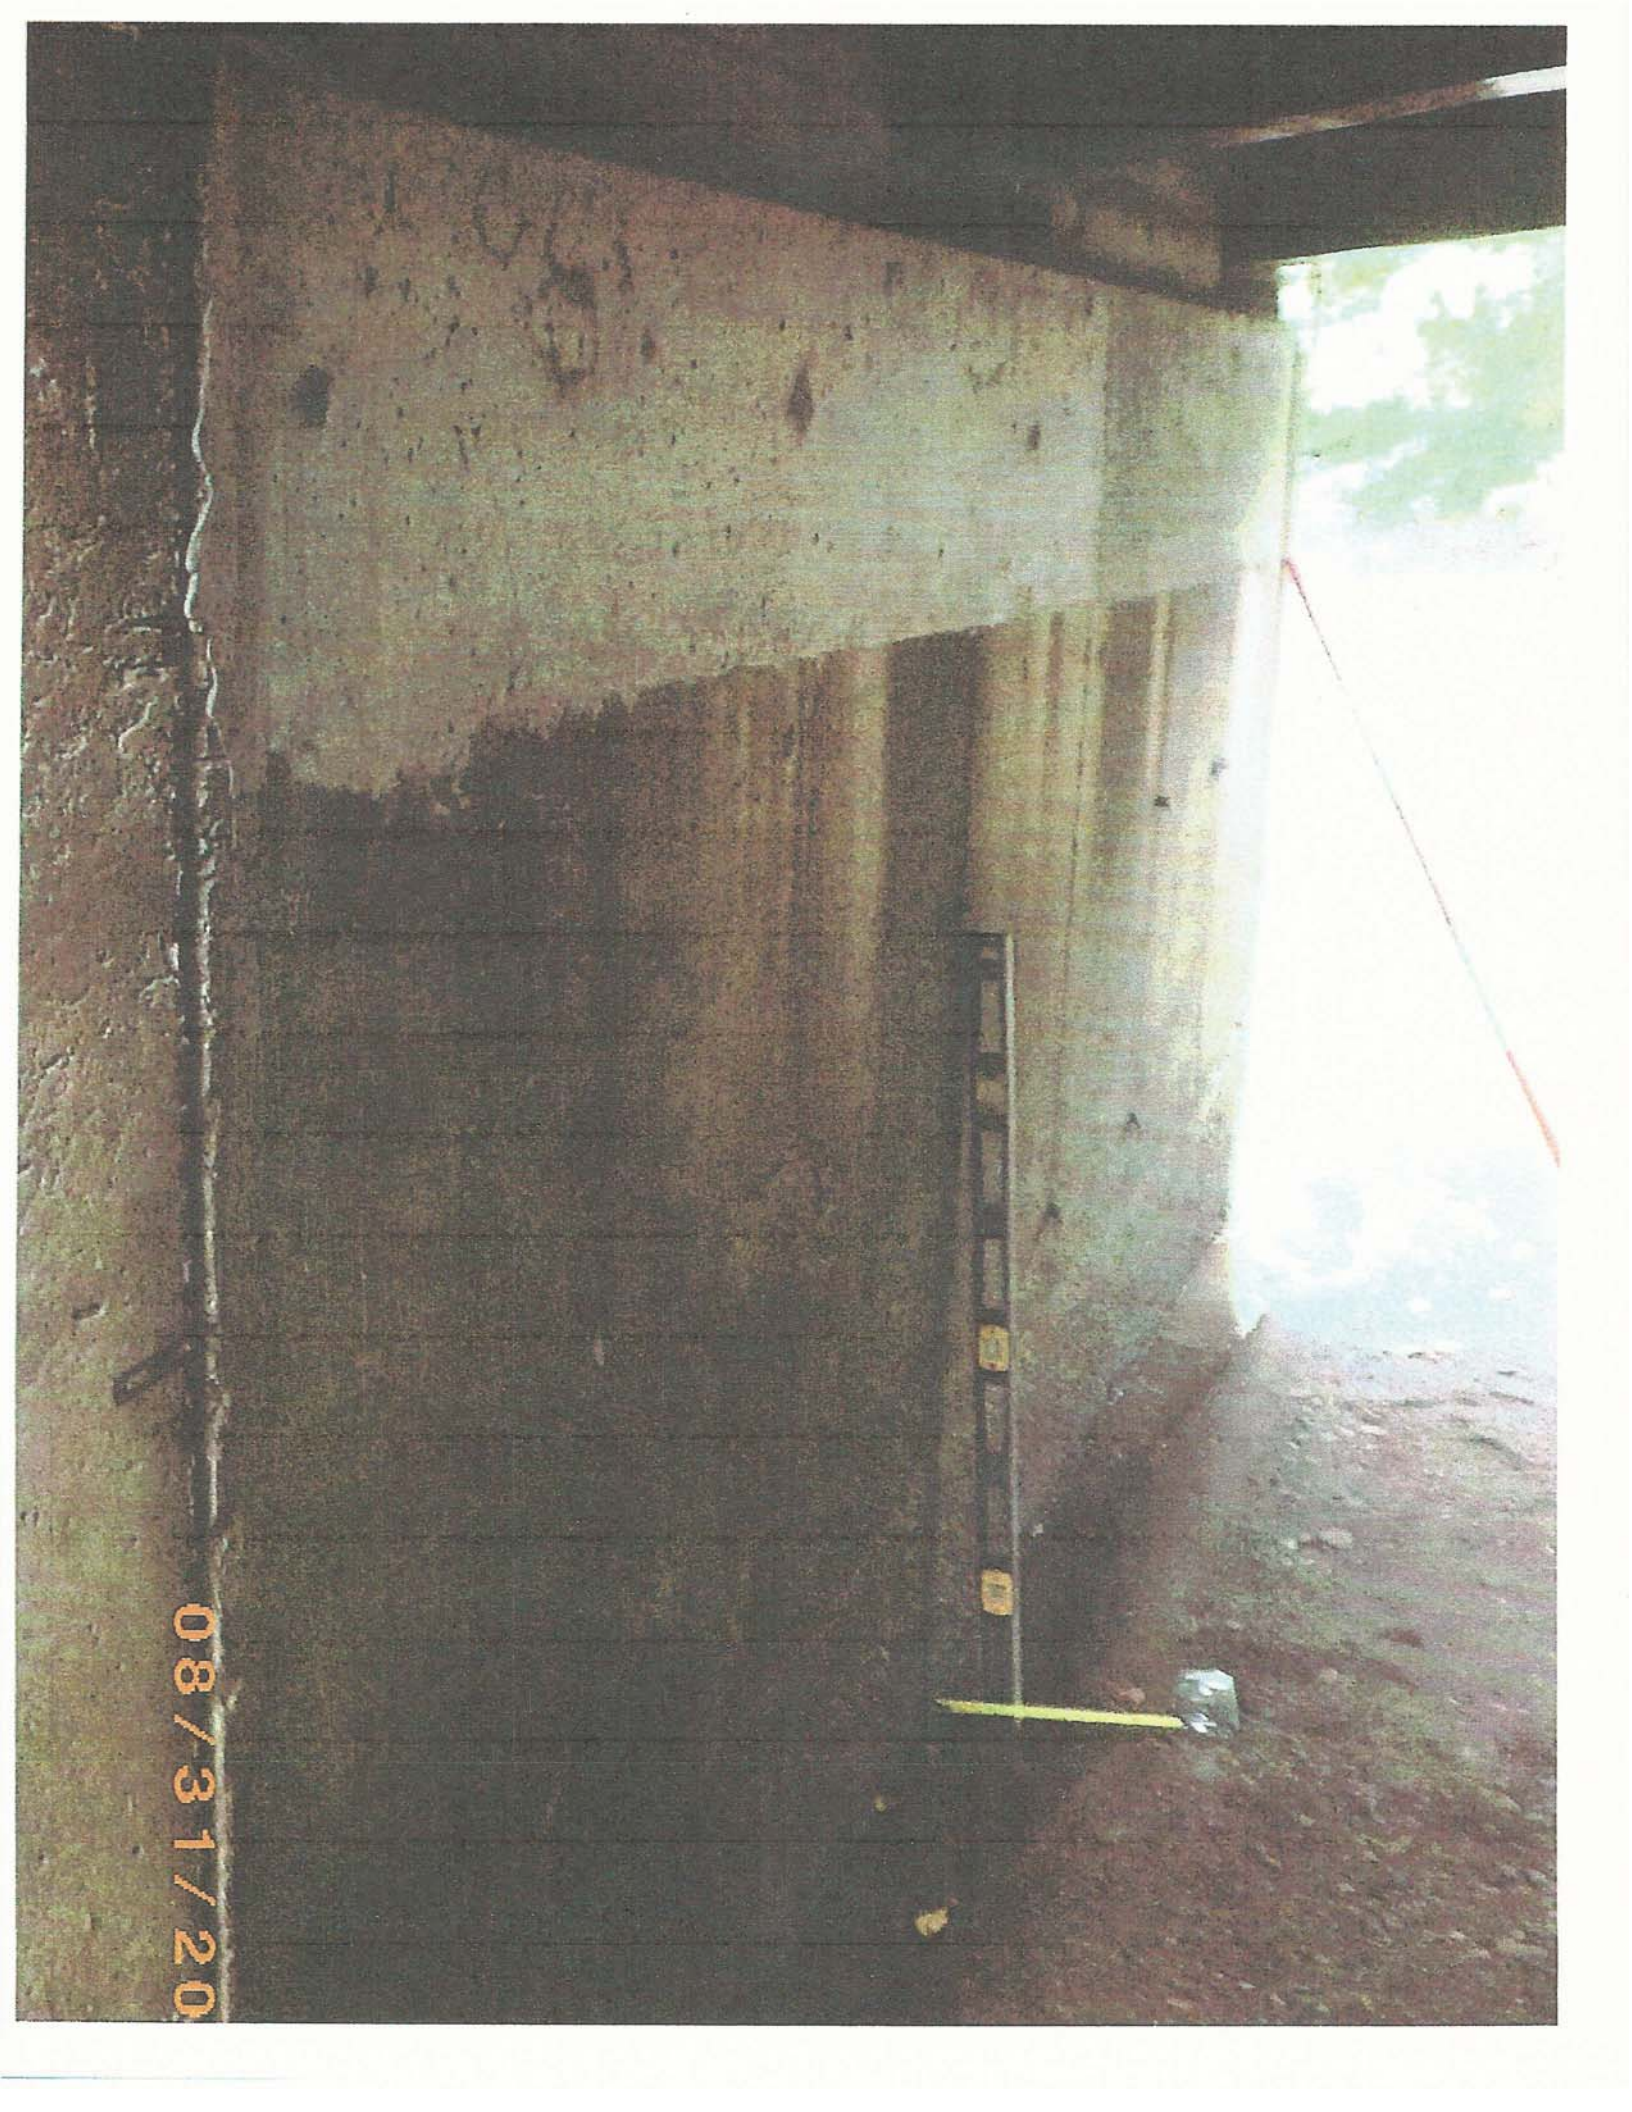
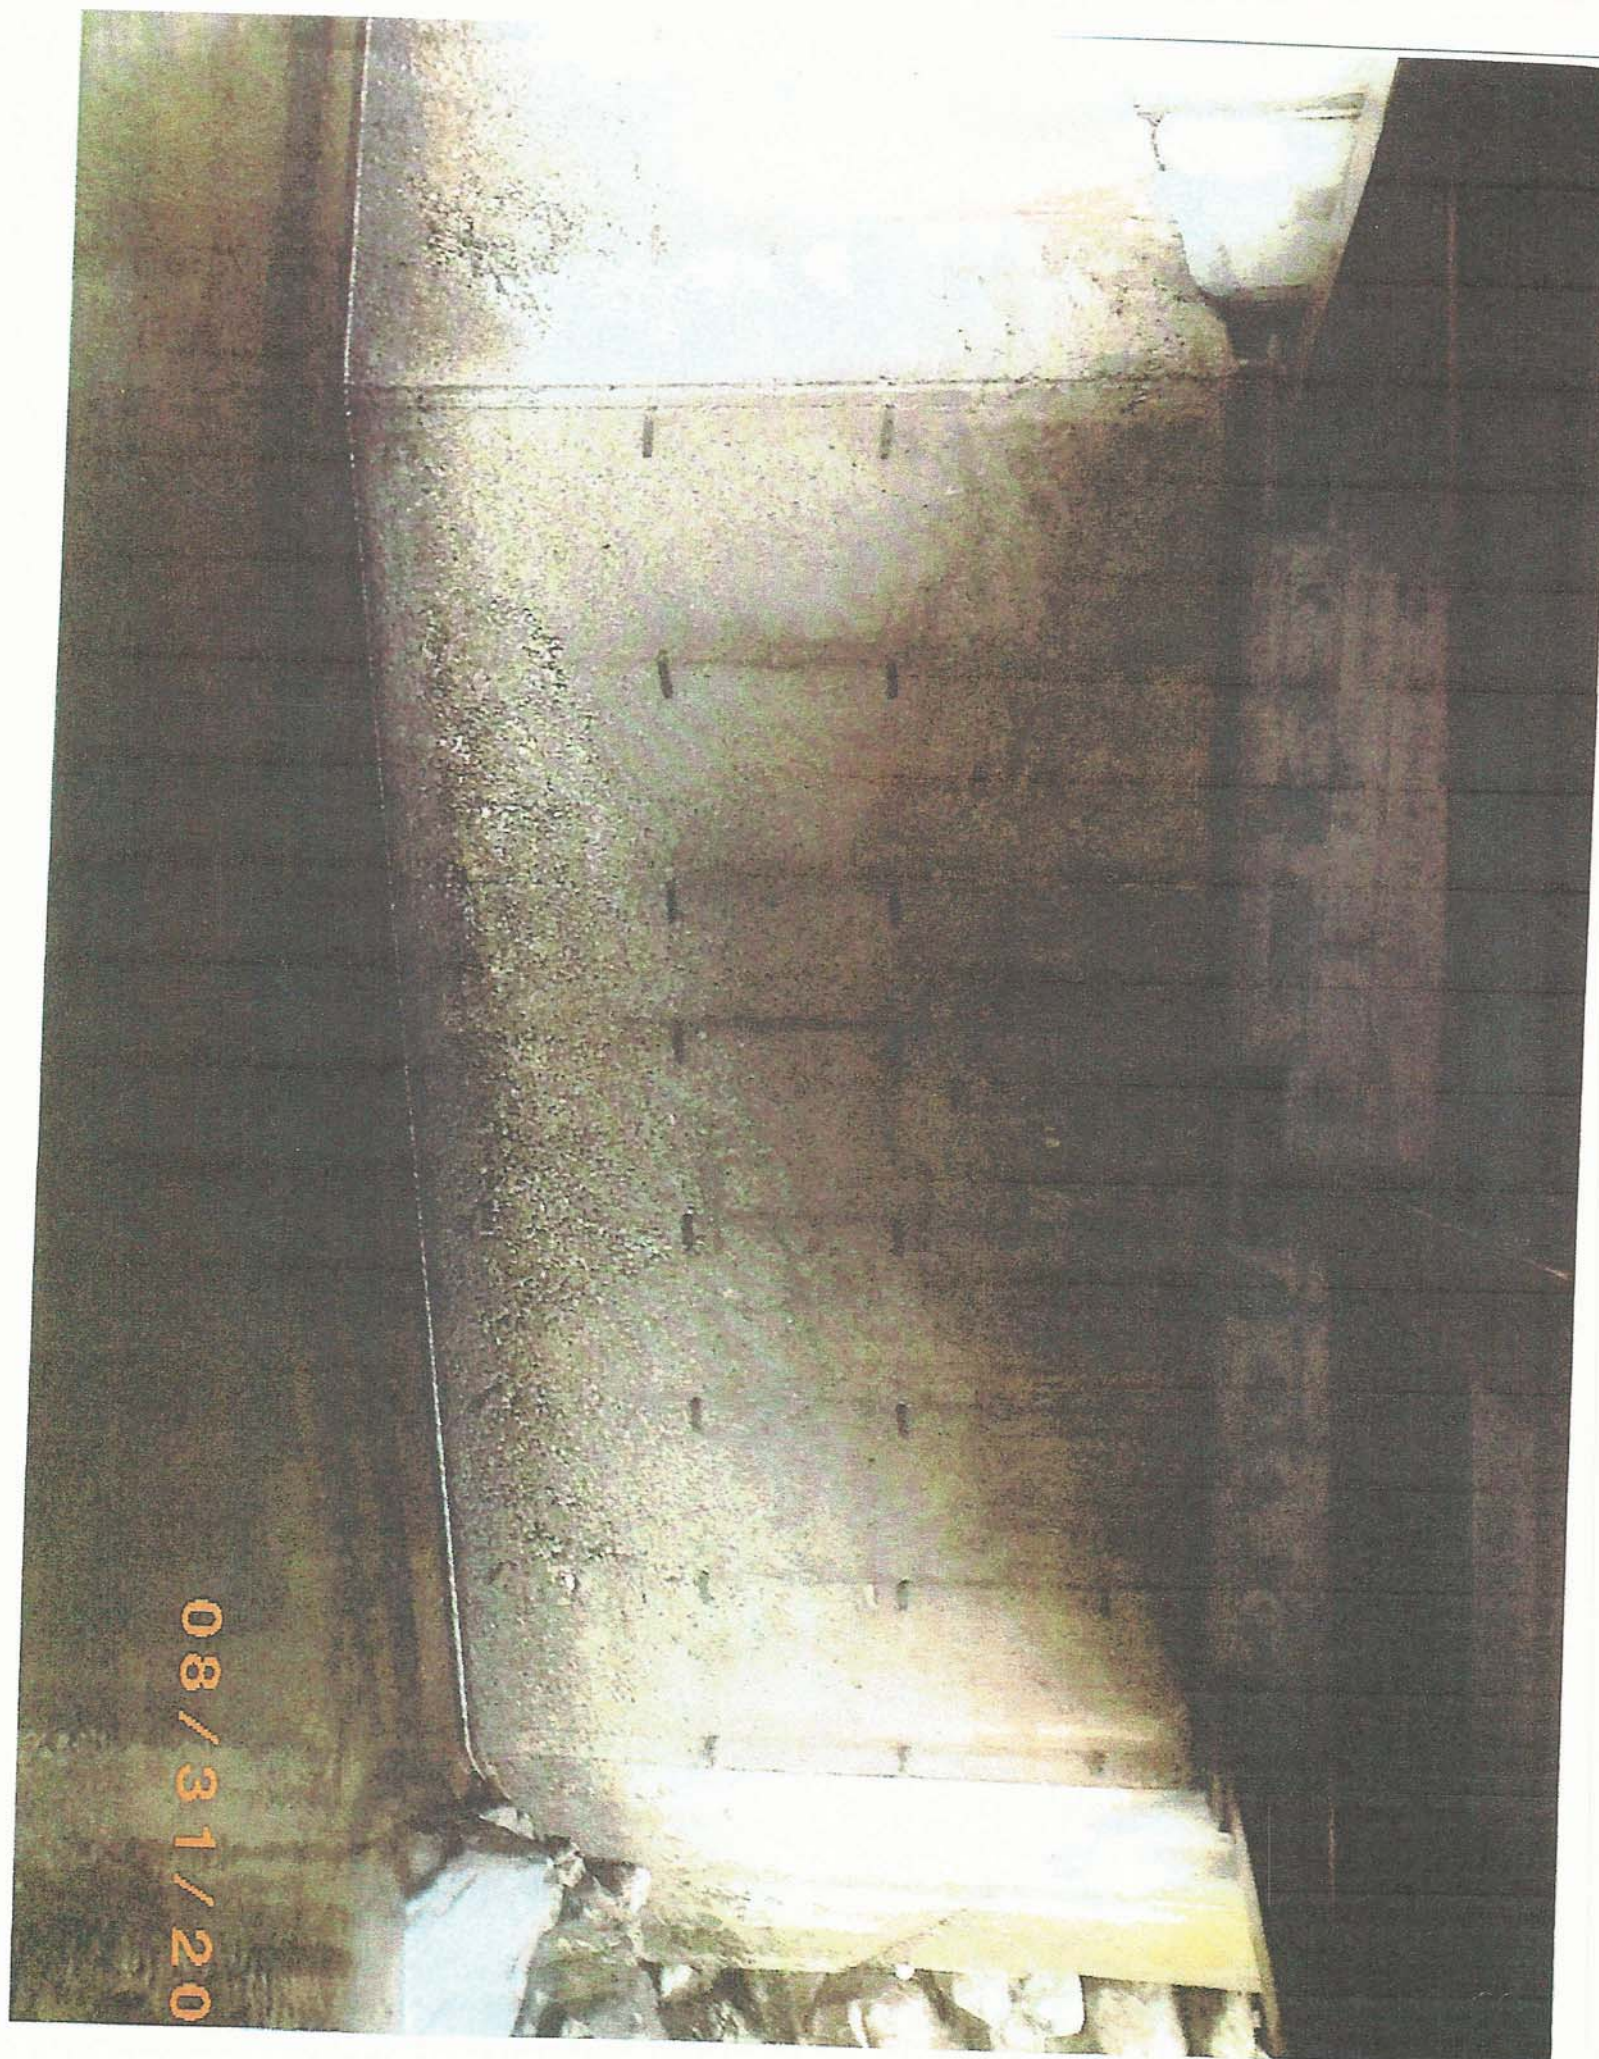
The recent water flow did cause some erosion along and behind the downstream end of abut. #1(south), which extends up the side slope, and has exposed a precast concrete block laying now, at the toe of slope. This abutment was noted as having a forward list for a number of years, which increased slowly up to 3" of rotation in 4' noted in 2012. I checked this today and noted 2-3/4" to 2-7/8" in 4', so no indication that this recent flow has caused any further displacement. Some cracking in the upper corners of the abutment are noted, but have been present, and look like thermal cracking, as the wing, and curtains were poured integral. No bending anchor bolts, or seat/curtain displacement either, though a slight drop in 4' horizontally.

Some scour has occurred along the north abutment which has had chronic undermining issues in the past. The abutment has been repaired at least twice over the years, with narrow knee walls, and riprap added to correct undermining. The water now is 5' deep along the abutment, still murky making visibility limited, but there is now undermining that extends along the upstream wing for approximately 6', and along the footing below the stem for approximately 10'. The voiding is at least 10" deep, and extends in 6' or more in some spots. The added narrow knee walls are cracked thru at the downstream end, but the abutment which was noted as having 3/4" of forward list in 4' remains the same; with no additional movement.

I would recommend, that abutment #2(north) be repaired with concrete flowed in under, to fill the voids, and jagged stone protection added again. The Town could get a better estimate on the void dimensions for quantities, once the water level, and clarity have improve.

Consideration should also be given to adding a larger and deeper knee wall along this abutment, as was done to the south abutment during the recon. project. Stone fill material needs to be added to correct the southern slope erosion. No loading restrictions are necessary at this time, though the undermining repair should be made this fall. Further scour and undermining could certainly destabilize the abutment.
