**Stream Corridor Plan
LaPlatte River and Tributaries
Town of Hinesburg, Vermont**

Prepared by the LaPlatte Watershed Partnership

June 2007

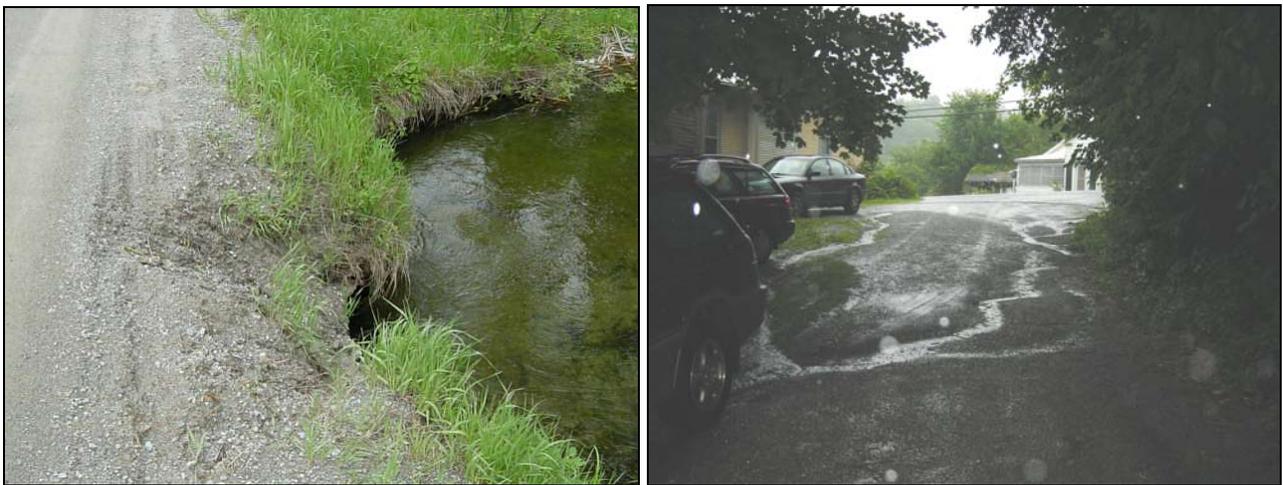
Runoff from roads, driveways, and road washouts during storms also appeared to be a source of increased sediment and increased runoff in the streams. Driveways and roads had essentially dammed floodplains and channeled runoff directly to streams, which was especially evident in hill reaches. Exposed soil from incremental development in the watershed was another source of sediment to stream channels.

Sand and gravel from roads and driveways washing into the channel.

Sediment from roads and driveways can be addressed with improved ditches, limiting future driveway lengths in sensitive areas, and other methods. The Better Back Roads program would be helpful.

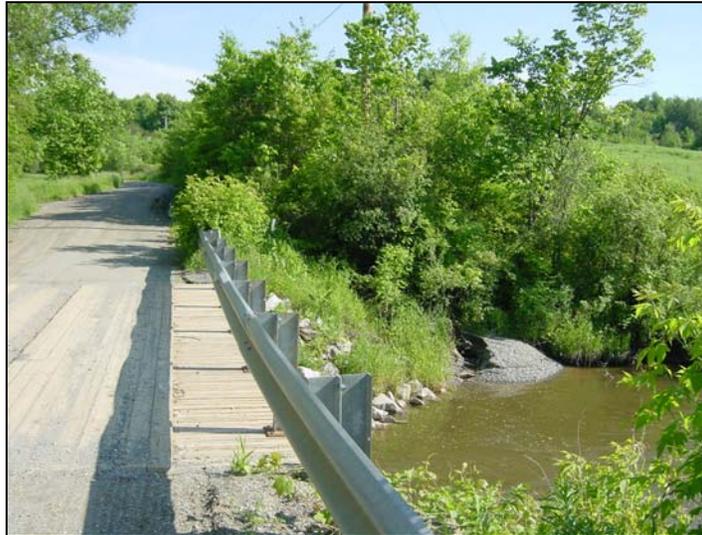
Leavensworth Road and bridge at M12 with large sediment deposit on the right where the road ditch meets the channel.

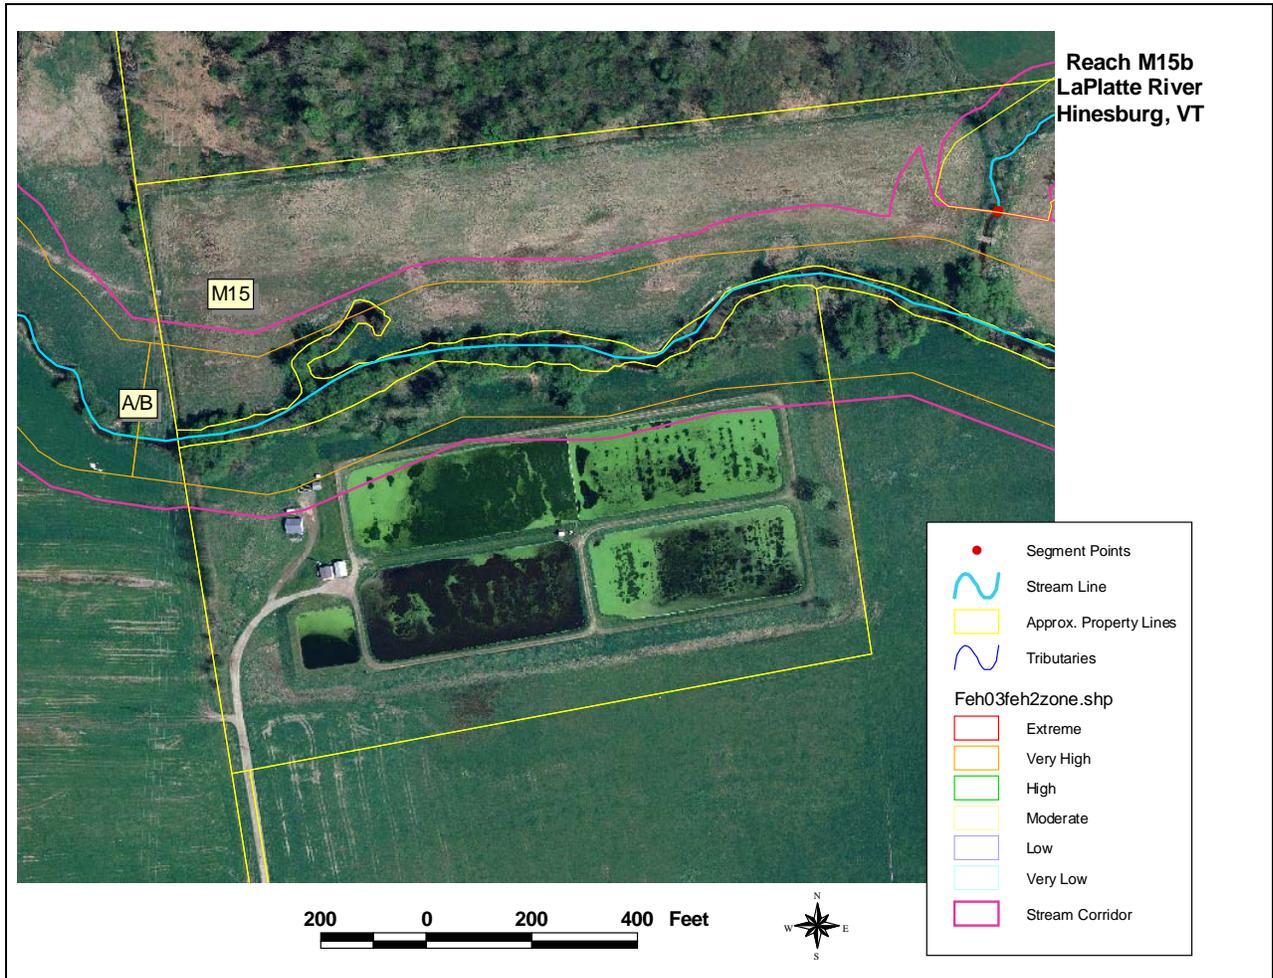
The channel was straightened and incised, resulting in greater stream power and increased sediment transport capacity. No recently abandoned channels were observed to capture as a restoration tool. The Hinesburg Sewage Treatment Plant is a permanent constraint within the corridor on the left bank. The LWP has been working with the Town of Hinesburg to plan future Plant expansions out of the stream corridor. Other than that, adjacent land use appeared to be fallow field and flow and sediment load alterations do not appear to be significant enough to inhibit the active geomorphic restoration of floodplain and meanders.

Downstream area of M15B with the STP on the left bank. The STP encroaches into both the FEH corridor and the Stream Corridor. The stream has begun to meander here and is migrating toward the berm of the lagoon.

Active restoration such as lowering of the floodplain may be preferable to a passive approach here due to the proximity of the Sewage Treatment Plant. The channel appeared to be adjusting and protection of the corridor could allow for passive geomorphic restoration, although an active approach near the STP might be preferable to provide protection and relief to that investment. Restoring the segment through a combination passive/active approach is a possibility as well.

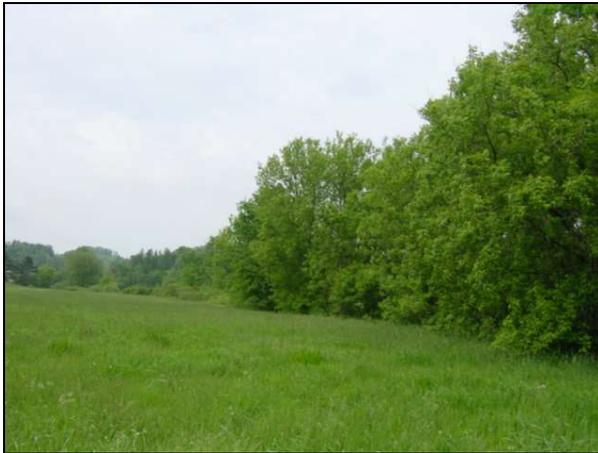
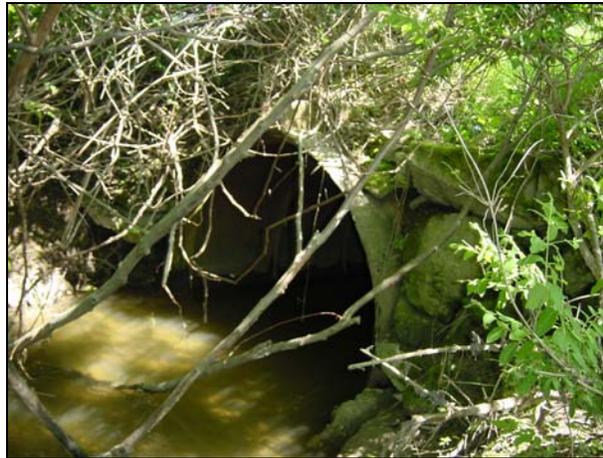
Reach M17 experienced a stream type departure (C to B) and currently appeared to be widening and aggrading, attempting to gain some floodplain and sinuosity in its incised and entrenched position.

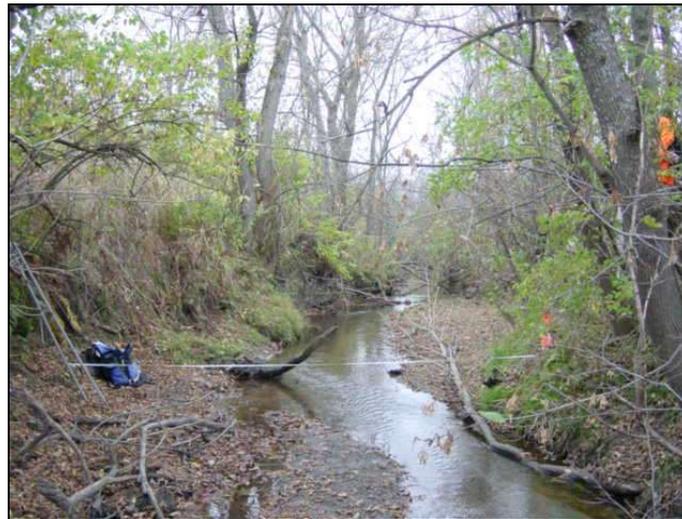
Reach M17, entrenched and now widening and aggrading.

The river corridor is undeveloped but the channel has been straightened and likely dredged deeper. If the channel were not actively managed, it may adjust to equilibrium conditions, although the 20-30 year “near-term” time line may not be realistic due to the clay present in the bed and banks, which has limited movement. However sediment supply is high, so protecting the river corridor and pursuing a passive restoration approach here could allow for floodplain and meander redevelopment over the long-term, without the cost of active restoration. Berms present in the reach are not the main reason the channel is incised.

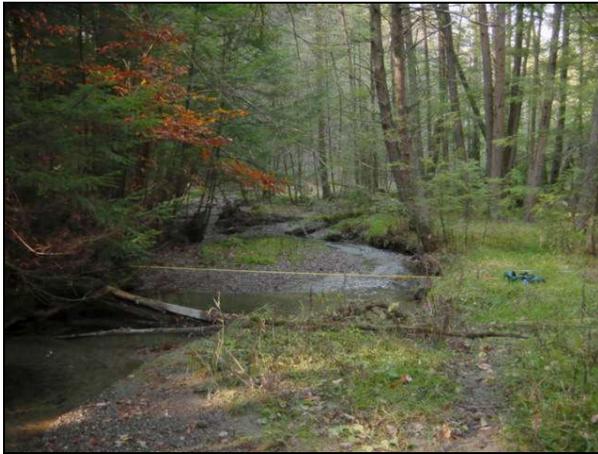
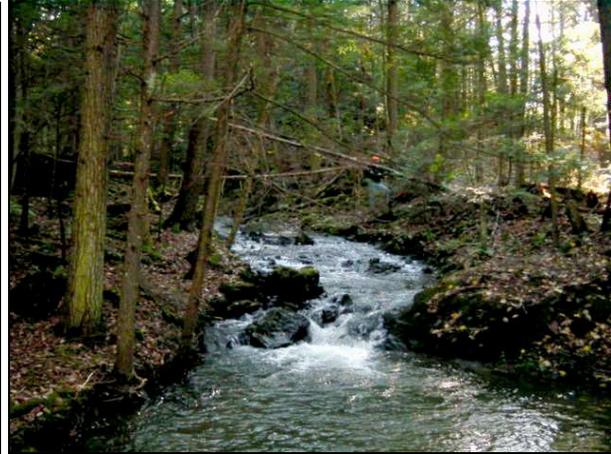
Ledge grade control toward downstream end

The river corridor is undeveloped and the channel is likely to adjust to equilibrium conditions in time. So protecting the river corridor is recommended. The segment appeared to be aggrading, but not due to significantly increased sediment supply or decreased peak flows. The stream has access to floodplain, but sediment is being generated in the upstream reach. Protecting the river corridor and addressing upstream issues is recommended.

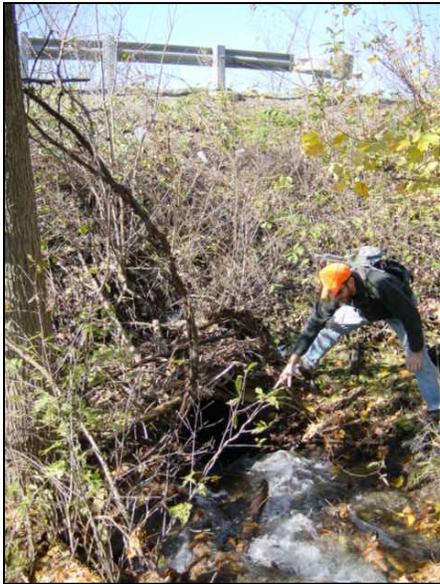
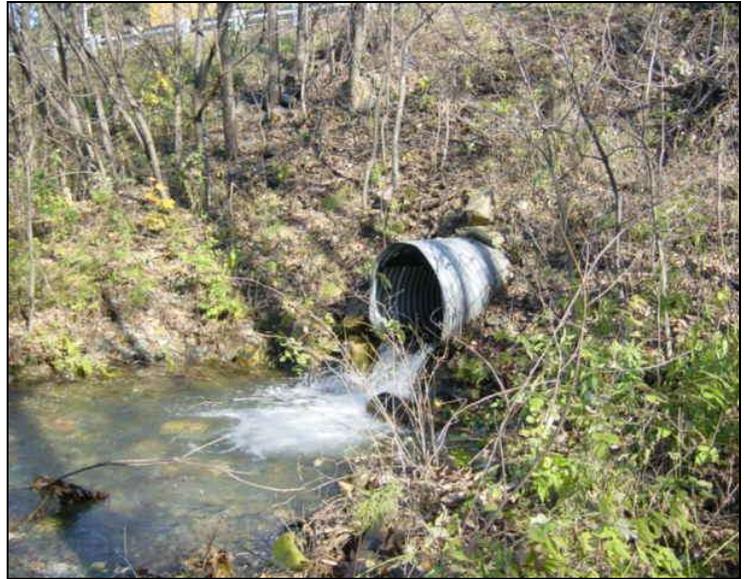
Culvert on segment M18B. The upstream end of the culvert was blocked by sediment and debris and was hardly visible (left). Extreme scour was apparent at the downstream end and beyond (right).

The river corridor is largely undeveloped except for one house on the left bank, but the channel is not likely to adjust to equilibrium due to the undersized culvert at Route 116. The streambed was actively eroding with active head cuts observed. The stream was deeply incised (1.9). The culvert should be replaced with protection provided to the house on the left bank if necessary. Sediment from upstream of the culvert would erode and enter the system, however that could aid adjustments underway downstream by slightly raising bed elevation and/or inducing meanders (such as in reach M17). If sediment introduction is undesirable from a water quality standpoint, structures could be placed to partially retain the sediment and encourage floodplain restoration or the sediment could be removed.

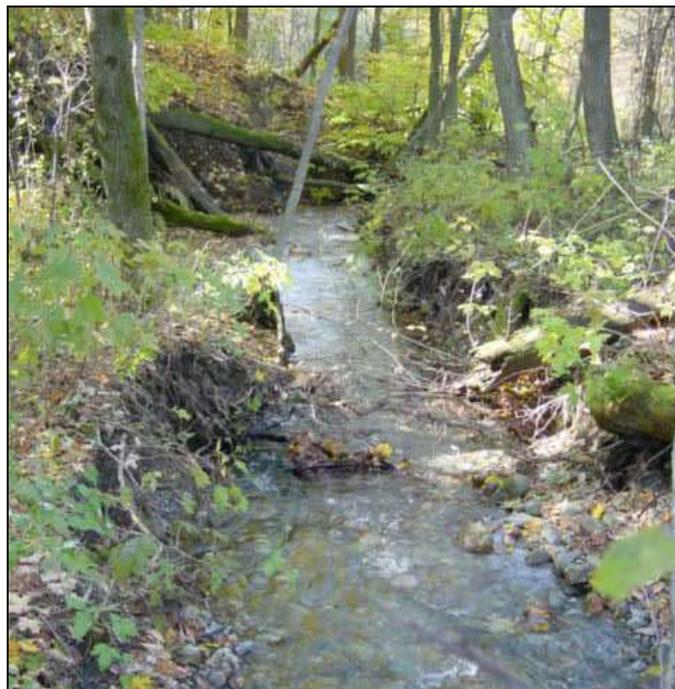
Extreme effects of constricting the channel and blocking flow of sediment has led to property damage with aggradation upstream and erosion downstream.

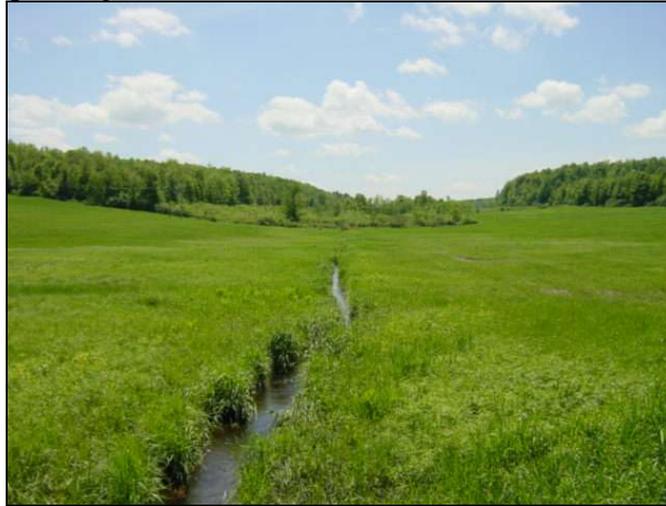
Channel and valley view. Note straightening and lack of woody riparian vegetation.

The river corridor is undeveloped and likely to adjust to equilibrium, although due to clay soils, may be in the long-term rather than the near-term. Protect the stream corridor to allow for adjustment to equilibrium. The landowner was working to fence the pasture and plant a 35-foot buffer (spring of 2007 planting).

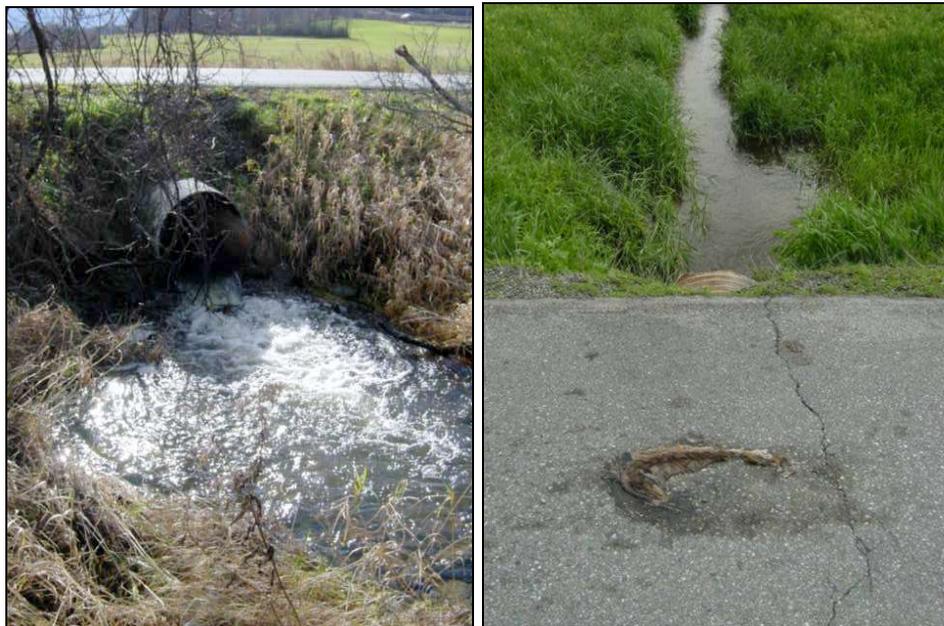
A culvert at Charlotte Road constricts the channel with sediment deposition upstream and scour downstream and a high incidence of road-killed wildlife. Sediment deposition is not likely to create a significant channel adjustment if it moves downstream, so replacing the structure with one of appropriate size is recommended.

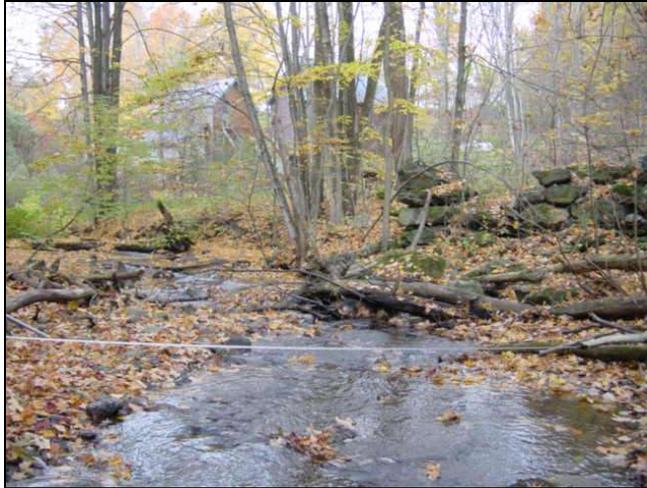
Reach view with old abutment.

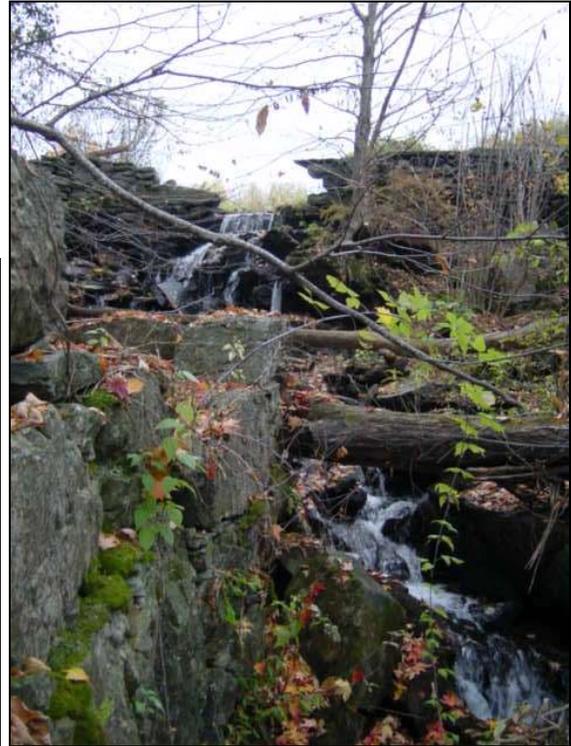
Old Mill dam near town cemetery.

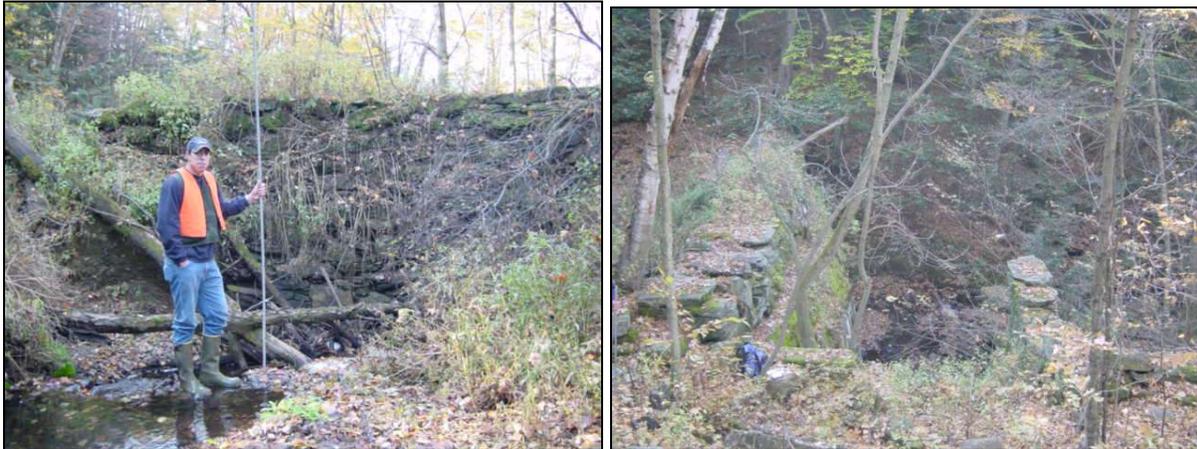
Old mill dam upstream and downstream photos.

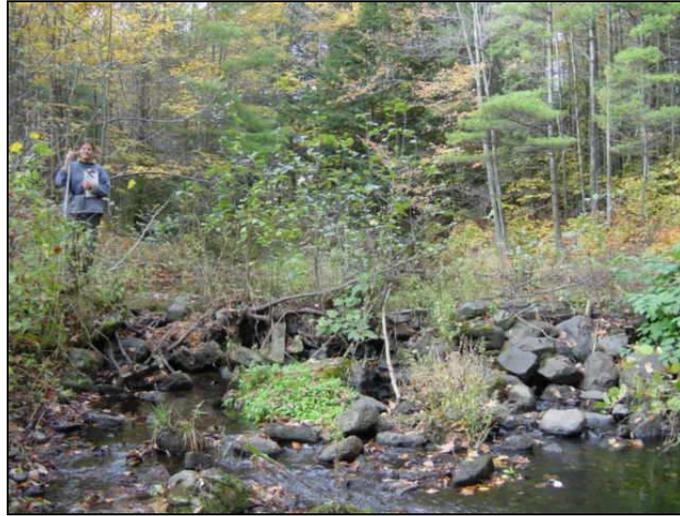
A dam was located in the reach and appeared to be non-functioning. Removal of this dam is recommended. A grade control structure may be necessary to prevent the channel from head cutting. Riprap and rock walls confine the channel toward the upstream end. Analysis of whether any of this could be removed without endangering infrastructure and homes is recommended.

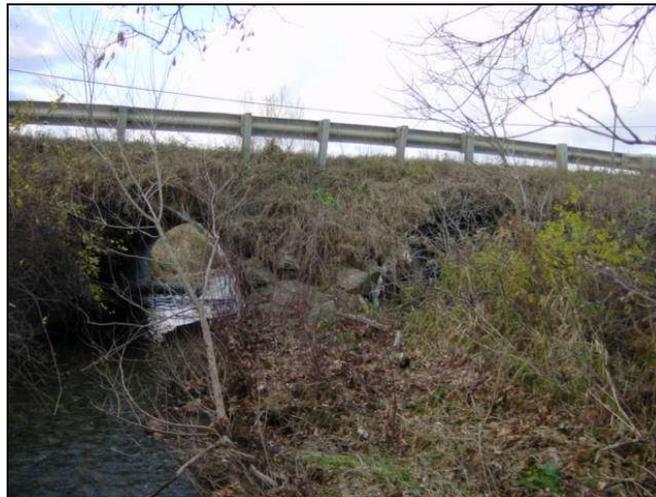
The double culvert at Route 116 constricts the channel and should be replaced with one of appropriate size. Route 116 also acts as a dam here. Sediment deposition has been a problem upstream of this culvert and has been cleaned out with riprap placed on the right bank.

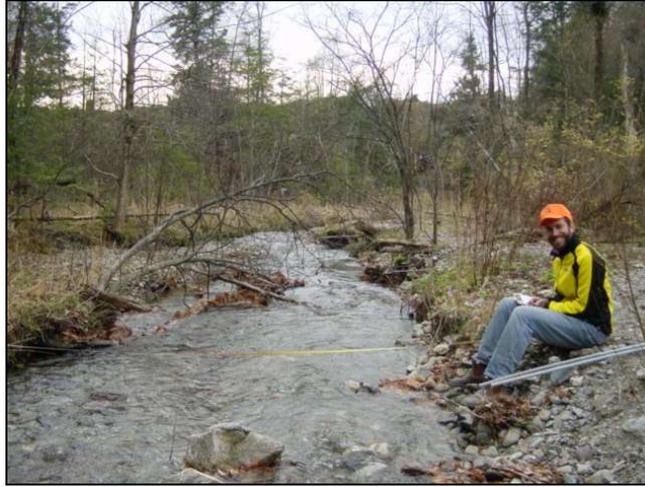
Attenuation area with floodplain connectivity.

The corridor is undeveloped and the channel is likely to adjust to equilibrium on its own, so protecting the stream corridor is recommended. This is also a valuable attenuation zone to buffer against upstream impacts. Planting stream buffer away from actively migrating banks is recommended.

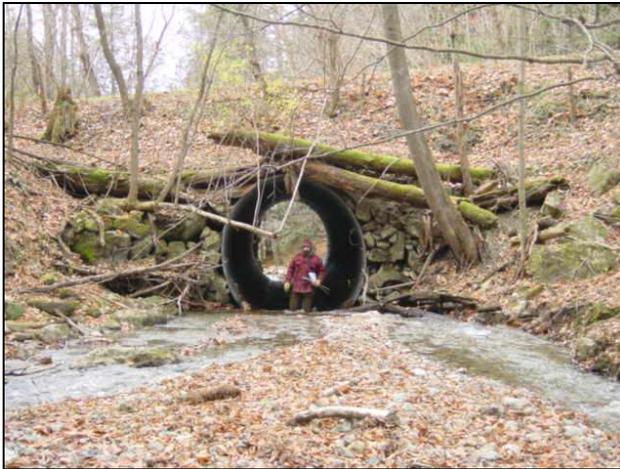
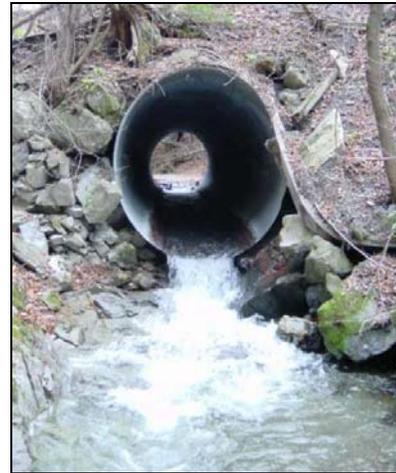
Beecher Hill Brook (T5.01B) culvert. Note aggradation forming bars and splitting flow upstream. Some erosion was noted downstream, although the downstream end falls onto ledge and boulders.

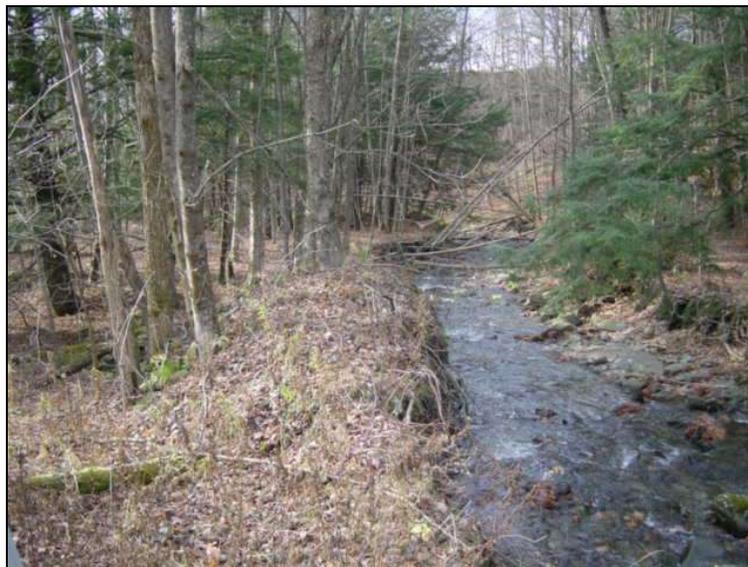
Segment T5.01D had been straightened, moved, and bermed historically, likely in conjunction with construction of North Road. Following the channel alteration, the stream had no access to floodplain and appears to have severely widened and incised. Continued incision and widening (channel enlargement) were evident in headcuts and scoured banks, leaving property at risk. This segment had ledge grade controls at both the upstream and downstream ends, helping confine these adjustments to this area.

Signs of an old channel were evident to the left of the photo. The channel appeared to have been moved to its current location and held in place by a berm, seen in the center of the photo.

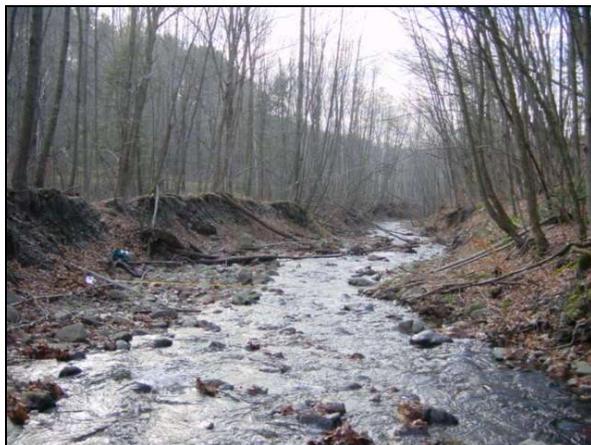
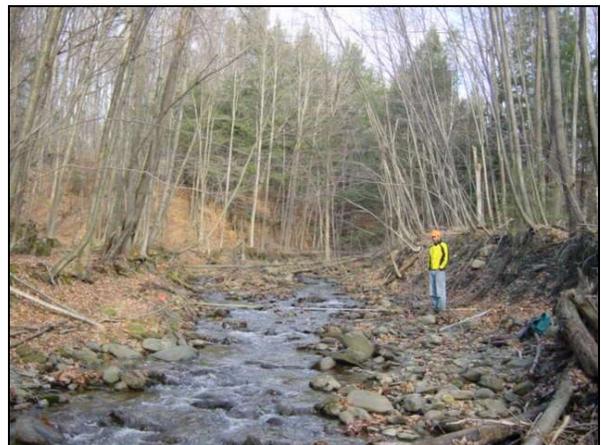
Significant channel enlargement following straightening and berming.

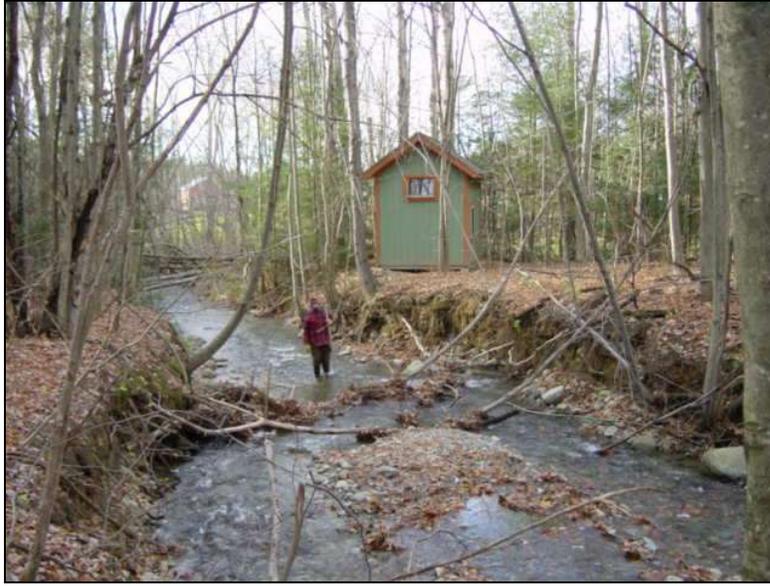
Channel enlargement further downstream leaving investments in danger.

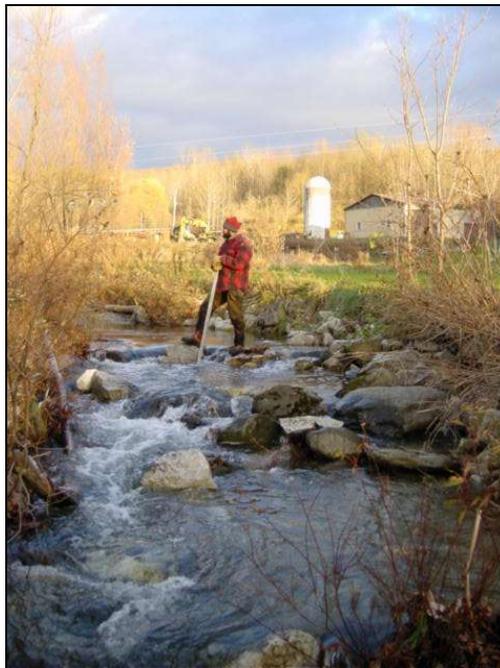
A head cut was identified downstream of the Beecher Hill Road bridge near North Road. This area has some floodplain access, so constructing a weir to arrest the head cut is recommended.

Headcut downstream of Beecher Hill Rd.

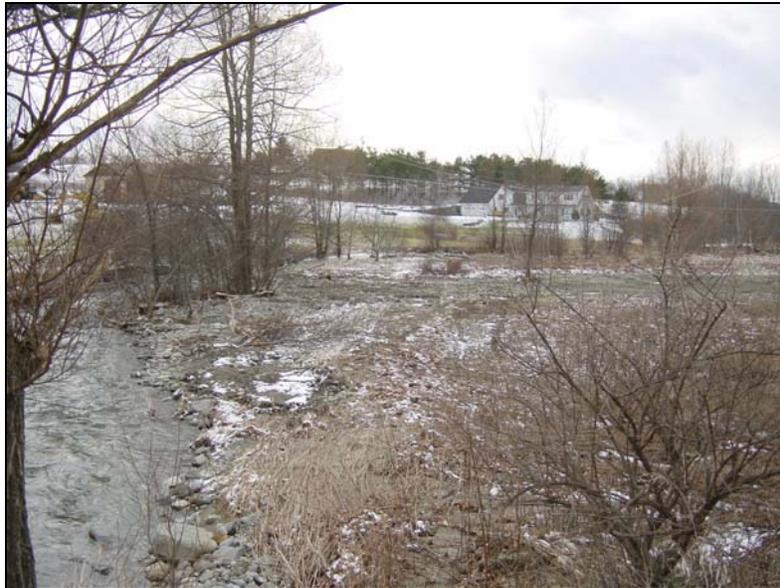
Floodplain fill replaced after January 18, 2006 storm flows, reducing sediment and flow attenuation in this area, which was between 2 degrading areas.

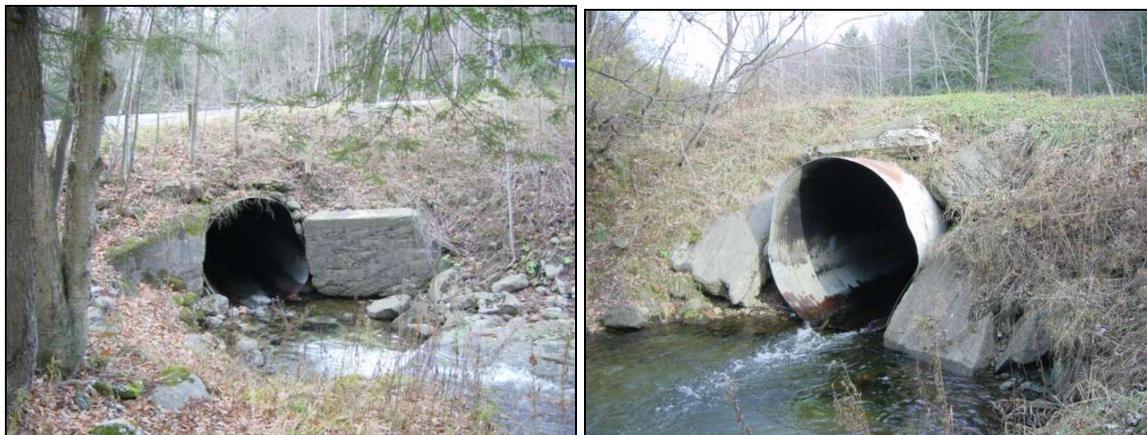
A bridge constricts the channel at Beecher Hill Road. Replacement with one of appropriate size is recommended. A culvert constricts the channel and has a significant downstream drop at the North Road. Grade controls upstream provide stability to this area. Replacement with one of appropriate size and orientation is recommended as a high priority to reduce erosion at the site. The segment is incised due to the berms. Parts of an abandoned channel exist that could be used for restoration. This should be examined in planning for restoration of the incised segment. The restoration may need to include bed forms and floodplain features in equilibrium with the higher stream power due to the North Road occupying some floodplain area.

Culvert at North Rd views: upstream end and downstream end.

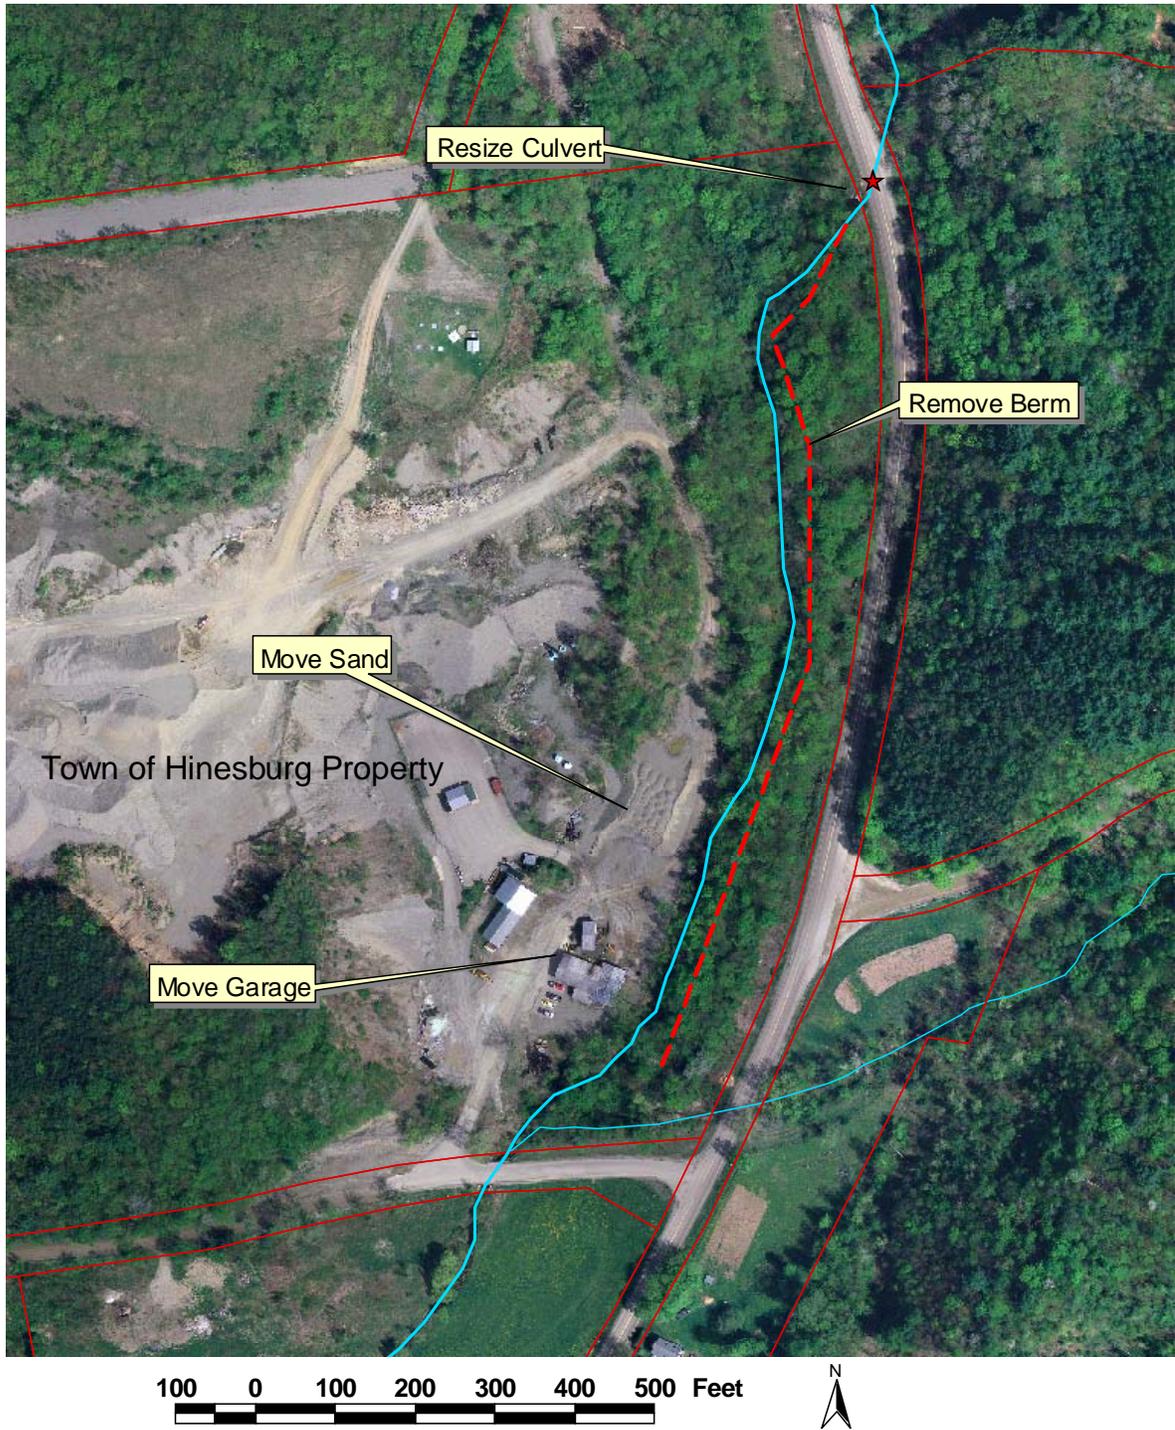
Town Garage Site T5.01D

Town Garage site map showing berm highlighted in red, North Rd to the east, Beecher Hill Rd to the south, the town garage and sand pile, and the location of the undersized culvert.

- Concept project components include:
- Conserve corridor
 - Move Town Garage and sand pile
 - Remove berm
 - Resize culvert upstream
 - Stabilize North Rd if and where necessary
 - Recapture old channels

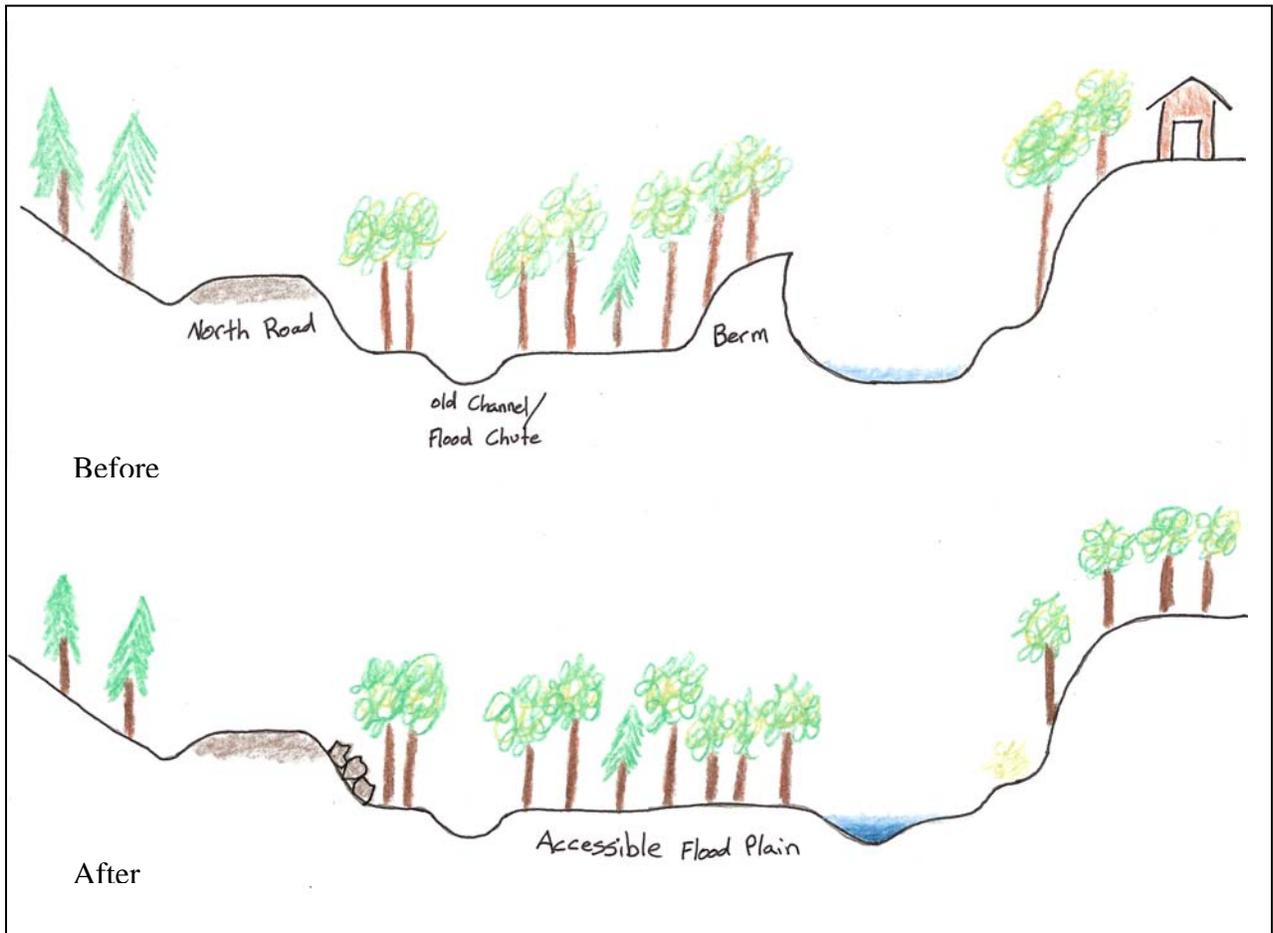
Conceptual cross sections to illustrate berm removal and relocation of garage and sand pile.
