## **MEMORANDUM**

RE: Groundwater, Surface Water, and Influent/Effluent Sampling Activities at the Burgess Brothers Landfill, Bennington/Woodford, Bennington County, Vermont, Technical Direction Document (TDD) Number (No.) TO1-01-16-03-0003; Task No. 0099. Document Control (DC) No. A-00058.

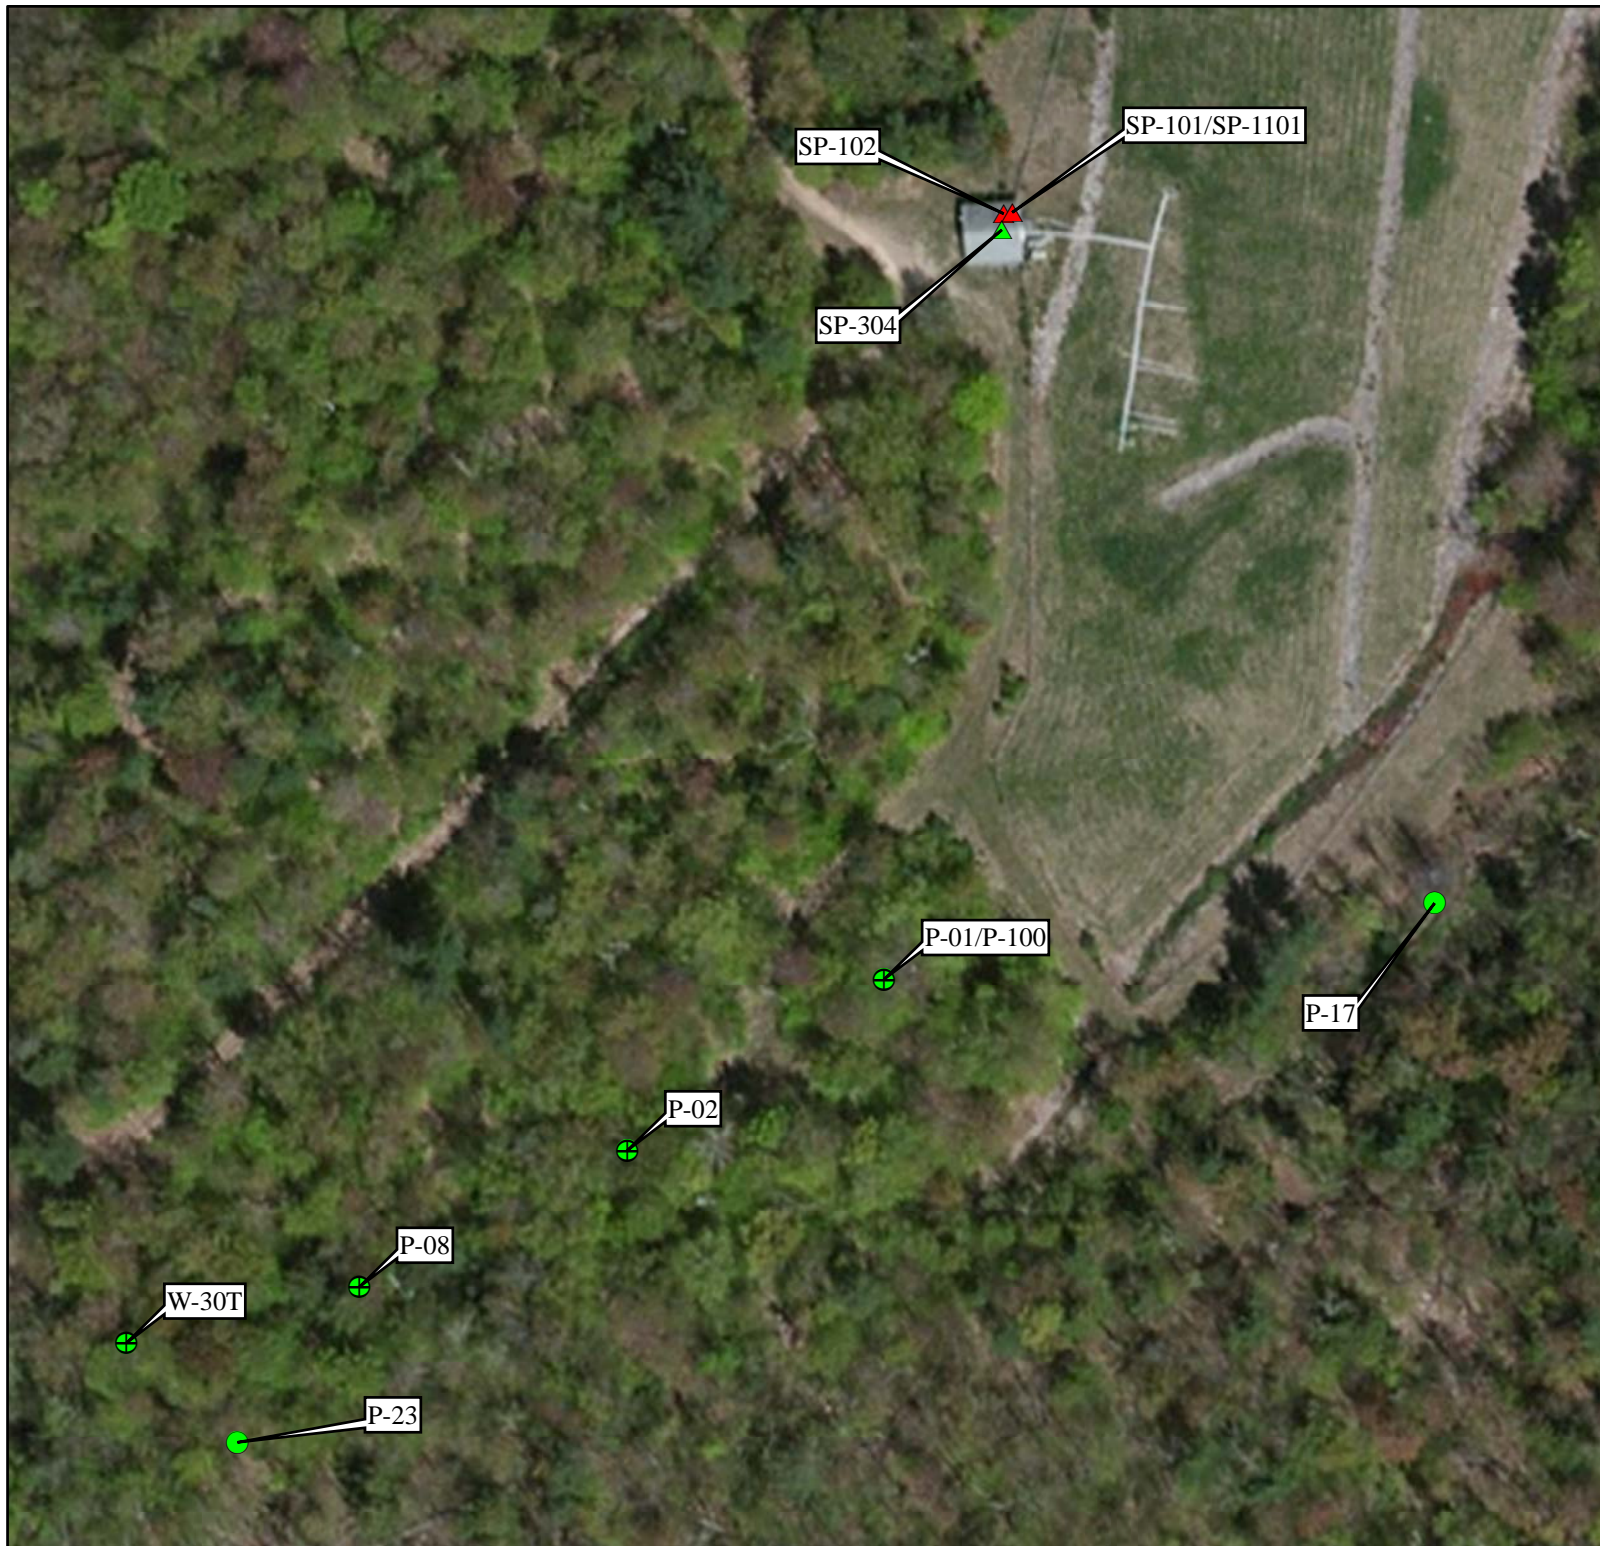
**Figure 2**

**Site Diagram and  
Sample Location Map**

V. Lincoln located the four monitoring wells (P-01, P-02, P-08, and W-30T) that were selected for sampling (see Attachment A, Figure 2). The following table summarizes the monitoring well specifications. The well depths and screened intervals were provided to START by V. Lincoln.

On 26 April 2016, START personnel John Kelly and Bonnie Mace; and EPA Remedial Project Manager (RPM) Terry Connelly mobilized to the Burgess Brothers Landfill, in Woodford/Bennington, Bennington County, VT to collect two surface water samples (P-17 and P-23) from a small on-site stream and two influent (SP-101 and SP-102) and one effluent (SP-304) water samples from the on-site groundwater treatment system (see Attachment A, Figure 2).

START and EPA personnel met with V. Lincoln and the groundwater treatment system operator in the on-site building. The groundwater treatment system operator reviewed the system plans and pointed out the influent/effluent sampling ports to the sampling team (see Attachment A, Figure 2).

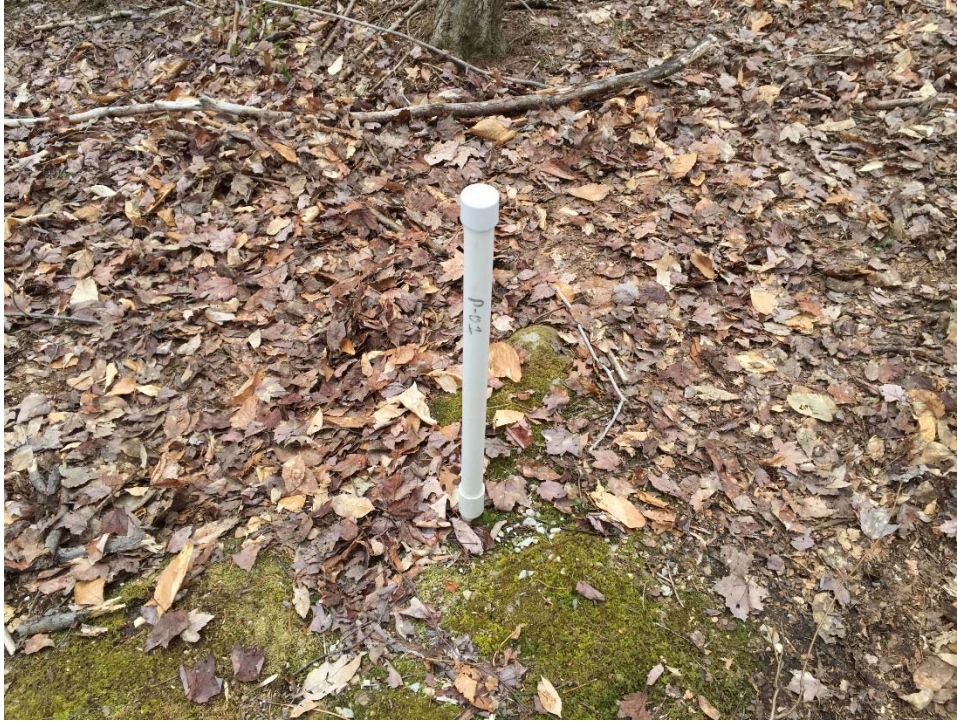
**SCENE:** View of monitoring well P-01. Photograph taken facing east.

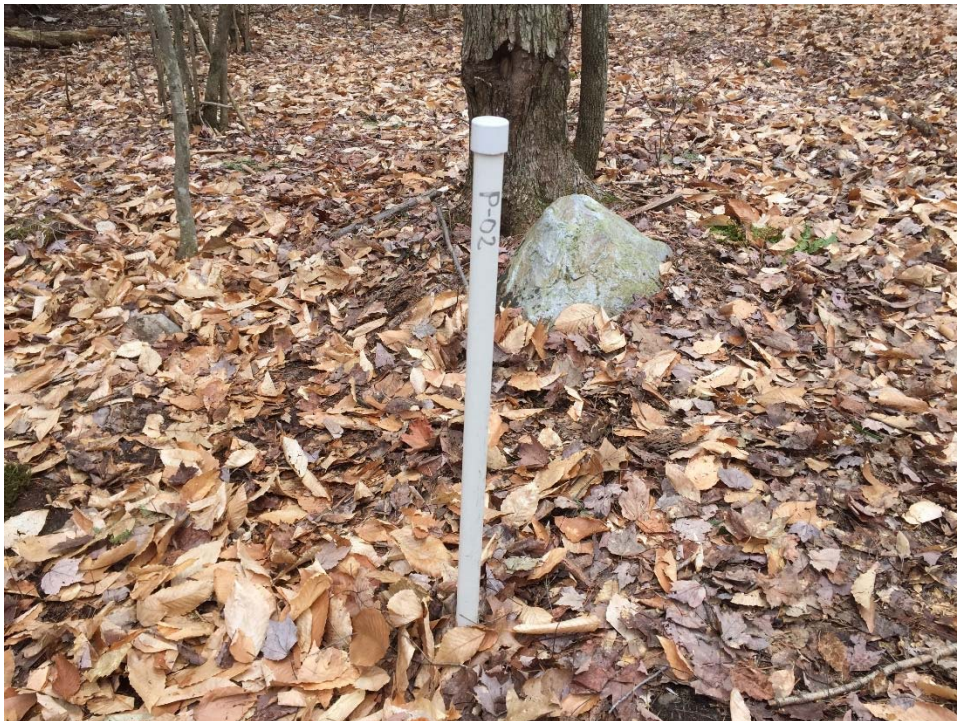
**SCENE:** View of monitoring well P-02. Photograph taken facing northeast.

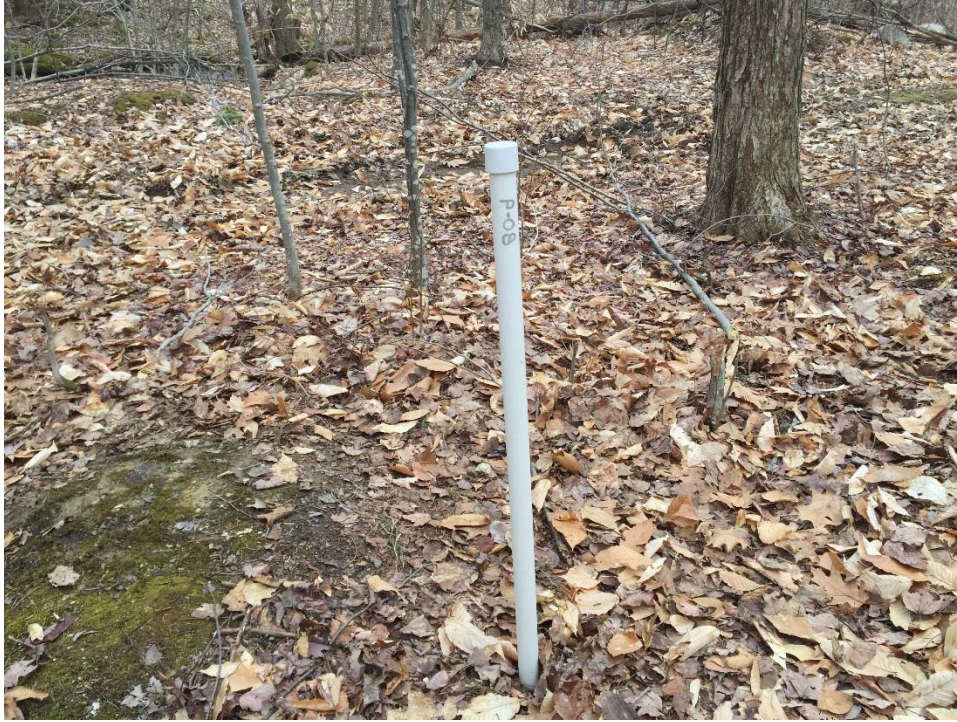
**SCENE:** View of monitoring well P-08. Photograph taken facing northeast.

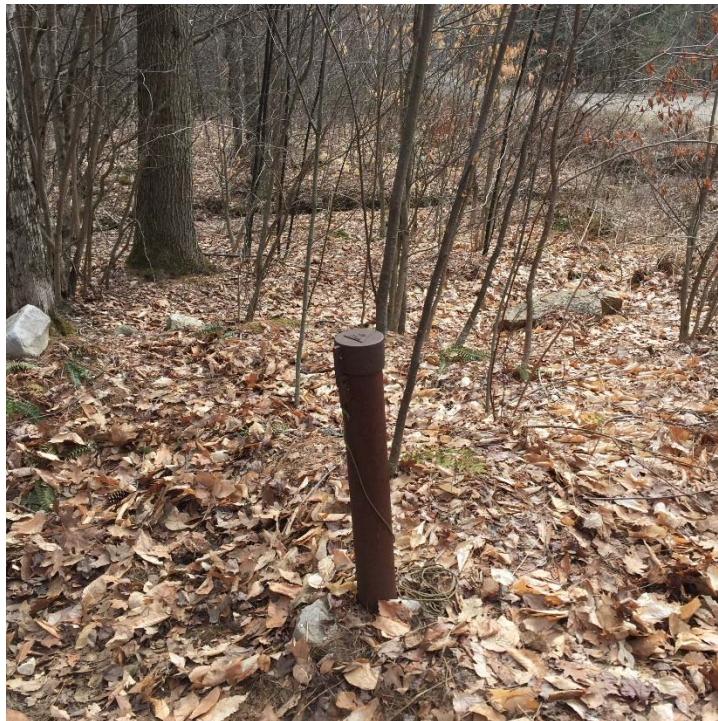
**SCENE:** View of monitoring well W-30T. Photograph taken facing southwest.

Three of the monitoring wells (P-01, P-02, and P-08) were constructed of 1-inch polyvinyl chloride (PVC) casing and secured with a PVC cap, and one well (W-30T) was constructed of a 2-inch PVC inner casing with an outer steel casing that was secured with a padlock. The key to the padlock was provided by V. Lincoln. The PVC caps and well cap were removed, and the headspace of the wells were screened for VOCs and combustible gases using a MultiRAE Plus unit. The radiation meter was carried around the site from well to well to monitor for radiation. Readings were recorded on the low-flow groundwater sampling Field Data Sheets.

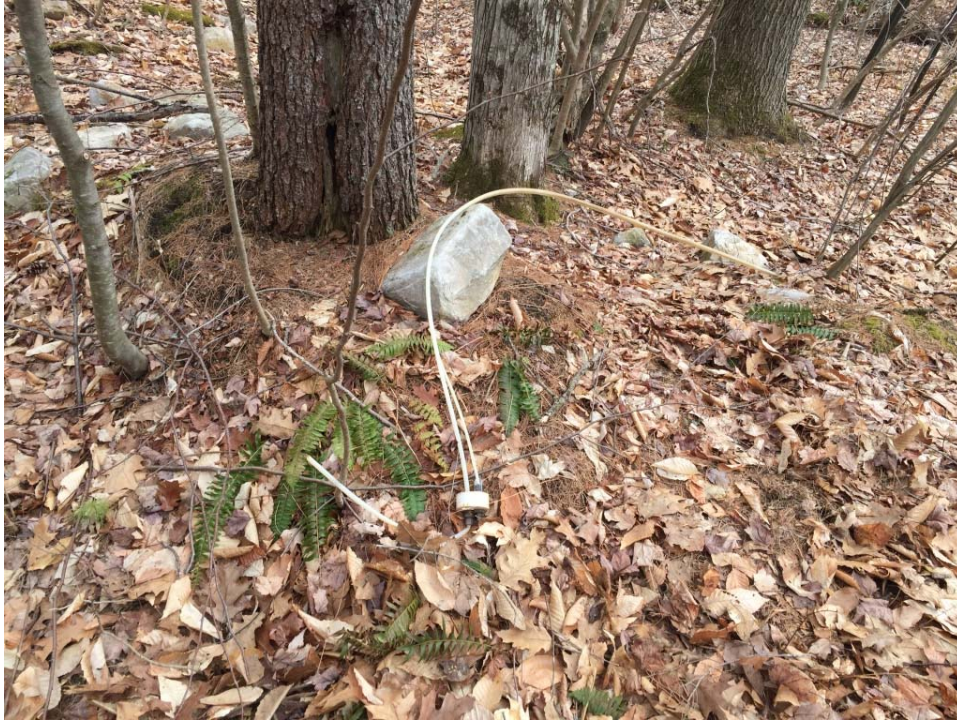
**SCENE:** View of tubing removed from monitoring well W-30T prior to purging and sampling. Photograph taken facing southwest.

The cap was removed from W-30T, and the dedicated Teflon and silicon tubing in the well were removed and placed aside until purging and sampling were completed. The tubing was then placed back into the well when the sampling was completed. None of the other monitoring wells had dedicated tubing.

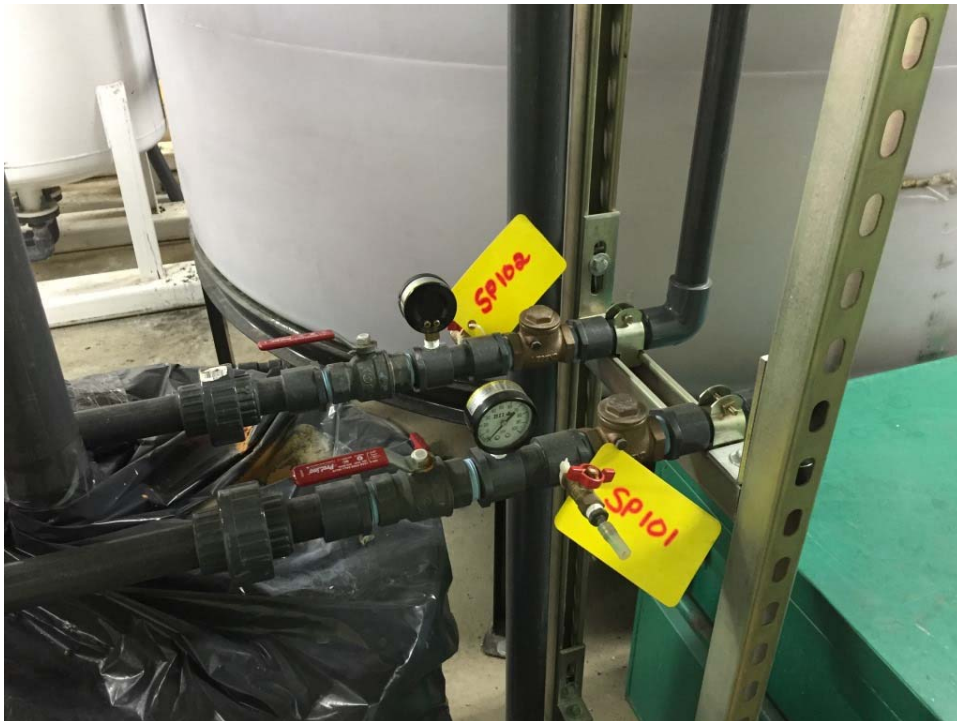
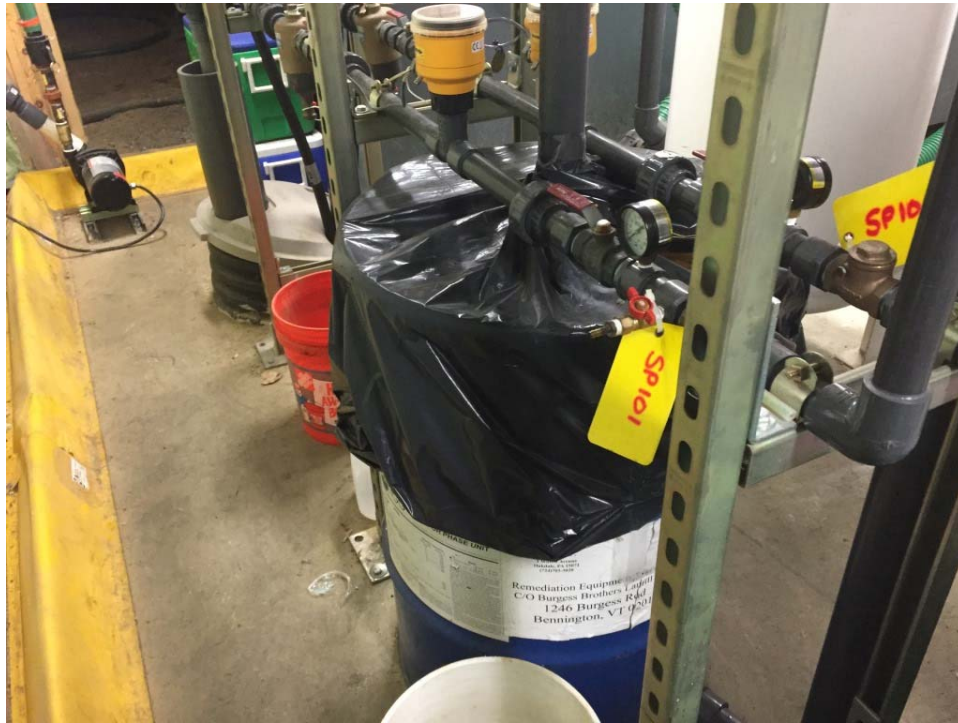
**SCENE:** View of influent sampling ports and sample locations SP-101 and SP-102.

Two influent water samples (SP-101 and SP-102), a field duplicate of sample SP-101 (SP-1101), and one effluent water sample (SP-304) were collected directly from metal ports in the on-site groundwater treatment system. Prior to purging and collecting effluent sample SP-304, dedicated Teflon tubing which was attached to the sampling port was removed (see Attachment C, Photo-Documentation Log). The tubing was placed back on the sampling port once the effluent sample was collected.

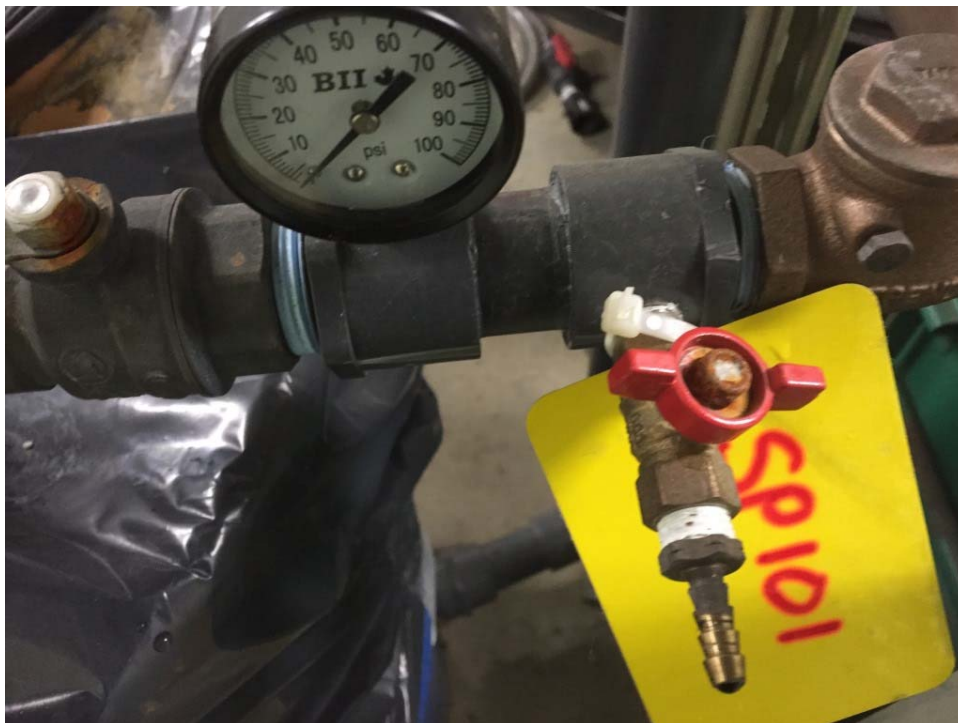
**SCENE:** Close-up view of plumber's tape or polytetrafluoroethylene (PTFE) tape used on the joint threads.

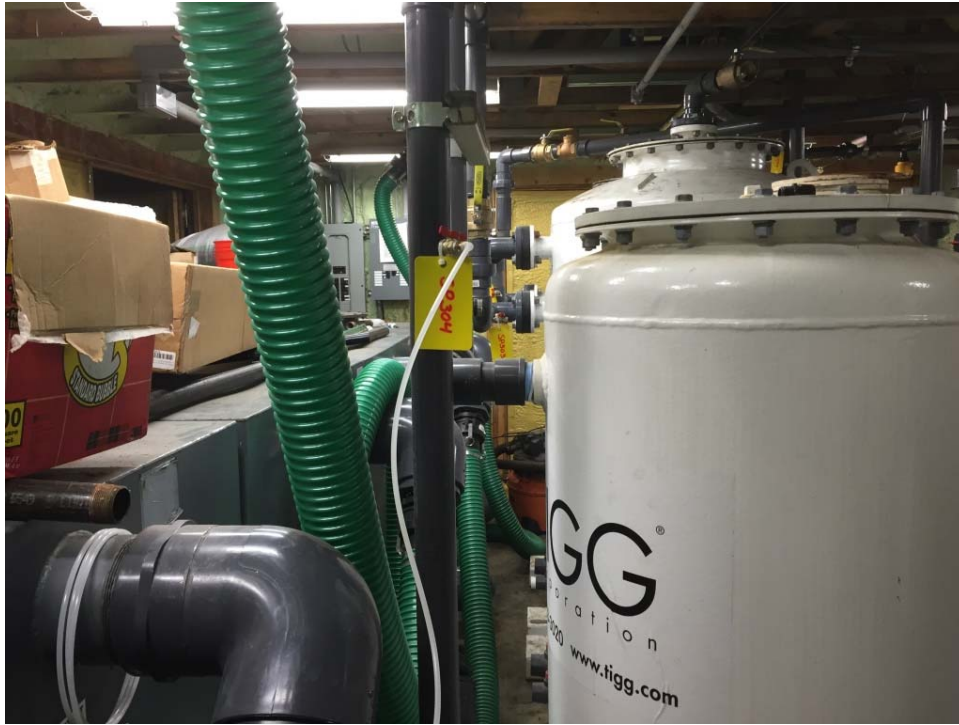
**SCENE:** View of effluent port and sample location SP-304, with silicone and polyethylene tubing used for previous sampling still attached.

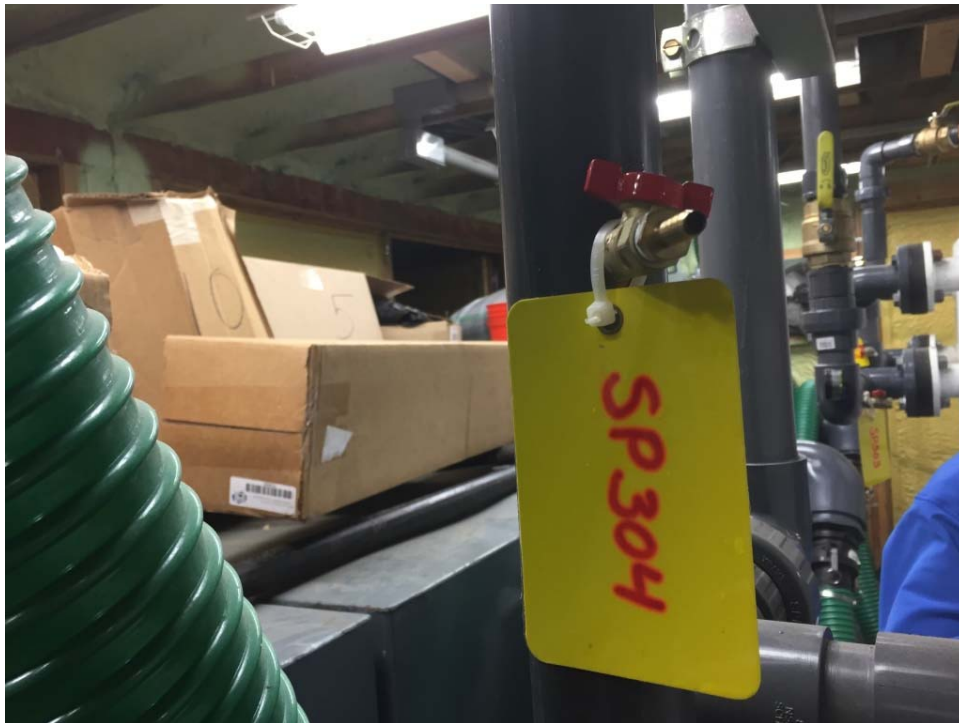
**SCENE:** Close-up view of effluent port and sample location SP-304 as sampled without any tubing attached.

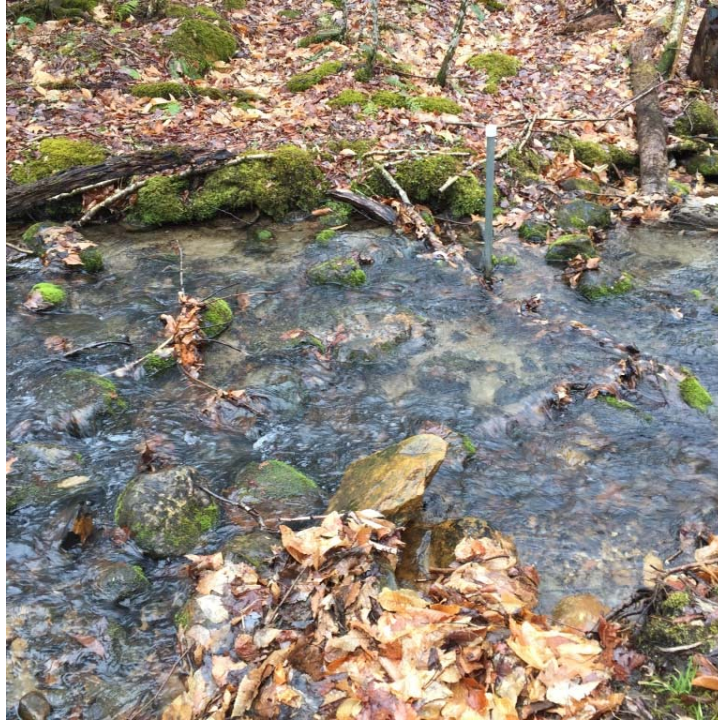
**SCENE:** View of surface water sample location P-23, collected just upstream of the piezometer. Photograph taken facing south.

EPA RPM T. Connelly showed the sampling team the location where the two surface water samples were to be collected. The two surface water samples (SW-P17 and SW-P23) were collected from a small on-site stream, beginning with the most downstream sample location (SW-P23) and proceeding upstream (SW-P17) (see Attachment A, Figure 2). Water quality parameters (temperature, specific conductance, pH, ORP, DO, and turbidity) were recorded prior to collecting the surface water samples at a location approximately 5 feet downstream of the sample location.

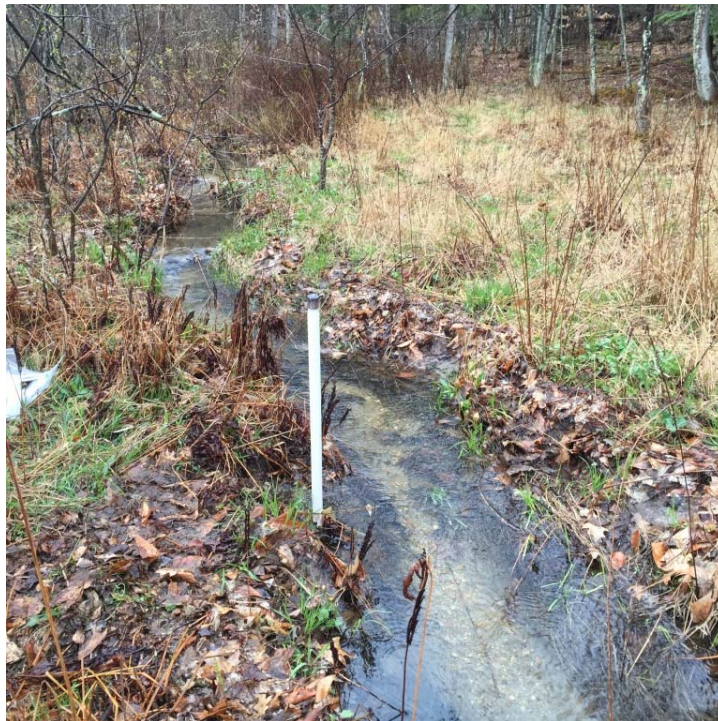
**SCENE:** View of surface water sample location P-17, collected just upstream of the piezometer. Photograph taken facing northeast.

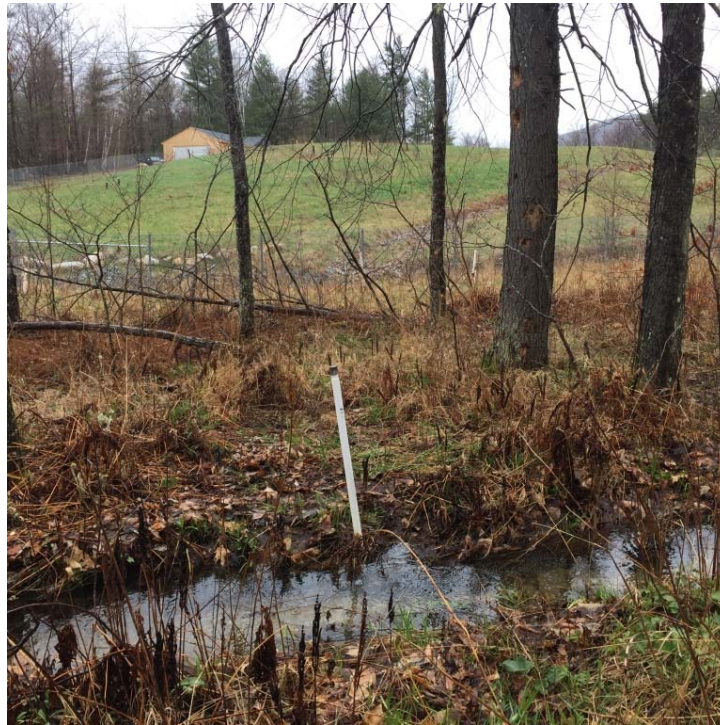
**SCENE:** View of surface water sample location P-17, with the treatment building in the background. Photograph taken facing northwest.
