North Bennington/Bennington PFOA

Water Sampling Test Results - June 8, 2016

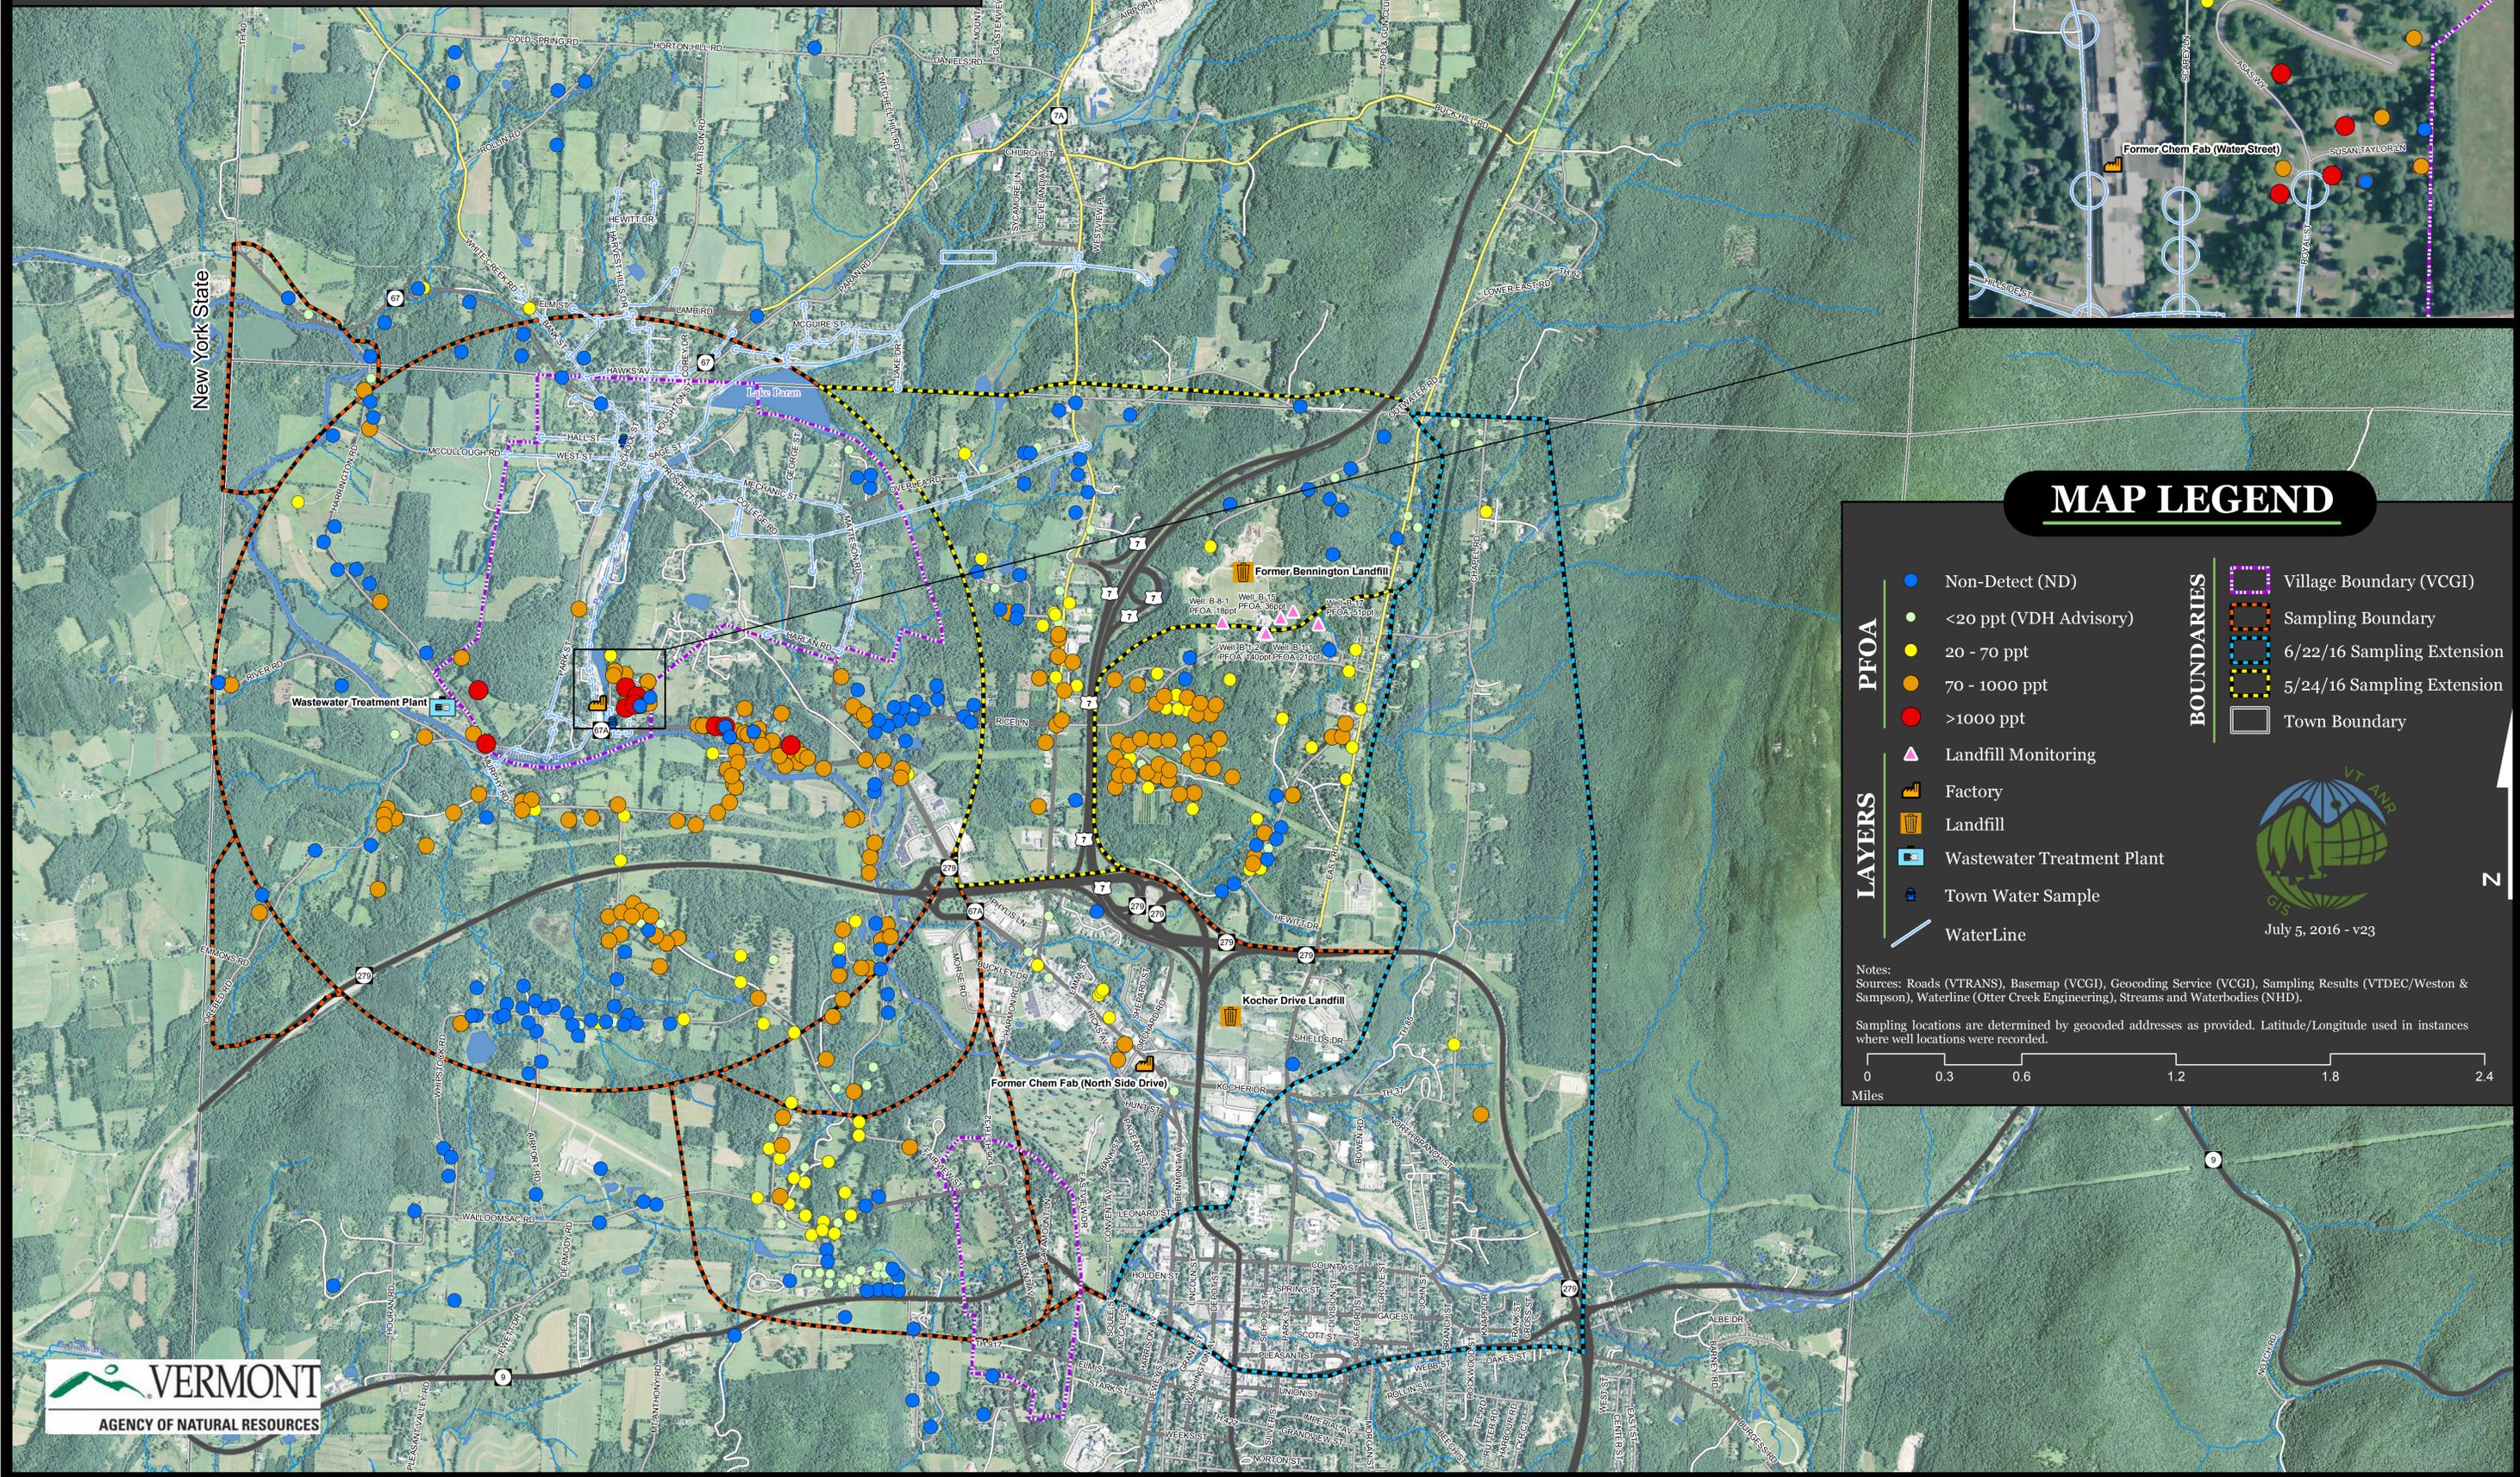
Sampling locations are determined by geocoded addresses as provided. Latitude/Longitude used in instances where well locations were recorded.
