Phosphorus Levels in Six Tributaries of Missisquoi Bay

Prepared for the
Vermont Department of Environmental Conservation

Fritz Gerhardt, Ph.D.

31 October 2015

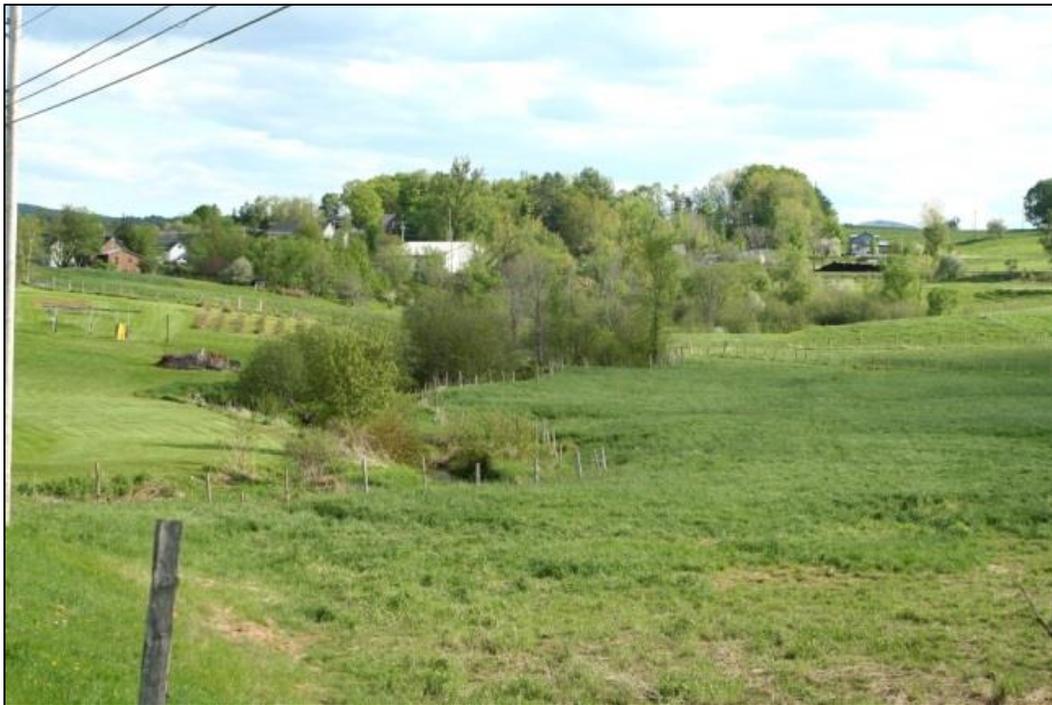
Figure 4. *View of Mud Creek during low flows near the village of Newport Center, Vermont on 21 May 2015.*

Stream flow measures the volume of water passing a given location per unit of time and is calculated by multiplying the area of the stream cross-section by water velocity. Stream flow affects both water quality and the quality of aquatic and riparian habitats. For example, fast-moving streams are more turbulent and better aerated than slow-moving streams. High flows also dilute dissolved and suspended pollutants but, at the same time, typically carry more surface runoff and associated sediment and nutrients. Stream flow is extremely dynamic and changes frequently in response to changes in temperature, precipitation, and season (Figure 4-5).

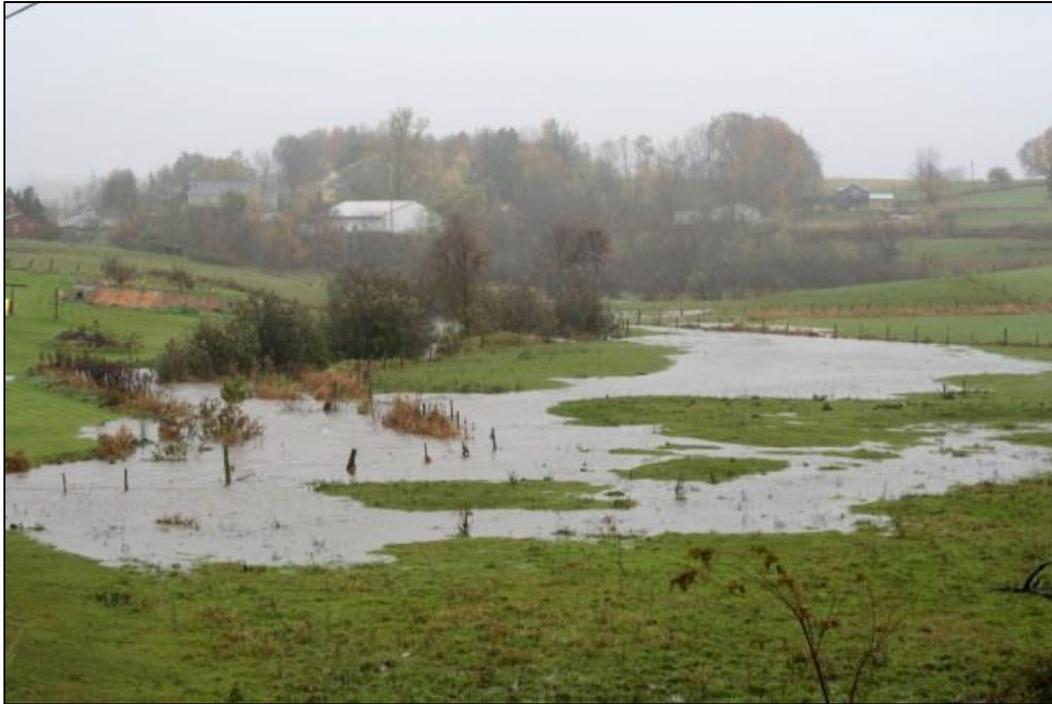
Figure 5. View of Mud Creek during high flows near the village of Newport Center, Vermont on 15 October 2010.

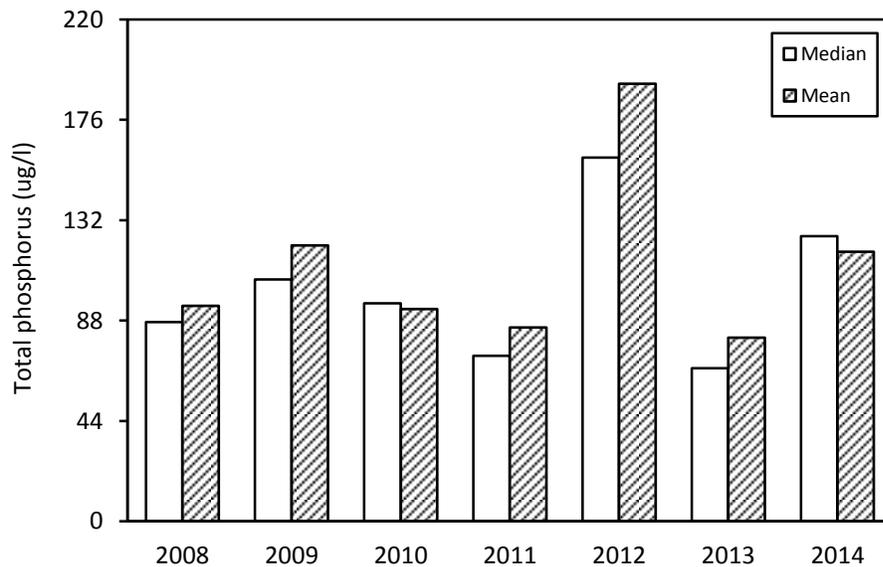
Figure 14. Mean and median total phosphorus concentrations at the Woods Hill Road site on Hungerford Brook during 2008-2014.

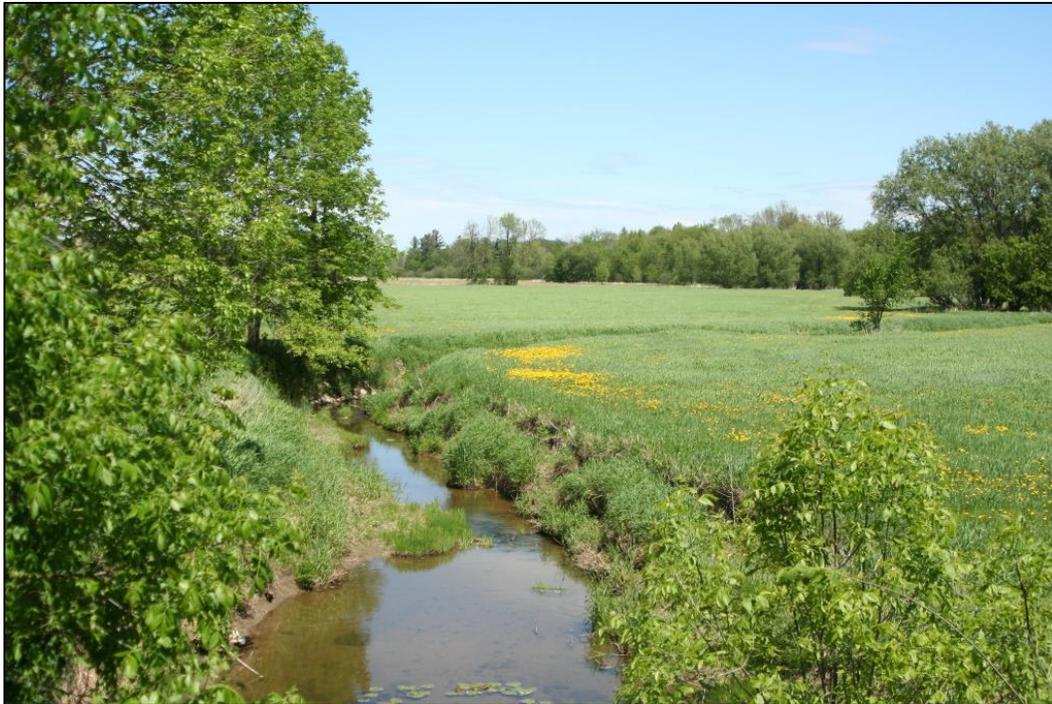
Figure 15. Numerous agricultural fields and unstable streambanks border much of Hungerford Brook, such as this area along Woods Hill Road in Swanton, Vermont on 21 May 2015.

Based on these data and observations, it seems likely that most of the phosphorus in this watershed is originating from nonpoint sources. Possible nonpoint sources include surface runoff from the many agricultural fields in this watershed and from streambank erosion, especially due to the finer soils found in this watershed (Figure 15).

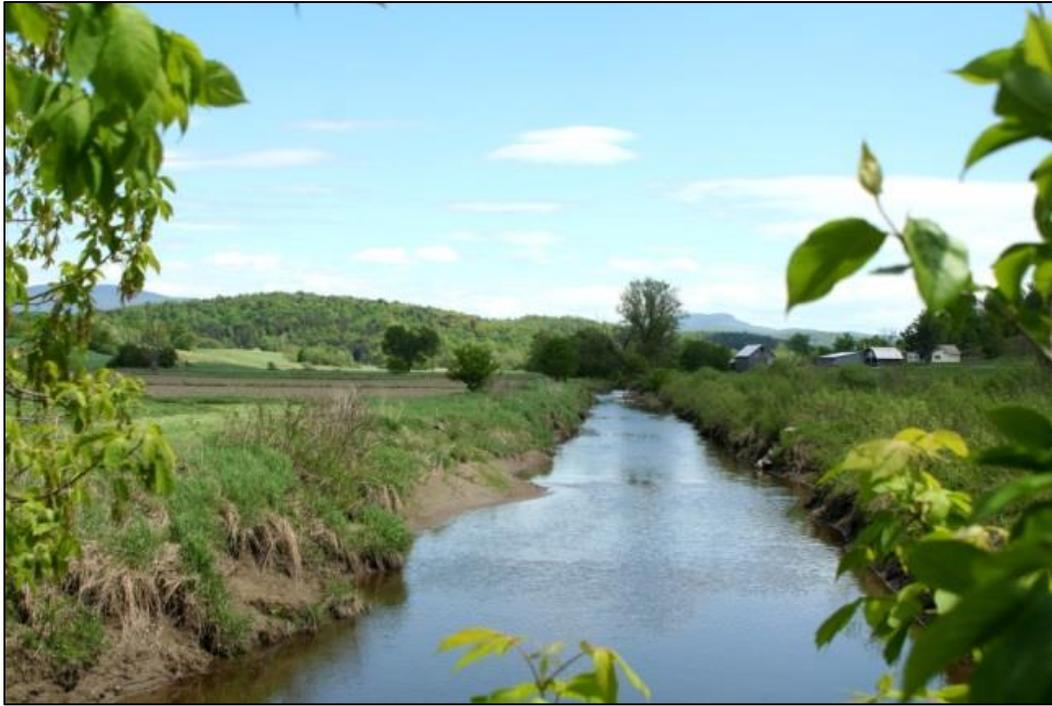
Figure 20. Numerous agricultural fields and unstable streambanks border Black Creek, such as this area upstream of Ryan Road in Fairfield, Vermont on 21 May 2015. Note that the channel has been dredged and straightened in this area.

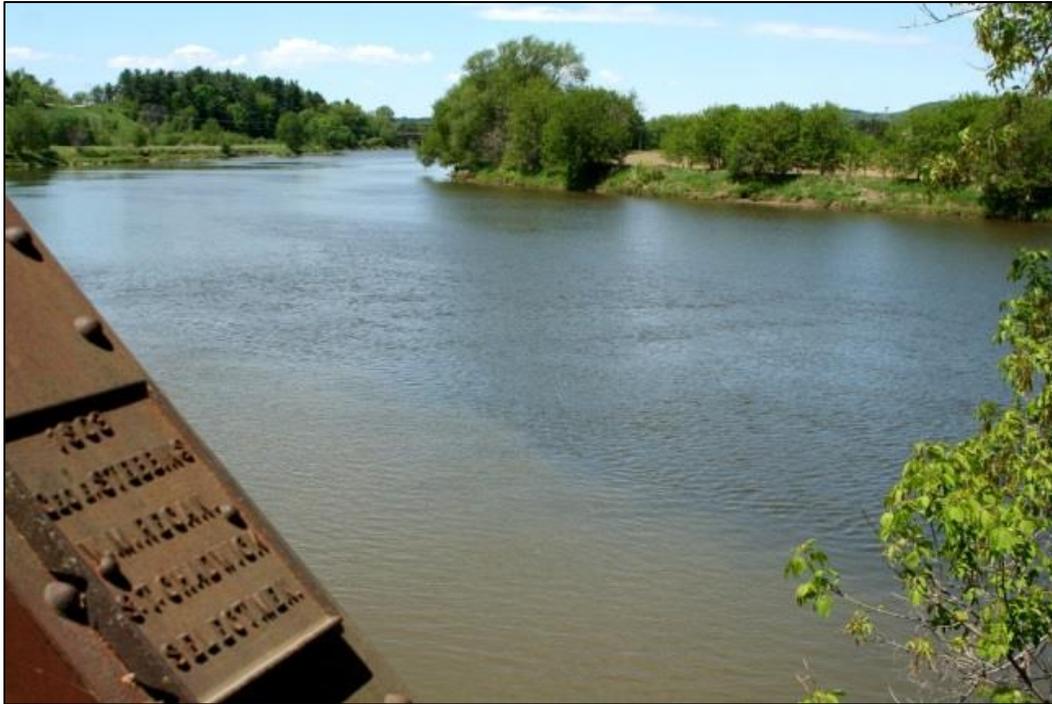
Figure 21. The muddy water flowing from Black Creek into the Missisquoi River just across from Sheldon Junction, Vermont on 21 May 2015 indicated that there may be significant nutrient and sediment sources further upstream.

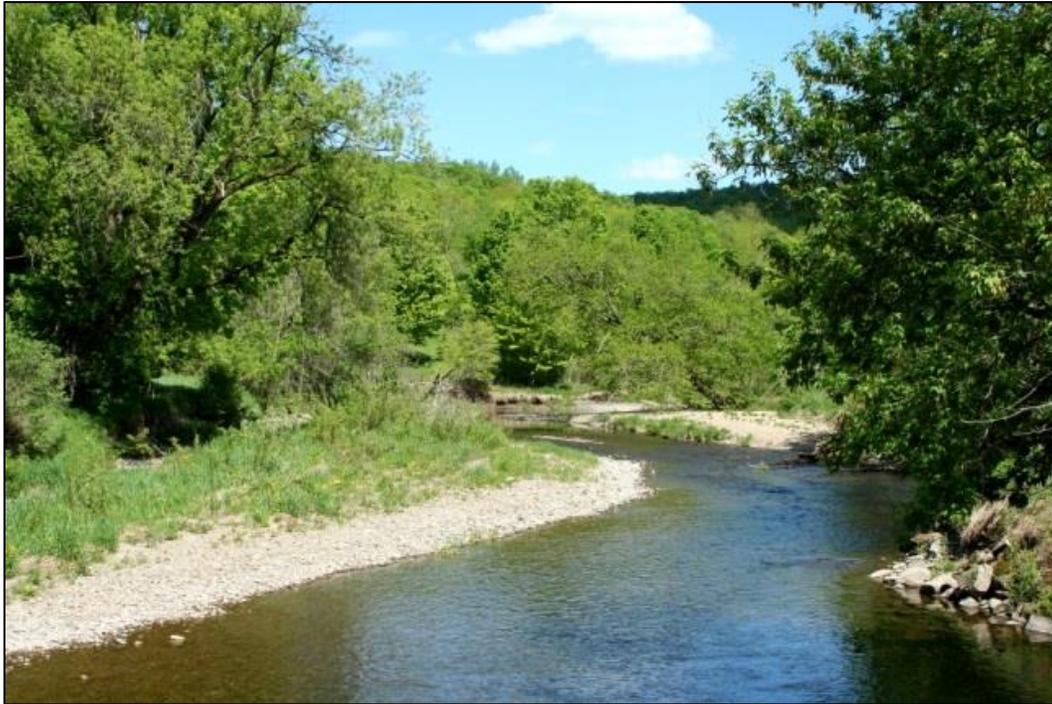
Figure 26. *The watershed of Tyler Branch is more forested than some of the other tributary watersheds of the Missisquoi River as evidenced by this area just upstream of Duffy Hill Road in Enosburg, Vermont on 21 May 2015.*

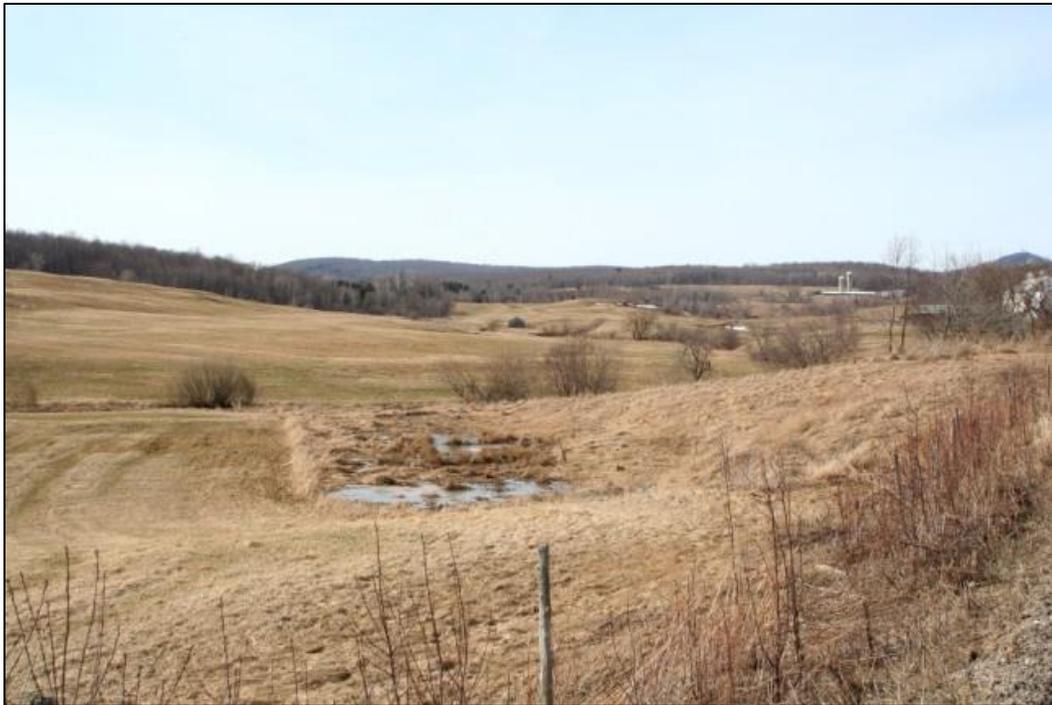
Figure 30. Numerous agricultural fields border Godin Brook and its tributary streams, such as this area at the end of Godin Road in Berkshire, Vermont on 13 April 2015.

Based on these data, it seems likely that much of the phosphorus in this watershed is originating from nonpoint sources that increase dramatically during heavy rains. Possible nonpoint sources include surface erosion and runoff from the many agricultural fields, especially corn and other row crops (Figure 30). However, the high total phosphorus concentrations at the Marvin Road site, even during low flows, suggest that there may also be point sources of phosphorus, possibly originating from farm roads and other impervious surfaces, such as the large barns, silage pads and other storage bunkers at the large farm operation along Richford Road. In contrast, the part of the watershed upstream of the two upstream sites is dominated by forest interspersed with some agricultural fields, one small farm, and residences. This difference in land uses is likely responsible for the lower phosphorus levels measured at the two upstream sites.

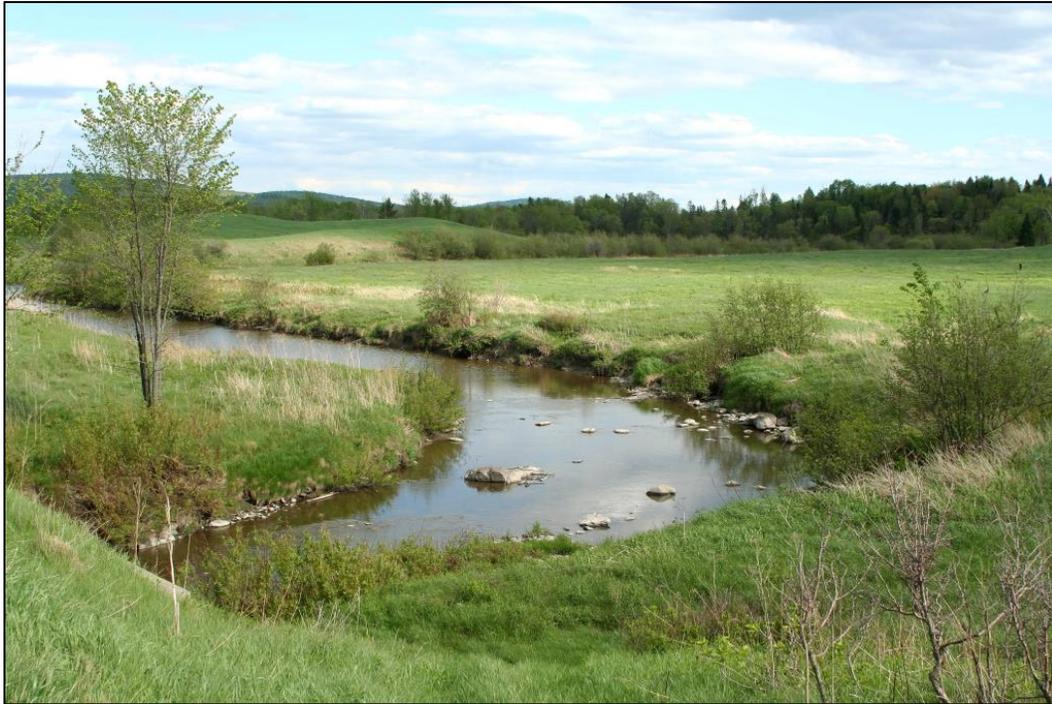
Figure 33. Numerous agricultural fields and unstable streambanks border much of Mud Creek, such as this area along Vermont Route 105 in Newport Town, Vermont on 21 May 2015.

Based on these analyses, it seems likely that much of the phosphorus along the main stem is originating from nonpoint sources. Possible nonpoint sources include surface runoff from the many agricultural fields in this watershed and from streambank erosion (Figure 33). In contrast, the high phosphorus levels along Tributary #10 may be originating from point source(s), such as the barns and barnyards that occur along this tributary. On 21 May 2015, we noted that abundant benthic algae, an indicator of high nutrient levels, and abundant silt were evident at several locations along Mud Creek and its tributaries (in particular, the Bear Mountain Road and Trib 10 sites, respectively). Previous studies had also noted that phosphorus levels and loadings were high in the Mud Creek watershed, especially in the western and downstream halves of the watershed (Howe et al. 2011, Stone Environmental 2011).

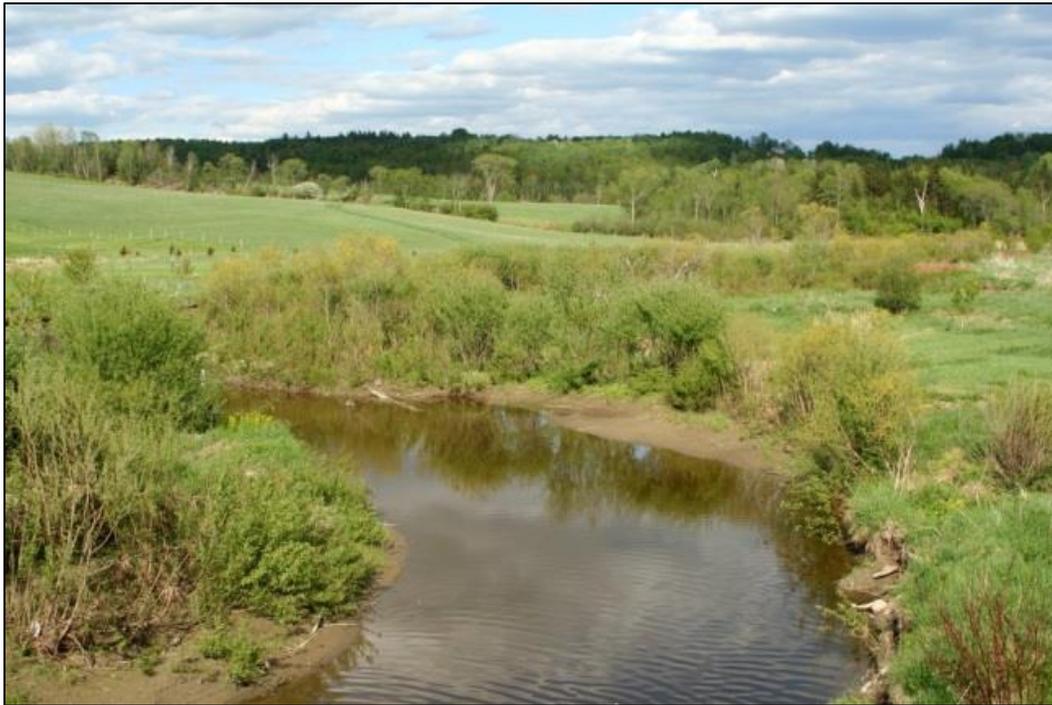
Figure 34. Numerous forested riparian buffers have already been restored along Mud Creek, such as this area along Vermont Route 105 in Newport Town, Vermont on 21 May 2015.

Due to the low number of sample sites in the Mud Creek watershed, it was not possible to identify specific areas for on-the-ground investigation at this time. Such efforts will require additional, targeted sampling to better pinpoint and assess possible nutrient and sediment sources. However, one possible first effort would be to further examine areas along the southern tributary (Tributary #10), where very high total phosphorus concentrations were measured in 2008-2010. On the other hand, numerous conservation projects have already been implemented in this watershed, especially restoring forested riparian buffers on a large farm located along Mud Creek in Newport Town (Figure 34).

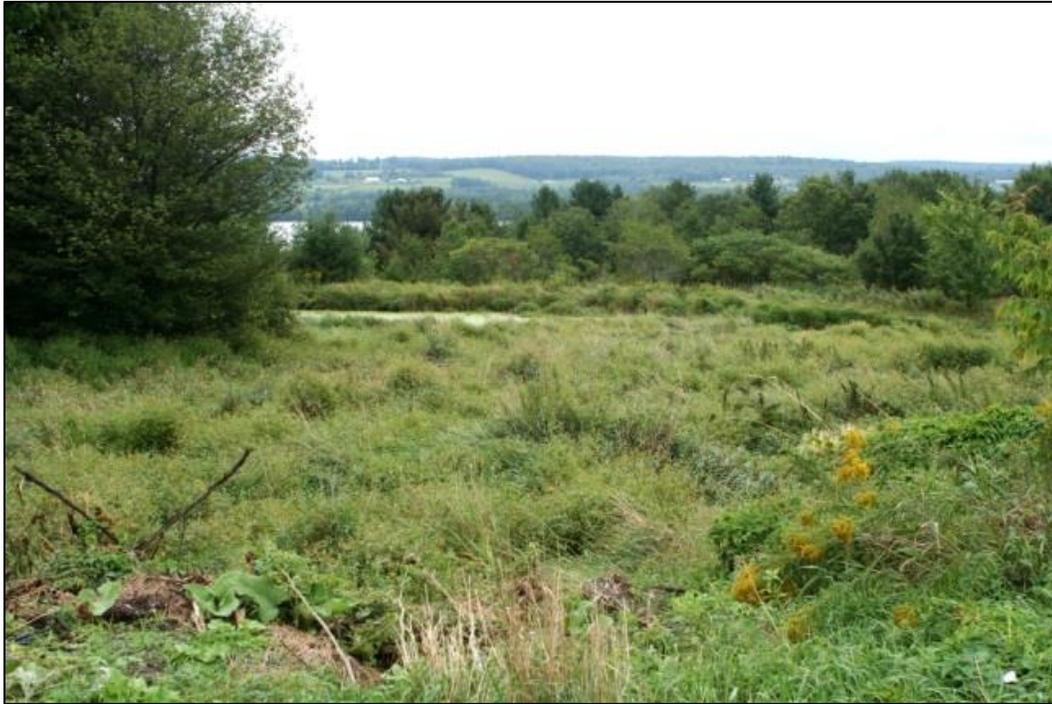
Figure 38. Old settling pond that is nutrient-rich and that often overflows during heavy rains into Sandy Bay Brook in Franklin, Vermont on 21 August 2015.

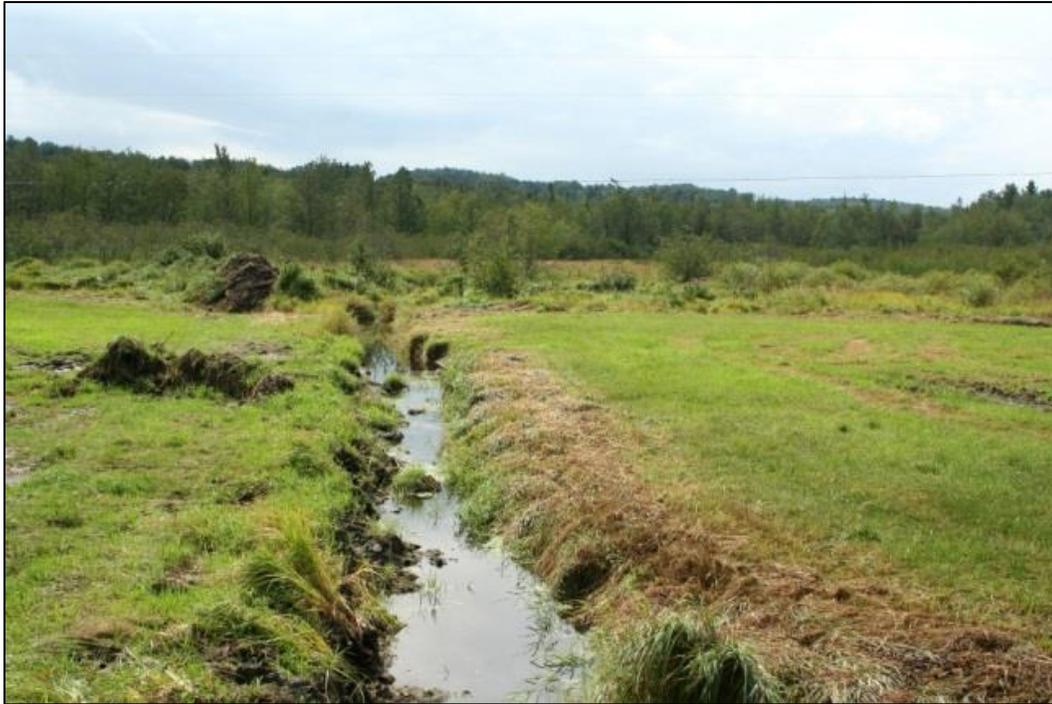
Figure 42. *Small tributary that flows north underneath Little Pond Road and into Marsh Brook in Franklin, Vermont on 21 August 2015.*

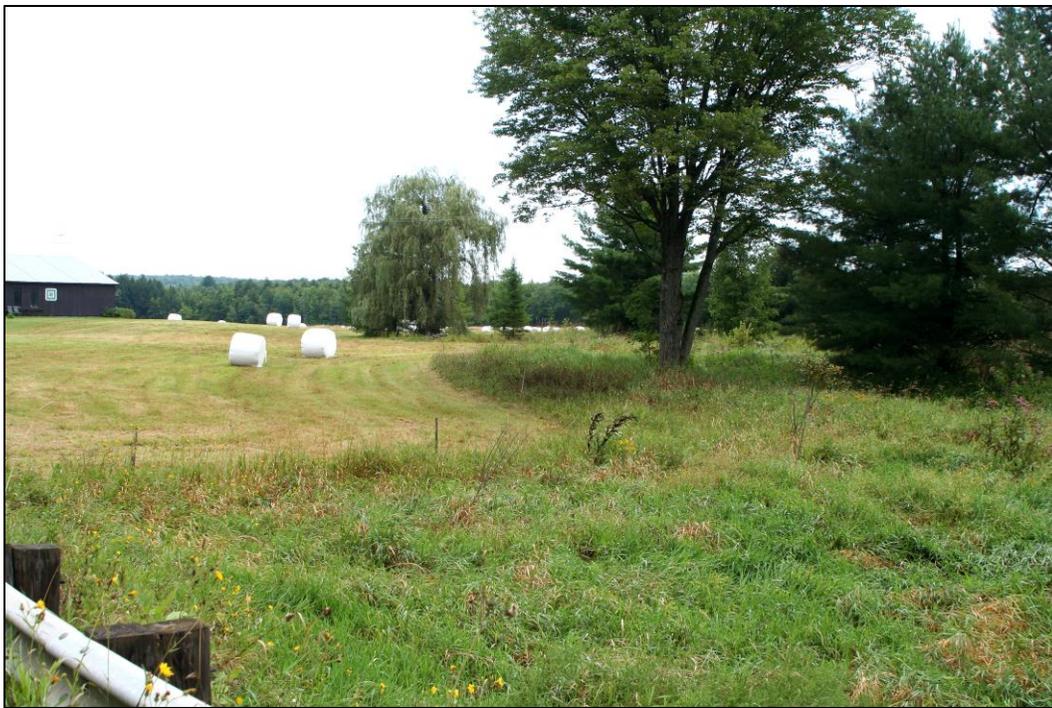
Figure 47. Old field and hay field along the downstream section of Dicky's Brook in Franklin, Vermont on 21 August 2015.

Based on these analyses and discussions with other stakeholders, it seems likely that much of the phosphorus flowing from this tributary into Lake Carmi is originating in the downstream section of this stream. However, it is unclear what the source(s) of this phosphorus might be. This short section of stream [approximately 620 m (2,030 ft)] passes alongside a hay field, through an unmown area of old field or pasture, past a residence, and through a small pond before flowing underneath Lake Road (Figure 47). One possibility is that there is an accumulation of phosphorus that is being released from the small pond, so that one possible future effort would be to measure total phosphorus concentrations in the pond itself or to sample immediately upstream and downstream of the pond in order to determine whether or not the pond is the source of the high phosphorus levels.

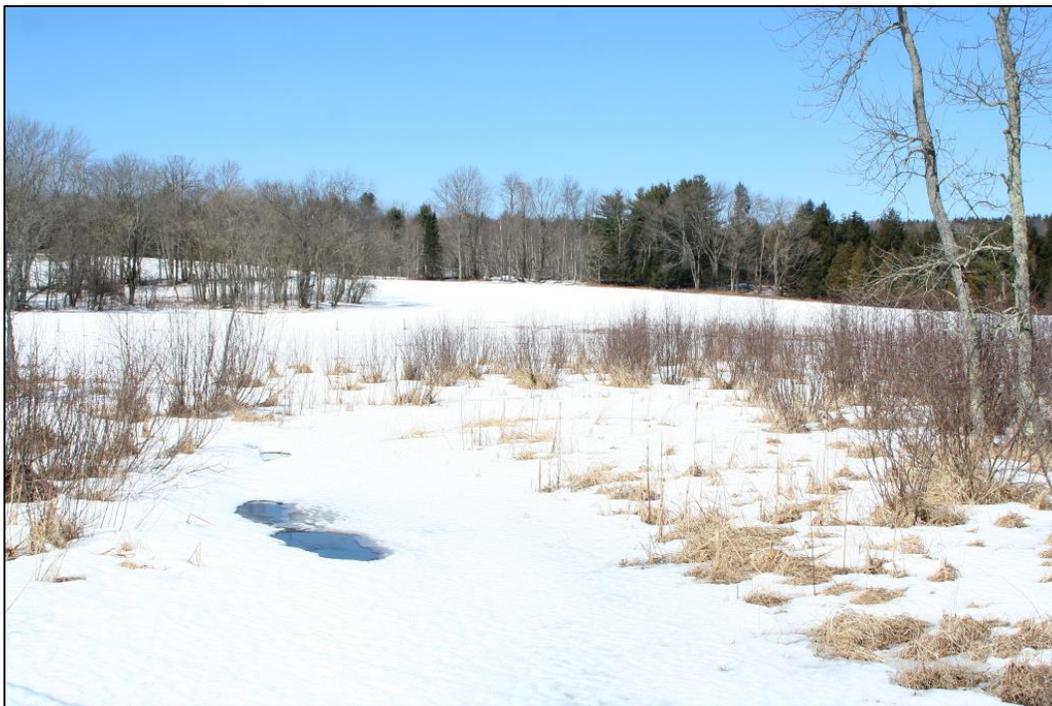
Figure 51. The downstream-most section of Alder Run flows through grazed wetlands just north of Lake Road in Franklin, Vermont on 31 March 2015.

Based on these analyses and discussions with other stakeholders, it seems likely that much of the phosphorus flowing from this tributary into Lake Carmi is originating in the downstream section of this stream. Like Dicky's Brook, it is unclear what the source(s) of this phosphorus might be. This short section of stream [approximately 900 m (3,000 ft)] passes through forested wetlands and a small area of grazed wetlands before flowing underneath Lake Road (Figure 51). It is possible that the grazing is releasing phosphorus from these wetland soils. Given that the downstream site has not been sampled since early in 2010, we recommend resampling phosphorus levels at the downstream site again to verify that this stream continues to export high levels of phosphorus into Lake Carmi.

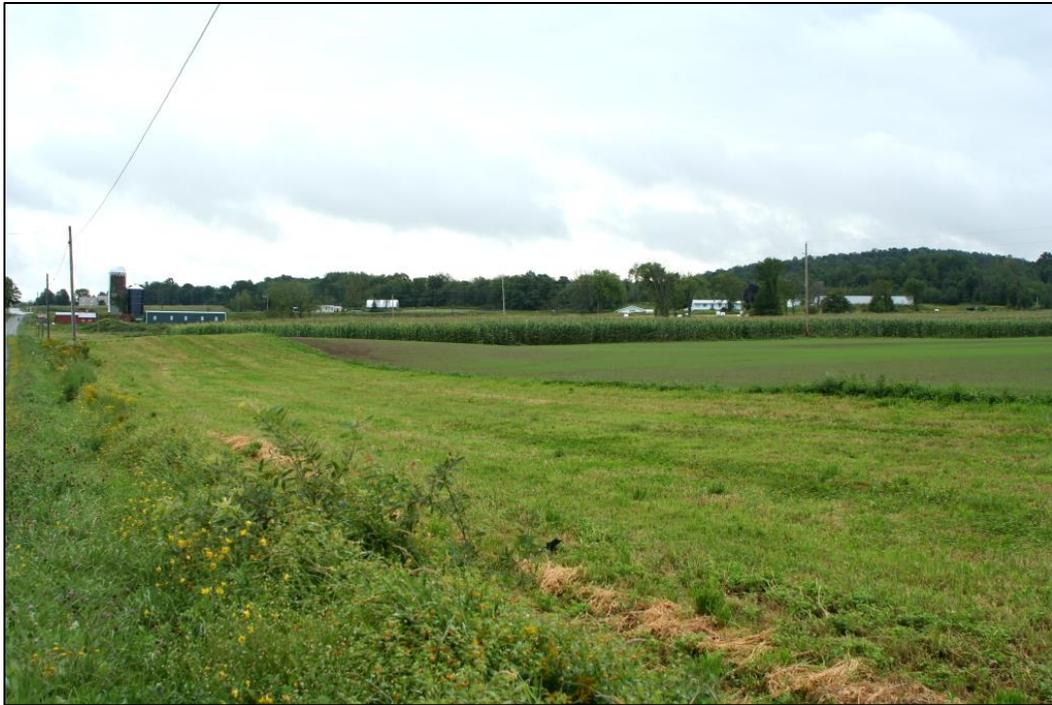
Figure 54. The edge of this field along Dewing Road was converted from corn to hay to reduce nutrient and sediment losses during heavy rains in Franklin, Vermont on 21 August 2015.

Based on these analyses and discussions with other stakeholders, there seem to be potential water quality issues in several of these tributaries. Along Dewing Road, the edge of a field was converted from corn to hay in 2012 in order to reduce nutrient and sediment losses during heavy rains. This change in land management may well have caused the improvements in water quality measured in Dewing Brook during the past few years (Figure 54).
