## West River

### Watershed Description

### Waterbody Facts (VT11-17)

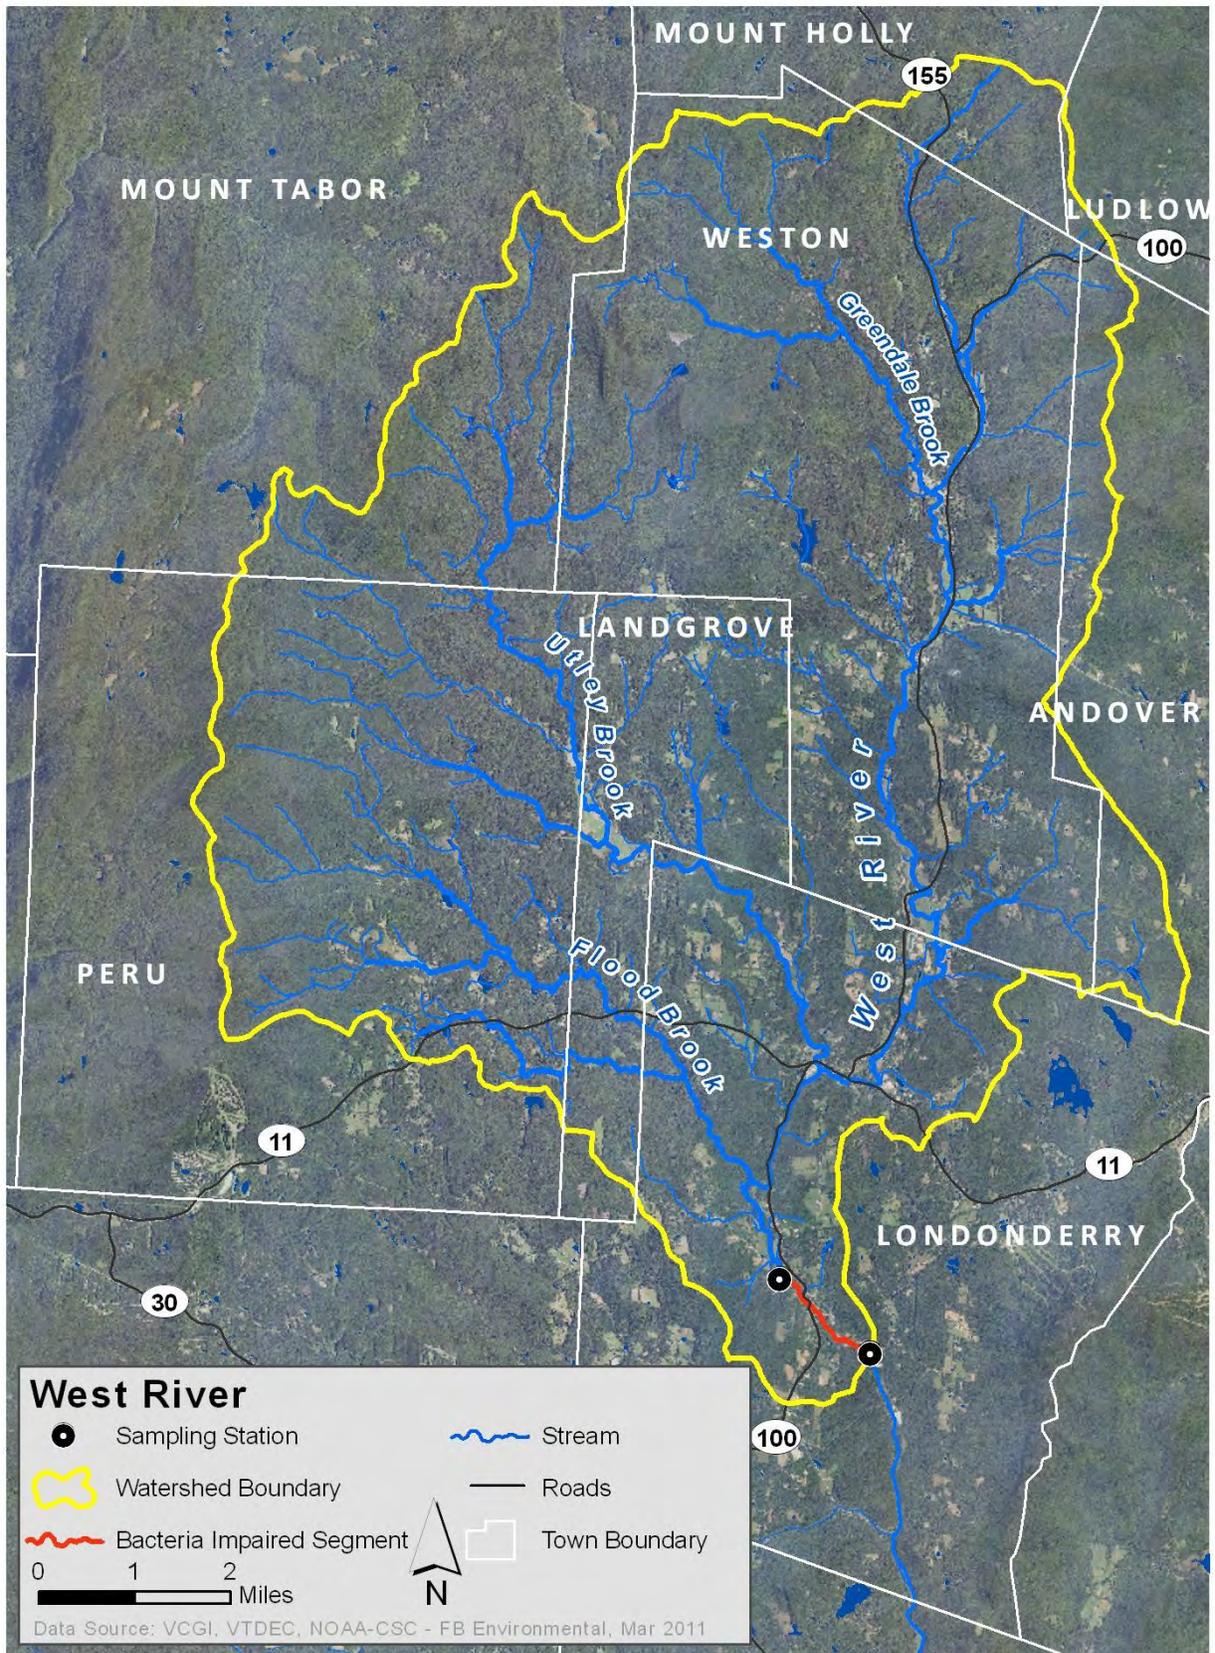
Figure 1: Map of the West River watershed with impaired segment and sampling stations indicated.

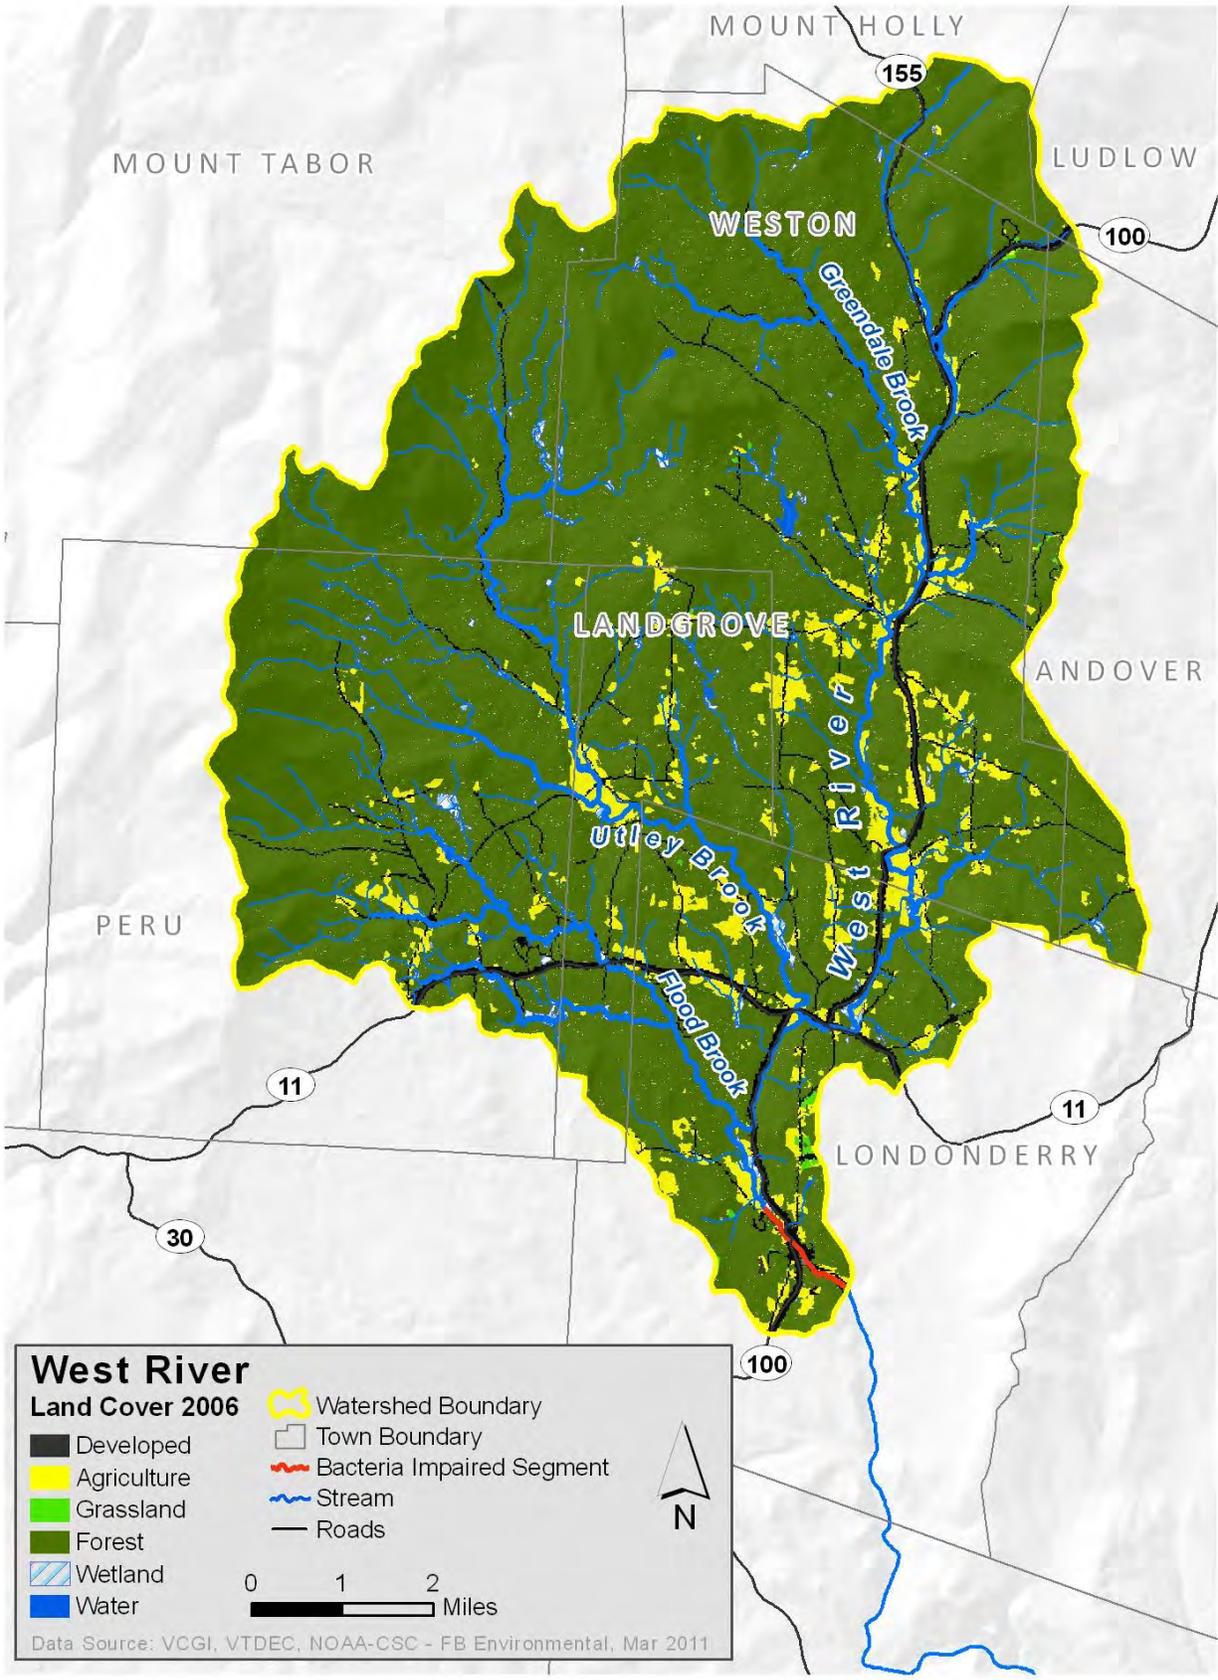
**Figure 2: Map of the West River watershed with impaired segment and land cover indicated.**

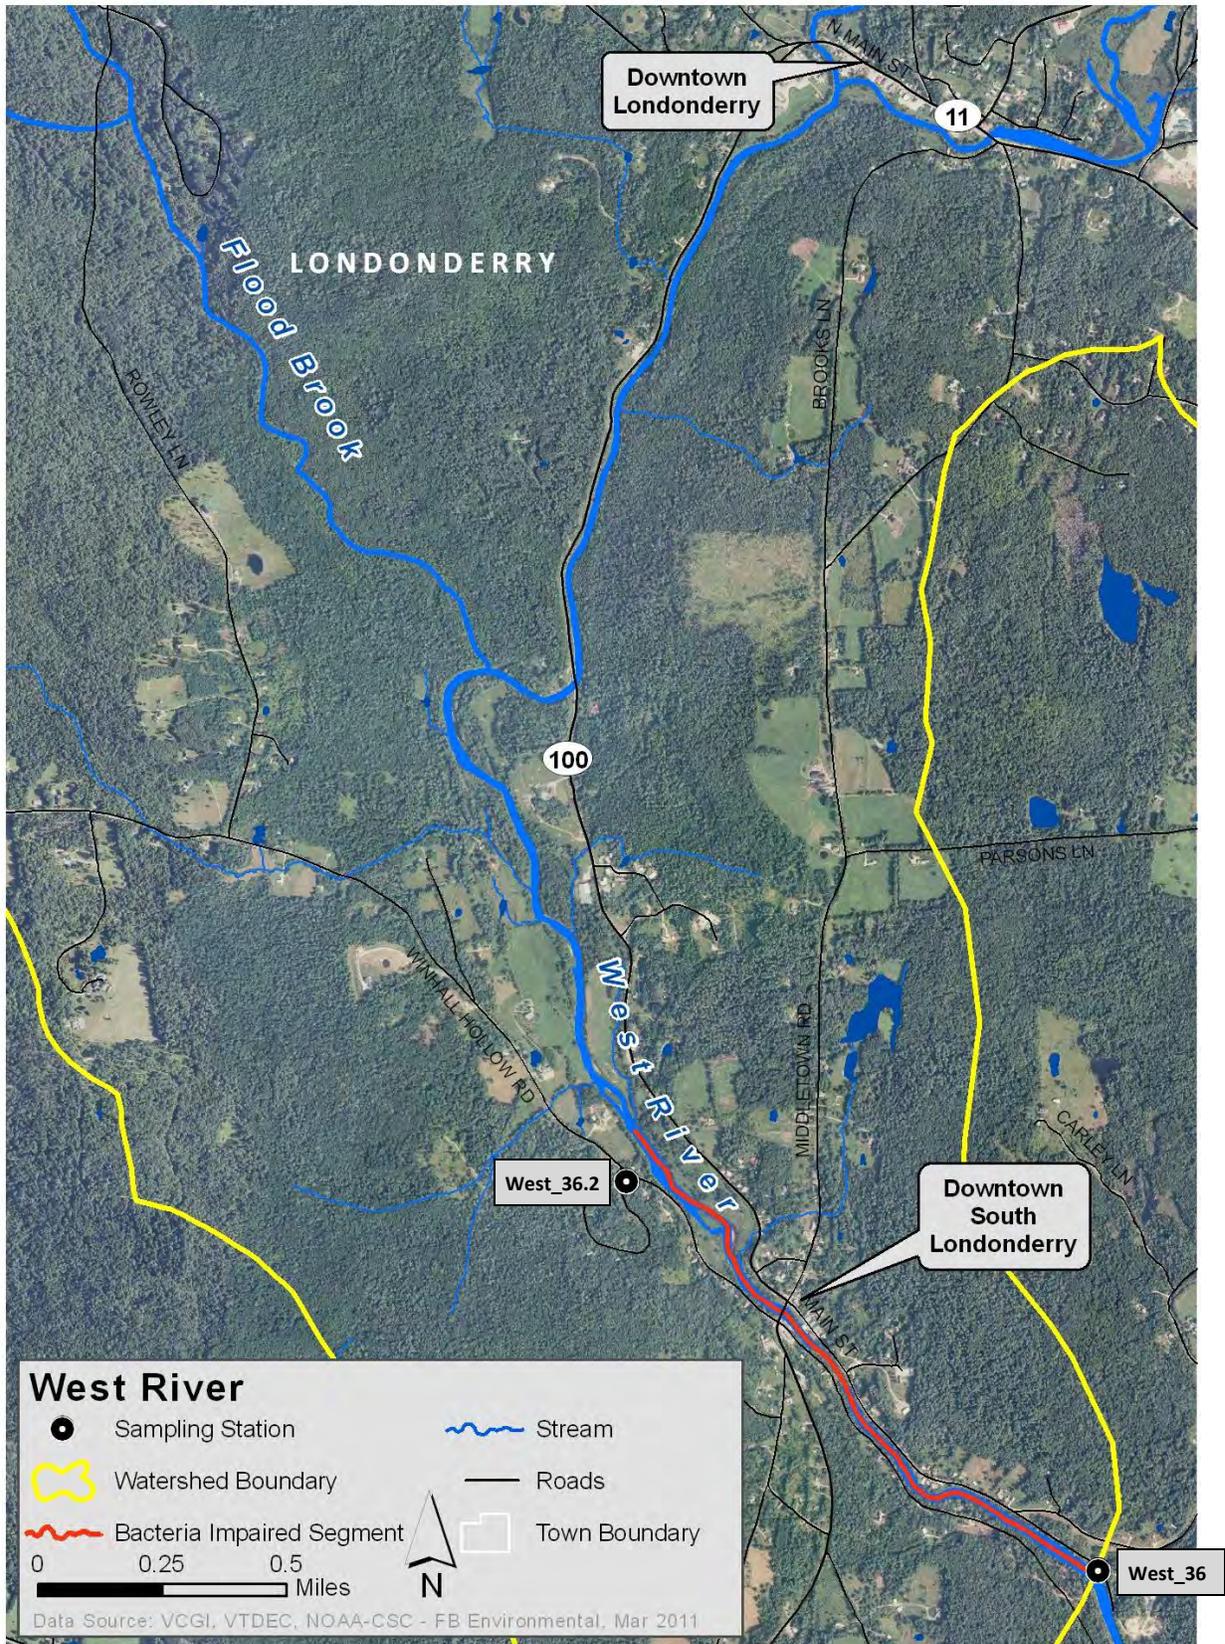
**Figure 3: Map of downstream reaches of the West River with impaired segment and sampling locations indicated.**

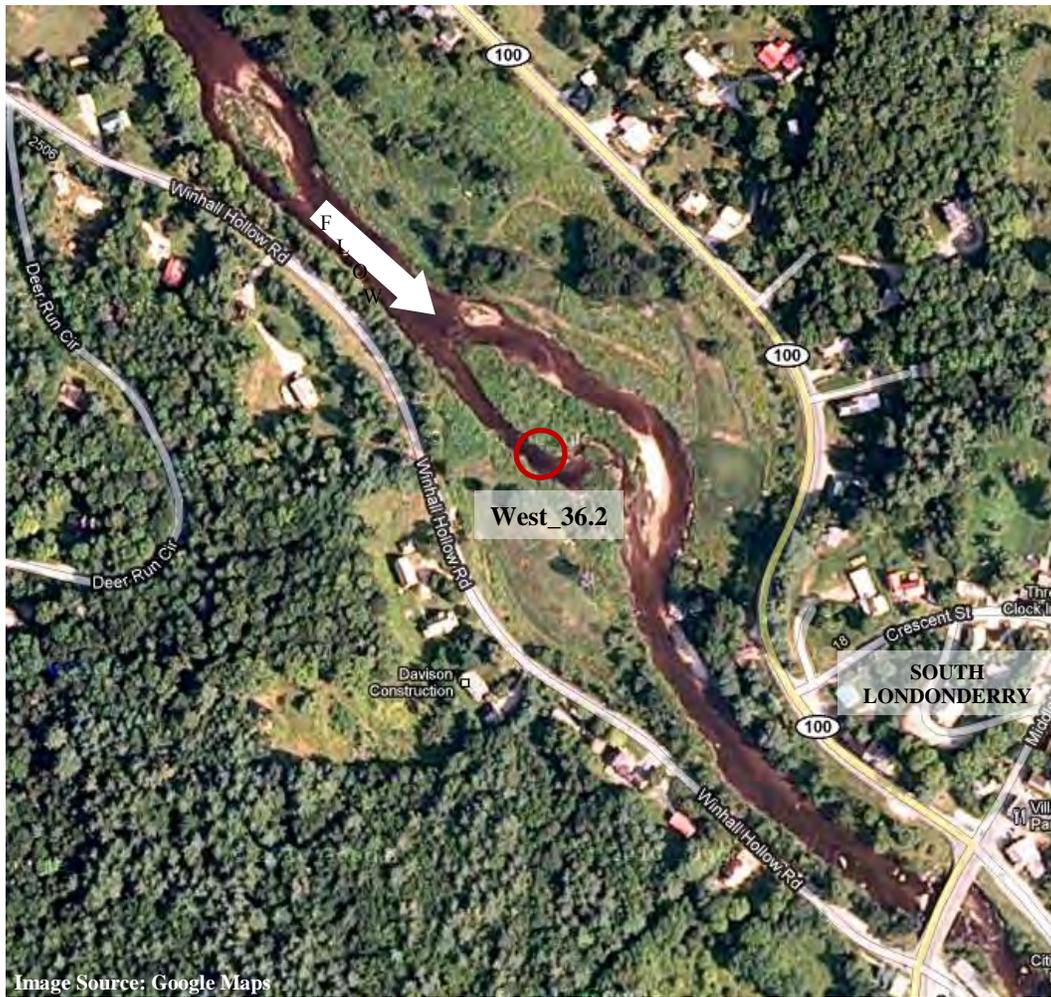
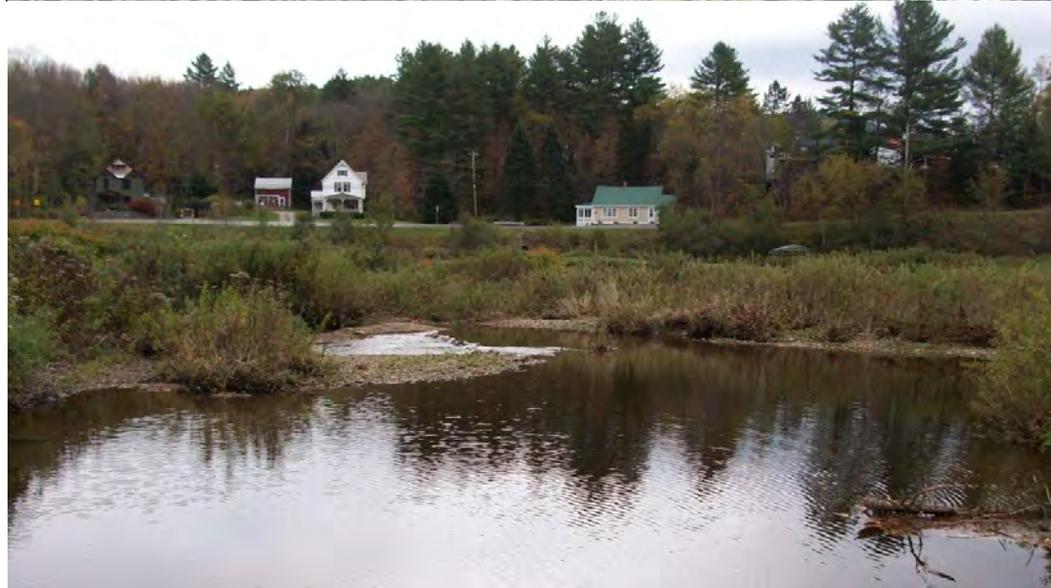
Prior to conducting the survey, available bacteria data were reviewed. A preliminary comparison of results from concurrent sampling events at West\_36.2 and West\_36 (on July 24, August 7 and September 18, 2007, as shown in Table 1) reveals that bacteria levels were roughly 2 to 8 times higher at downstream West\_36 compared to upstream West\_36.2. This observation suggests that there may be significant bacteria loads situated between West\_36.2 and West\_36. Location West\_36.2 was visited during reconnaissance survey and it was observed that this location is a swimming area that is not directly connected to the primary flow of the West River. As shown in Figure 4, location West\_36.2 is along the west shore of the river and is separated from the primary flow of the river by a sand bar. At the time of our visit, the West\_36.2 area was a backwater where water pooled and flowed northward (opposite the primary flow direction) prior to rejoining the main flow of the river. Based on this observation, we recognized West\_36.2 as a useful sampling point in terms of notifying and protecting swimmers, but not as a location representative of ambient river conditions. Bacteria data from West\_36.2 were deemed unsuitable to support bacteria source investigation. As a result, any bacteria sources upstream of West\_36 (i.e., in the entire headwater watershed) could be causing the elevated bacteria measurements observed at location West\_36.

**Figure 4: Aerial map and photograph of Sampling Location West 36.2 in South Londonderry showing the backwater area with flow northward.**

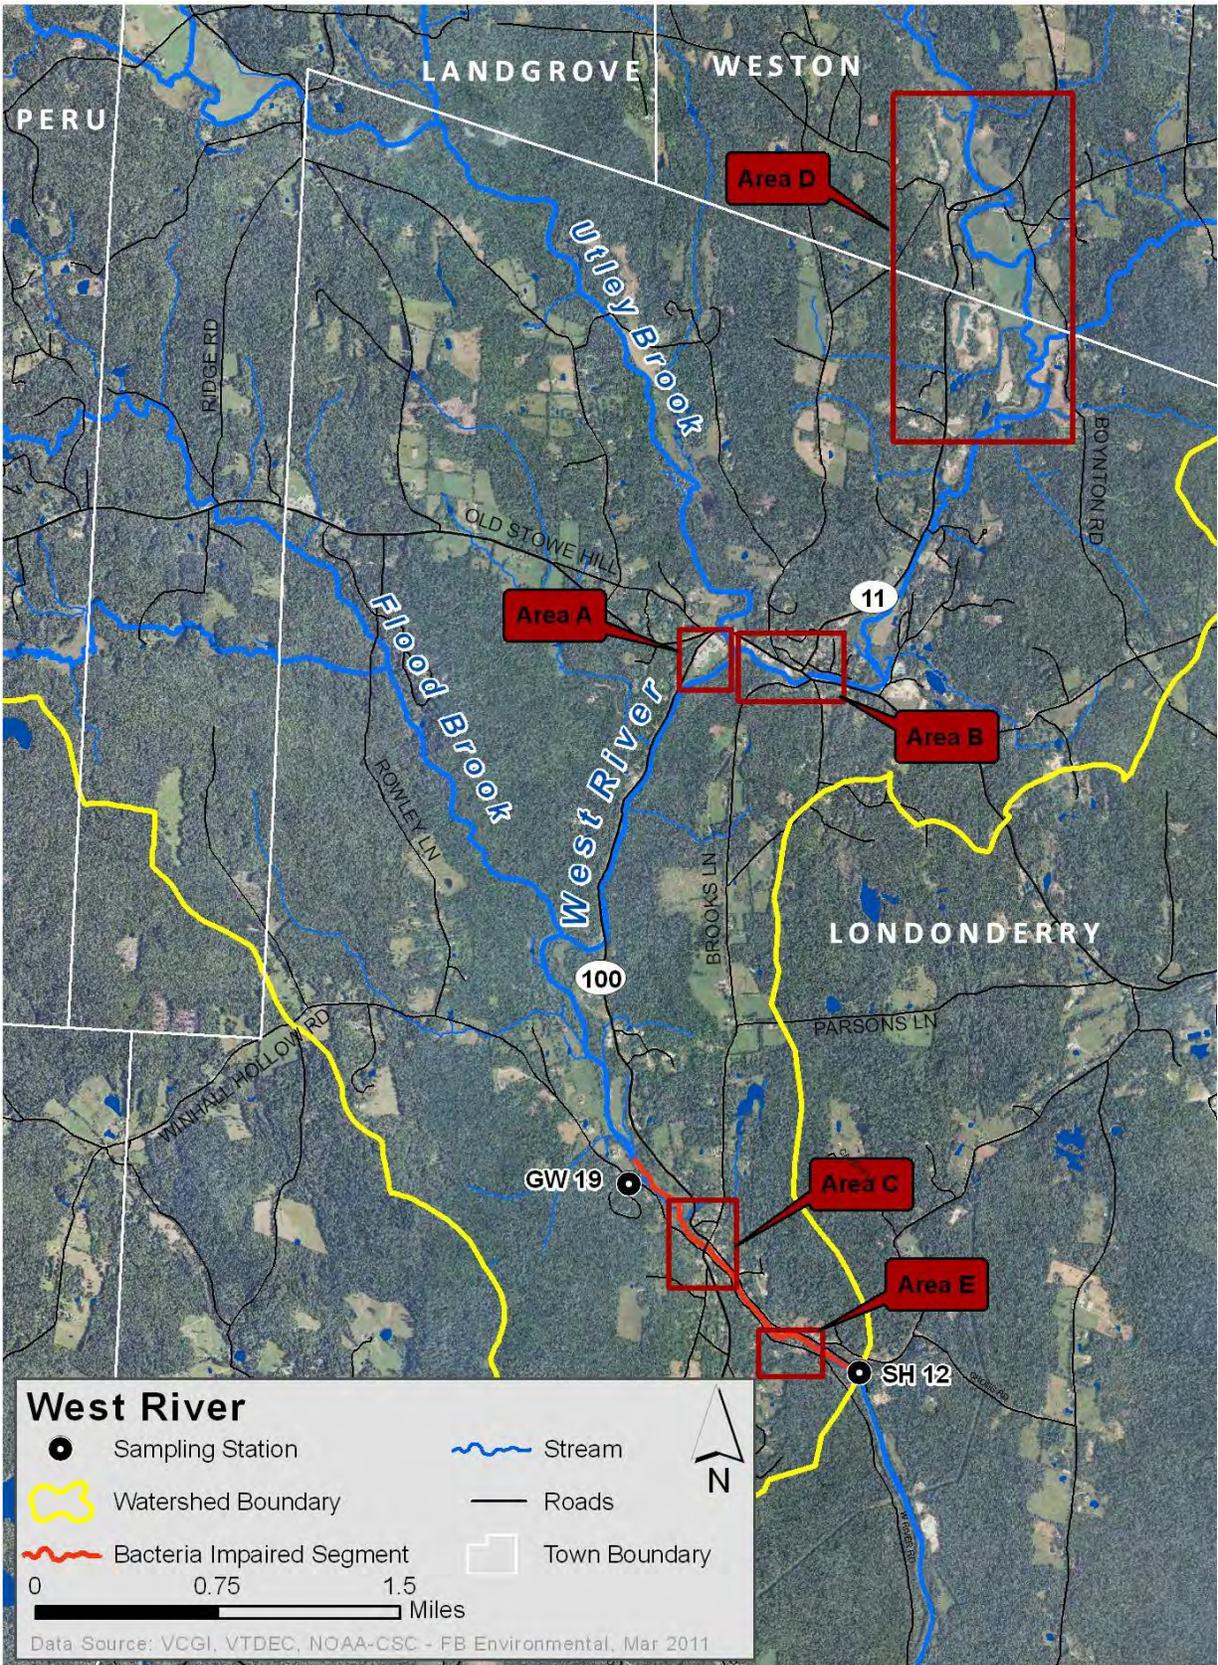
The bacteria source reconnaissance survey focused on identifying potential bacteria sources in the West River headwater watershed and resulted in identification of numerous potential bacteria sources. These potential bacteria sources were consolidated and prioritized into areas A through E, as shown in Figure 5 and described below.

- A. Green Mountain Mall/Clarks Supermarket, downtown Londonderry - potentially failing septic system sources;
- B. North Main Street Area, downtown Londonderry – potentially failing septic systems and storm drainage system sources;
- C. Downtown South Londonderry – storm drainage system and potentially failing septic system sources;
- D. Sheep farming and other agricultural activities, north of downtown Londonderry – potential animal waste runoff and manure management-related sources; and
- E. Small horse farm, South Londonderry – potential animal waste management sources

Figure 5: Aerial map of five potential bacteria source areas in the West River headwater watershed.

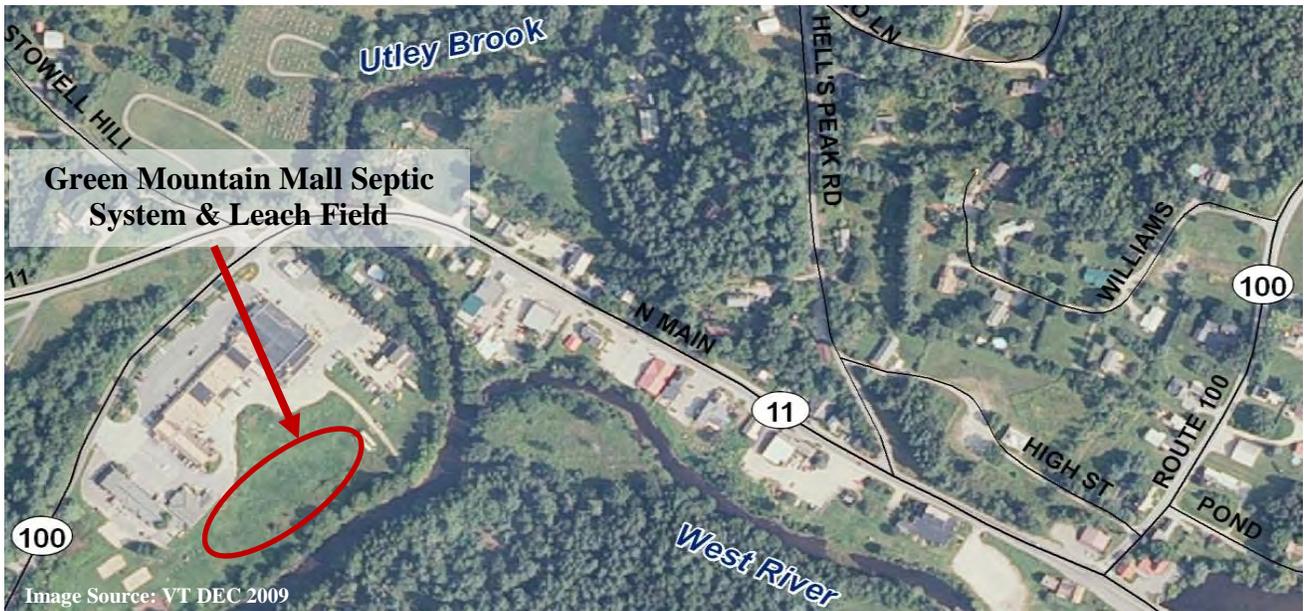
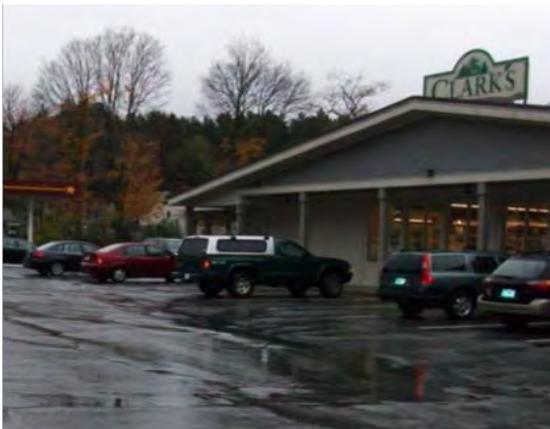
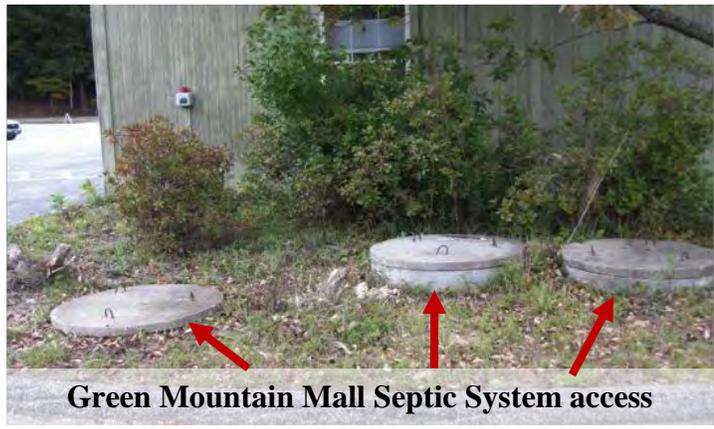
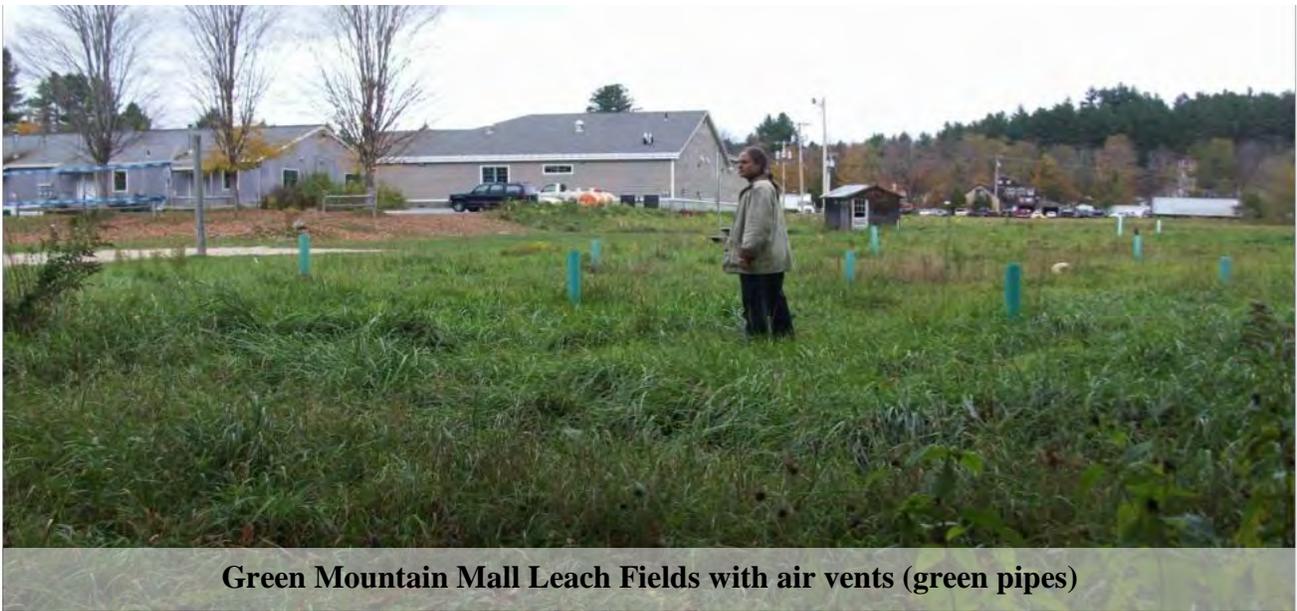
This mall and supermarket are situated immediately adjacent to the West River in downtown Londonderry, as shown in Figures 6. Utley Brook joins the West River immediately upstream of the mall and supermarket (Figure 6). The septic system for this commercial property is located between the buildings and the river. Photographs of the septic system access covers and leach field air vents are shown provided in Figures 6. The leach field appears to be situated in the flood plain of the West River. The elevation of the leach field was estimated to be only 3 to 4 feet above the West River's water level at the time of the reconnaissance survey.

During a field visit on October 5, 2010, strong septic odors were detected at several locations near the access covers and in the leach fields. Strong odors are an indicator of septic system failure. The septic system leach field is close to the river (less than 100 feet away). Due to several factors, including this septic system's odor, size, and close proximity to the river, it was suspected that untreated wastewater could possibly be reaching the river at this location.

On April 20, 2011, John Akielaszek, from DEC's Wastewater Management Division, met with the permittee and an engineer for a follow-up inspection at the site. At the time of this visit, no sewage odors were noticed. There are two pairs of leach fields at the site; only one field of each pair is in use during a 6-month period. At the time of this visit, the pair of fields operating for the next 6 months had recently been activated. Although animal burrows had allowed soils to enter some of the aeration chambers, there was no evidence of sewage having surfaced, and all sewage and water entering the chambers was infiltrating subsurface. It was agreed that the field containing some chambers coated with soils will need to be excavated and the infiltrative surface returned to its operating condition. However, the site does not appear to be a source of bacterial contamination (Akielaszek, 2011).

Figure 6: Aerial map and photographs of Area A: the Green Mountain Mall and septic system.

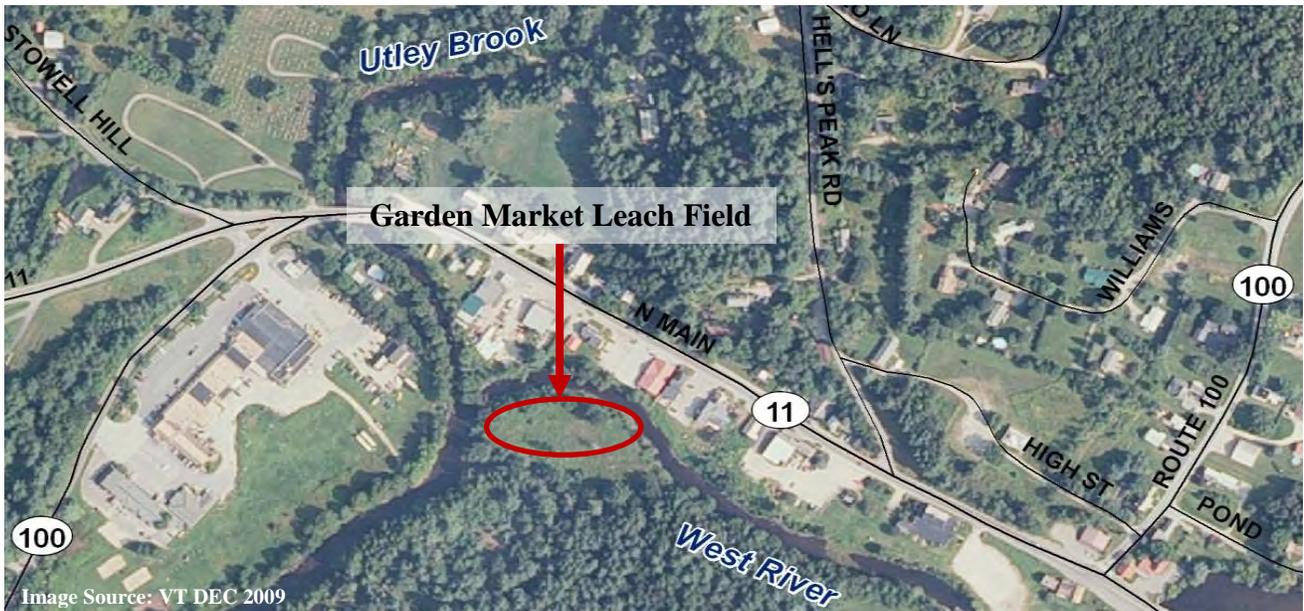
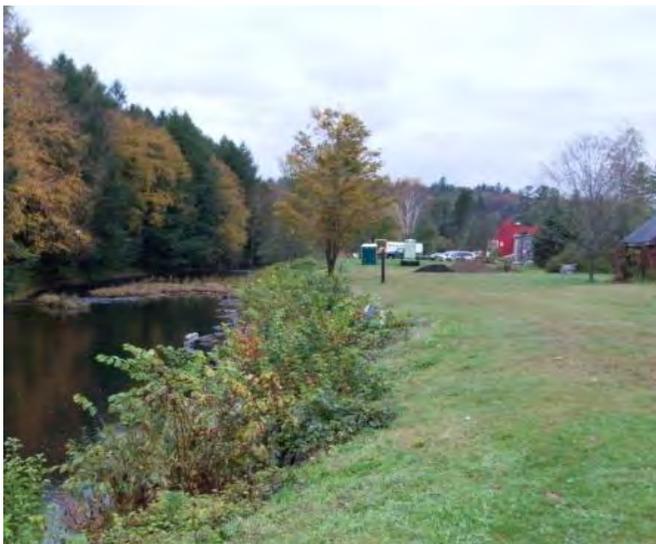
There are six to eight businesses situated between North Main Street and the West River in Londonderry, as shown in Figure 7. These businesses are along the south side of North Main Street and include a Gulf gas station, a white house with a hairdresser shop, the Telley Deli, the Garden Market, and Stoddard's restaurant. The septic systems for each of these businesses is likely to be close to the West River. In the case of the Garden Market, the septic system leach field is across the West River in the low-lying meadow shown in Figure 7 (indicated by a red circle). Due to the close proximity of these septic systems to the river, they should be investigated to ensure that they are functioning properly.

**View of West River and back of North Main Street businesses**

**Figure 7: Aerial map and photographs of Area B: the North Main Street area adjacent to the West River.**

In addition, stormwater runoff from North Main Street business parking lots and adjacent properties may be having an adverse impact on the West River. A storm drain survey should be conducted to assess potential impacts of stormwater runoff to this reach of the West River.

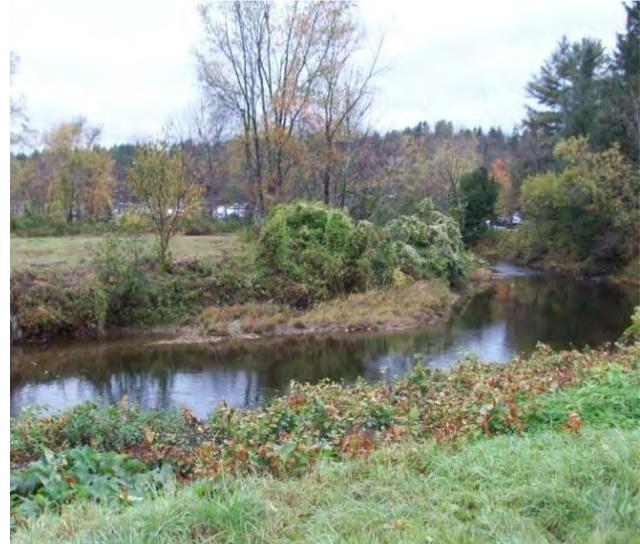
**View across West River to the Garden Market Leach Field**

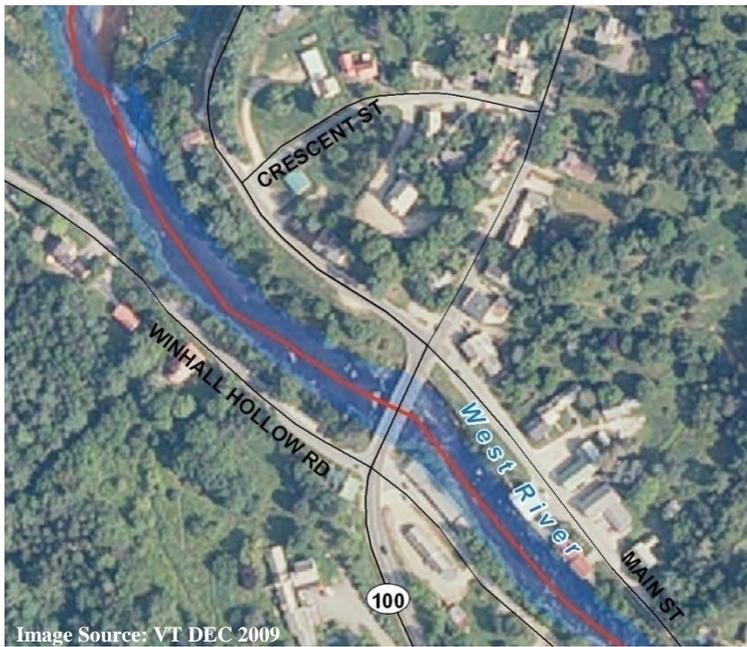
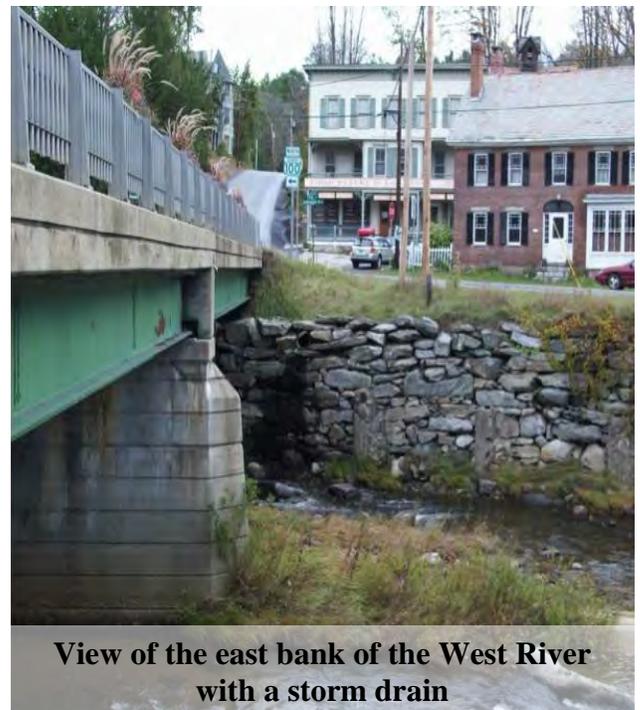
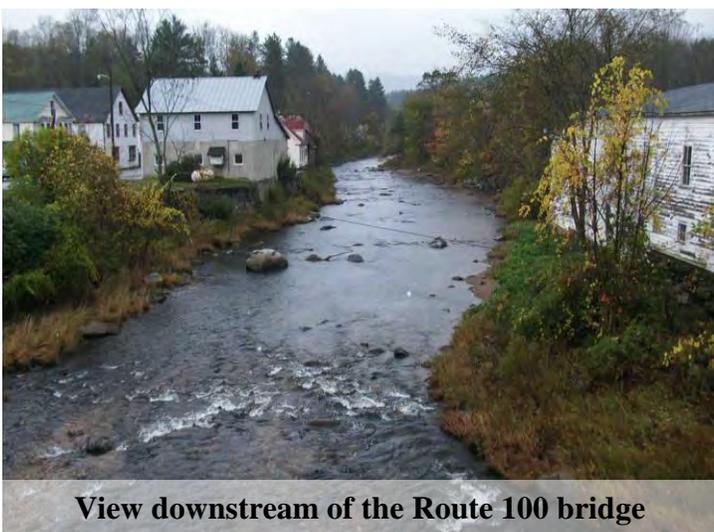
**Figure 8: Aerial map and photographs of Area C: downtown South Londonderry.**

The downtown South Londonderry area is situated immediately upstream of sampling location West\_36 and is shown in Figure 8. A South Londonderry river and homeowner survey was conducted in 2008 (WRWA 2008b). The 2008 survey featured a visual inspection of the West River shoreline through the South Londonderry downtown area and resulted in identification of numerous stormwater drainage pipes and several potential illicit discharges. The survey also featured a survey of homeowners that gathered information regarding septic system status.

The South Londonderry downtown area has a stormwater drainage network that appears to discharge water during dry periods. Dry weather flows in stormdrains may be indicative of illicit discharge, but may alternatively be due to other factors, such as a high groundwater table. Stormdrains should be tested for bacteria and other pollutants to determine whether or not potentially harmful illicit discharges are present. Septic systems in the downtown South Londonderry area should also be tested to ensure that they are functioning properly.

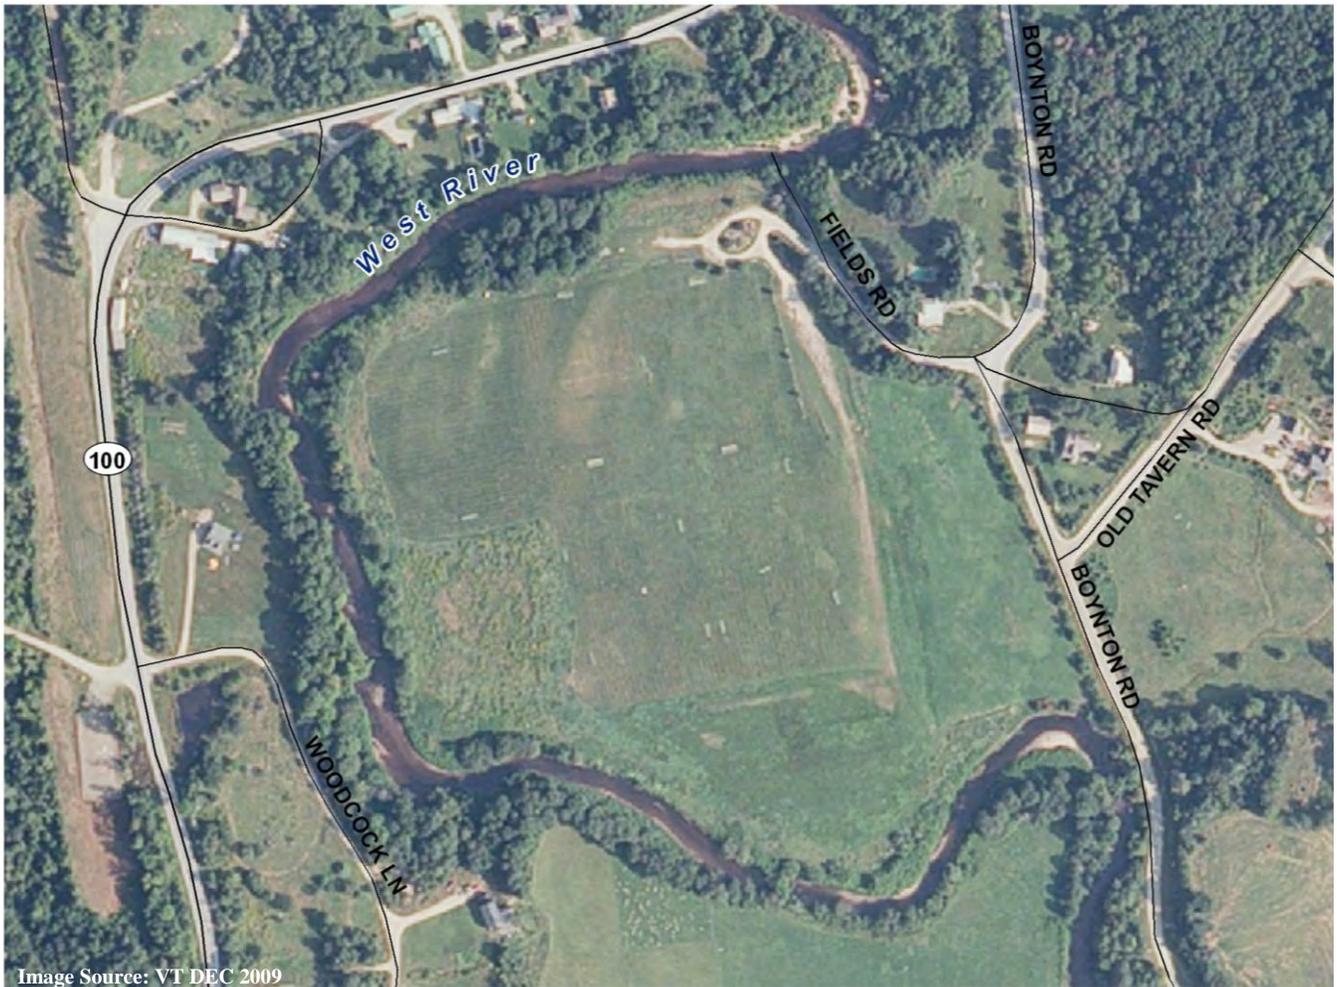
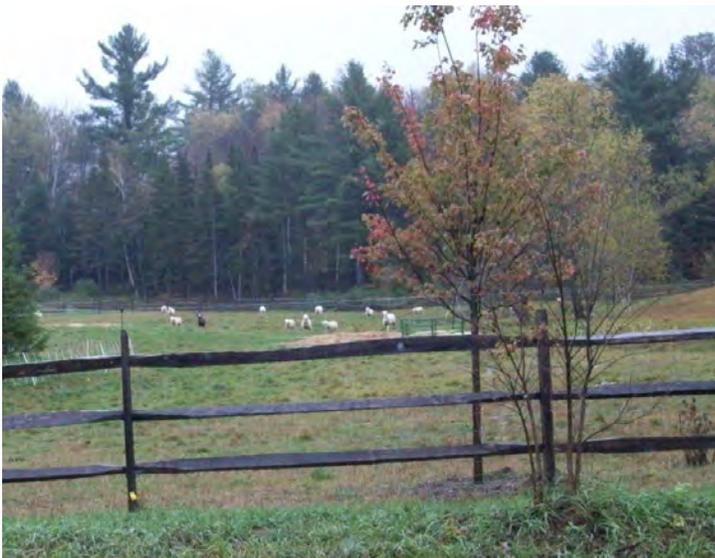
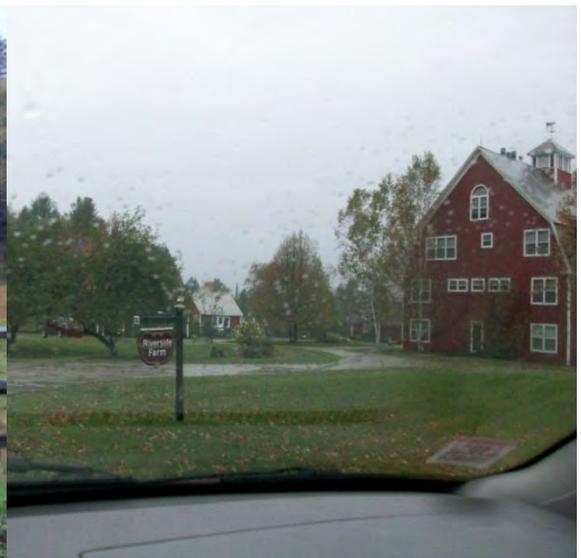
Agricultural lands along the West River in northern Londonderry and in Weston may be contributing bacteria and other pollutants to the river. A farm situated in south Weston is shown in Figure 9. The aerial view shows that there is little stream buffer and that land immediately adjacent to the river is used for grazing sheep. Manure management and stream buffer practices should be reviewed at farms along the West River.

**Figure 9: Aerial map and photographs of Area D: Sheep Farms in Weston.**

Agricultural activities including livestock maintenance and manure applications to croplands adjacent to the river likely result in fecal bacteria contributions. Several on-site improvement projects may be appropriate to reduce pollutant runoff from farms to the river. The Natural Resources Conservation Service, the Consolidated Farm Services Agency, USEPA, and other agencies can provide technical assistance and partial funding to support these projects. Potentially appropriate improvement projects may include fencing sheep out of the stream, constructing manure storage facilities, and improving barnyard maintenance.

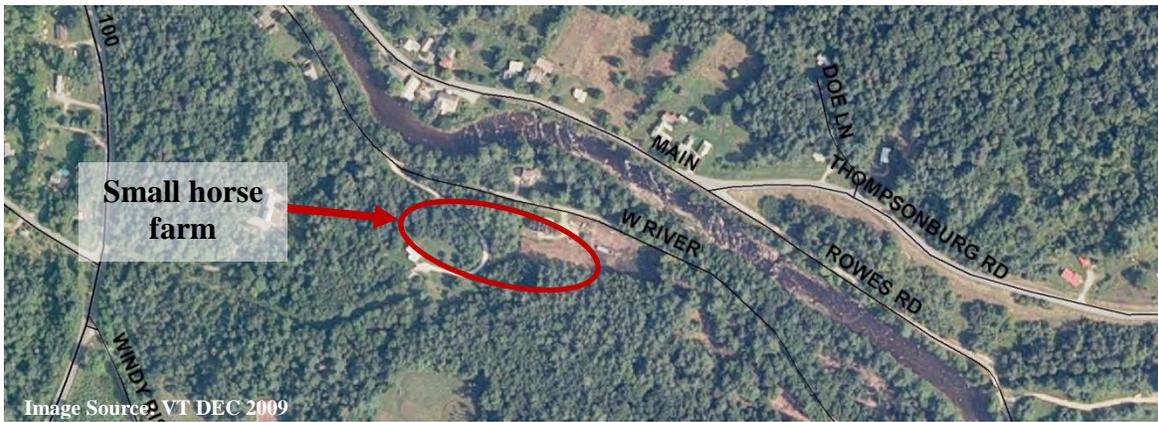
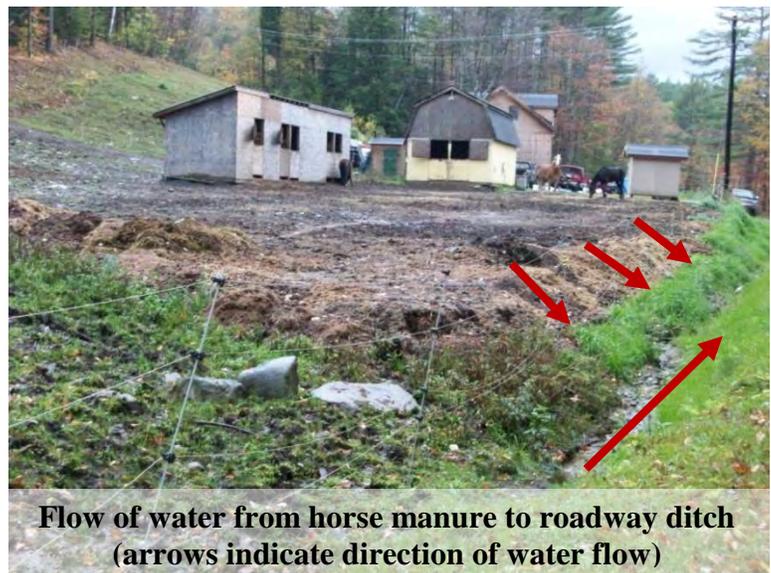
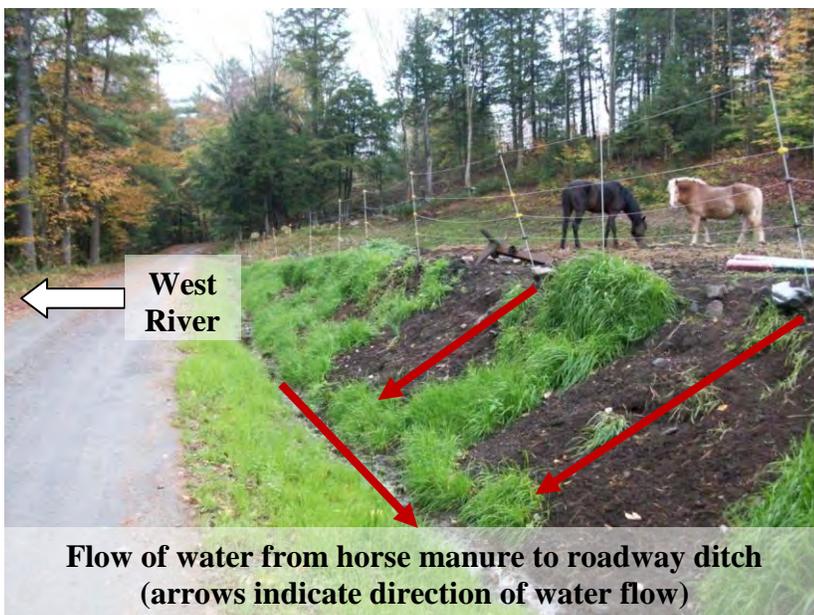
A small horse stable was observed during field reconnaissance in South Londonderry. As shown in Figure 10, manure from this stable is reaching the adjacent roadway gully. The gully discharges directly to the West River, situated on the opposite side of the road. The manure management at this location should be modified to prevent direct runoff of manure-laden waters from the site.

Figure 10: Aerial map and photographs of Area E: Small Horse Farm in South Londonderry.

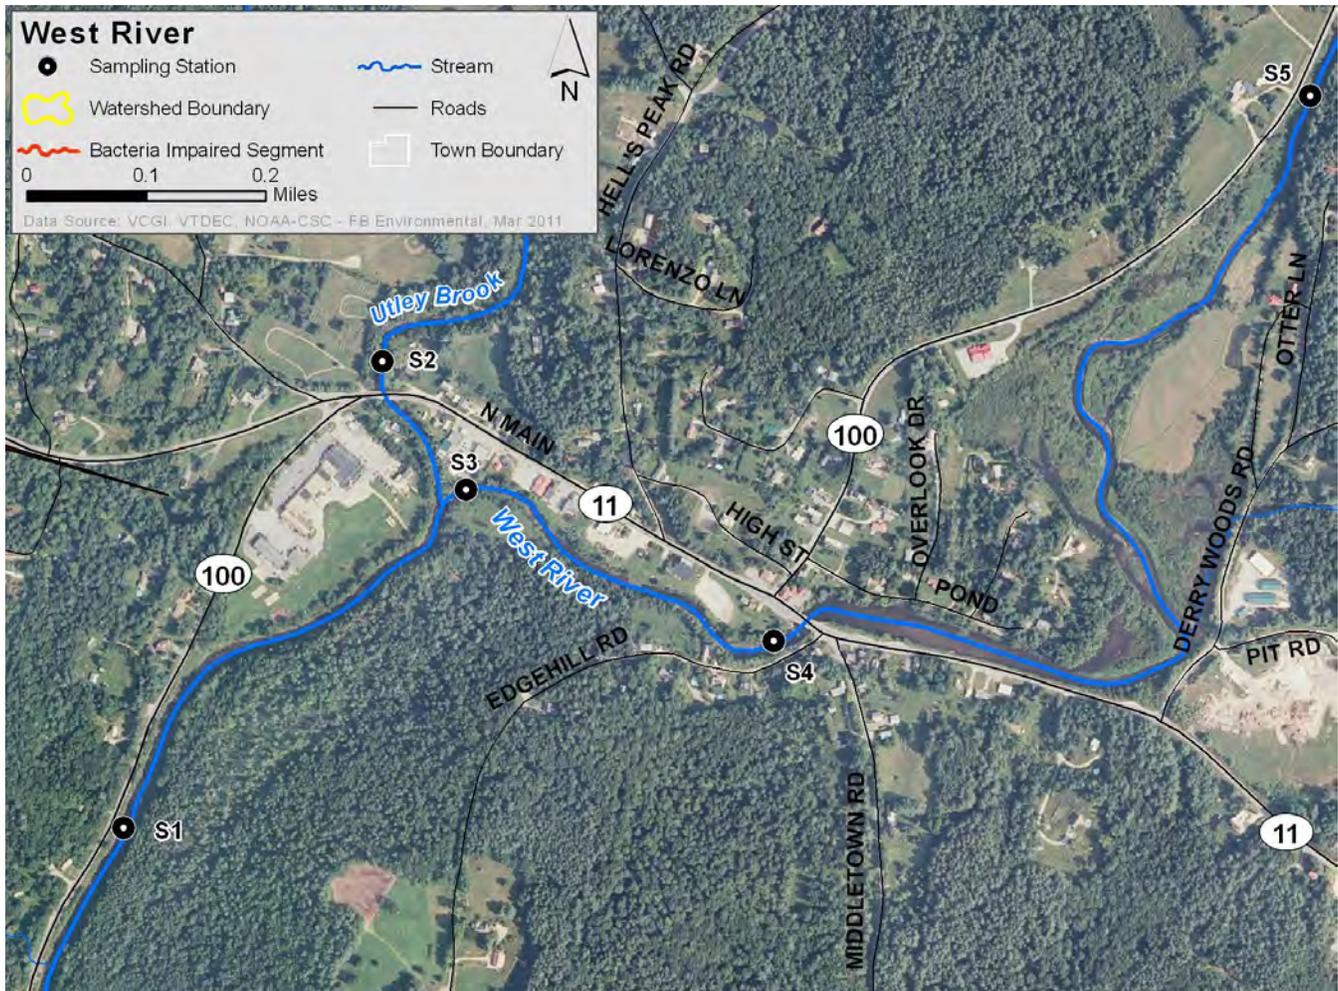
Figure 11: Aerial map with recommended bacteria sampling locations.

**Location 5** sampling is designed to capture bacteria entering the West River from the north. Sources of bacteria upstream of location 5 may include the sheep farms and other agricultural activities described as source area D above. Downtown Weston is also situated upstream of location 5 and is a potential source area. Location 5 is immediately above the downtown Londonderry impoundment.

**Location 4** is situated immediately below the downtown Londonderry impoundment and above the North Main Street developed area. The downtown Londonderry impoundment may be a source of bacteria due to the development along its shore and potential wildlife sources around the impoundment.

**Location 3** is situated immediately downstream of the North Main Street developed area described as potential source area B above and upstream of both the Utley Brook confluence and the Green Mountain Mall area A.

**Location 2** is designed to capture bacteria entering the West River from Utley Brook and to characterize any potential bacteria sources in this relatively large tributary.

**Location 1** is situated immediately downstream of the Green Mountain Mall area and is designed to capture any bacteria sources from area A. Location 1 will also serve as an upstream bracket location to support comparison with location West\_36. Thus, any significant differences between location 1 and location West\_36 results may be due to sources situated between these two locations.

We recommend sampling at these five locations and at location West\_36 throughout the 2011 sampling season. Ideally, this would result in 7 to 9 surveys from May through September of 2011. The resulting bacteria data would support more accurate identification of bacteria sources and would serve to identify specific next steps to mitigation these sources.
