## *North Branch of the Deerfield River*

### Watershed Description

### Waterbody Facts (VT12-05)

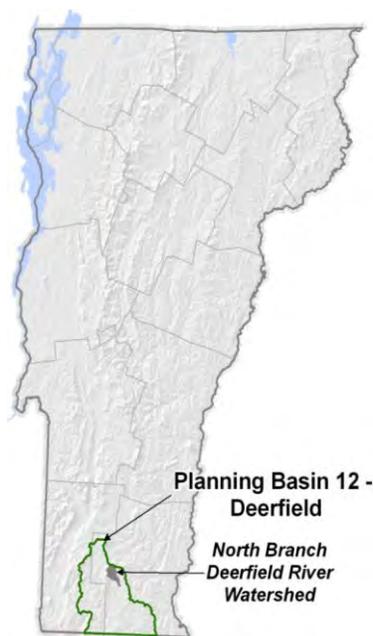
**Figure 1: Map of North Branch watershed with impaired segment and sampling stations indicated. Insert area corresponds to figure 4 below.**

The bacteria-impaired segment of the North Branch begins where another tributary enters the river in the Sitzmark Golf Course in Wilmington and runs approximately 1 mile upstream. The North Branch watershed (Figure 1) covers 11 square miles, in Stratton, Wardsboro, Dover, and Wilmington. Overall, land use in the watershed is 85% forested, 6.5% agricultural, 7.5% developed, and 1% wetland, as shown in Figure 2 (based on 2006 Land Cover Analysis by NOAA-CSC).

The North Branch is a Class B, cold water fishery with designated uses including swimming, fishing and boating (VTDEC, 2008). Since 2005 samples have been collected year round from the sampling stations shown in Figure 1 and Figure 3. Bacteria data from sampling locations WQ3 and WQ4 have exceeded Vermont's water quality criteria for *E.coli* bacteria. Table 1 below provides bacteria data collected at these sampling locations from 2005-2009. Table 1 provides the water quality criteria for *E.coli* bacteria along with the individual sampling event bacteria results and geometric mean concentration statistics for the North Branch. For the North Branch, the current single sample water quality criterion is exceeded in nearly 20% of the samples.

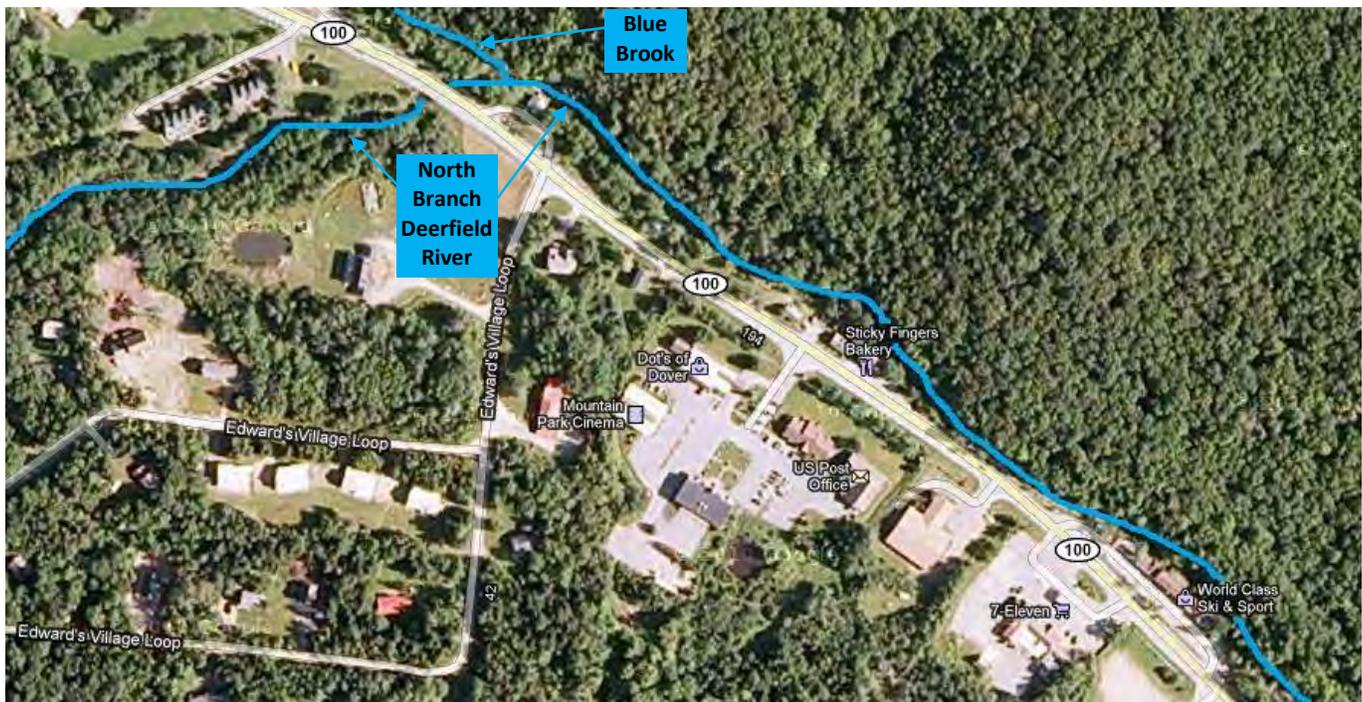
**Figure 4: Aerial view of the North Branch as it follows along VT Rte. 100 in Dover. The confluence with Blue Brook takes place opposite of the intersection of Edward's Village Loop and Vt. Rte. 100 (Source: Google Maps).**

Both Dover and Wilmington are characterized by high mountainous terrain with thin soils and steep slopes. Both towns have a high percentage of land with slopes greater than 15% (Dover, 2008; Wilmington, 2010). These factors make development within the towns difficult. Figure 4 provides a more detailed aerial view of the North Branch as it flows along VT Rte. 100 in central Dover. Much of the commercial and residential development within Dover is concentrated around the river and its tributaries, like the area shown in Figure 4 above. Land use and settlement patterns within Dover and Wilmington have been significantly influenced by the presence of Mount Snow (Dover, 2008).

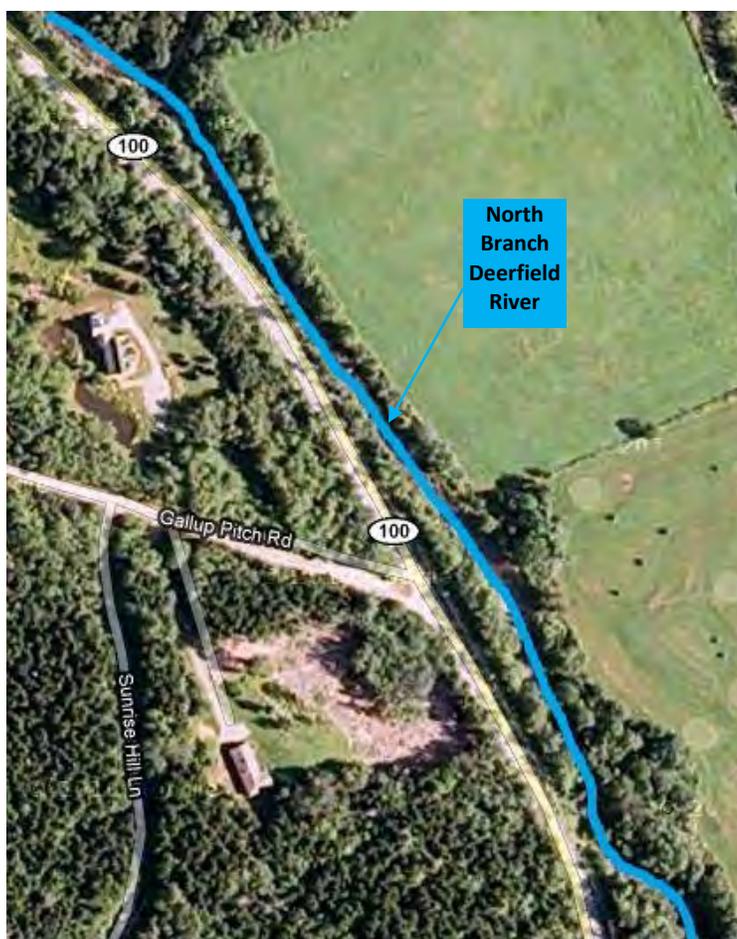
**Figure 5: Aerial view of the impaired segment of North Branch after the Village of West Dover as it continues to follow VT Rte. 100 (Source: Google Maps).**

Development has encroached upon the North Branch most visibly in central Dover and in the village of West Dover along the bacteria impaired segment of the river, as shown in Figure 5. The presence of VT Rte.100 and other development causes high volumes of stormwater to enter the river during rain events. Stormwater flows off of impervious surfaces such as roads, sidewalks, and rooftops when it rains. As stormwater flows over impervious surfaces in a developed area, it picks up a suite of pollutants, including bacteria (Smartwaterways, 2010). Stormwater can flow directly into the river or into one of the many separate storm sewers that empty into the river (Smartwaterways, 2010). Storm sewers are pipes that carry water way from impervious surfaces such as roads and parking lots to the nearest surface water. Where the storm sewer releases the water into the river is called an outfall. Stormwater outfalls on the North Branch are regulated by Vermont DEC, and the North Branch has a total of 10 permitted stormwater outfalls along it (North Branch).
