Little Otter Creek: Headwaters

Watershed Description

Waterbody Facts (VT03-07)

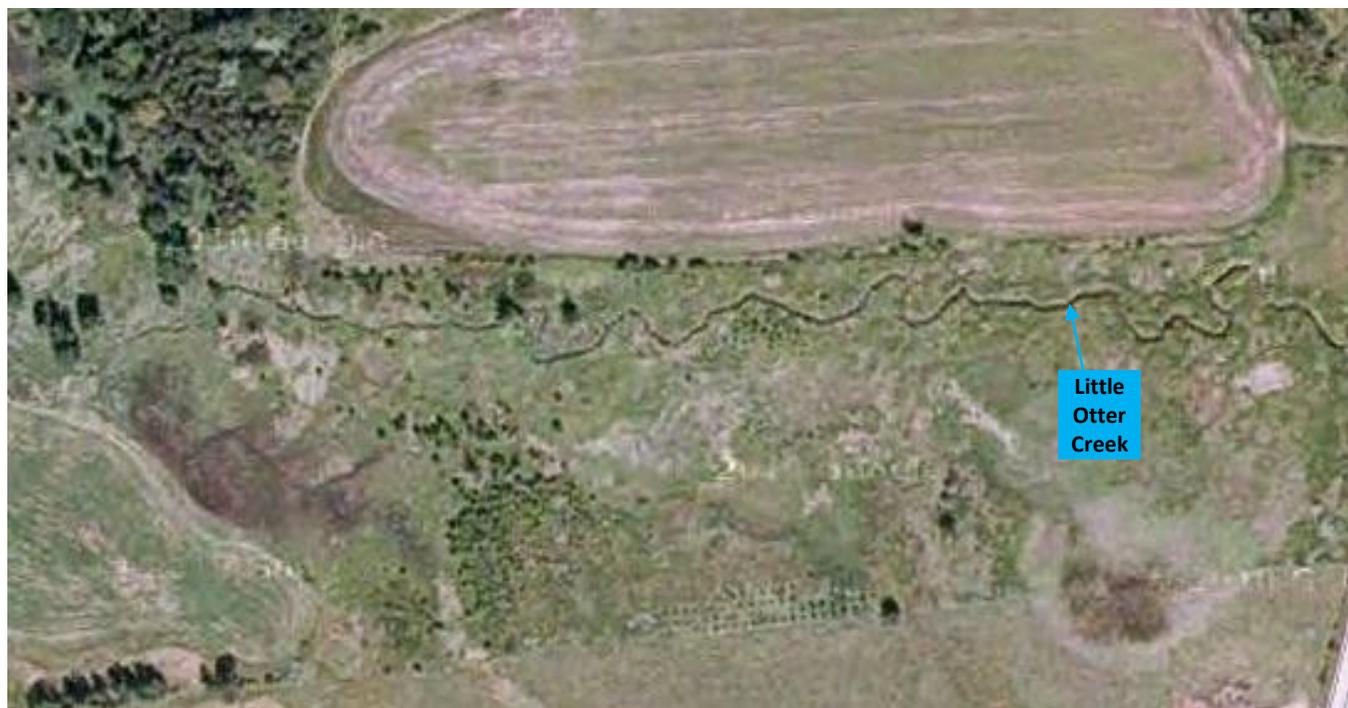
Figure 4: Aerial view of Little Otter Creek Headwaters from approximately river mile 15.4 to river mile 16 (Source: Google Maps).

Figure 4 shows the reach from approximately river mile 15.4, the beginning of the impaired segment (middle left hand side), to river mile 16 in New Haven. As seen in this aerial image, there are large tracts of agricultural land along the creek's banks with minimal riparian buffer. Agriculture remains an important cultural and economic resource in Addison County (ACRPC, 2008). This impaired segment of Little Otter Creek Headwaters is completely within the town of New Haven, where agriculture is the dominant land use and an essential part of the local economy (New Haven, 2010). A 2007 agricultural census found that there are 73 farming operations within the town of New Haven, several of which reside in the small watershed around the impaired segment of Little Otter Creek's headwaters. The types of farms present are primarily dairy, poultry, fruit and vegetable farms, and horse stables (New Haven, 2010). Given the large percentage of its watershed dedicated to agricultural land uses, Little Otter Creek Headwaters is considered an agricultural stream (Medalie, 2007). Much of the agricultural land surrounding the impaired segment and in the creek's course beyond this segment was once wetland. Up to one-third of Addison County's farmland may have once been wetland (ACRPC, 1994).

From the top of the impaired segment at river mile 16.4 down to the end of the impaired segment one mile upstream from sampling station LOC14.4, the stream flows very close to agricultural lands. Land use has a profound effect on waters movement, storage and ultimately its water quality (RRPC, 2008). The long term health of Little Otter Creek Headwaters is closely linked to the use of best management practices (BMPs) on agricultural lands, aimed at reducing pollutant loads, particularly bacteria, to the creek. Figure 4 shows the need for wider riparian buffers along the creek's course.
