Middlebury River

Watershed Description

This bacteria TMDL summary applies to a 2 mile reach of the Middlebury River (VT03-12), a 18.6-mile long river located southeast of Lake Champlain (Figure 1). A tributary of Otter Creek, the Middlebury River is formed by the confluence of three main branches originating in the Green Mountain National Forest (ACRWC, 2009). The Middlebury flows westerly out of the Green Mountains and into the Champlain Valley where large areas of land are in agricultural use. The Middlebury River watershed covers 62.8 square miles, primarily in the towns of Ripton, Middlebury and Salisbury. Overall, land use in the watershed is 85% forested, 13% agricultural, 1% developed, and 1% wetland, as shown in Figure 2 (based on 2006 Land Cover Analysis by NOAA-CSC). The watershed is home to an estimated 2,326 residents (MRWP, 2001).

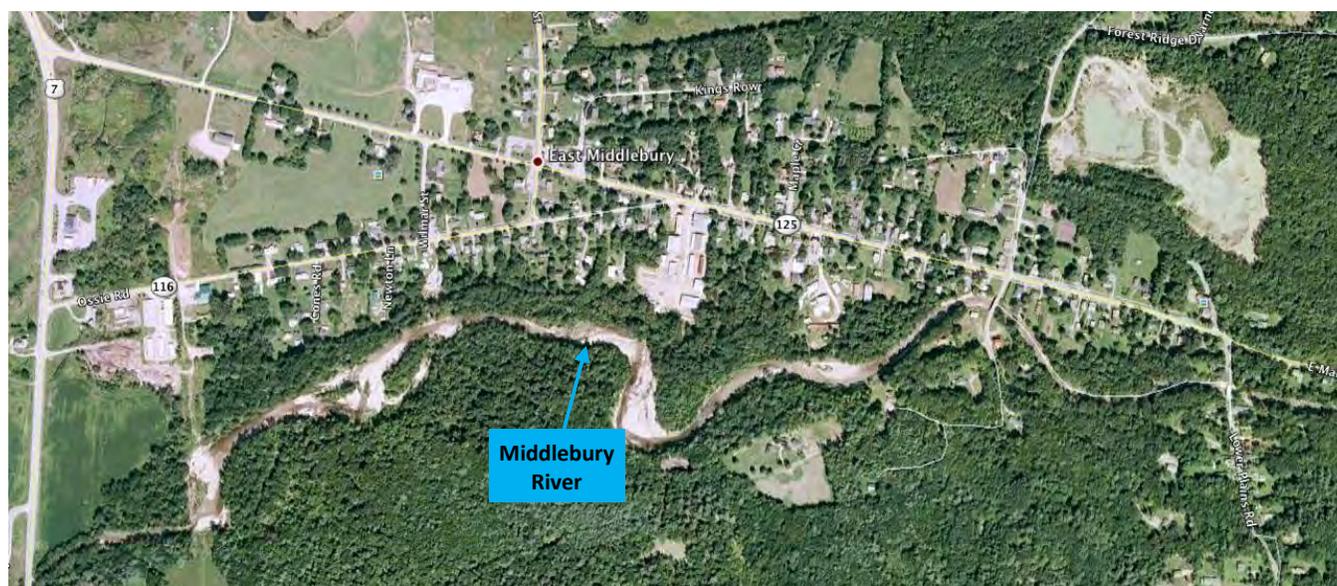
Figure 4: Aerial view of the Middlebury River from the Middlebury Gorge to Route 7 (RM 5.7 to 3.0) in East Middlebury.

Figure 4 shows the reach from approximately rivermile 5.7 to rivermile 3.0 along the village of East Middlebury. The Middlebury River Corridor Planning project investigated the geomorphology of the river and found that the main erosion hazards were due to human built encroachments in the river corridor associated with development in natural deposition areas. These erosion hazard areas are primarily located in the village of East Middlebury (shown in Figure 4), the village of Ripton and along Route 125 between them (MALT, 2009). Erosional and depositional areas along the riverbank are visible in Figure 4. High eroding embankments subject to collapse are reportedly located upstream of Middlebury Gorge (ACRWC, 2009).

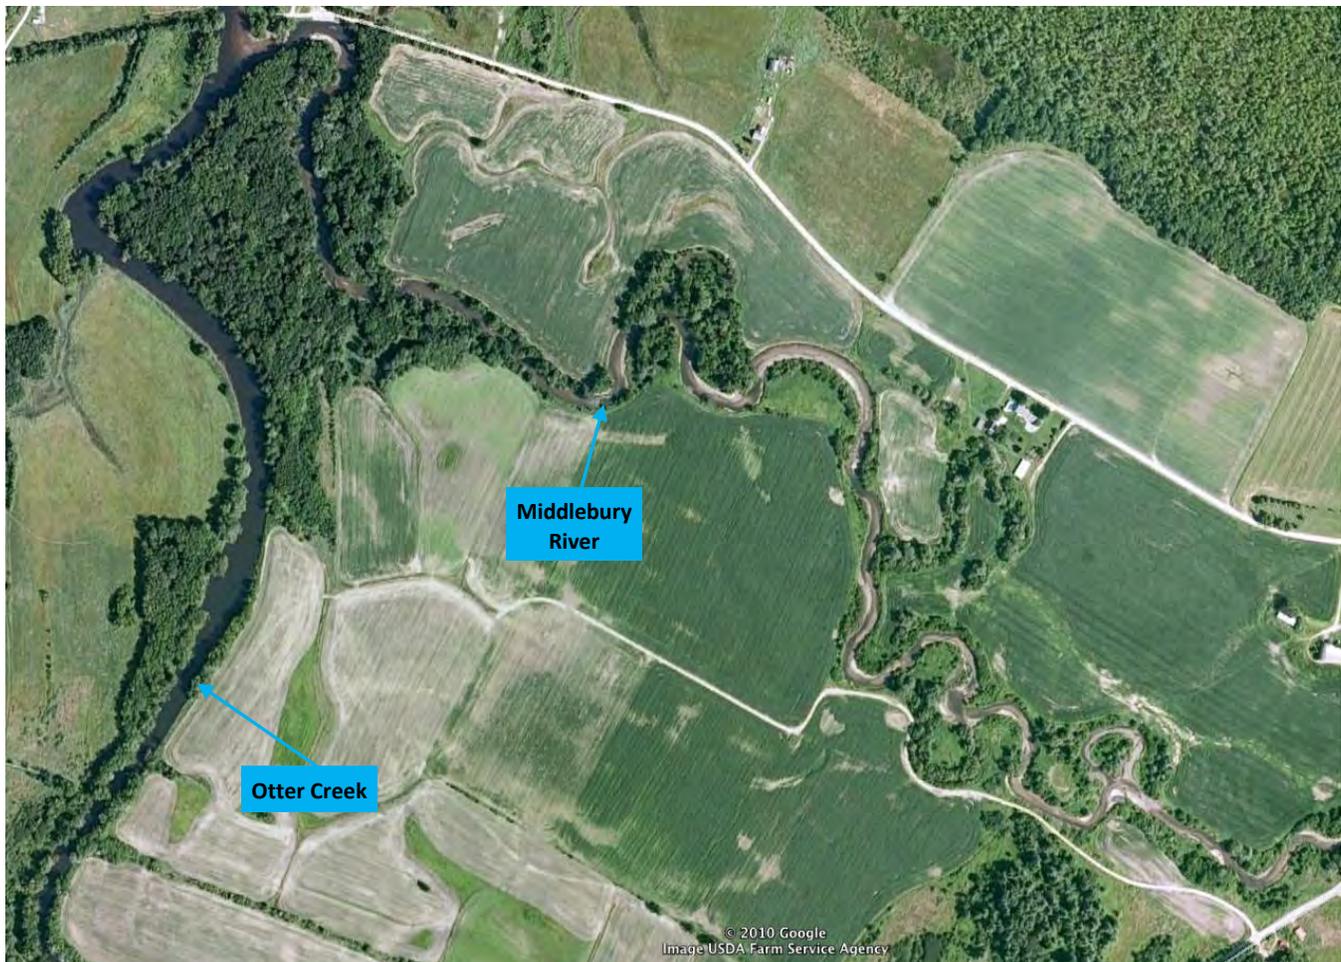
From East Middlebury village, the Middlebury River flows through the Champlain Valley flatlands and into Otter Creek. This reach is in large-scale agricultural land use and typically has narrow riparian buffers. Figure 5 provides an aerial view of a reach of the Middlebury River including the confluence with Otter Creek. The Middlebury meanders through croplands and pasture with narrow riparian buffers. The Middlebury River joins Otter Creek (in the upper left corner of Figure 5), another bacteria impaired waterbody, and Otter Creek flows on northward eventually flowing into Lake Champlain.

Figure 5: Aerial view of the Middlebury River and confluence with Otter Creek.
