Impacts of Tropical Storm Irene on Streams in Vermont

George Springston and
Kristen Underwood

Norwich University Dept. Geology and Environmental Science
South Mountain Research and Consulting

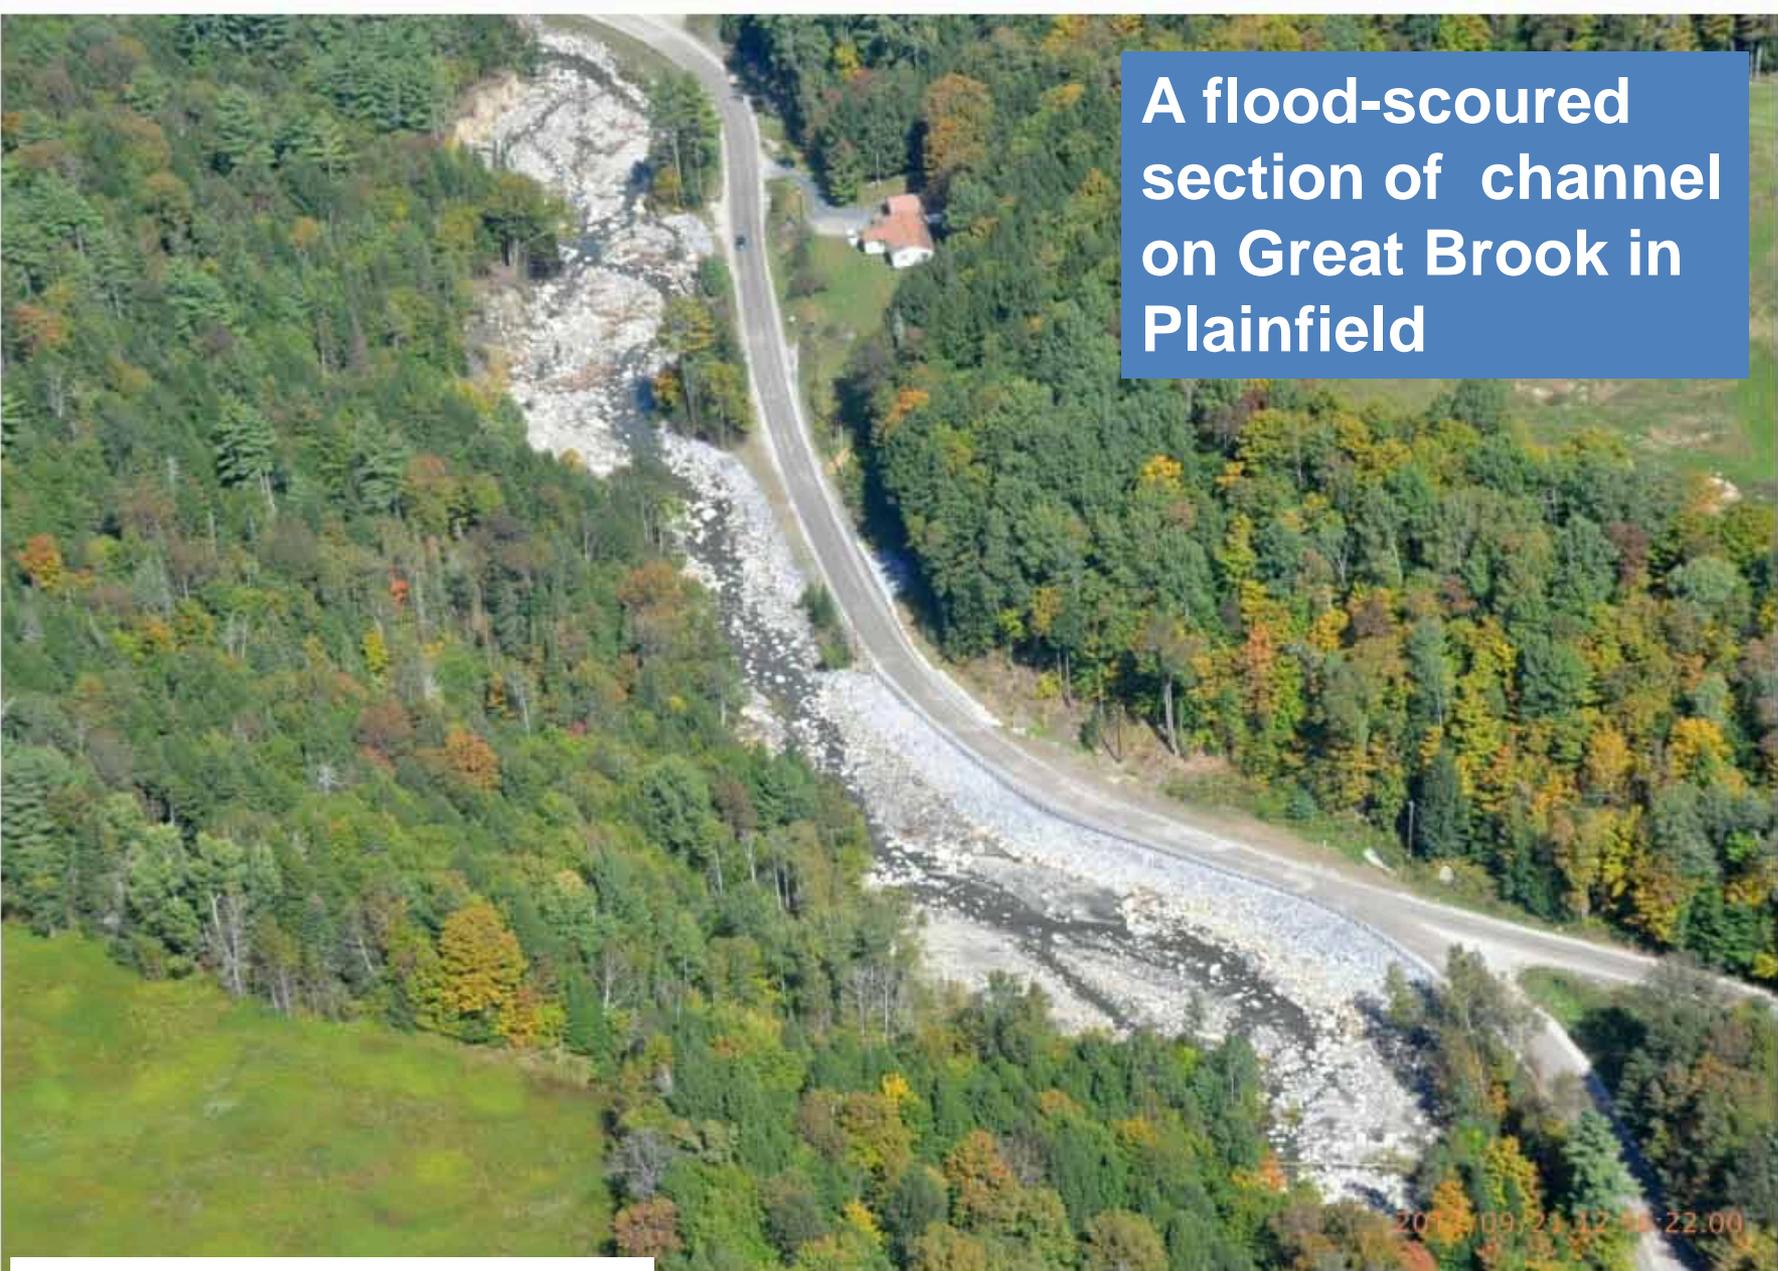
A flood-scoured section of channel on Great Brook in Plainfield

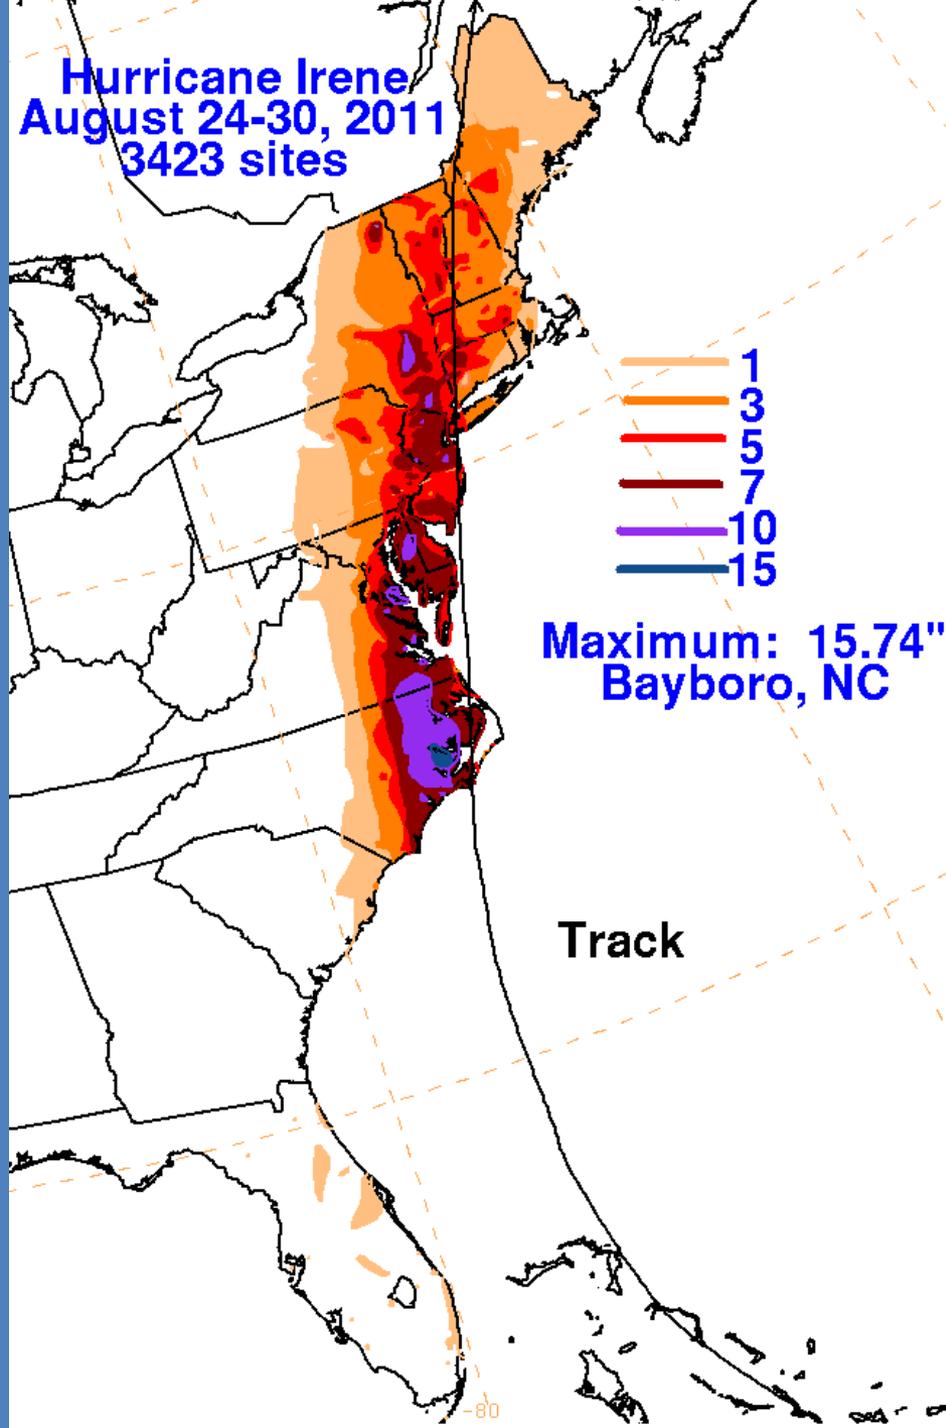
Hurricane Irene
August 24-30, 2011
3423 sites

Maximum: 15.74"
Bayboro, NC

Track

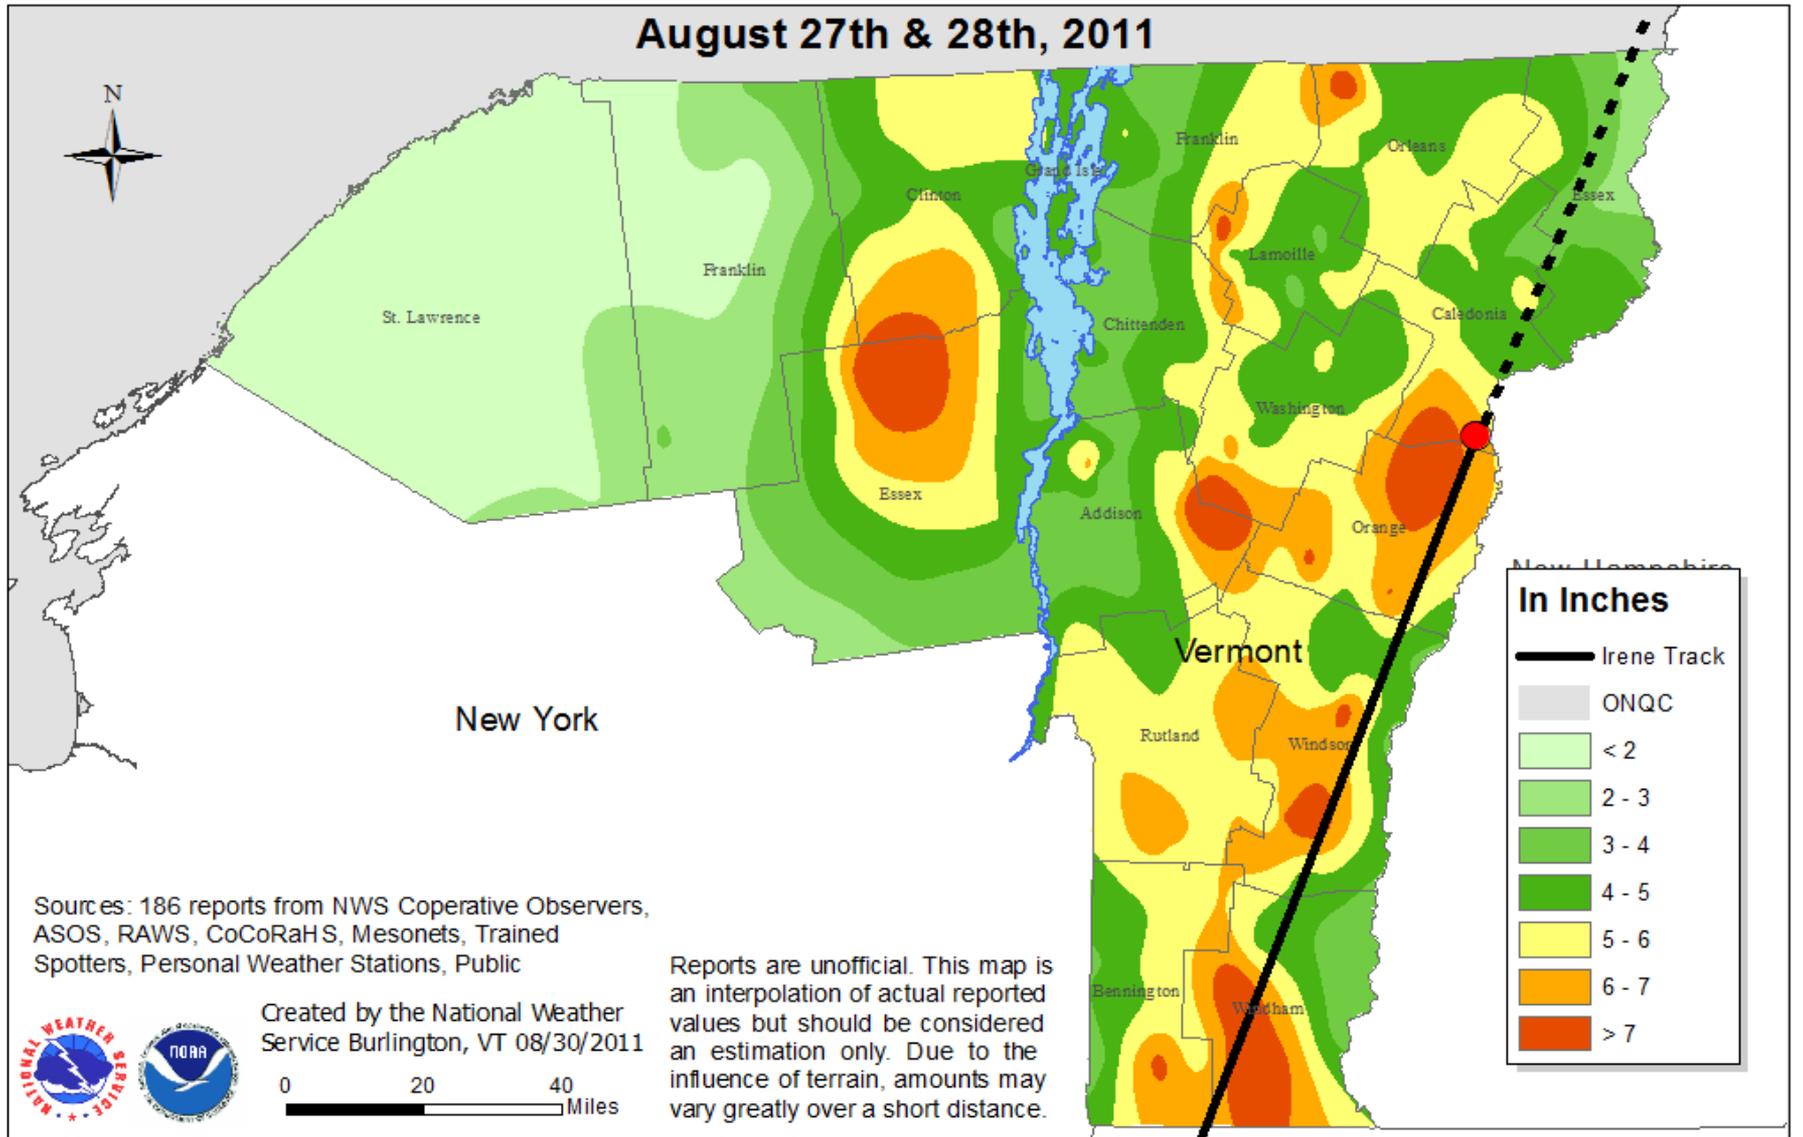
Tropical Storm Irene Total Rainfall - Northern New York & Vermont

August 27th & 28th, 2011

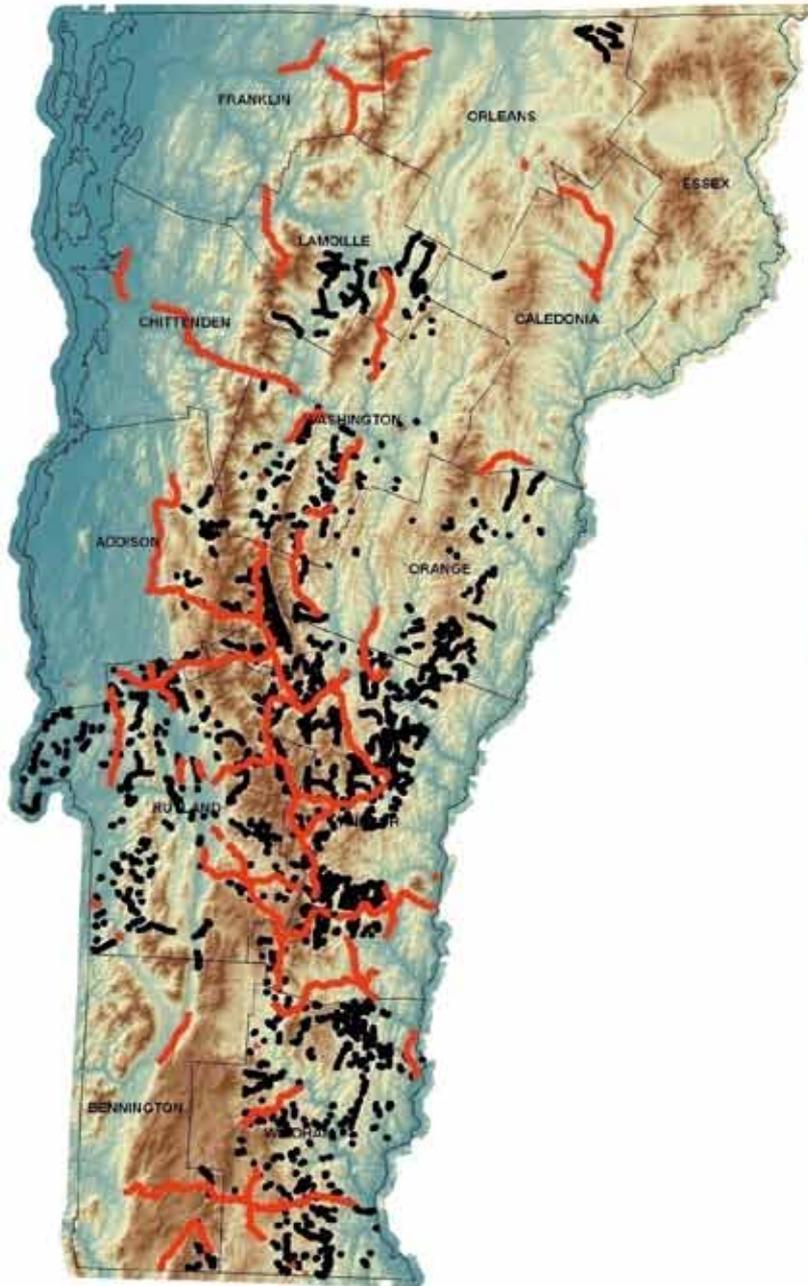
Damage to Roads From Tropical Storm Irene

— State Road Closures (draft)
— Local Road Damage (draft)

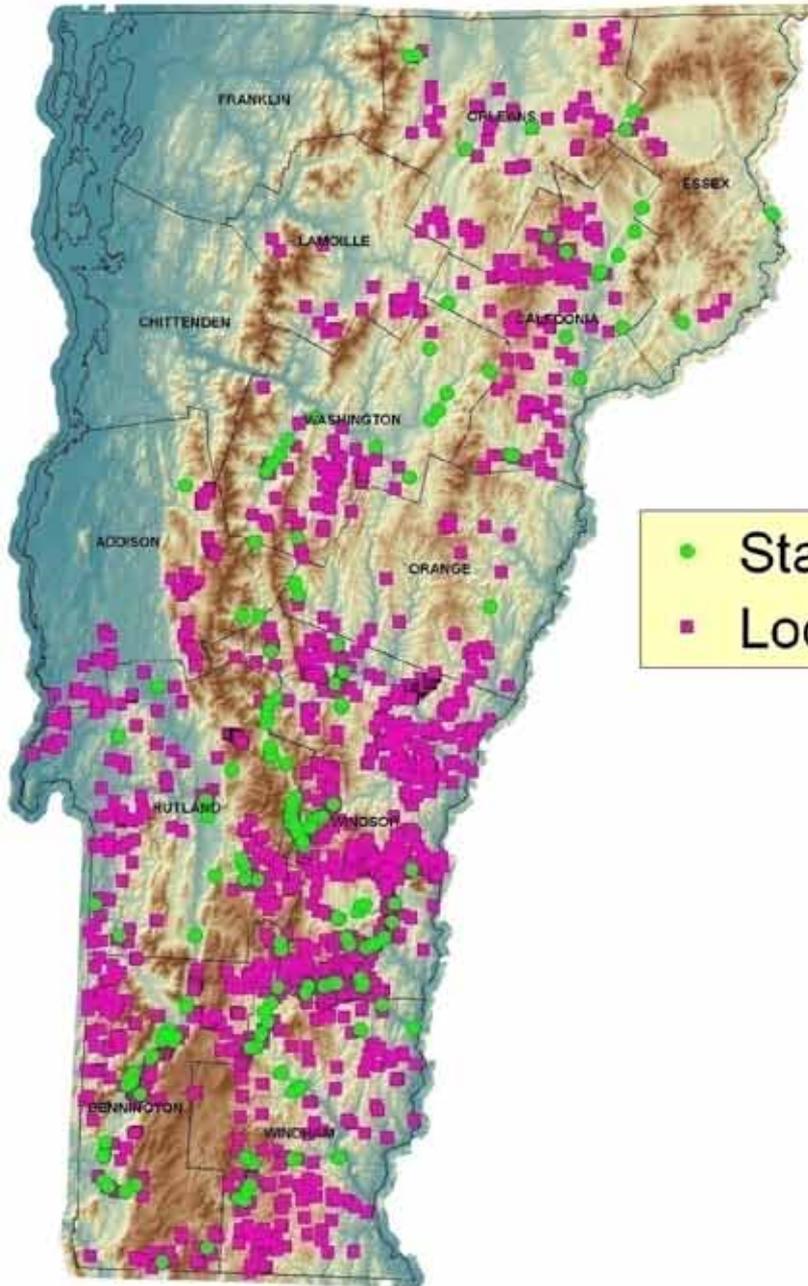
Damage to Bridges and Culverts From Tropical Storm Irene

- State Bridge, Culvert Damage (draft)
- Local Bridge, Culvert Damage (draft)

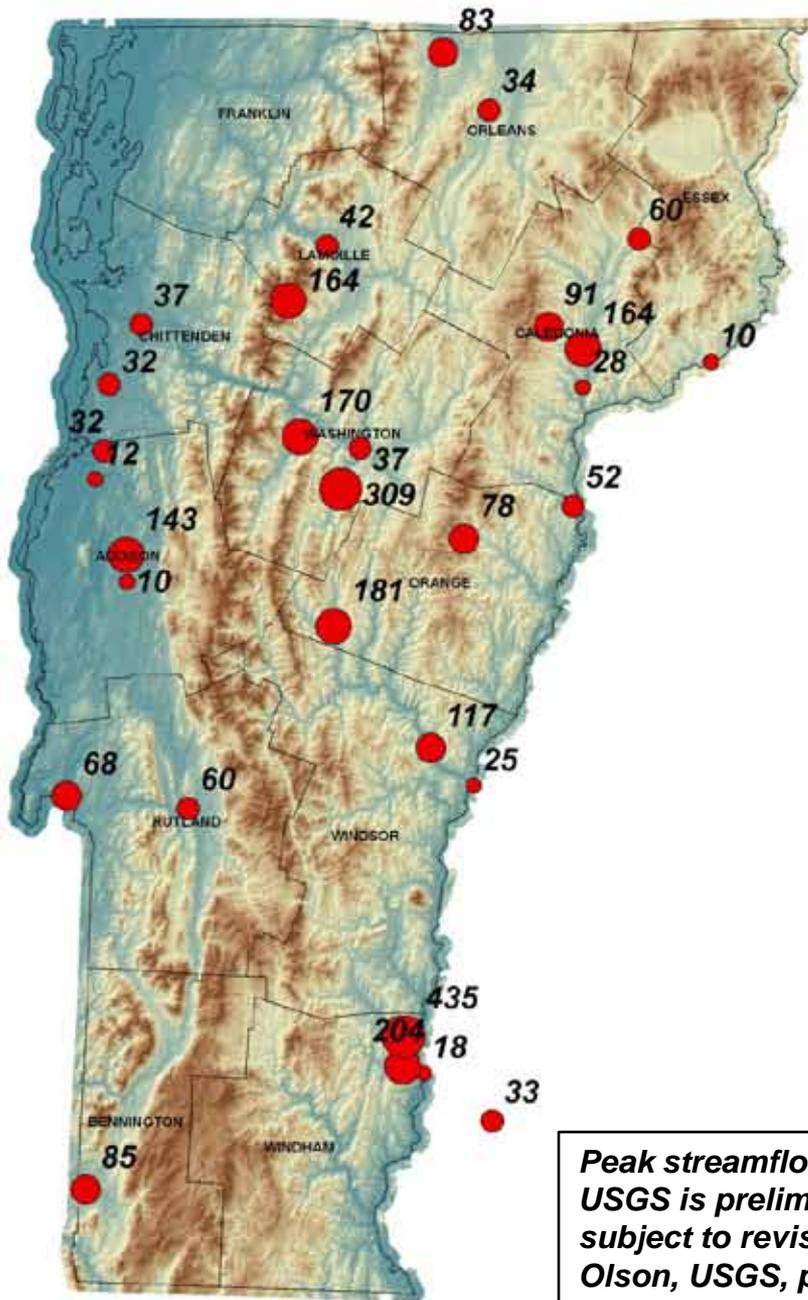
Peak Streamflows at USGS Gage Sites From Tropical Storm Irene

Peak Streamflow from Irene cfs / square mile

- 10 - 28
- 29 - 61
- 62 - 117
- 118 - 204
- 205 - 435

*Peak streamflow data from
USGS is preliminary and
subject to revision. (Scott
Olson, USGS, personal
communication, 1/12/2012.)*

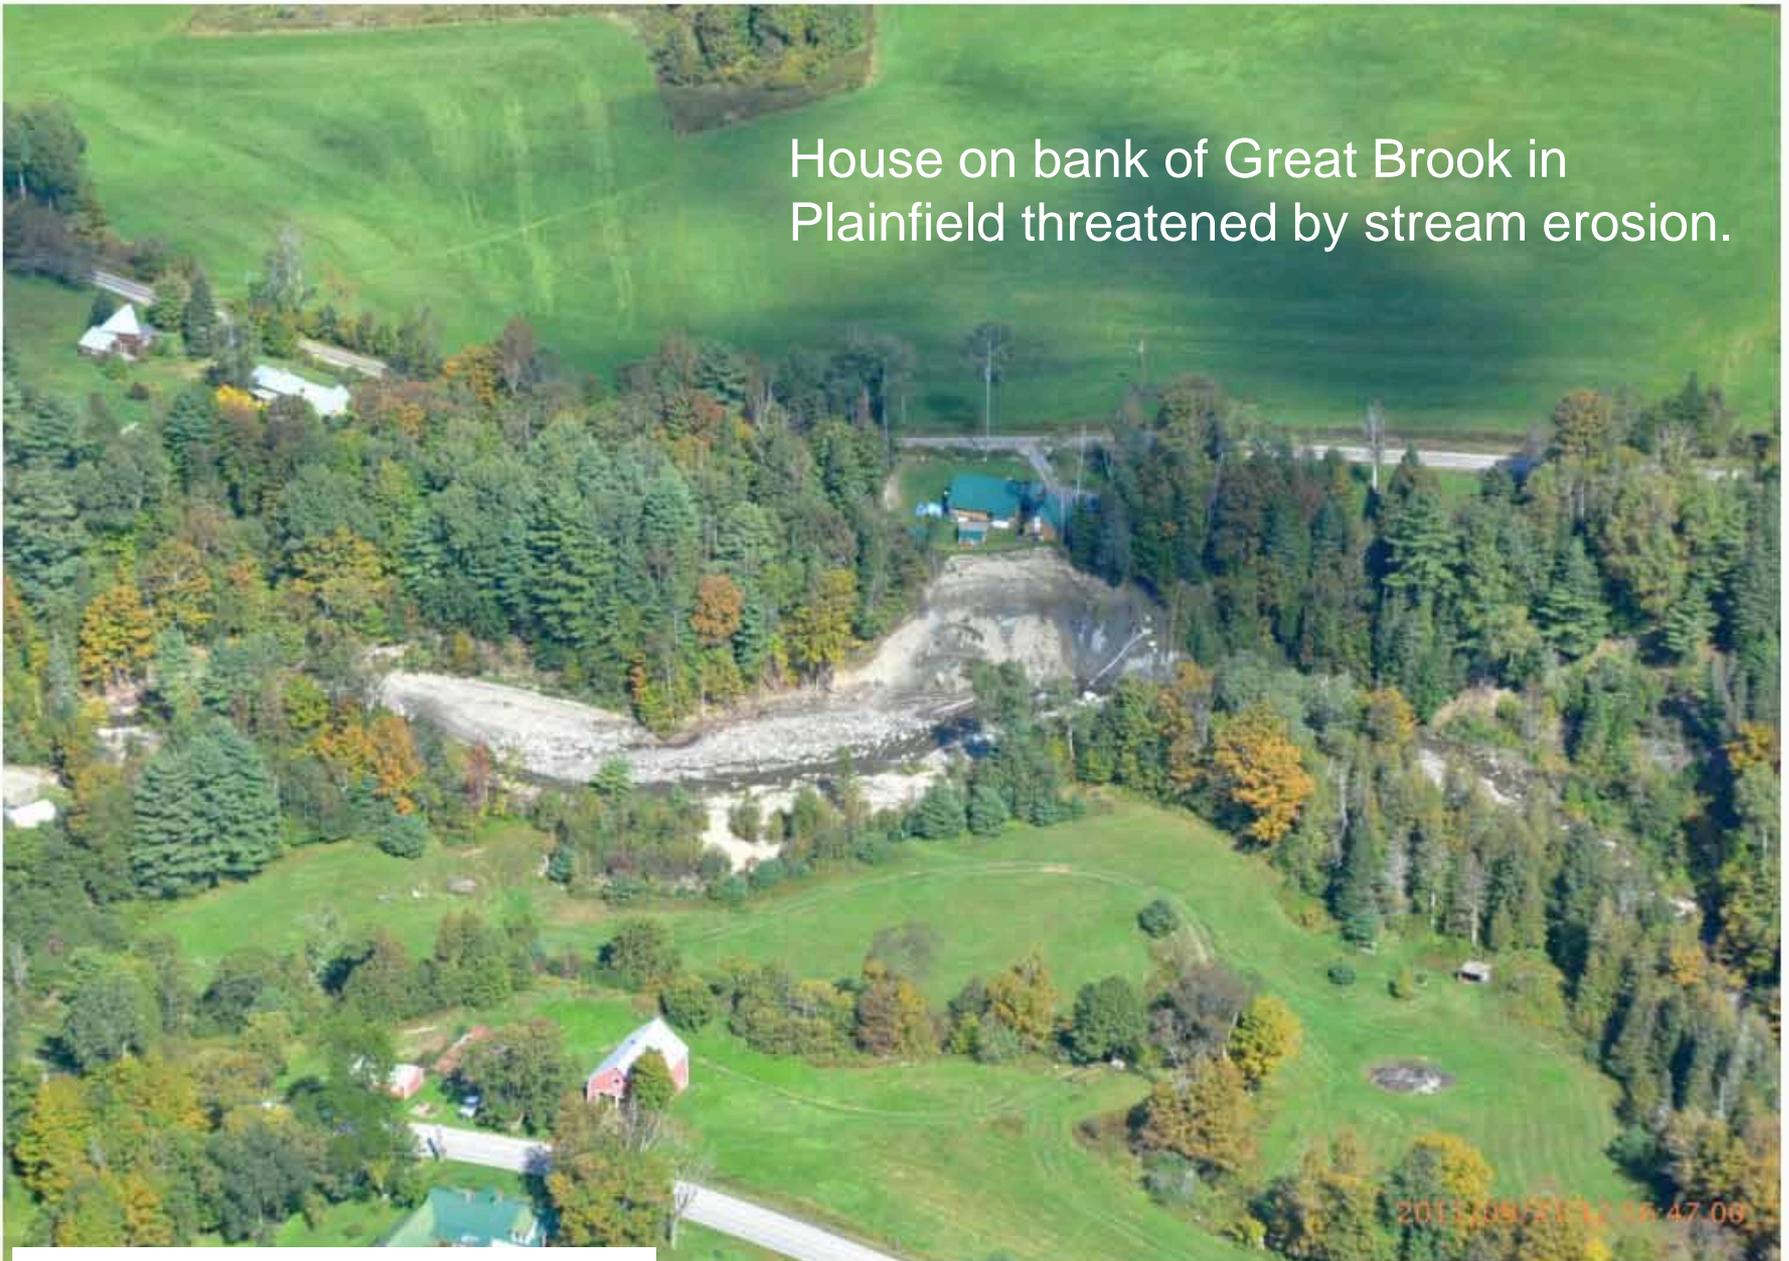
House on bank of Great Brook in Plainfield threatened by stream erosion.

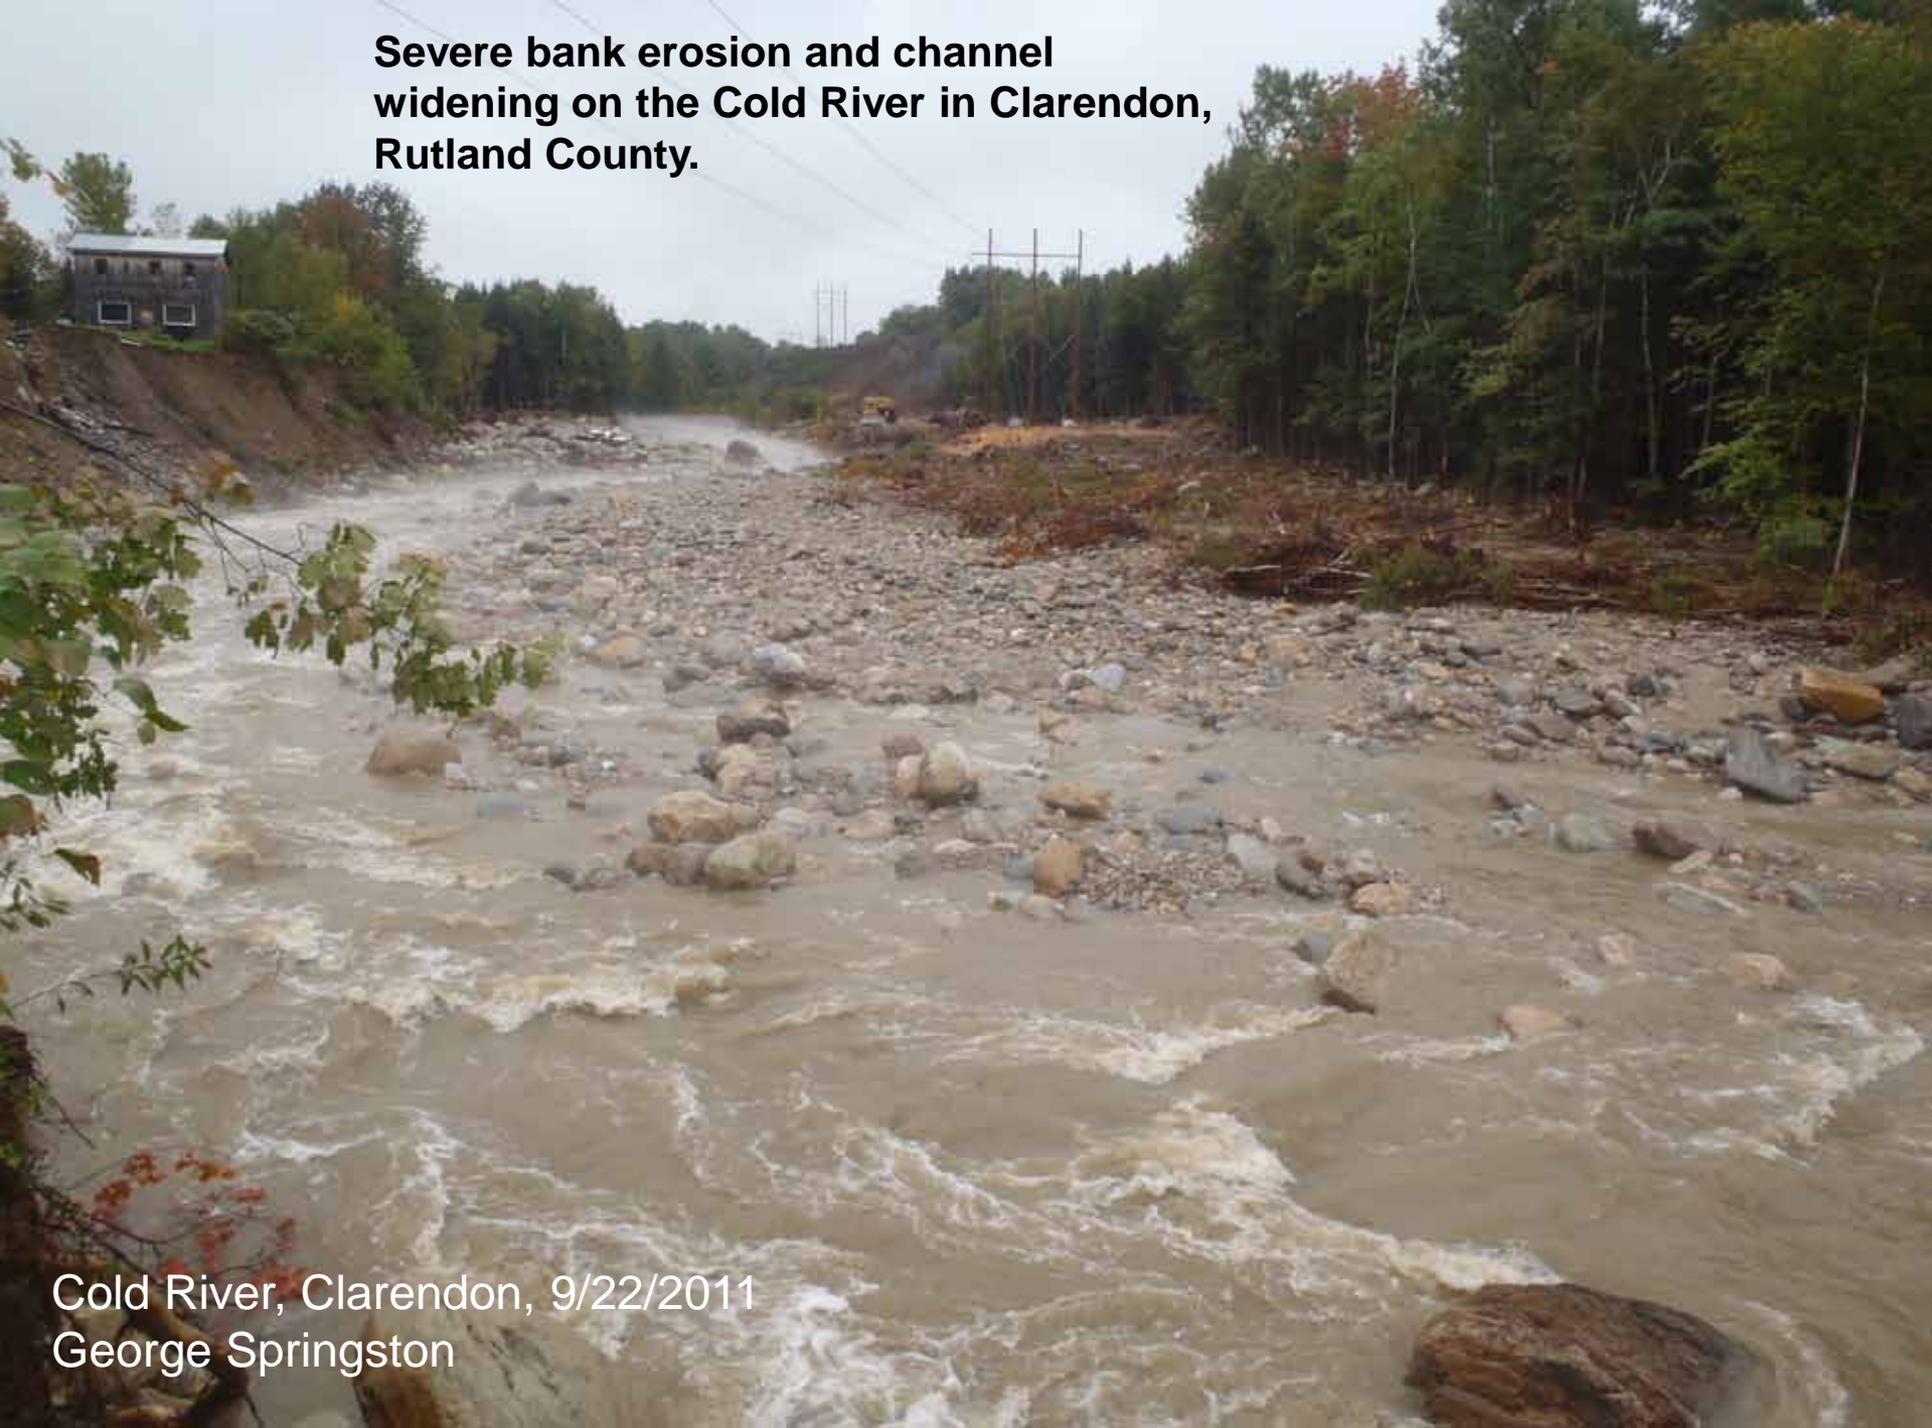
Cold River, Clarendon, 9/22/2011
George Springston

**Severe bank erosion and channel
widening on the Cold River in Clarendon,
Rutland County.**

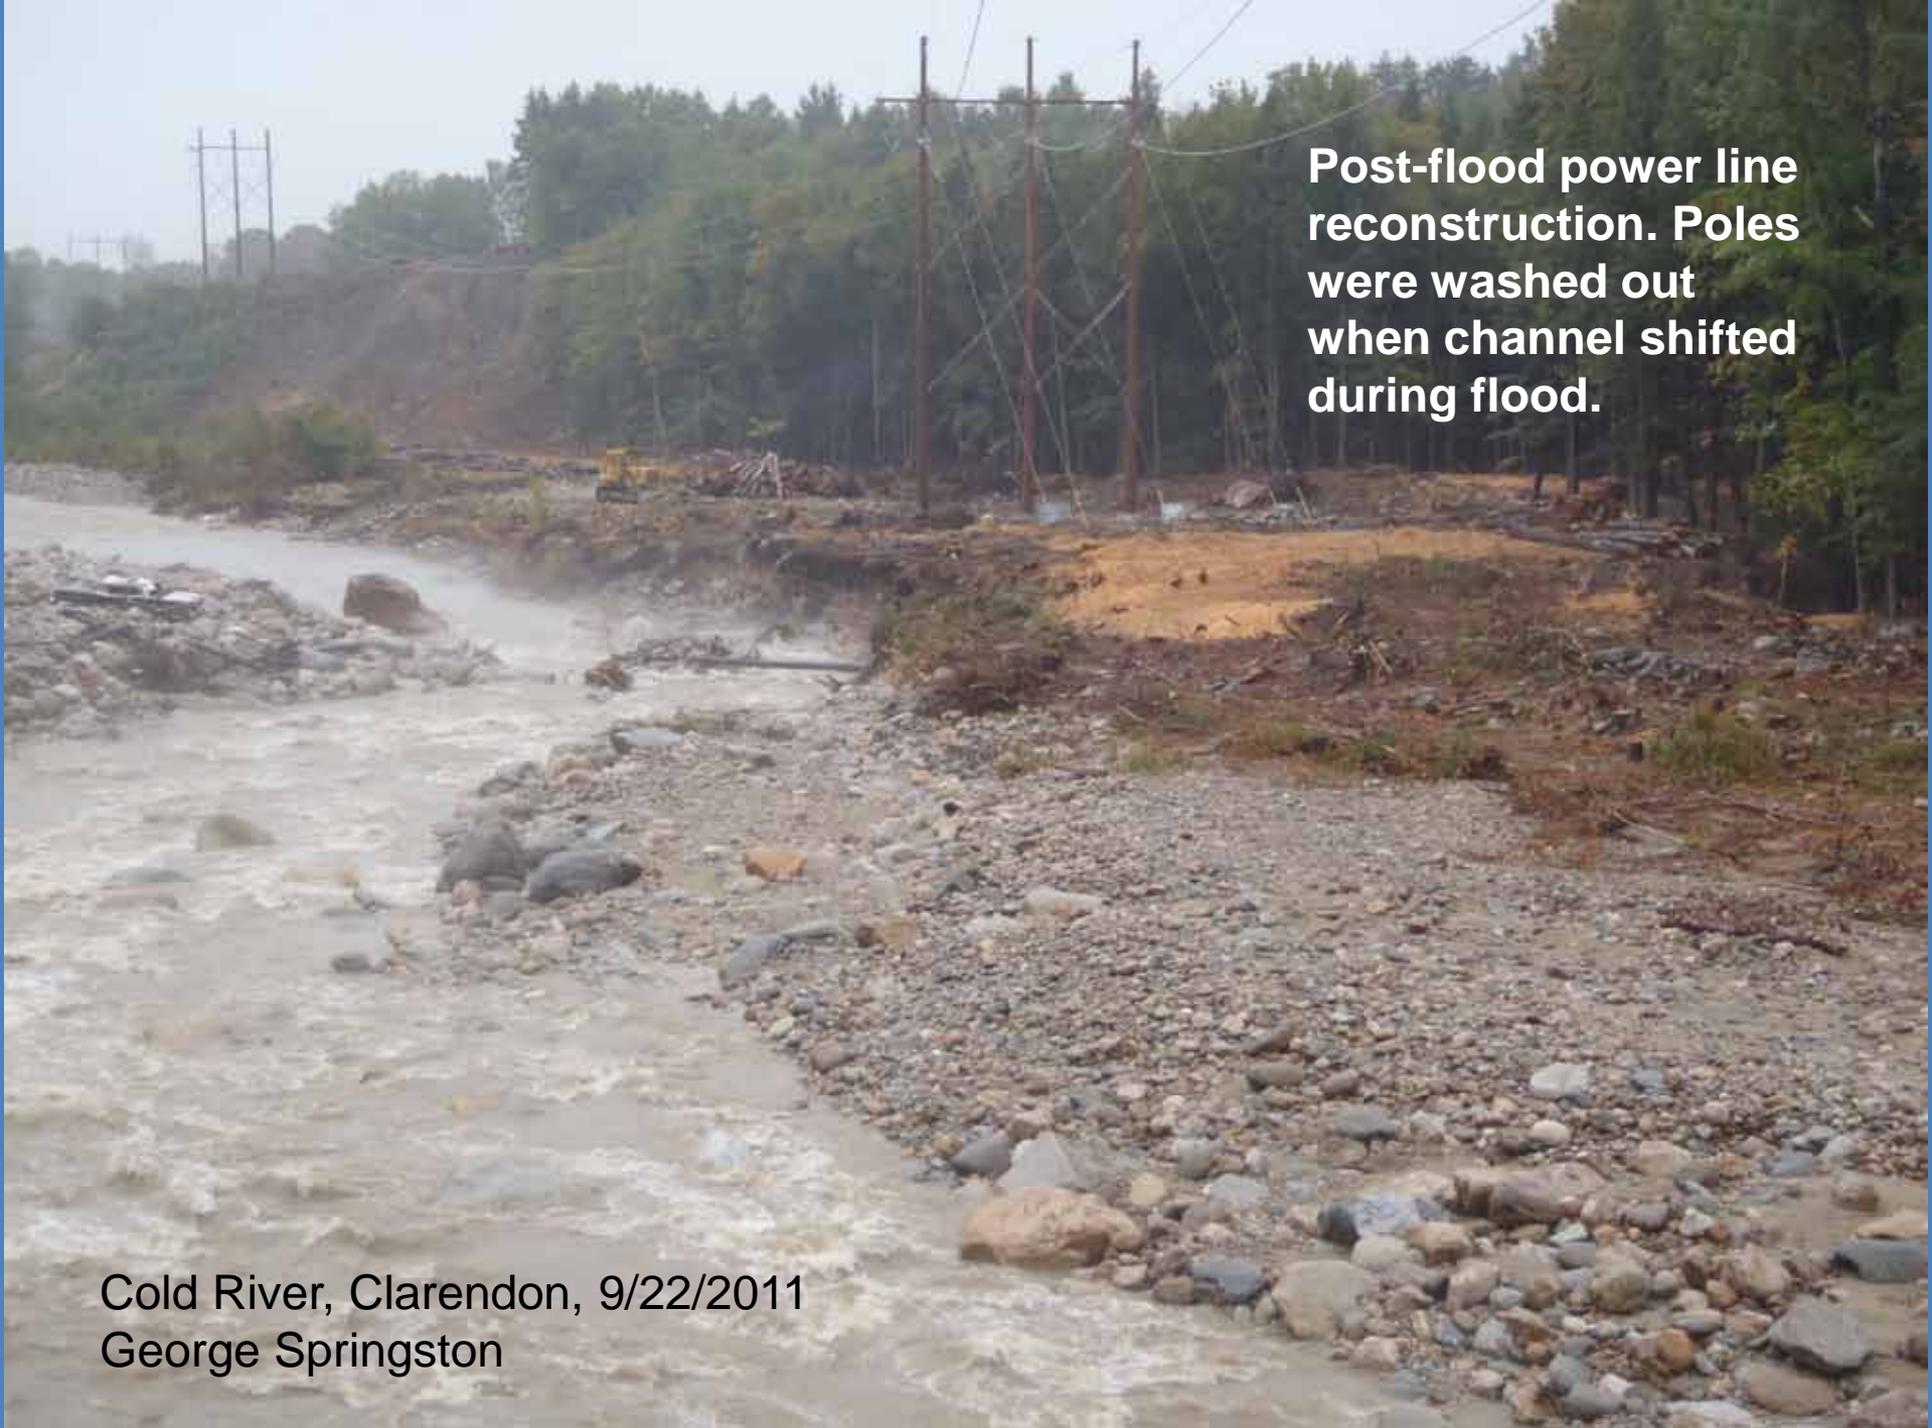
Cold River, Clarendon, 9/22/2011
George Springston

Post-flood power line reconstruction. Poles were washed out when channel shifted during flood.

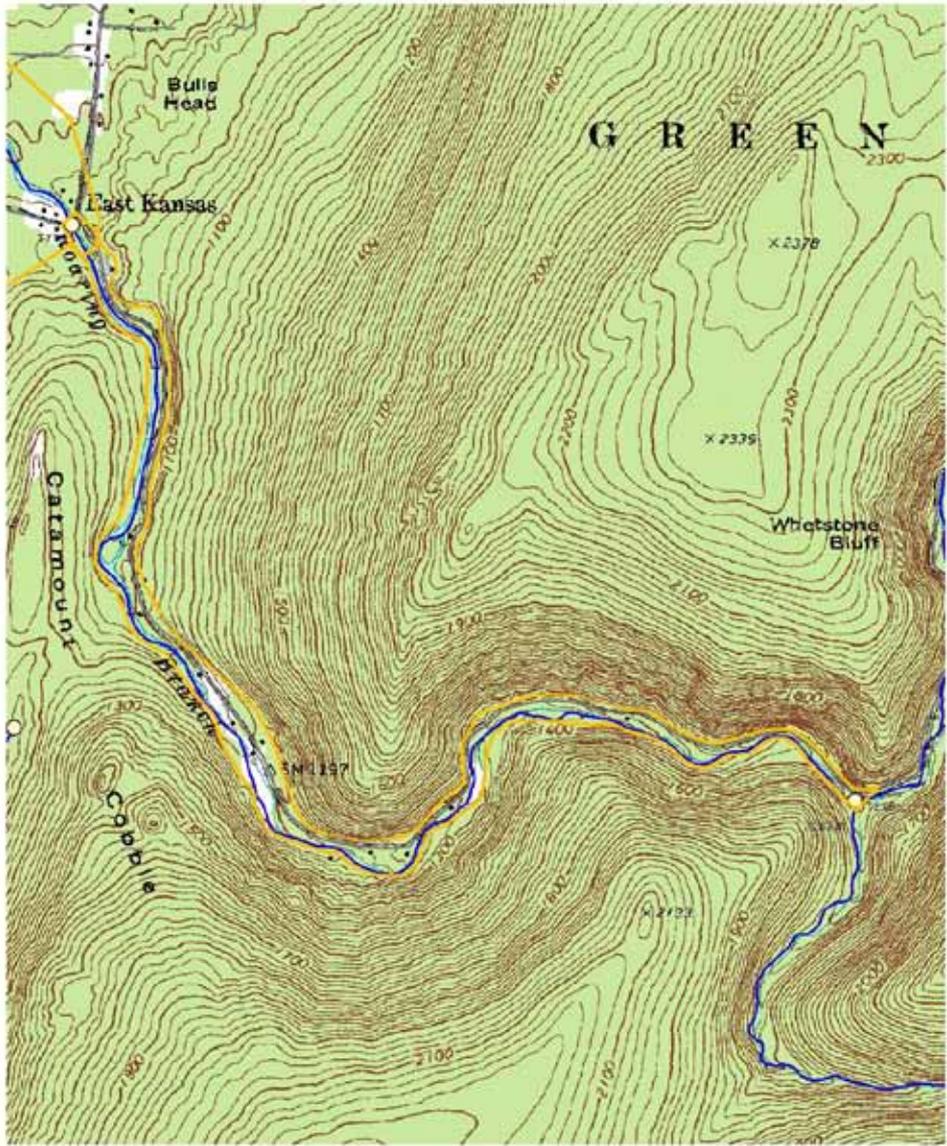
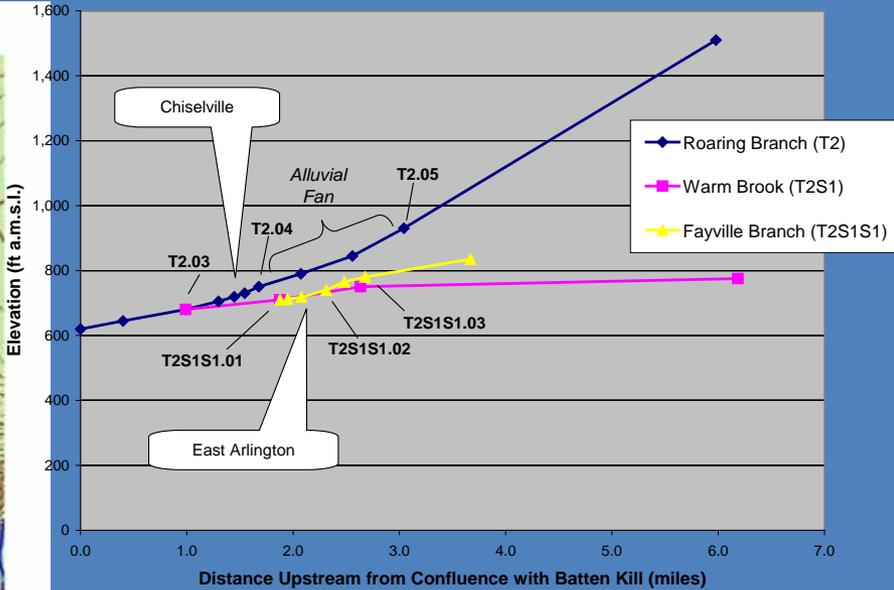
Roaring Branch, Battenkill River

Homes elevated well above flood stage were lost to catastrophic bank erosion

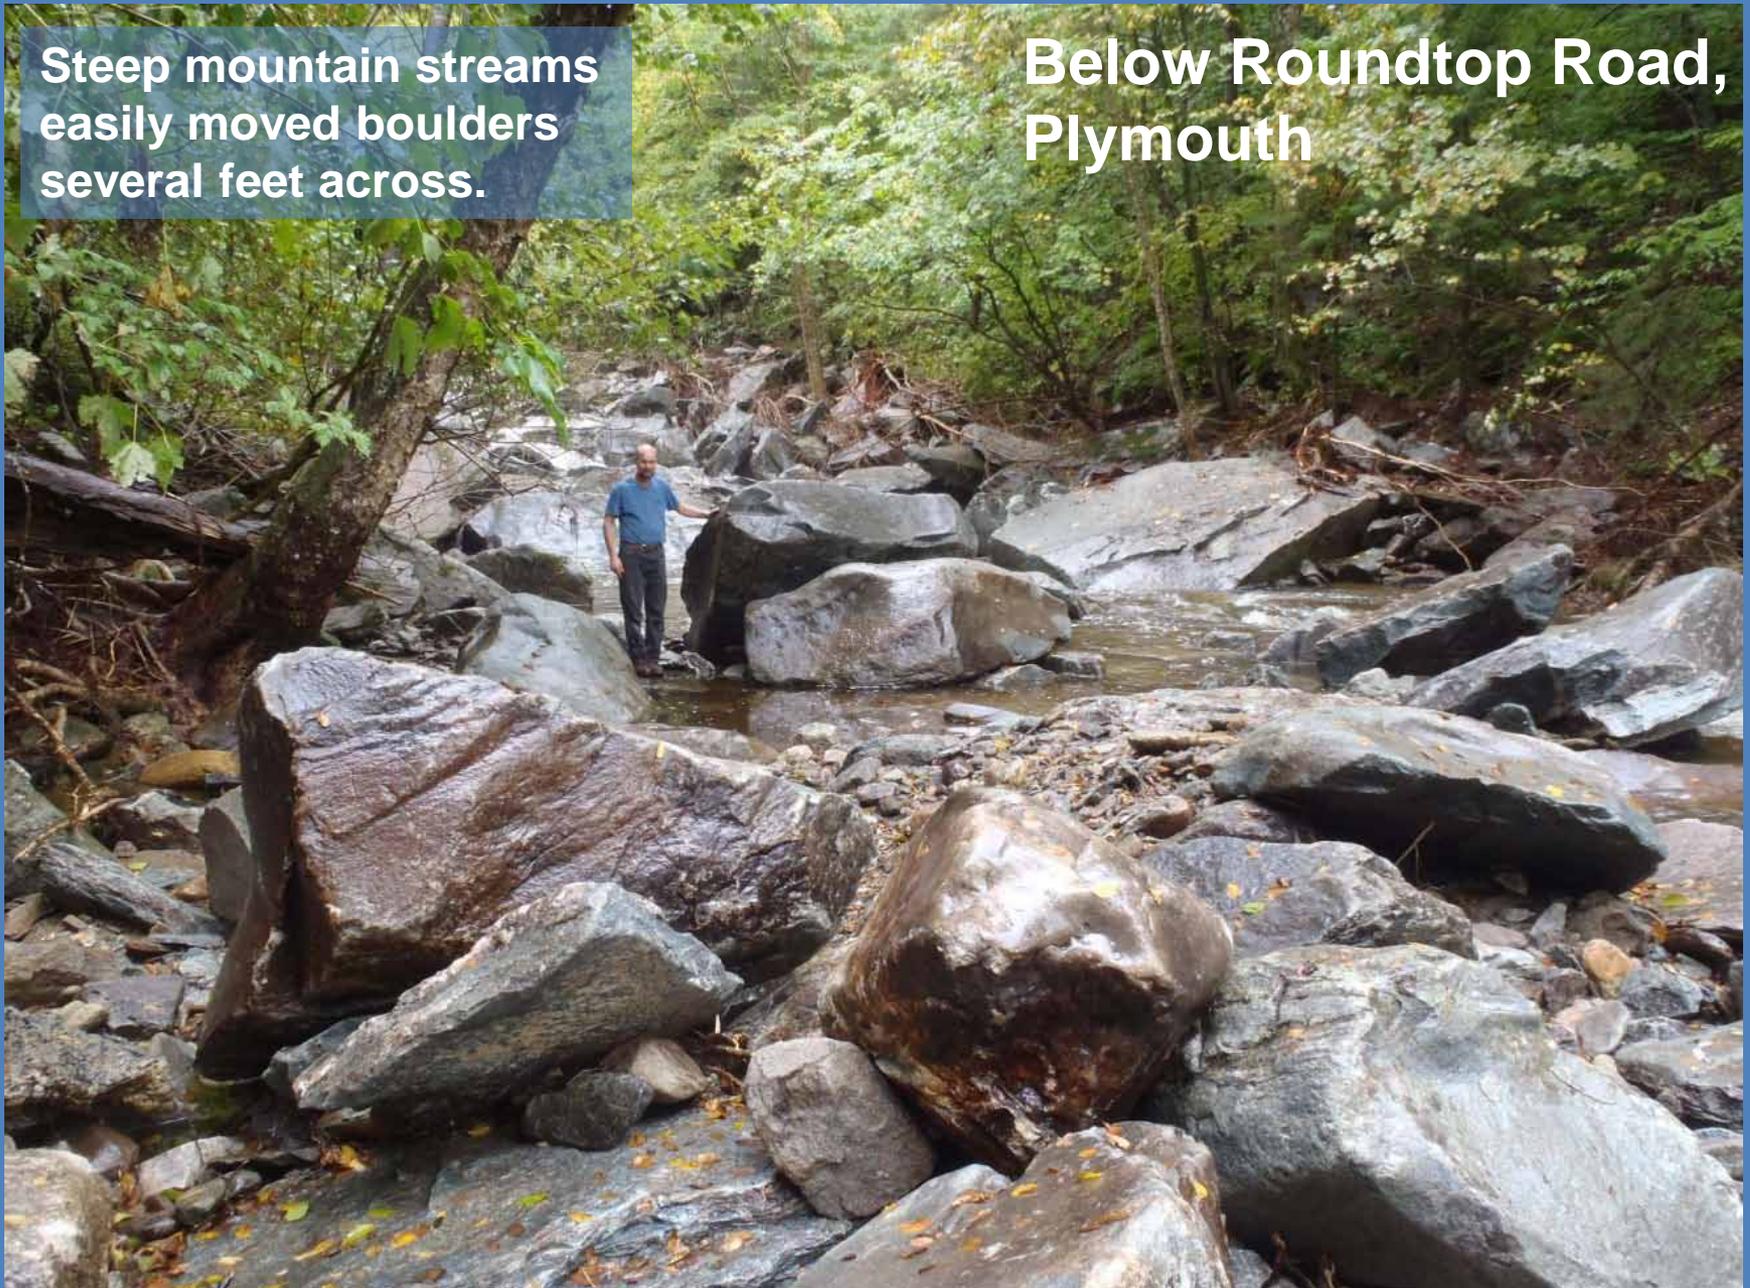
Below Roundtop Road,
Plymouth

Steep mountain streams
easily moved boulders
several feet across.
