Impacts of Tropical Storm Irene on Streams in Vermont

George Springston and
Kristen Underwood

Norwich University Dept. Geology and Environmental Science
South Mountain Research and Consulting

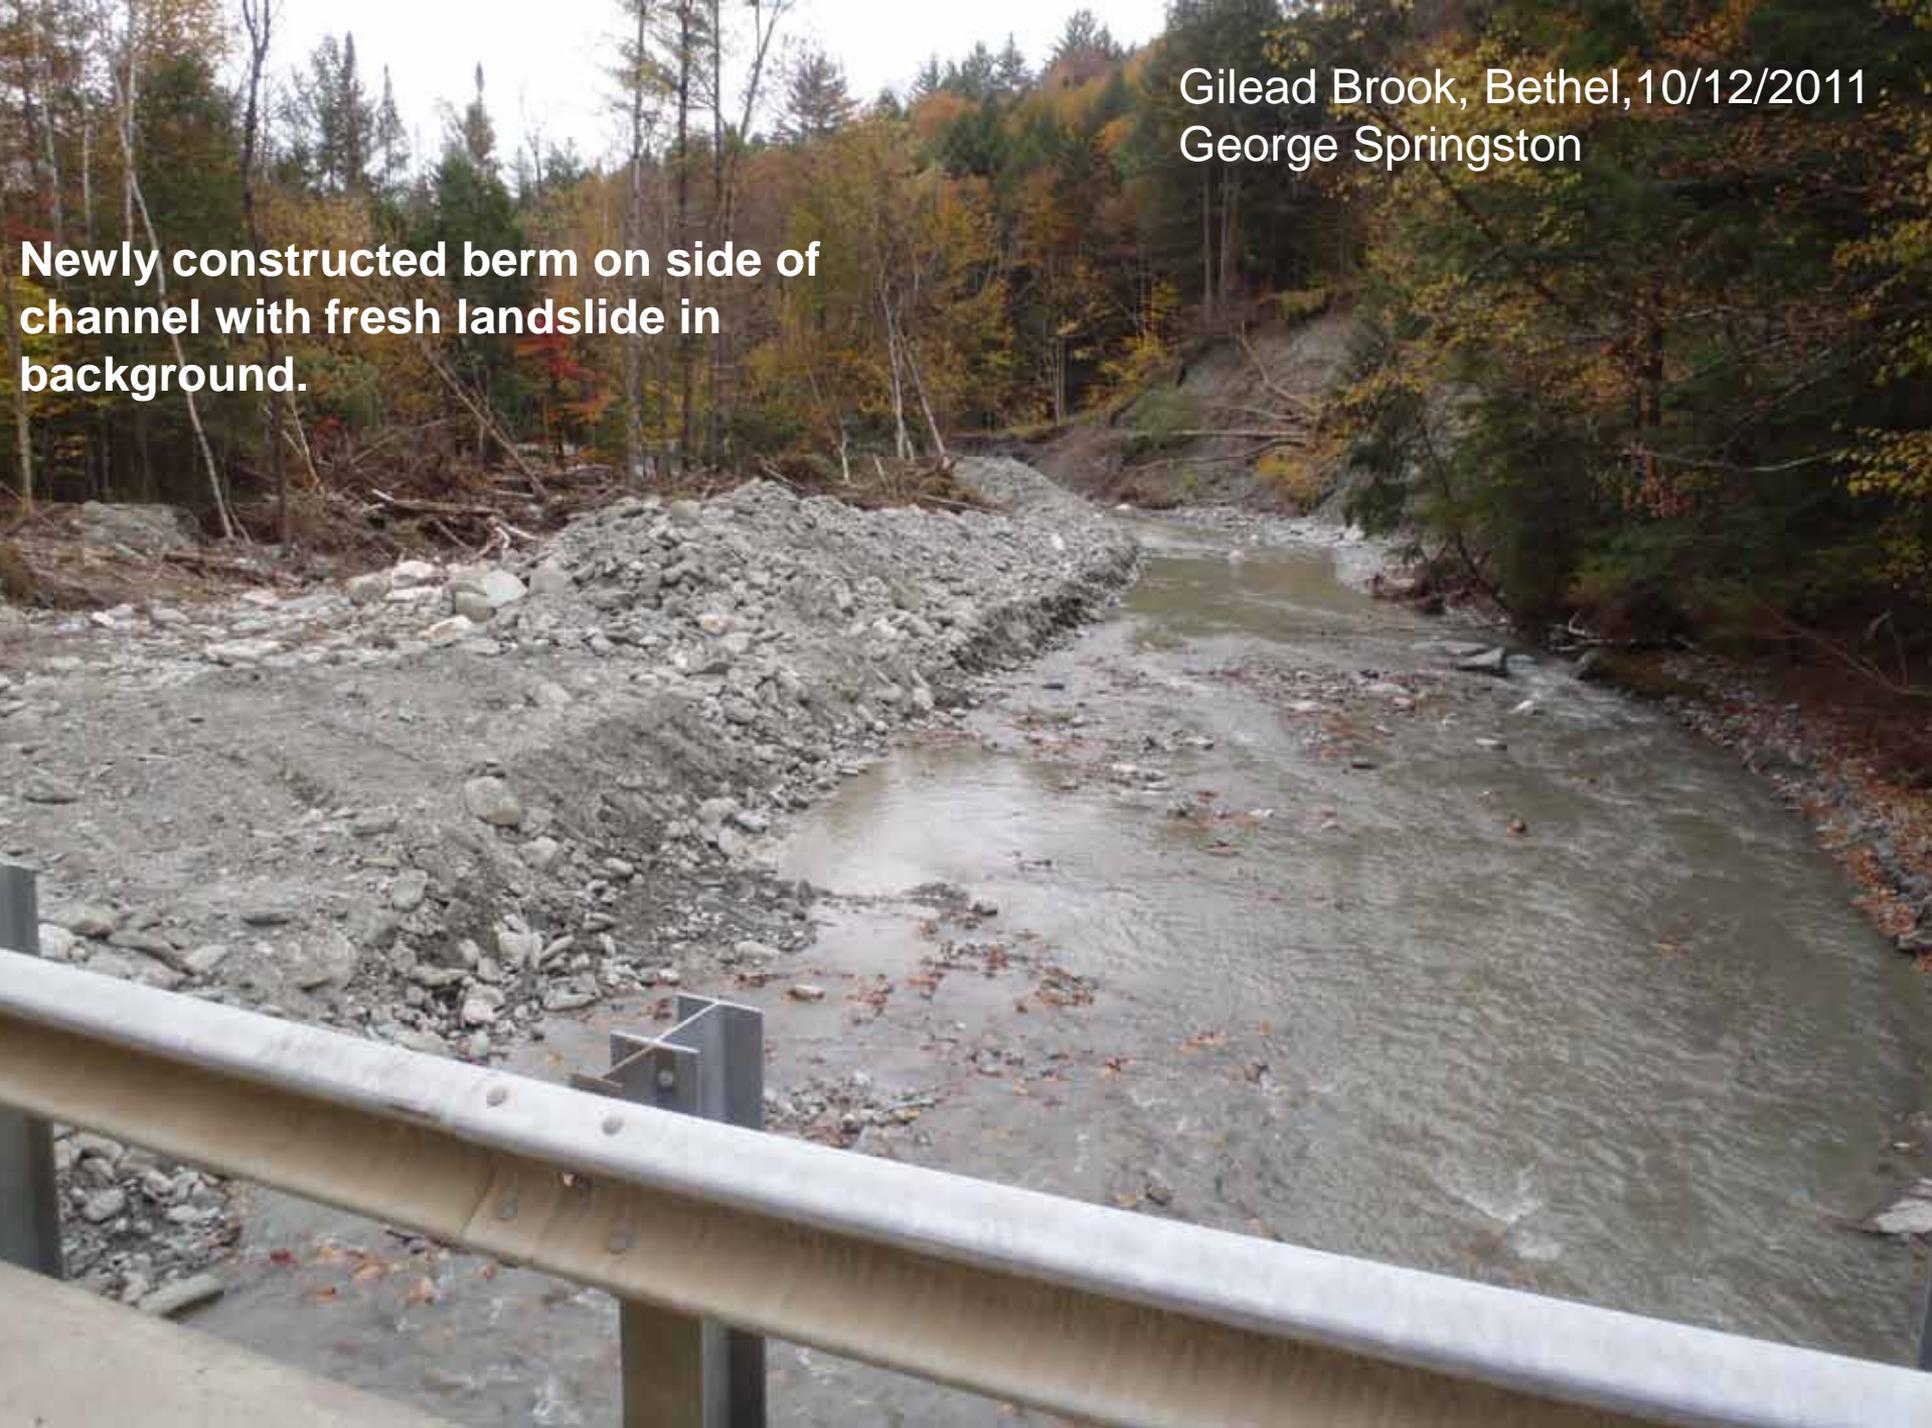
Gilead Brook, Bethel, 10/12/2011
George Springston

**Newly constructed berm on side of
channel with fresh landslide in
background.**

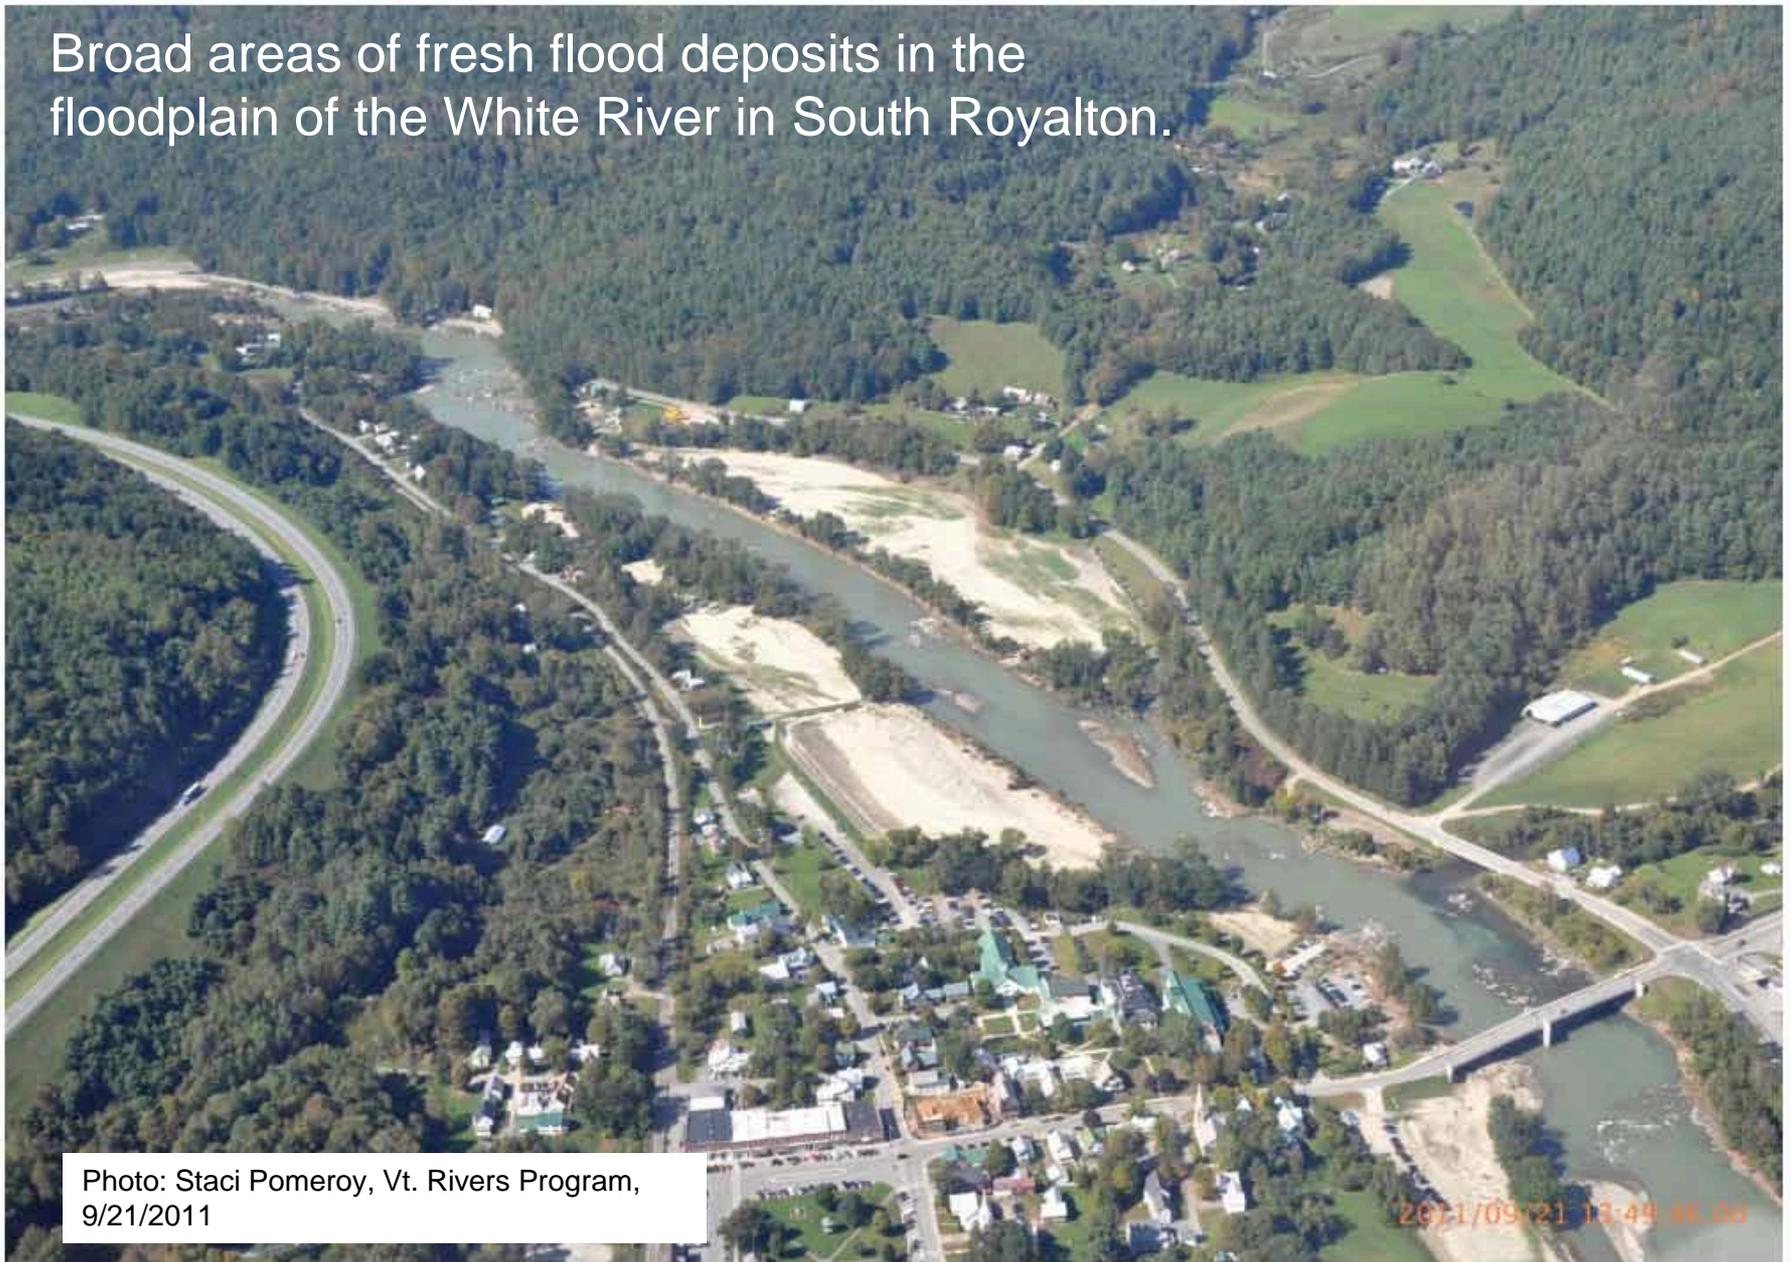
Broad areas of fresh flood deposits in the floodplain of the White River in South Royalton.

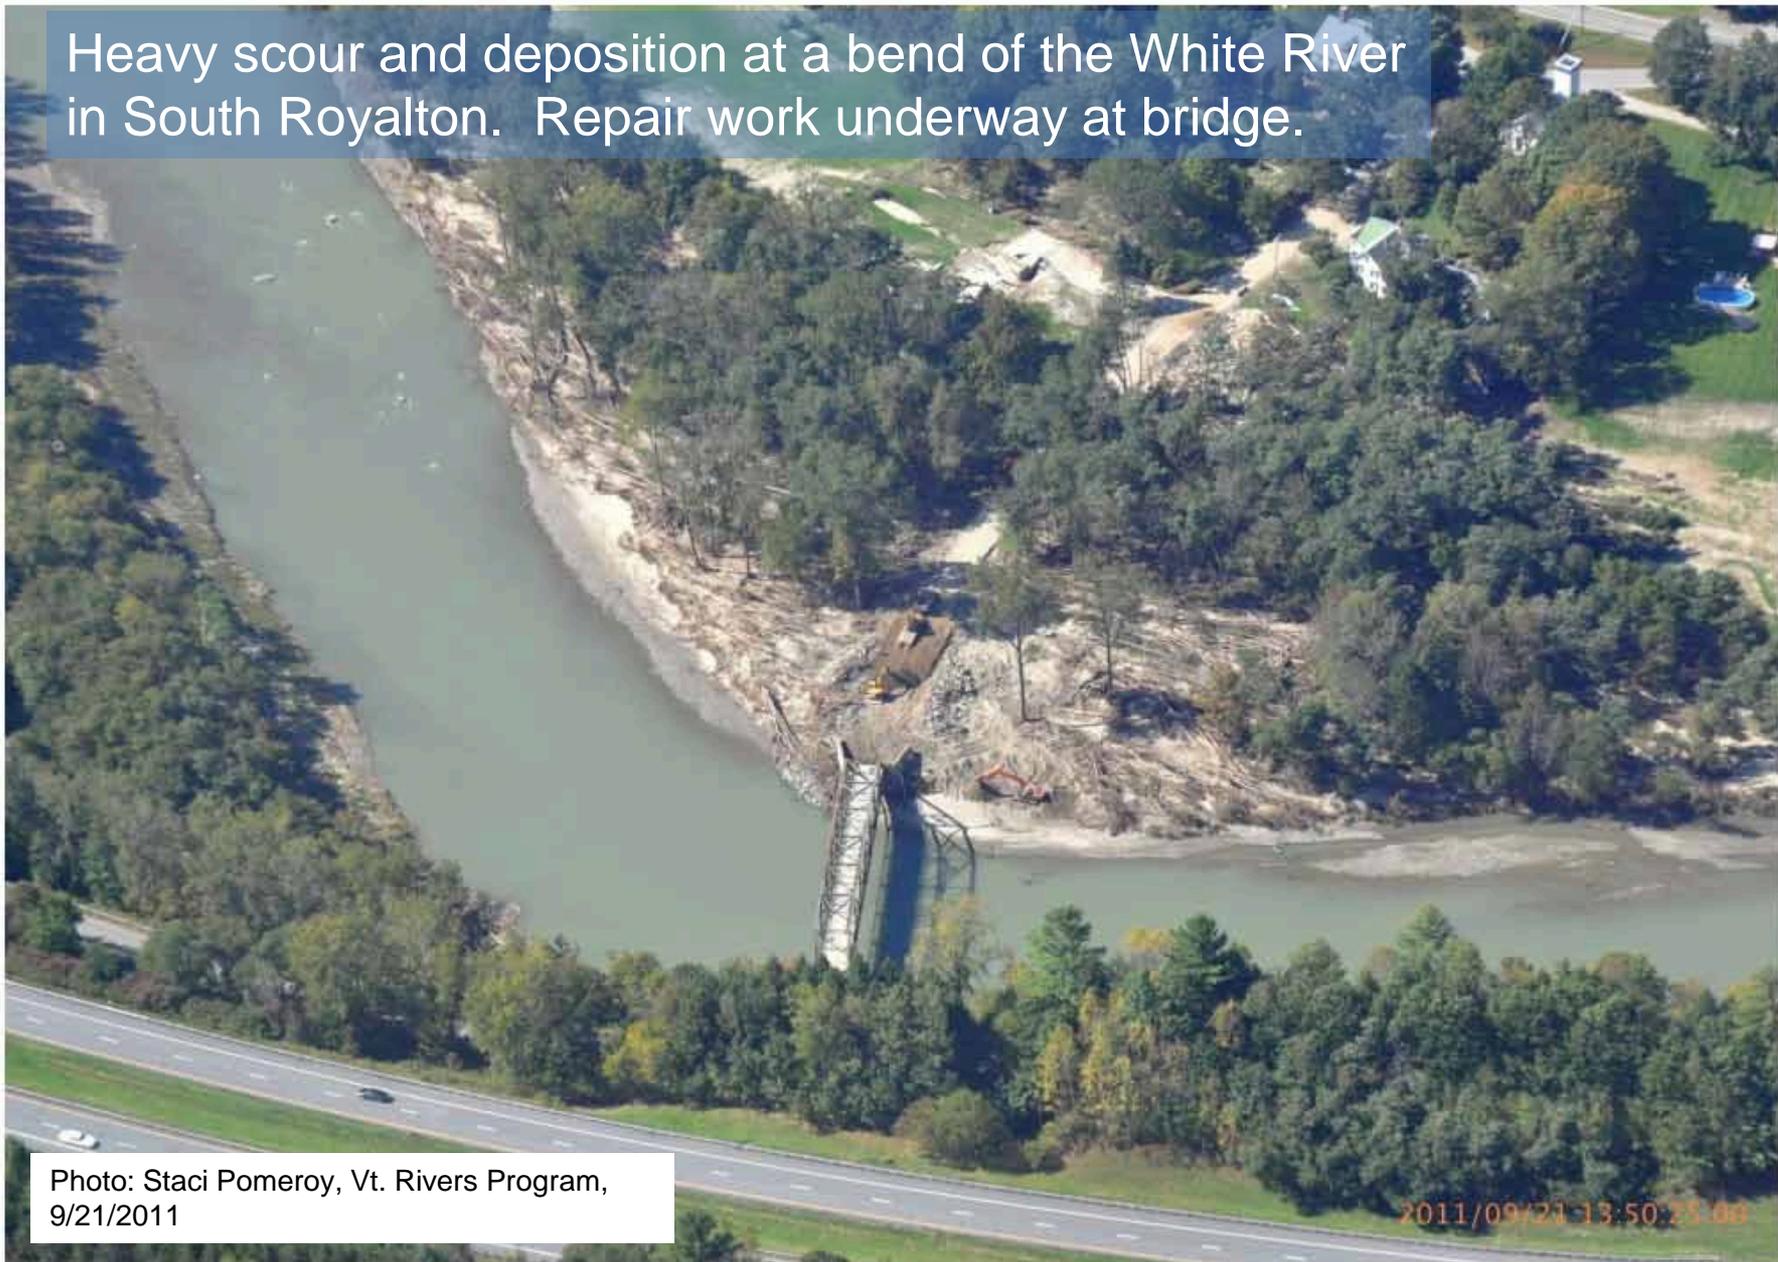
Heavy scour and deposition at a bend of the White River in South Royalton. Repair work underway at bridge.

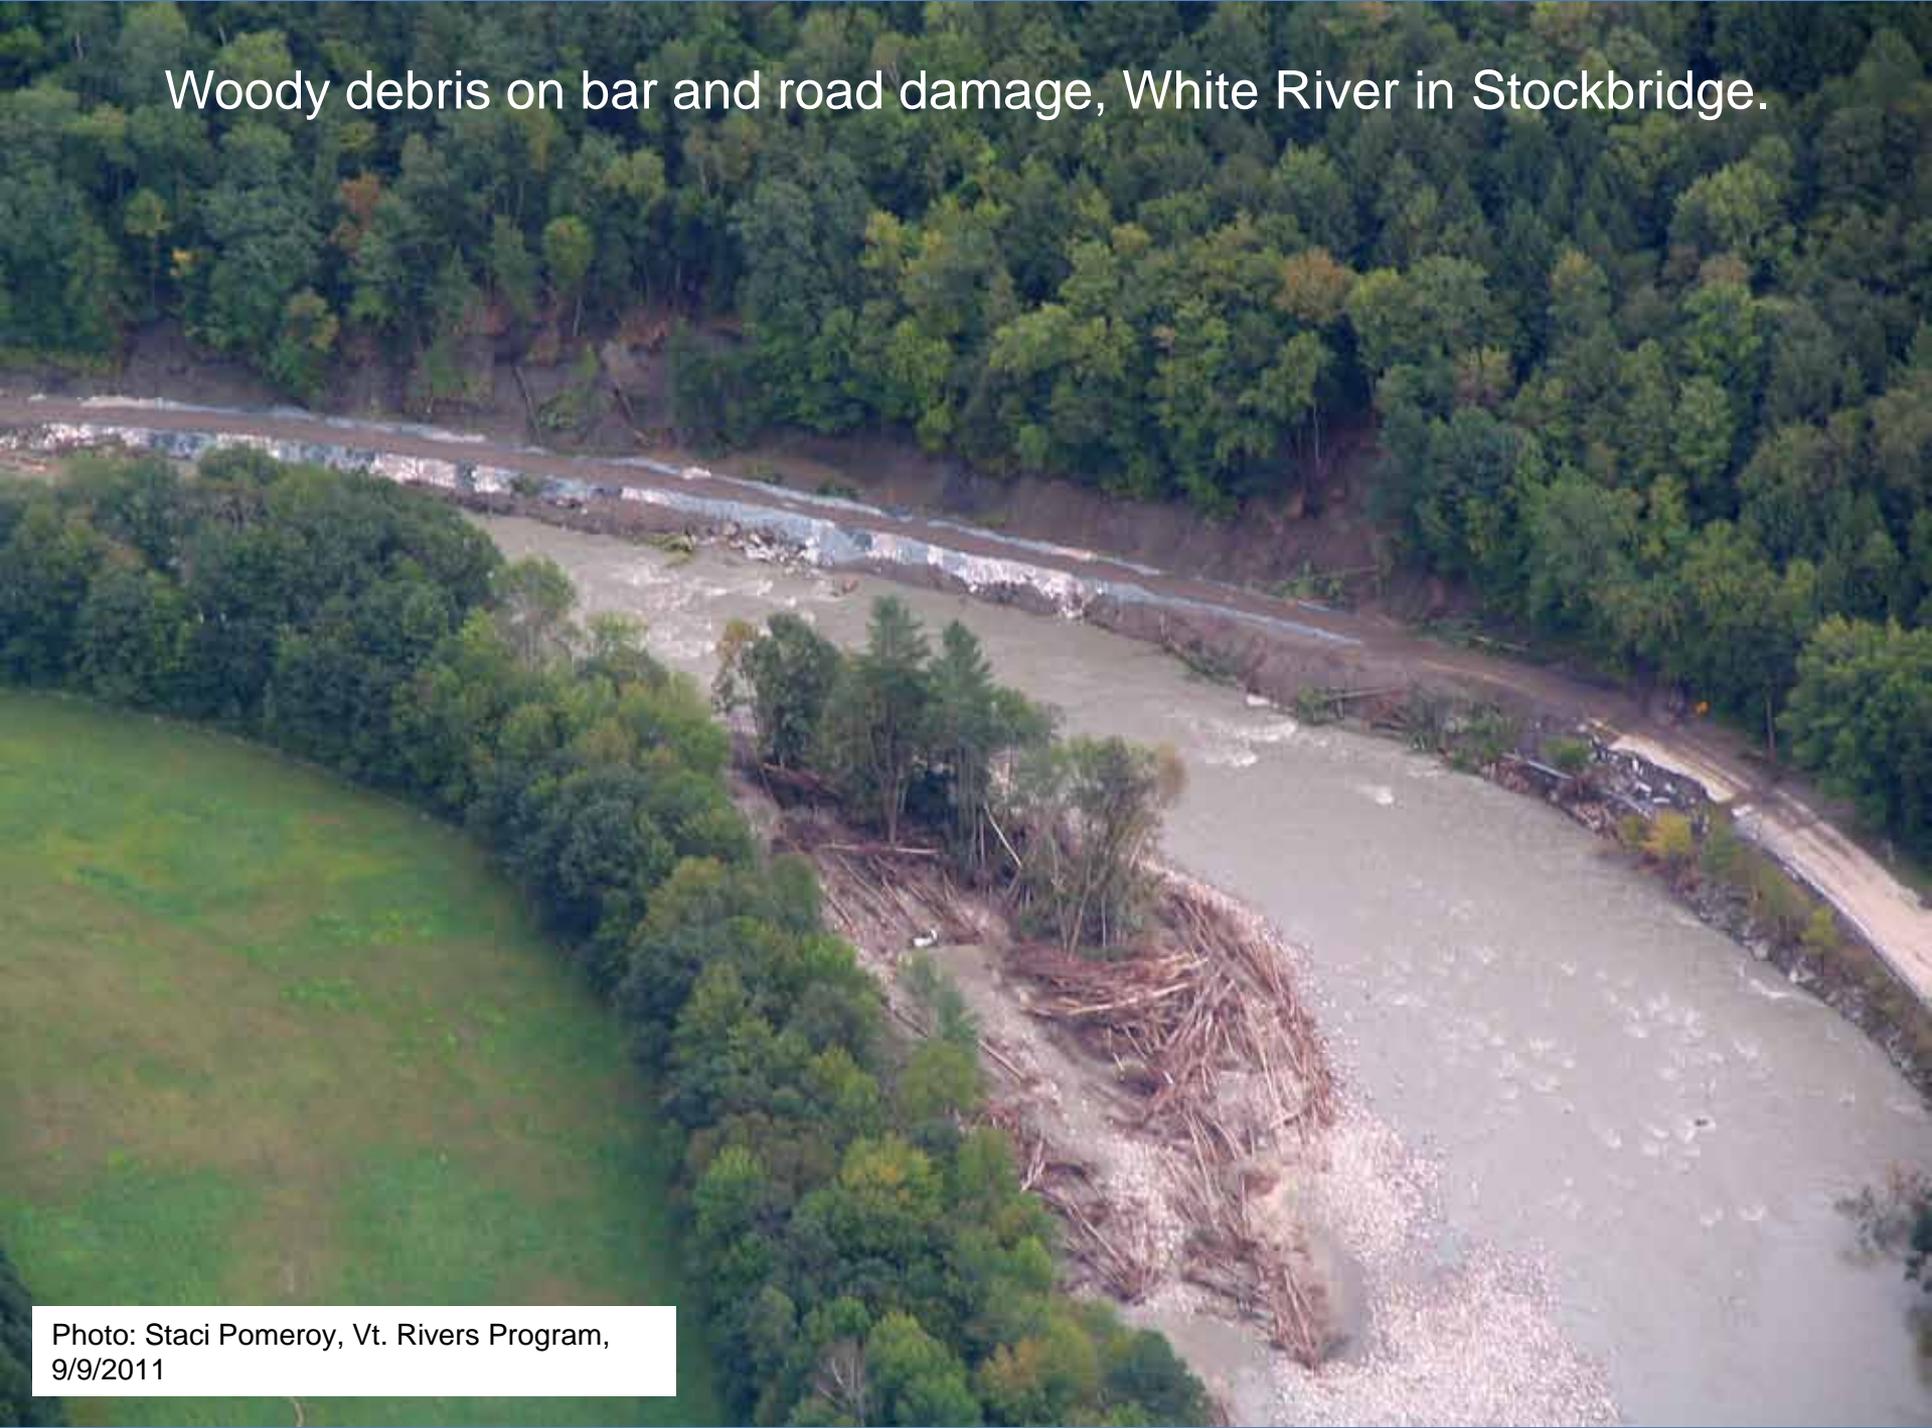
Woody debris on bar and road damage, White River in Stockbridge.

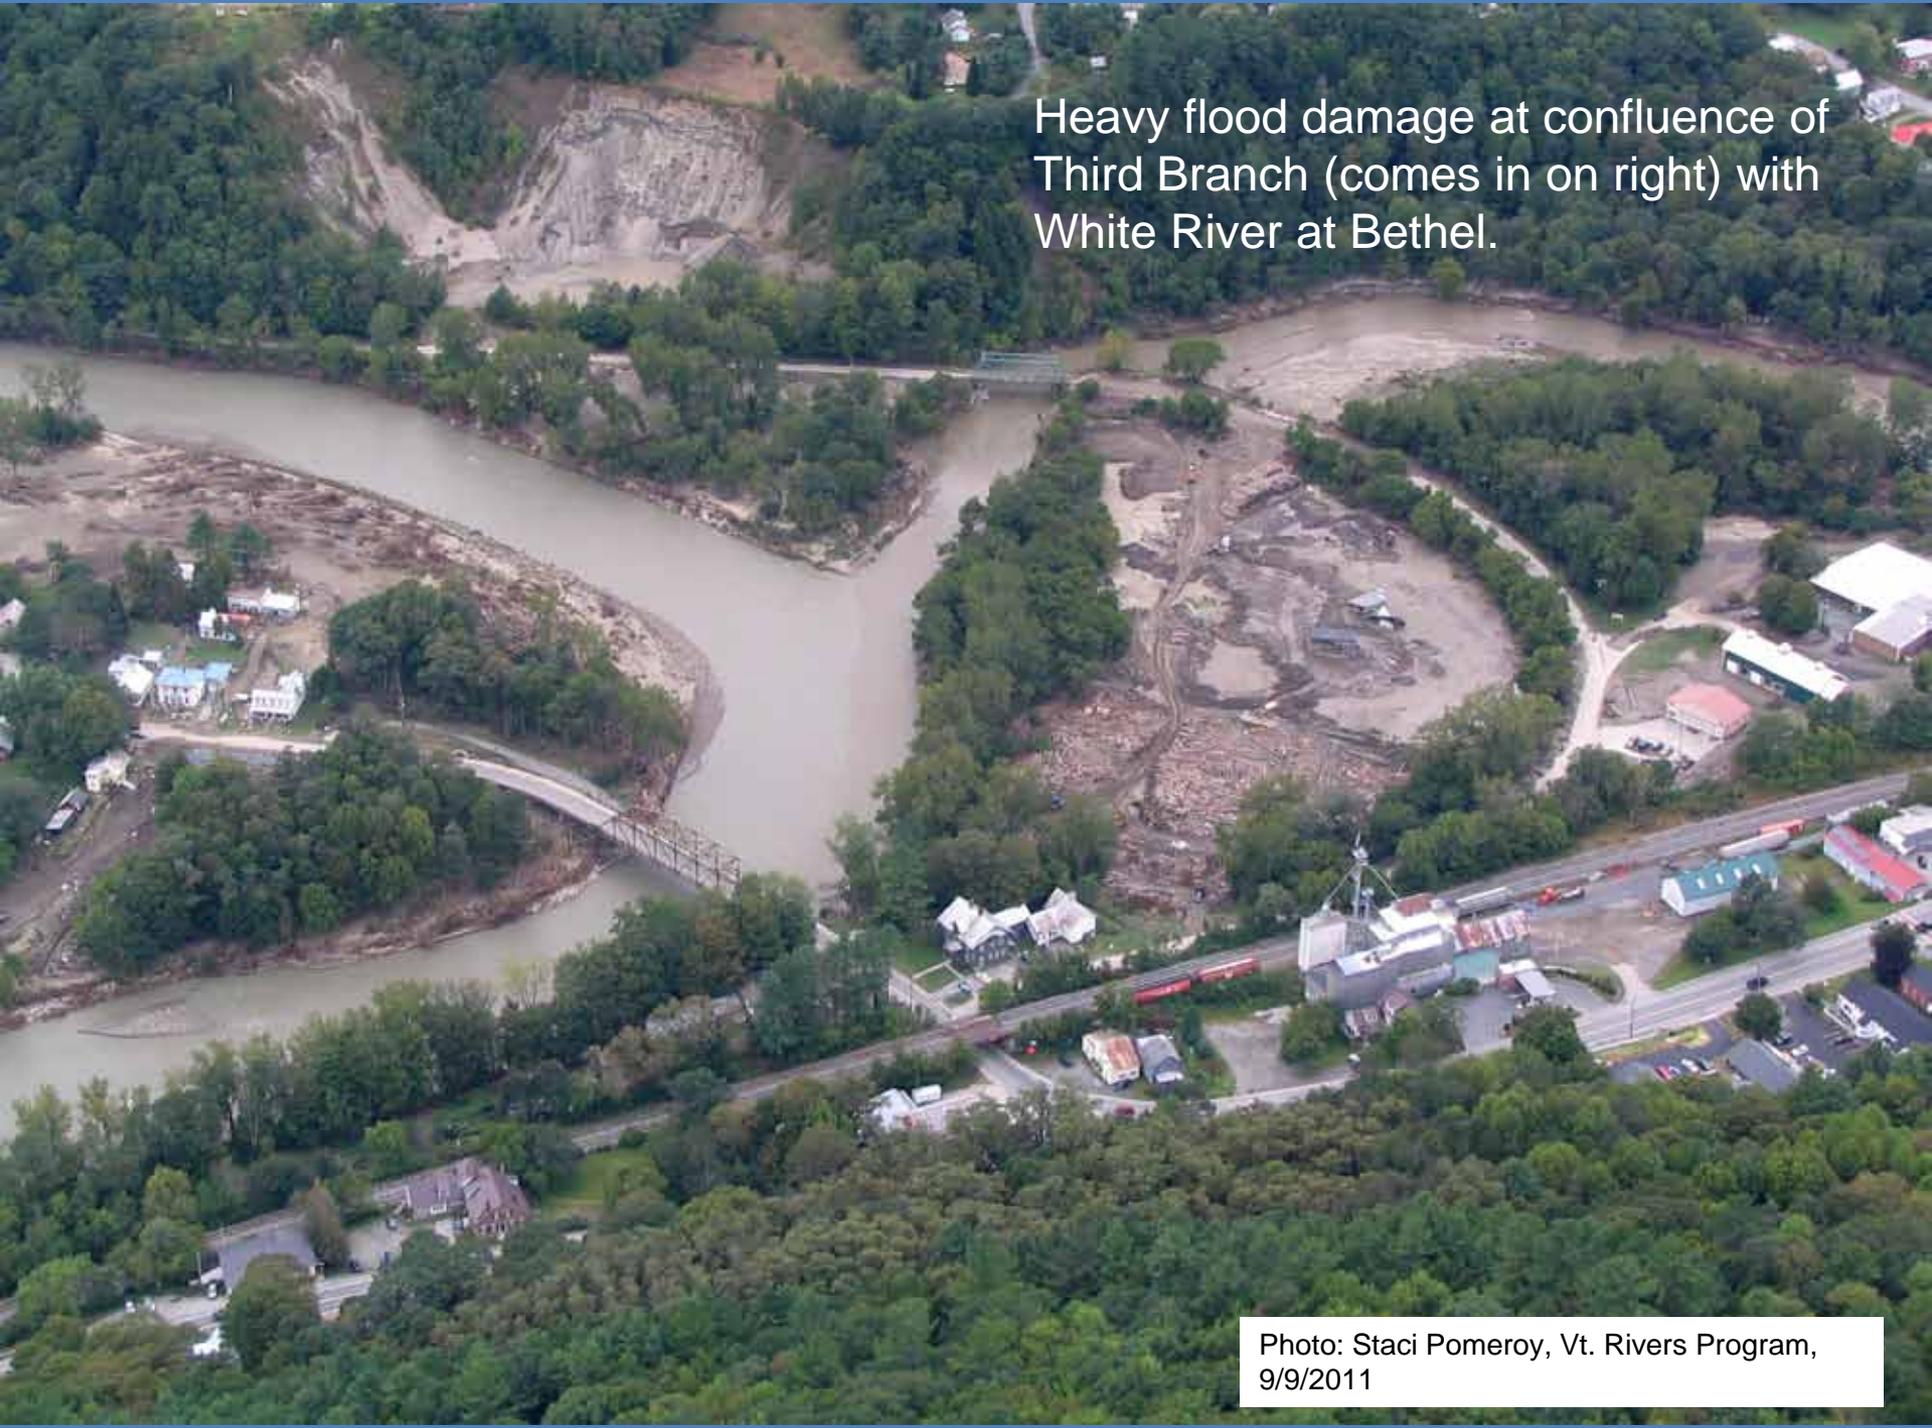
An aerial photograph showing the confluence of the Third Branch (on the right) and the White River (on the left) at Bethel. The river water is a turbid, brownish-grey color, indicating heavy sediment from flooding. Large areas of land, particularly on the right side, are covered in mud and debris, showing significant erosion and destruction of vegetation. A bridge crosses the river in the lower-left quadrant. In the background, a large, light-colored rock outcrop or cliff face is visible. The surrounding area includes residential and commercial buildings, some of which appear to be partially submerged or surrounded by floodwater. A road and a railway line are also visible in the lower-right section of the image.

Heavy flood damage at confluence of Third Branch (comes in on right) with White River at Bethel.
