Hazard Evaluation at the Jeffersonville Landslide Site

George Springston and Adam Sevi, Norwich University

Presented to Jeffersonville Hazard Mitigation Committee, March 24, 2014

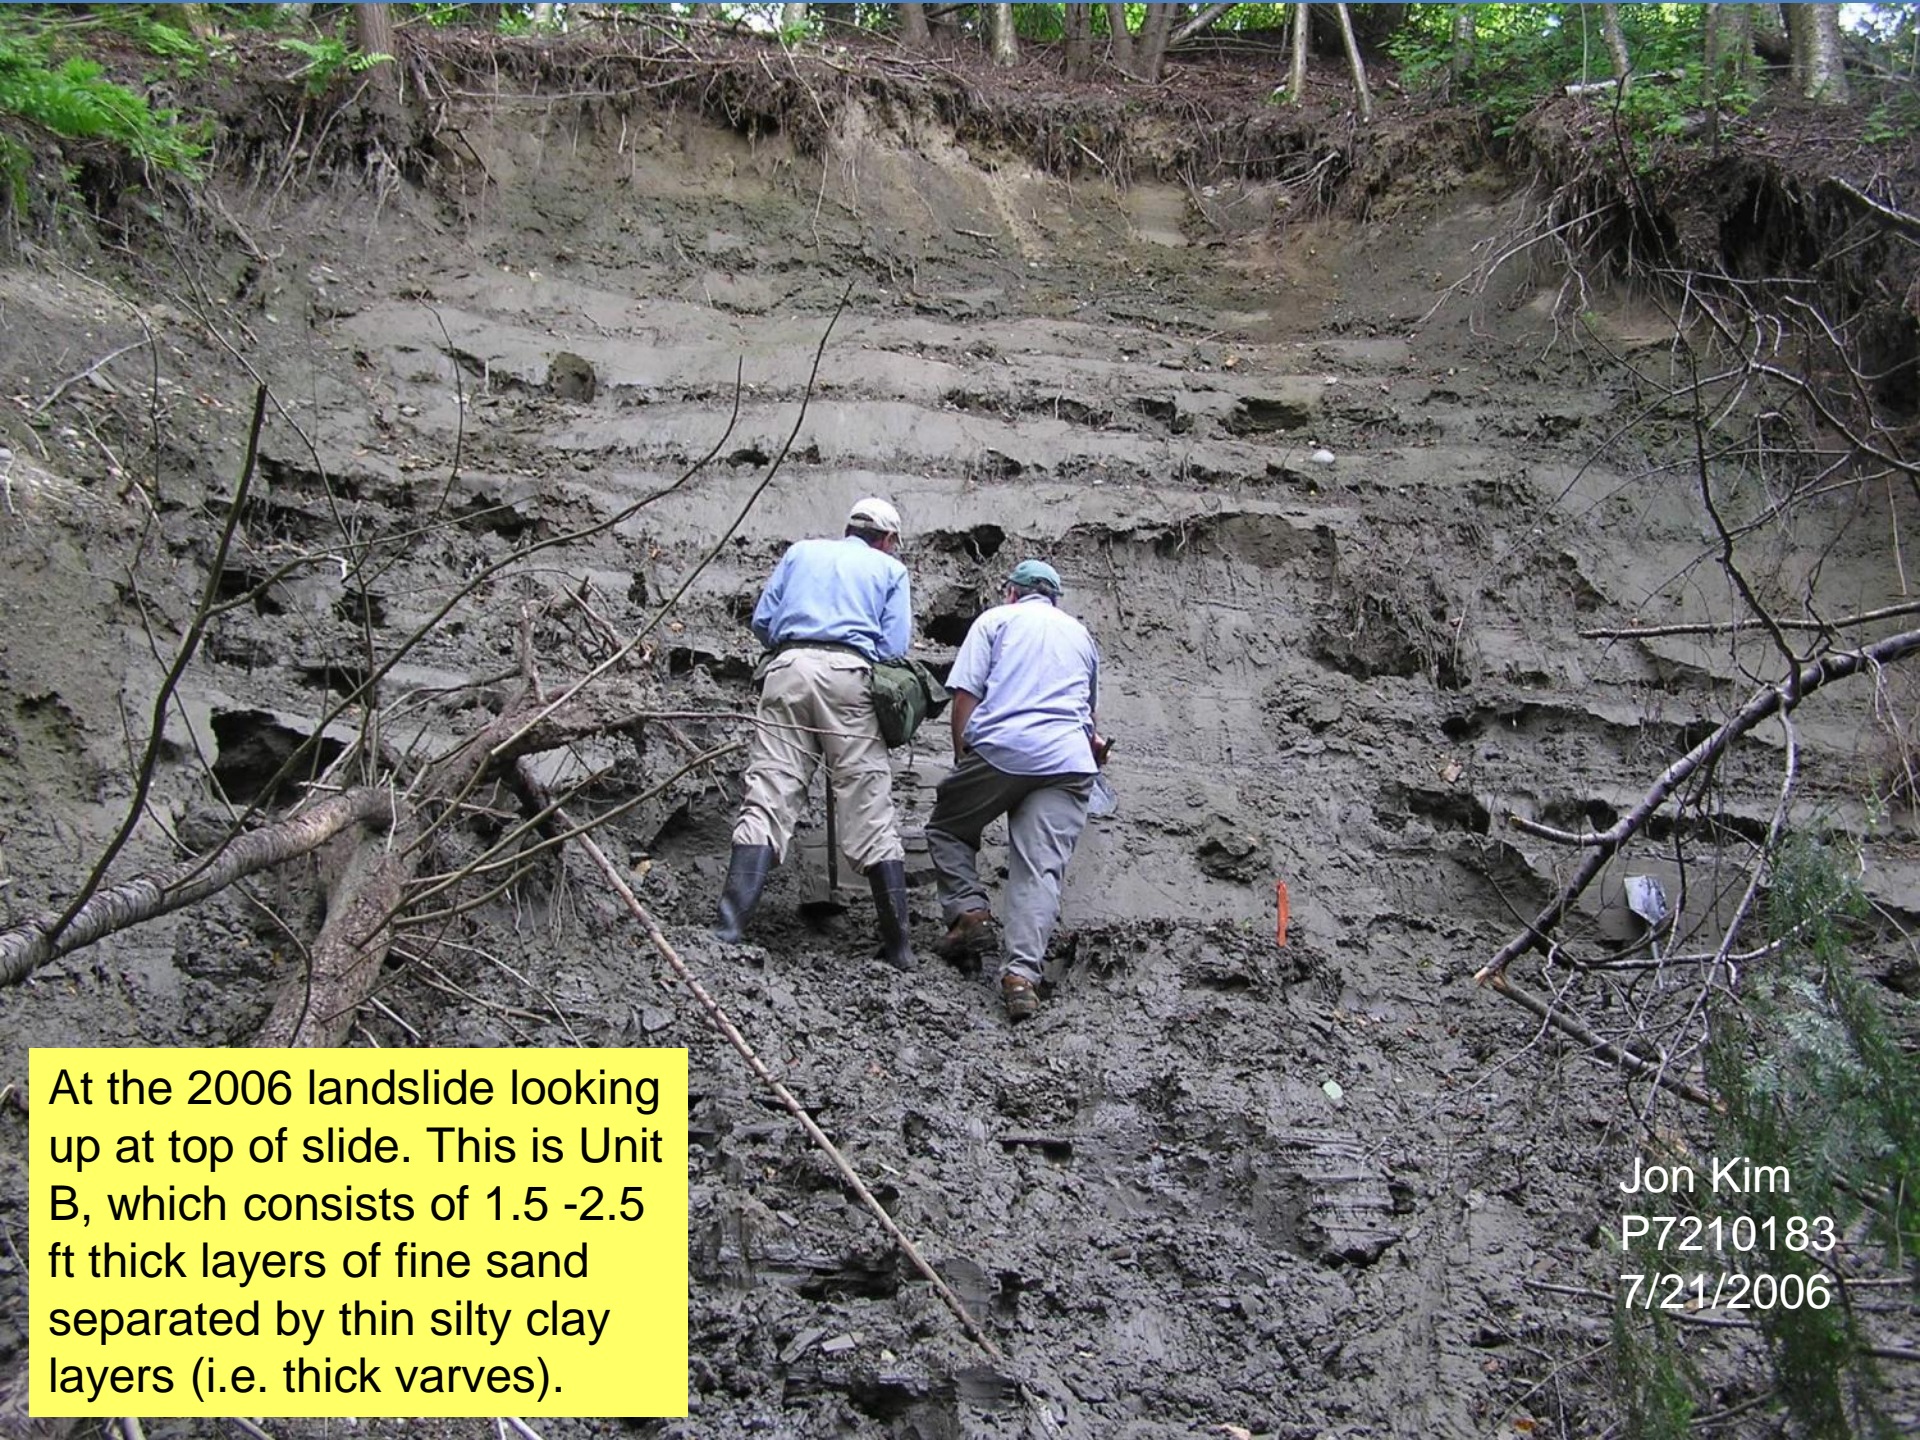
Jon Kim
P7210183
7/21/2006

At the 2006 landslide looking up at top of slide. This is Unit B, which consists of 1.5 -2.5 ft thick layers of fine sand separated by thin silty clay layers (i.e. thick varves).

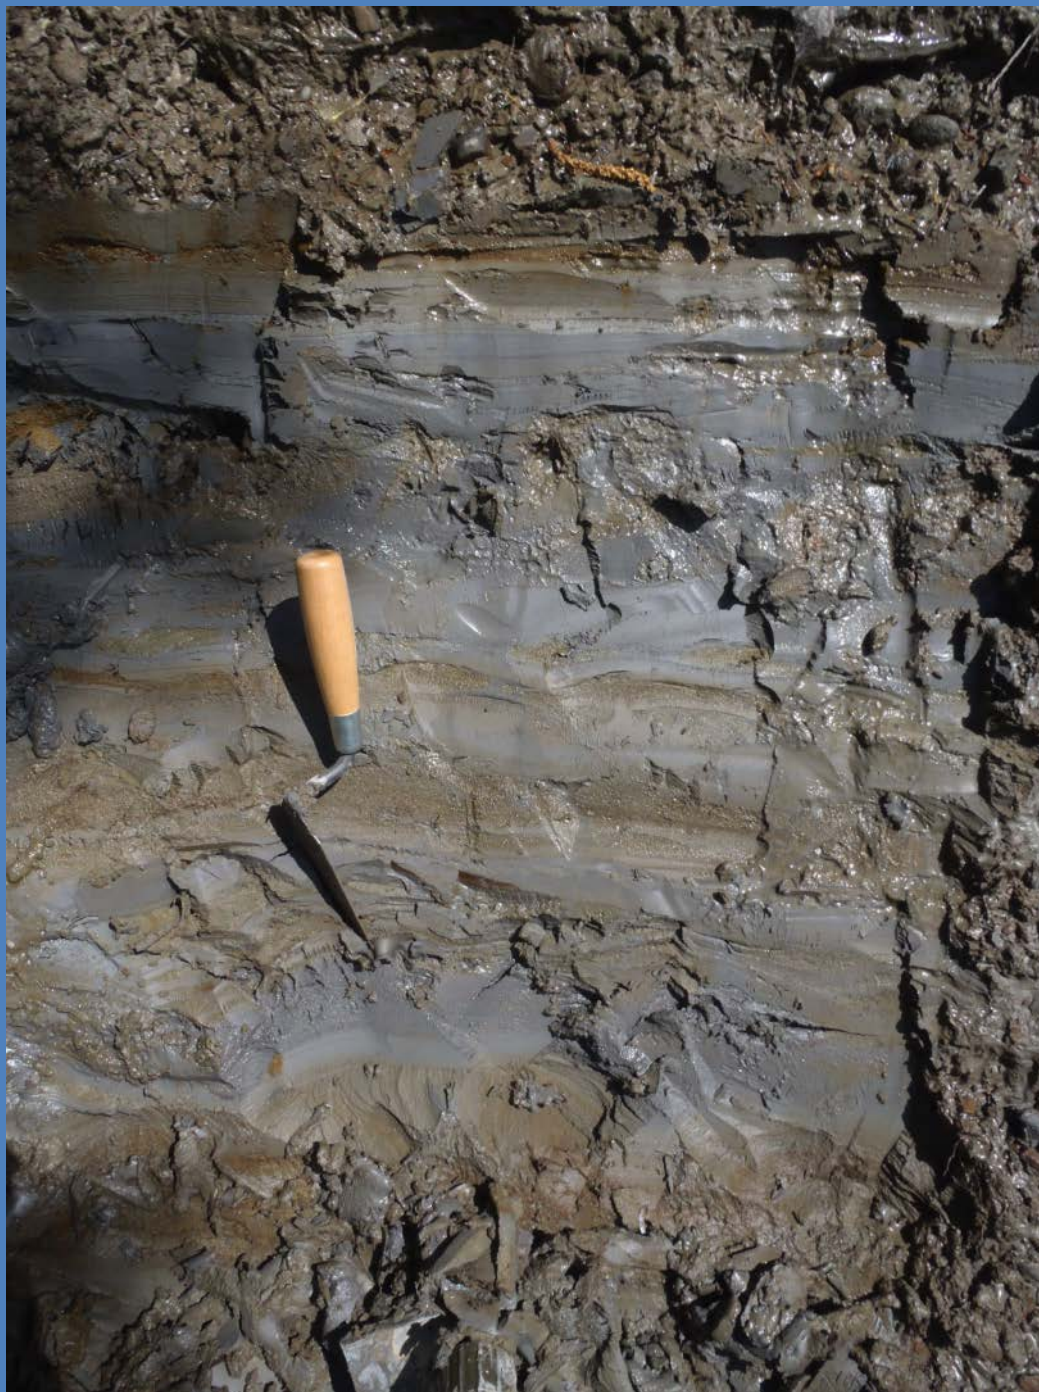
Stiff, varved lacustrine deposit (Unit C) at site of 2011 landslide. Very fine sand and clayey silt are brown and silty clay is grey. Trowel for scale. Photo by G. Springston, 5/19/2011.

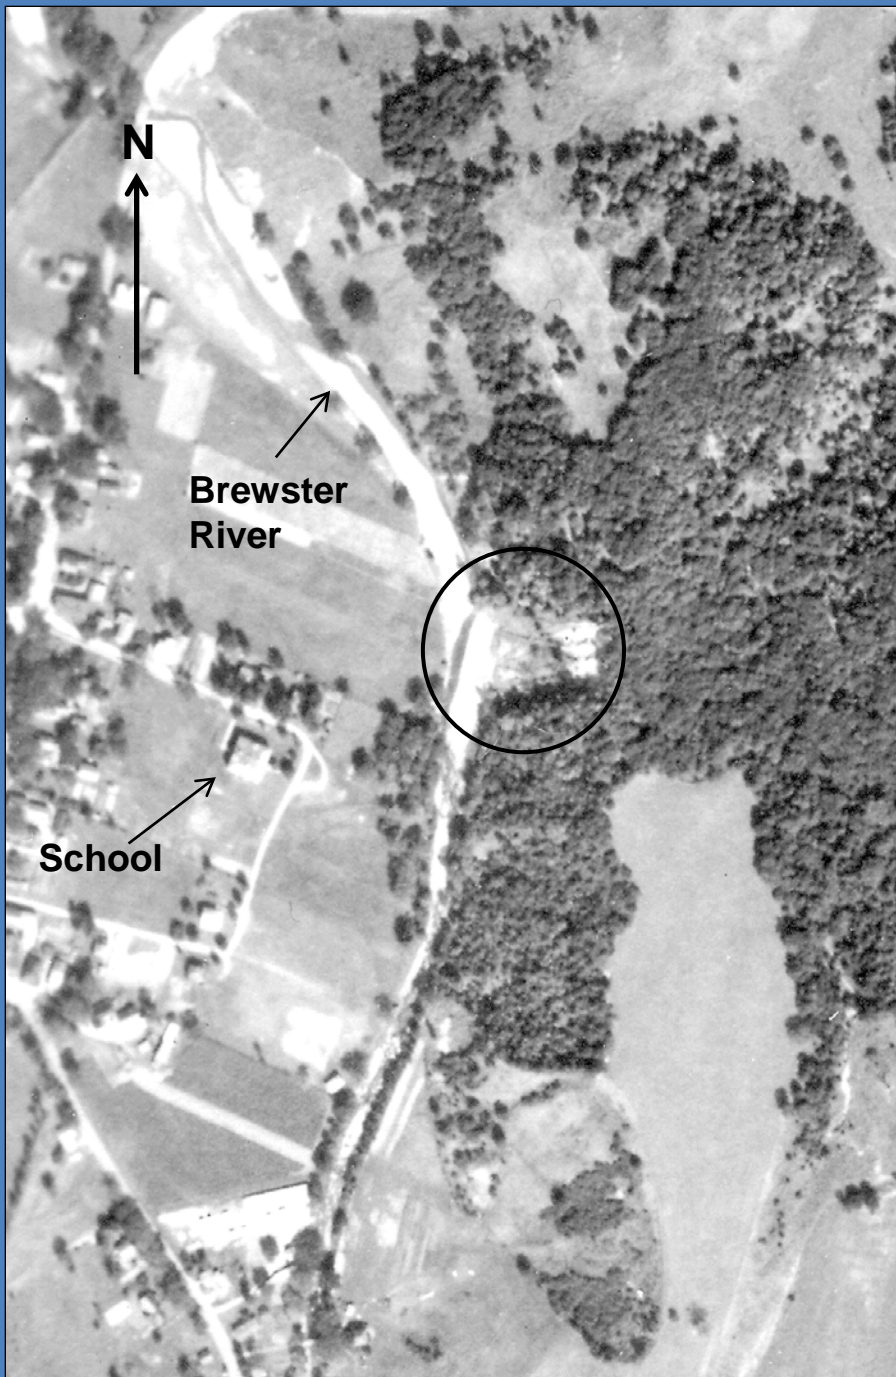
**Aerial photo taken
August 1, 1942.
Landslide scar is circled.**

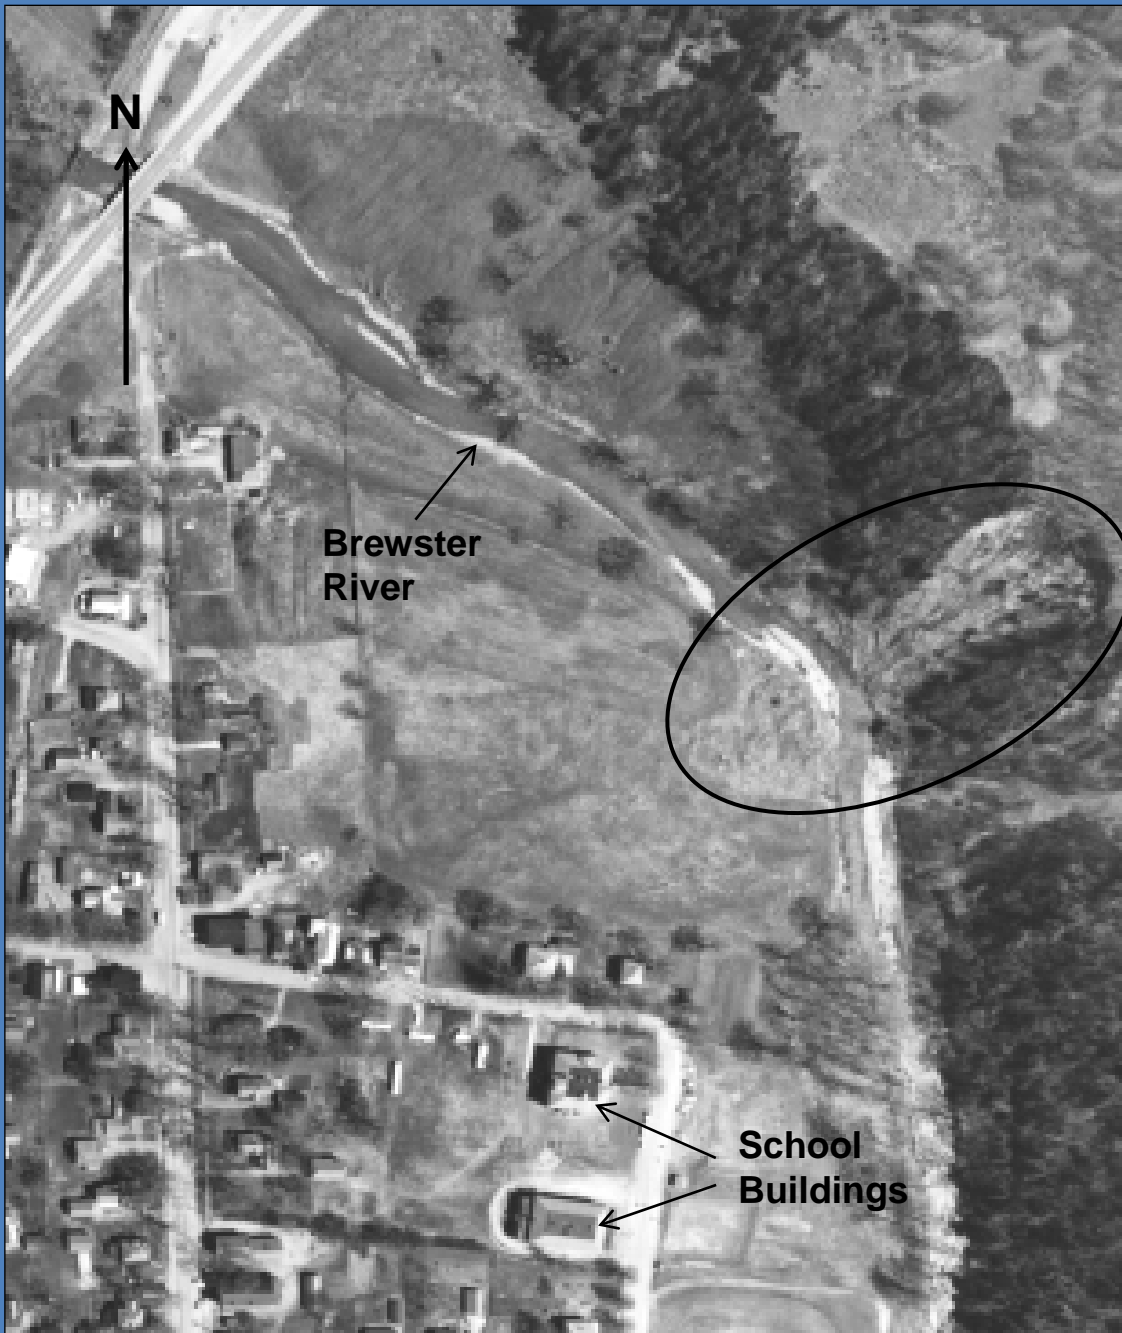
Aerial photo
taken in the
spring of 1962.
The 1954
landslide is
circled.

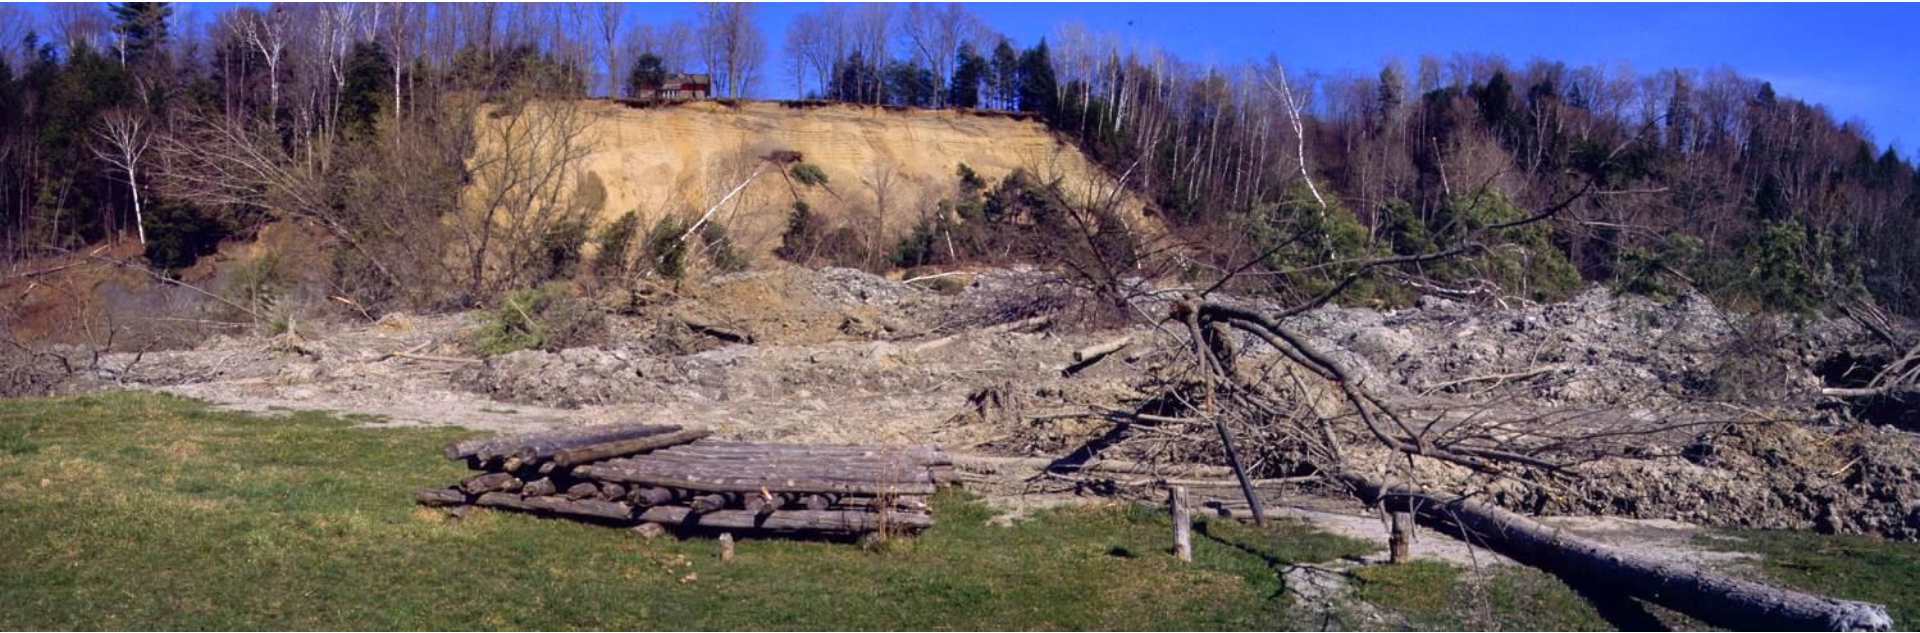
Jeffersonville landslide after the April 18, 1999 slide

**Note house on top at edge of landslide.
Mosaic of photos taken on April 20, 1999 by
Jon Kim, Vermont Geological Survey.**

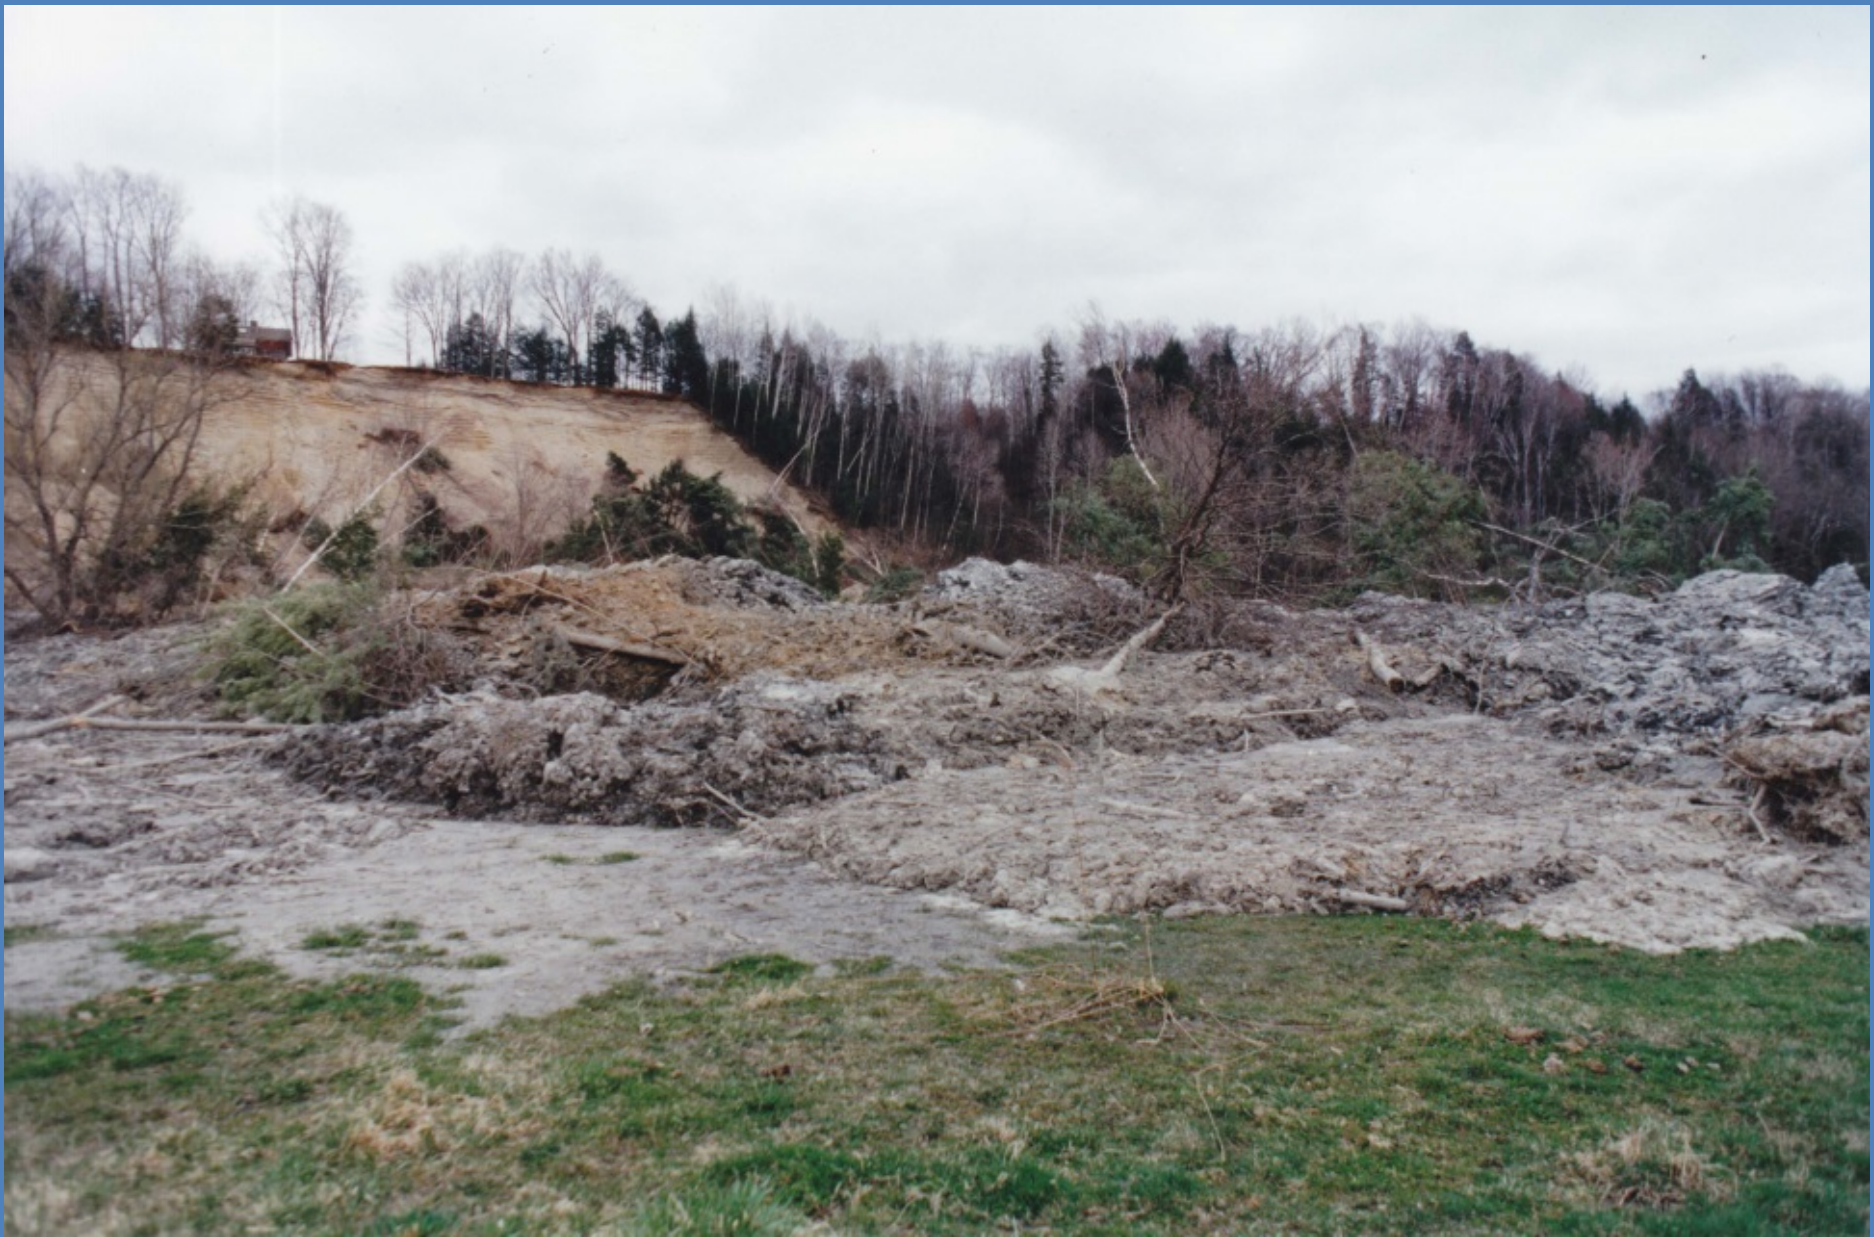
View of the 1999 landslide deposit looking southeast. Vermont Landscape Change Program photo LS21623_000 used courtesy of Paul Bierman, University of Vermont.

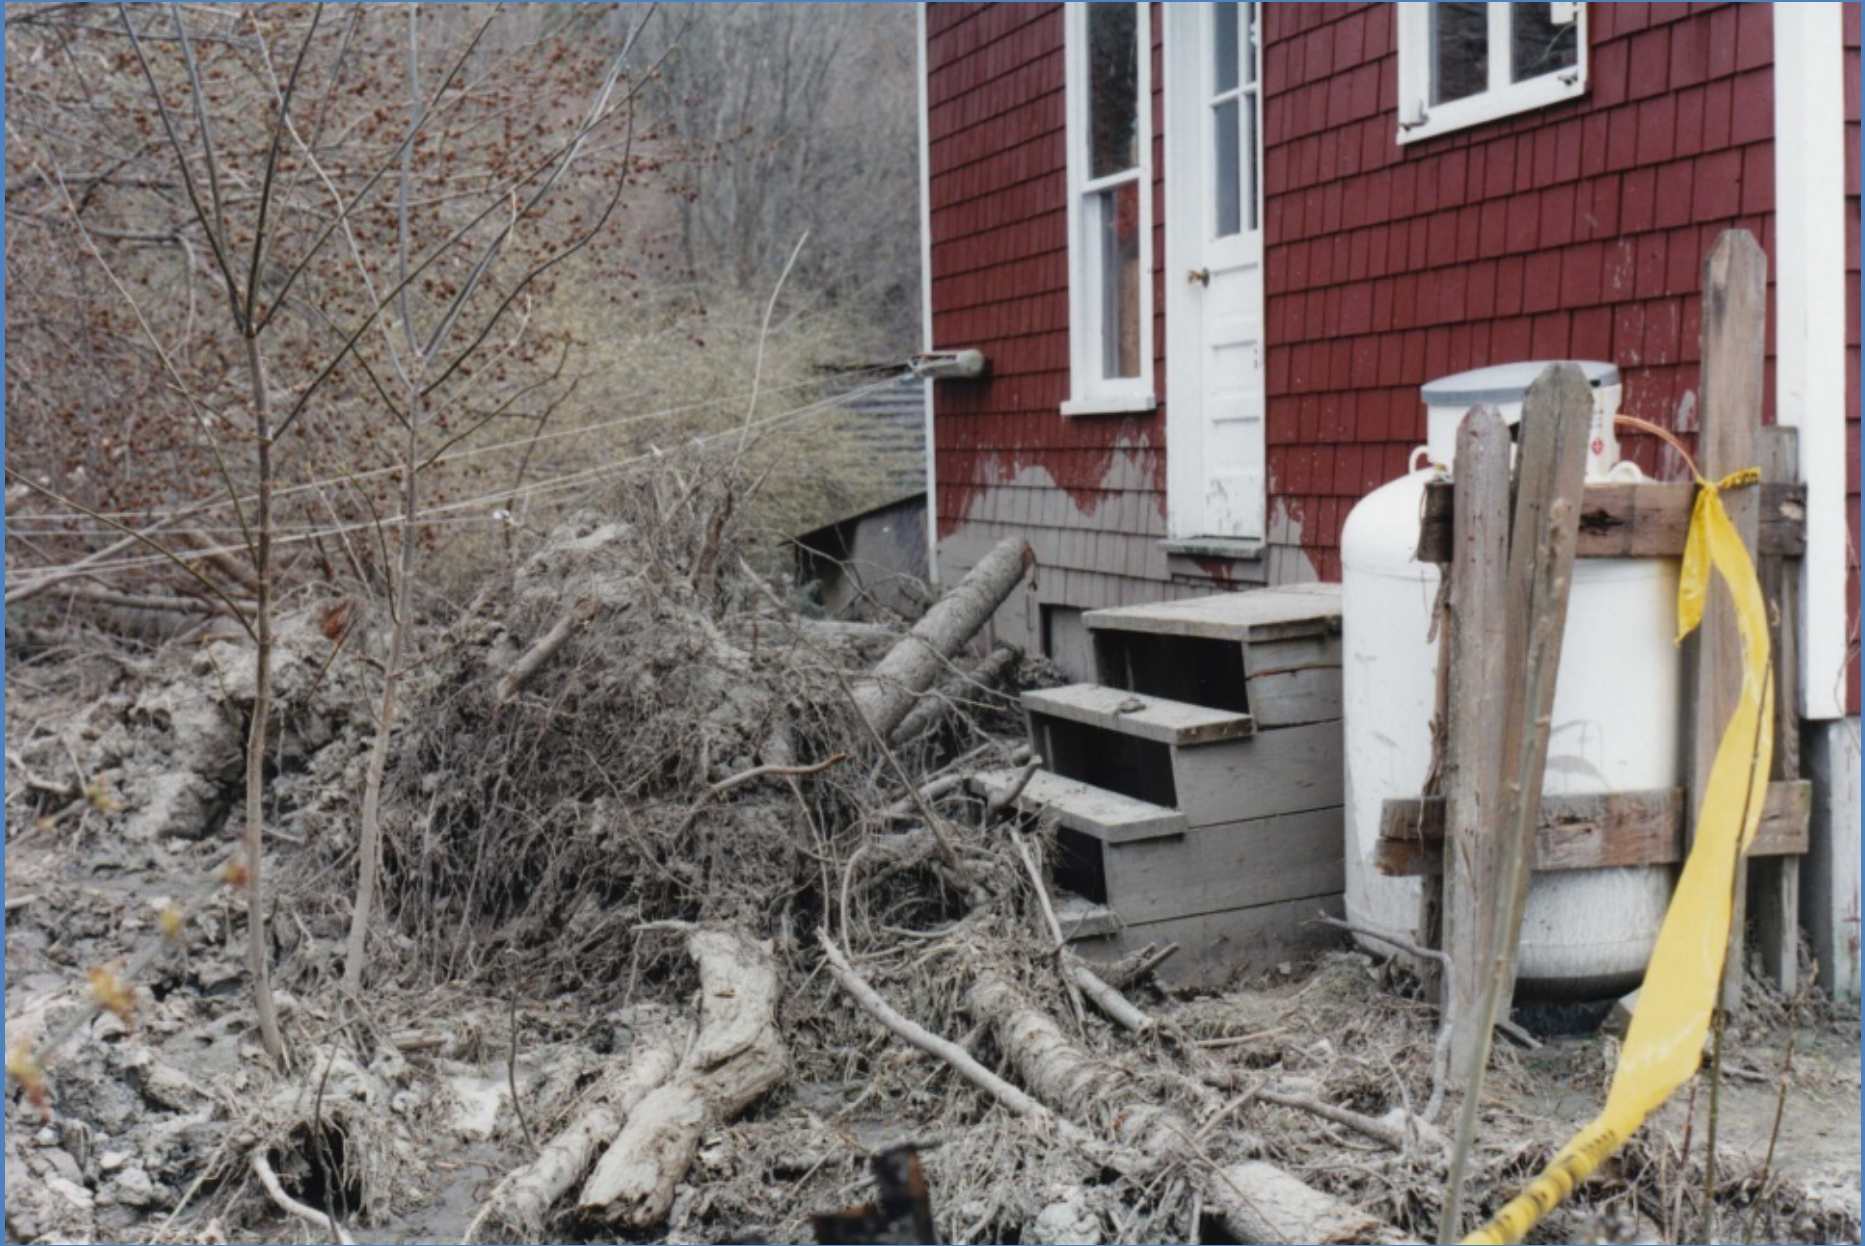
Landslide deposit pushed up against house at southwest corner of 1999 landslide. Vermont Landscape Change Program photo LS21615_000 used courtesy of Paul Bierman, University of Vermont.

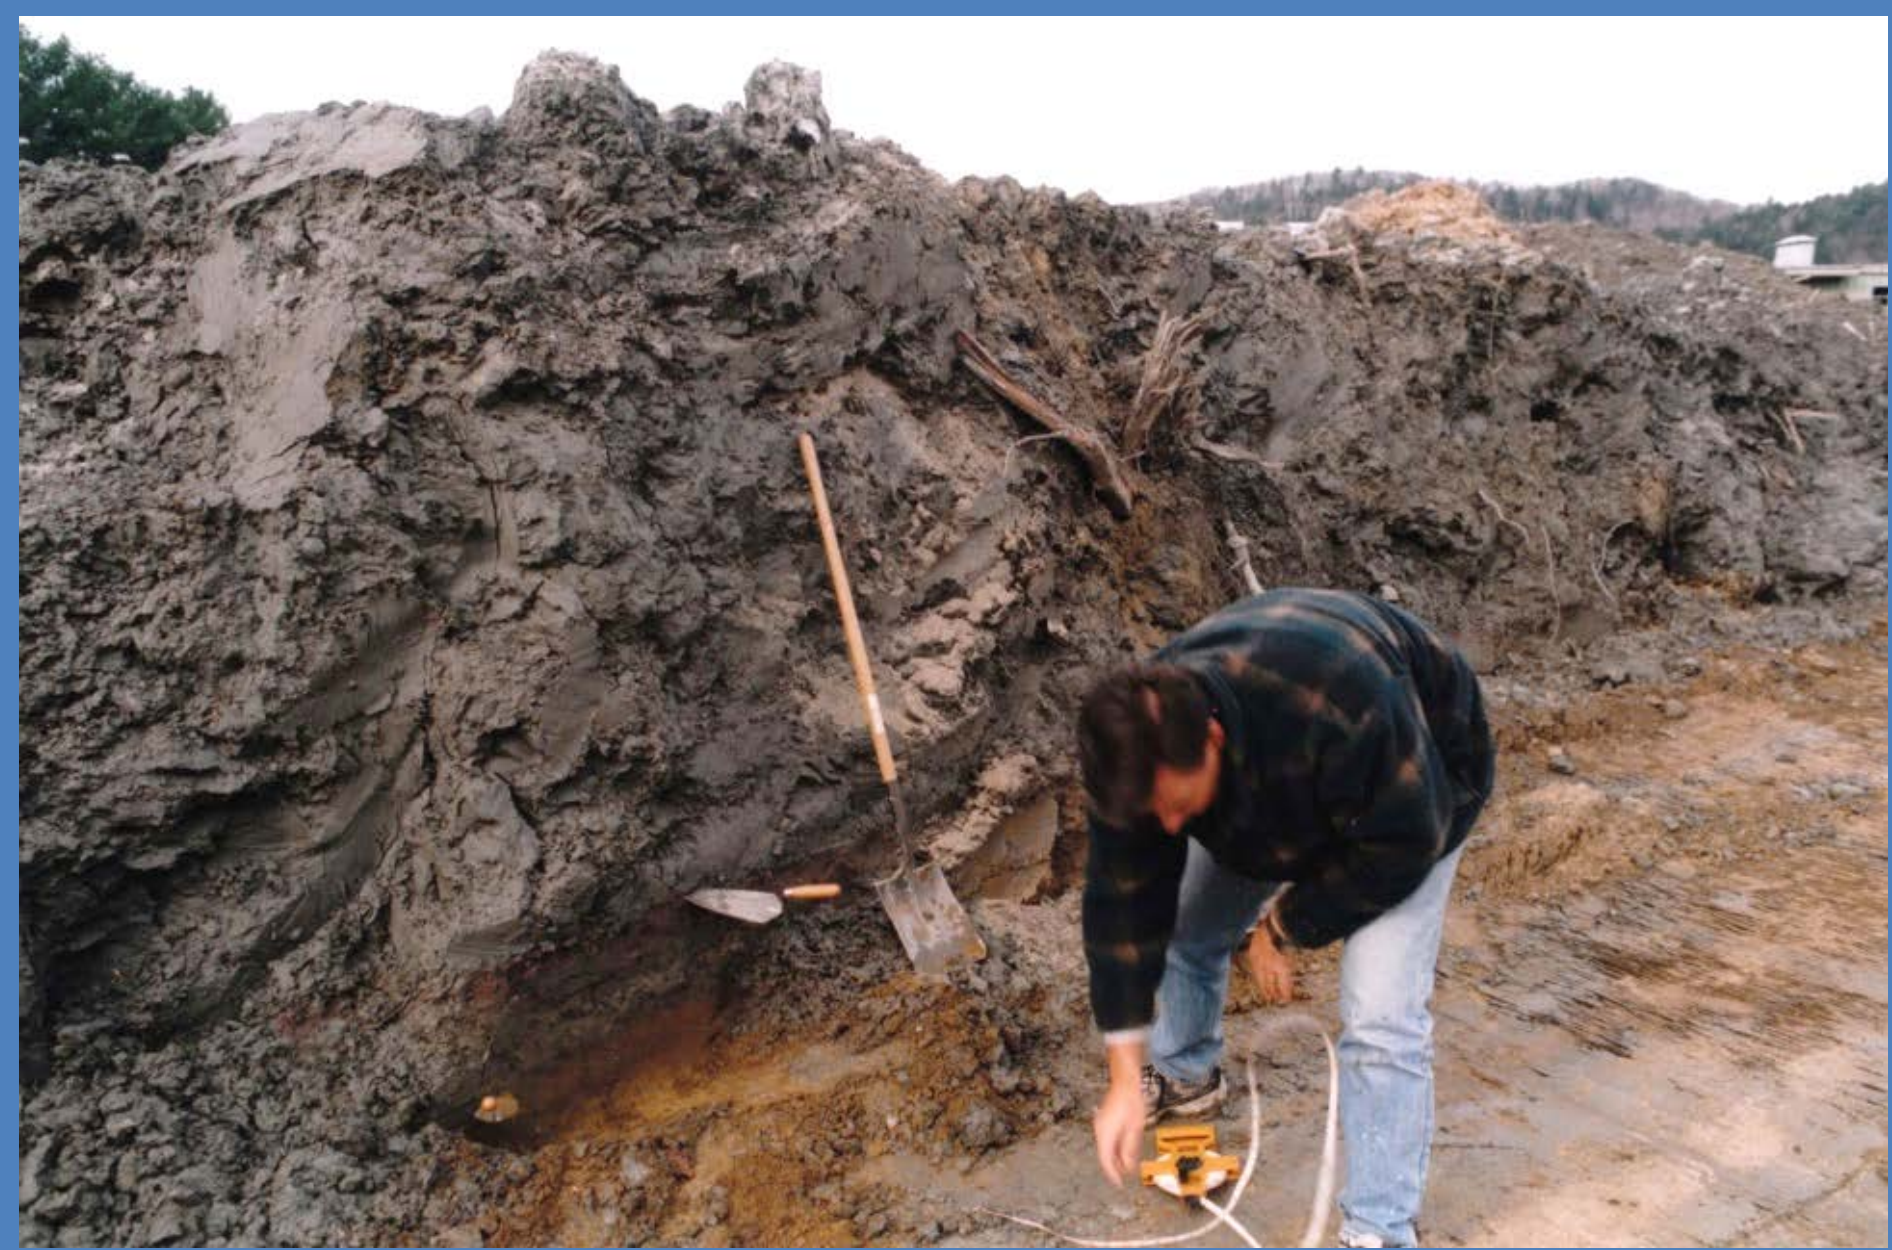
Cut in silt and clay of the 1999 landslide deposit. Vermont Landscape Change Program photo LS21616_000 used courtesy of Paul Bierman, University of Vermont.

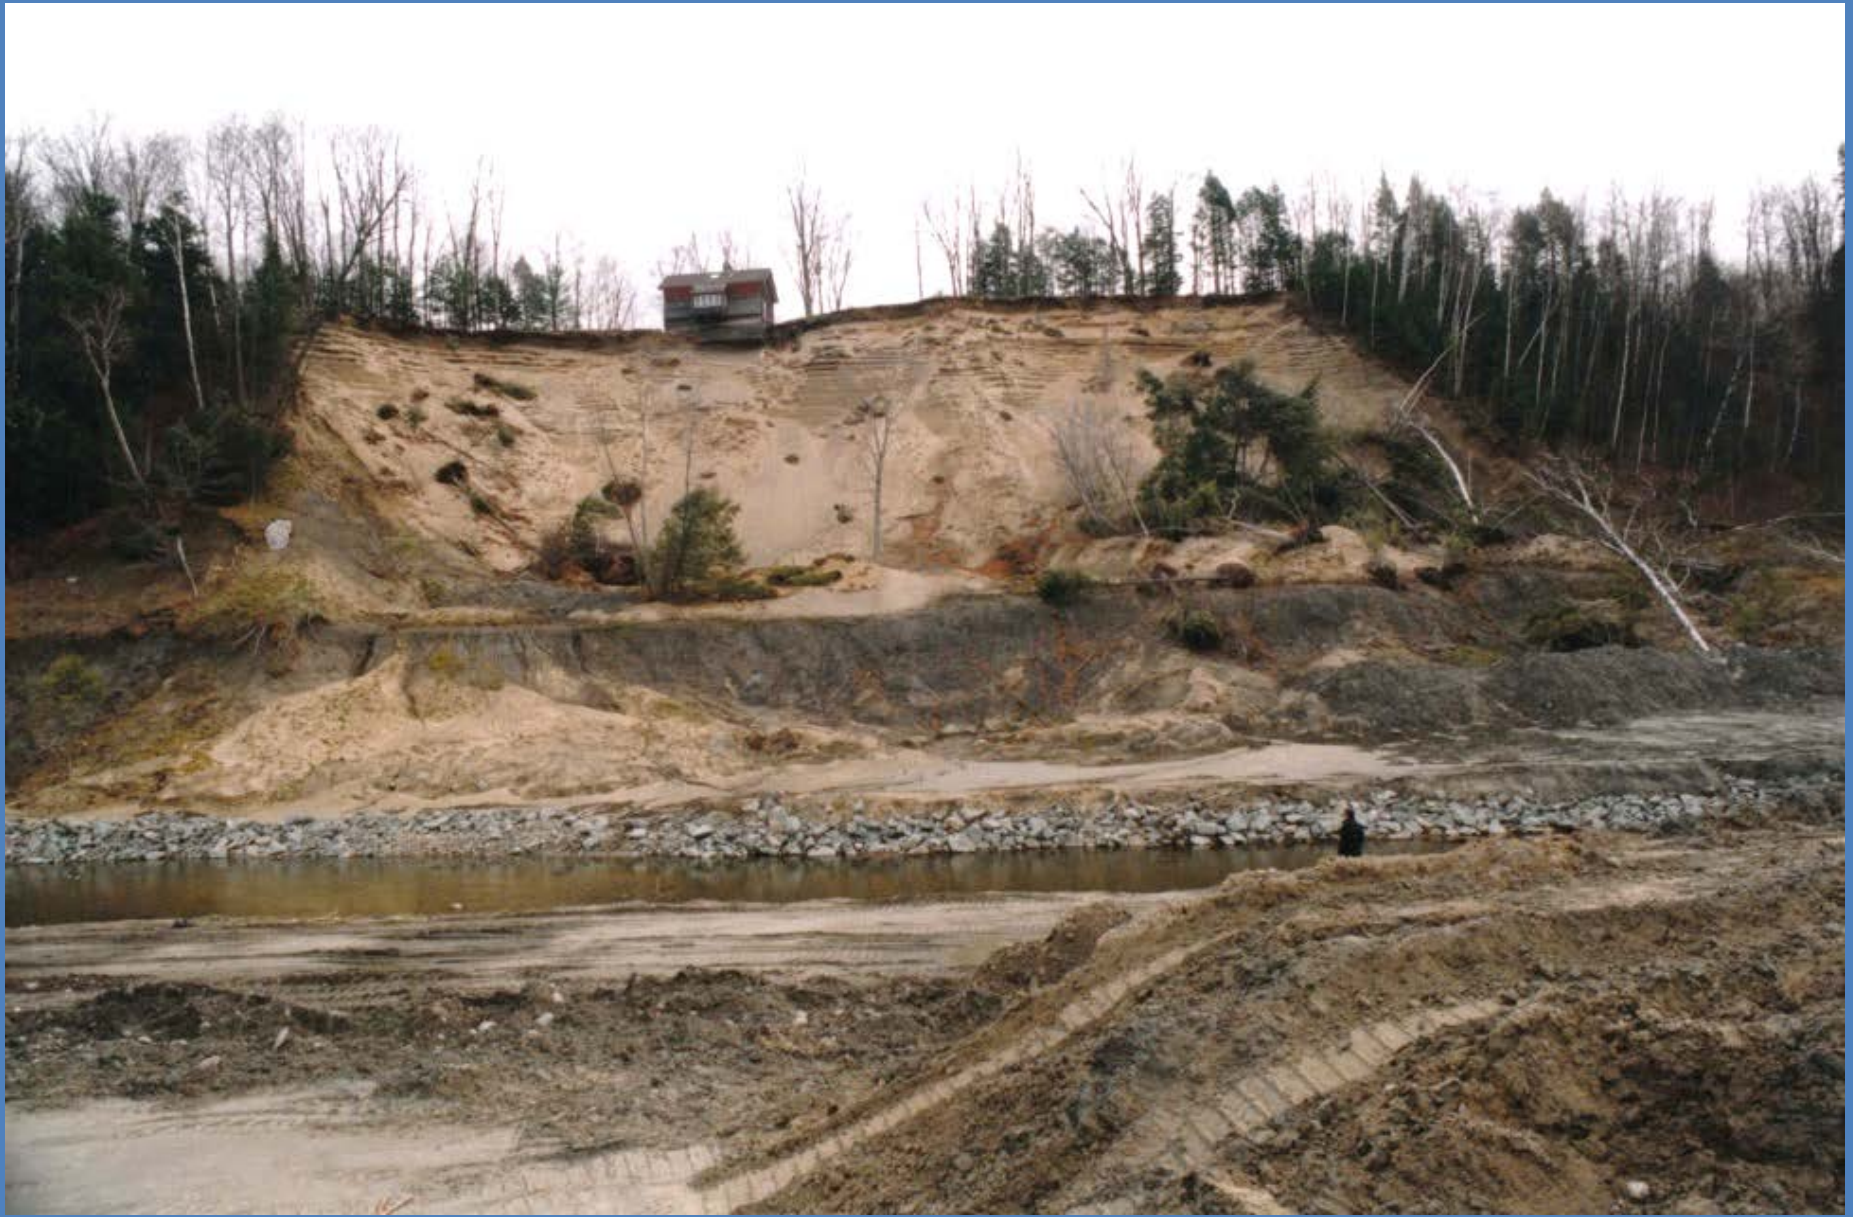
Looking east across river at 1999 landslide with house at top. Note prominent dark-grey bench on lower part of slope. Rip-rap has been placed at the toe of the slope on the far bank of the river. Vermont Landscape Change Program photo LS21620_000 used courtesy of Paul Bierman, University of Vermont.

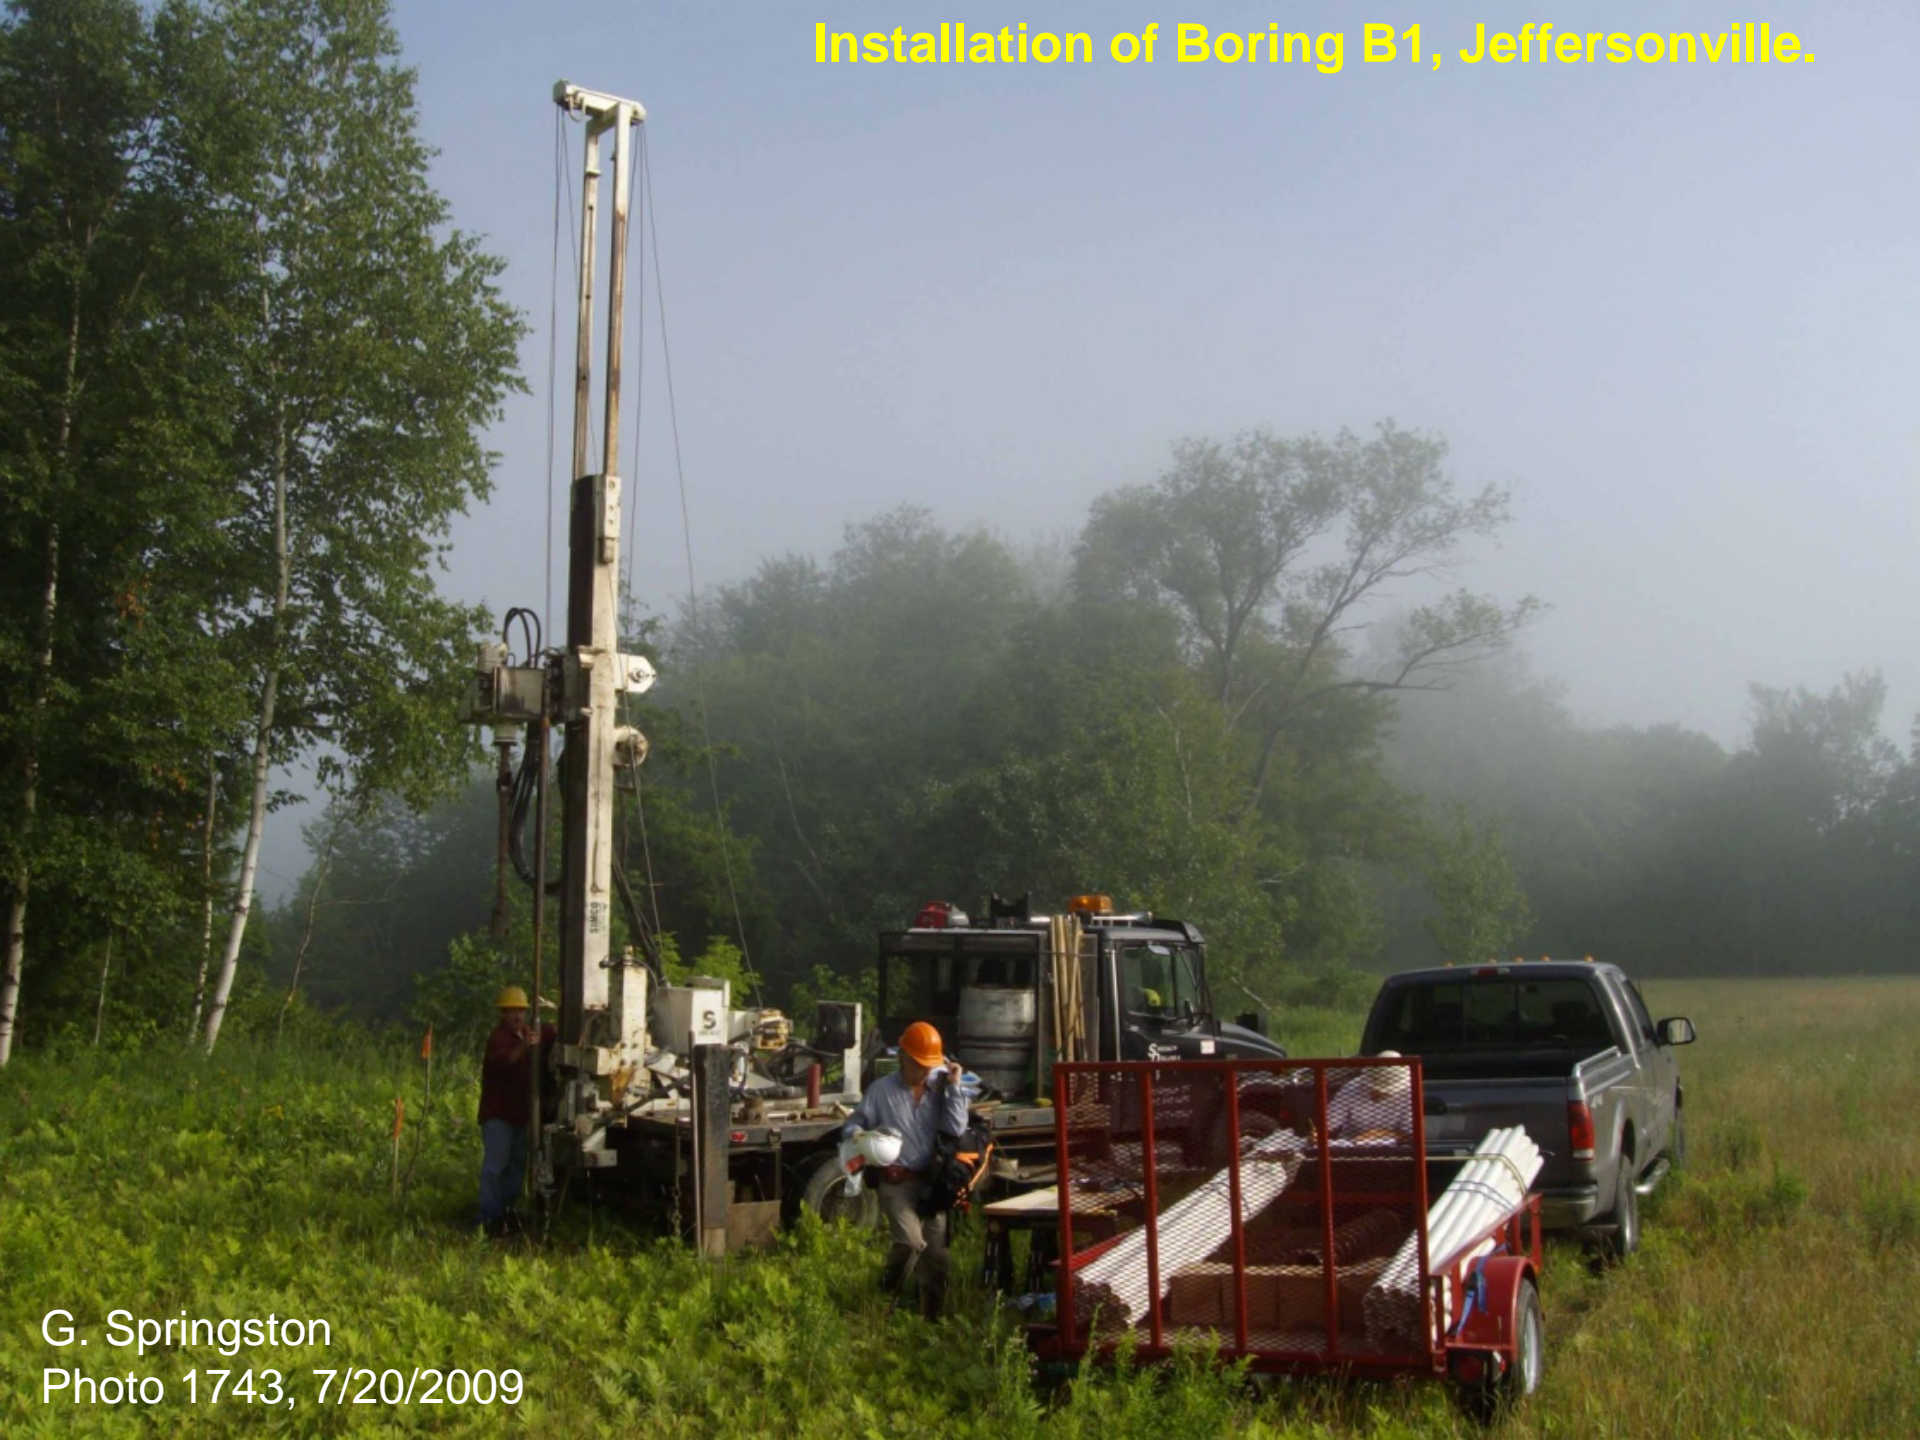
G. Springston
Photo 1743, 7/20/2009

Installation of Boring B1, Jeffersonville.

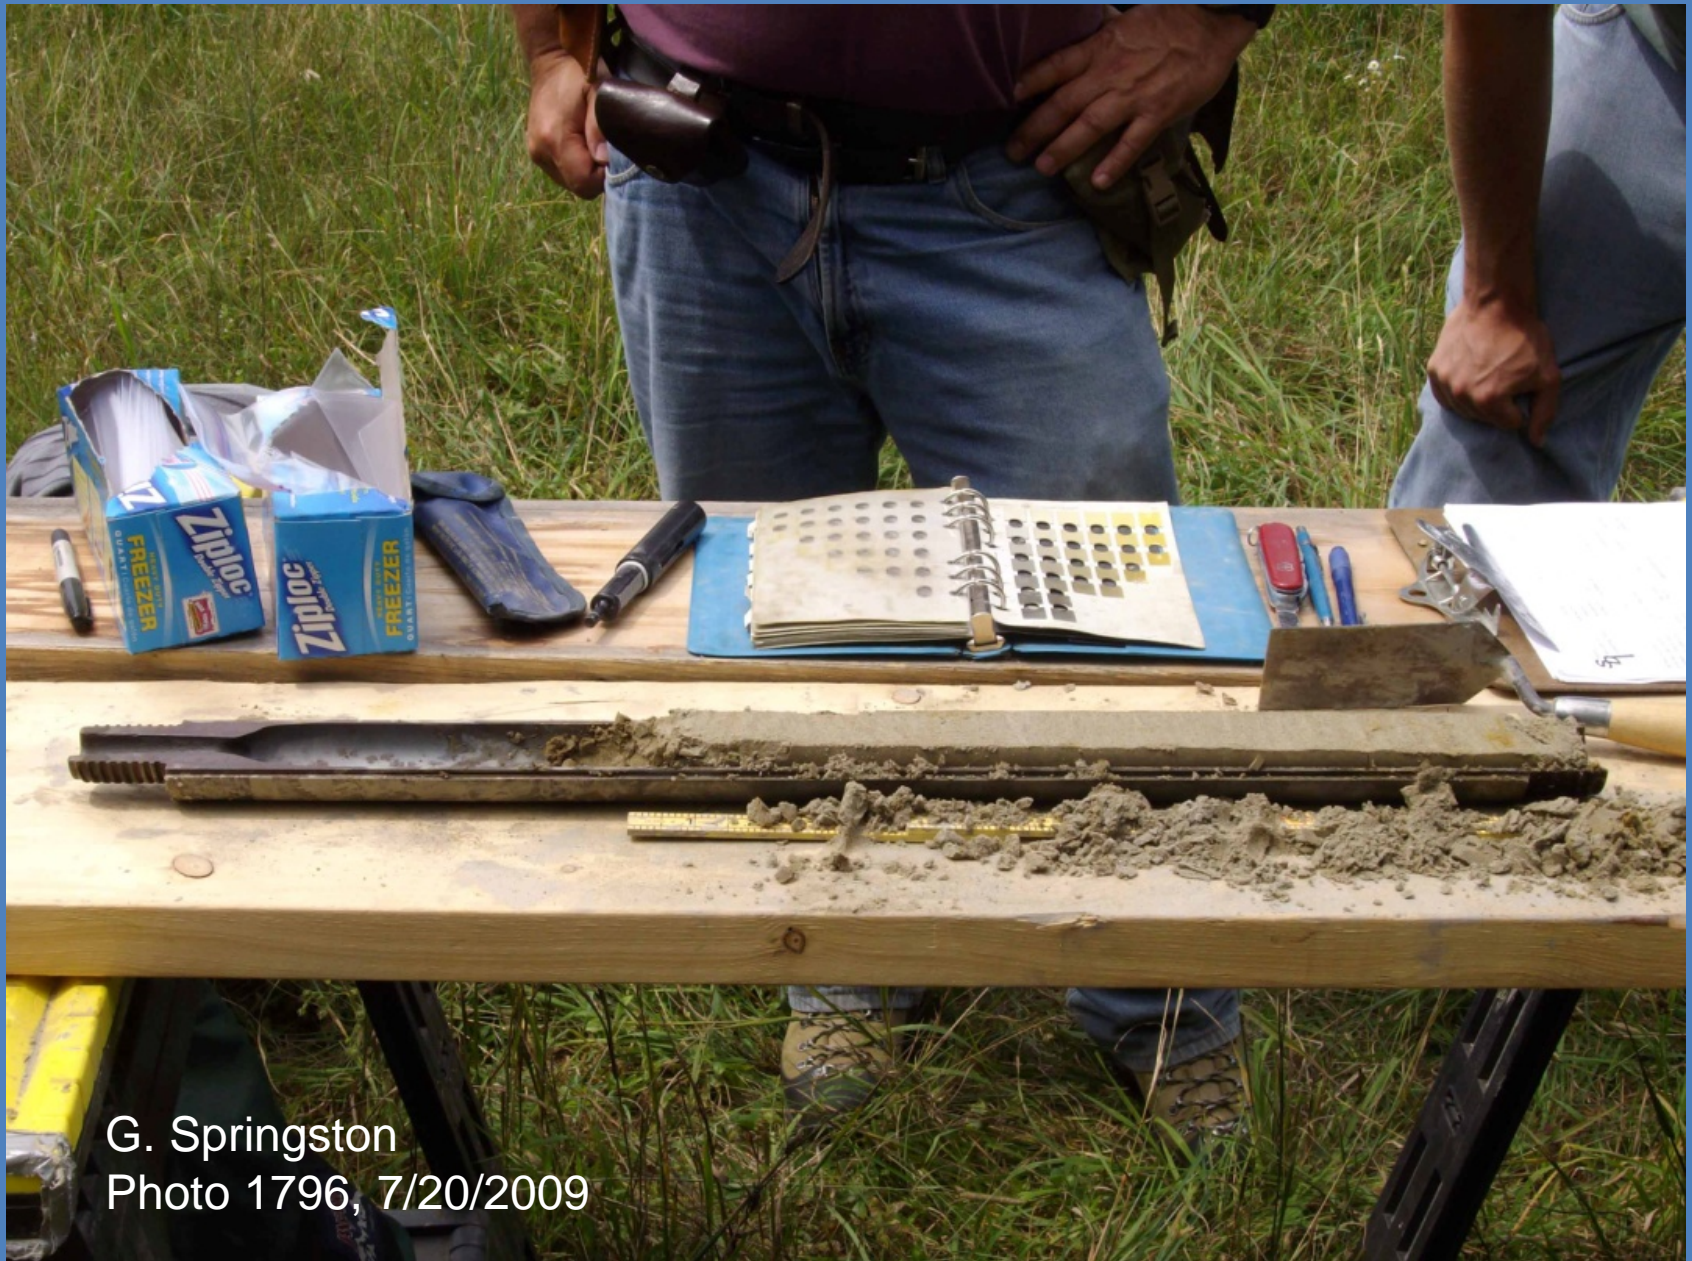
G. Springston
Photo 1796, 7/20/2009

Examining a section of laminated fine sand and silt in the split spoon sampler, Jeffersonville.
