Hazard Evaluation at the Jeffersonville Landslide Site

George Springston and Adam Sevi, Norwich University

Presented to Jeffersonville Hazard Mitigation Committee, March 24, 2014

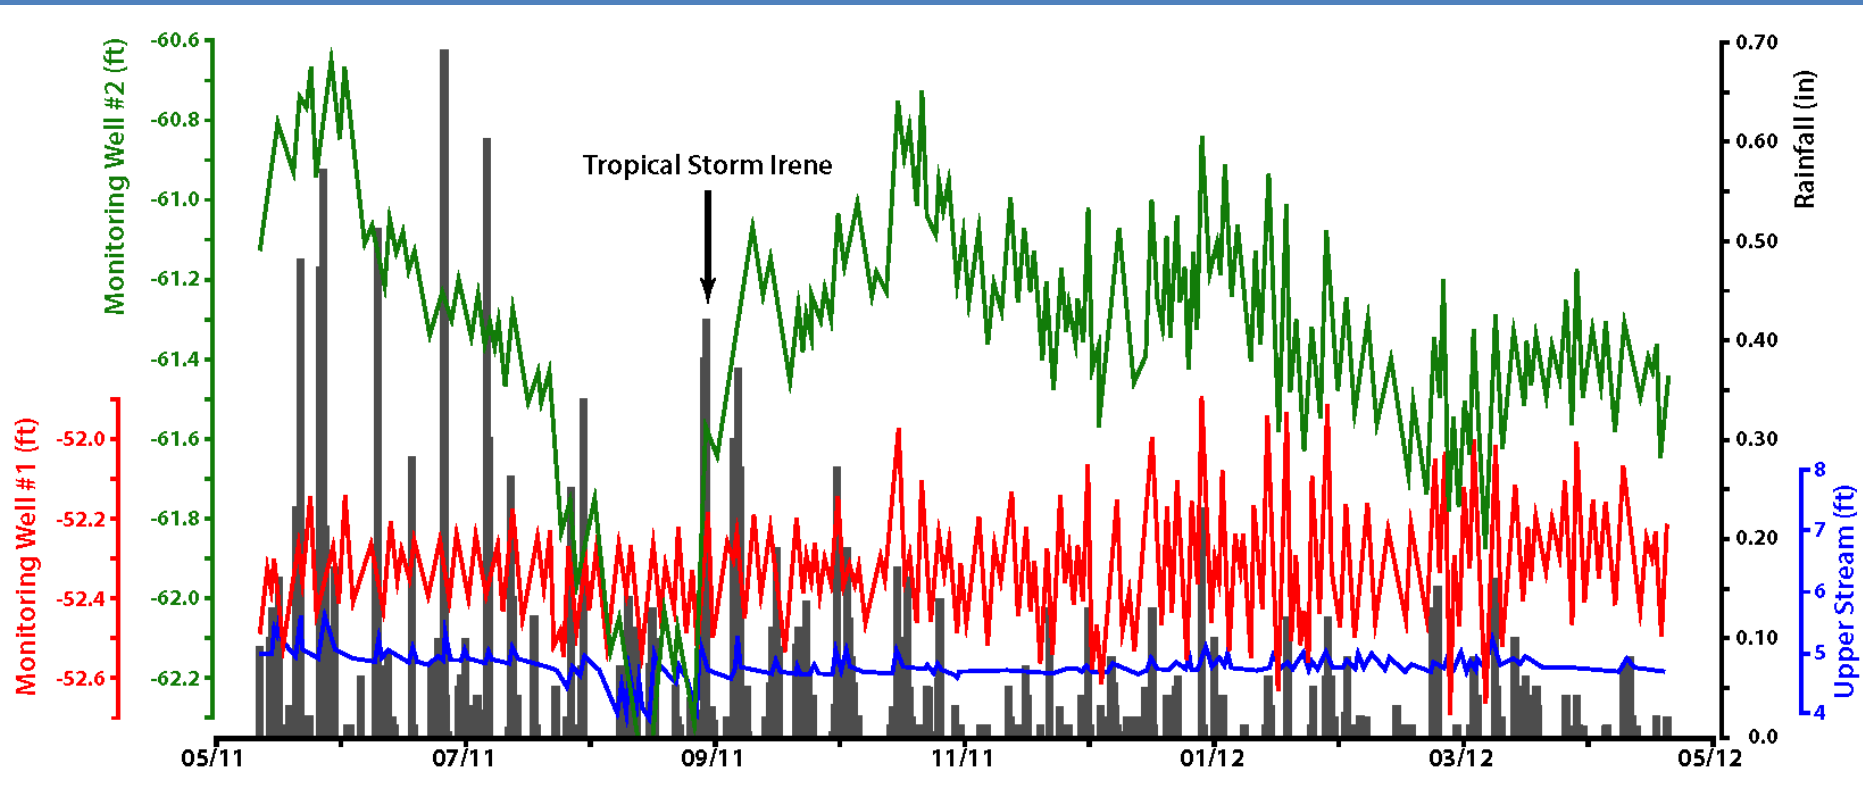
Precipitation and water levels at Jeffersonville from May of 2011 to May of 2012.

Monitoring well MW1: red
Monitoring well MW2: green
Gauge on upper stream: dark blue
Rain gauge (hourly): grey
