A Rockfall and Debris Slide at Smugglers Notch

Mount Mansfield,
Cambridge, Vermont

Studies in Vermont Geology No. 4, 1988

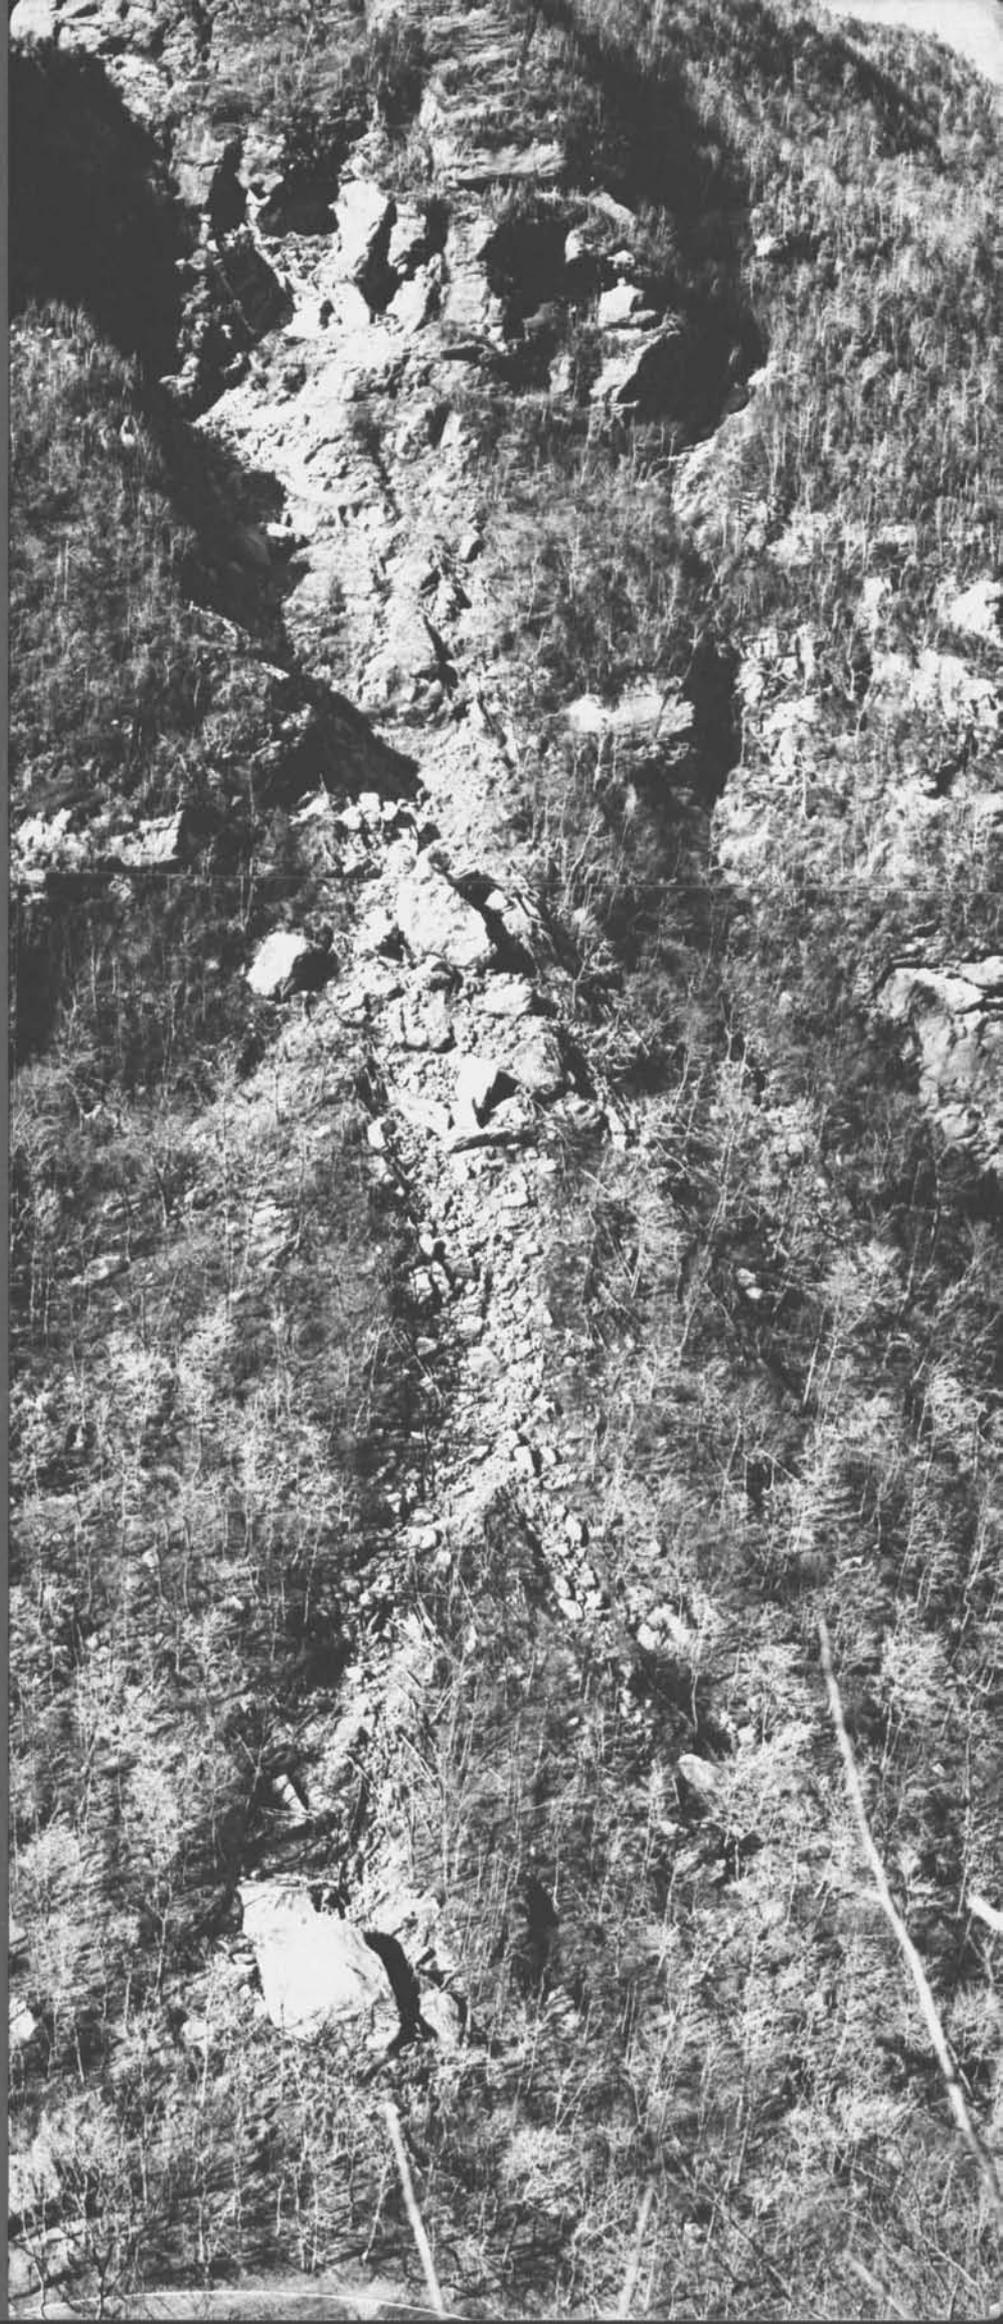
COVER PHOTO:

Scar and debris of the July 13, 1983 rockfall and debris slide on the west wall (east facing) of Smugglers Notch. Note the road, VT. Rt. 108, at bottom of photo. The location of this feature is shown on Figure 1.

On July 13, 1983 at approximately 7 A.M. (E.D.T.), a block of schist estimated to have weighed 11,500 tons (10.4×10^6 kg) broke loose from an east-southeast facing cliff near the 3000 ft (914 m) elevation in a tributary valley to Smugglers Notch, Mount Mansfield, Cambridge, Vermont (Plate I C, Location C, in the centerfold). The block traveled diagonally across this narrow drainage valley, smashed into the opposite wall at a point some 50 feet (15 m) lower, and broke into many smaller blocks. Several large and small fragments travelled about 1300 ft (400 m) downslope to the road (VT. Rt. 108) level, 2180 ft (664 m), into Smugglers Notch proper (Cover Photo).

Because of the cantilevered geometry, the area of the block connected to the rest of the mountain (i.e., along the lower triangular surface and a portion of the base) may have been under high tensile stress and close to the threshold of failure. The surface on which final failure took place did not appear to be a natural joint surface because the fracture was fresh and slightly irregular (Figure 2). The large block traveled diagonally (southeast) across the small tributary valley colliding with the opposite wall at an elevation about 50 ft (15 m) lower and broke into many smaller fragments ranging from 1 to 1100 yd³ (1 to 850 m³) in volume. Two large blocks remained in the slide channel near the point of impact of the original block with the wall, and other large blocks, one 1100 yd³ (850 m³) in volume and weighing about 2550 tons (23.1 × 10⁵ kg), stopped a little more than one-third of the way down the slope (Figure 3 and Cover Photo).

As other large fragments tumbled down the 42 degree slope, they broke into smaller pieces and scoured the soil, trees, and other vegetation in their paths. At this stage, the moving mass acquired the characteristics and proportions of a debris slide (Varnes, 1978). The main mass of the debris slide lost momentum as it was slowed by a 20 to 50 ft (6 to 15 m) high thicket of yellow birch that formed a protective buffer upslope from Vt. Route 108 (Cover

Photo). Two boulders, one about 5 tons (4500 kg), the other 26 tons (23,600 kg), plowed through the trees leaving two distributary tracks trending east and northeast and branching away from the main debris chute. These boulders came to rest in the yellow birch thicket. A small boulder slightly damaged the roof of the tourist information booth north of the slide channel. At least two other boulders knifed through the trees and bounced across Route 108 leaving several large holes in the pavement. They came to rest in the parking area on the east side of the road. Two additional large blocks created a major distributary channel oriented in a southeasterly direction and came to rest about 25 ft (8 m) from the west side of Vt. Route 108. These two blocks were estimated to weight 550 and 1200 tons (5 and 11 x 10⁵ kg) with volumes of 240 and 510 yd³ (190 and 390 m³) respectively. The width of the slide chute at the 2300 ft (700 m) level measured 120 ft (37 m). The chute is somewhat wider above the 2600 ft (792 m) level and flares into two easily discernible distributaries below 2300 feet (700 m) (Cover Photo).

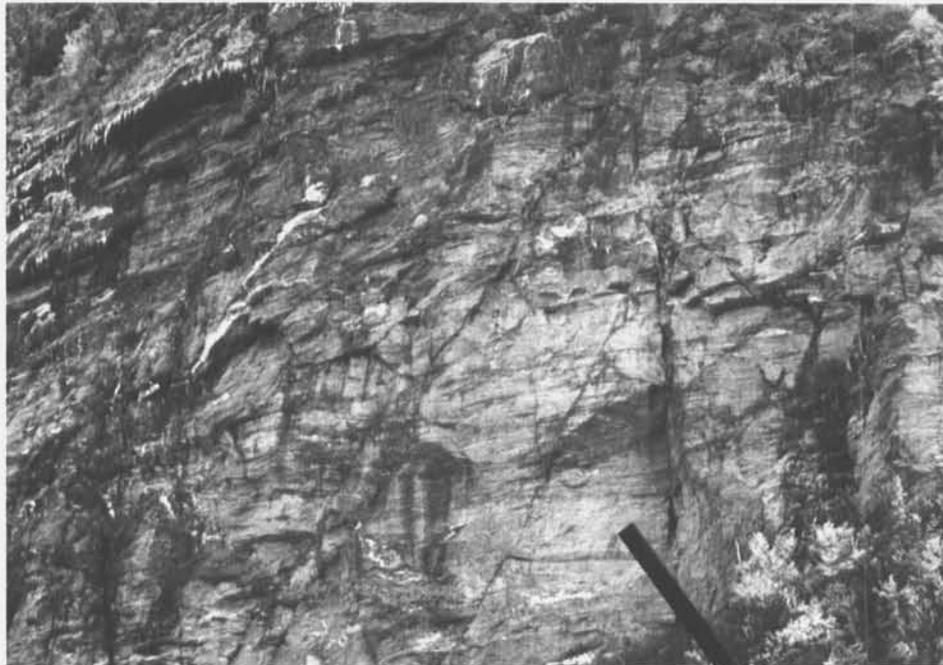
A. Typical wedge shaped block formed by intersecting joints. The position of this block on the west wall of Smugglers Notch is shown at Location A on the panorama.

The failed block was defined by joints and foliation surfaces having attitudes that are common in Smugglers Notch (Plate I C and Figure 2). Strikes and dips of these joint sets and the foliation vary through a range of 5° to 10°. The joint and foliation attitudes of the failed block are shown on Figure 2. The joint system and foliation which define this block establish a prominent fracture pattern which also defines other similar blocks that take the form of crude rectangular prisms. In addition, other common intersecting joint sets combine with foliation surfaces to create wedge-like blocks that take the form of triangular prisms (Plate I A, Location A).

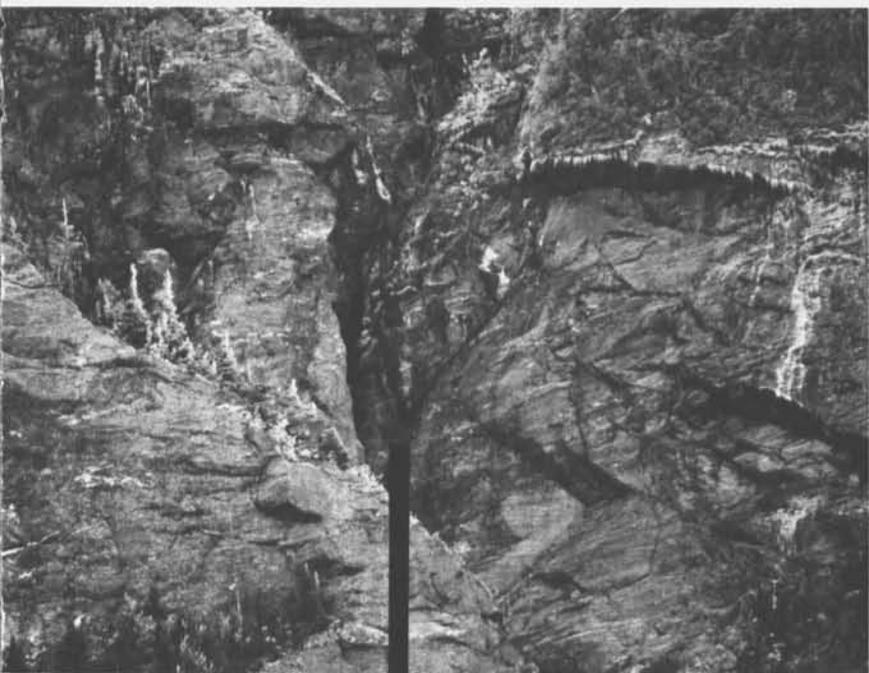
B. Cleft (fault) in the west wall of Smugglers Notch at the head of the tributary valley in which the rockfall/debris slide occurred. The position of this cleft is shown at Location B in the panorama.

Average relief in this steep walled valley is 1800 ft (550 m). Several steep tributary drainage valleys empty into Smugglers Notch from its east and west sides. One of these tributary valleys is the site of this investigation (Plate I B, Locations B and C). The growth and location of these tributary valleys is controlled by prominent brittle fractures (joints, faults) that weather and erode more rapidly than immediately adjacent areas. Christman (1956, 1959) attributed the development of Smugglers Notch, the main (north-south) valley, to headward erosion by an ancient (glacial meltwater) river. The valley is cur-

On the west wall of Smugglers Notch (Plate I) a wide range of orientations for the brittle fractures is well displayed. Certain fracture sets are dominant. Several prominent, near vertical, clefts that trend N. 85°E. are visible. The cleft in the vicinity of the rockfall (Plate I B, Location B) contains a .5 to 1 in (1 to 2 cm) wide gouge zone and displays numerous, closely-spaced, parallel joints whose surfaces are strongly weathered (rusty oxidation). Also, foliation immediately adjacent to this zone is highly contorted for a width of 1 ft (30 cm). This cleft and others parallel to it are shear zones (faults) that control the development of the narrow, incipient valleys which are tributary to the main, Smugglers Notch valley. Scree deposits that head at the base of these narrow clefts indicate that the greatest rockfall activity occurs in and immediately adjacent to these zones. The presence of intersecting joints, faults and easily cleavable foliation surfaces produce a rock mass of naturally segmented blocks which are highly susceptible to chemical decomposition and mechanical disintegration. The east-southeast exposure and high elevation

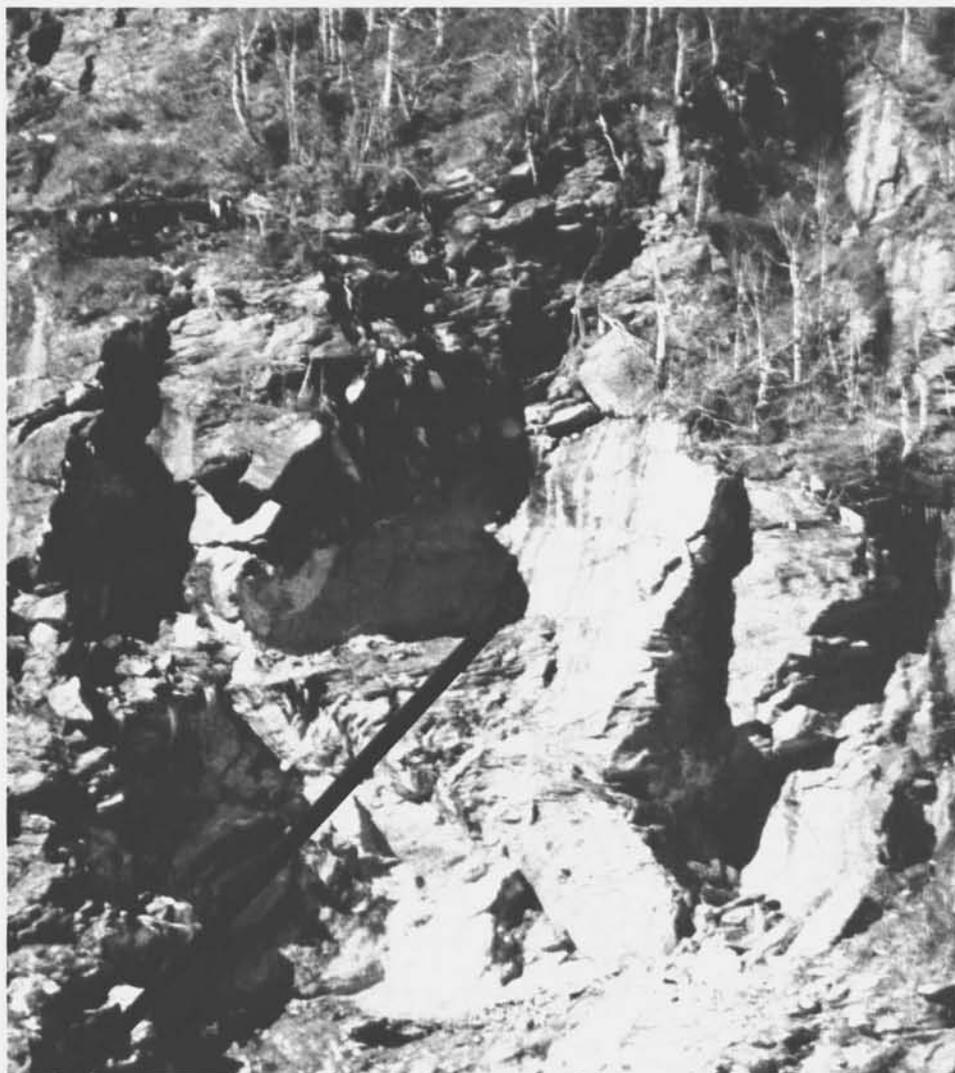
C

C. Scar at the site where the failed block of the July 13, 1983 rockfall originated. The position of this site on the west wall of Smugglers Notch is shown at Location C.

Hydrostatic pressure: At times during the period of this study, i.e., following rainstorms or during periods of melting snow and ice, water ran down the exposed joint faces where the failed block had rested. This phenomenon is apparently common (note the stained joint surface shown in Plate I C). Water in joints or tension cracks, when confined, exerts pressure that increases linearly with depth within the cracks (Hoek and Bray, 1977). The force is small when a small area of rock is examined, but the water force can be large when very large areas (many square yards or meters) are involved (Hoek and Bray, 1977).

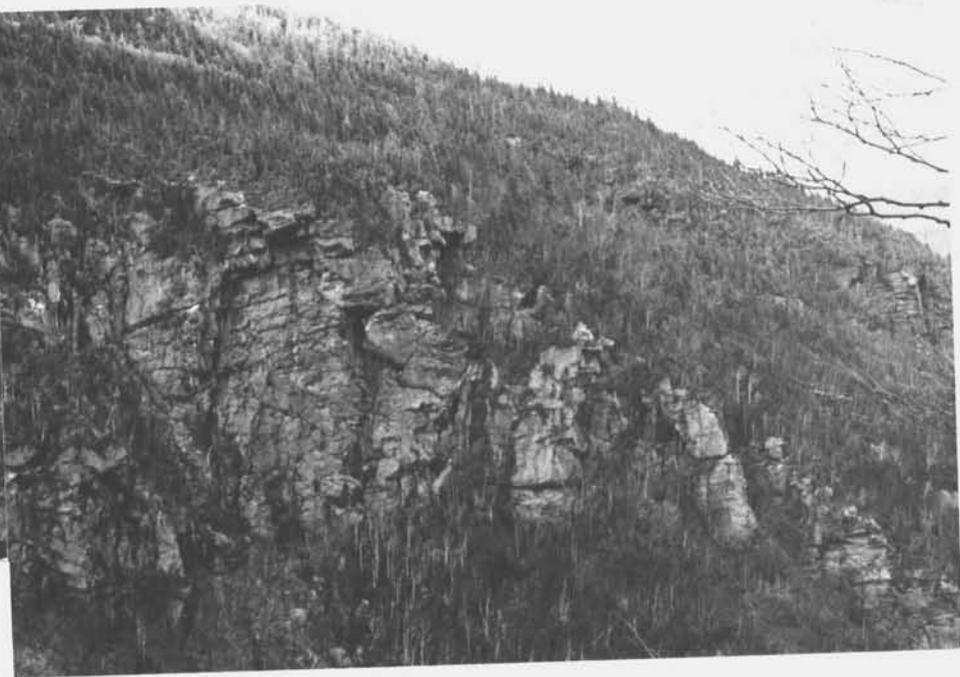
Plate I

Panorama of the west wall of Smugglers Notch, Mount Mansfield, Cambridge, Vermont. All views looking west. Photographs taken in October 1987.

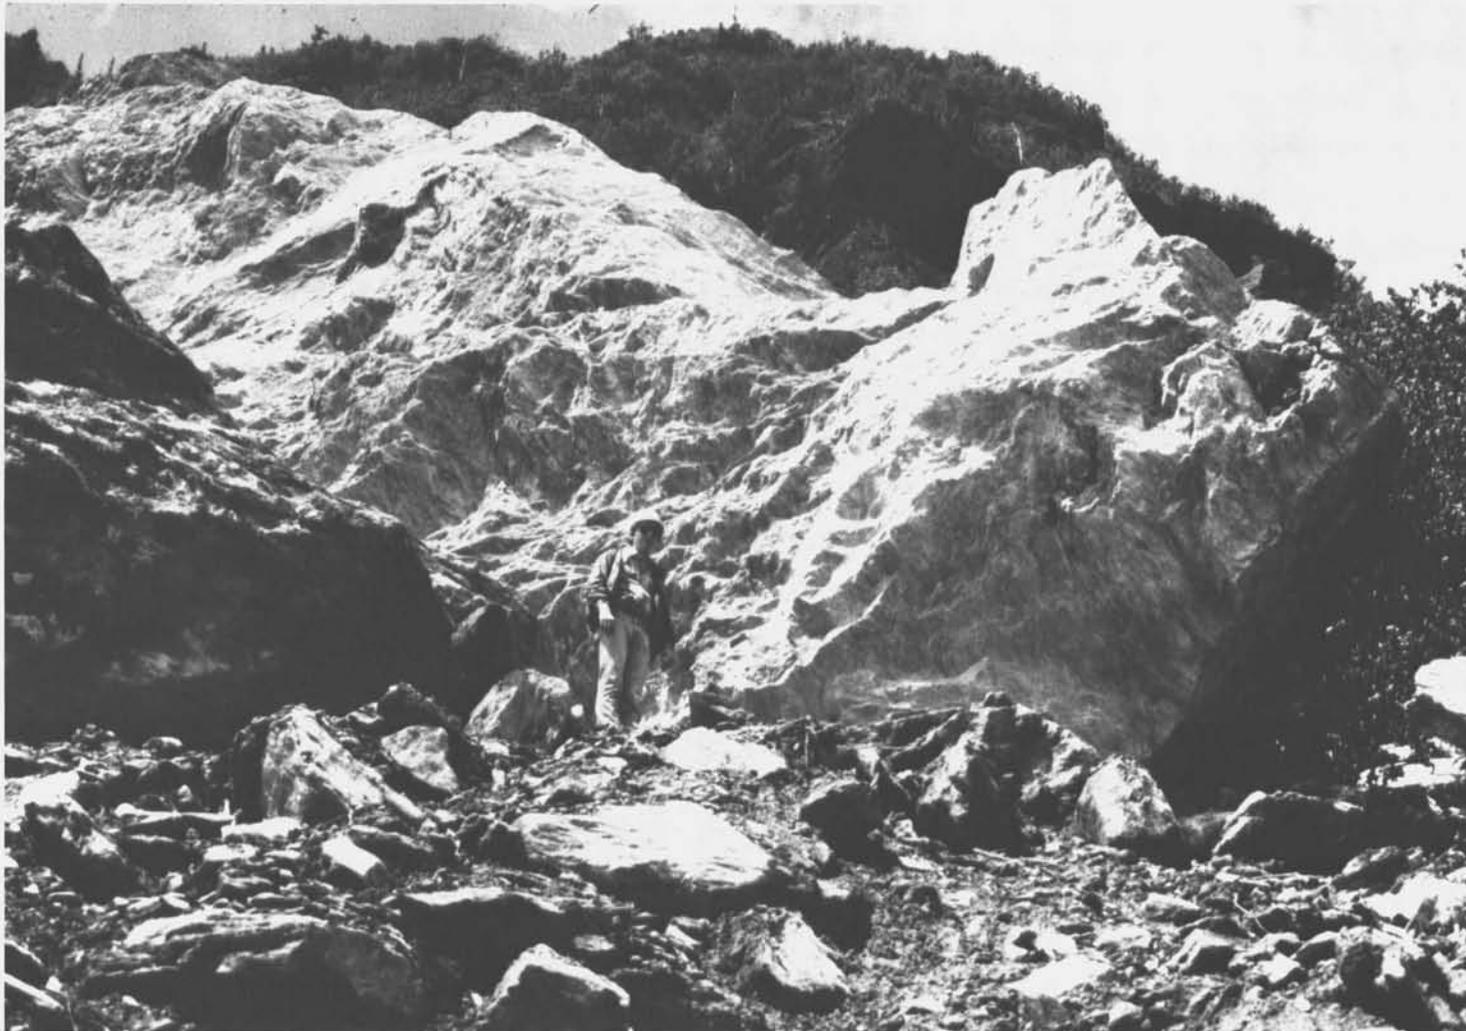
FIGURE 3

Photograph of the 2550 ton (23.1×10^5 kg) block that stopped about 1/3 of the way down the slope of the tributary valley in which the failure occurred. This block is visible in the Cover Photo.
