**Stowe Mountain Resort  
SMR 2000 Community Plan  
Water Quality Management Plan**

**2012 Monitoring Report**

May 31, 2013

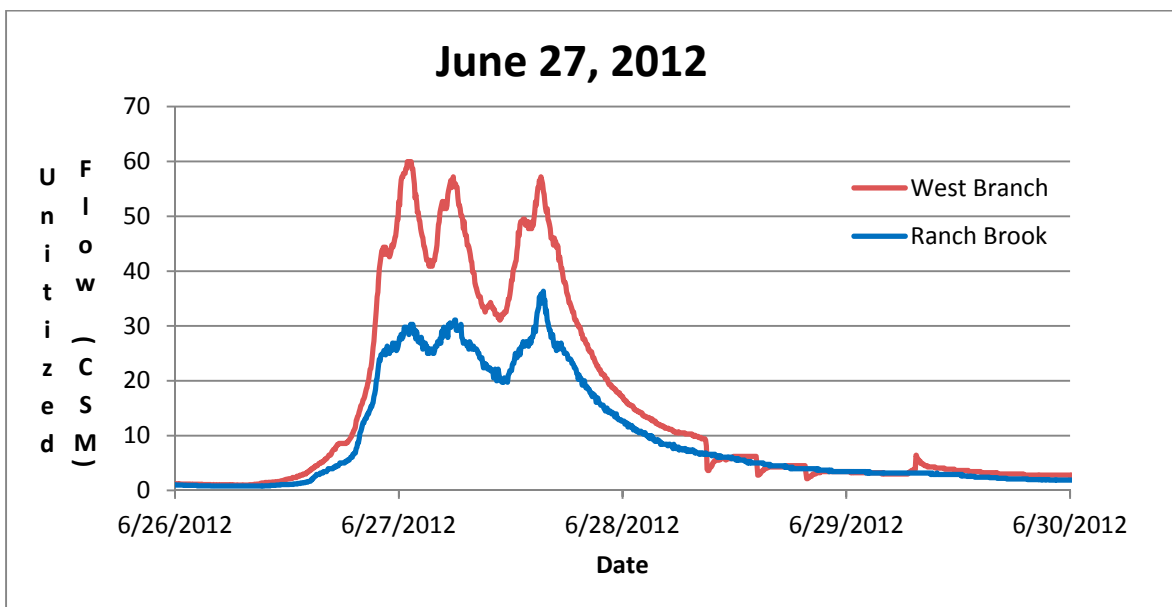
Based on data from U.S.G.S., the March 8, 2012 event resulted in the peak stream flow values for the year on Ranch Brook. The peak flow on Ranch Brook was 162 cfs (42.6 cfs/sq. mile). Peak flow data for the West Branch was not available for the majority of the event and the hydrographs could not be compared. The June 27, 2012 rain event resulted in the annual peak stream flow value for the West Branch. The peak flow on the West Branch was 280 cfs (60.0 cfs/sq. mile), compared with 138 cfs (36.3 cfs/sq. mile) on Ranch Brook. The peak flow in the West Branch was approximately 1.65 times the peak flow on Ranch Brook. Figure 2 shows the hydrographs, including the ascending and descending limbs, for the West Branch and Ranch Brook from June 26, 2012 to June 30, 2012.

**Figure 2. Unitized hourly stream flow for Ranch Brook and West Branch for June 27, 2012**

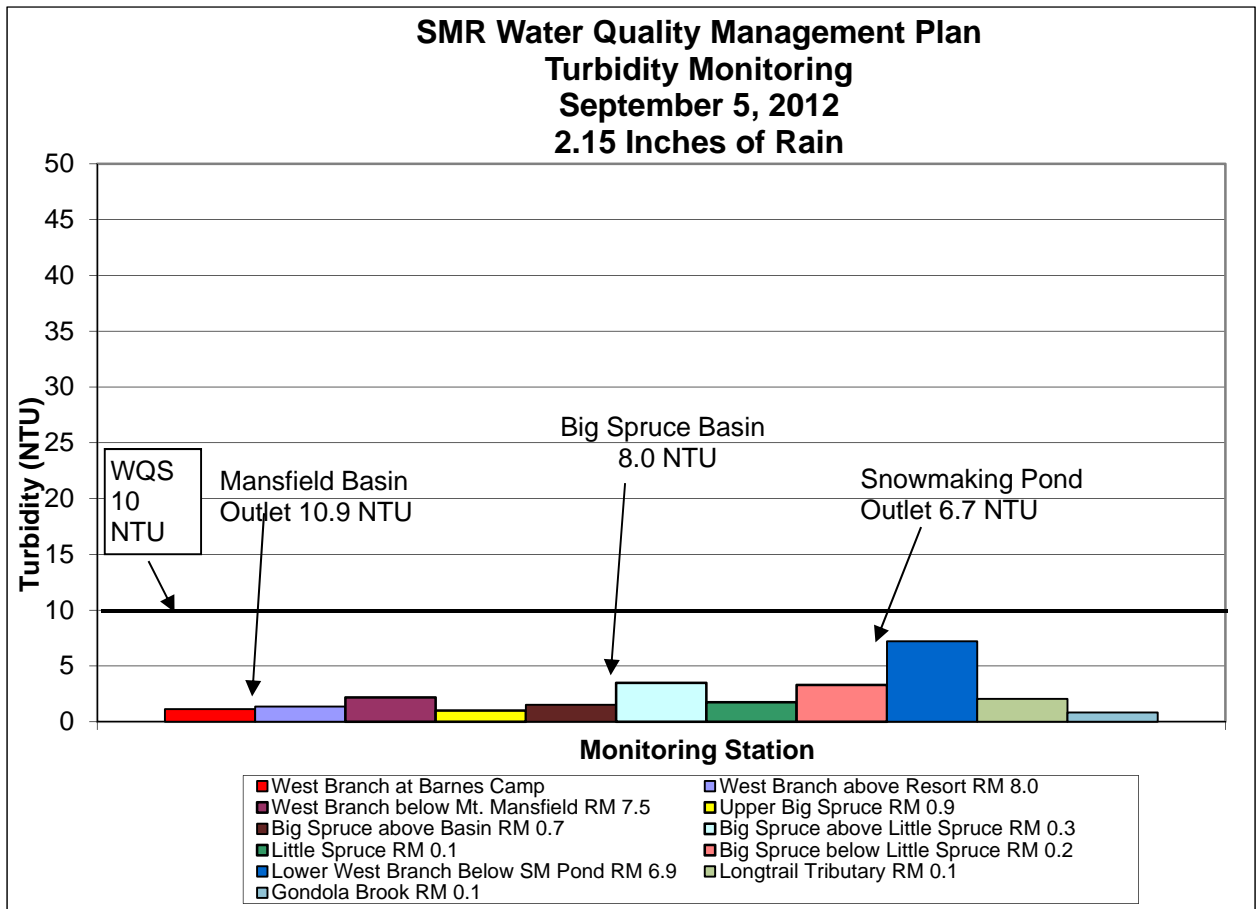
All surface water quality stations, except for the West Branch below the Snowmaking Pond station, had turbidity values less than 5 NTU for the September 5, 2012 rain event (Figure 9). The West Branch below the Snowmaking Pond station had a turbidity value of 7.2 NTU, which is still below the water quality standard of 10 NTU. Outflow from the Big Spruce

Basin, the Snowmaking Pond, and Mansfield Basin were noted to be slightly to moderately turbid at the time of sampling, but did not have elevated turbidity values. The outlet of the Snowmaking Pond was noted to have a high flow.

**Figure 9. Turbidity results from September 5, 2012**

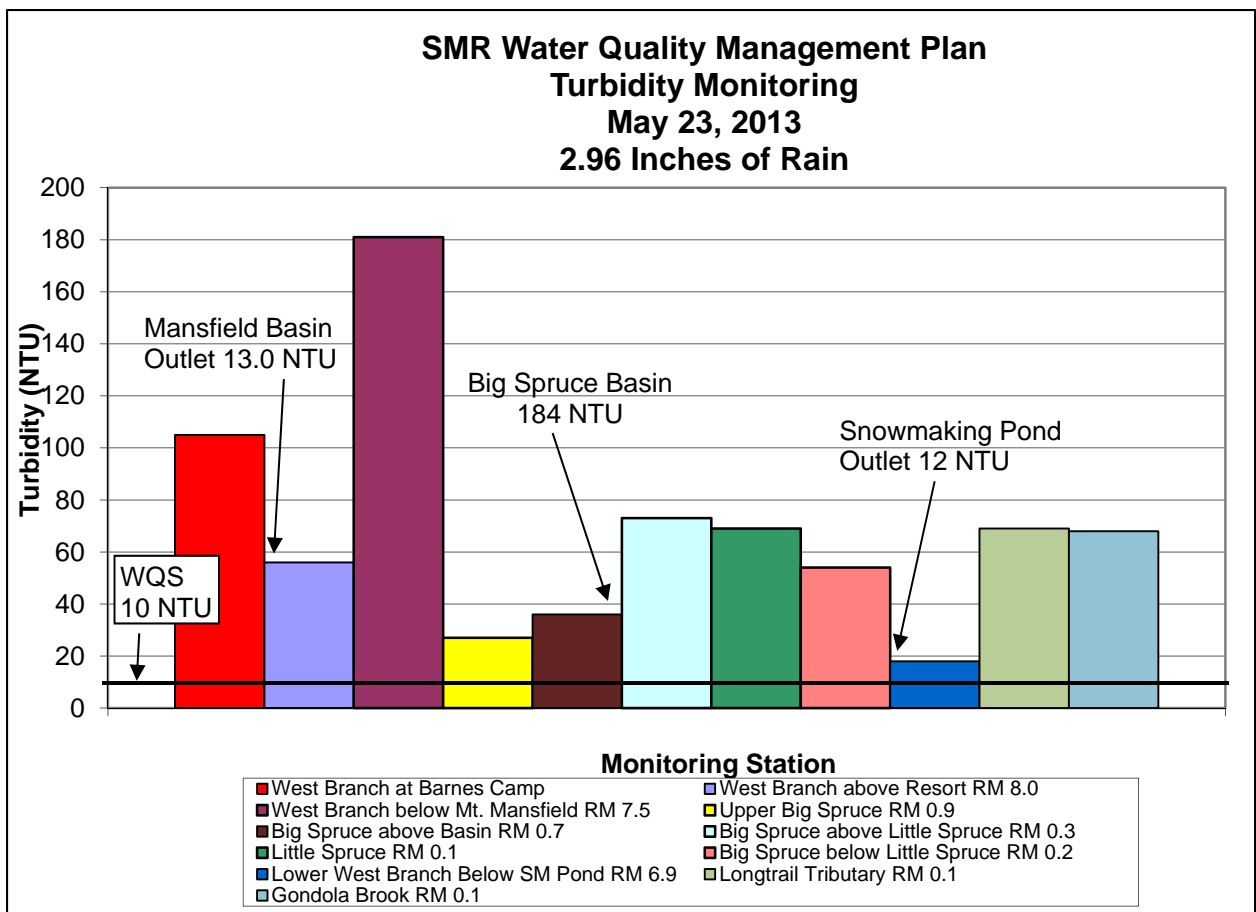
According to BCE field notes taken during sampling, all surface waters appeared turbid to very turbid. Outlet discharges were noted to all be slightly to moderately turbid. Lab results confirmed that all stream samples collected on May 23 had turbidity values greater than the water quality standard of 10 NTU (Figure 18). The Mansfield Exit Basin and Big Spruce Basin outlets had turbidity values greater than 100 NTU, while the Mansfield Basin and Snowmaking Pond outlets had turbidities less than 30 NTU. The range of turbidity values by station on May 23, 2013 are shown on the map in Figure 19. Please note that the turbidity categories on the map legend are different than previous maps in the report as a result of much higher turbidities for this extremely high flow event. Background turbidity levels were high for this event, as indicated by the elevated turbidity for the West Branch station at Barnes Camp (RM8.2) on May 23 of 105 NTU.

Club Brook has historically incised and is currently undergoing a widening process is resulting in eroded banks. Ski Club Brook, located outside of lands owned by the SMR, is a major source of sediment to Big Spruce Basin and Big Spruce Brook. The sample from the Big Spruce Basin outlet had a turbidity of 184 NTU.

Due to extremely high flows, there was difficulty in collecting the West Branch stream station below the Snowmaking Pond (RM6.9); as a result, the sample contained mostly water from the Snowmaking Pond outlet which effectively discharging water of much lower turbidity into the West Branch.

Figure 18. Turbidity results from May 23, 2013

Figure 19. Turbidity results from May 23, 2013

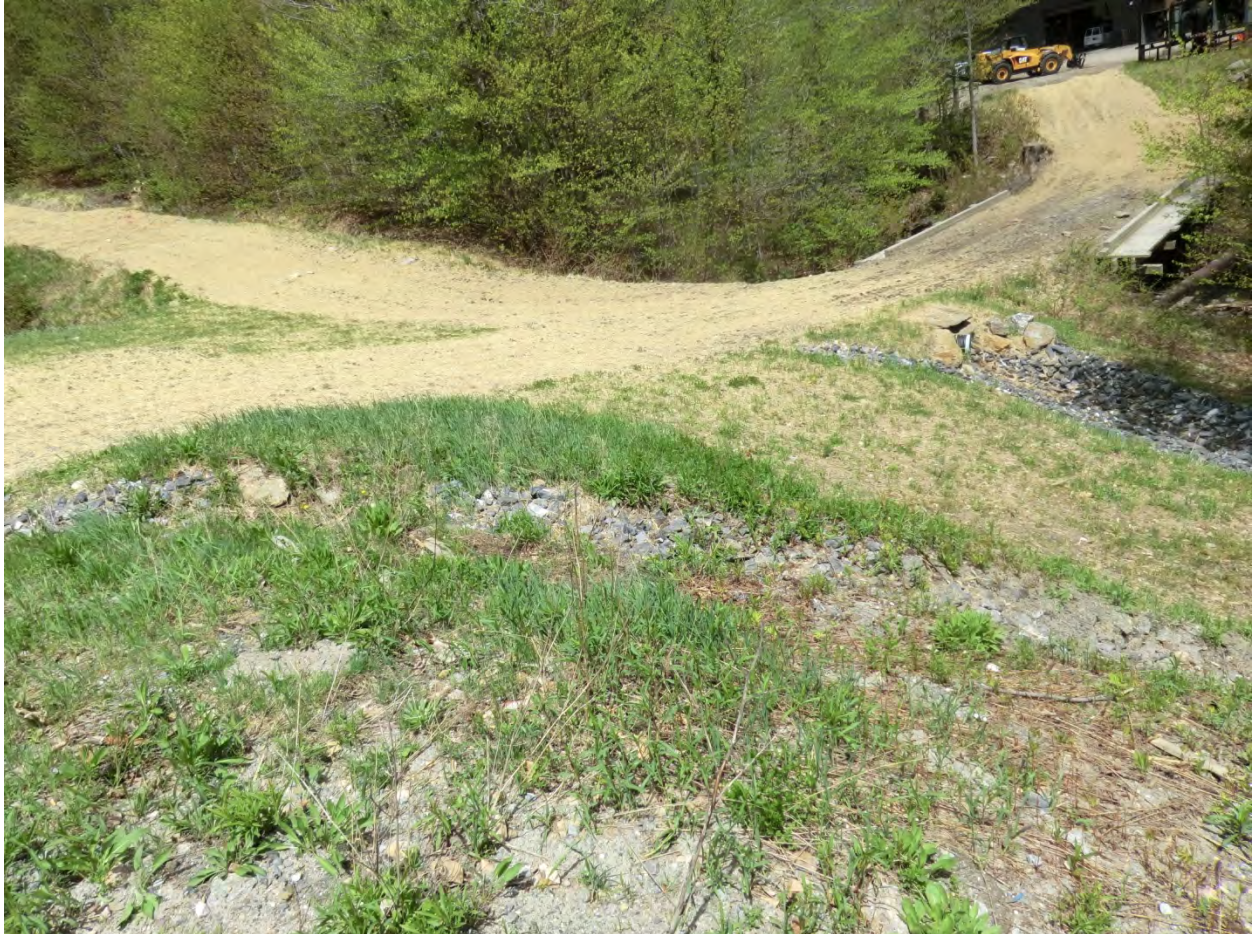
In June 2012, major improvements in the vicinity of the snowplant occurred (refer to pages 3 through 5 of Appendix 3). Existing swales around the snowplant were cleaned out and armored and rip rap stone check dams were installed to slow flows and remove sediment. A culvert was replaced along the work road adjacent to the plant, which is only used in the winter. The flow through the culvert was redirected into a new sediment basin that discharges into a low lying forested area (Figure 21).

Figure 21. Erosion control and stormwater management improvements in vicinity of Snowplant Work road, photo taken May 13, 2013 by Mary Nealon of BCE.

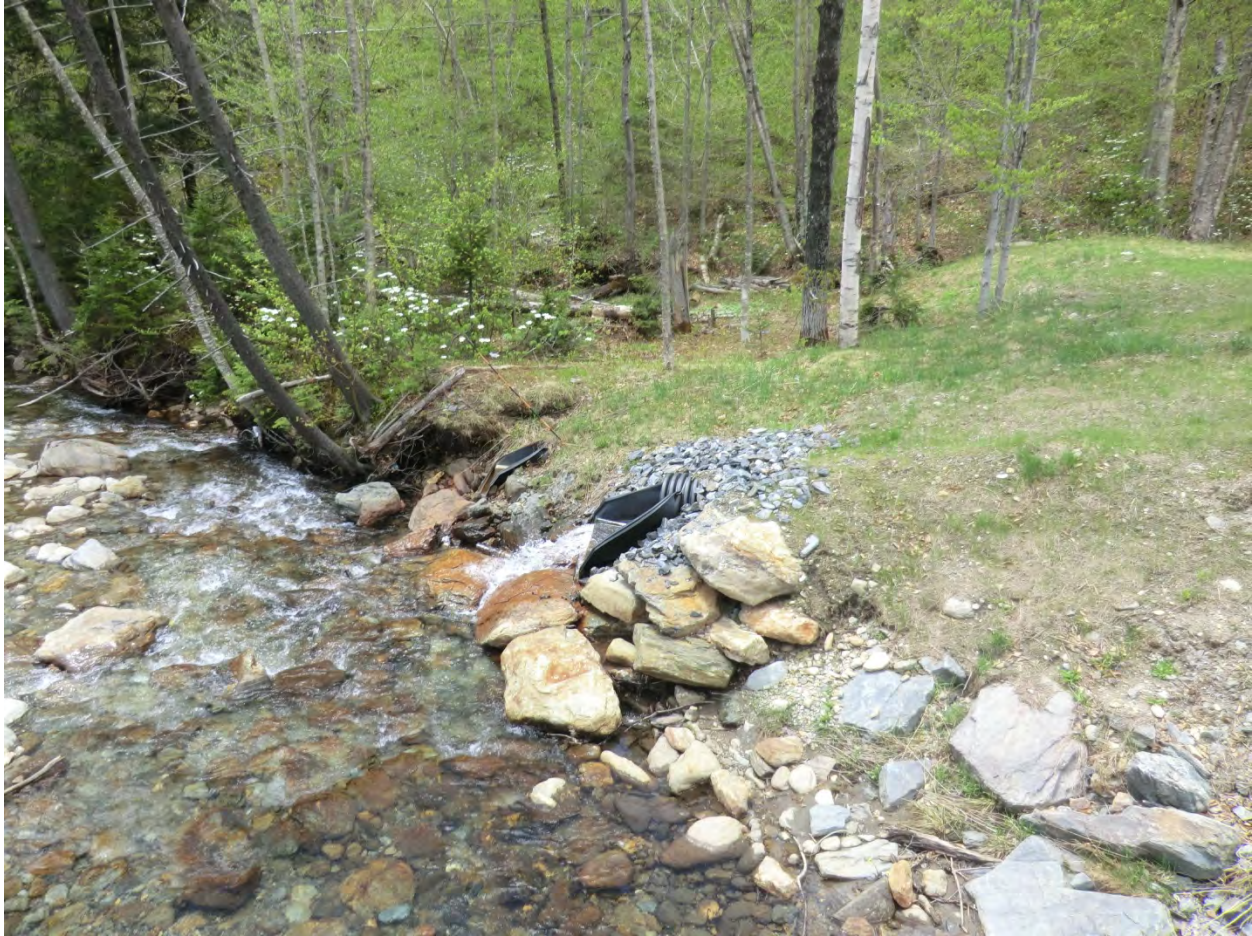
During August 2012, the on-mountain stream run-off was diverted from this area and now directly discharges into the West Branch (see Figure 22). Multiple culverts were replaced or realigned to make this stream/stormwater separation. The separation was implemented in order to increase the handling capacity of the current storm water system (refer to pages 21 and 22 of Appendix 3).

**Figure 22. Separation of on mountain stream run-off and stormwater at Mansfield Exit; photo taken on May 13, 2013, by Mary Nealon of BCE.**

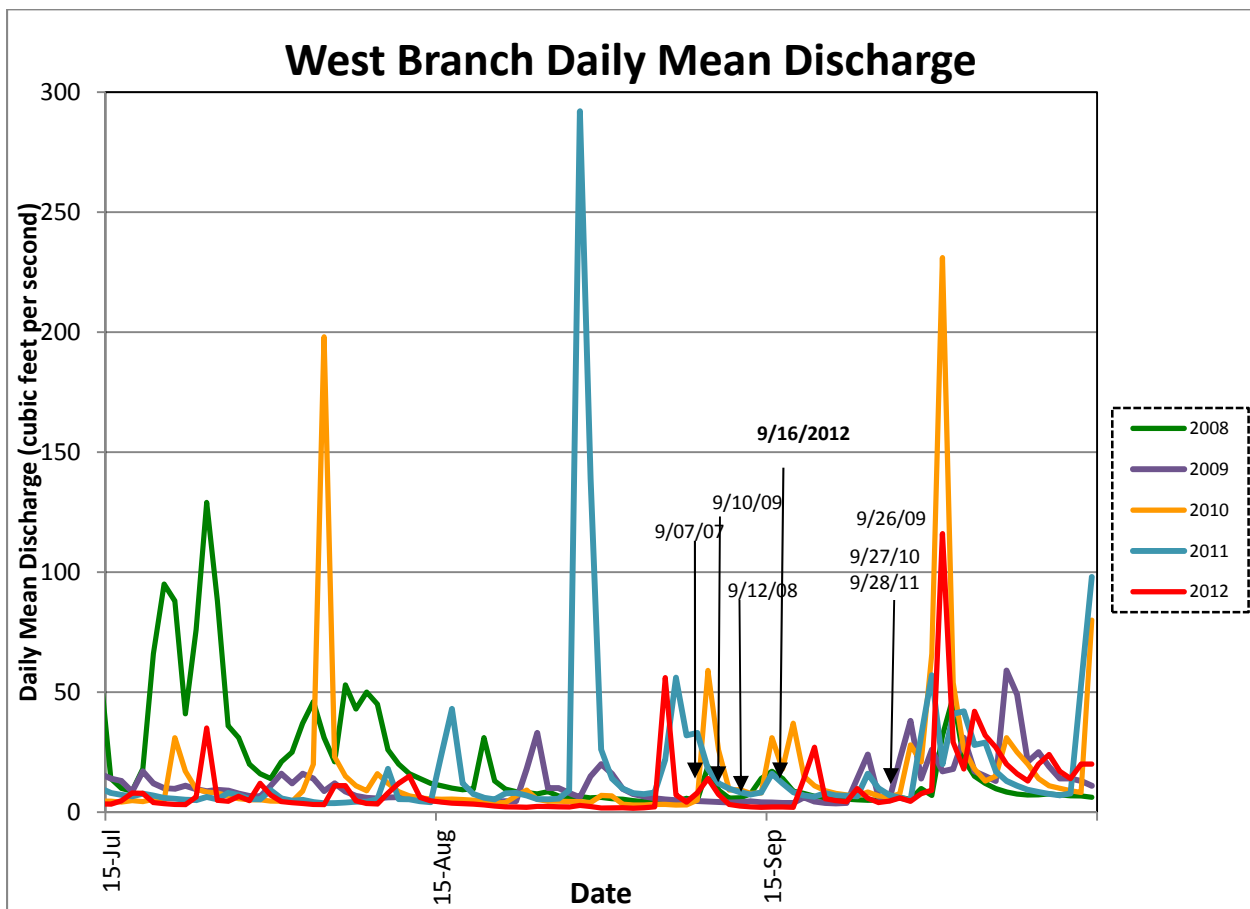
Macroinvertebrate kick net sampling and habitat assessments were conducted by Catherine Szal on September 16, 2012. Biomonitoring and habitat assessments were conducted on the four West Branch stations, two Big Spruce Brook stations, and one Pinnacle Brook station. The sampling took place under moderate flow conditions. Two replicate kick net samples were collected at each station with the exception of Big Spruce RM 0.3, where habitat is limited. Figure 25 shows the flow conditions in the West Branch for the past five monitoring years. During the 2010 field season, a large flood event occurred during early August, causing major damage at the resort and changes to the channel morphology and extreme scouring of the bed. A second flood event took place about a week after the kick net samples were collected on

September 26, 2010. During 2011, the daily mean stream flow exceeded 250 cfs as a result of Tropical Storm Irene. During July 2008, stream flows were higher than average, causing scouring of the substrate on a regular basis during the mid-portion of the summer. A number of large storm events preceded the kick net sampling performed by Bear Creek Environmental in 2006. The 2009 and 2012 monitoring seasons are characterized as having low to moderate flows. Stream flow conditions prior to sampling appear to be strongly correlated with density and richness of macroinvertebrates in the West Branch and tributaries (Bear Creek Environmental, 2010).

Figure 25. Daily mean discharge on West Branch between mid-July and mid-October for monitoring years 2007 through 2012

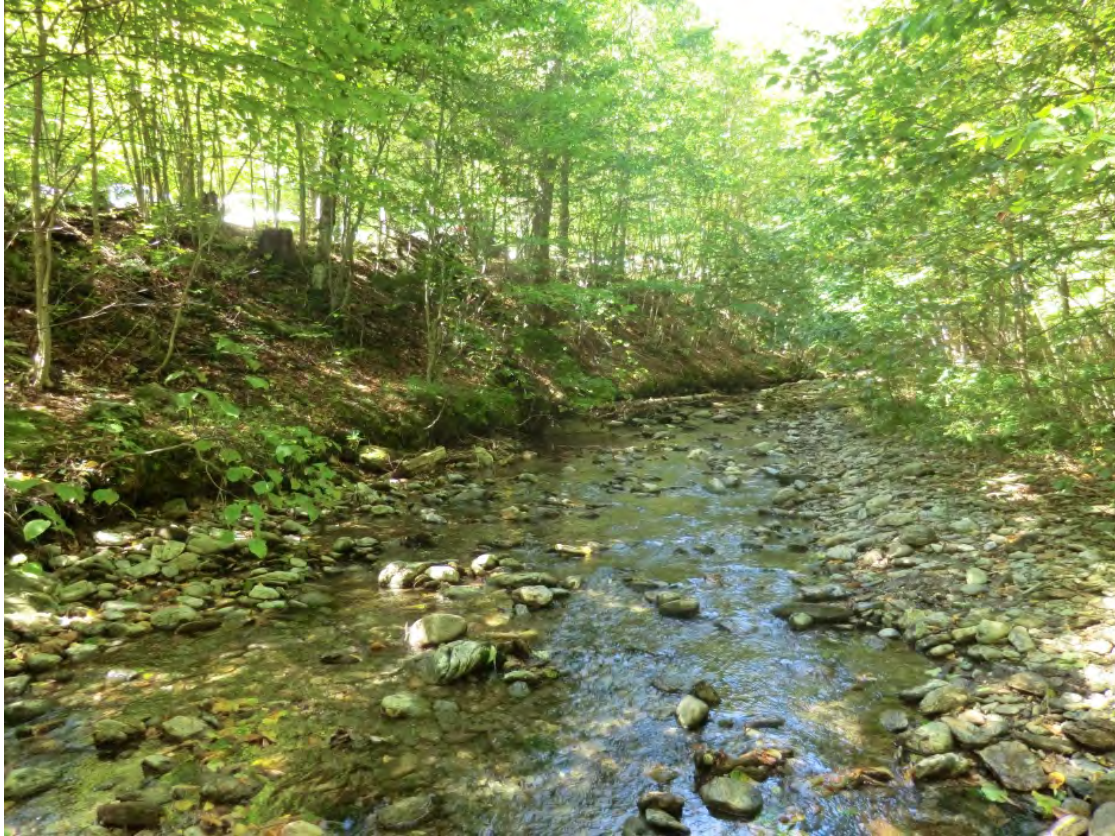
There was light sand and silt noted at West Branch RM8.8 station. Embeddedness was estimated to be 25%. Stream bank stability was fair (25-50% stable). The canopy was partly open given the start of leaf fall, and the percent canopy was 70 percent (Figure 26).

**Figure 26. West Branch RM 8.8 in picnic area off of Route 108 (9/16/2012)**

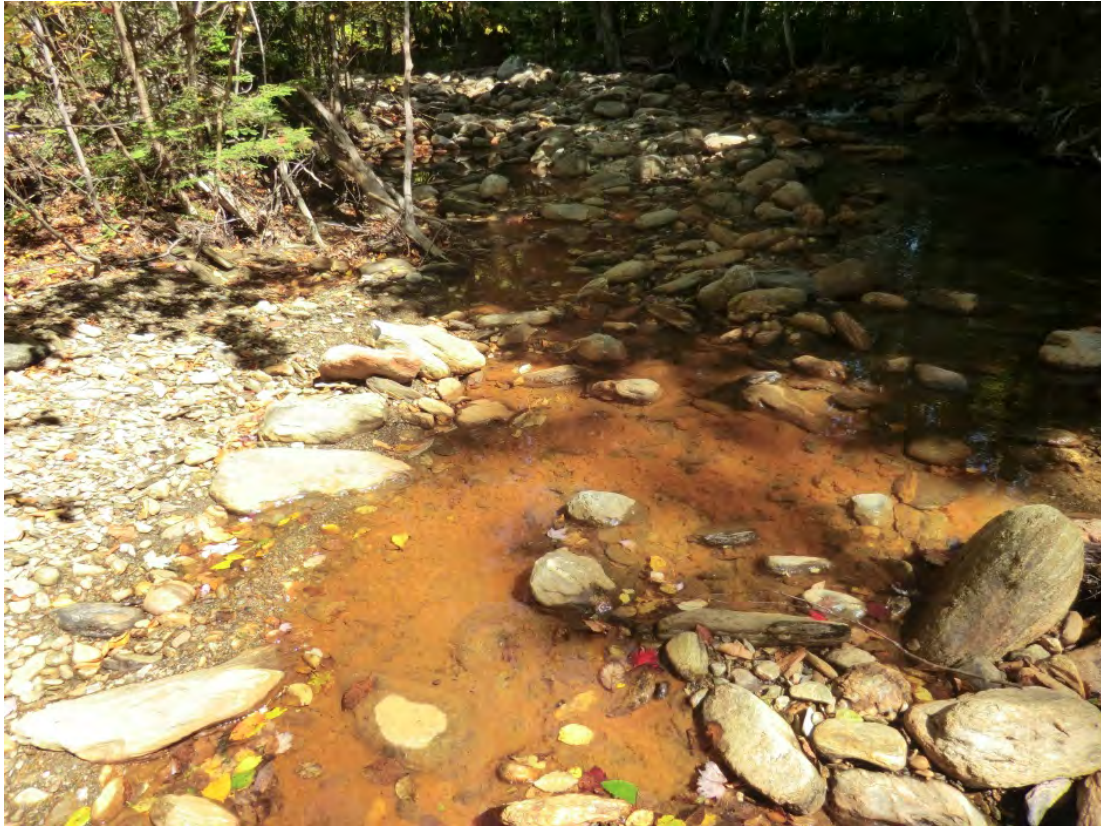
West Branch RM 8.0 is located downstream of the transfer lift crossing. Sandy and silt patches in the substrate were noted with embeddedness ranging from 5-25 percent (very good). Bank stability was good (50-75% stable). Canopy cover was estimated to be 50 percent. The diatom cover was 90 percent. Iron staining was common, with several iron seeps present. A strong iron seep was noted along the west side of the channel, adjacent to the Mansfield parking lot (Figure 27).

**Figure 27. Iron staining at West Branch RM8.0  
(9/16/2012)**

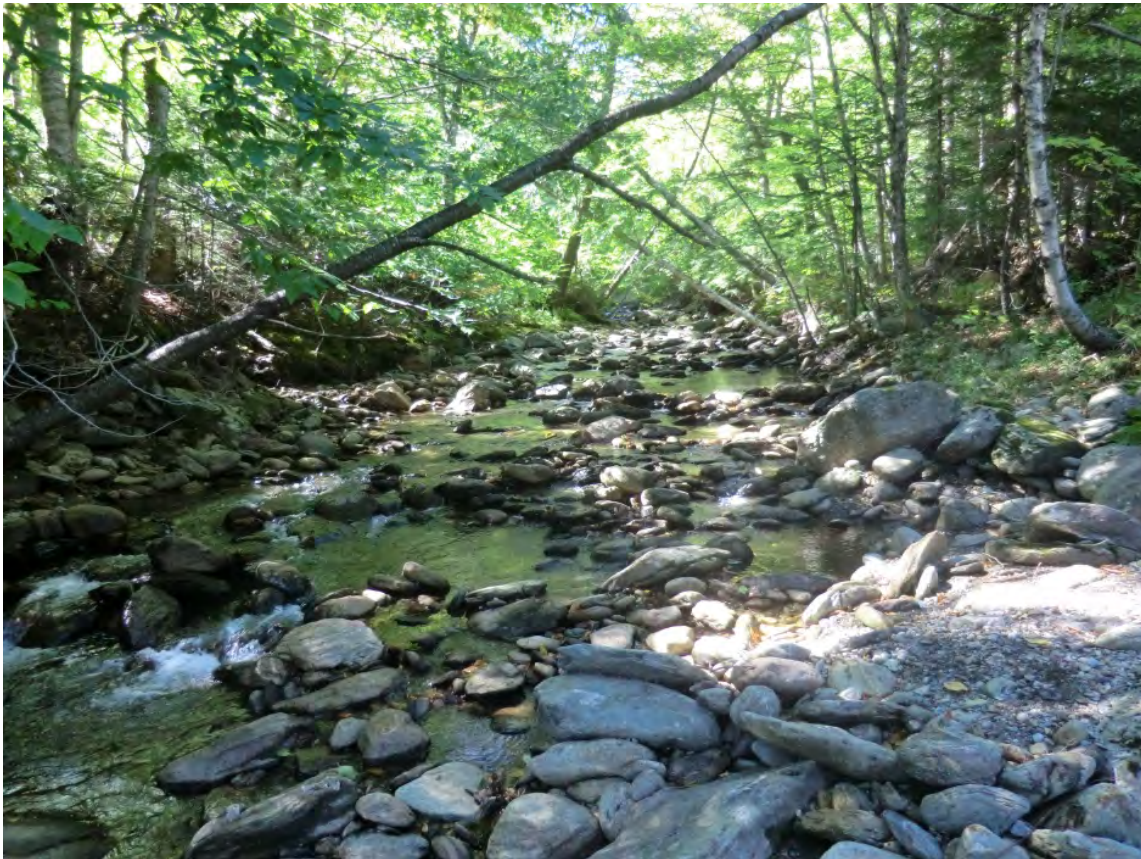
The August 4, 2010 flood event resulted in bank erosion and a buildup of sediment near the upper end of West Branch RM7.5. The high flows in August 2010 also exacerbated the stability of the valley wall, creating further instability of mass failures. In fall 2011, very little CPOM was noted; in 2012, little to moderate CPOM was noted. This suggests that the leaf pack is reestablishing in this area. Embeddedness was estimated to be 5-25% with a lot of sand and gravel in interstitial spaces. Slight iron staining was noted. Bank stability was rated as good (50-75% stable). Canopy cover was estimated to be 80 percent, as shown in Figure 28.

**Figure 28. West Branch RM7.5  
(9/16/2012)**

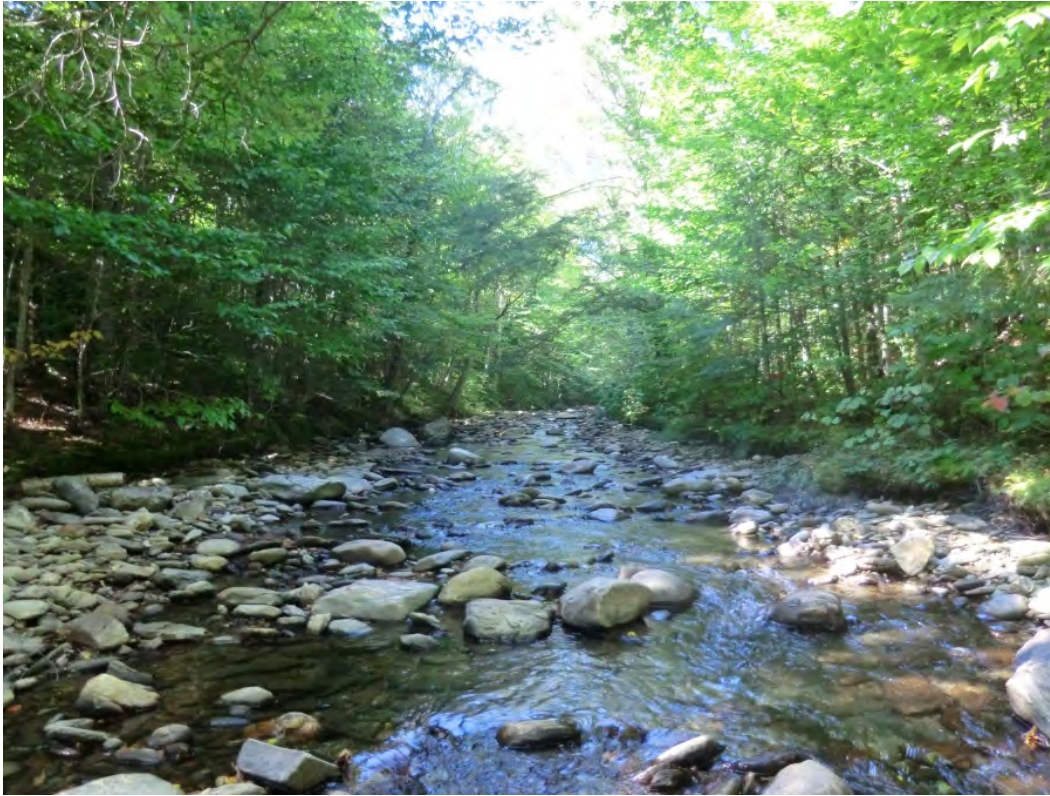
The lowest West Branch monitoring station was impacted by the August 4, 2010 high flow event, but the changes were not as dramatic as the other monitoring stations on the West Branch and Big Spruce Brook. The overall channel morphology was noted to be better in 2012 than in 2011 (Figure 29). Figure 30 shows an area of bank erosion near the confluence with Pinnacle Brook. Sand and gravel appear to be moving through this area. Bank stability was rated as good (50-75% stable). Substrate embeddedness was rated as 5-25 percent within the area the kick net samples were collected, and 0-25 percent within the pebble count reach. The diatom coverage was approximately 90 percent. Canopy cover was estimated to be 60 percent.

**Figure 29. West Branch RM 6.5 above the confluence with Pinnacle Brook (9/16/12)**

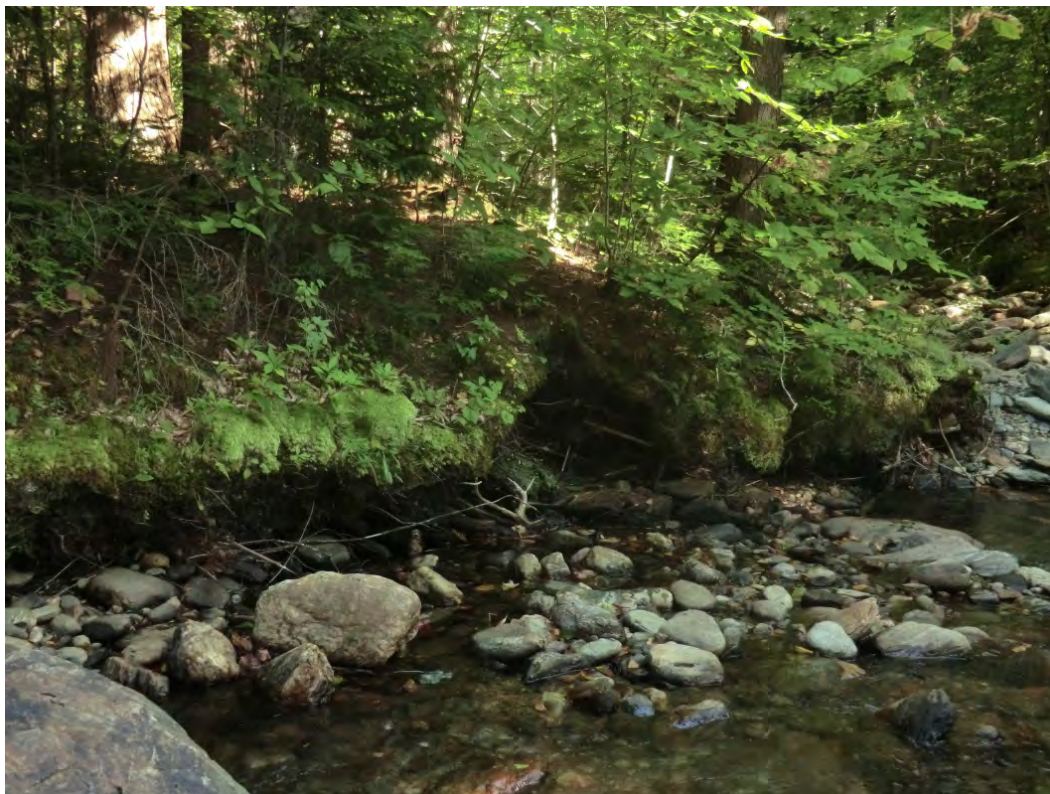
**Figure 30. West Branch RM 6.5. had bank erosion at the downstream end (9/16/12)**

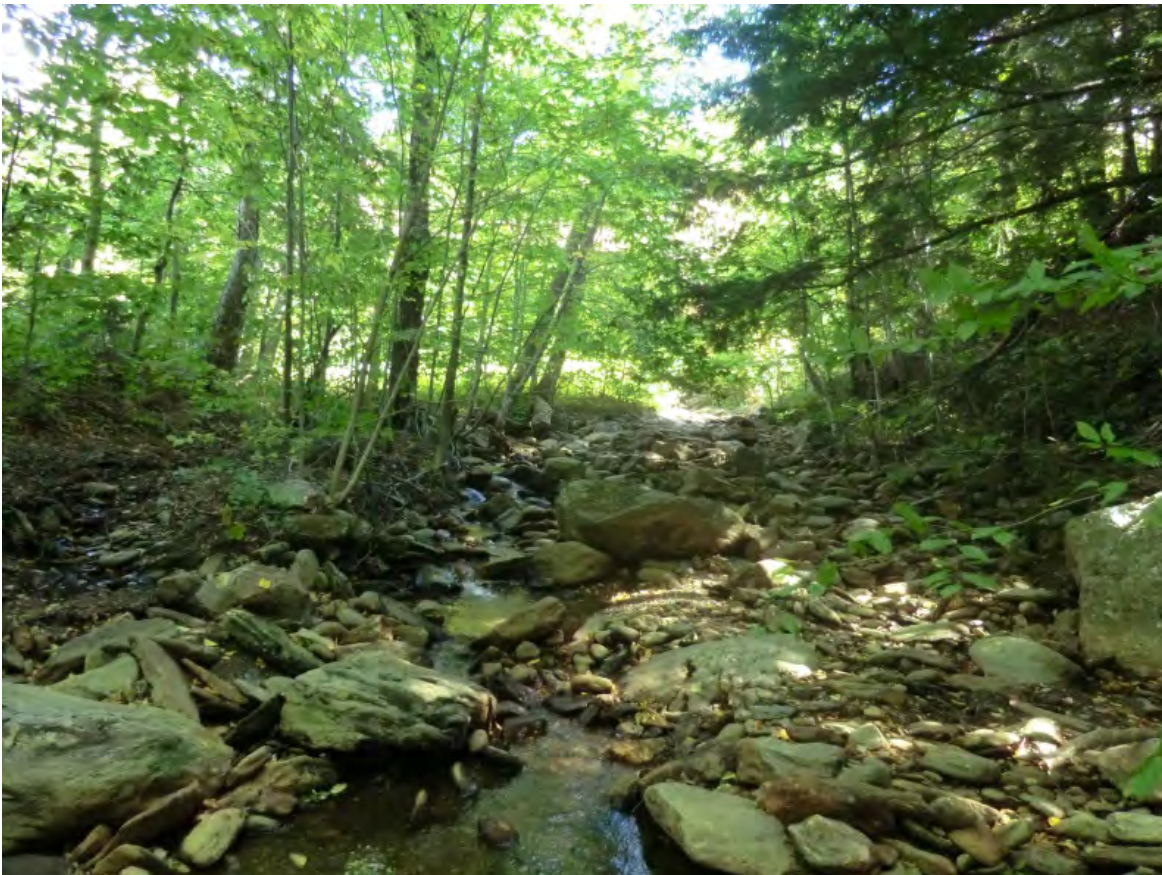
Several active iron seeps were noted in 2012. One major iron seep was remediated in October 2010 using limestone to intercept and treat the groundwater; however, the limestone became clogged and repair work was conducted in late fall 2011 to allow the groundwater to flow freely through the limestone treatment area. For this reason, one kick net sampling was conducted immediately upstream of the active iron seep in 2012 (Figure 31). The site was 5-25 percent embedded, with an estimate of 10 percent overall. Bank stability was rated as good (50-75% stable). Canopy cover was 60 percent at the time of sampling.

**Figure 31. Big Spruce Brook RM 0.3 (9/16/12)**

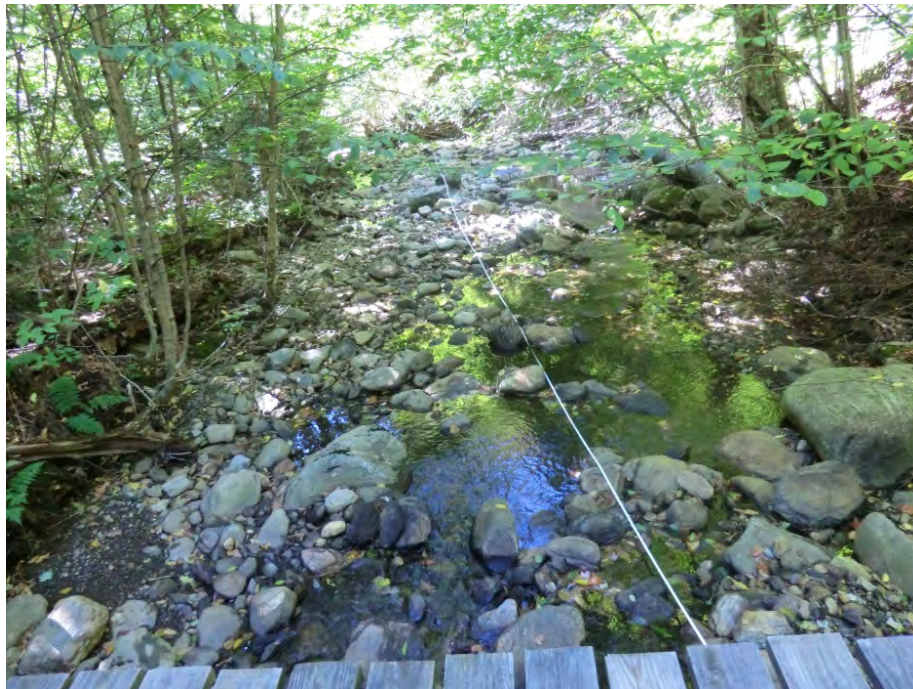
stability was rated as fair (25-50% stable). The embeddedness was rated as 5-25 percent (very good), although the silt rating was high. Percent canopy cover averaged 60 percent. Figure 33 shows a downstream view of the station.

**Figure 33. Looking downstream from footbridge at Big Spruce RM0.2 (9/16/12)**

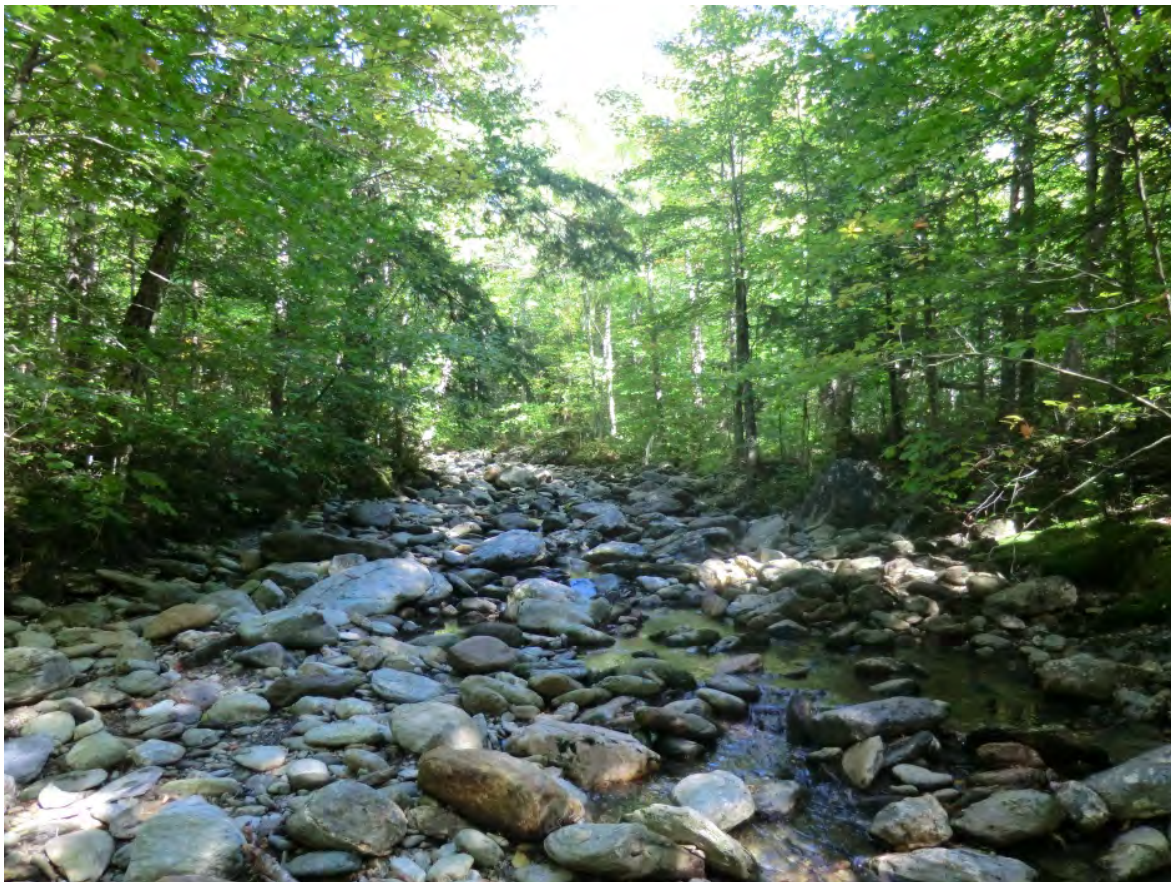
According to the 2011 report, the August 2010 high flow event did not have as much of an effect on the Pinnacle Brook RM0.1 station. In 2012, bank stability was rated as excellent (75-100 percent stable). Embeddedness was very good (5 to 25 percent). Quite a bit of gravel was noted to be moving through this station. Canopy cover was approximately 70 percent. There was 90% diatom cover and a trace of blue-green algae. Figure 34 shows the Pinnacle Brook monitoring station.

**Figure 34. Pinnacle Brook monitoring station (9/16/12)**

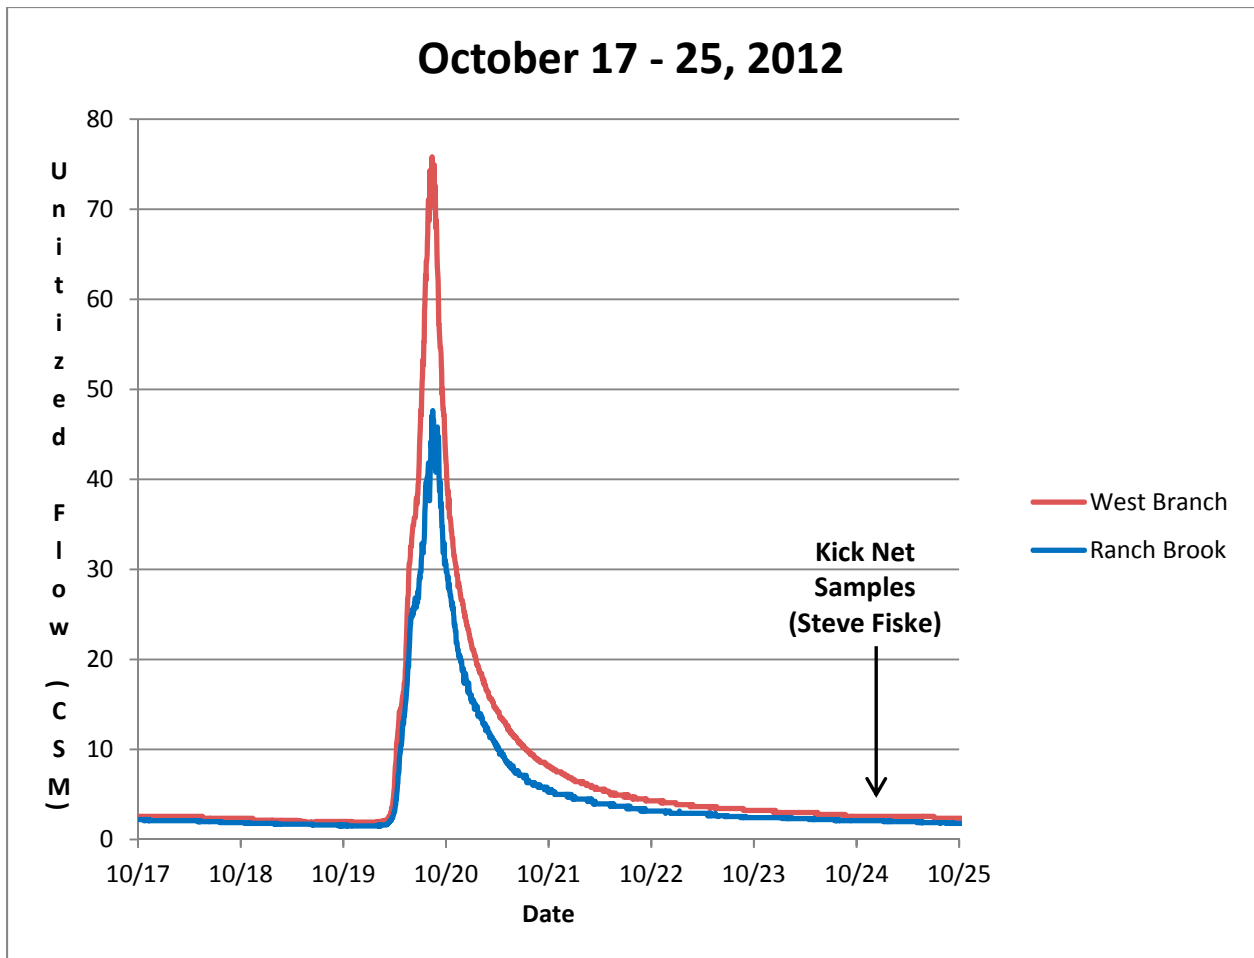
**West Branch of Little River – RM 8.0:** The upper West Branch station was added in 2006 to provide a control station on the West Branch that is located above the discharge from the Mount Mansfield sedimentation basin. Bear Creek Environmental sampled at Stowe Mountain Resort in mid-September 2012 under baseflow conditions following a field season with stable flow conditions. These September 2012 samples are the first set of samples that have met Class B2-3 water quality standards in the seven years of monitoring. Steve Fiske also collected kick net samples during fall 2012 and sampled on October 24, 2012 following a freshet event that took place on October 19, 2012 (Figure 35).

**Figure 35. Unitized flows for the West Branch and Ranch Brook from October 17 through 25, 2012. Kick net samples on the West Branch were collected following the October 19, 2012, high flow event.**

Other than the Pinkham Pearson Coefficient of Similarity (PPCS) index, the metrics met Class B2-3 biocriteria. The PPCS reflects a shift in functional feeding groups possibly due to rapid recolonization after the freshet event.
