**Stowe Mountain Resort  
SMR 2000 Community Plan  
Water Quality Management Plan**

## **2015 Monitoring Report**

June 9, 2016

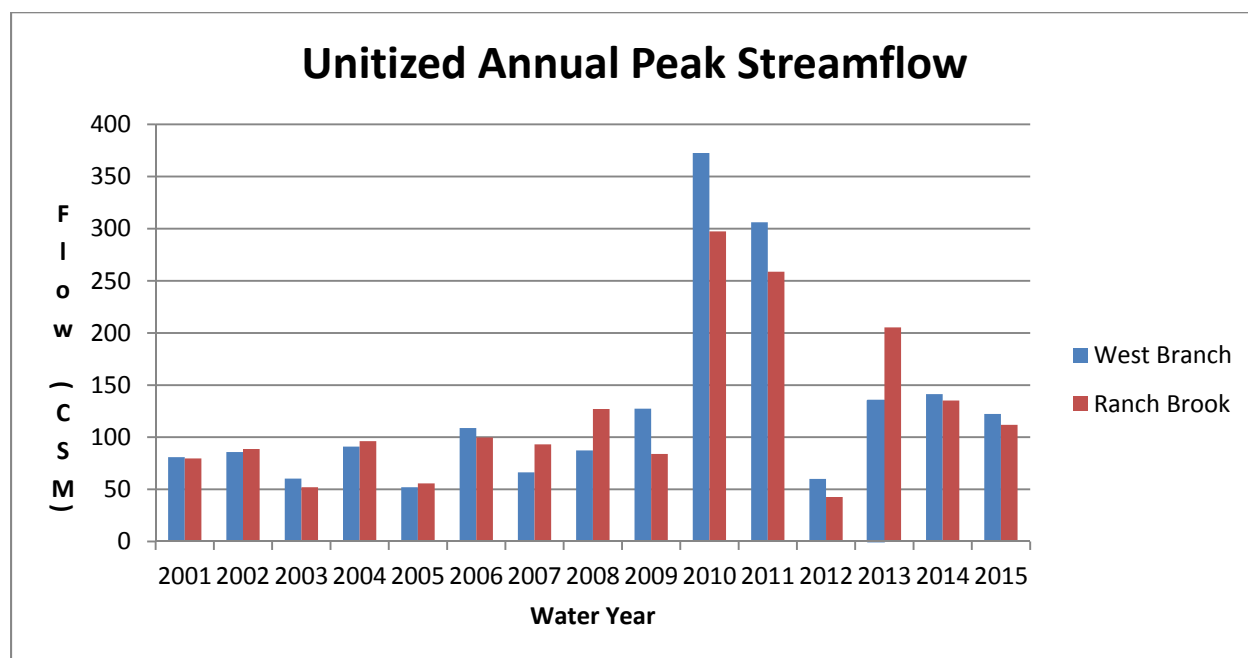
**Figure 1. Annual unitized peak stream flow values for the West Branch and Ranch Brook**

Based on data from U.S.G.S., the rain event that began on June 8, 2015 resulted in the peak stream flow values for the year on June 9<sup>th</sup> for both the West Branch and Ranch Brook. The total precipitation for the event was 5.07 inches on top of Mt. Mansfield and 3.21 inches in the vicinity of the resort. The peak flow in the West Branch watershed was 571 cfs (122.3 cfs/sq. mile) compared with 425 cfs (111.8 cfs/sq. mile) in the Ranch Brook watershed based on data from the USGS. The peak flows for the West Branch and Ranch Brook for the 2015 water year were close to the mean peak flows for the period of record (2001 through 2015).

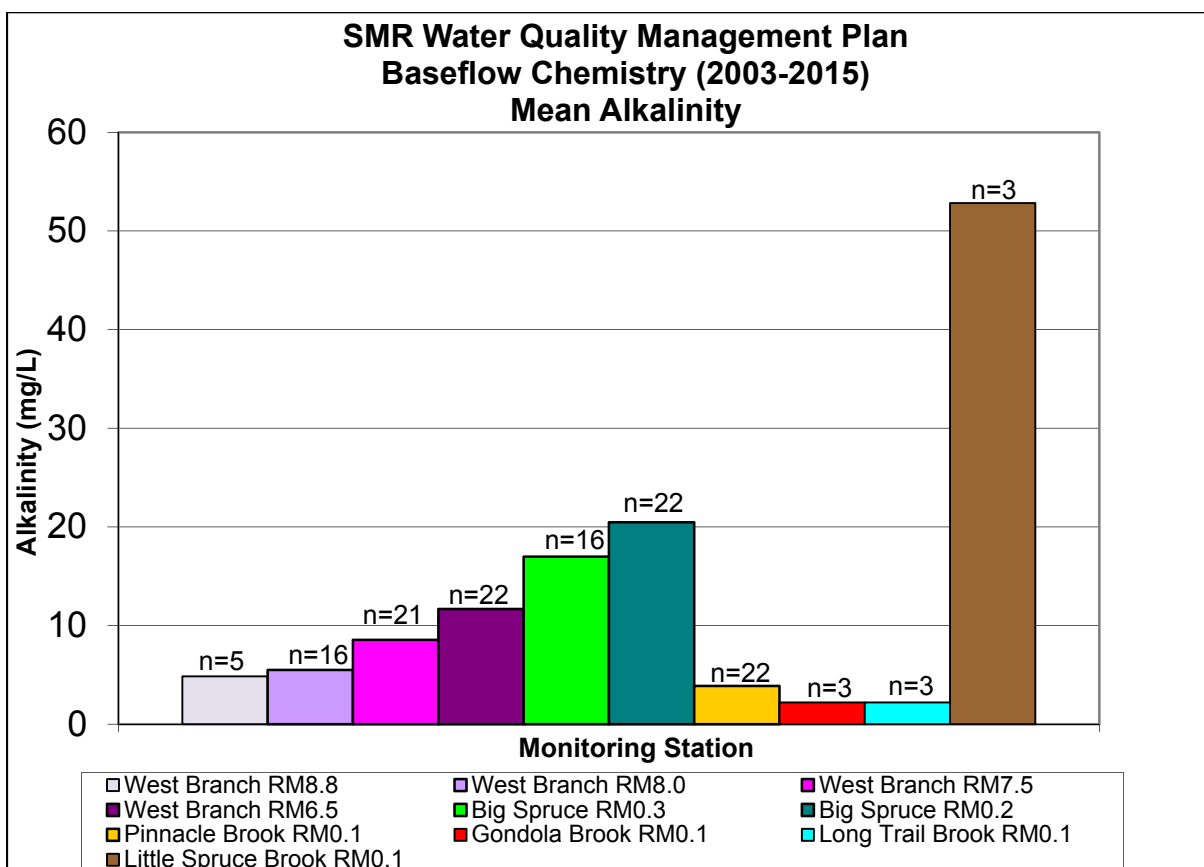
**Figure 2. Mean alkalinity for biomonitoring stations**

The Big Spruce stations have had the highest alkalinity historically; while Pinnacle Brook, Long Trail Brook, Gondola Brook, and the upper West Branch stations have the lowest. For past years, alkalinity has shown an increasing trend from upstream to downstream on the West Branch. For the September 2015 sampling round, Little Spruce Brook at RM 0.1 had the highest alkalinity by far, as mentioned above. Big Spruce Brook was next highest at RM 0.2 (54 mg/L CaCO<sub>3</sub>), followed by Big Spruce at RM 0.3 (35 mg/L). The lowest alkalinity values were observed for the stations on Gondola Brook and Pinnacle Brook, both at 2.2 mg/L CaCO<sub>3</sub>. The alkalinity values at the upper West Branch stations, RM 8.8 and 8.0, were also very low at 2.5 mg/L as CaCO<sub>3</sub>, as were the alkalinities on Long Trail Brook and Big Spruce RM 0.9 (2.6 and 2.9 mg/L CaCO<sub>3</sub>, respectively). These low alkalinity values suggest that some of the streams at and surrounding Stowe Mountain Resort have a very low buffering capacity and are susceptible to the impacts from acid precipitation.

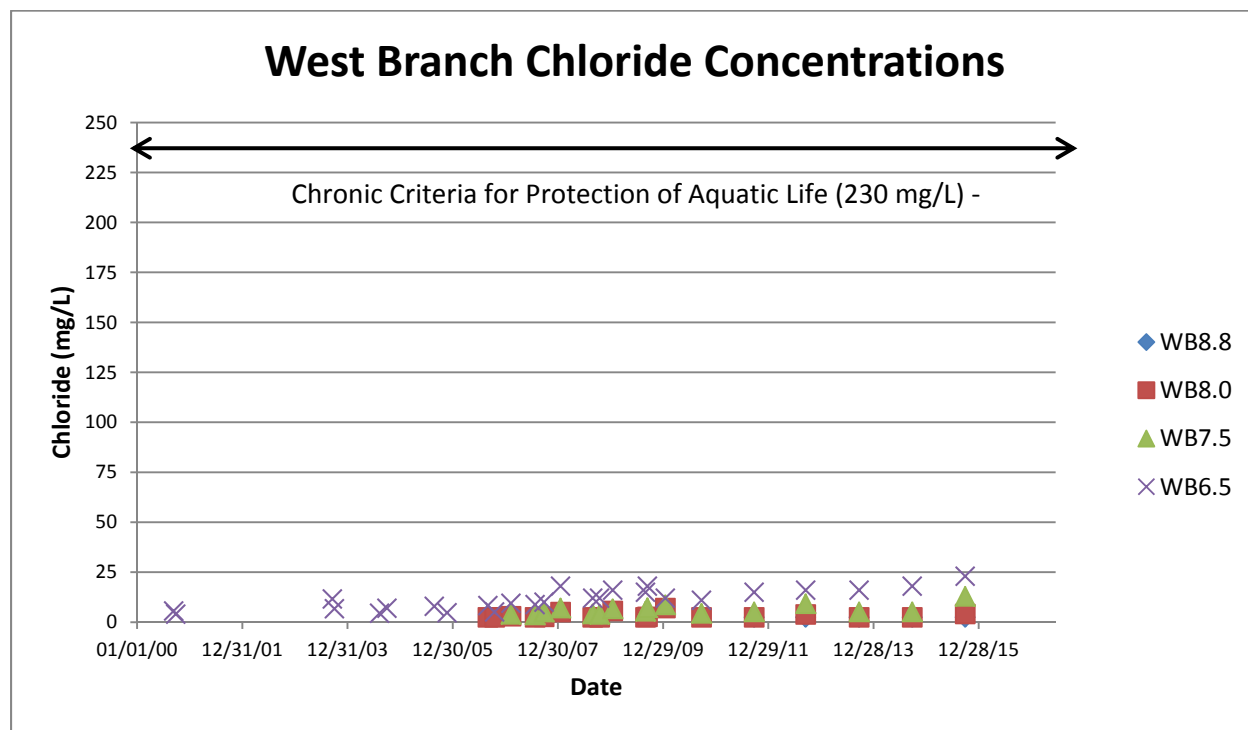
**Figure 3. Chloride concentrations from 2000 through 2015 for West Branch of Little River**

Chloride concentrations for the West Branch watershed and the Spruce Peak watershed over time are plotted below in Figures 3 and 4. As shown in Figure 3, the chloride concentrations at all the stations West Branch stations under baseflow conditions have been less than 25 mg/L. These concentrations are well below the chronic criteria for protection of aquatic life, which is listed as 230,000 µg/L (230 mg/L) in the Vermont Water Quality Standards (State of Vermont, 2014). As expected, the most downstream West Branch station sampled (WB6.5) had slightly higher chloride concentrations than the upstream stations. The average concentration for the 24 samples at WB6.5 is 11.4 mg/L.

Chloride concentrations were lowest at the most upstream station, WB 8.8 and were less than the detection limit of 2.5 mg/L for the annual sampling that was conducted in September 2011 through 2015. Water quality samples collected at Gondola Brook and Long Trail Brook, which enter upstream of WB8.0, were also less than the detection limit in 2013-2015.

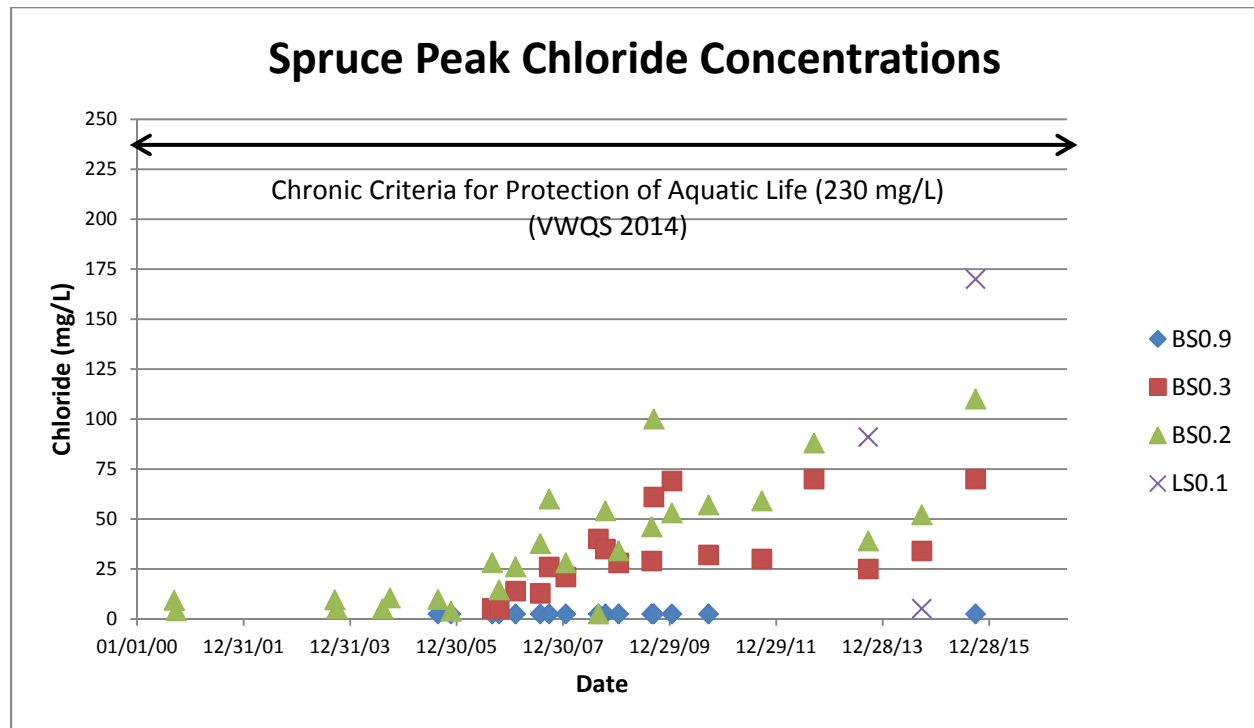
Figure 4. Chloride concentrations from 2000 through 2015 for Spruce Peak

Baseflow sampling in the Spruce Peak watershed has been conducted for different lengths of time at the monitoring stations. BS0.2, the most downstream station at Big Spruce Brook has the longest period of record (2000, 2003-2015). Chloride concentrations at this most downstream station suggest an upward trend over time. Baseflow sampling has been conducted at BS0.3 since 2006. In general, chloride concentrations at BS0.3 have been slightly lower than BS0.2. The most upstream Big Spruce station (BS0.9) has been sampled 16 times over the years with chloride concentrations being recorded less than the detection limit of 2.5 mg/L each time. The highest chloride concentrations recorded have been at the Little Spruce station, near the mouth of the brook. Baseflow sampling has been conducted at LS0.1 annually during the past

three years. Chloride concentrations at LS0.1 have ranged between 5.2 mg/L in 2014 to 170 mg/L in 2015. The most recent chloride value is elevated, but still below the chronic criteria for chloride listed in the VWQS.

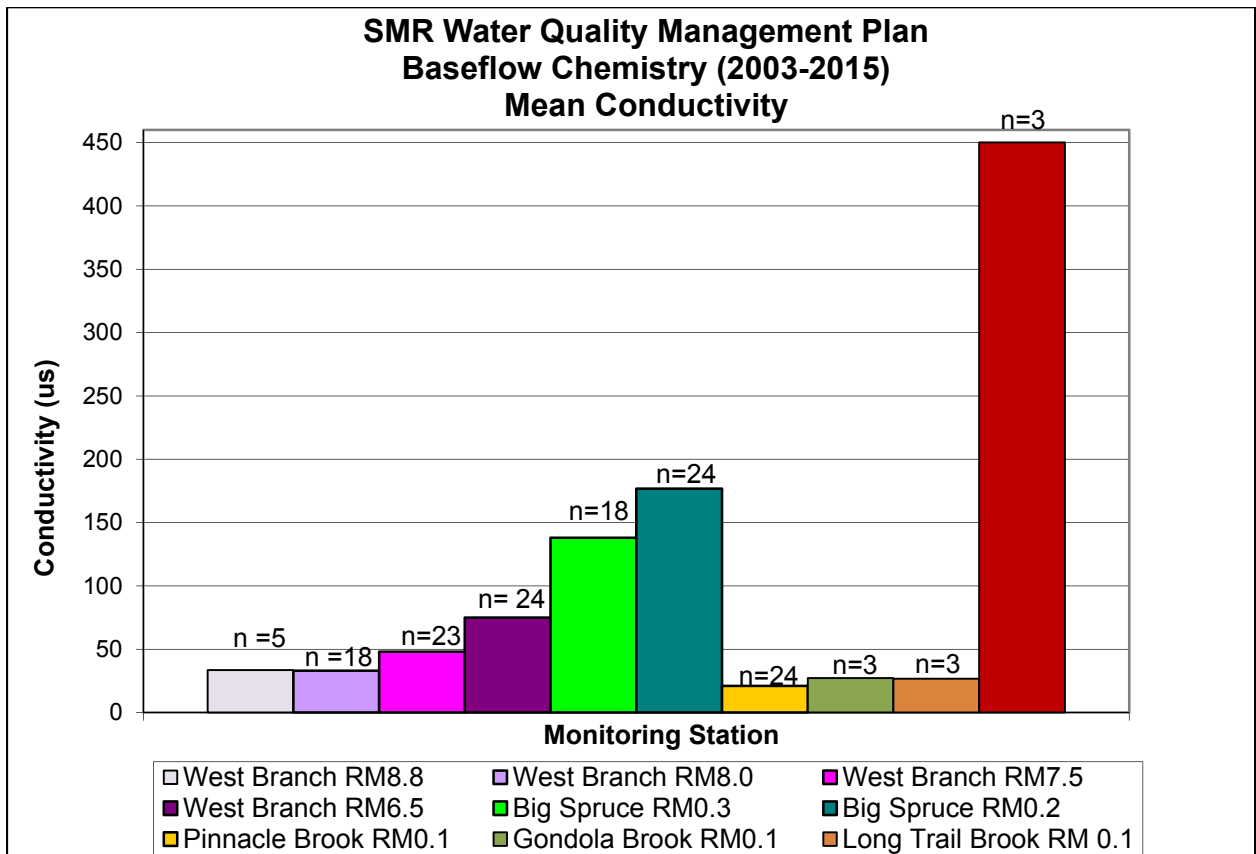
**Figure 5. Mean conductivity for biomonitoring stations**

Mean conductivity levels were highest on Little Spruce (only three monitoring years) and at the lower Big Spruce stations. The lowest mean conductivity has been measured on Pinnacle Brook, which is a reflection of its undeveloped watershed. Road salt, dissolved solids, and elevated metals are likely reasons for the higher conductivity values reported for Little Spruce and Big Spruce Brooks. There is a trend of increasing conductivity on the West Branch and Big Spruce Brook from upstream to downstream. In 2015, a historic high conductivity for the project was recorded at Little Spruce RM 0.1 (951  $\mu$ S). Additional water quality sampling is recommended during summer 2016 to investigate the sources of elevated chloride, conductivity and alkalinity on Little Spruce and Big Spruce Brooks.

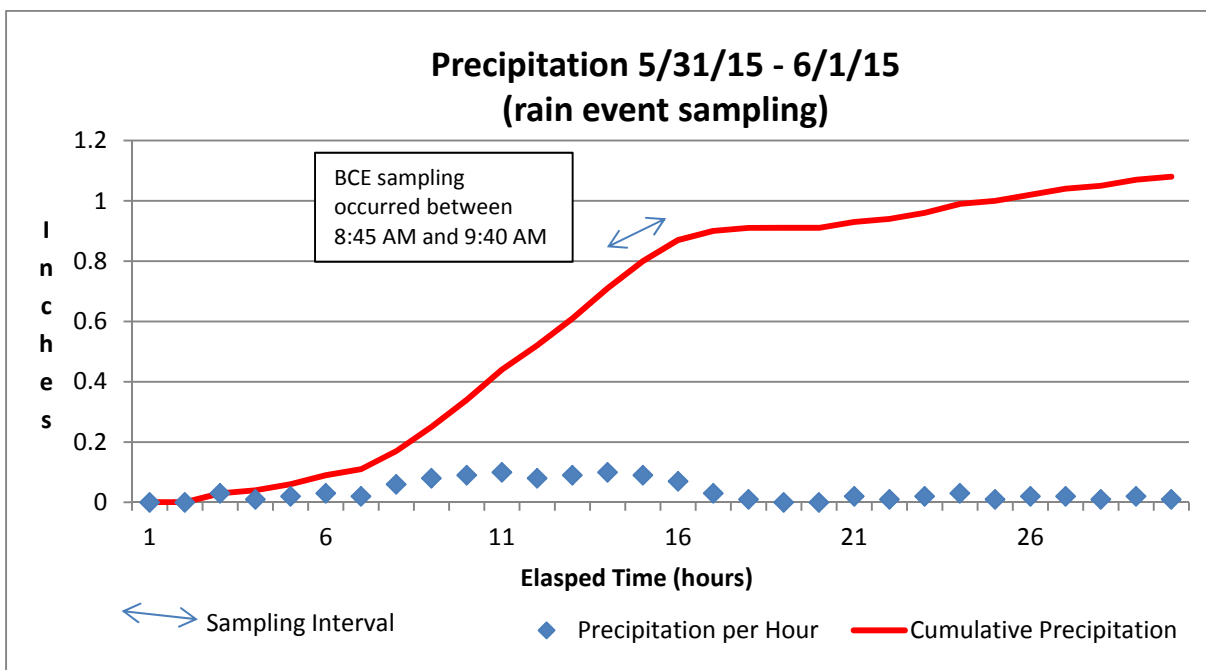
**Figure 6. Precipitation for June 1, 2015 event**

Bear Creek Environmental, LLC conducted the first round of event-based monitoring on June 1, 2015. The rain started around 8:00 PM in Stowe on May 31<sup>st</sup> and was heaviest around 7:00 AM on June 1<sup>st</sup>. Sampling occurred between 8:45 AM and 9:40 AM on June 1<sup>st</sup>, during which time the rain was light. As shown in Figure 6, the total rainfall at the time of sampling was 0.87 inches. The peak flow recorded in the Ranch Brook watershed was 140 cfs (36.8 cfs/sq. mile). There is a gap in flow data for the West Branch gauge on June 1, 2015, which Rick Kiah of the USGS attributed to likely being caused by equipment malfunction (personal communication). Figure 7 shows the hydrographs for the West Branch from May 30, 2015 to June 1, 2015 and Ranch Brook from May 30, 2015 to June 3, 2015.

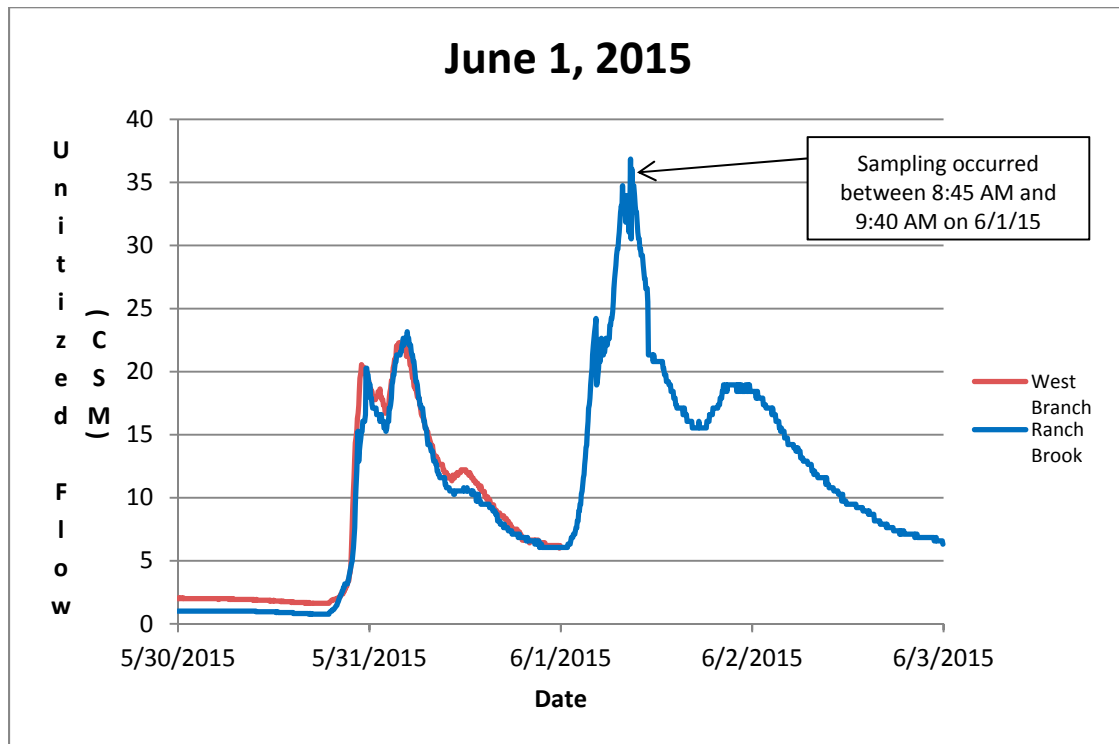
**Figure 7. West Branch and Ranch Brook hydrographs for June 1, 2015 sampling event**

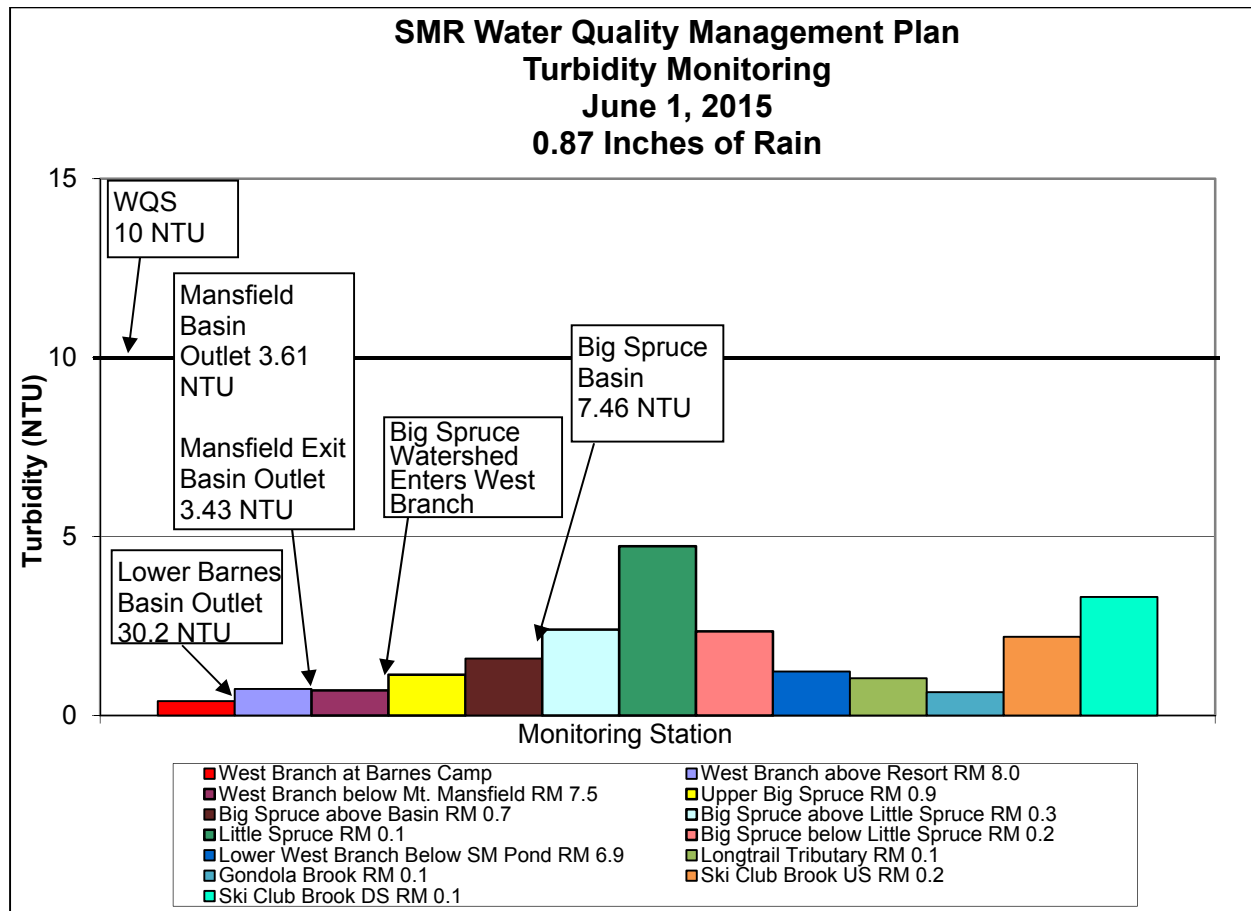
**Figure 8. Turbidity results from June 1, 2015**

As shown in Figure 8, turbidity values were below the water quality standard of 10 NTU at all surface water stations on June 1, 2015. The highest turbidity result was on Little Spruce Brook at RM 0.1 (4.73 NTU), which was well below the VWQS. The stream station with the lowest turbidity value was the West Branch at Barnes Camp (RM 8.2). All sediment basin outlets were below 50 NTU as presented in Figure 7. Overall, instream turbidity values were quite low, indicating that erosion and sediment control measures implemented and maintained by the Resort are working effectively.

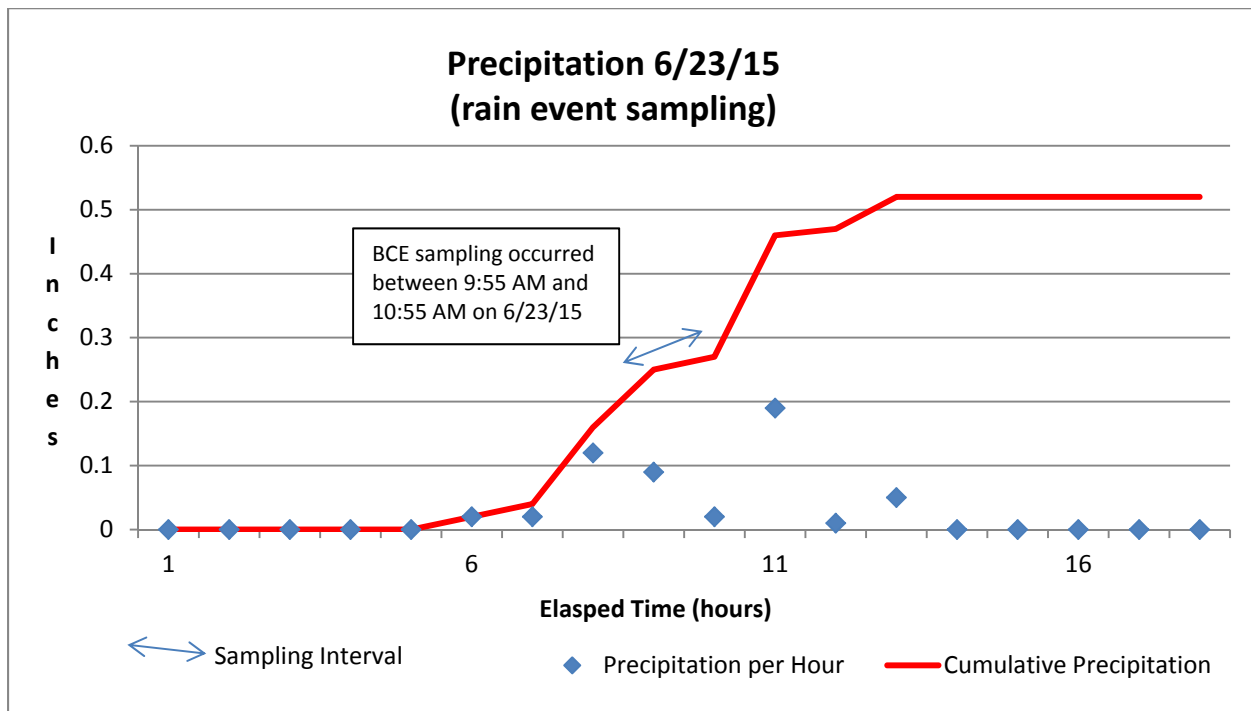
**Figure 10. Precipitation at Stowe Mountain Resort on June 23, 2015**

The second round of event based sampling took place on June 23<sup>rd</sup> between 9:55 AM and 10:55 AM. The resort received 0.46 inches of rain over the course of that morning, as shown in Figure 10. Accepted data from the USGS indicate that the West Branch of the Little River peaked at 91 cfs (19.5 cfs/sq. mile). Sampling occurred at the peak of the hydrograph (Figure 11). This was a partial sampling round, with twelve samples collected and analyzed for turbidity.

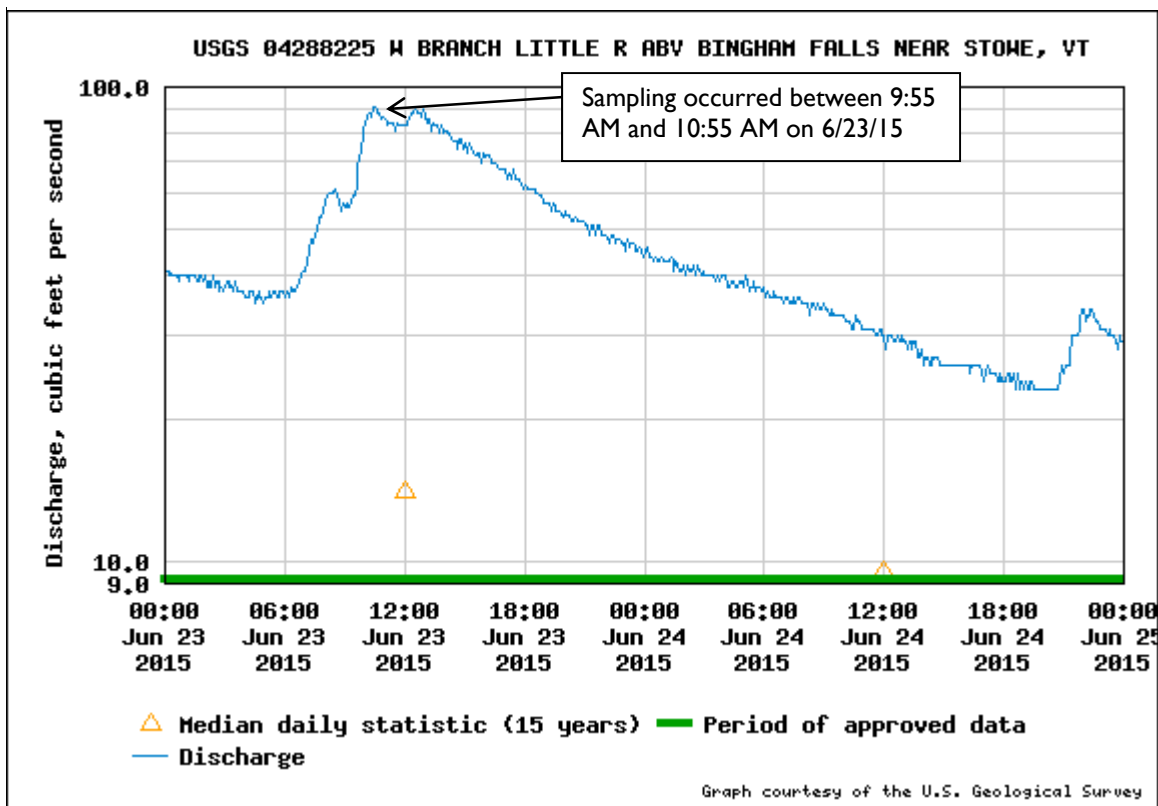
Figure 11. West Branch hydrograph for the June 23, 2015 sampling round

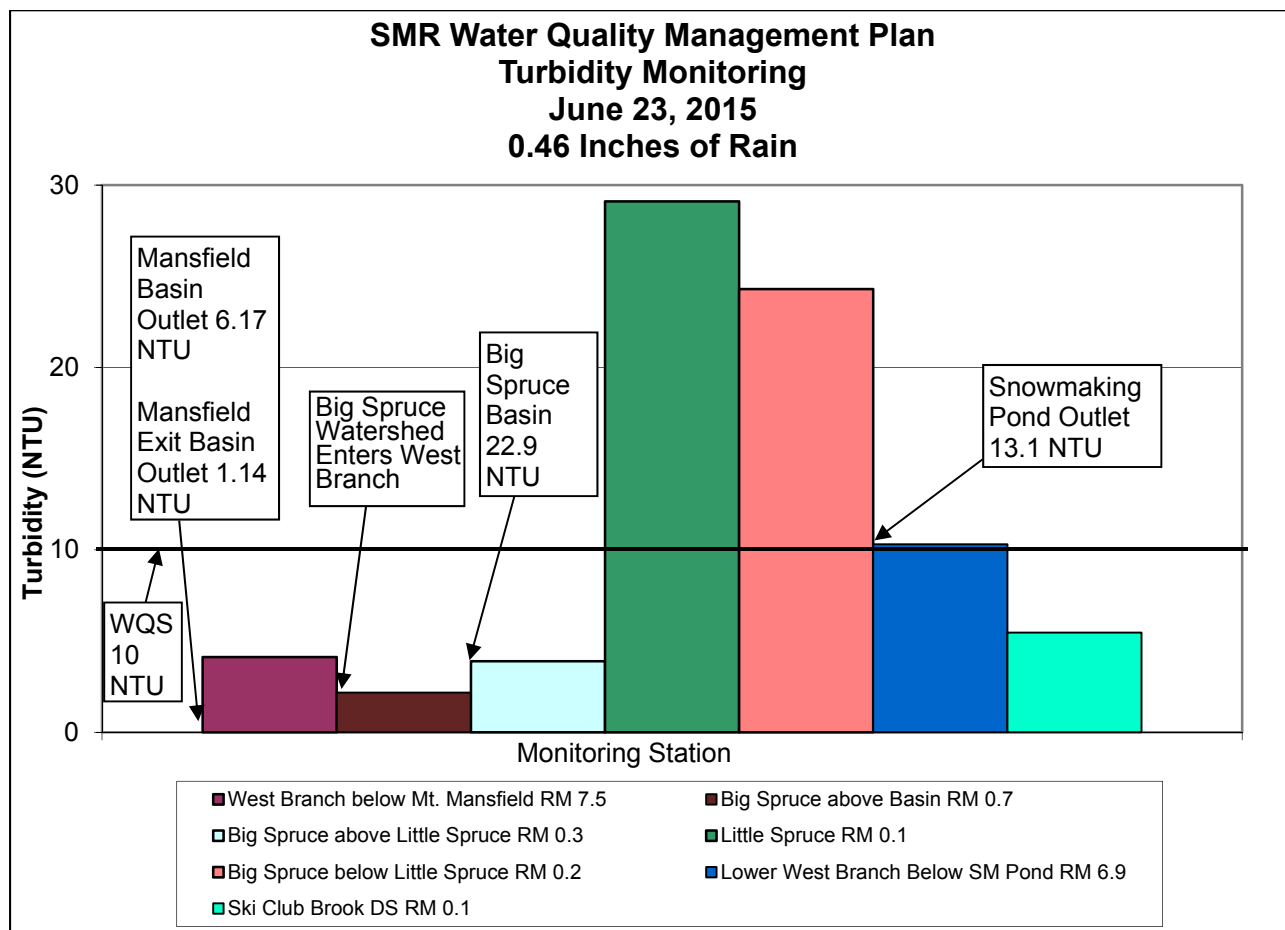
**Figure 12. Turbidity results from June 23, 2015**

As shown below in Figure 12, turbidity exceeded Vermont Water Quality Standards at three stations on June 23, 2015. The station on Little Spruce Brook (RM 0.1) had the highest turbidity of any surface water station at 29.1 NTU, followed by Big Spruce RM 0.2 (24.3 NTU), and the West Branch RM 6.9 (10.3 NTU). The lowest turbidities of the samples collected were observed at Big Spruce RM 0.7 and West Branch 7.5.

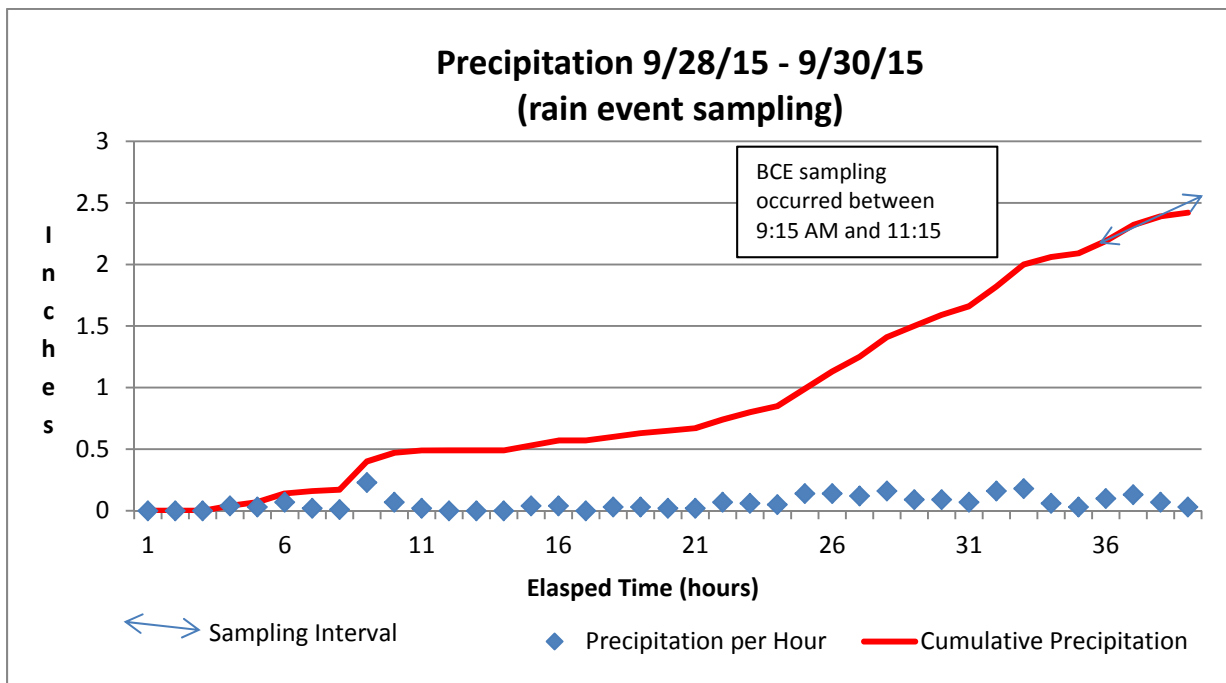
**Figure 14. Precipitation data for September 29<sup>th</sup> and 30<sup>th</sup>**

Steady rainfall over the course of the day on September 29, 2015 and overnight into the 30<sup>th</sup> resulted in high flows on the West Branch of the Little River. A total of 2.42 inches of rain fell over 23 hours during this event (Figure 14). According to accepted data from the USGS, the West Branch peaked at 154 cfs (33 cfs/sq. mile) at 6:30 AM on September 30<sup>th</sup>, immediately before sampling began (Figure 15). Bear Creek Environmental collected a full sampling round between 9:15 AM and 11:15 AM on the 30<sup>th</sup>, which were sent to Endyne, Inc. for turbidity analysis. The results from the sampling are reported below.

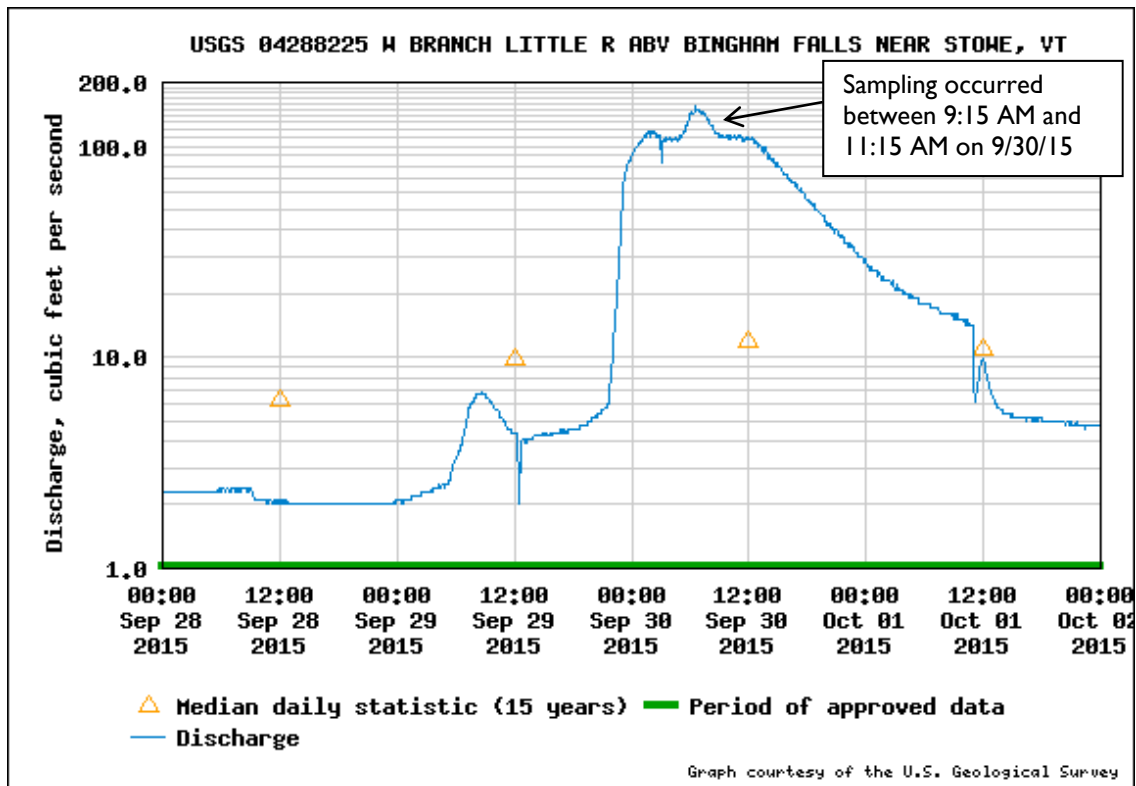
**Figure 15. Hydrograph of the West Branch for September 30, 2015 event**

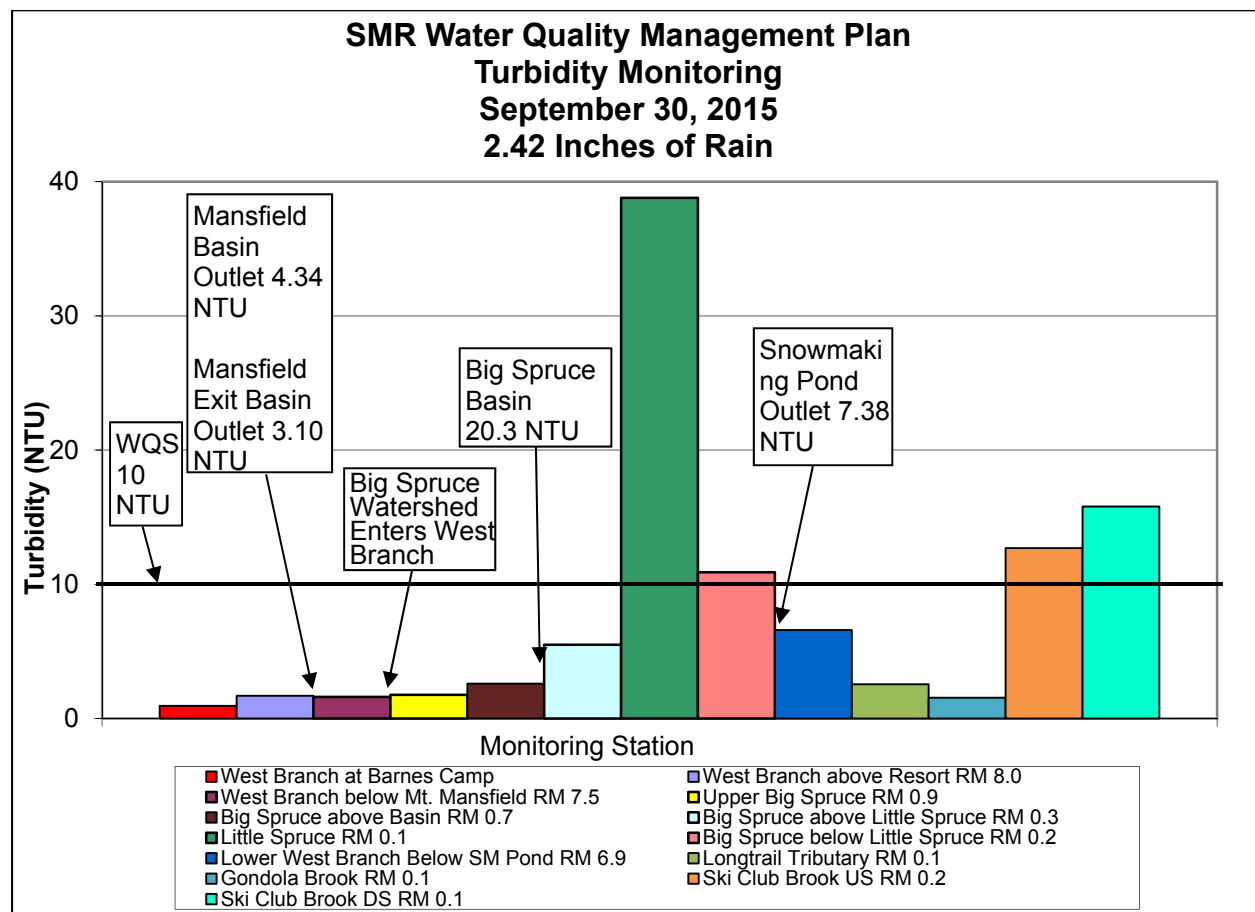
**Figure 16. Turbidity results for sampling conducted on September 30, 2015.**

BCE turbidity results for September 30, 2015 were good overall. Four stations exceeded the VWQS – Little Spruce Rm 0.1 at 38.8 NTU, Ski Club drainage Downstream at 15.8 NTU, Ski Club drainage Upstream at 12.7 NTU, and Big Spruce RM 0.2 at 10.9 NTU. The remaining stream stations were below 10 NTU. The West Branch at Barnes Camp RM 8.2 and Gondola Brook had the lowest turbidities, 0.94 NTU and 1.54 NTU, respectively. The basin outlet samples had very low turbidities, the highest of which being the Big Spruce Basin outlet, which measured 20.3 NTU. Figures 16 and 17 show the BCE turbidity results for this rain event.

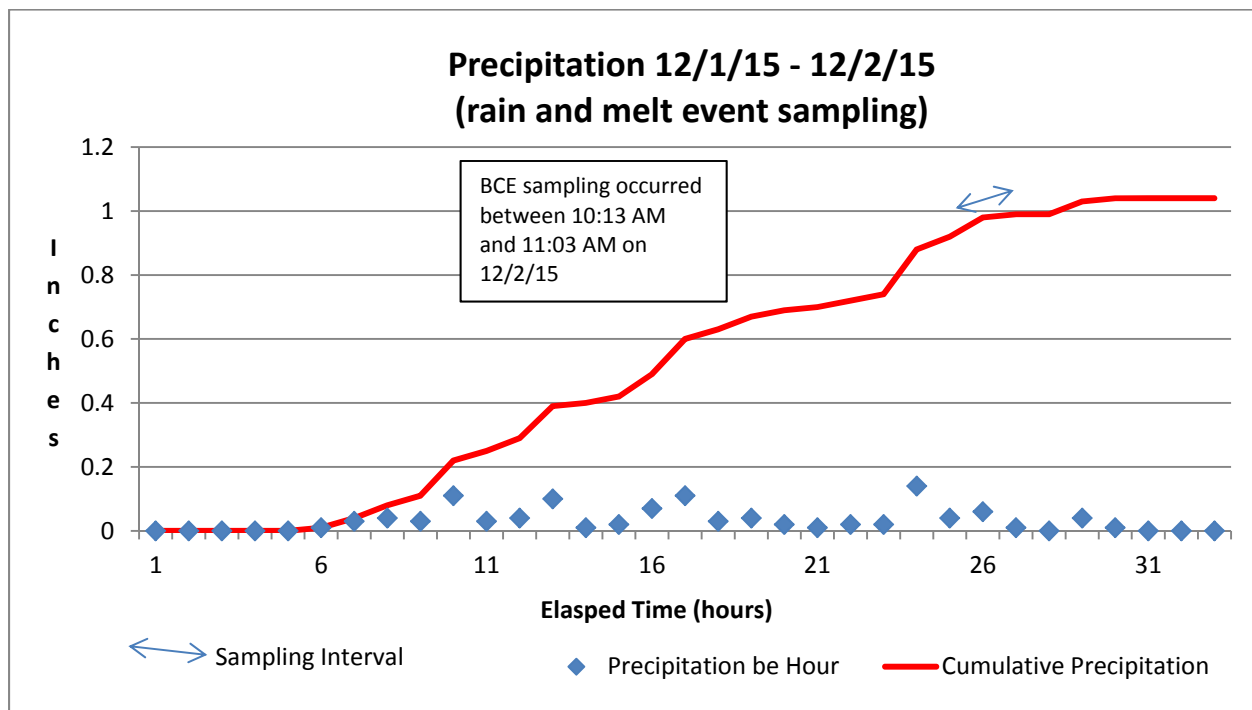
**Figure 18. Precipitation data for December 1<sup>st</sup> and 2<sup>nd</sup>, 2015**

On December 1<sup>st</sup> and 2<sup>nd</sup>, 2015, 0.99 inches of rain fell at Stowe Mountain Resort preceding an event-based sampling round. Due to a warm November, there was no snow on the ground at the base of the mountain, but there was snow on the trails that likely contributed some melt runoff during this event. The pattern of rain during the two days is shown below in Figure 18. The West Branch Little River peaked at 84 cfs between 8:00 AM and 8:30 AM on December 2<sup>nd</sup>. Sampling occurred later that morning (Figure 19).

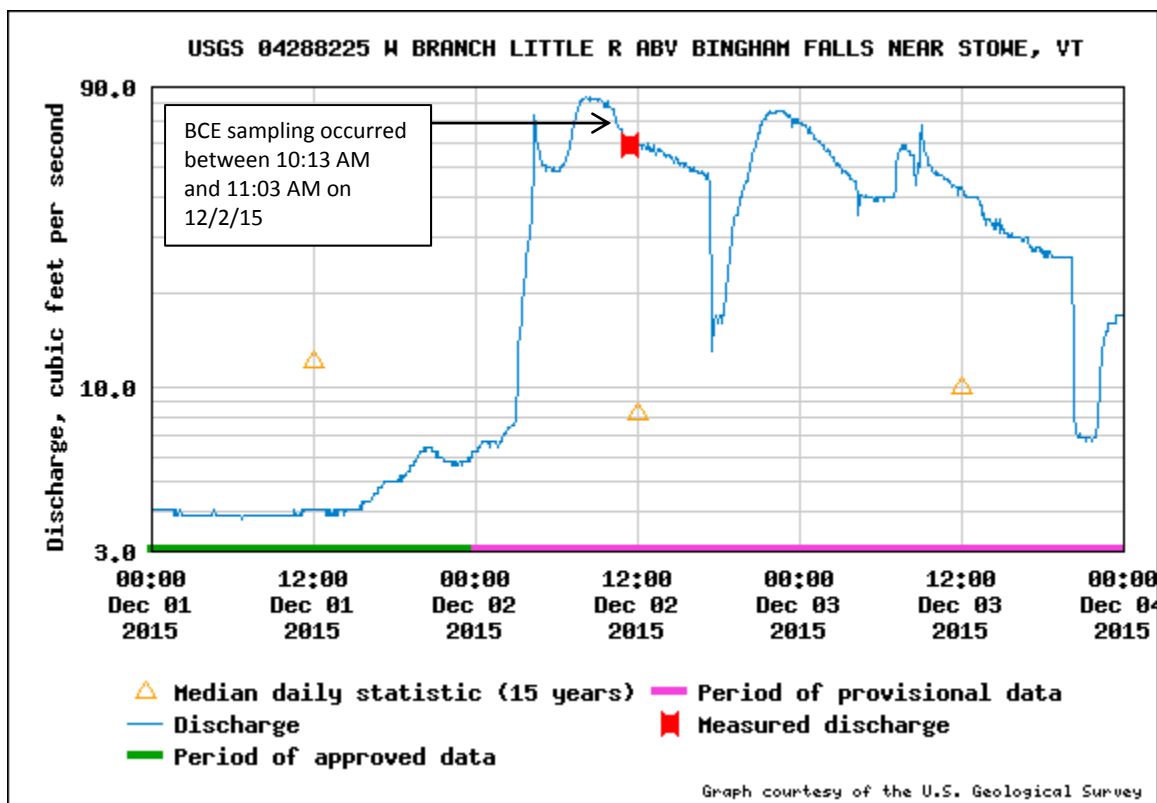
**Figure 19. Hydrograph of the West Branch for the December 2, 2015 event**

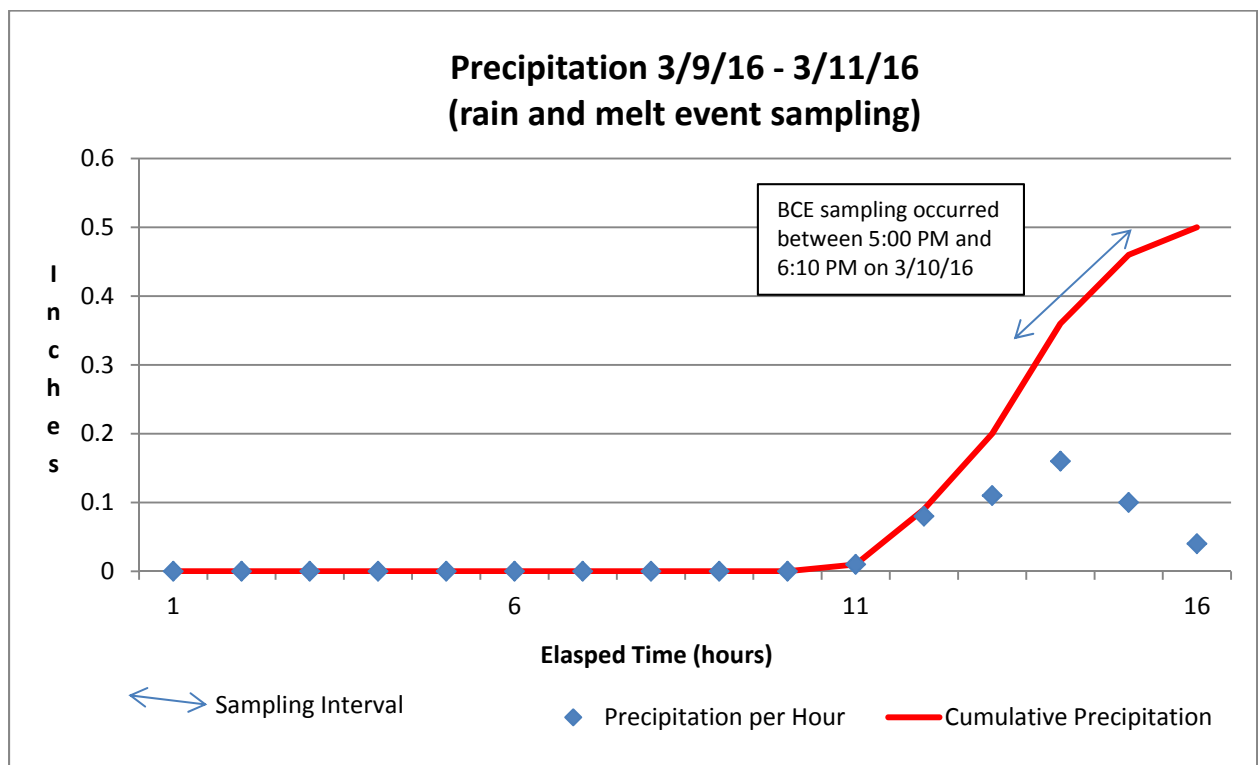
**Figure 22. Precipitation data for the March 10, 2016 sampling event.**

The final event-based sampling round that occurred at Stowe Mountain Resort for the 2015-2016 monitoring year took place on March 10, 2016. Warm temperatures and 0.50 inches of rain sparked increased runoff from snowmelt and elevated flows in the West Branch watershed. Figure 22 below shows the pattern of rain that occurred at the resort leading up to sampling on the 10<sup>th</sup>. The peak flow in the Ranch Brook watershed was 214 cfs (56.3 cfs/sq. mile) at approximately 7:00 PM on the 10<sup>th</sup>. Flow gauging was discontinued on the West Branch Little River on February 29, 2016, so data for the West Branch during this event are not available. Figure 23 shows the hydrograph, including the ascending and descending limbs, for Ranch Brook from March 8 through March 12, 2016.

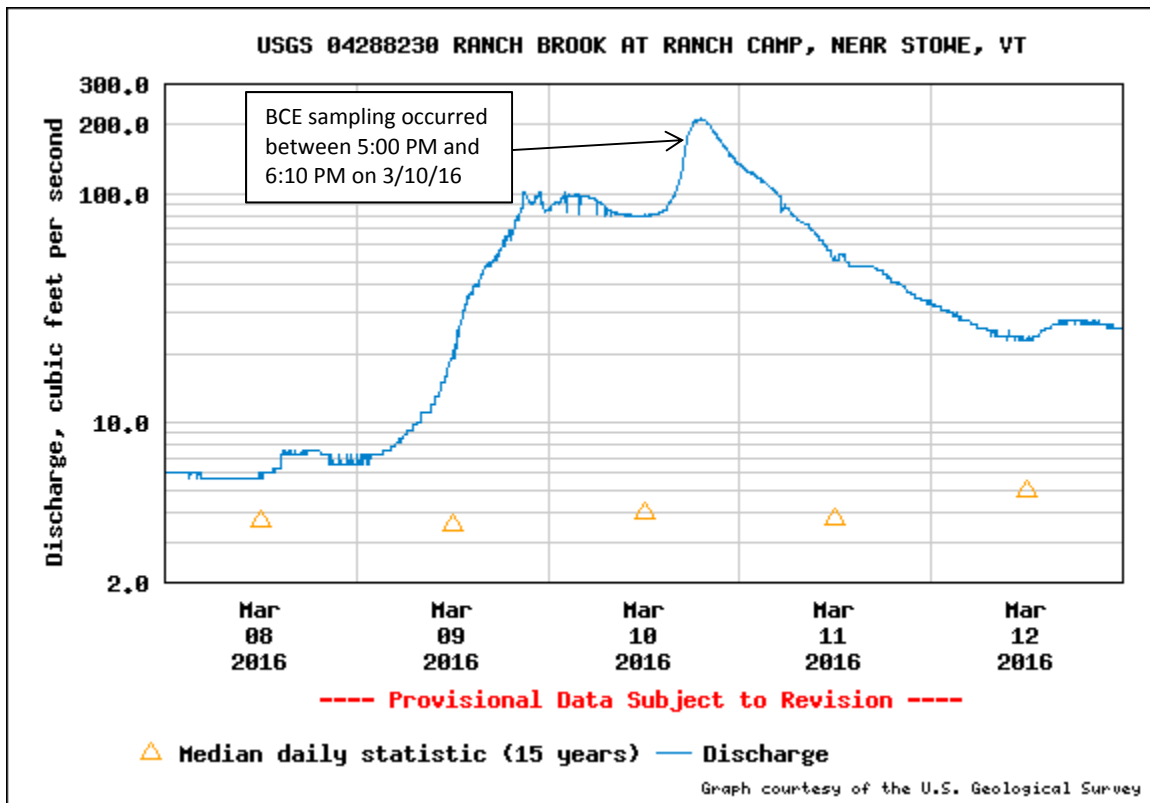
**Figure 23. Hydrograph for Ranch Brook for the March 10, 2016 sampling event**

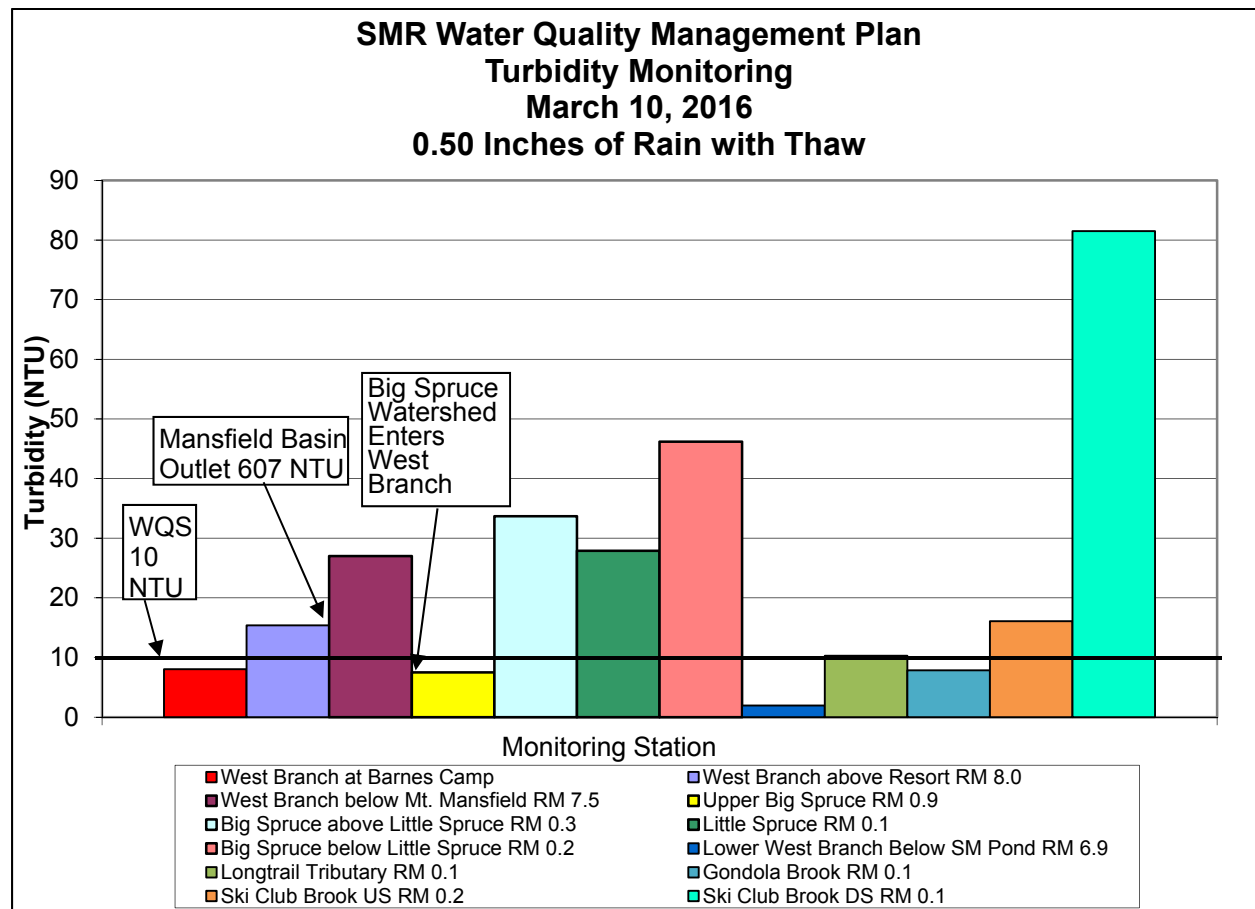
**Figure 24. Turbidity results for sampling conducted on March 10, 2016.**

Stream turbidities were generally elevated during sampling on March 10, 2016. Eight of the eleven stream stations that were sampled had turbidities that were above the VWQS of 10 NTU (Figures 24 and 25). The highest stream turbidity measured was at Ski Club drainage Downstream (81.5 NTU), followed by Big Spruce RM 0.2 (46.2 NTU), and Big Spruce RM 0.3 (33.7 NTU). The lowest turbidity for the stream samples on March 10<sup>th</sup> was at Big Spruce RM 0.9 (7.51 NTU), followed by Gondola Brook (7.85 NTU) and the West Branch Rm 8.2 (8.03 NTU). Only one sediment basin was sampled during the event, the Mansfield Basin outlet. The turbidity of the sample from the basin outlet was very turbid, measuring 607 NTU. This event occurred before the resort conducted its annual spring sand cleanup of the parking lots.

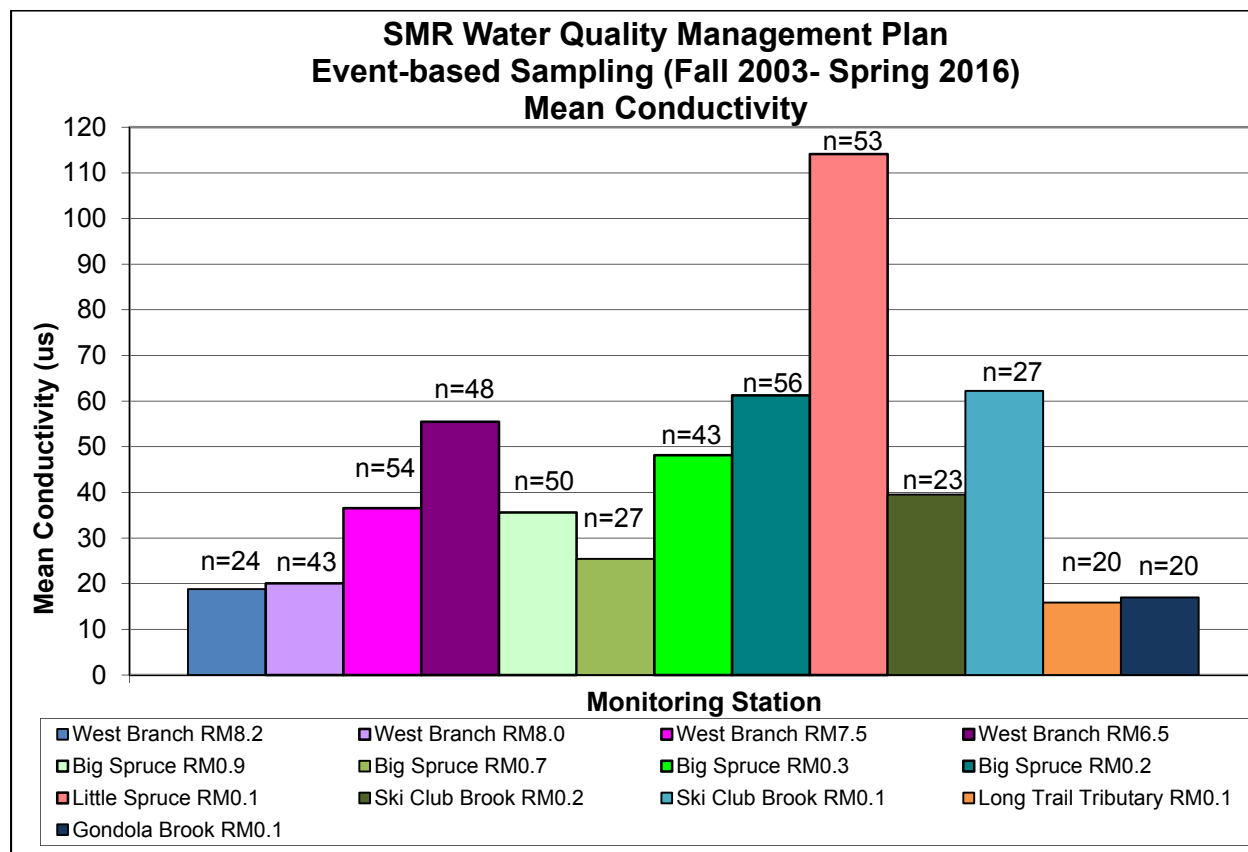
**Figure 26. Mean conductivity reported for event-based sampling for fall 2003 through spring 2016.**

In general, conductivity levels were highest on Little Spruce Brook and lowest on upper West Branch, Long Trail Brook, and Gondola Brook. The mean conductivity for the period of fall 2003 through spring 2015 for each of the monitoring stations is provided below in Figure 26.
