**Stowe Mountain Resort  
SMR 2000 Community Plan  
Water Quality Management Plan**

## **2015 Monitoring Report**

June 9, 2016

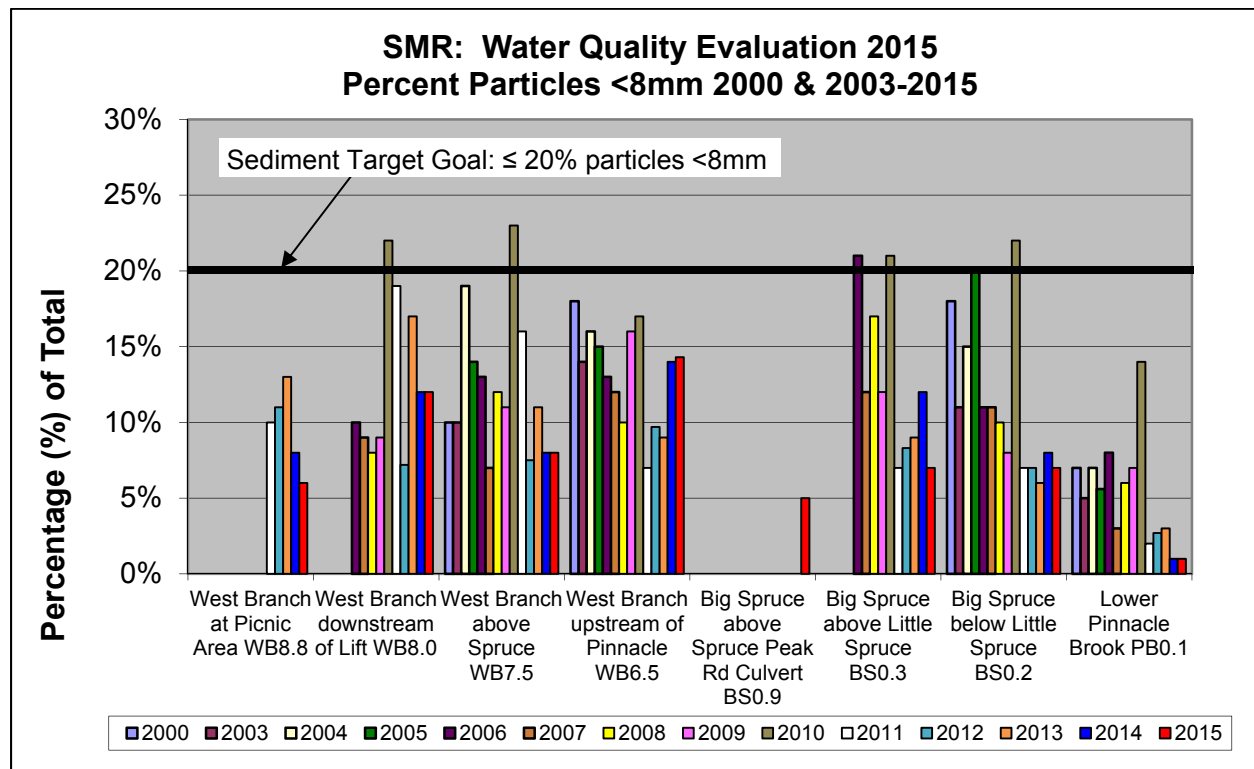
**Figure 27. Substrate Assessment – Percent particles less than 8 mm.**

there was a shift toward smaller particle sizes in 2010. A high flow event in August 2010 was the primary cause and the percentage of fines has generally decreased since 2010 as the sediment works its way through the study area. This shift can be seen for each station on the graphs in Appendix 3.

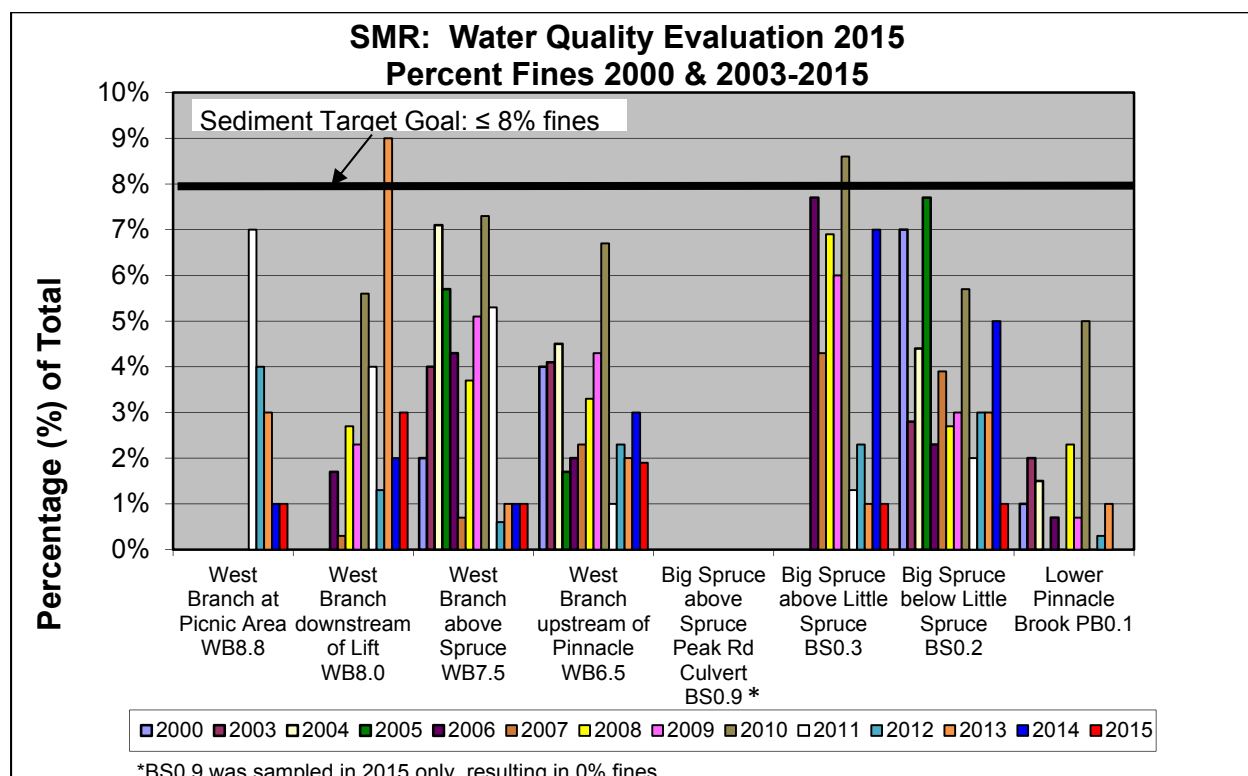
**Figure 28. Substrate Assessment – Percent fines.**

All the monitoring stations in 2015 also met the target for percent fines. Four of eight monitoring stations met all three target goals for sediment in 2015 – West Branch RM 8.8, West Branch RM 7.5, West Branch RM 6.5, and Pinnacle Brook RM 0.1. The remaining four stations met two of three target goals for sediment (all but embeddedness) – West Branch RM 8.0, Big Spruce RM 0.9, Big Spruce RM 0.3, and Big Spruce RM 0.2. Streams in the vicinity of SMR will continue to be monitored for changes in channel substrate condition as the MDP continues to be implemented.

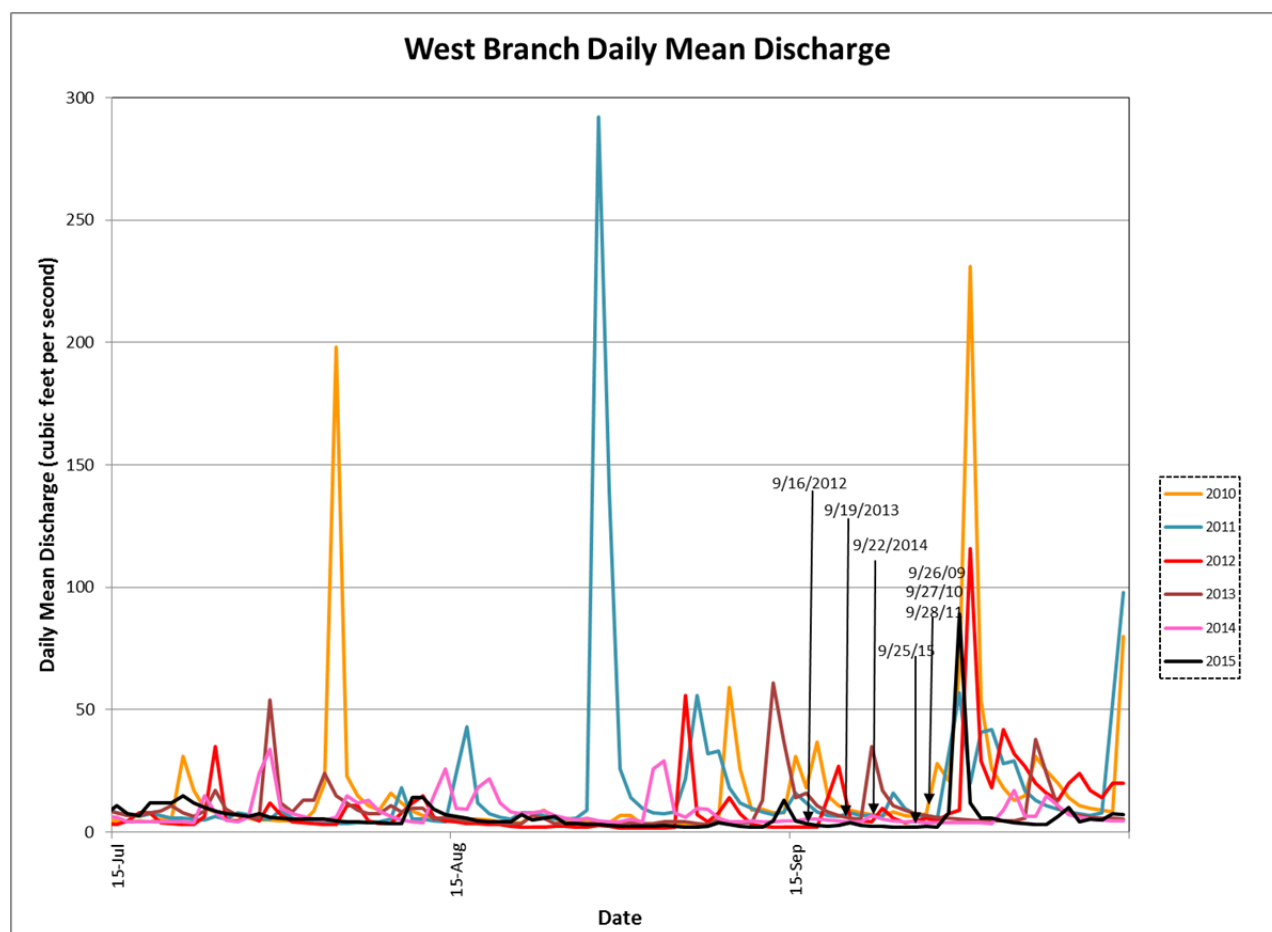
**Figure 29. Daily mean discharge on West Branch between mid-July and mid-October for monitoring years 2010 through 2015.**

monitoring years. During the 2010 field season, a large flood event occurred in early August, causing major damage at the resort and changes to the channel morphology and extreme scouring of the streambed. A second flood event took place about a week after the kick net samples were collected on September 26, 2010. During 2011, the daily mean stream flow exceeded 250 cfs as a result of Tropical Storm Irene. The 2012, 2013, and 2014 monitoring seasons are characterized as having low to moderate flows during the monitoring period. In 2015, flows were typically low from mid-July to late September. On the September 25, 2015 sampling date, the flow was only 2.1 cfs.

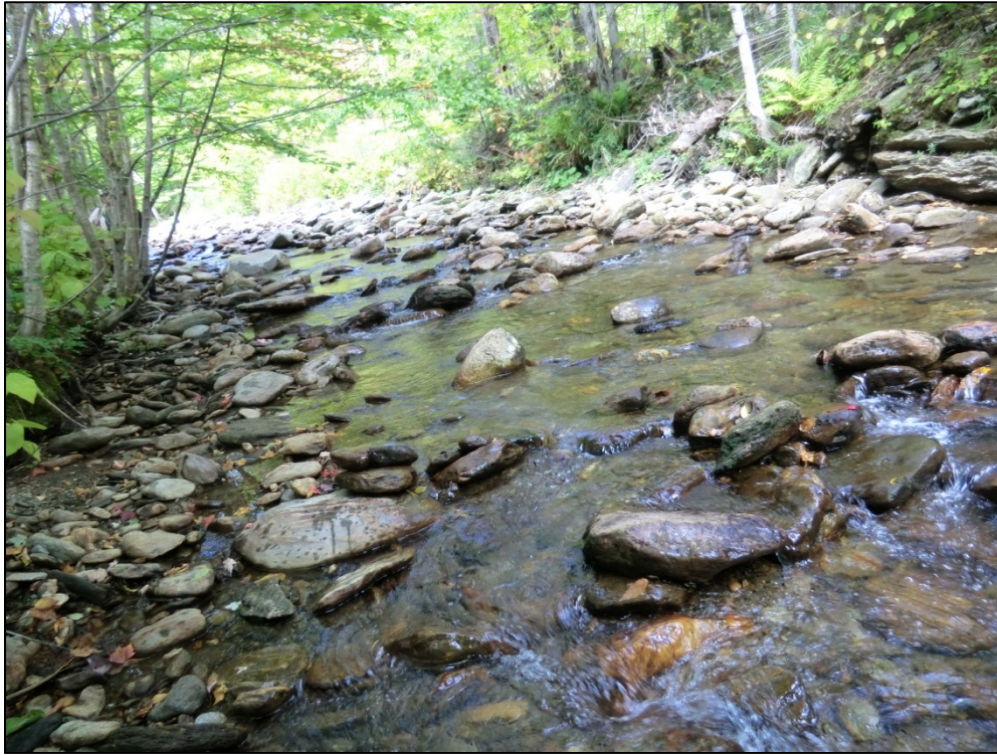
**Figure 30. West Branch RM 8.0 (9/25/15)**

West Branch RM 8.0 is located downstream of the transfer lift crossing. Small iron seeps were present along the stream margins. Embeddedness was in the range of 25-50% in the riffle and was more embedded in pool habitat (Figure 30). Bank stability was good (50-75% stable). Canopy cover was estimated to be partly open, creating a cover of about 60 percent. The diatom cover was 70 percent.

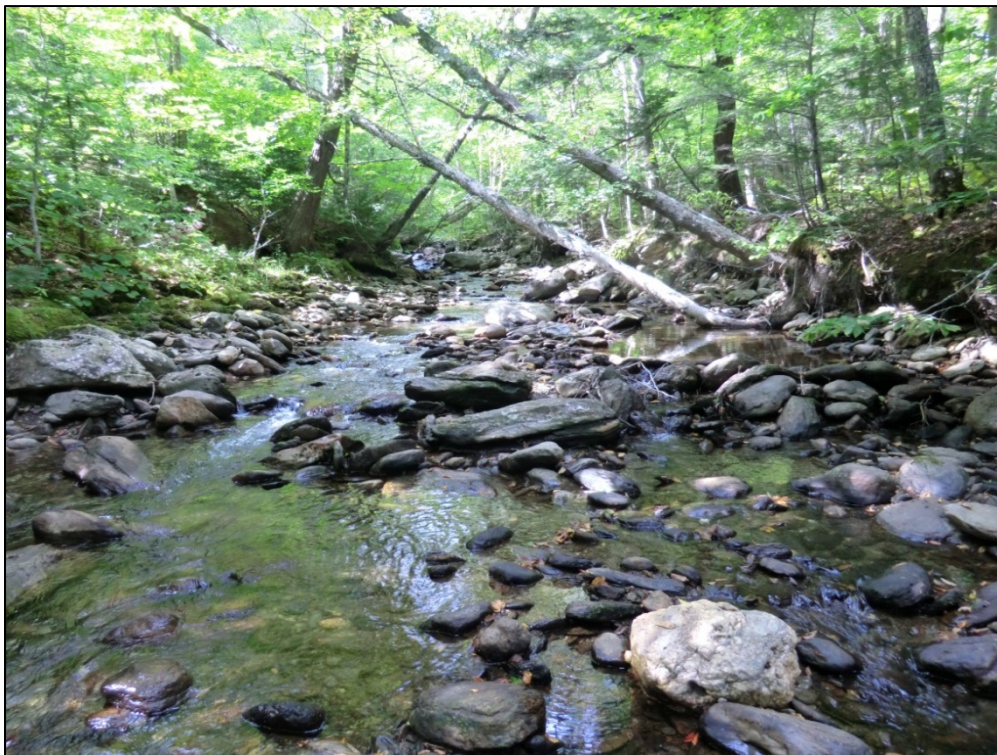
**Figure 31. West Branch RM7.5 (9/25/2015)**

West Branch RM 7.5 is located downstream of the exit to the Mansfield parking lot, below the outlets of both the Mansfield Basin and the Mansfield Exit Basin. Diatoms were the dominant periphytic cover. Embeddedness was estimated to be 5-25%, and light iron staining was noted. The leaves were mainly on providing a canopy cover of 80 percent, as shown in Figure 31.

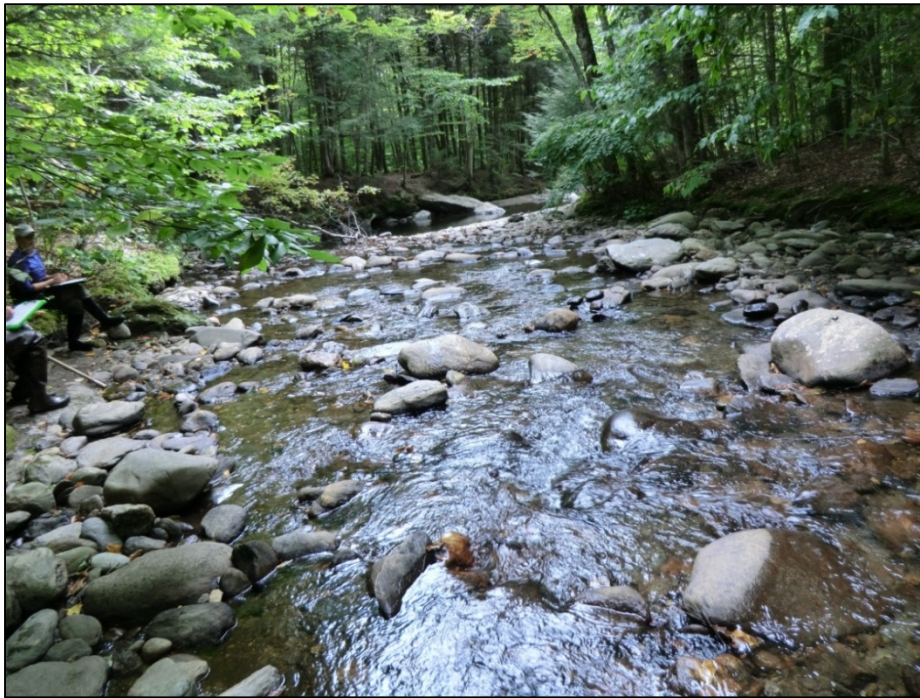
**Figure 32. West Branch RM 6.5 above the confluence with Pinnacle Brook (9/25/15)**

The lowest station on the West Branch is at RM 6.5, and is located immediately upstream of the confluence with Pinnacle Brook. Bank stability in 2015 was rated as good at WB 6.5, and substrate embeddedness was rated as 5-25 percent. The diatom coverage was approximately 90 percent. Canopy cover was partly open and was estimated to be 70 percent, as shown in Figure 32.

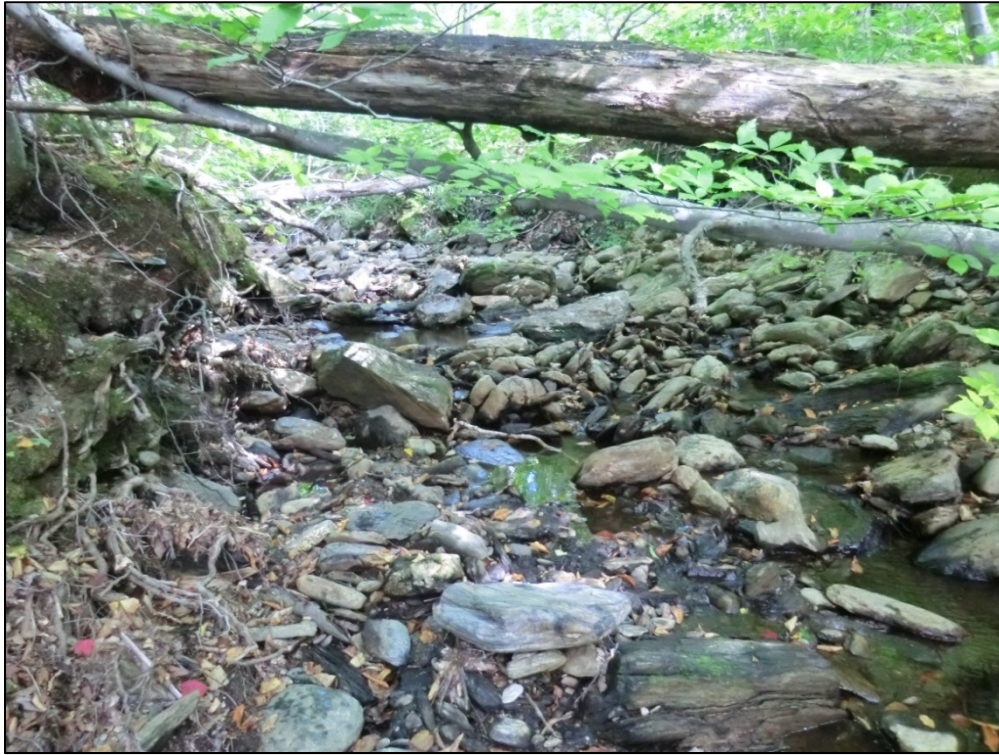
**Figure 33. Big Spruce Brook RM 0.9 (9/25/15)**

Biomonitoring was conducted for the first time at Big Spruce RM 0.9, located below the Spruce Peak ski trails and upstream of the Spruce Peak Road culvert crossing. Some isolated iron seeps were present. The silt rating was 4, reflecting heavy silt and fine particulate material (FPOM). Bank stability was poor with only 0 to 25% of the bank stable. The station offered limited areas for kick net sampling (Figure 33). The canopy was partly open and was estimated to be 60%.

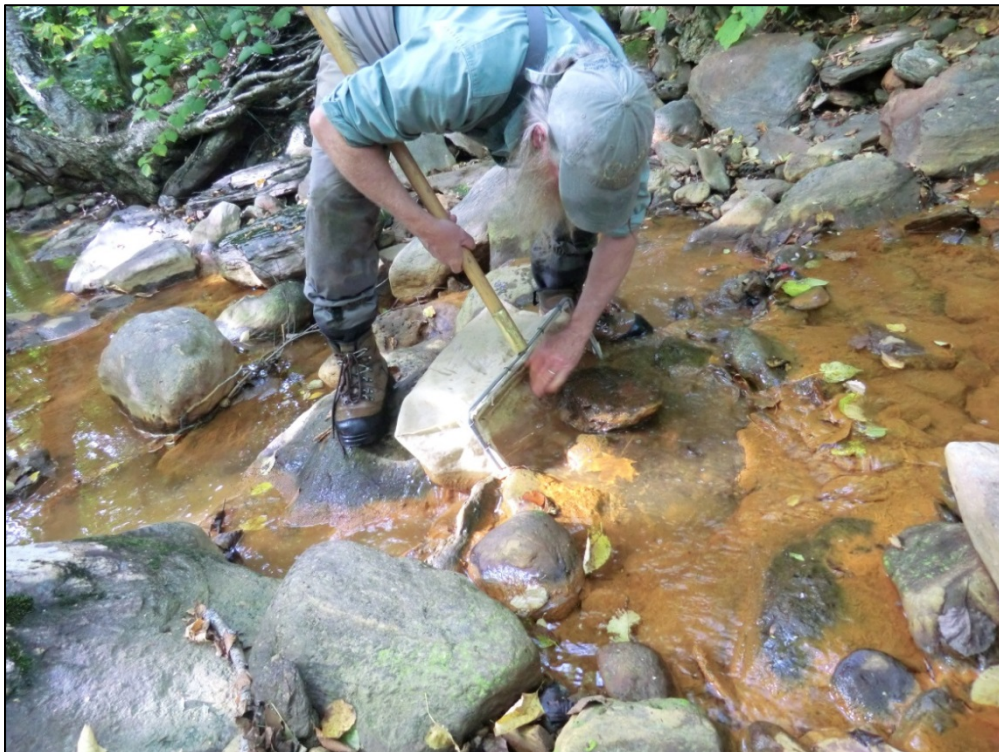
**Figure 34. Big Spruce Brook RM 0.8 (9/25/15)**

Biomonitoring was also conducted for the first time at Big Spruce RM 0.8, located in an area with heavy iron seeps downstream of the Spruce Peak Road crossing. Kick net sampling was conducted by Steve Fiske of the VDEC within a strong seep (Figure 34). Based on field notes from the VDEC, the substrate was 100% covered with iron floc and precipitate. The water column iron was also elevated, and was reported to be 838 µg/L or just below water quality criteria for the protection of aquatic biota. This average allowable concentration (chronic criteria) to protect aquatic life is 1,000 micrograms per liter.

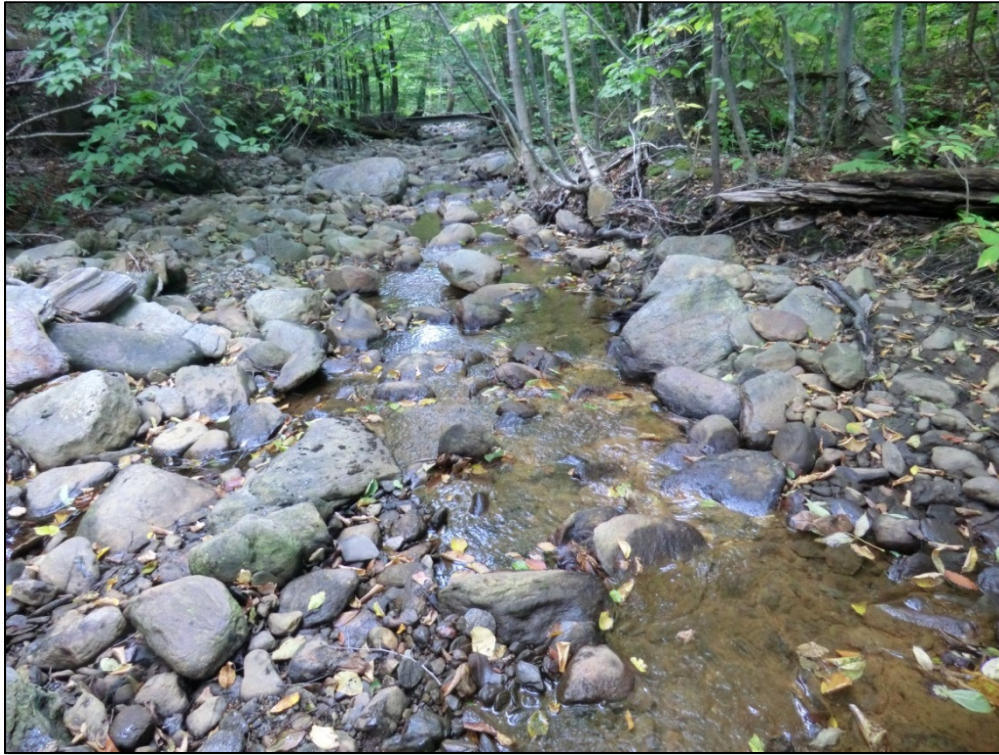
**Figure 35. Big Spruce Brook RM 0.3 (9/25/15)**

This upper biomonitoring station on Big Spruce Brook at river mile 0.3 is located downstream of the Golf Cottage and upstream of the confluence with Little Spruce Brook. Big Spruce station RM0.3 has historically had several iron seeps. One major iron seep was remediated in fall 2010 using limestone to intercept and treat the groundwater. Iron seeps were noted to be heavier in 2015 than recent years. Kick net sampling was conducted in an area with less iron. The station was 5-25 percent embedded and had a silt rating of 4. Bank stability was rated as good and canopy cover was 80 percent at the time of sampling (Figure 35).

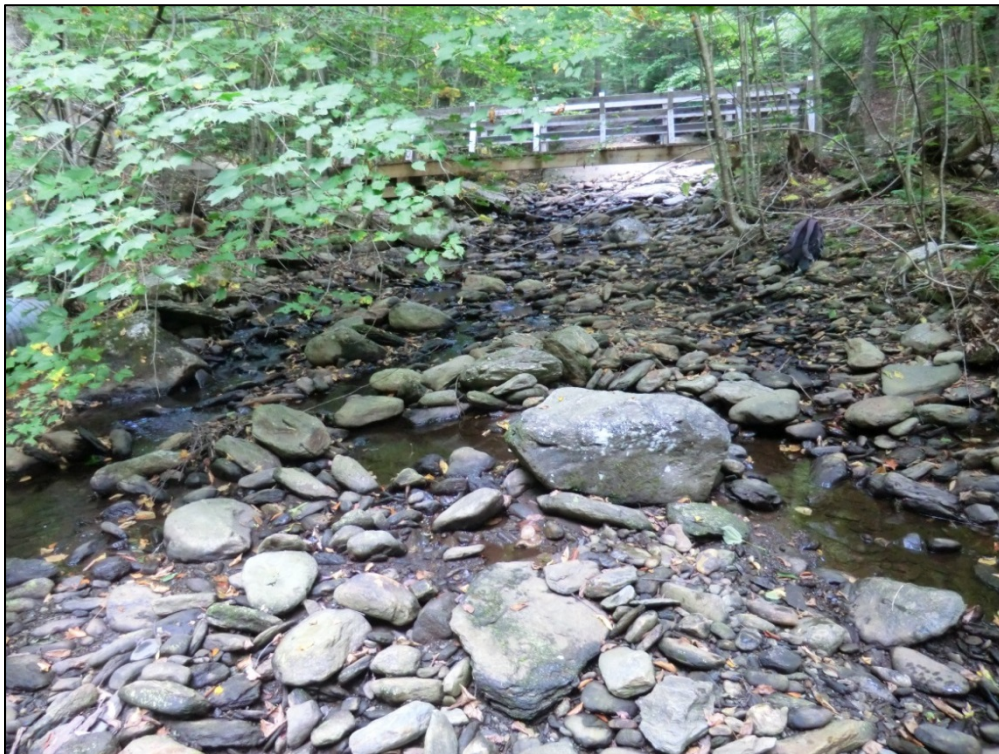
**Figure 36. Looking upstream at Big Spruce RM0.2 (9/25/15)**

Big Spruce RM 0.2 is located downstream of the Little Spruce Brook confluence. Bank stability at RM0.2 was rated as poor in September 2015. Significant bank erosion occurred during the August 4, 2010 flood event, and the channel and banks are still undergoing an adjustment process in response to this large flood event. Embeddedness in 2015 was rated as 25-50 percent. Heavy organic rich silt was noted, and a silt rating of 5 (chocolate) was given based on field observations. The substrate was hard to kick net due to the shallow riffles and wide channel (Figure 36). A small iron seep and iron staining were noted within the reach. Percent canopy cover averaged 70 percent.

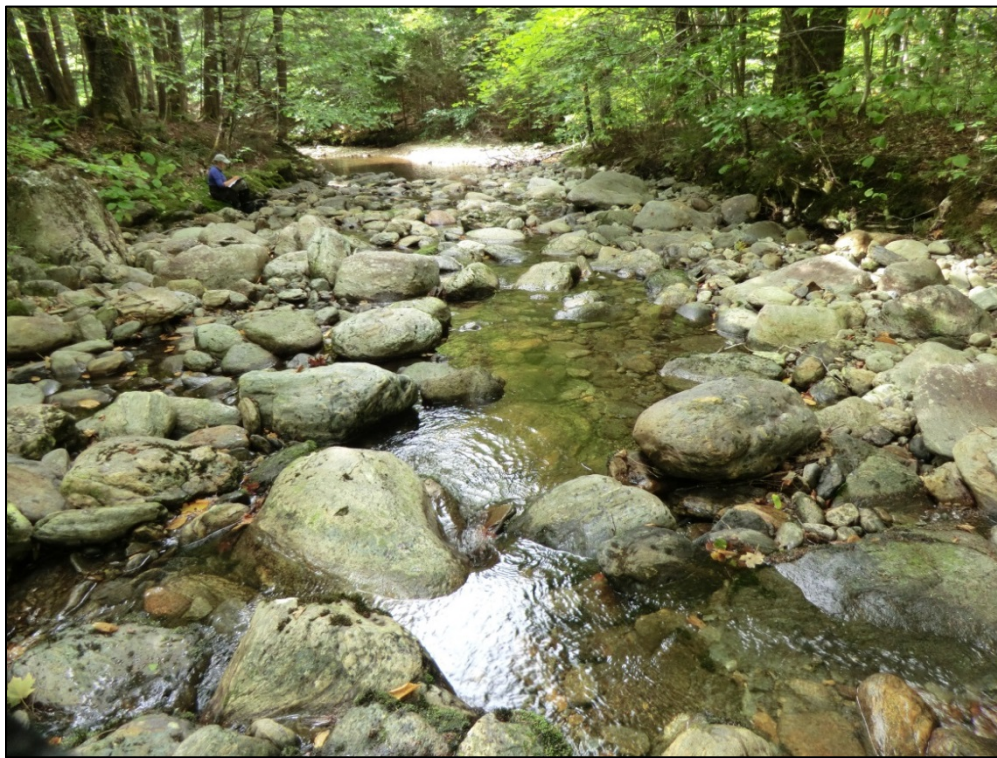
**Figure 37. Pinnacle Brook monitoring station (9/25/15)**

The reference/control station for biomonitoring is located at the mouth of Pinnacle Brook. In 2015, bank stability was rated as excellent (75-100% stable). Based on habitat observations, the silt rating was low and embeddedness was very good (5 to 25 percent). Canopy cover was approximately 70 percent and leaves were still on the trees. There was 80% diatom cover and a 2% cover of blue-green algae. A small iron seep was noted along the right bank. Figure 37 shows the Pinnacle Brook monitoring station.

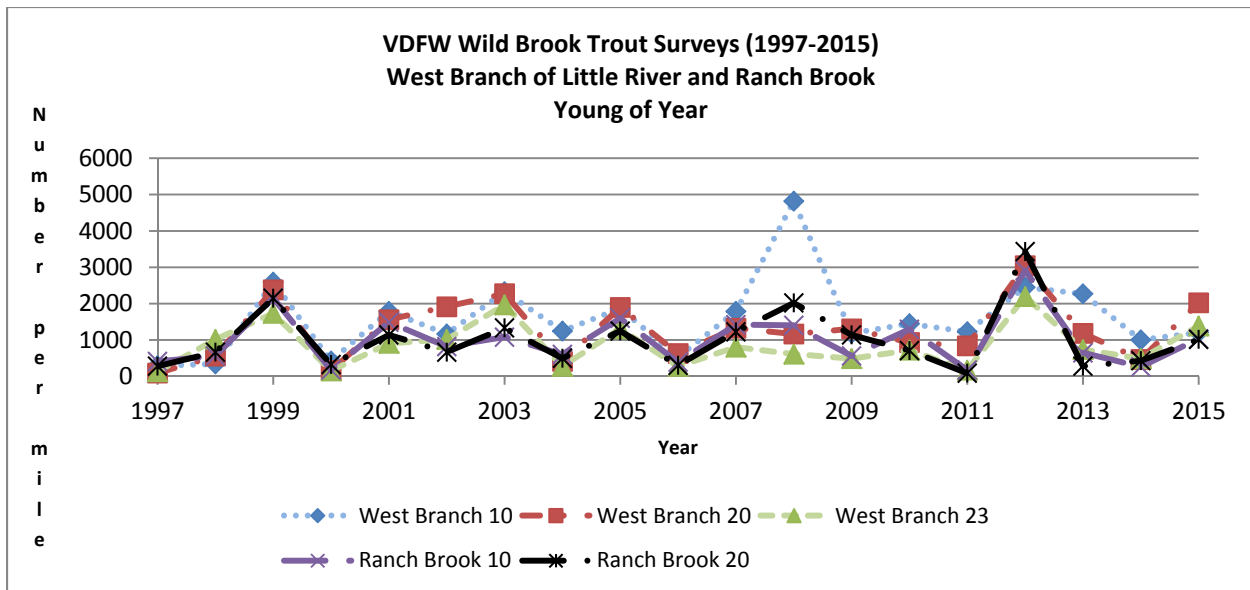
**Figure 39. Vermont Fish and Wildlife Department brook trout young-of-year data.**

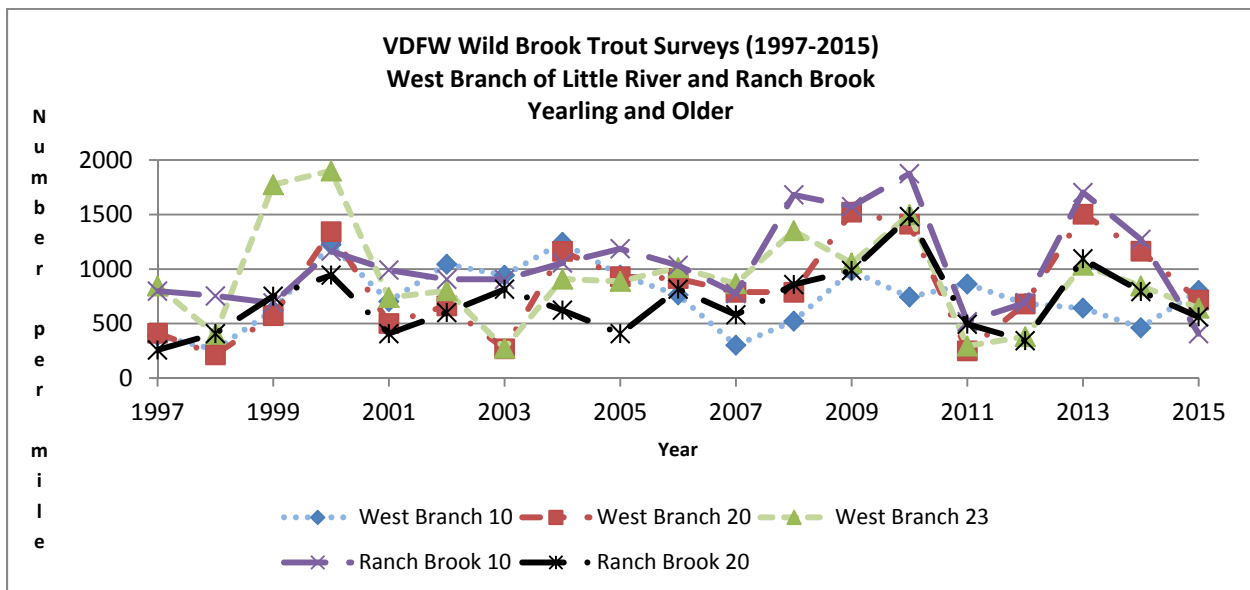
**Figure 40. Vermont Fish and Wildlife Department brook trout yearling and older data.**
