# West River Watershed

## Updated Water Quality/Aquatic Habitat Assessment Report

October 2014

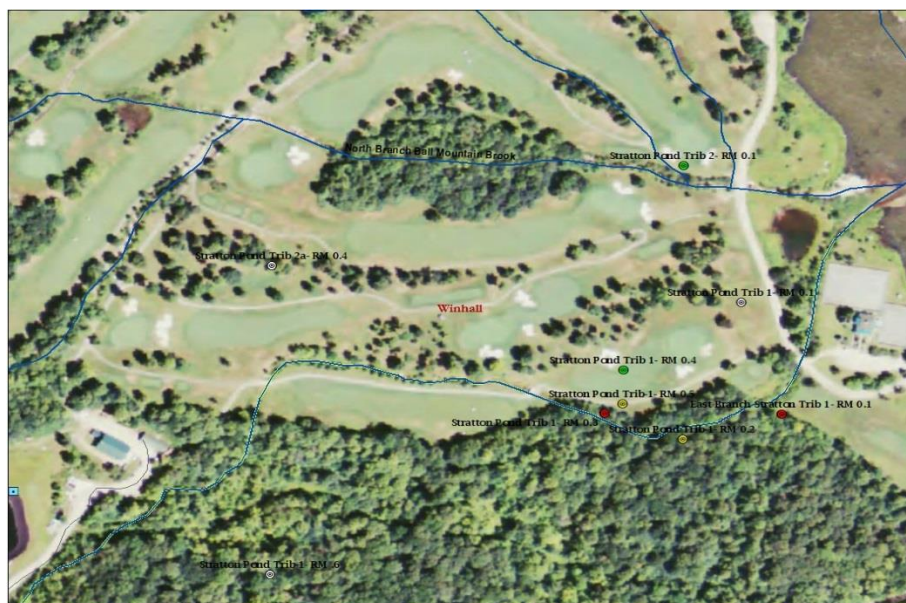
**Figure 4. Trib 1 & Trib 2 to Stratton Pond & Adjacent Land Use**

Water quality monitoring was also done on Tributary 2 to Stratton Pond/North Branch during baseflow and storm events twice each in 2013. Substrate and aquatic habitat conditions were also assessed in addition to the chemistry and biomonitoring on this stream. During the baseflow conditions, there weren't the same levels of chloride and conductivity as seen in Tributary 1. During the storm event sampling (same 9/12/14 and 1.2" event), conductivity jumped to 1887 (average was 468 during baseflow), turbidity was 100 NTUs, and the temperature jumped to 16.1°C (average was 12.5 during baseflow).

Tributary 2 had substrate embeddedness of 25-50% and fines at 22%. The embeddedness was higher than the 2012 results and percent fines have "increased steadily since 2009." Bank stability was rated at 50 to 75%, which was an improvement over the 2012 results.

Again some of the storm event sampling results and the habitat conditions indicate that

stormwater runoff should be examined so that increased turbidity, temperature, deposition of fines, and other water quality effects do not lead to decreased health of the aquatic community.

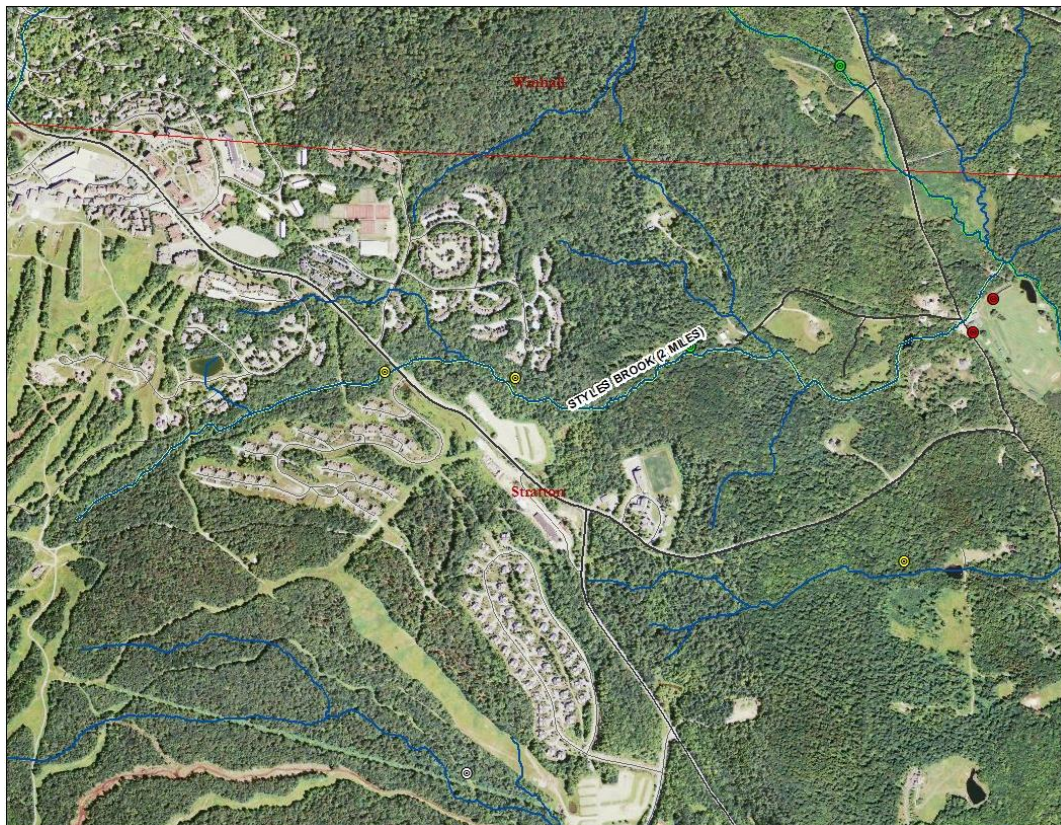
**Figure 5. Styles Brook watershed land use**

Two sites were sampled for water quality parameters, substrate conditions, aquatic biota, and aquatic habitat on Styles Brook in 2013. Site MP-13E is near the Tree Top development area but upstream of Parking Lot #2 and the Maintenance Area. Site 14 is co-located with the ANR biomonitoring site at rm 0.8, which is downstream of all of these developments.

As seen in Table 9 above, Styles Brook macroinvertebrate community is only in “good-fair” health. Information from storm events sampling at the outlets of five culverts indicate possible reasons for the good-fair condition at rm 0.8 and also highlight where changes could occur to improve water quality and aquatic health.
