Vermont Agency of Natural Resources
Watershed Management Division

WHITE RIVER TACTICAL BASIN PLAN

July 2013

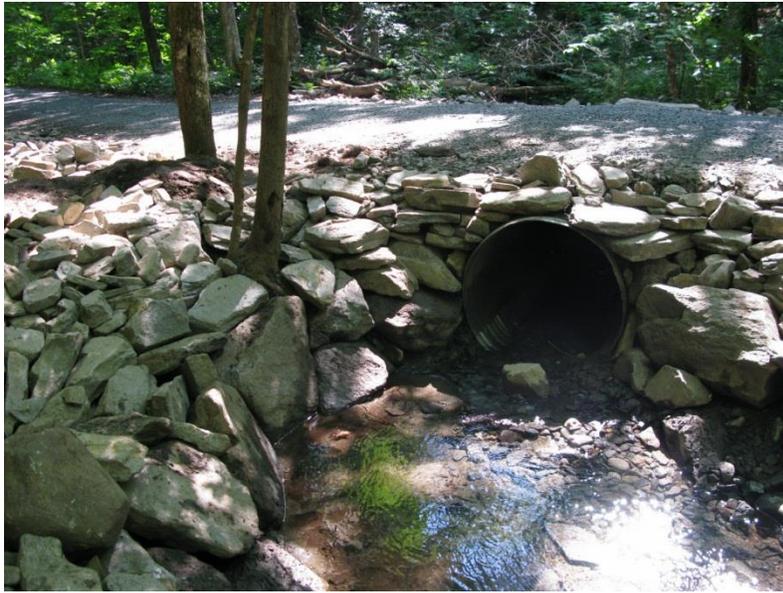
Figure 5.- Class 4 Road culvert header installation (Photo credit Greg Russ)

sites have been restored using BMP practices such as culvert headers (Figure 5), culvert outlet stabilization, stone-lined waterways, reinforced stream crossings, and water bar installation. Most of the restored sites withstood the significant precipitation and severity of TS Irene with minimal damage compared to those sites yet restored. Additional sites will be restored as funded is secured.
