Peacham Barnet Water Quality Study Summer 2005

A final report Submitted to the Connecticut River Joint Commission, November 30, 2005 from the Peacham
Conservation Commission

Figure 1 – Generalized map of water quality sampling sites.

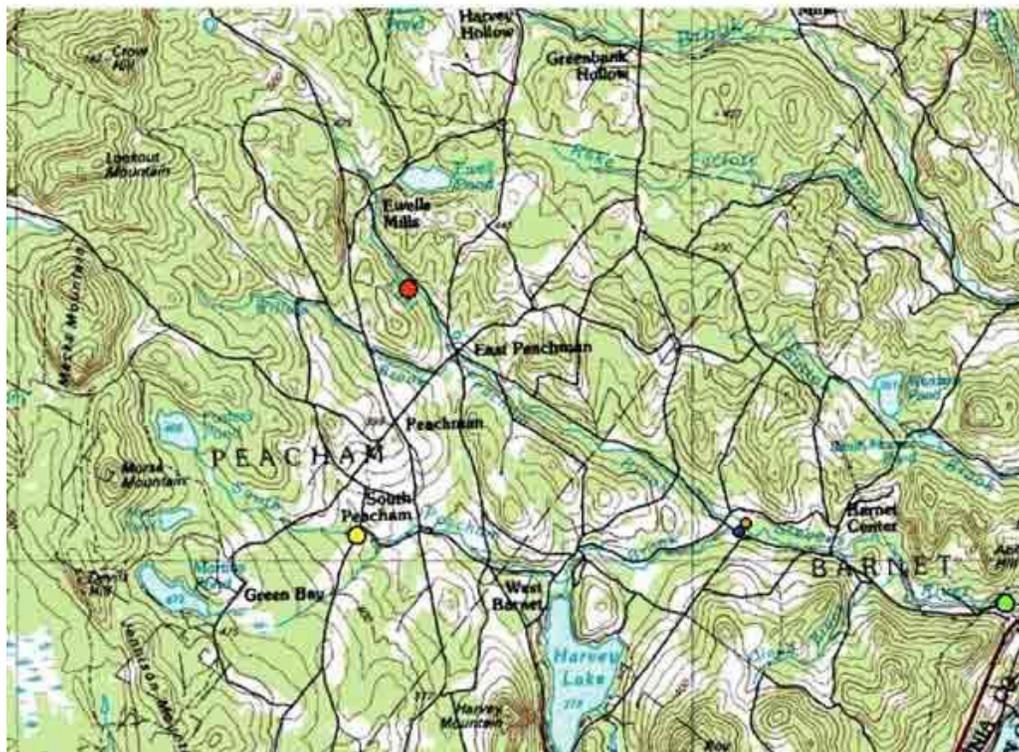
Site Name	Elevation (m)	Location Latitude/Longitude		Map Color	Water body
SR01	235	N 44°18.773'	W072°06.413'	BLUE	South Peacham Brook
PH01	231	N 44°18.781'	W072°06.387'	ORANGE	Peacham Hollow Brook
ASR01	N/A	N44°18.103'	W072°03.492'	GREEN	Stevens River
SPB01	353	N44°18.879'	W072°10.647'	YELLOW	South Peacham Brook
PH02	374	N44°20.768'	W072°09.952'	RED	Peacham Hollow Brook

This project investigated specific water quality parameters on the Stevens River main stem and its major tributaries, South Peacham Brook, and Peacham Hollow Brook (See Figure 1, and Table 1). The five sampling sites were spread out over the watershed (see map), the closest to the Connecticut River was at Anderson Street in Barnet (ASR01, green). Sampling then moved upstream in elevation, to a site on South Peacham Brook (SR01, blue) and a site on Peacham Hollow Brook just above their confluence (PH01, orange). These were preceded by a site on Peacham Hollow Brook (PH02, red) and the final site on South Peacham Brook at the intersection of Governor Maddox road and County Road (SPB01, yellow). The Stevens River drainage is a sub watershed contained within Basin 14, as designated by The Vermont Department of Environmental Conservation (VT ANR, 1999).
