**Agency of Agriculture Food & Markets**

**Memorandum**

**TO:** DAVID HUBER & WENDY HOUSTON-ANDERSON  
**FROM:** JOHN D. E. ROBERTS  
**SUBJECT:** LAKE CARMİ SEDIMENT RUNOFF ON 1-12-2018  
**DATE:** JANUARY 29, 2018

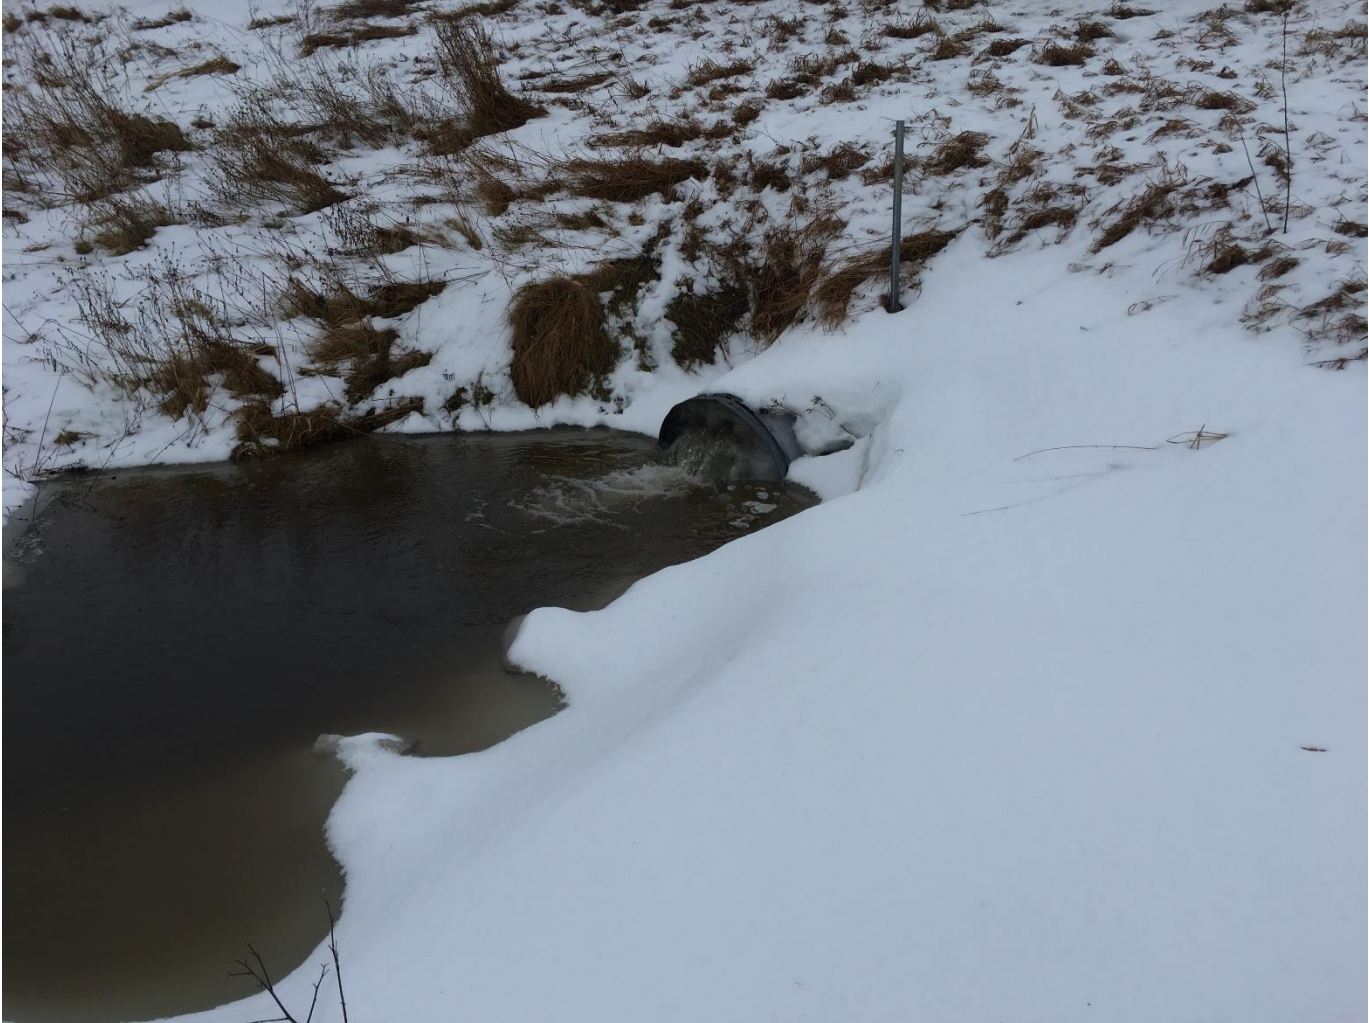
*IMG\_1732, Taken on 1-23-2018 by John D. E. Roberts . View of the 30” culvert under Route 236 that is frozen, except for two small holes*

I learned that a culvert passing under State Route 236, State Park Road, was plugged with ice during the big melt on January 12. This caused a tremendous amount of water to flow up and over Route 236, then down the highway for approximately 200 feet before spilling to the west side of the highway near an equipment yard. The flow caused a large amount of erosion and undermined the edge of the highway, stirring up a lot of sediment. I was able to get in touch with Mr. Tim Wilson, Agency of Transportation superintendent of the state highway garage in Enosburg Falls. Route 236 resides within Mr. Wilson's jurisdiction. Mr. Wilson confirmed that a 30" culvert was plugged with ice and that the highway crew tried de-icing the culvert with very limited success. Mr. Wilson said the volume of water was tremendous and the velocity of flow was stirring up a lot of silt and sediment from around the road and cutting through the equipment yard on the west side of Route 236.

Based on what I observed on the two different days I went up to this area, coupled with talking to the landowner and most specifically the highway engineer, Mr. Tim Wilson, I believe that the source for most of the silt that washed into Lake Carmi on January 12 was due to the very large volume of water that flowed up and over Route 236 because the culvert under the highway was plugged.

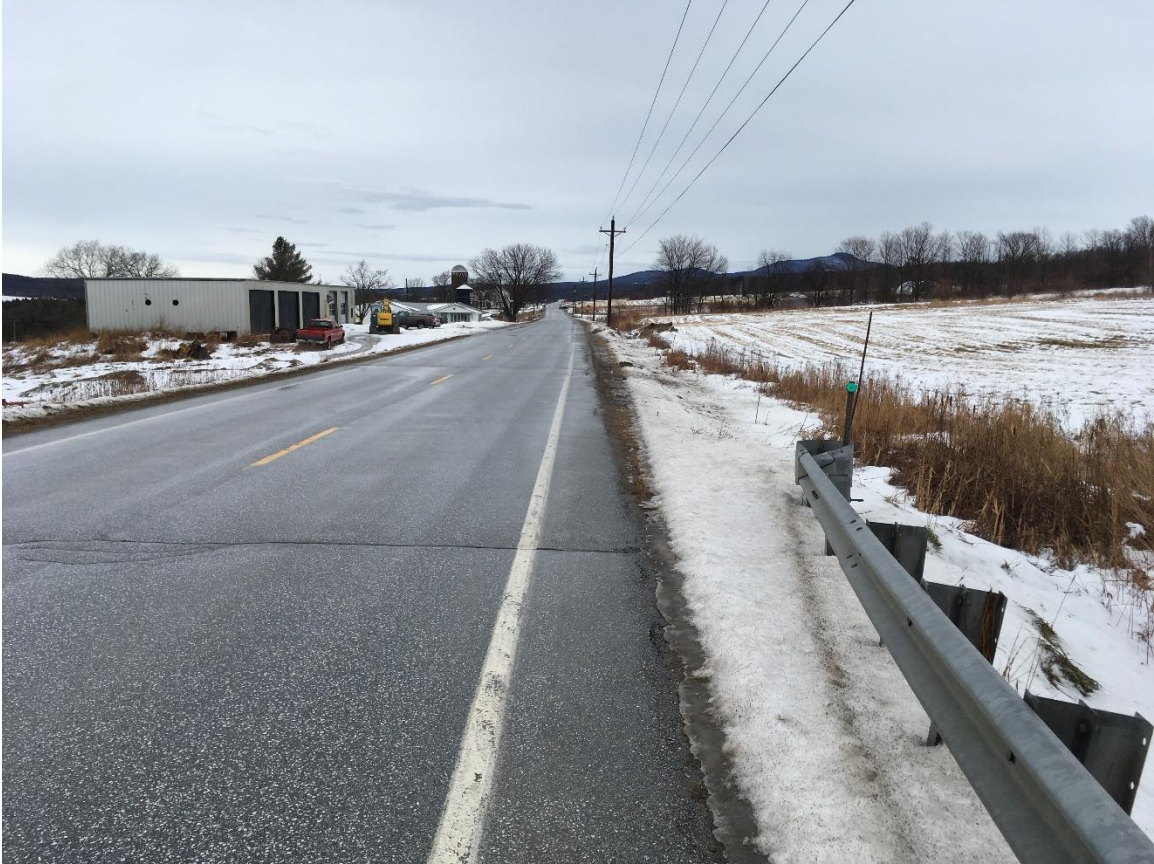
*IMG\_1731, Taken on 1-23-1028 by John D. E. Roberts. The view from the point where the frozen culvert passes under Route 236 looking north in the direction that the large amount of water flowed, then crossed 236 where the garage and red pick-up truck are on the left of the photo.*

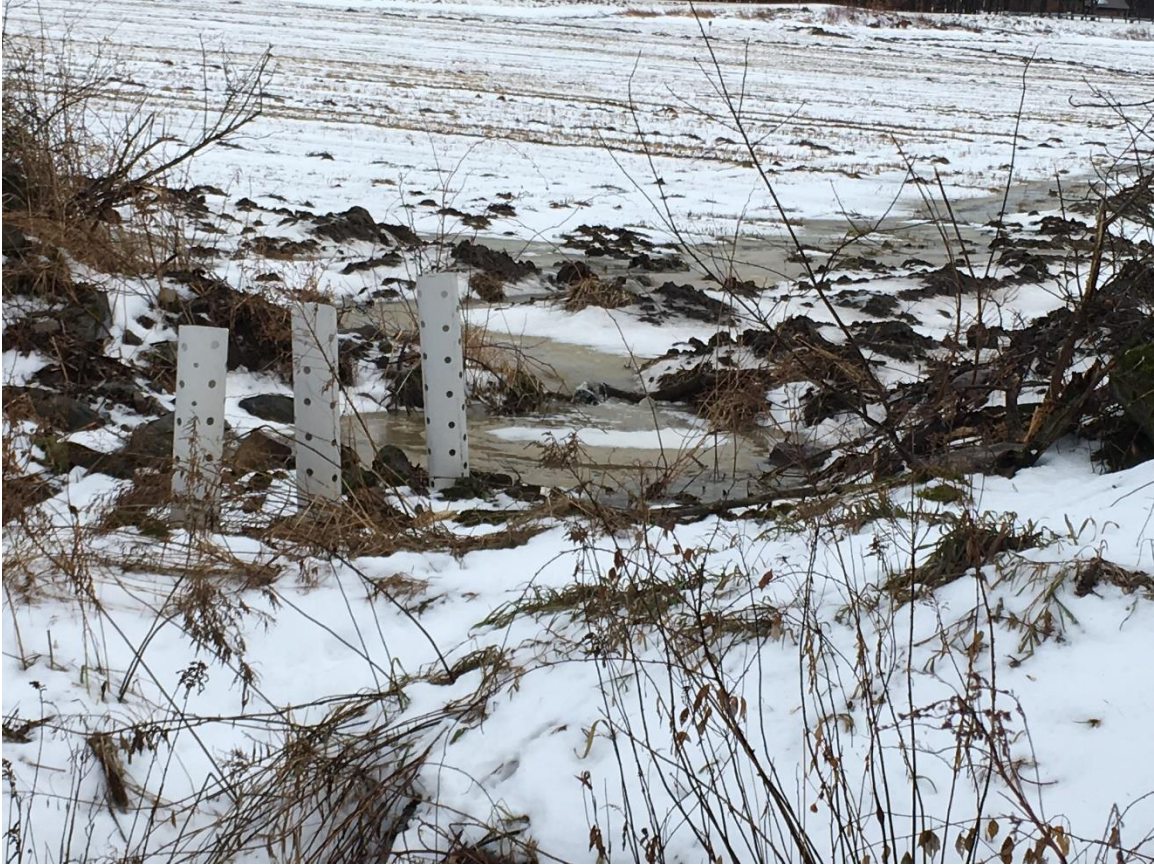
*IMG\_1719, Taken on 1-23-2018 by John D. E. Roberts. Showing the water flowing off the field where the tiling was done in the fall of 2017 with some mild sediment in the water on this day.*

On January 23, the temperature rose back up over 40 degrees and it was raining. I went back up to Lake Carmi and met with the farmer who was the landowner of the land that the water flow had crossed from Route 236. This farmer had also done some tile drain work in the fall of 2017 on one of these fields identified on the map. In the initial email that drew my attention to this runoff situation, these were the fields owned by the farmer, that the complainant assumed the sediment had come from. The farmer and I walked up from Hammond Shore Road to the field that was tiled and followed a brook known locally as Kane Brook. There was a considerable flow of water coming down the brook. Most of the way the water flowed in a grassed waterway over a 6" tile drain. The water had some sediment in it but not heavy, a camel color. When we reached the field that had been tiled in the fall, there was water flowing out of the tile which appeared to be very light brown. This flow was joined by water that was flowing on the surface along the edge of the soil ridges left by the tile installation. This water was also very lightly colored with sediment. The tiled field was a grass field and no erosion was observed at the time of the investigation.

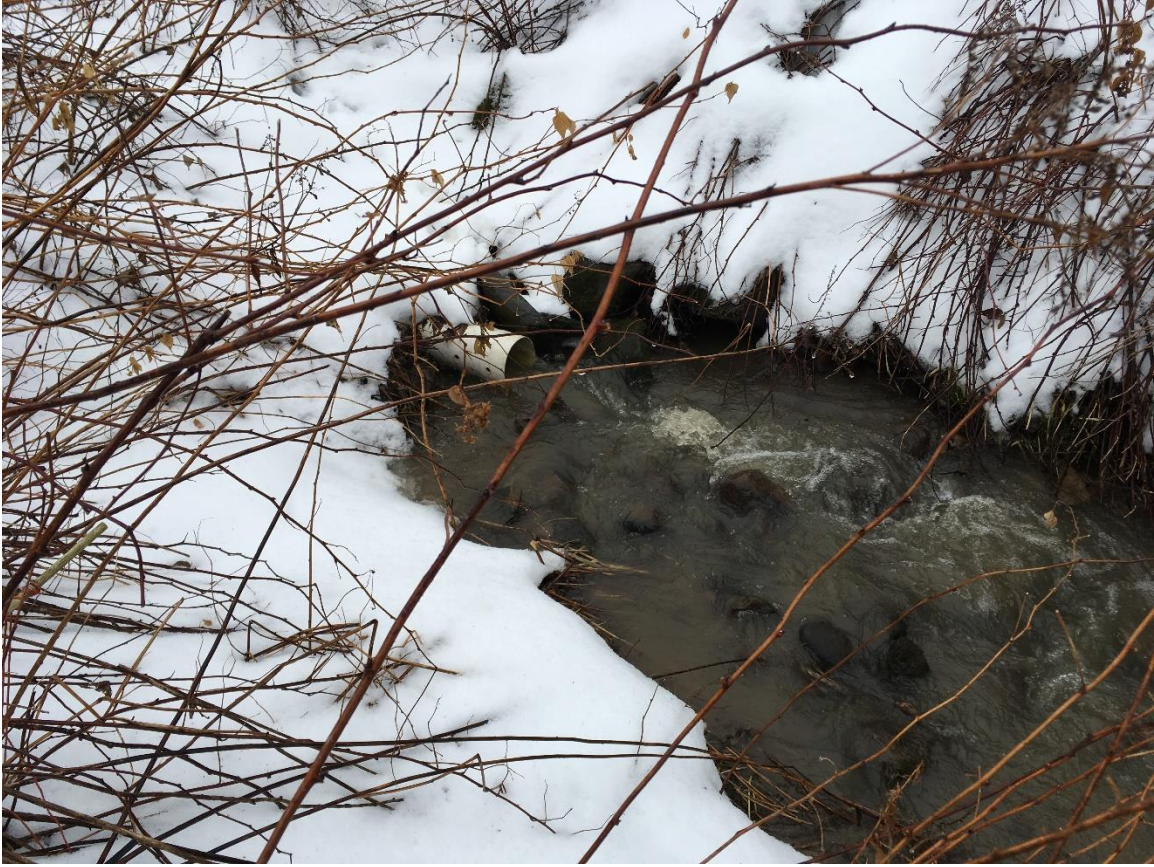
*IMG\_1722, Taken on 1-23-2018 by John D. E. Roberts. The photo depicts where the tile under the grassed waterway leading from the tiled field comes out by the cedar woods down near Lake Carmi. The water coming out of the tile has some mild sediment in it on this day.*
