FINAL MEMO

REVIEW OF BASIN 17 STREAM GEOMORPHIC ASSESSMENTS & SEDIMENT STRESSED CONDITIONS IN STEARNS BROOK

FY22 TACTICAL BASIN PLANNING SUPPORT GRANT TASK 3.3

Stearns Brook Sediment Stressed Conditions

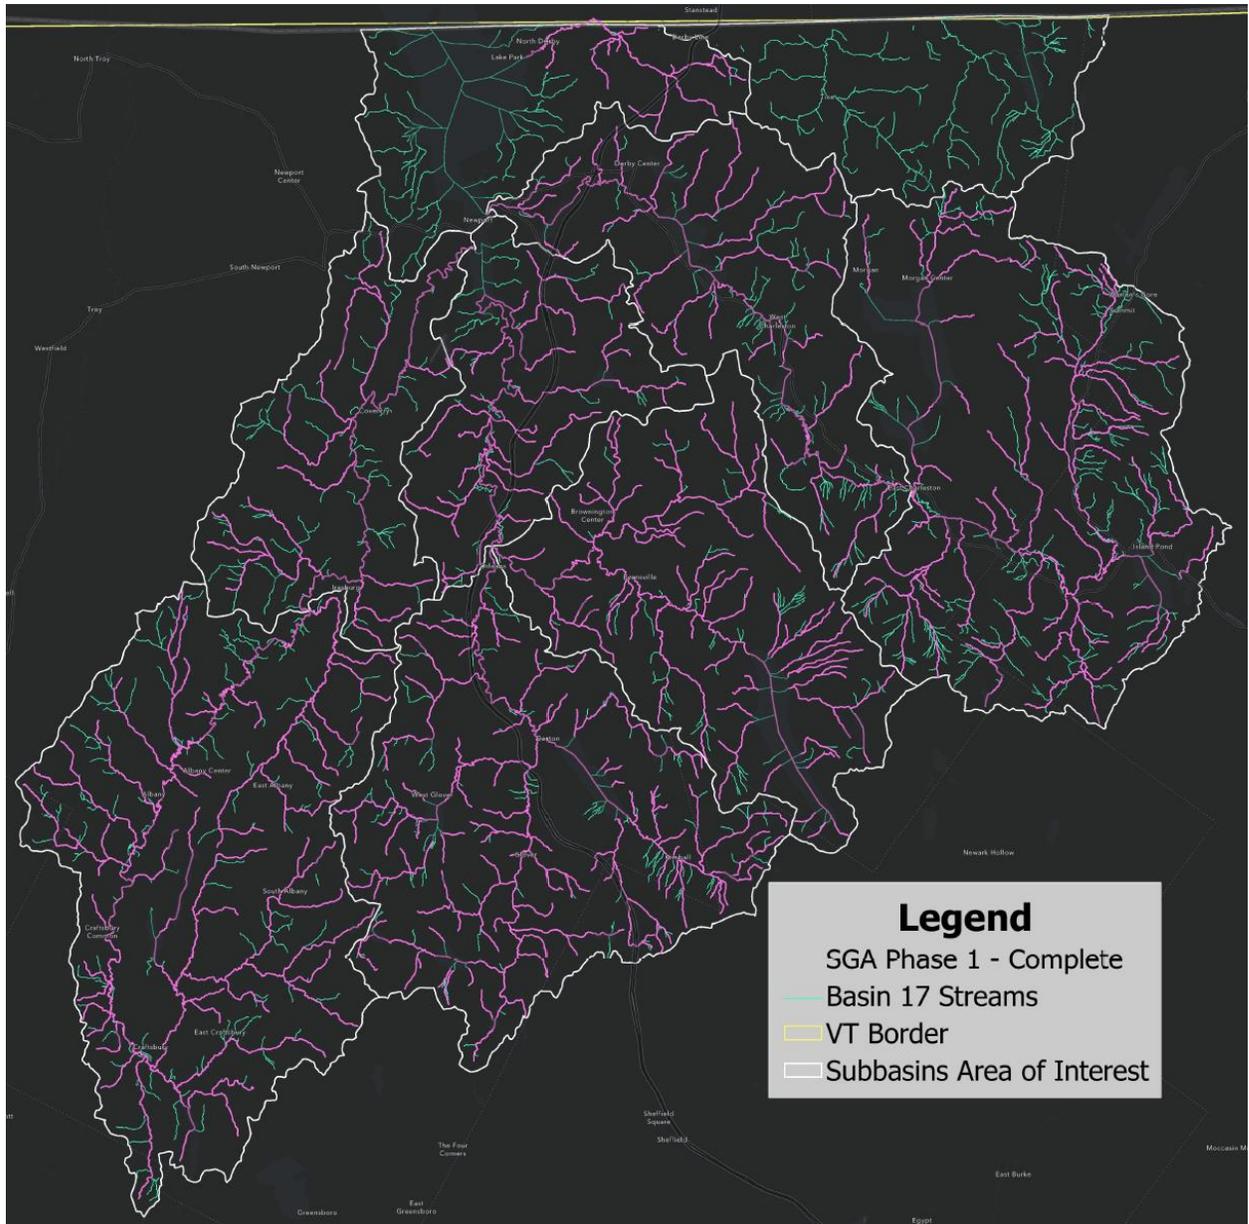
Figure 1. Map illustrating the Basin 17 area of interest by subbasins (white polygons), streams as mapped by the VHD (cyan lines), and all reaches with completed Phase 1 assessments (pink lines).

According to these data, SGA Phase 1 has been performed on 738.5 miles of stream and Phase 2 assessments have been performed on 67.6 miles of stream (Figures 1 & 2). When viewed in context to the 1,213.1 miles of streams mapped by the Vermont Hydrography Dataset, Phase 1 assessments have been performed across 61% of the area of interest, whereas Phase 2 assessments have occurred across only 6%.

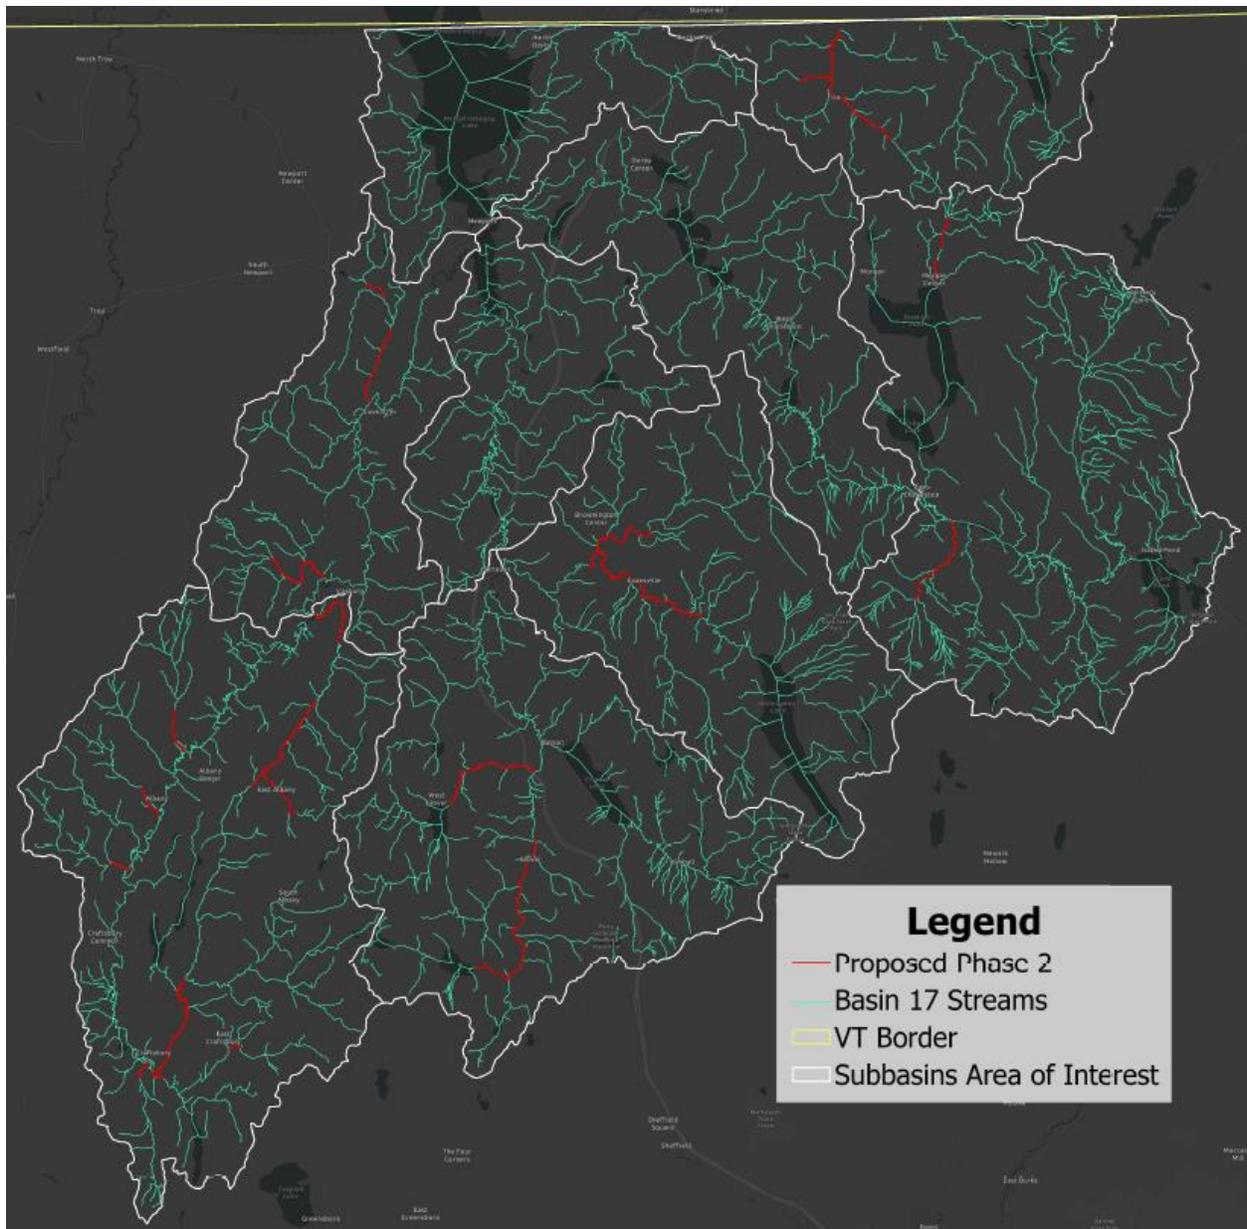
Figure 3. Map illustrating the Basin 17 area of interest by subbasins (white polygons), streams as mapped by the VHD (cyan lines), and all reaches with proposed Phase 2, Phase 2 lite, or similar geomorphic condition assessments (red lines).

MWA and ANR compiled a list of streams and reaches that may warrant additional assessment and study to better characterize the geomorphic conditions and stressors, identify conservation and restoration opportunities, and initiate project development and outreach efforts. This list is not intended to be exhaustive or comprehensive, but rather a needs-based strategic approach to expand the narrative and data collection efforts that help characterize river conditions. Figure 3 provides a map of streams and reaches where further geomorphic assessments would provide valuable data and insight to the geomorphic conditions and processes in the basin. These reaches comprise 49.9 stream miles, which would provide a 4% increase in geomorphic assessment coverage across the basin, bringing the total to 117.5 miles (10% of total). The primary reaches and streams proposed for geomorphic or similar assessments are listed in Table 2.

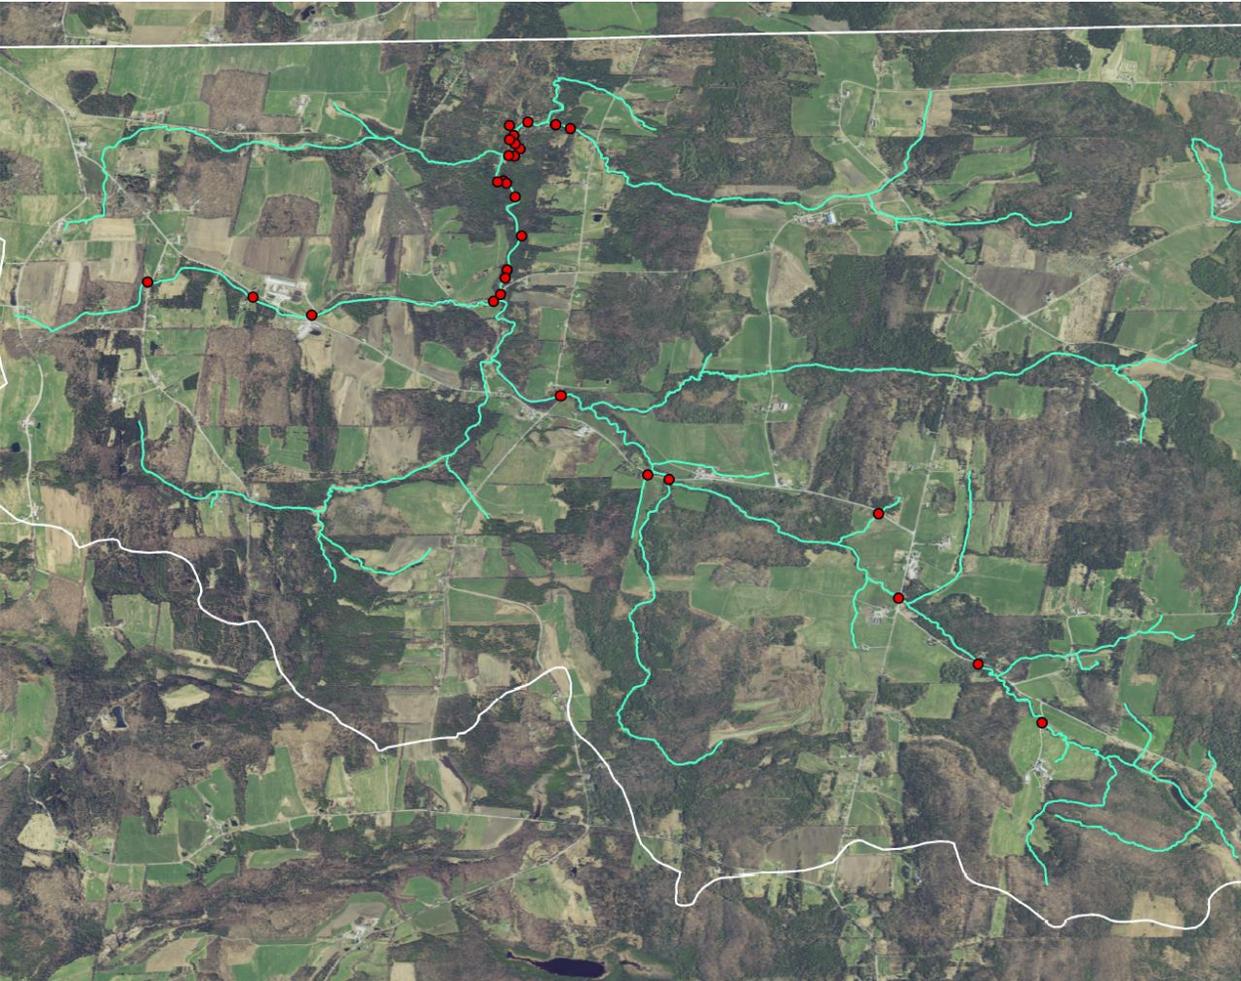
Figure 4. Map illustrating streams in the Stearns Brook subbasin and observations made during the October 2021 site visit.

MWA and DEC performed a site visit to Stearns Brook on October 28, 2021 to identify potential sources or remedies for the documented sediment stressed conditions in the watershed. During the site visit, several stops were made at road-stream crossings and other locations to observe conditions related to sediment sourcing and fluvial erosion (Figure 4). In addition, MWA walked the lower reaches of Stearns Brook downstream of Twin Bridges Road and recorded observations of streambank erosion, riprap, riparian encroachment, and 4x4 trail stream crossings. The site visit provided valuable field observations of potential water quality concerns and a review of past, in progress, and future potential clean water projects.

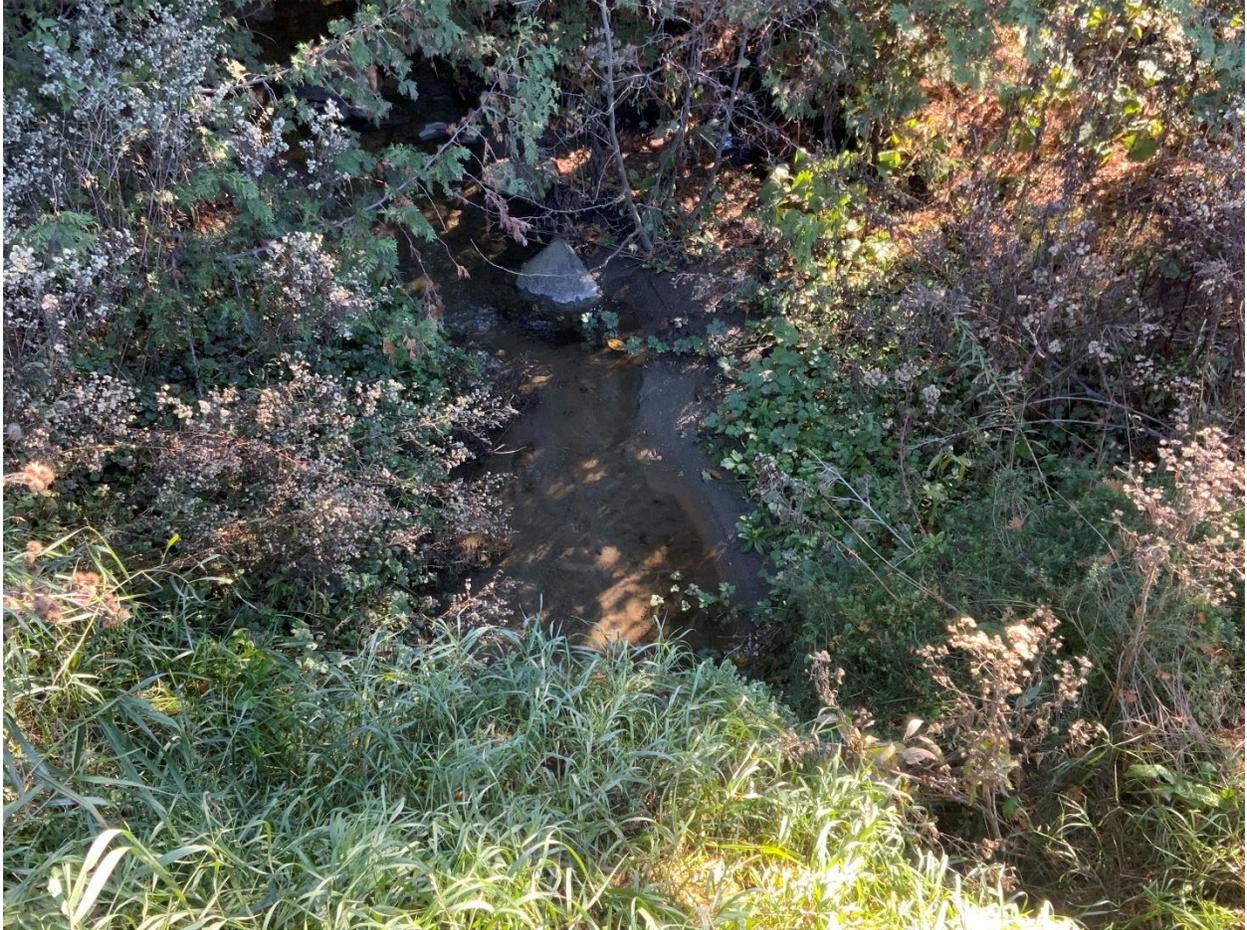
Figure 5. Sediment deposition near the Valley Rd and Tice Hurst Rd stream crossing, downstream of a large dairy operation.

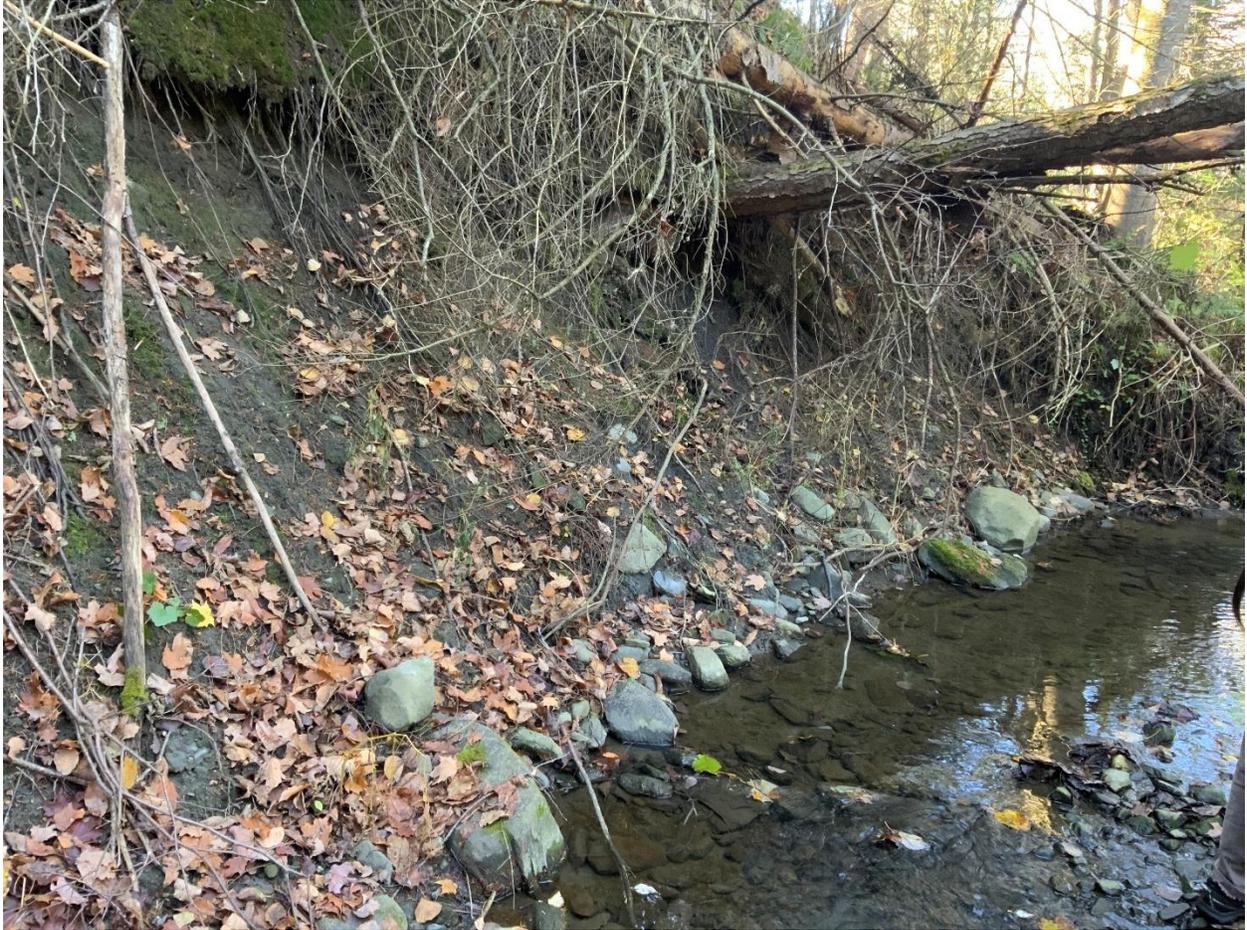
Figure 6. Bank erosion near the downstream end of an unnamed tributary flowing from the west alongside Holland Rd, prior to the confluence with Stearns Brook.

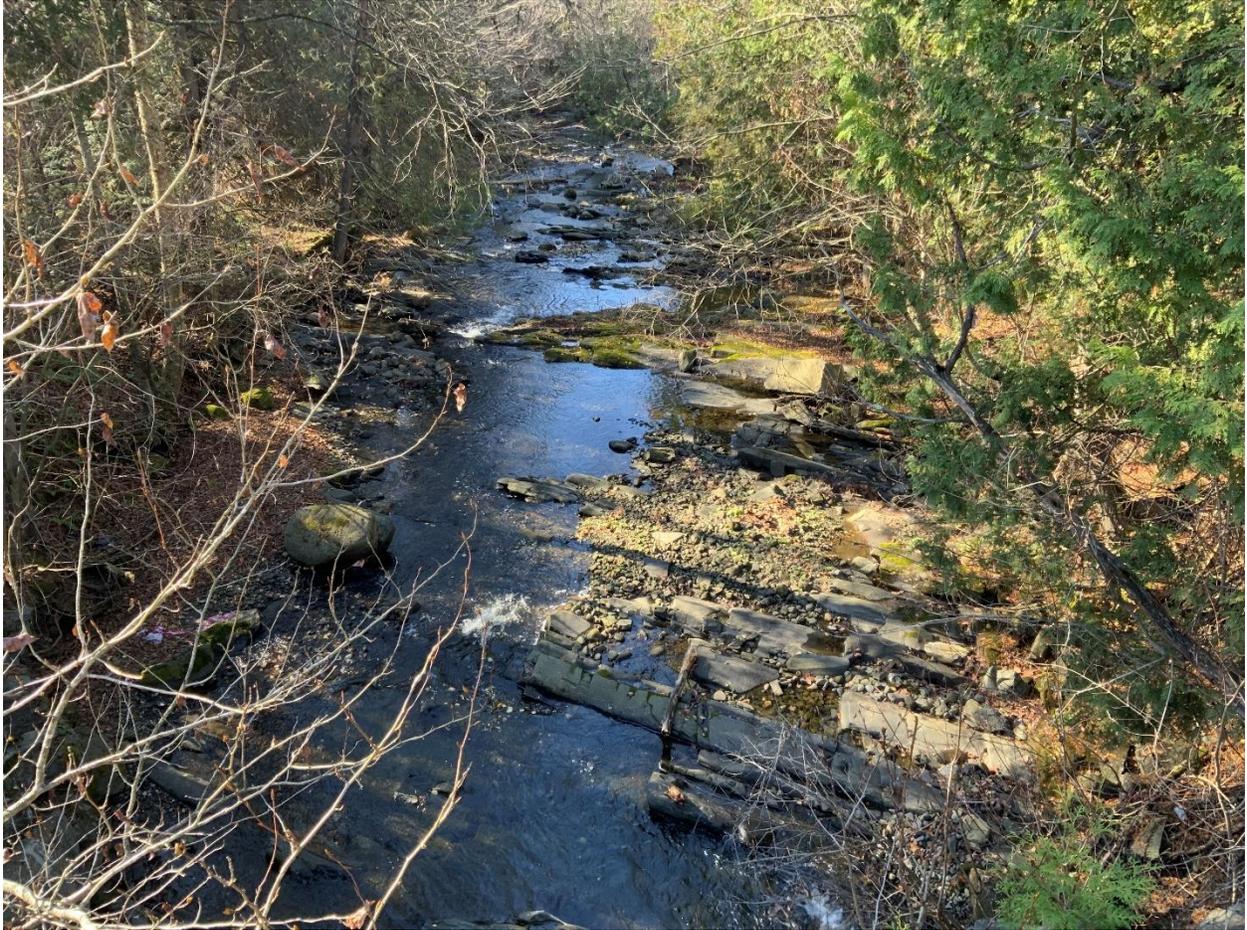
Figure 7. Boulder-bedrock substrate dominates the channel at the bridge crossing on Stearns Brook Rd.

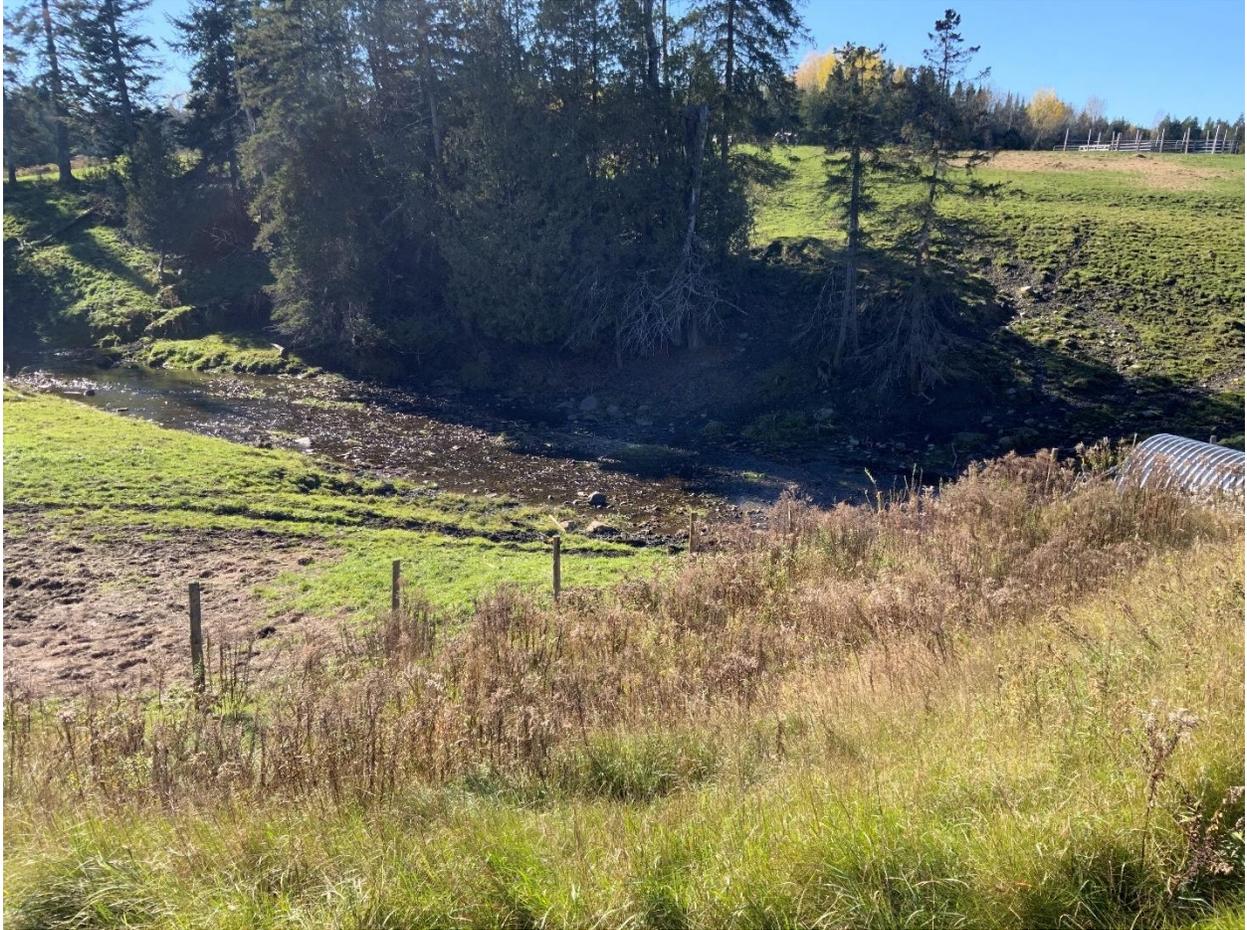
Figure 8. Riparian degradation and channel and bank erosion resulting from cattle pressure near the large culvert crossing on Valley Rd, downstream of a large dairy operation.

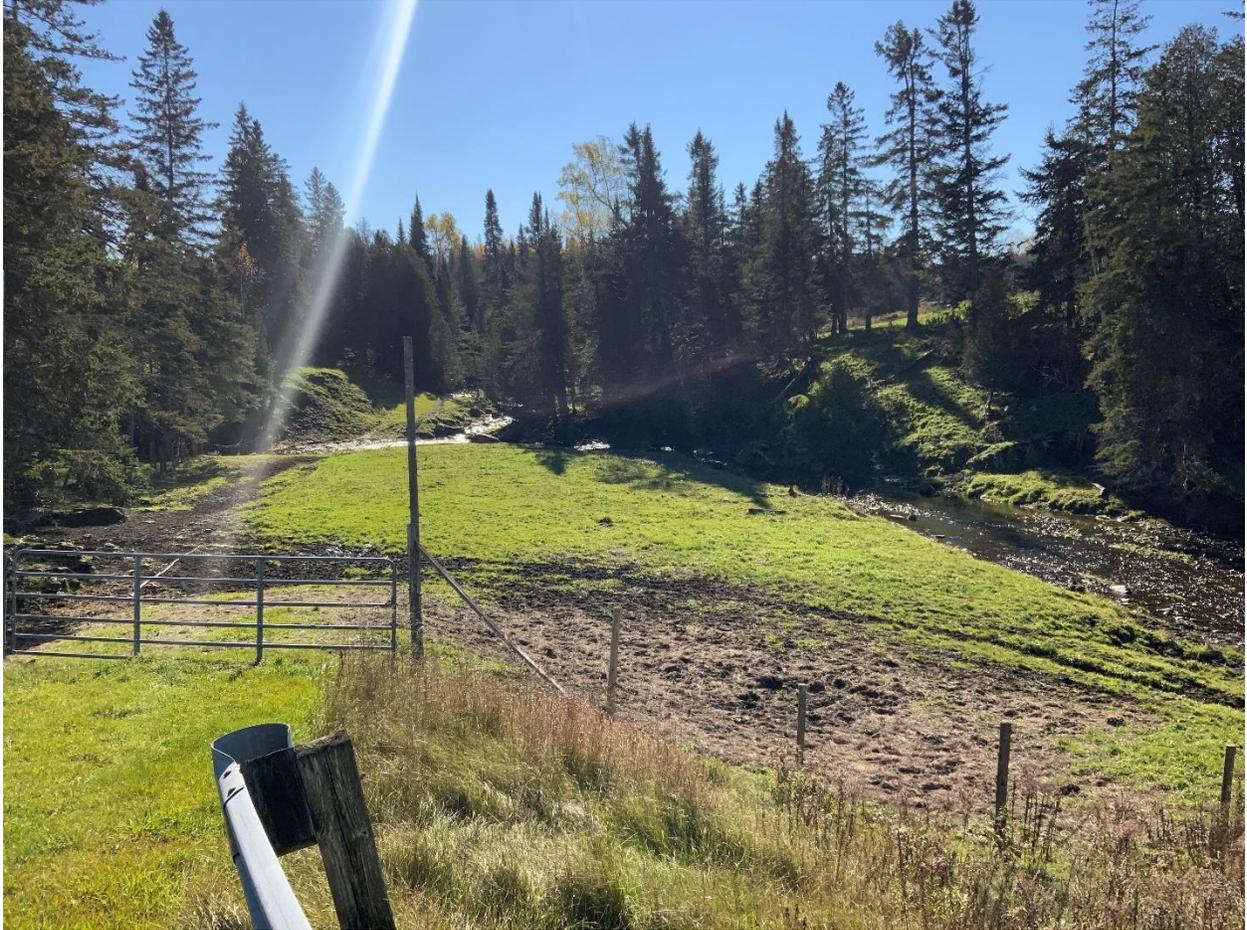
Figure 9. Soil compaction, riparian degradation, and channel and bank erosion resulting from cattle pressure near the large culvert crossing on Valley Rd, downstream of a large dairy operation.

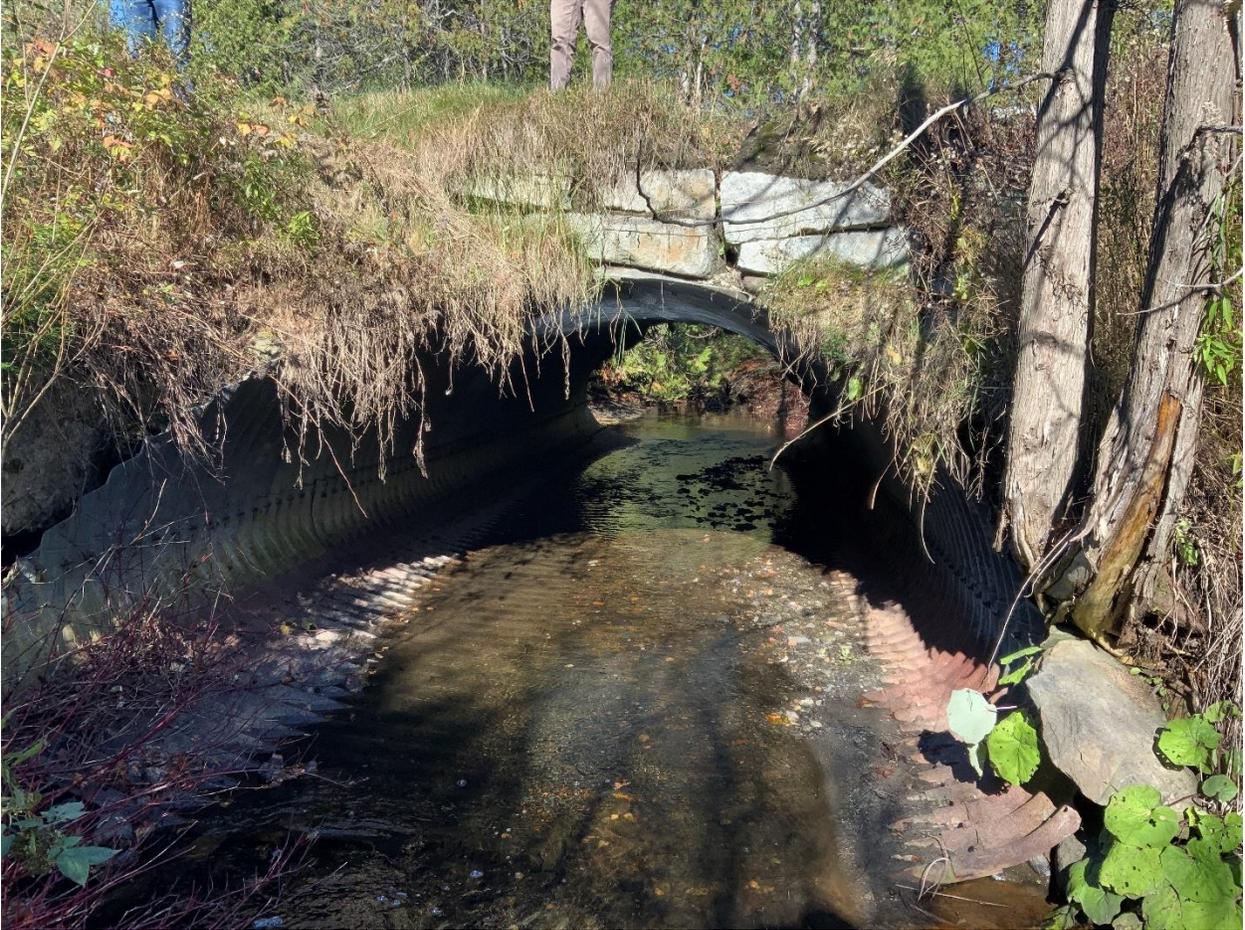
Figure 10. A potential compromised culvert crossing on Valley Rd downstream of Truscott Rd, with fine and coarse sediment deposition.

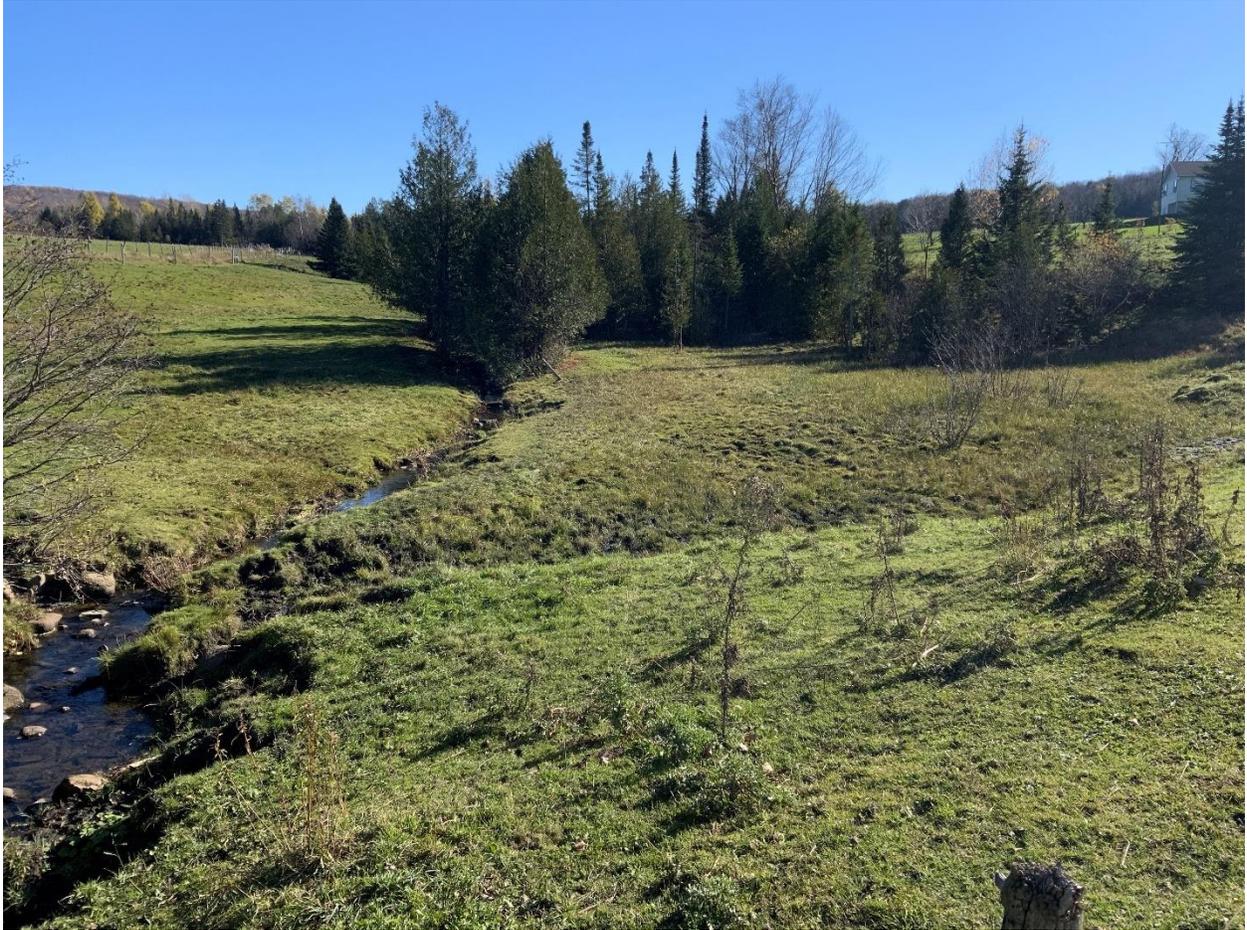
Figure 11. Riparian degradation and erosion resulting from cattle pressure on Fortin Farm Rd. A potential opportunity for wetland and stream restoration using low-tech, process-based restoration approaches.

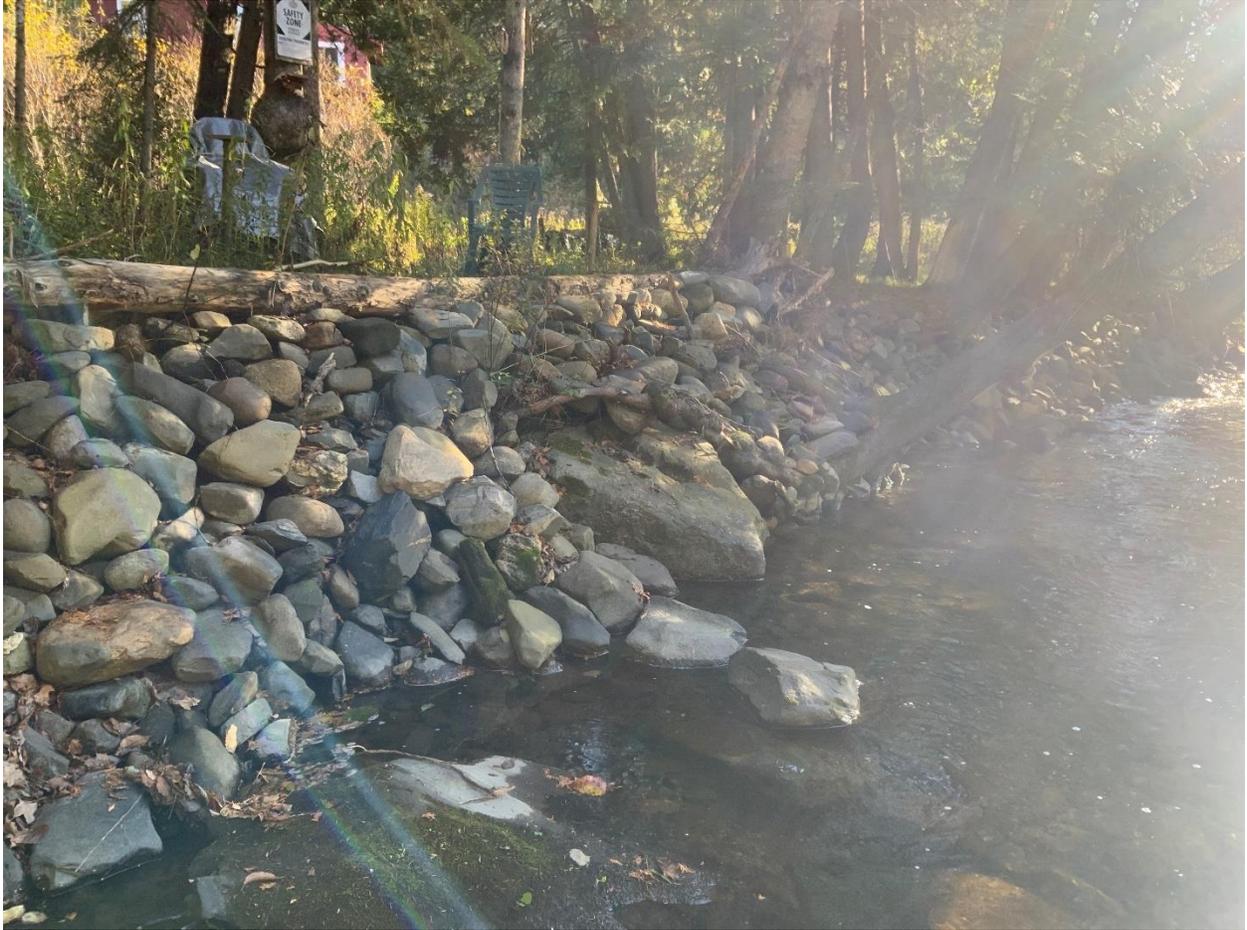
Figure 12. Landowner-installed bank armoring on lower Stearns Brook, downstream of Twin Bridges Rd.

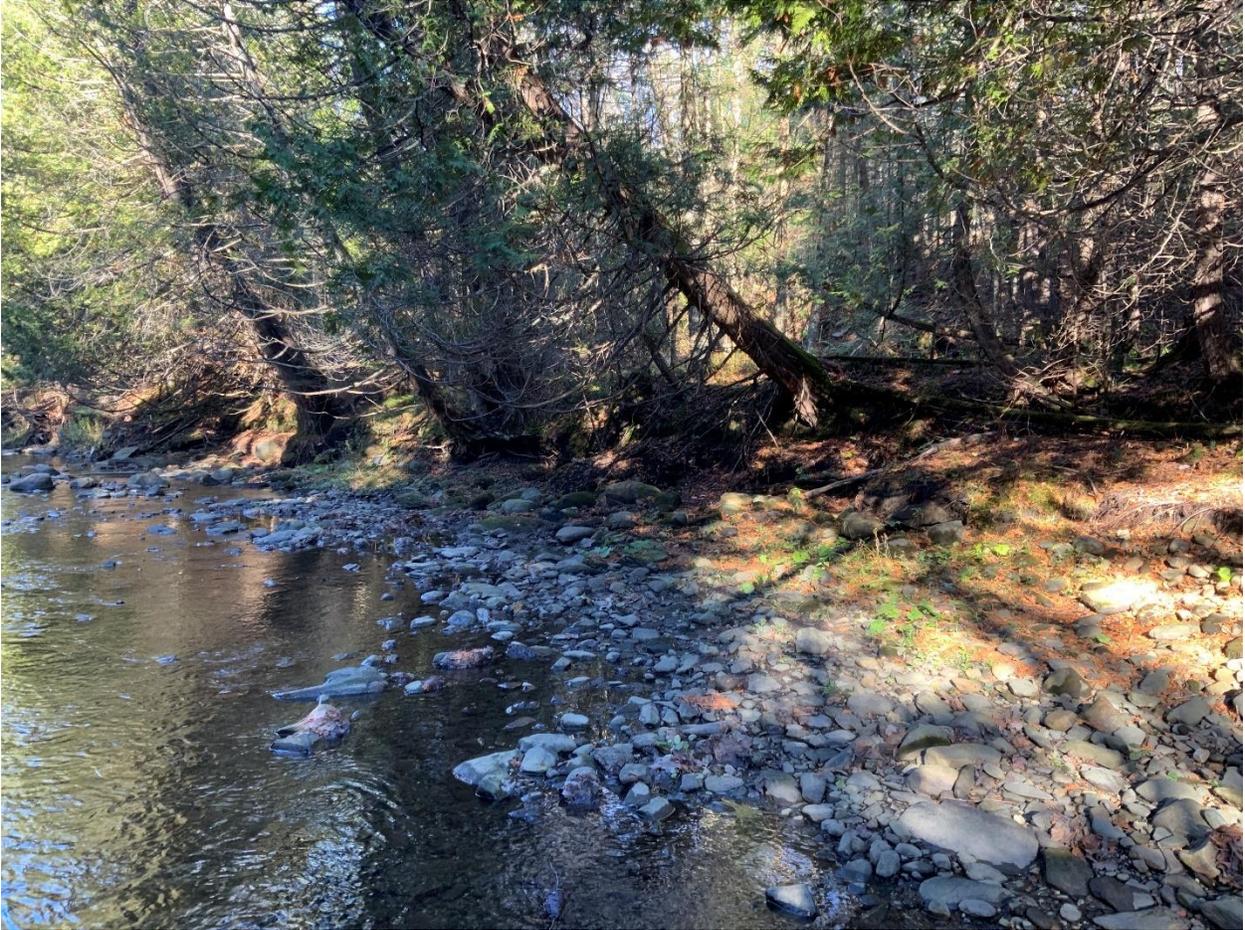
Figure 13. Overhanging vegetation and gravel bars along lower Stearns Brook, downstream of Twin Bridges Rd.

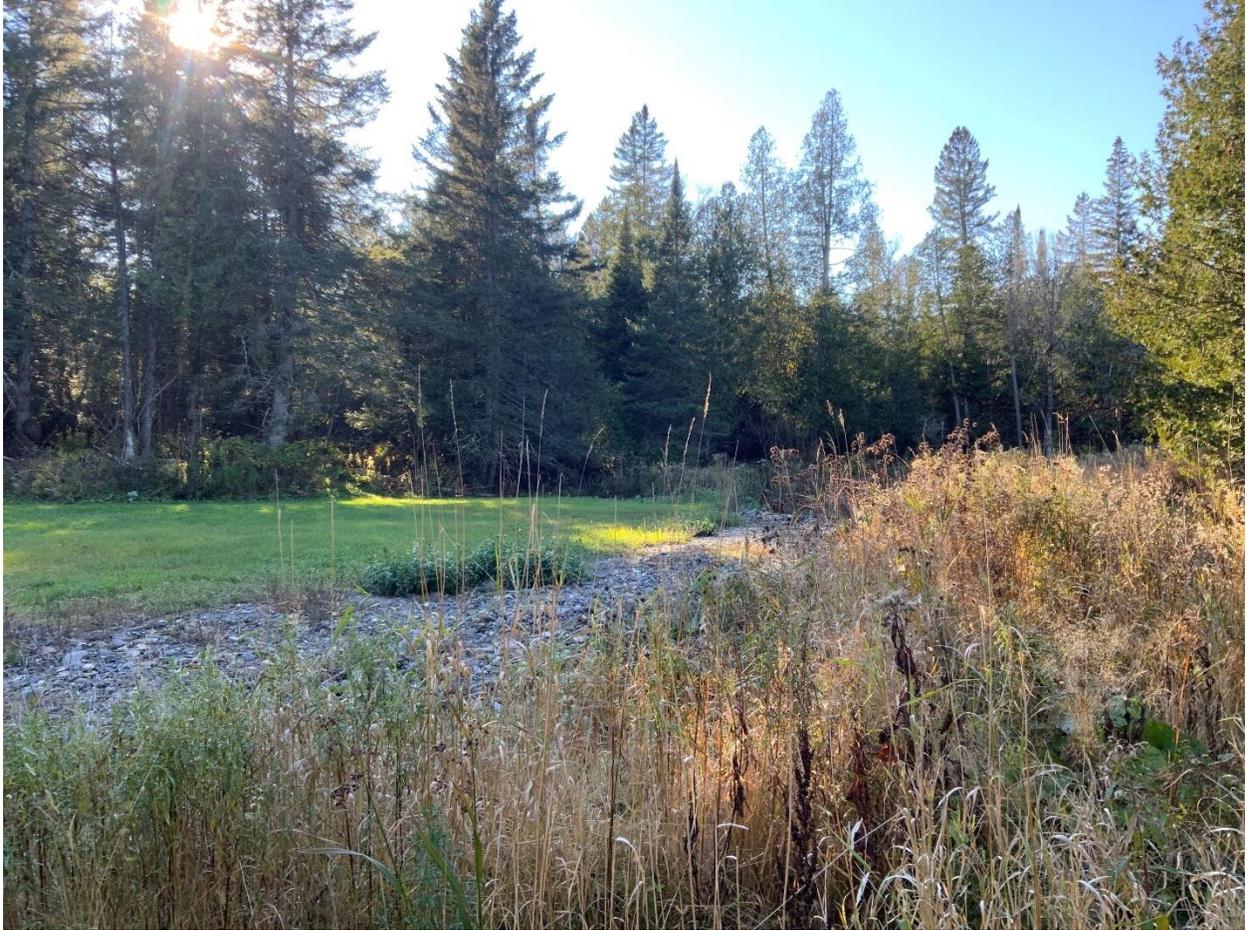
Figure 14. Mowed lawn and point bar excavation or grading along left bank, Stearns Brook, downstream of Twin Bridges Rd.

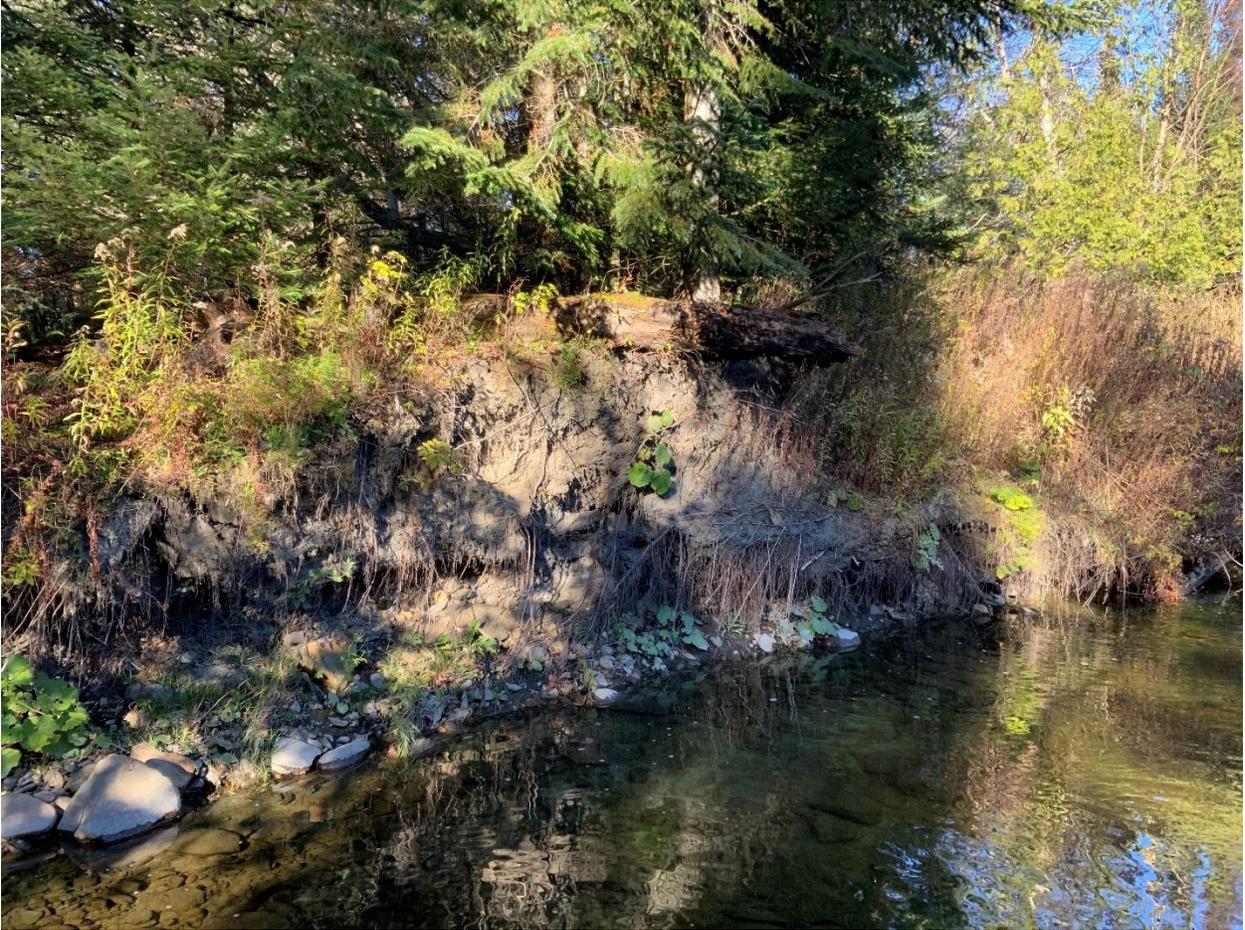
Figure 15. Bank failure on an outer bend, lower Stearns Brook, downstream of Twin Bridges Rd.

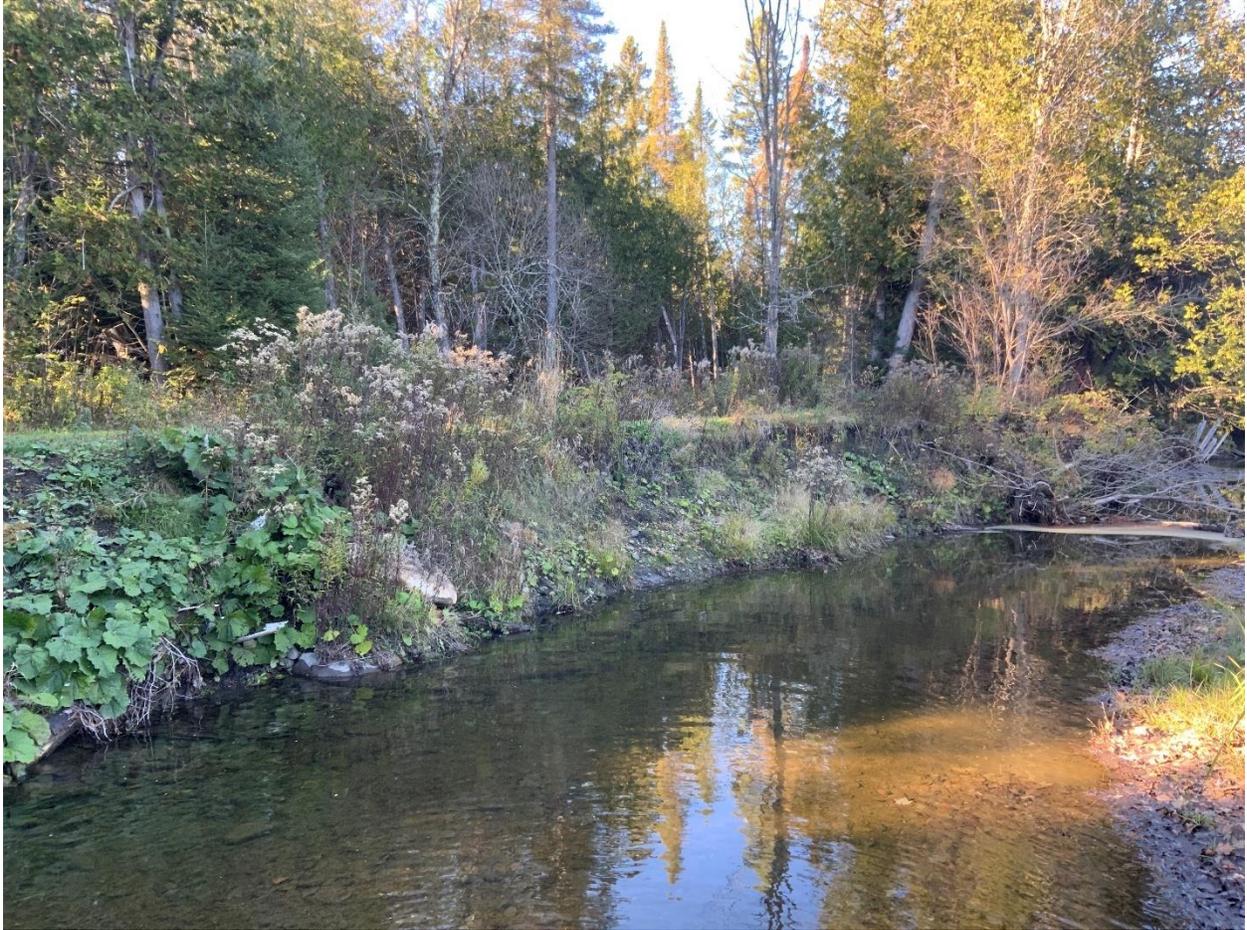
Figure 16. A snowmobile trail and apparent indications of alterations to streambanks on lower Stearns Brook, downstream of Twin Bridges Rd.

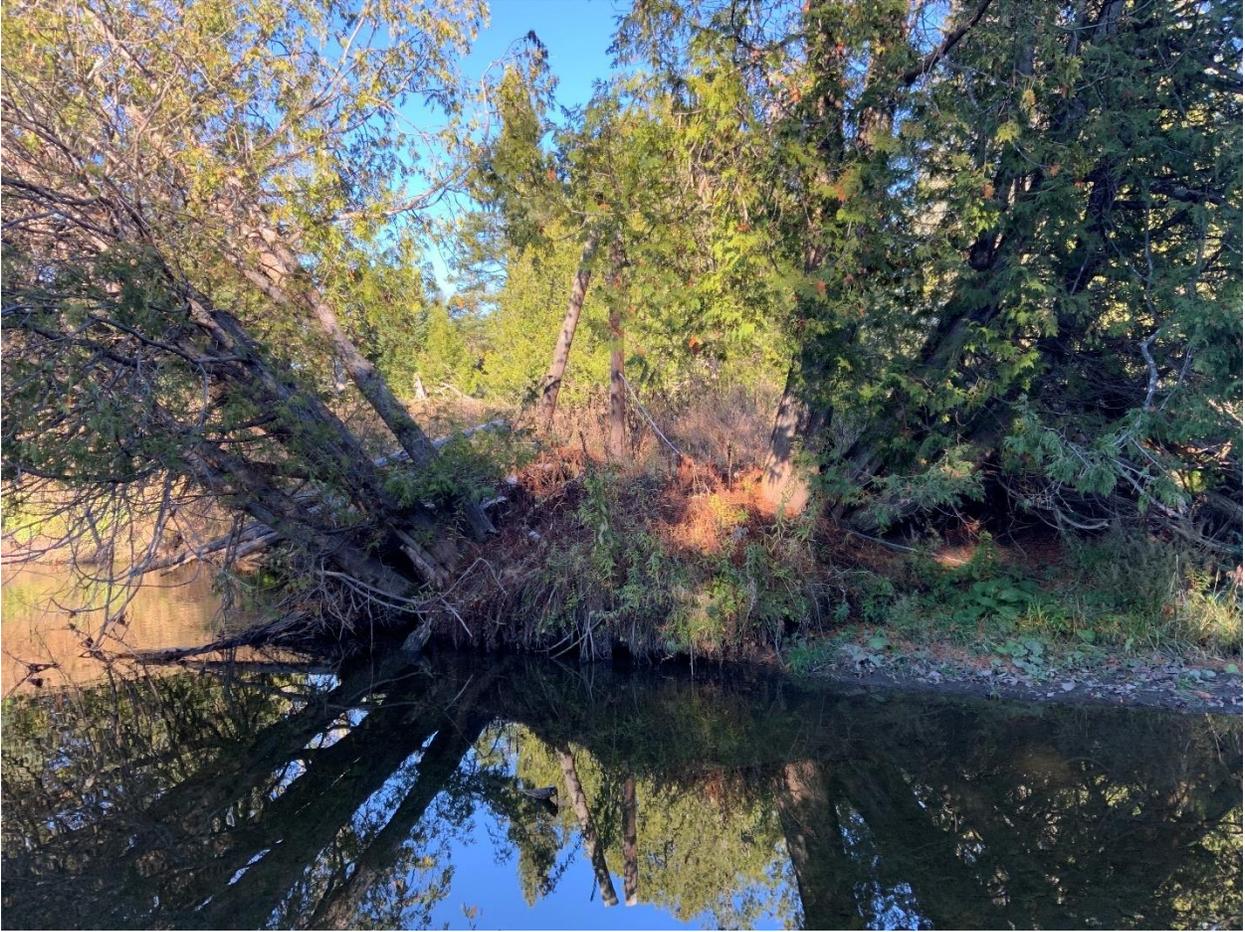
Figure 17. Overhanging vegetation on lower Stearns Brook, downstream of Twin Bridges Rd.

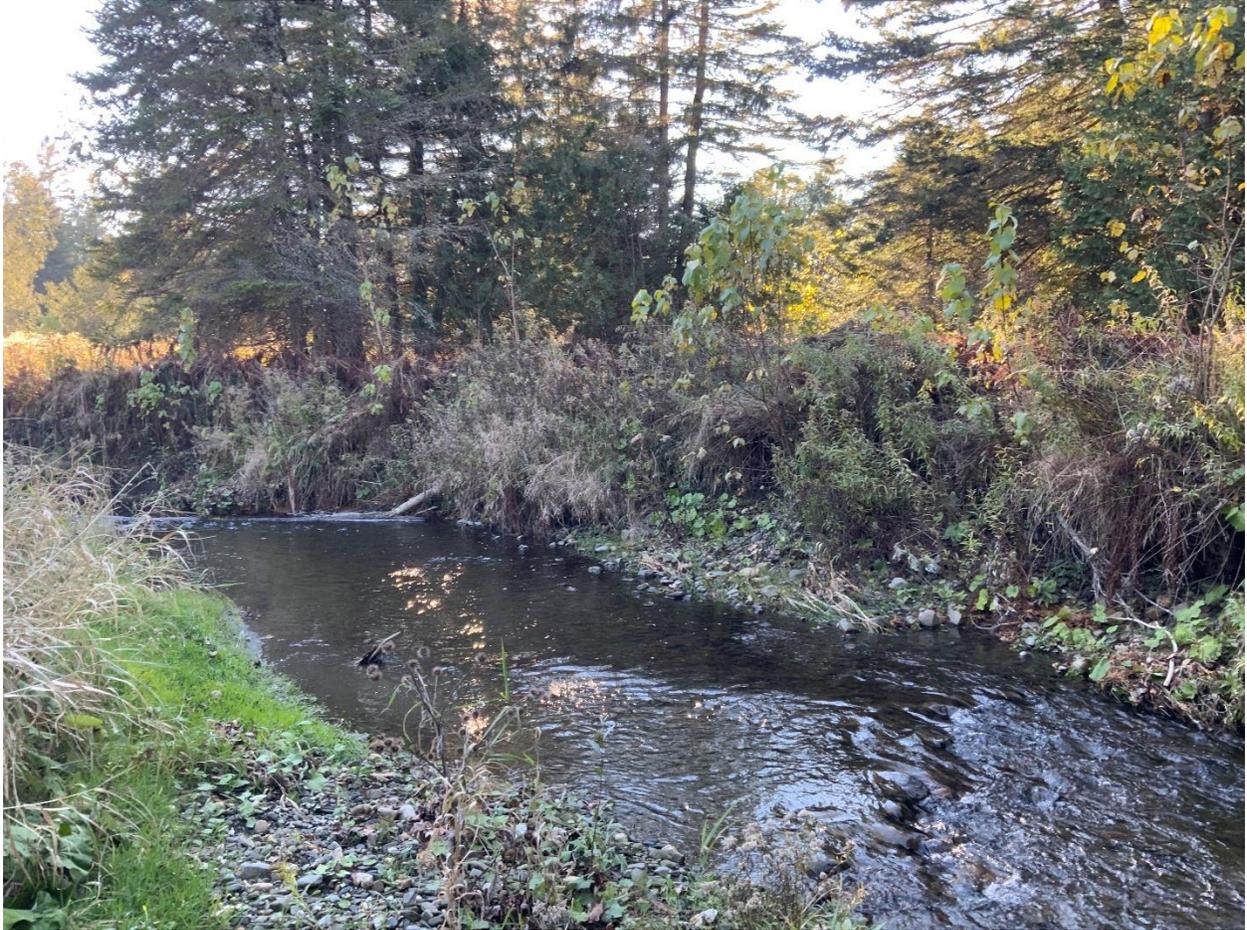
Figure 18. Looking upstream at an outer bend, lower Stearns Brook, downstream of Twin Bridges Rd.

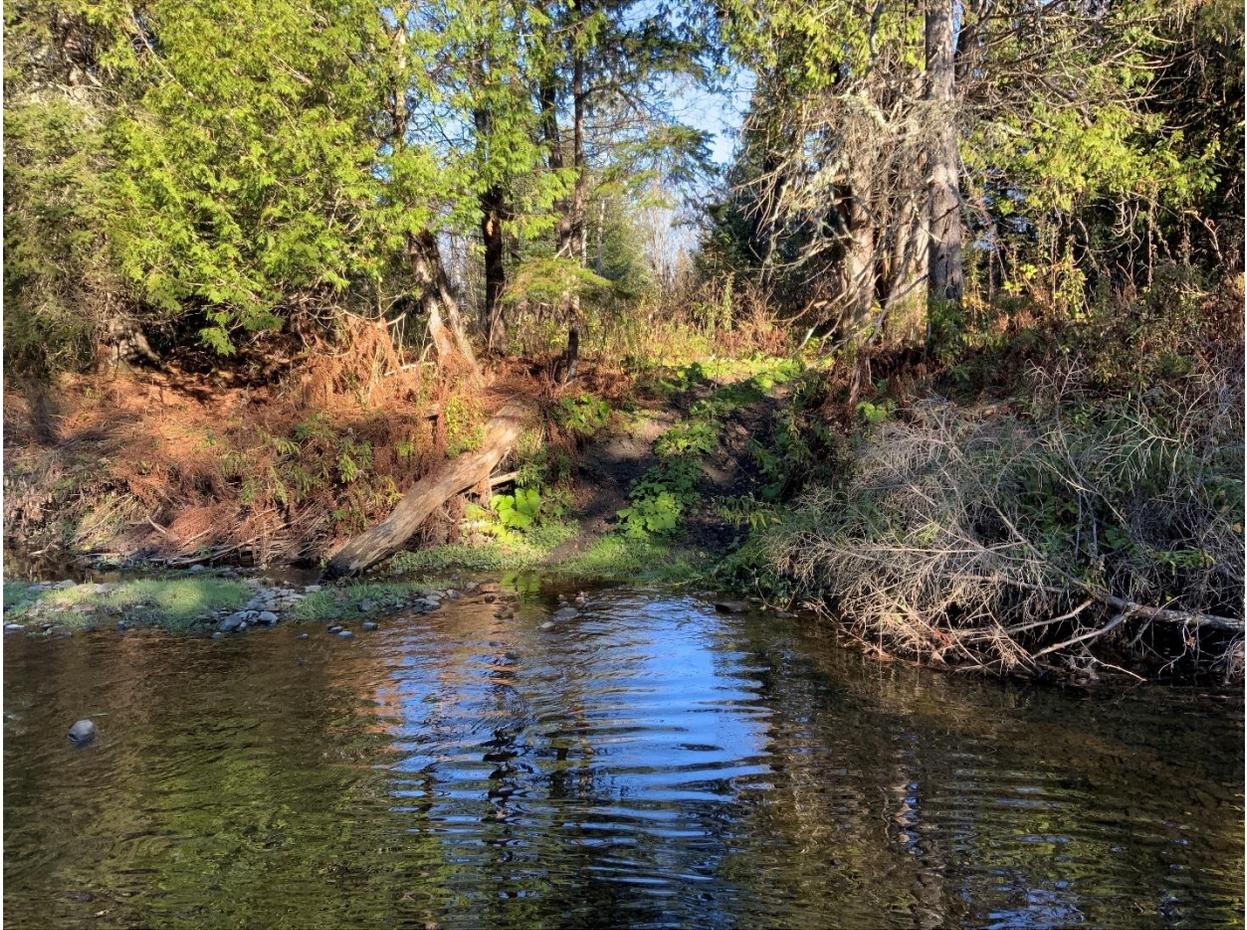
Figure 19. Vehicle or ATV ford dug into streambank on lower Stearns Brook, downstream of Twin Bridges Rd.
