FINAL MEMO

REVIEW OF BASIN 17 STREAM GEOMORPHIC ASSESSMENTS & SEDIMENT STRESSED CONDITIONS IN STEARNS BROOK

FY22 TACTICAL BASIN PLANNING SUPPORT GRANT TASK 3.3

Stearns Brook Sediment Stressed Conditions

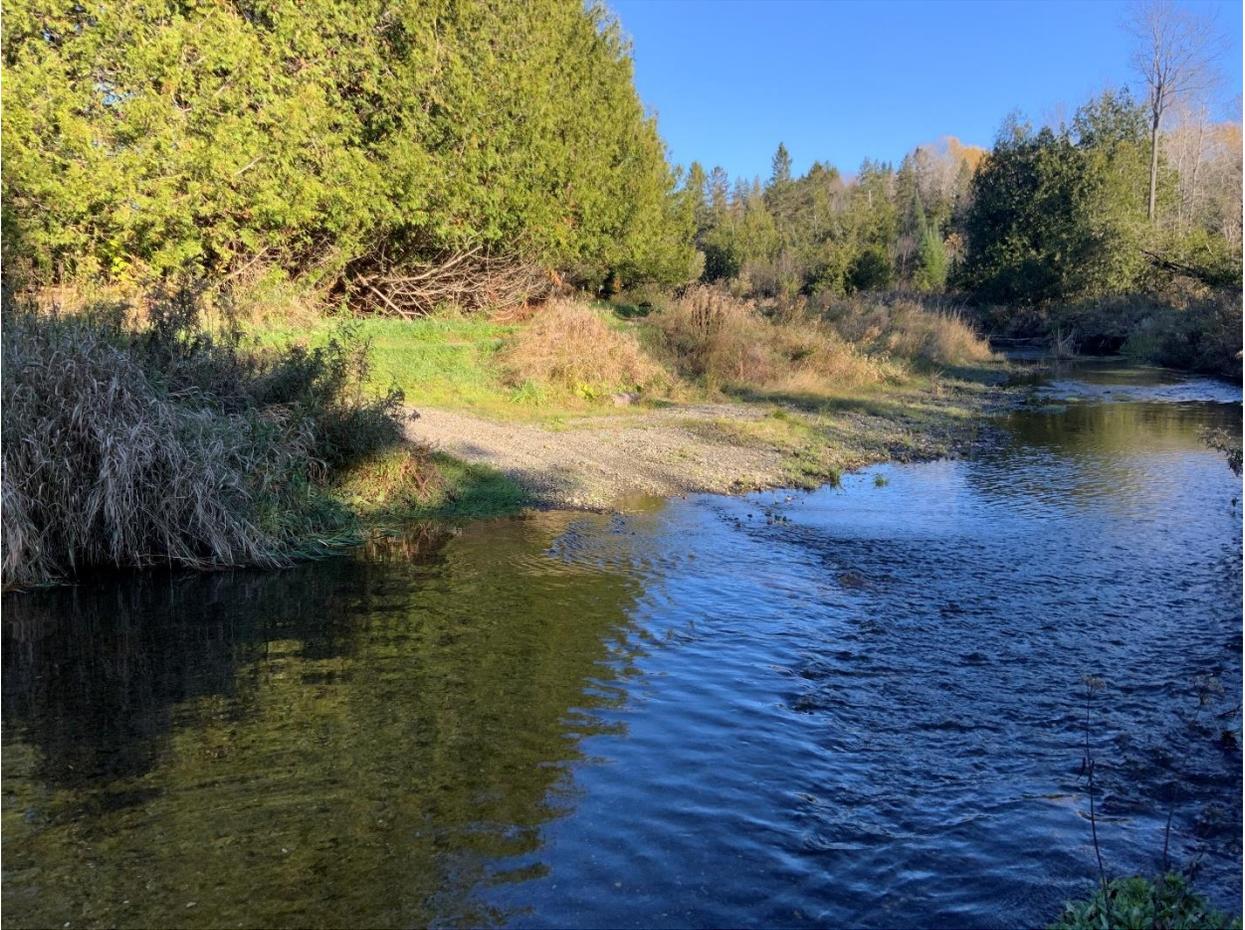
Figure 20. Vehicle or ATV ford dug into streambank on lower Stearns Brook, downstream of Twin Bridges Rd.

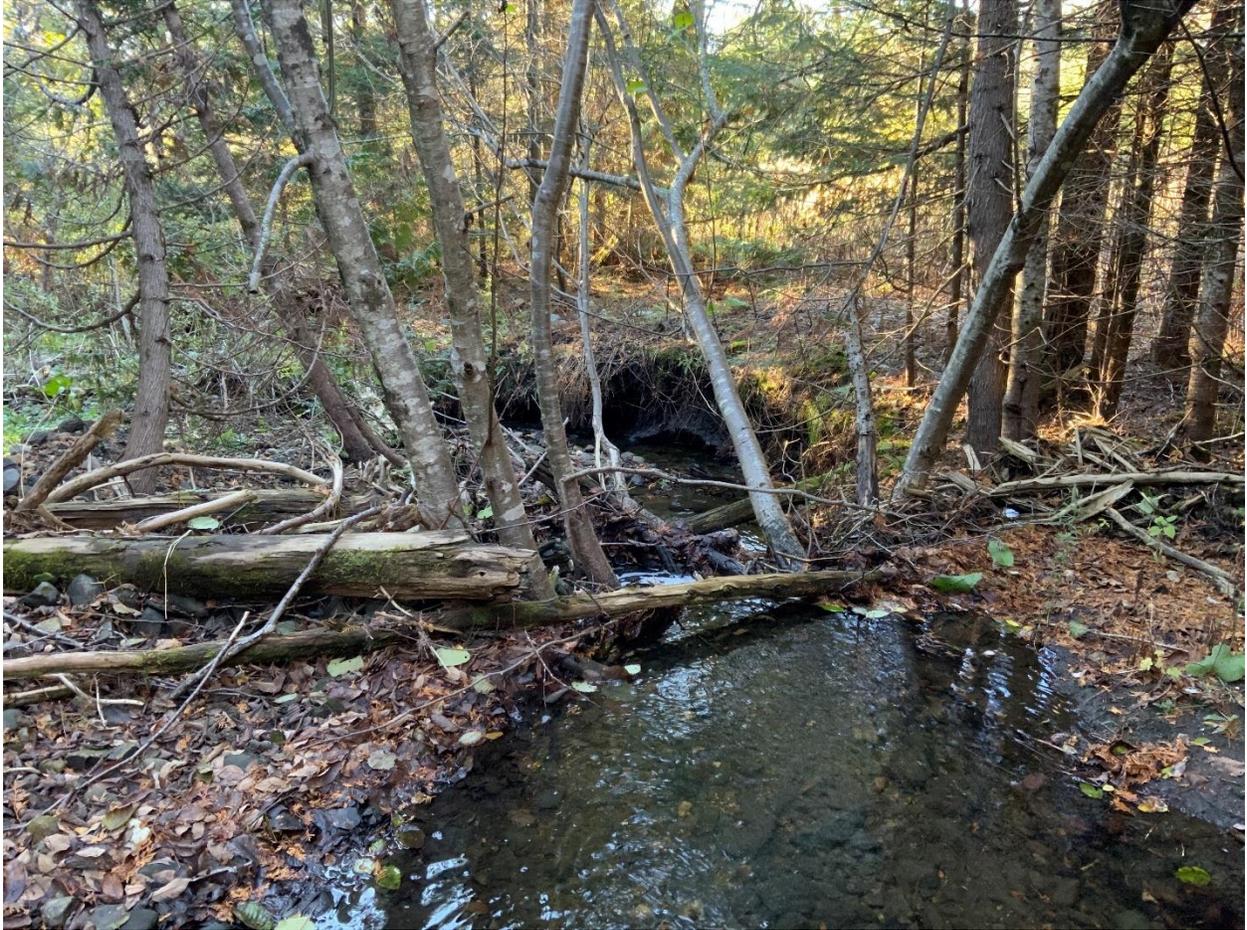
Figure 21. Channel avulsion caused by woody debris jams on unnamed tributary draining Stearns Brook Rd, upstream of the Canadian border.
