North Bennington PFOA

Water Sampling Test Results - June 8, 2016

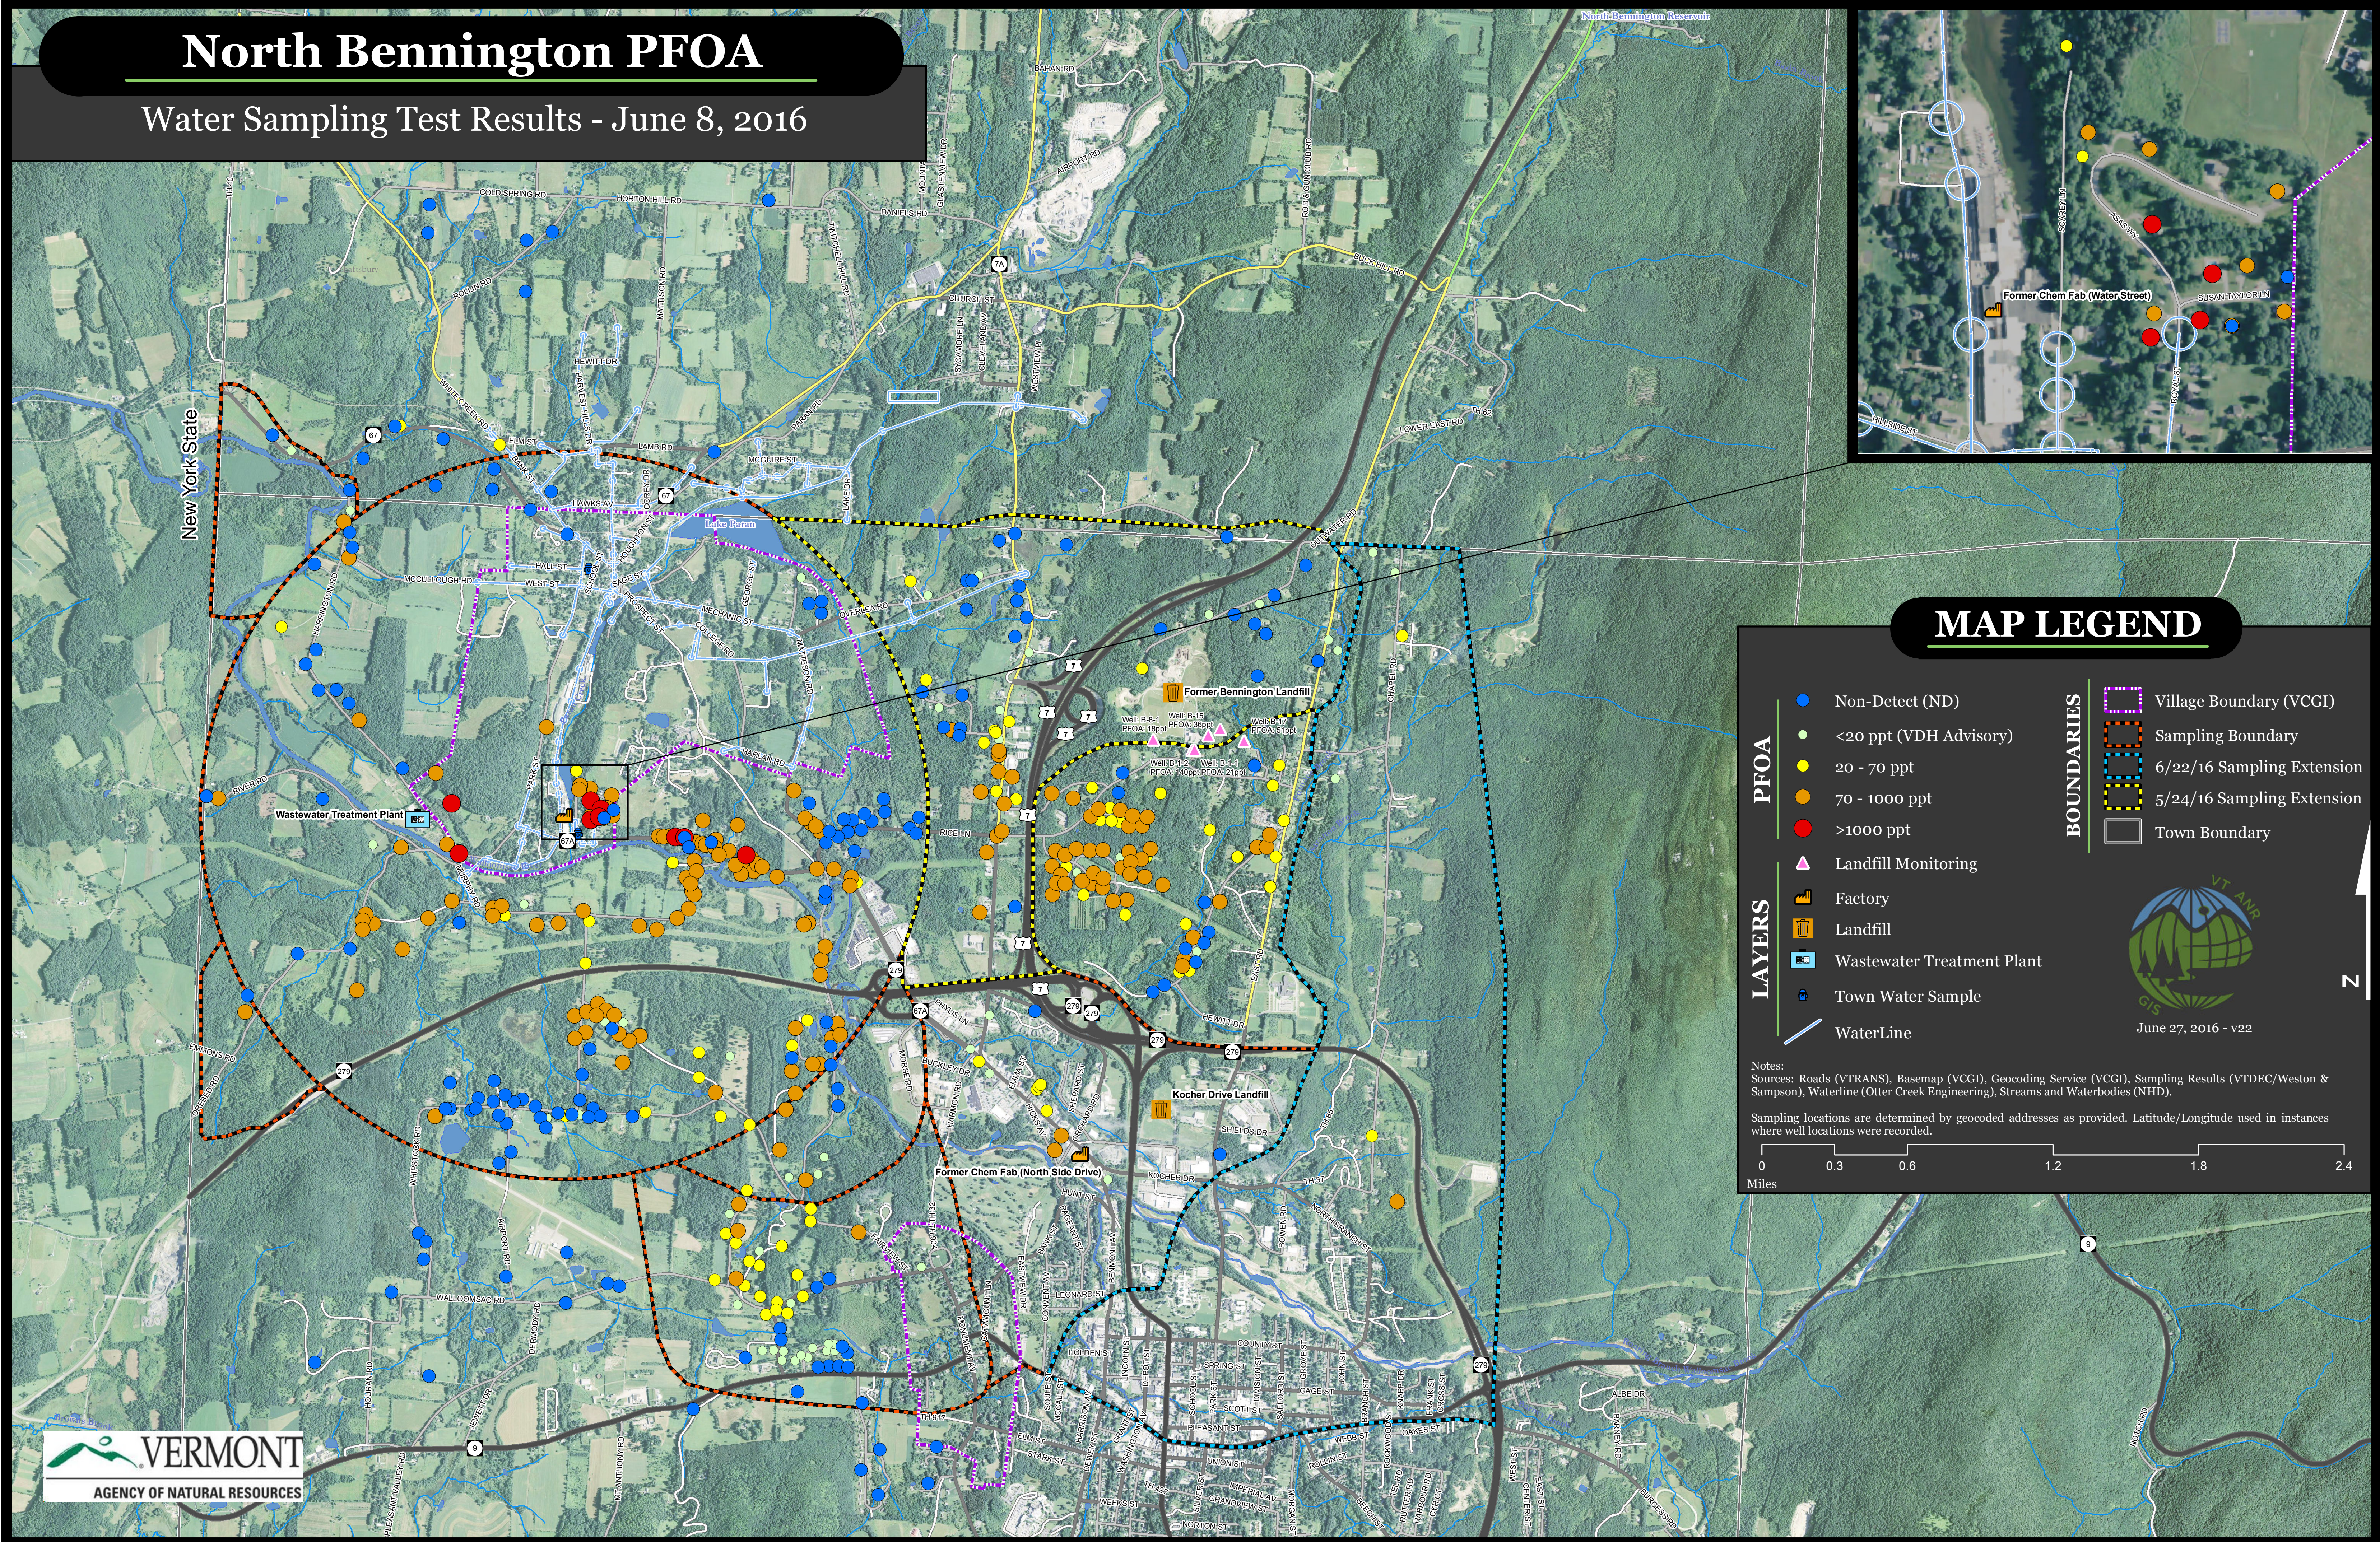
Sampling locations are determined by geocoded addresses as provided. Latitude/Longitude used in instances where well locations were recorded.
