Allen Brook

Watershed Description

Waterbody Facts (VT08-02)

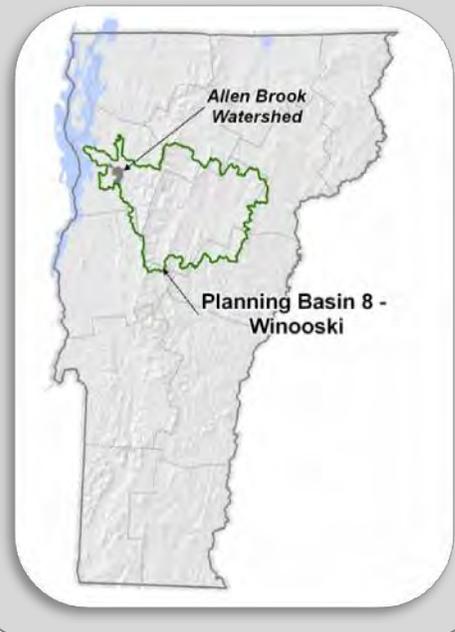
- **Town:** Williston
- **Impaired Segment Location:** From River Cove Rd. upstream to Route 2
- **Impaired Segment Length:** 4.6 miles
- **Classification:** Class B
- **Watershed Area:** ~ 11 square miles
- **Planning Basin:** 8- Winooski River

This bacteria TMDL summary applies to 4.6-mile segment of Allen Brook, an approximately 10-mile long stream located entirely in the Town of Williston in Chittenden County (Figure 1). The headwaters of the stream flow in a northerly direction through sparsely developed and forested land until it intersects Interstate Route 89. North of the Interstate, the stream flows in a westerly and then a northerly direction through areas of significant residential, commercial and industrial land uses (VTDEC, 2008a). Allen Brook flows into Muddy Brook just before it enters the Winooski River, which flows to Lake Champlain (Barg et al., 2003).

Biological monitoring data (macroinvertebrate and fish) indicate that the principal aquatic life and habitat impairment in Allen Brook stems from excess sediment, nutrient enrichment, high temperatures, habitat alterations from stormwater runoff from developed areas, erosion, and lack of streambank vegetation (VTANR, 2008). The bacteria impaired segment extends from the mouth of Allen Brook, upstream to Route 2 and is believed to be the result of *E. coli* numbers above state standards due to stormwater runoff, occasional malfunctioning septic systems and beaver (VTANR, 2008). There are eleven sampling stations in Allen Brook (Figure 1) including three within the impaired segment (Figure 3).

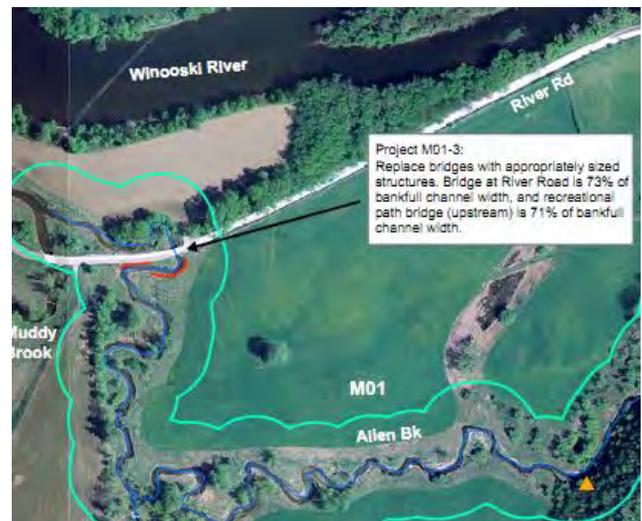
Example of a restoration project to replace bridges at River Cover Rd. (Source: Fitzgerald, 2008)

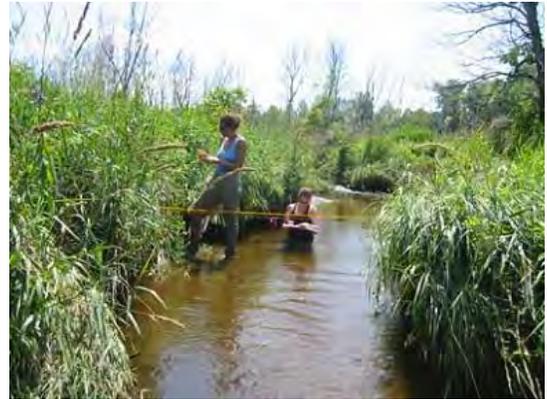
Both historic and recent beaver activity has been recorded in Allen Brook (Photo: Fitzgerald, 2006)

Wildlife, including beaver, which have been documented throughout the stream (Fitzgerald, 2006) are a potential source of bacterial contamination in Allen Brook.
