## Whetstone Brook

### Watershed Description

### Waterbody Facts (VT13-14)

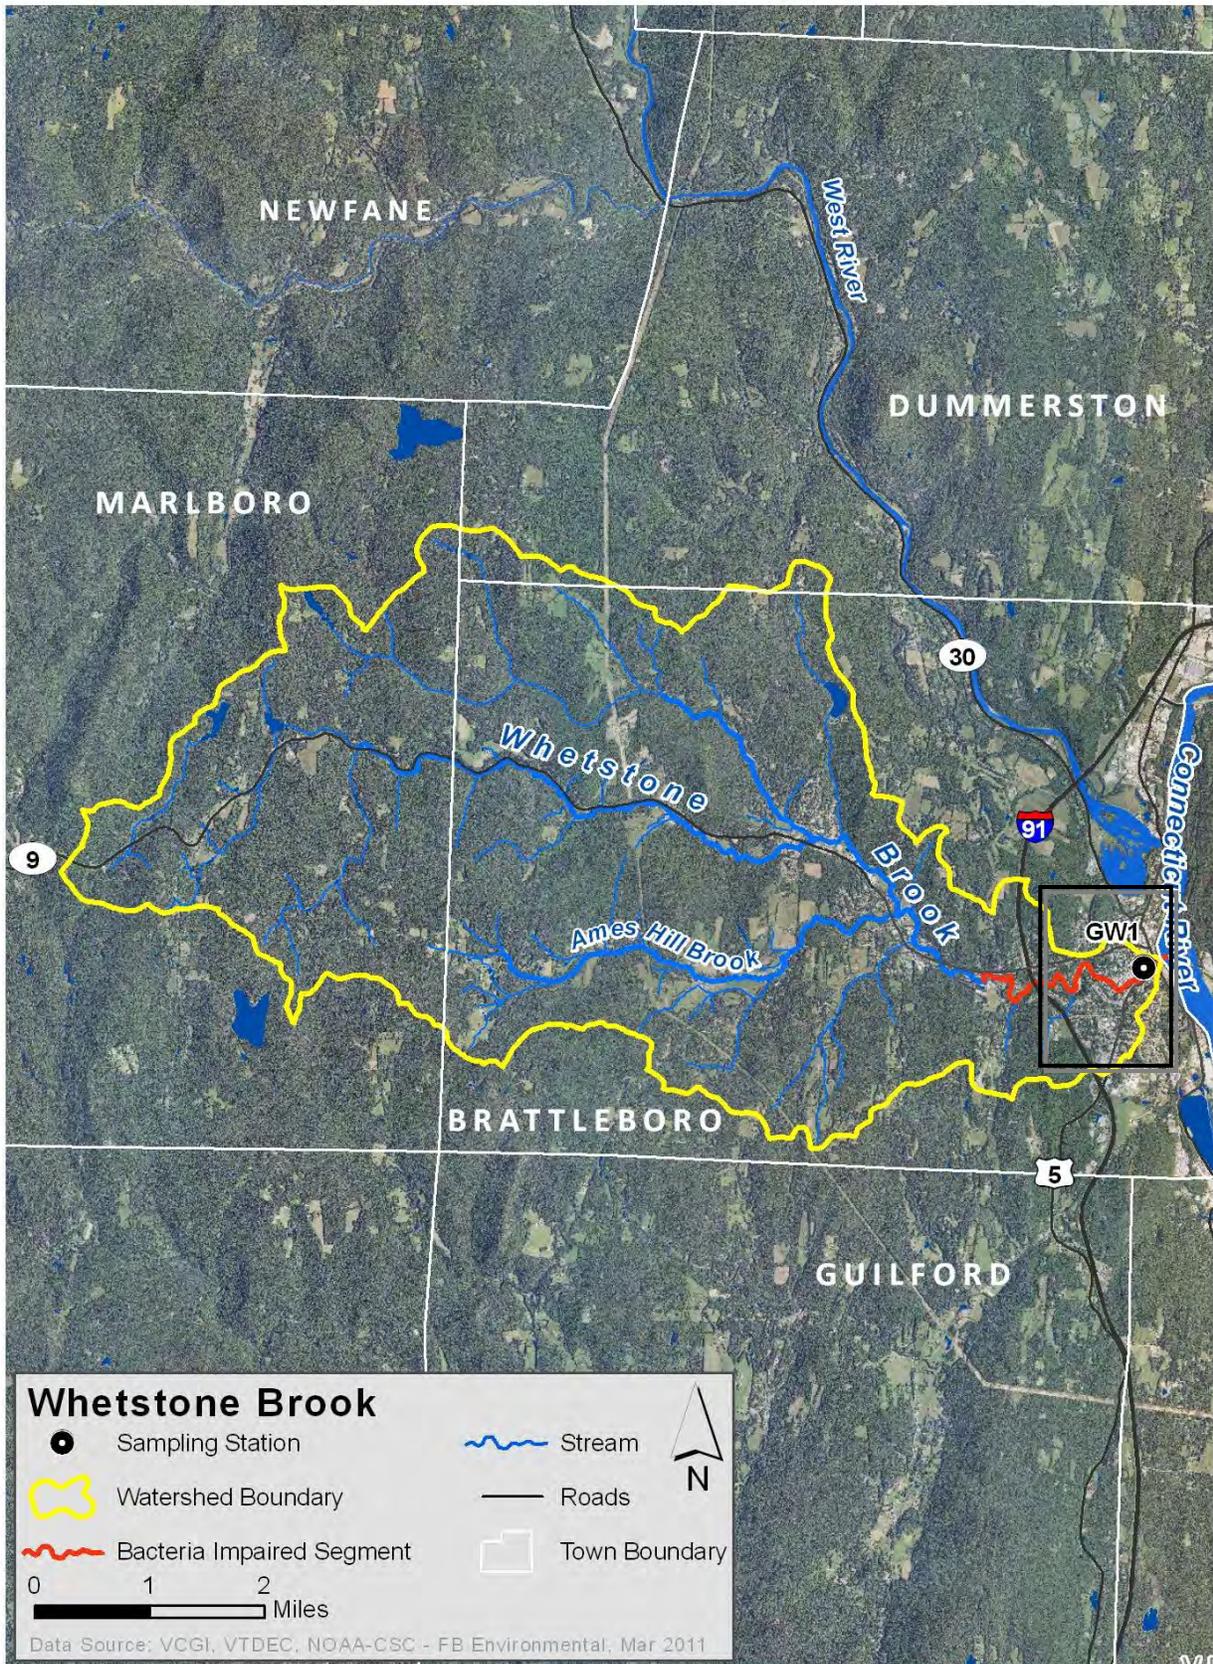
**Figure 1: Map of Whetstone Brook watershed with impaired segment and sampling stations indicated. Insert area corresponds to figure 4 below.**

The bacteria-impaired segment of Whetstone Brook runs from its mouth on the Connecticut River upstream for 2.5 miles. The Whetstone Brook watershed (Figure 1) covers 28 square miles, in Dummerston, Marlboro, and Brattleboro. Overall, land use in the watershed is 84% forested, 8% agricultural, 7% developed, and 1% wetland, as shown in Figure 2 (based on 2006 Land Cover Analysis by NOAA-CSC).

Whetstone Brook is a Class B, cold water fishery with designated uses including swimming, fishing and boating (VTDEC, 2008). Since 2005 samples have been collected in the summer from the sampling station shown in Figure 1 and Figure 3 near the brooks outlet. Bacteria data from sampling location Whetstone\_2 has exceeded Vermont's water quality criteria for *E.coli* bacteria. Table 1 below provides bacteria data collected at this sampling location in 2007. Table 1 provides the water quality criteria for *E.coli* bacteria along with the individual sampling event bacteria results and geometric mean concentration statistics for Whetstone Brook. For Whetstone Brook, the current single sample water quality criterion is exceeded in two of the four sampling events.

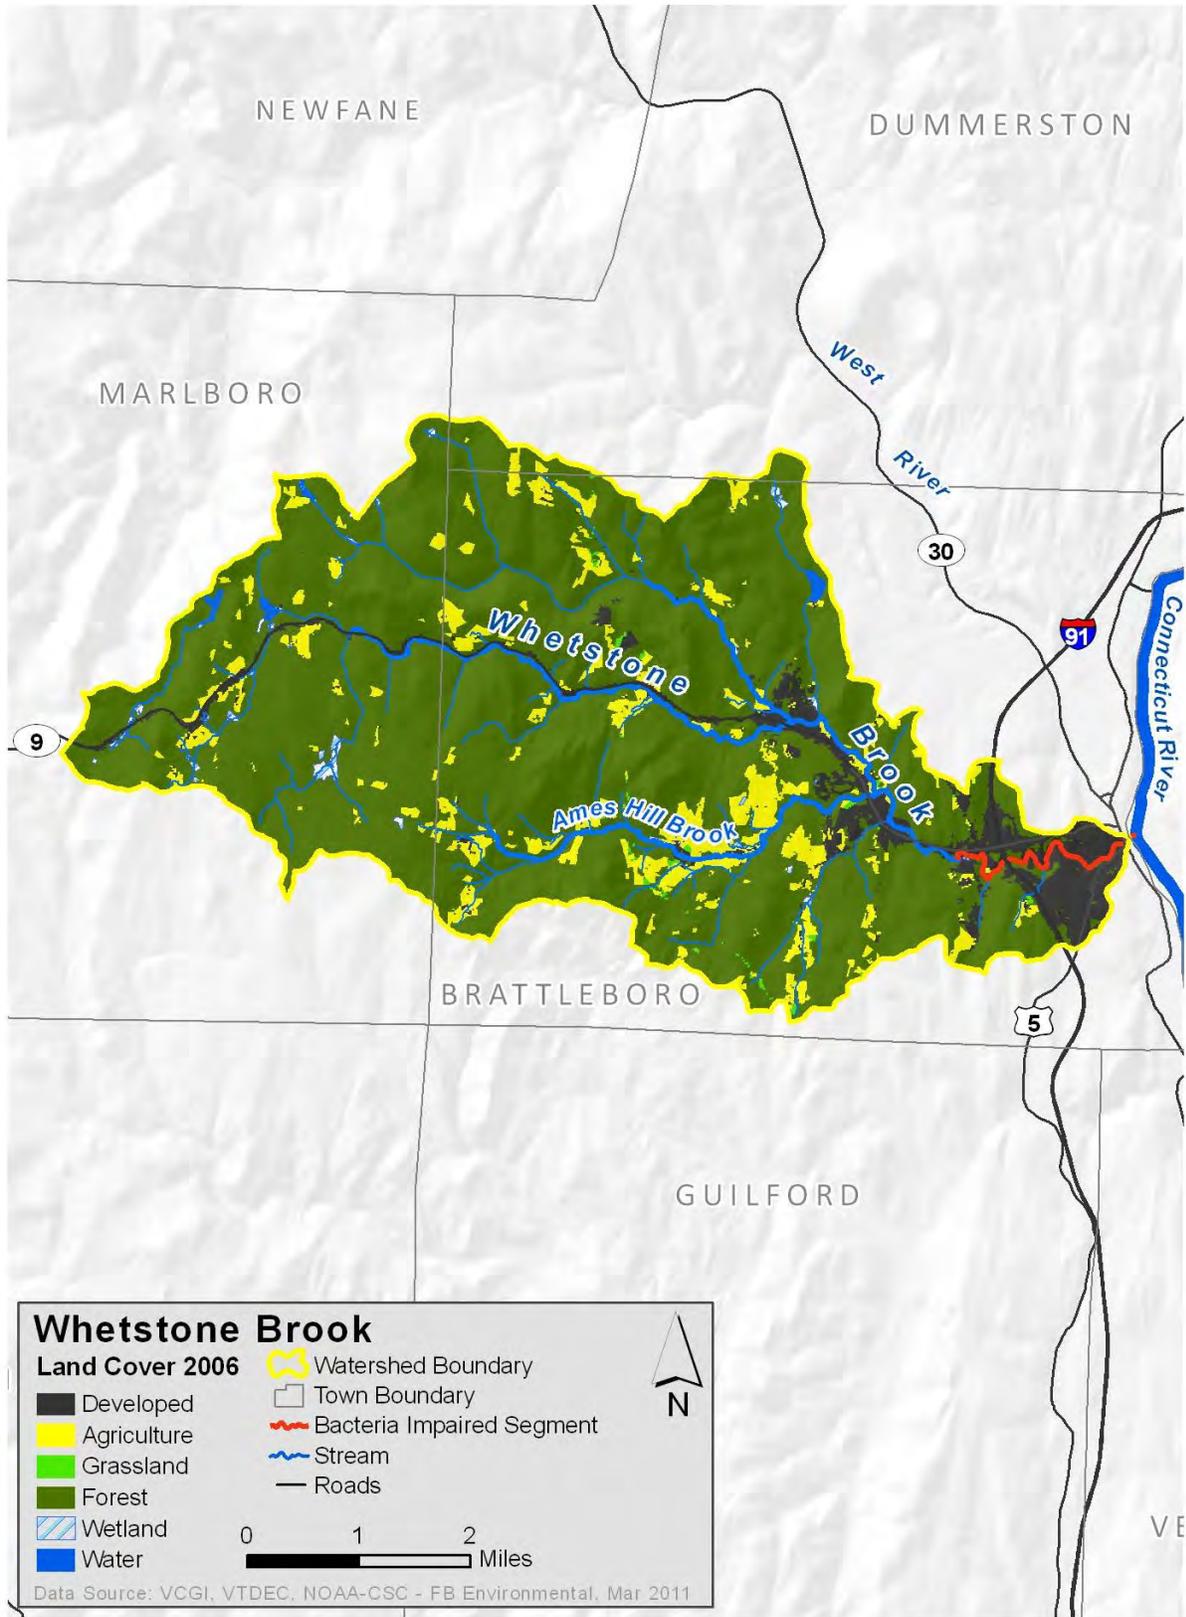
**Figure 2: Map of Whetstone Brook watershed with impaired segment and land cover indicated.**

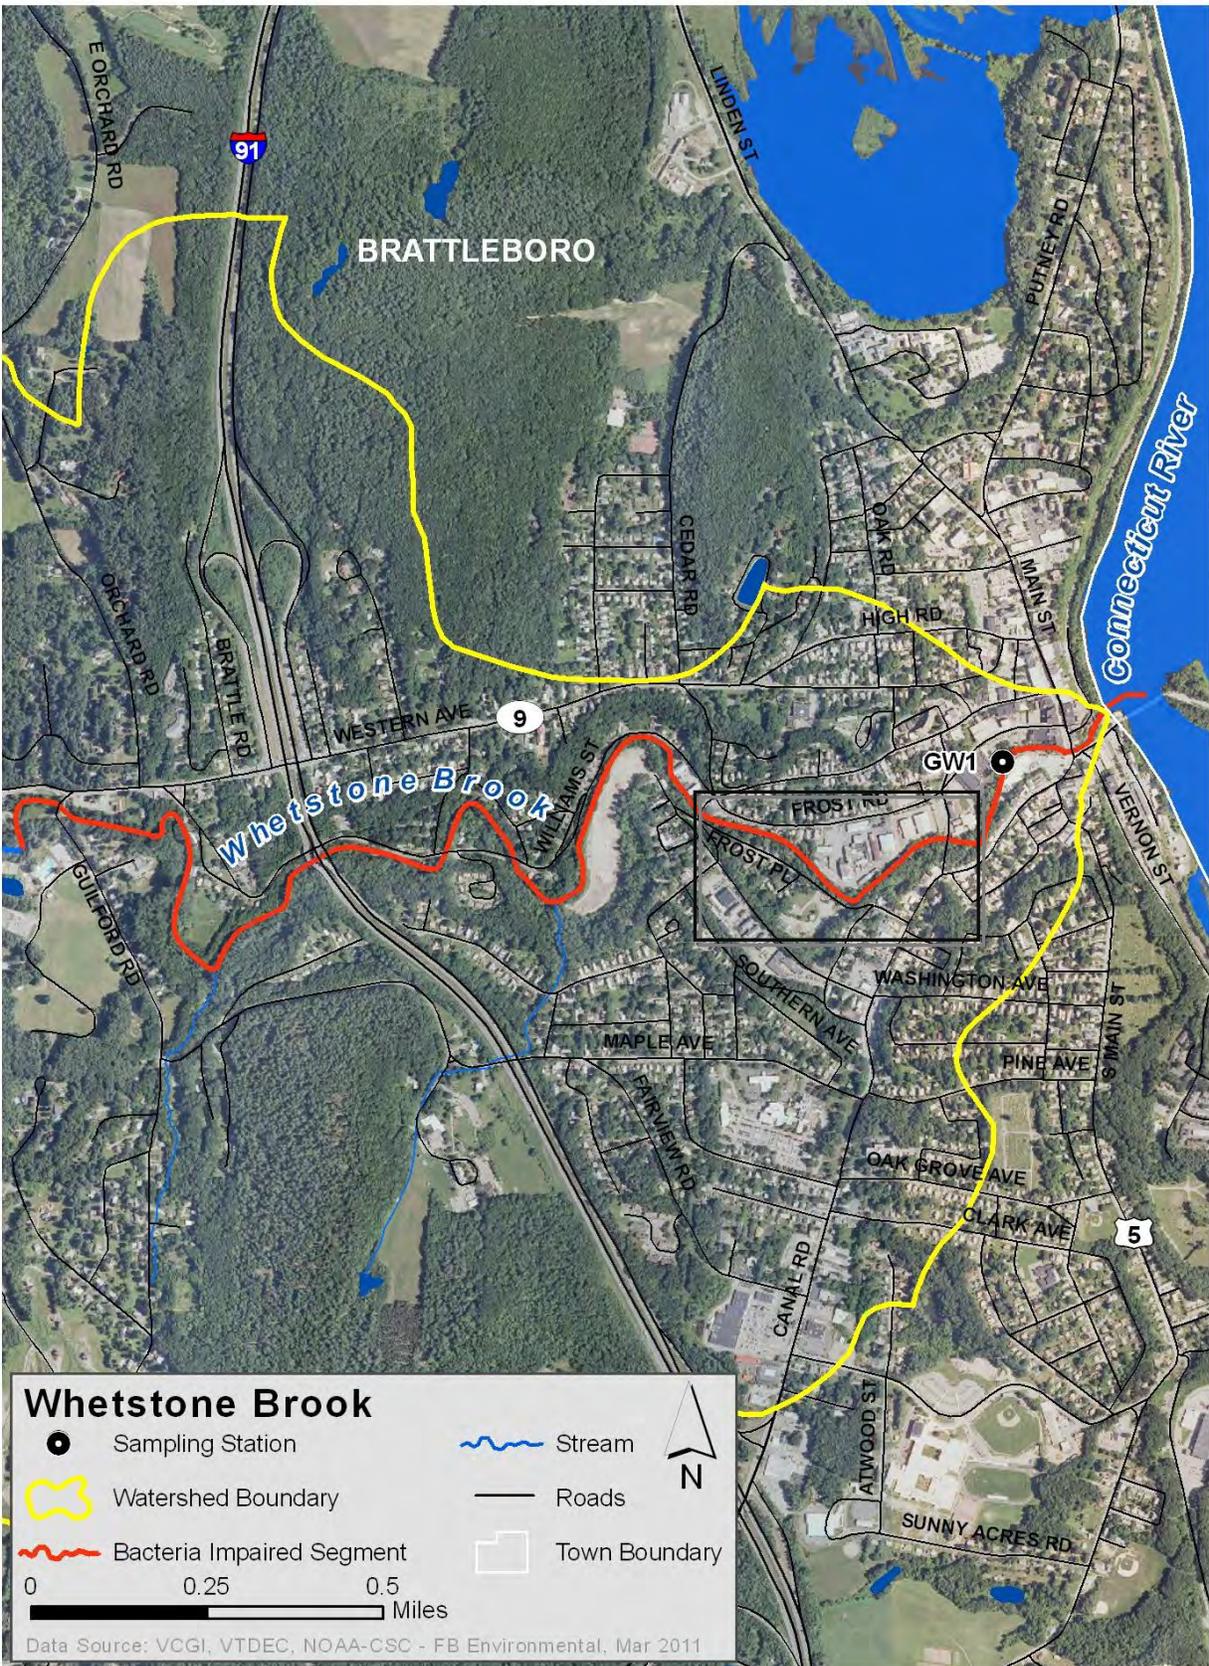
**Figure 3: Map of Whetstone Brook watershed impaired segment and sampling stations indicated. Insert area corresponds to figure 5 below.**

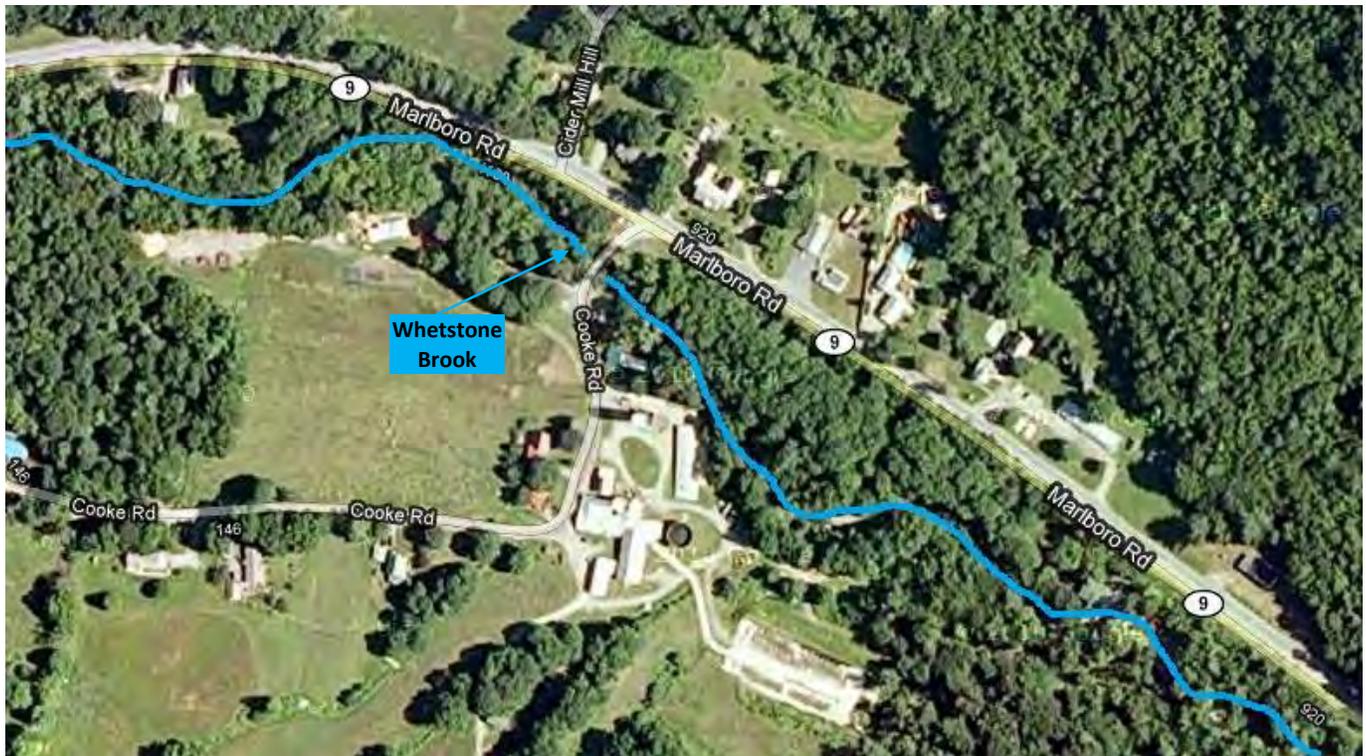
**Figure 4: Aerial view of Whetstone Brook (shown in blue) as it follows along VT Rte. 9 in Brattleboro (Source: Google Maps).**

Figure 4 provides a more detailed aerial view of Whetstone Brook as it flows along VT Rte. 9 in central Brattleboro. Much of the rural and residential development within Brattleboro is concentrated around the brook and its tributaries in a similar manner as shown in Figure 4. Large sections of Whetstone Brook's floodplain have development in and around it. The brook has a history of frequent, severe, and unpredictable flooding, especially in areas where development is encroaching on the brook's floodplain (Whetstone). The frequent flooding is likely a product of development restricting the brook's access to its floodplain and the rapid descent of the brook into the Connecticut River flatlands in central and eastern Brattleboro. Nearly 20% of the land within Brattleboro is comprised of slopes greater than 25%. During severe rain, or rapid snowmelt in the spring, water from these steep hillsides reaches the low lying portions of the watershed quickly, causing significant flood damage and saturating the surrounding soils (Brattleboro, 2003).

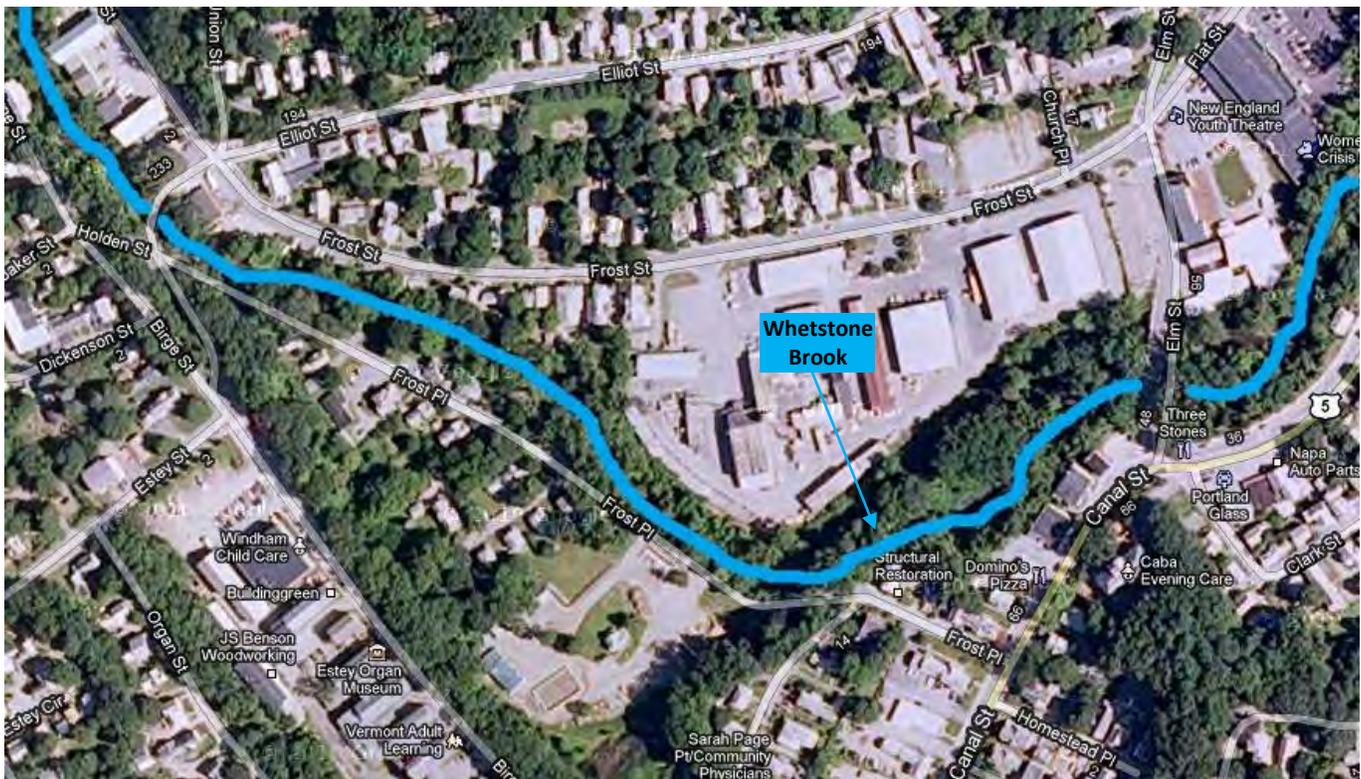
**Figure 5: Aerial view of the impaired segment of Whetstone Brook in downtown Brattleboro where the brook begins to widen out (Source: Google Maps)**

Brattleboro has a population of around 12,000 people and is the largest municipality within Windham County, Vermont. Brattleboro is over twice as populated as any other town in Windham County (Brattleboro, 2003). Once the brook enters West Brattleboro Village, development is concentrated around its banks. Dense residential and commercial development remains around the brook as it flows east. After passing under Interstate 91 Whetstone Brook continues into downtown Brattleboro where development is densely concentrated, as seen in figure 5 (Whetstone, 2008).

Development within the Whetstone Brook watershed is greatest in downtown Brattleboro along the impaired segment of the brook, as shown in Figure 5. This dense residential and commercial development causes high volumes of stormwater to enter the brook during rain events. Stormwater flows off of impervious surfaces such as roads, sidewalks, and rooftops when it rains. Stormwater can flow directly into the brook or into Brattleboro's separate storm sewer (Brattleboro, 2003). Storm sewers are pipes that carry water away from impervious surfaces such as roads and parking lots to the nearest surface water. Where the storm sewer releases the water into the brook is called an outfall. Stormwater released at outfalls into Whetstone Brook can have a negative impact on the brook's water quality. As stormwater
