# Basin 14

## Stevens, Wells, Waits, Ompompanoosuc Rivers Water Quality & Aquatic Habitat Assessment Report

Agency of Natural Resources  
Department of Environmental Conservation  
Water Quality Division

April 1999

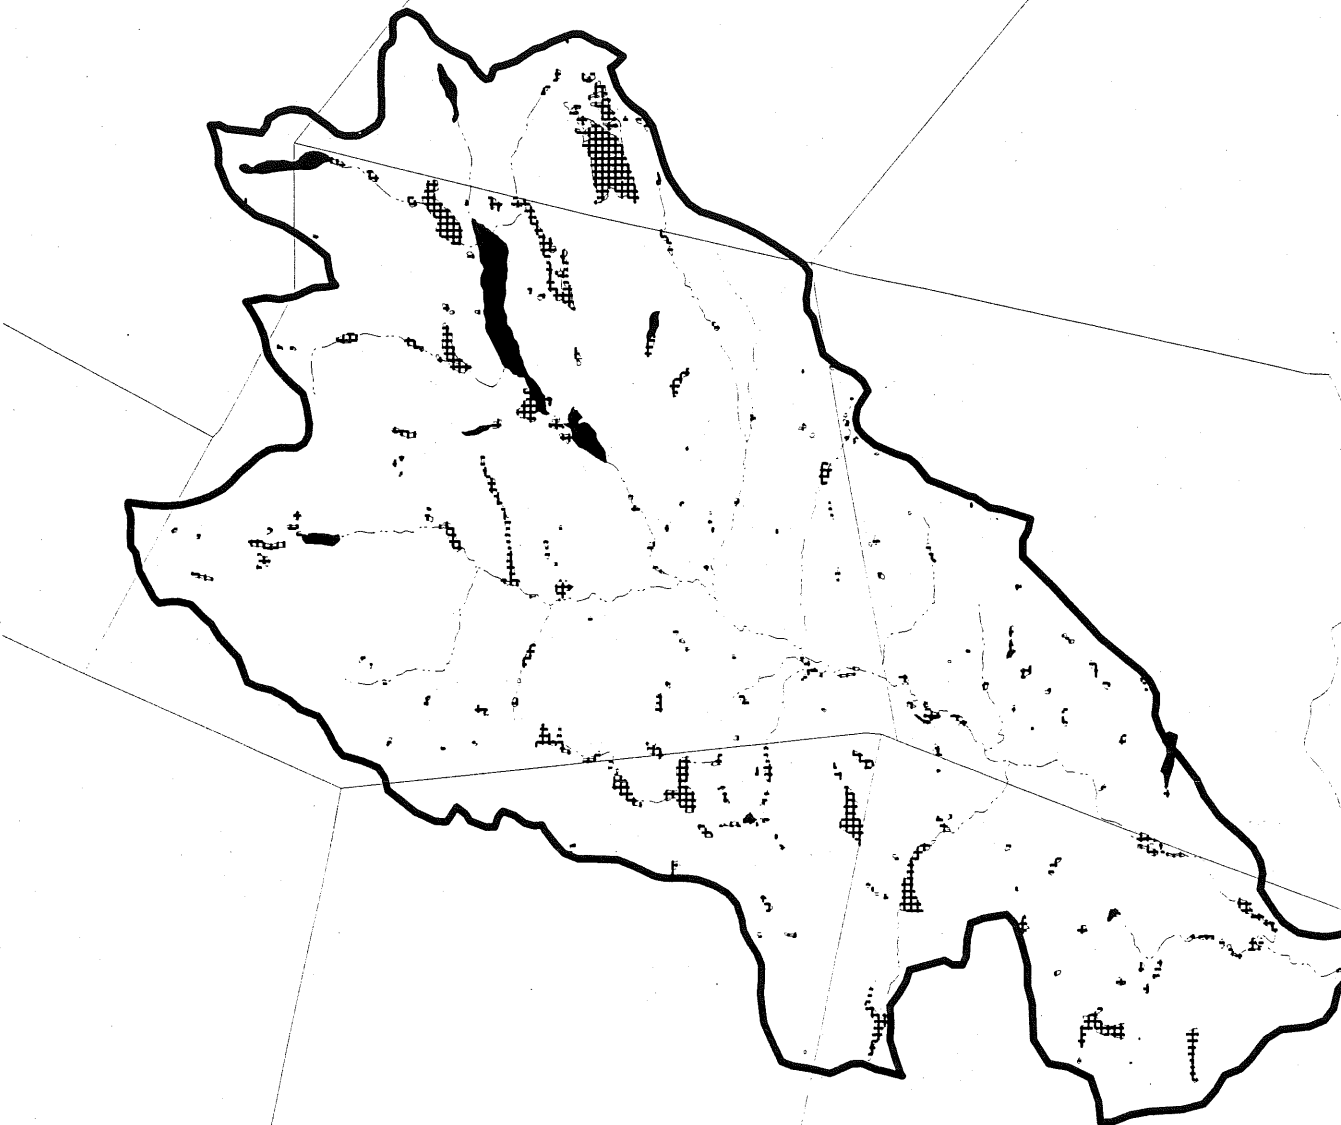
# Wells River Watershed

- Rivers
- NWI Wetlands
- Lakes
- Wells River Watershed Boundary
- Towns
