# Vermont Wetlands Bioassessment Program Restoration Monitoring 2023 Update

**Vermont Department of Environmental Conservation**

Wetlands Program

March 27th, 2024

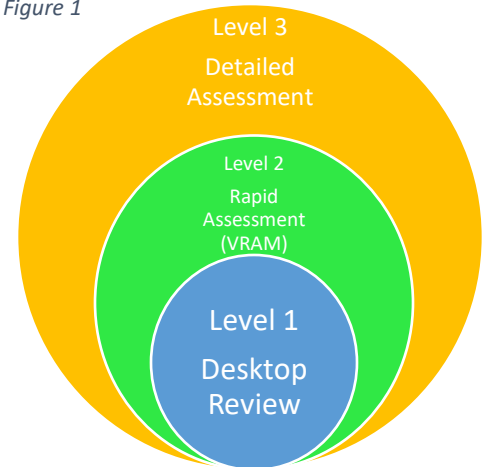
Figure 1

Monitoring is conducted at three levels described by the EPA (Figure 1). Level 1 is a broad, landscape level desktop analysis that consists of reviewing air photos, LiDAR elevation data, and other spatial information. Level 1 review is used to discern wetland type and boundary, presence of anthropogenic stressors, and to identify surrounding landscape context. Level 2 assessments employ an in-field rapid assessment using the Vermont Rapid Assessment Method (VRAM), that focuses on wetland condition and function, and evaluates Restoration Indicators of Success. Level 3 assessments are site-specific detailed biological, physical, and chemical assessments. Vegetation plots are sampled in representative areas of the wetland, where all plant species within the plot are identified and the percentage of cover of each species is estimated. The soil is described according to the Army Corps of Engineers (ACOE) Wetland Delineation methodology (6). When surface water that is influential to the wetland's ecology is present, water samples are collected and analyzed at Vermont Agriculture and Environmental Laboratory (VAEL) for a suite of parameters including pH, conductivity, nitrogen, chloride, and phosphorous levels. When possible, restoration site plots are paired with a monitoring plot in a nearby 'reference' wetland that is in a more natural condition.

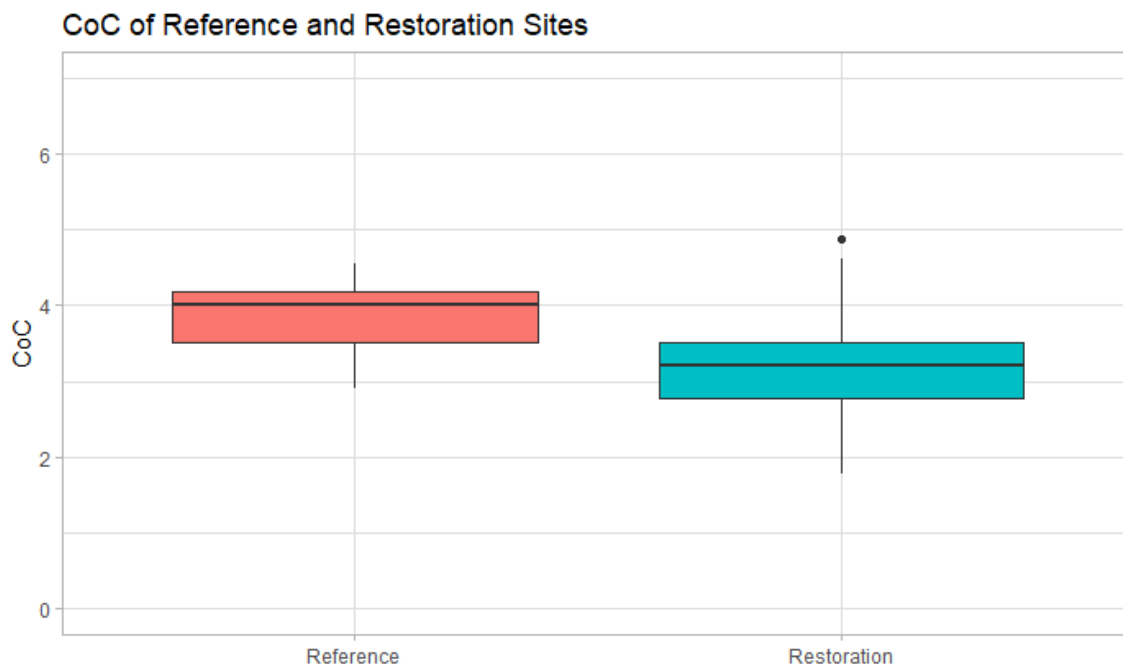
The Average CoC value for the restoration sites is 3.15, while the average CoC of the reference sites is 3.83 (Figure 2). There is significant variation and some overlap between the highest-scoring restoration sites and the lowest scoring reference sites (See Appendix).

Figure 2: Average CoC of Reference and Restoration Sites

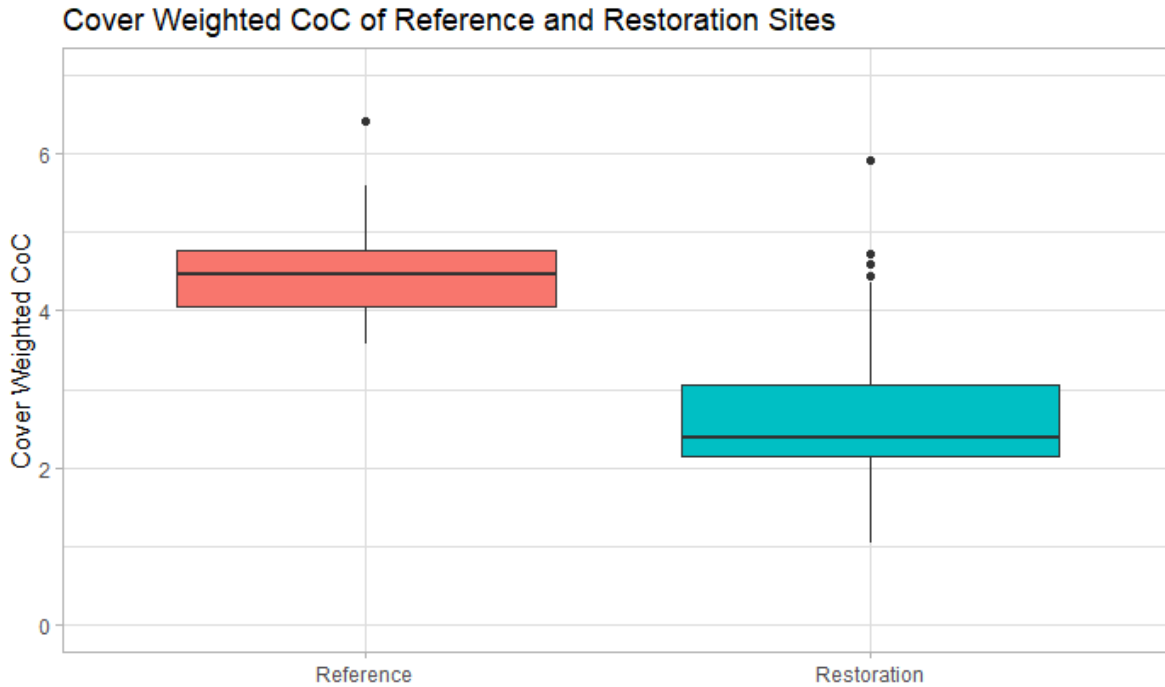
The difference is greater between Cover Weighted CoC scores for reference and restoration sites, with restoration sites averaging 2.69, and reference sites 4.56 (Figure 3). Overlap between the two wetland types was much lower than with Average CoC (the outlier restoration site had unusually high initial recruitment of native sedges).

Figure 3: Cover Weighted CoC of Reference and Restoration Sites

Data analysis from this project indicates that Cover Weighted CoC outperforms average CoC in differentiating reference and restoration sites. This suggests that average CoC may be insensitive to the high cover of specific invasive species often observed in new restoration sites, a factor that Cover Weighted CoC is able to consider.

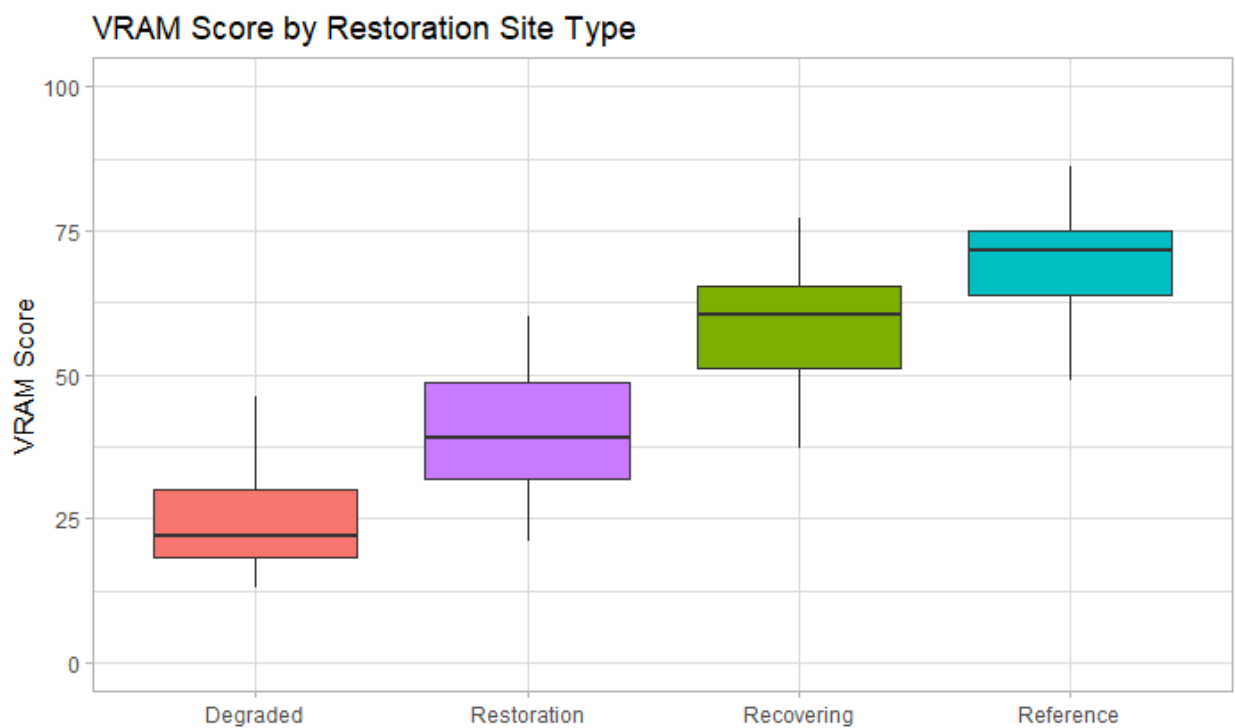
The restoration site types exhibit varying average VRAM scores (Figure 4).

*Degraded* sites averaged a score of 25, with a range of 13 to 46.

*Restoration* sites averaged a score of 41, with a range of 21 to 60.

*Recovering* sites (that had recovered from past disturbance with no restoration work) averaged a score of 57, with a range of 37 to 77.

*Reference* sites averaged a score of 70, with a range of 49 to 86.

Figure 4: VRAM Score by Restoration Site Type

The range of VRAM scores within some of the restoration site type categories indicates the diversity in condition and function of sites in the same category. The restoration site types are widely varied in stage and success level. The *reference* sites consist of areas of intact habitat near the *restoration* sites, and as such support mature forest or other similar habitat but are also influenced by same landscape-level disturbance and past land use history. Most of the *reference* sites are influenced by disturbance such as edge effects. The best-condition reference sites in Vermont usually receive VRAM scores from 80 to 95, but these high quality sites are not typically found in the same landscape to compare directly with the project's restoration sites. The *recovering* sites were mostly shrub swamps of similar successional stage to each other, and therefore varied less (although sample size was also smaller).

Several important findings emerge from this project. It is visible in the CoC and RIS figures (Figures 4 and 5) that wetland condition increases along a continuum in this order: degraded wetlands in current agricultural use, active restoration sites, wetlands recovering from past disturbance, and reference sites. Establishing this trend makes it possible to determine whether individual restoration sites have been successful or not.

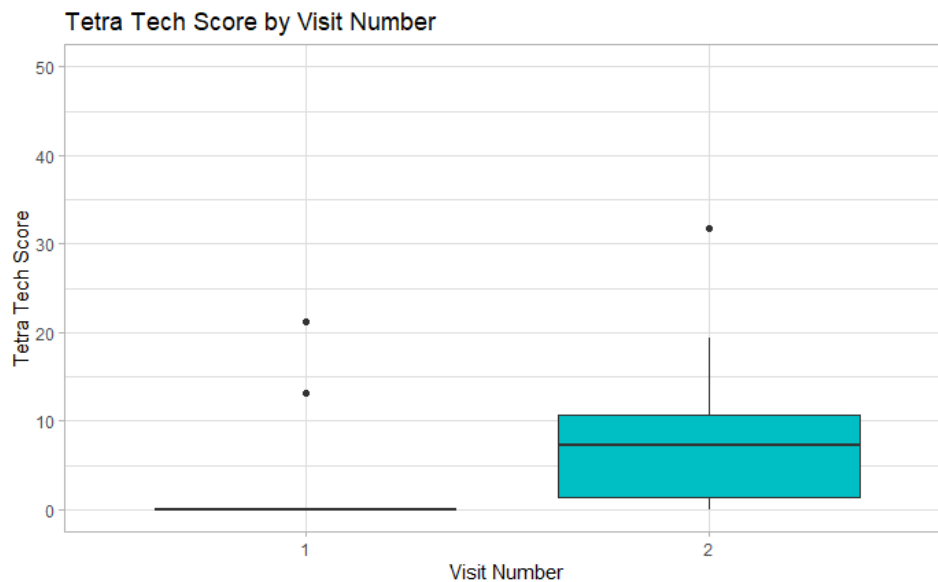
Figure 6 shows the Tetra Tech Score by visit number. Note that for most of the initial visits, the score was zero. This indicates a new, very disturbed restoration site. By the second visit, scores usually ranged between 2 and 10, showing improvements in the restoration site condition. Figure 7 shows the Tetra Tech Score by site type. Restoration sites usually score between 0 and 10 (with the higher scores usually from revisit plots). Reference sites score much higher, averaging around 25. The Recovering site type has a very wide range of scores from 0 to 40, indicating the variability in recovery success and timing amongst these sites.

Figure 6: Tetra Tech Score by Visit Number

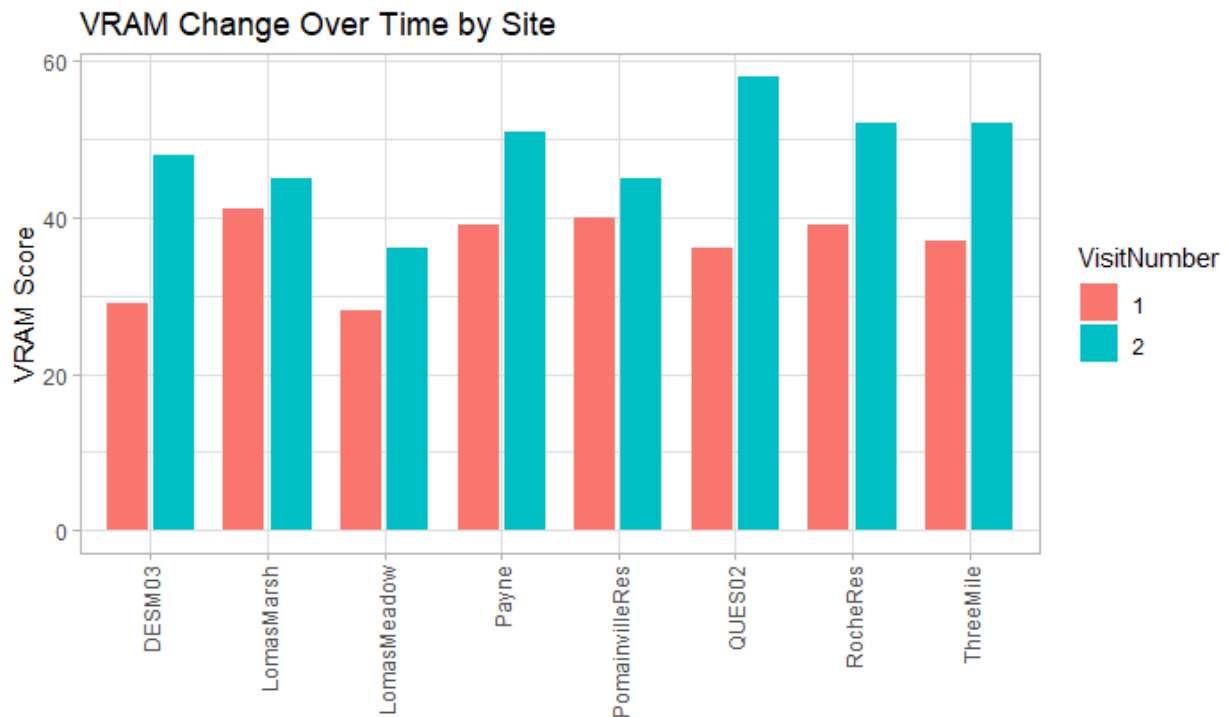
Notable increases in both VRAM and RIS scores were observed across all sites (Figure 8 and Figure 9). The RIS metric showed more significant changes over the five-year period, highlighting its use in assessing restoration progress. The greatest improvements were observed at sites with a very low initial score. Rate of improvement appeared to slow when scores reached 25 to 30, indicating that initial success after rapid restoration of hydrology is followed by slower response from habitat features and vegetation from the interplay of invasive species with native species. The Quesnel restoration site displayed the most significant improvement, while the Lomas site showed the least. Notably, the Quesnel site was a more highly disturbed cornfield at the start of restoration activities, whereas the Lomas site was a wet pasture with woody vegetation already repopulating the area at the start of restoration activities, starting in better condition.

Figure 8: VRAM scores from initial visit and revisit.

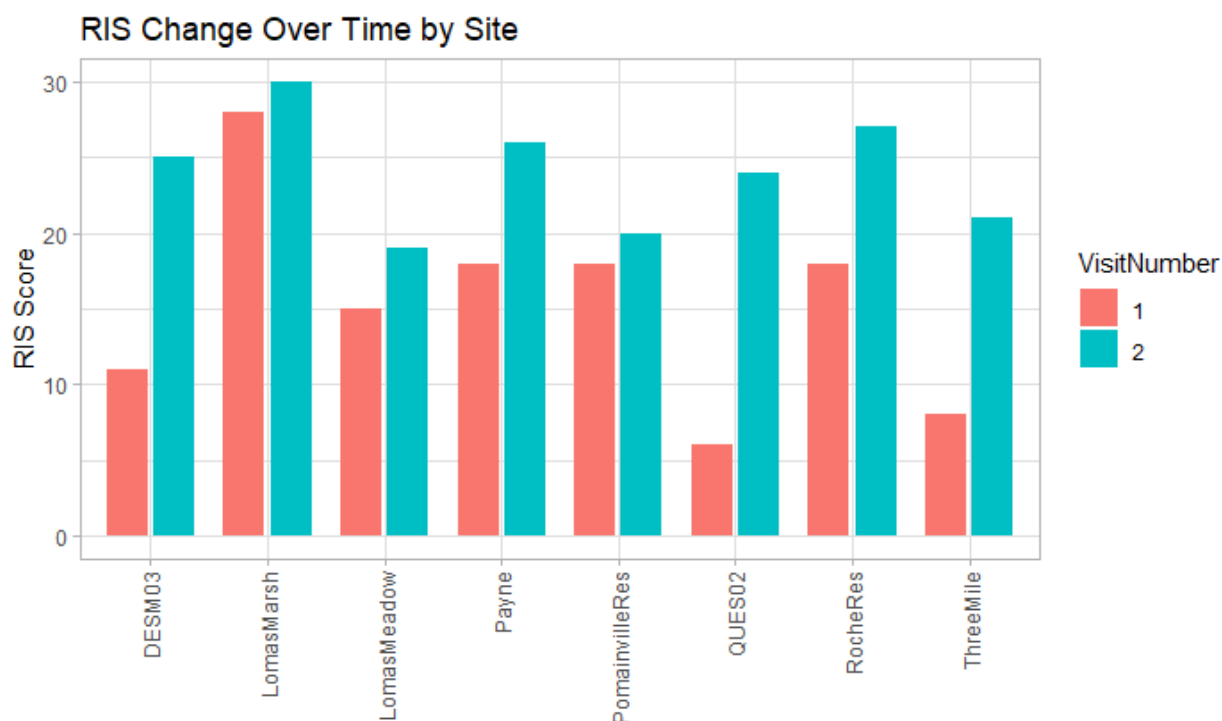
Figure 9: RIS scores from initial visit and revisit.

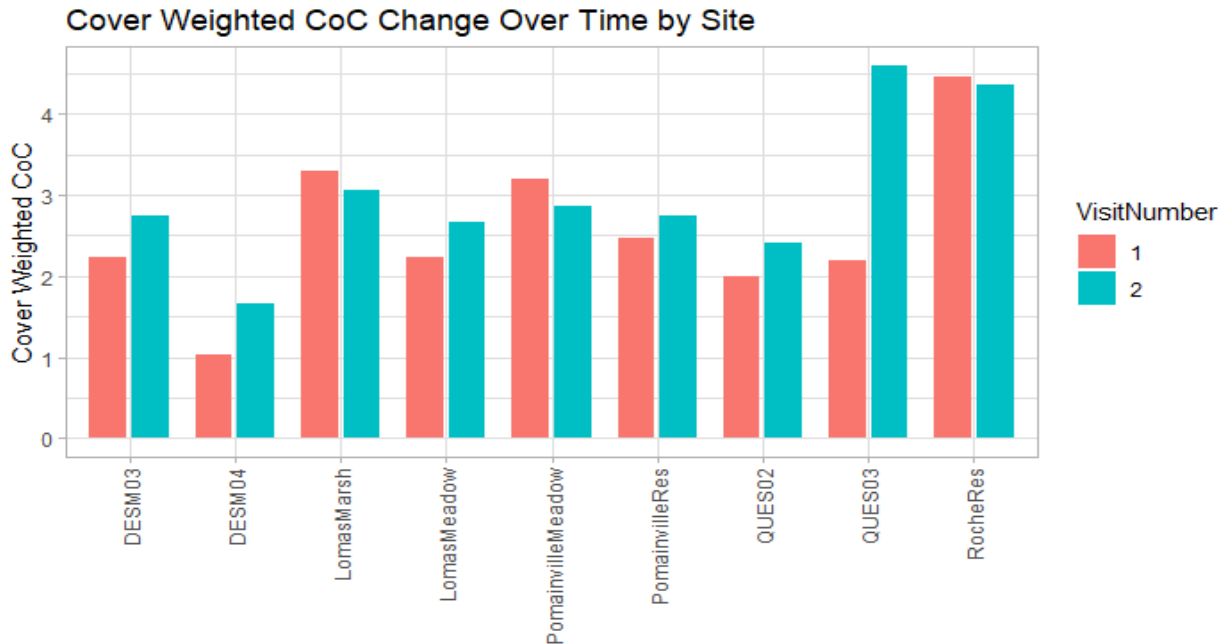
Improvements in CoC were less consistent than what was observed in VRAM and RIS scores, with three sites showing a decrease (Figure 10). One of these sites was in a meadow at the Lomas site which already presented a diversity of native vegetation. It was affected by a ditch plugging between the two visits, but otherwise had not changed significantly. The other site, one of the Pomainville plots, may have declined as early successional woody vegetation crowded out some of the herbaceous vegetation, which may just be part of the successional trajectory of that site. A plot at the Roche site decreased in score slightly, apparently because of construction of a nearby swale in between visits, and seeding in of an early successional native species. These changes are expected of the normal progression of this particular restoration project. Conversely, one of the Quesnel restoration project sites increased substantially in score because an area of reed canary grass monoculture was replaced by a constructed swale that was growing in with native emergent wetland vegetation.

Figure 10: Cover Weighted CoC scores from initial visit and revisit. See Table 1 for the name of each site.
