Out of the Blue

A Newsletter of the
Watershed Management Division

Summer 2012 No. 41

Vermont Agency of Natural Resources
Department of Environmental Conservation

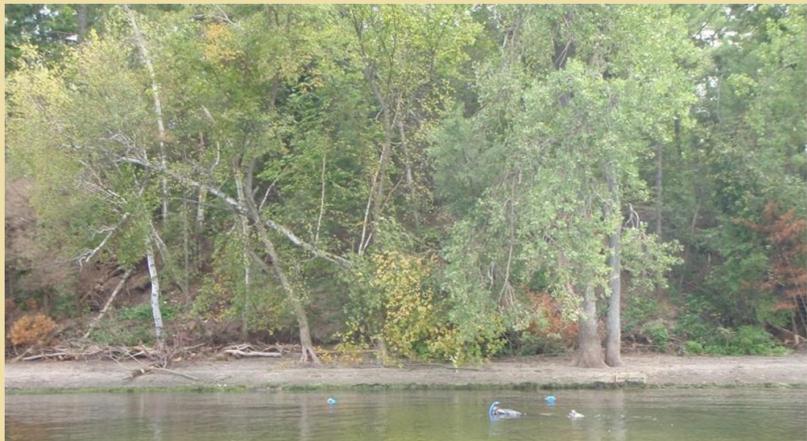
Two adjacent shorelines with similar slopes on Malletts Bay, summer 2011. The degrade aquatic habitat, also lead to the unstable bank conditions, caused by the floodwaters. Natural vegetation stabilizes lake shores the best (and is free!) while

How can we protect the lake from the inevitable storms and floods of the future? **Lakeshore buffered by natural rock and vegetation can resist erosion and provides better habitat, as well. Property owners seeking to repair damaged shoreline should consider using these lake-friendly methods.** There's nothing engineered better to stabilize a bank than the roots of a tree.

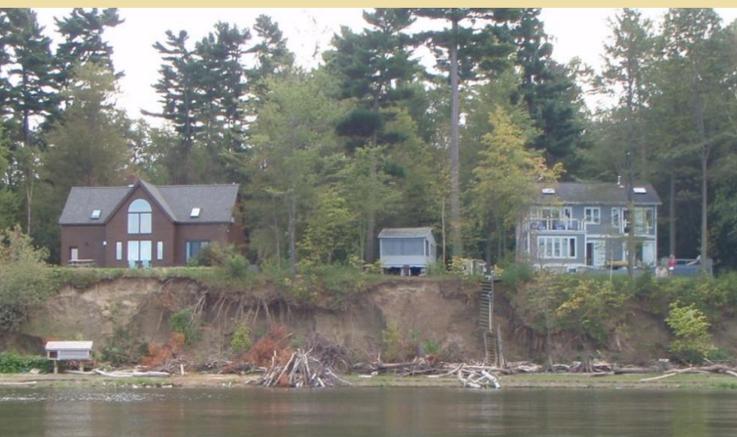
Shoreline with natural vegetation replaced by lawns, which is causing massive erosion and water quality problems. Re-vegetating the shoreline is protecting aquatic habitat and water quality.

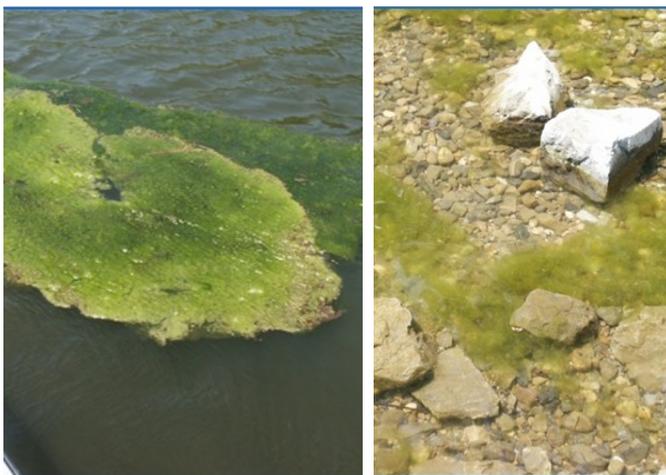
Category 1: Examples of green algae growth which does not pose a health risk.

The new guidance first helps community members sort out lake occurrences that are either not algae blooms at all (e.g. pine pollen accumulations in the spring) or are green or other kinds of algae blooms that do not pose a health risk. These occurrences are described as Category 1 or Low Health Risk.

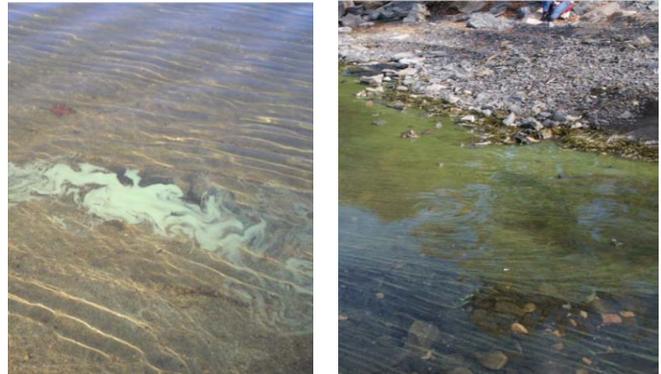
Category 2: Examples of low numbers of cyanobacteria indicating a situation that warrants monitoring.

Second, if cyanobacteria are present but in low numbers, it is a Category 2 situation, where toxins may be present, but at low concentrations. In this case the situation can be monitored and people and pets should avoid visible scums.

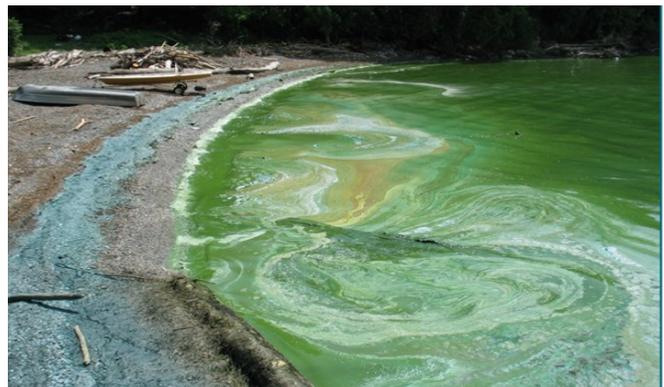
Category 3: Example of a cyanobacteria bloom that poses a risk to people and animals and contact should be avoided.

Category 3 is a situation where cyanobacteria are present in large numbers and cover an extensive area. In this case, the bloom may pose a risk to people and animals, and contact should be avoided. Since sampling for toxin presence can take a day or two, and the bloom may dissipate or be blown elsewhere, the guidance focuses on the importance of informing people and communities to avoid swimming (for dogs too) or having other water contact until the bloom has entirely died off.
