Basin 8 - Winooski River Watershed Water Quality and Aquatic Habitat Assessment Report

**Vermont Agency of Natural Resources
Department of Environmental Conservation
Watershed Management Division
Monitoring Assessment and Planning Program**

June 2017

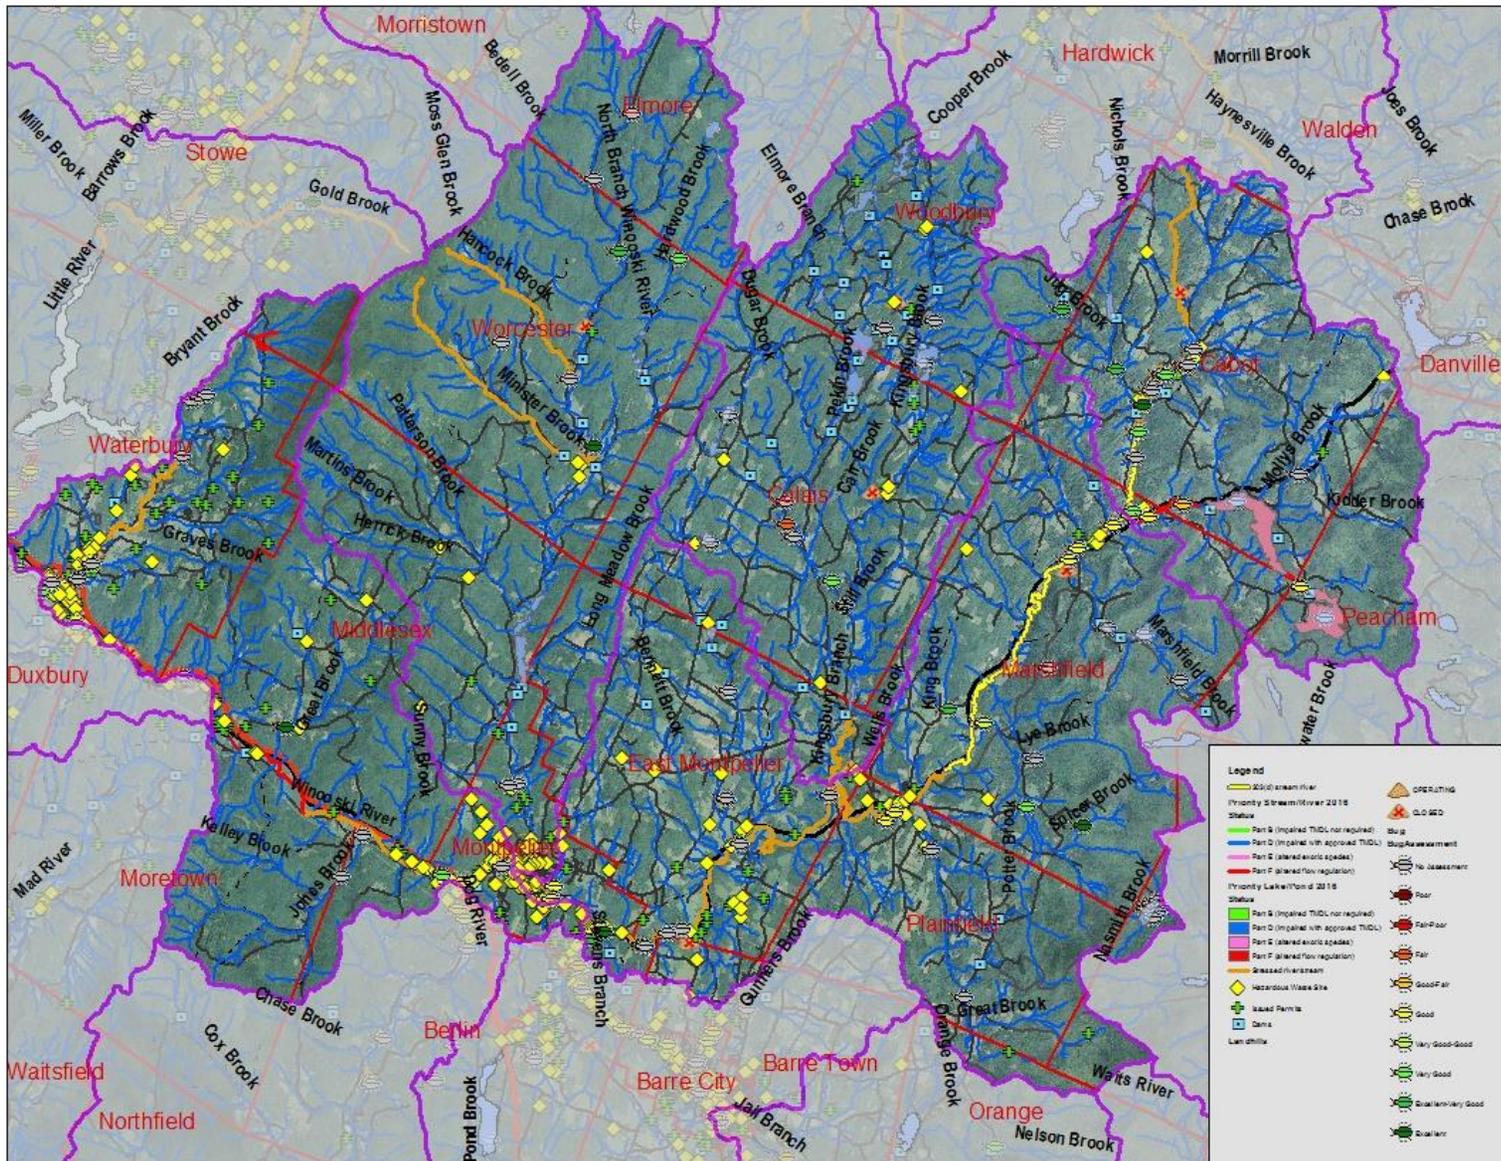
Figure 1. Upper Winooski Watershed with Assessment Information and Status

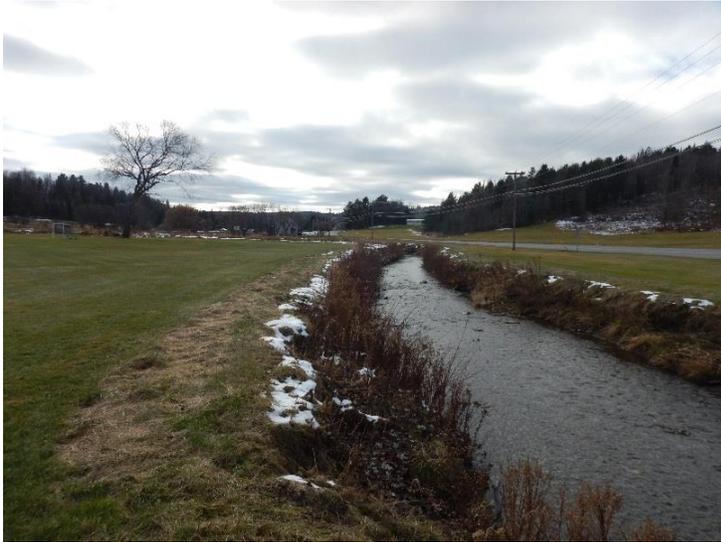
Photo 1 – Winooski River mainstem and riparian area downstream of Cabot Village

Wild brook trout are abundant in the Winooski mainstem upstream of Cabot Village. Temperature and habitat conditions deteriorate downstream of the village primarily due to a lack of riparian habitat. In 2014, a maximum temperature of 82°F was observed above the Green Mountain Power Co (GMP) powerhouse and the temperature reached at least 75°F on 22 days between June and October. The GMP hydro-electric generation results in extreme daily fluctuations in flow as well as rapid temperature changes of >5°F.

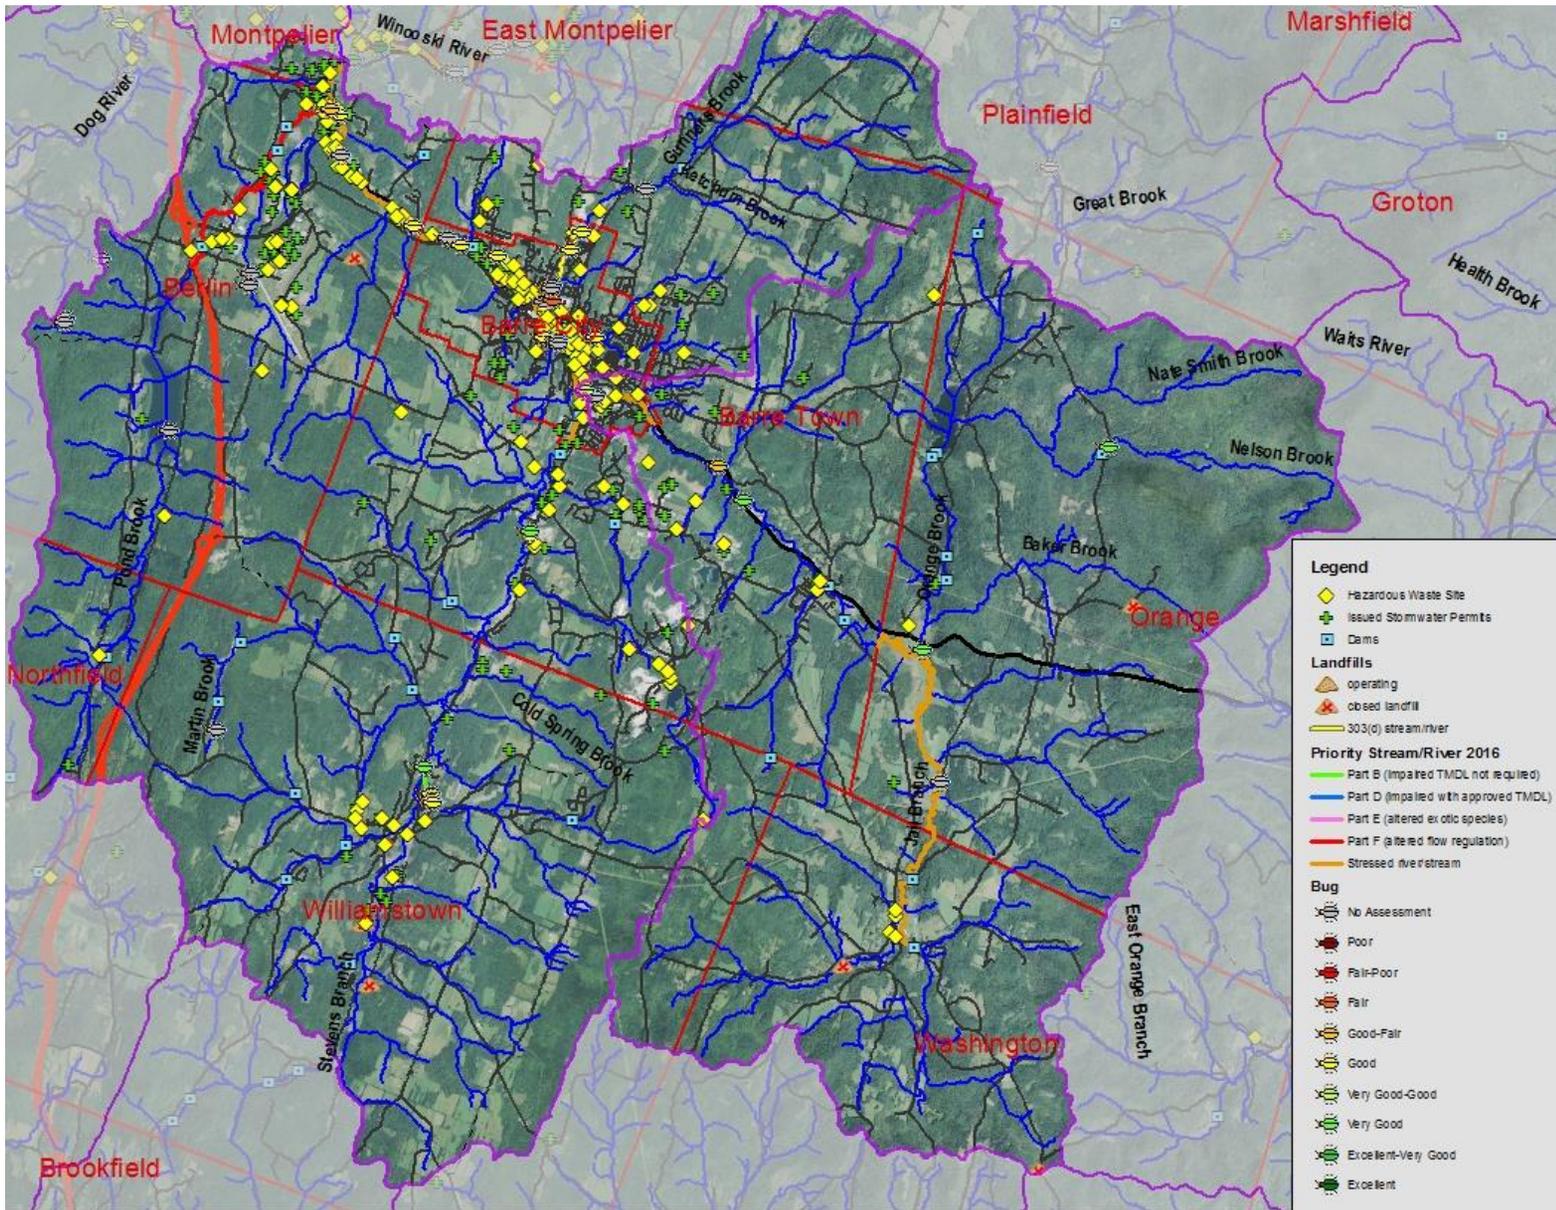
Figure 2. Stevens Branch watershed with Assessment Information and Status

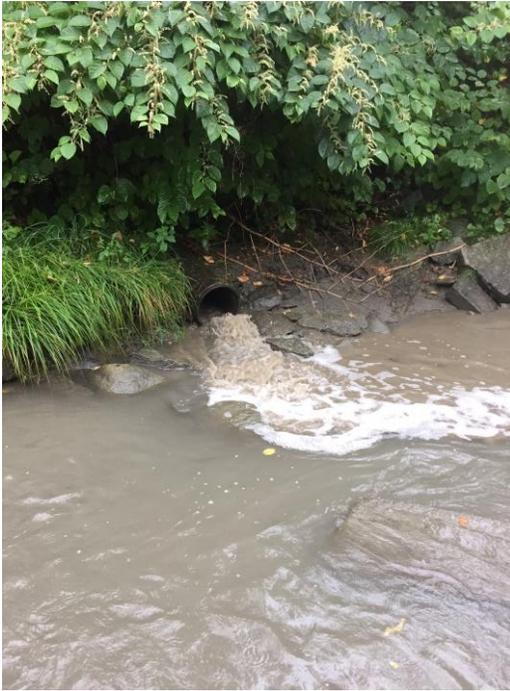
Direct roadside storm water discharge from Boynton St in Barre City

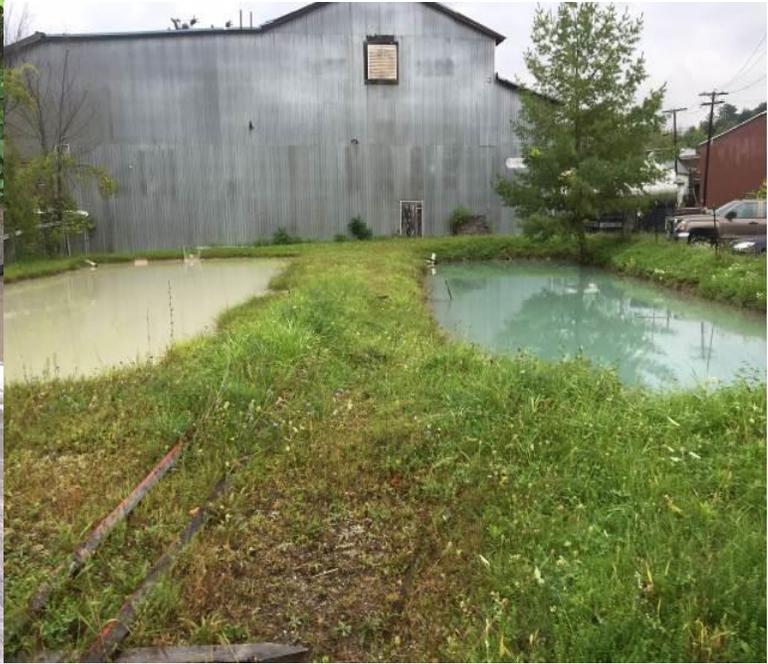
Granite processing waste pit within the riparian area on Boynton St.

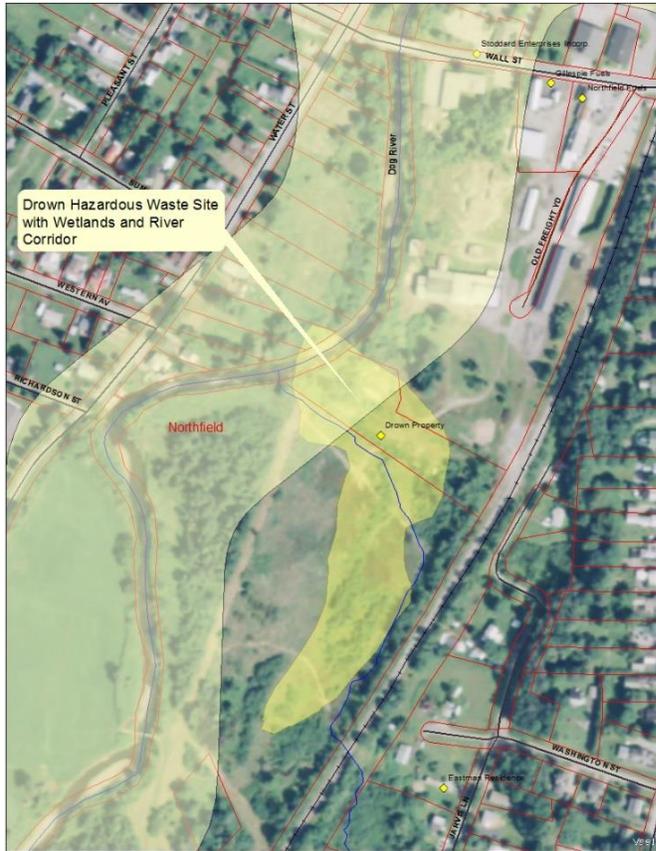
Figure 4. Drown Hazardous Waste Site

Environmental Compliance Services, Inc. (ECS) performed a Phase I Environmental Site Assessment of the Drown property at 11 Wall Street in Northfield in 2013. The stated purpose of their assessment “was to identify and record existing, potential or suspected conditions that may impose an environmental liability to, or restrict the use of, the property and to identify evidence of a release or a potential release of oil and hazardous materials (OHM).” Environmental Compliance Services then did an update of their September 2013 Phase I Environmental Site Assessment in June 2014 for the town of Northfield, which had received the property. In addition to the historical land use research, three soil samples were taken in locations that the town wanted sampled:

“In the “Granite Shed” sample, the PAH benzo(a)pyrene exceeded the Industrial EPA Regional Screening Level (RSL). The PAHs benzo(a)anthracene and benzo(b)flouranthene exceeded the Residential RSL. Arsenic exceeded the Industrial RSL in all three samples. Although the arsenic concentrations in the “Sawmill” and “Granite Shed” samples could potentially be within the range of background concentrations in Vermont (generally less than 10 milligrams per kilogram (mg/Kg)), which often exceed the Industrial RSL, the concentration in the “L Drown” sample was 50 mg/Kg, which is elevated above background concentrations. There were no other exceedences of applicable soil standards, although other PAHs, metals, TPH, and VOCs were detected. No PCBs were detected above laboratory reporting limits in any of the three samples.”

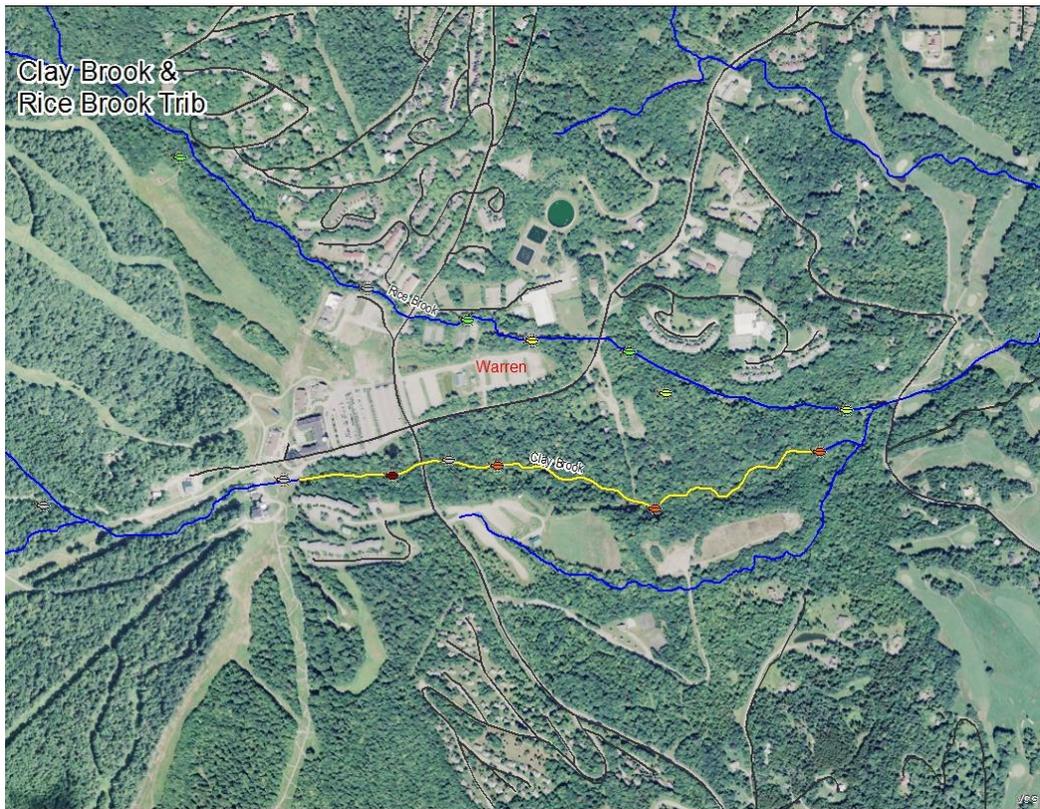
Figure 6. Clay and Rice Brooks and Adjacent Development

The macroinvertebrate community at sites on Clay Brook from 1991 through 2006 (8 samples) have been either fair or poor (with “good-fair” achieved in 2006 at two sites) between rivermiles 1.8 and 2.3. From 2006 to the present (2016), the aquatic community has remained impaired getting “fair”, “fair-poor” or “poor” assessments. There were brief indications of improvement at the rm 2.0 site on two different years but that improvement did not hold.
