# White River Watershed

## Updated Water Quality/Aquatic Habitat Assessment Report

December 2016

**Vermont Agency of Natural Resources**  
**Department of Environmental Conservation**  
**Watershed Management Division**  
**Monitoring, Assessment and Planning Program**

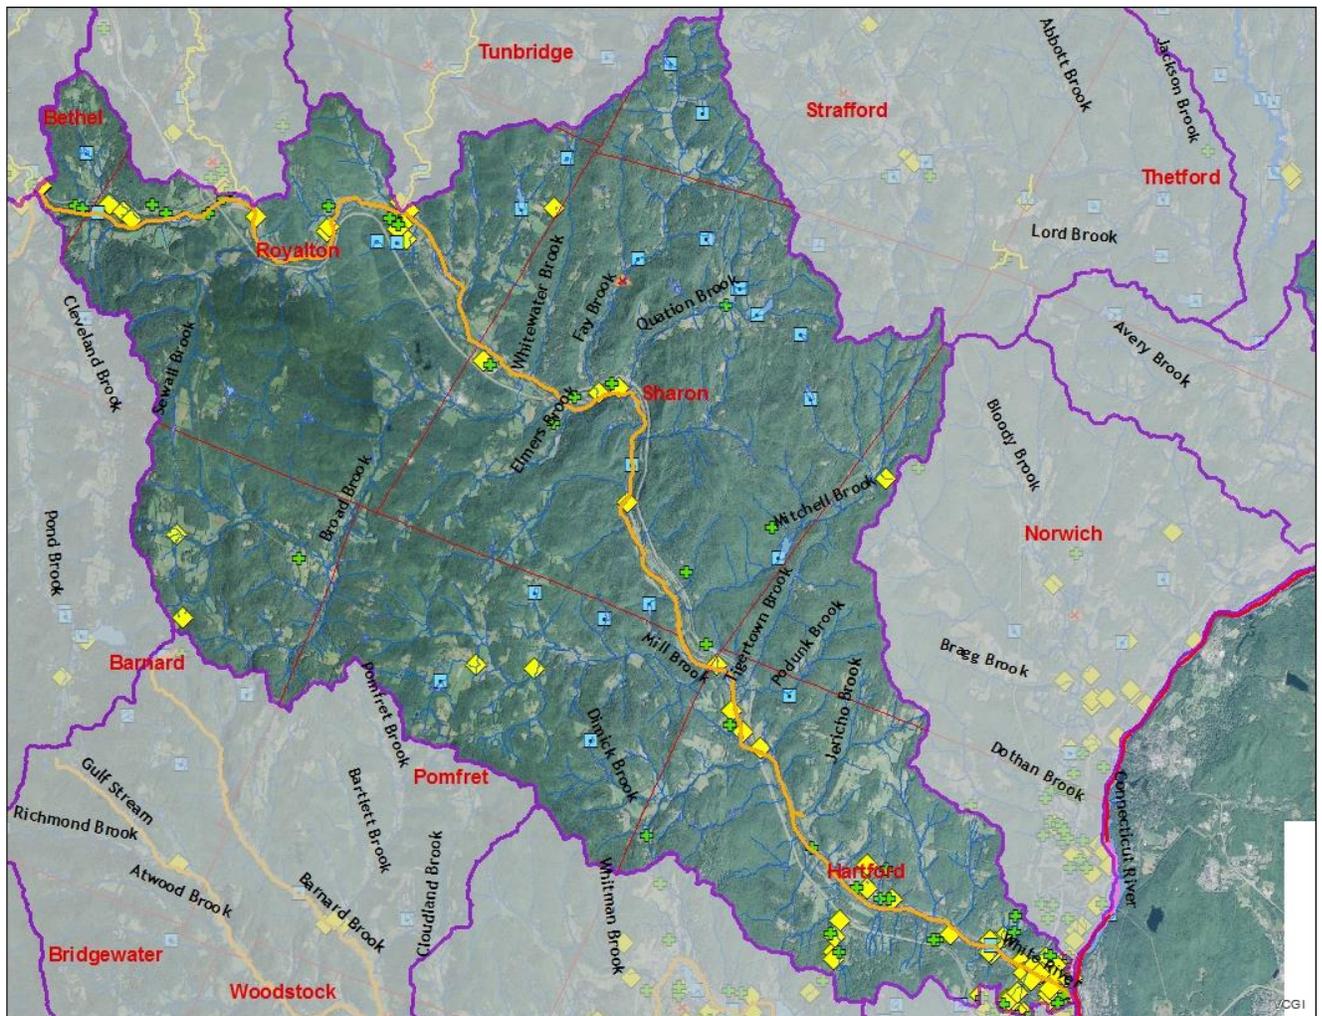
Figure 1. The Lower White River showing the stressed reach (orange line), hazardous waste sites (yellow diamond), dams (turquoise squares), stormwater permits (green crosses)

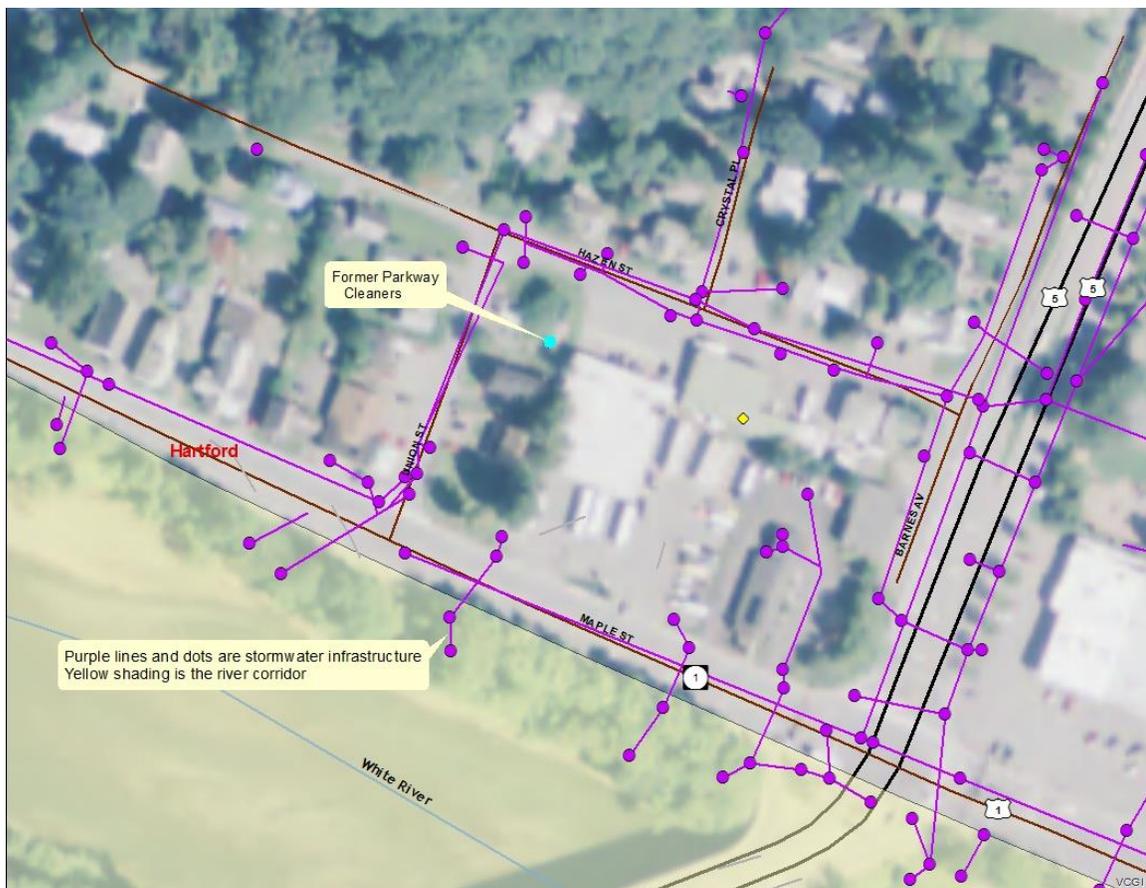
Figure 2. Former Parkway Drycleaners Site in relation to the Lower White River

The Former Parkway Drycleaners site (2006-3470) is located about 500 feet from the White River and a number of assessments done on this site have found tetrachloroethene (PCE) and trichloroethene (TCE) in the soil, soil gas, indoor air of neighboring residences, and groundwater. Some of the monitoring and assessment results are in documents done for: a Phase 1 Environmental Site Assessment (ESA); a limited Phase II Subsurface Investigation (LSI) in 2006; a Removal Program Preliminary Assessment/Site Investigation Report in 2010; and then a Final Preliminary Assessment (PA) Report in 2014 by H&S/Nobis Environmental.

Surface topography on the PDC property slopes down towards Hazen Street along the northern boundary, and Union Street along the western boundary. Three storm drains were noted; two along Hazen Street (at the northwestern and northeastern property boundaries), and one opposite the northwestern corner of the PDC property, and it is likely that surface water runoff feeds into one or more of these storm drains. The storm drains discharge storm water to the White River..., which constitutes the Probable Point of Entry (PPE) into the Surface Water Migration Pathway. From the PPE, surface water flows east-southeast in the White River for approximately 0.4 miles prior to discharge into the Connecticut River. Surface water in the Connecticut River generally flows south for 14.6 miles to the 15-mile downstream Target Distance Limit located at the Bridge Street crossing in Windsor.... No Surface Water Pathway sampling has been performed as part of past PDC site investigations.”

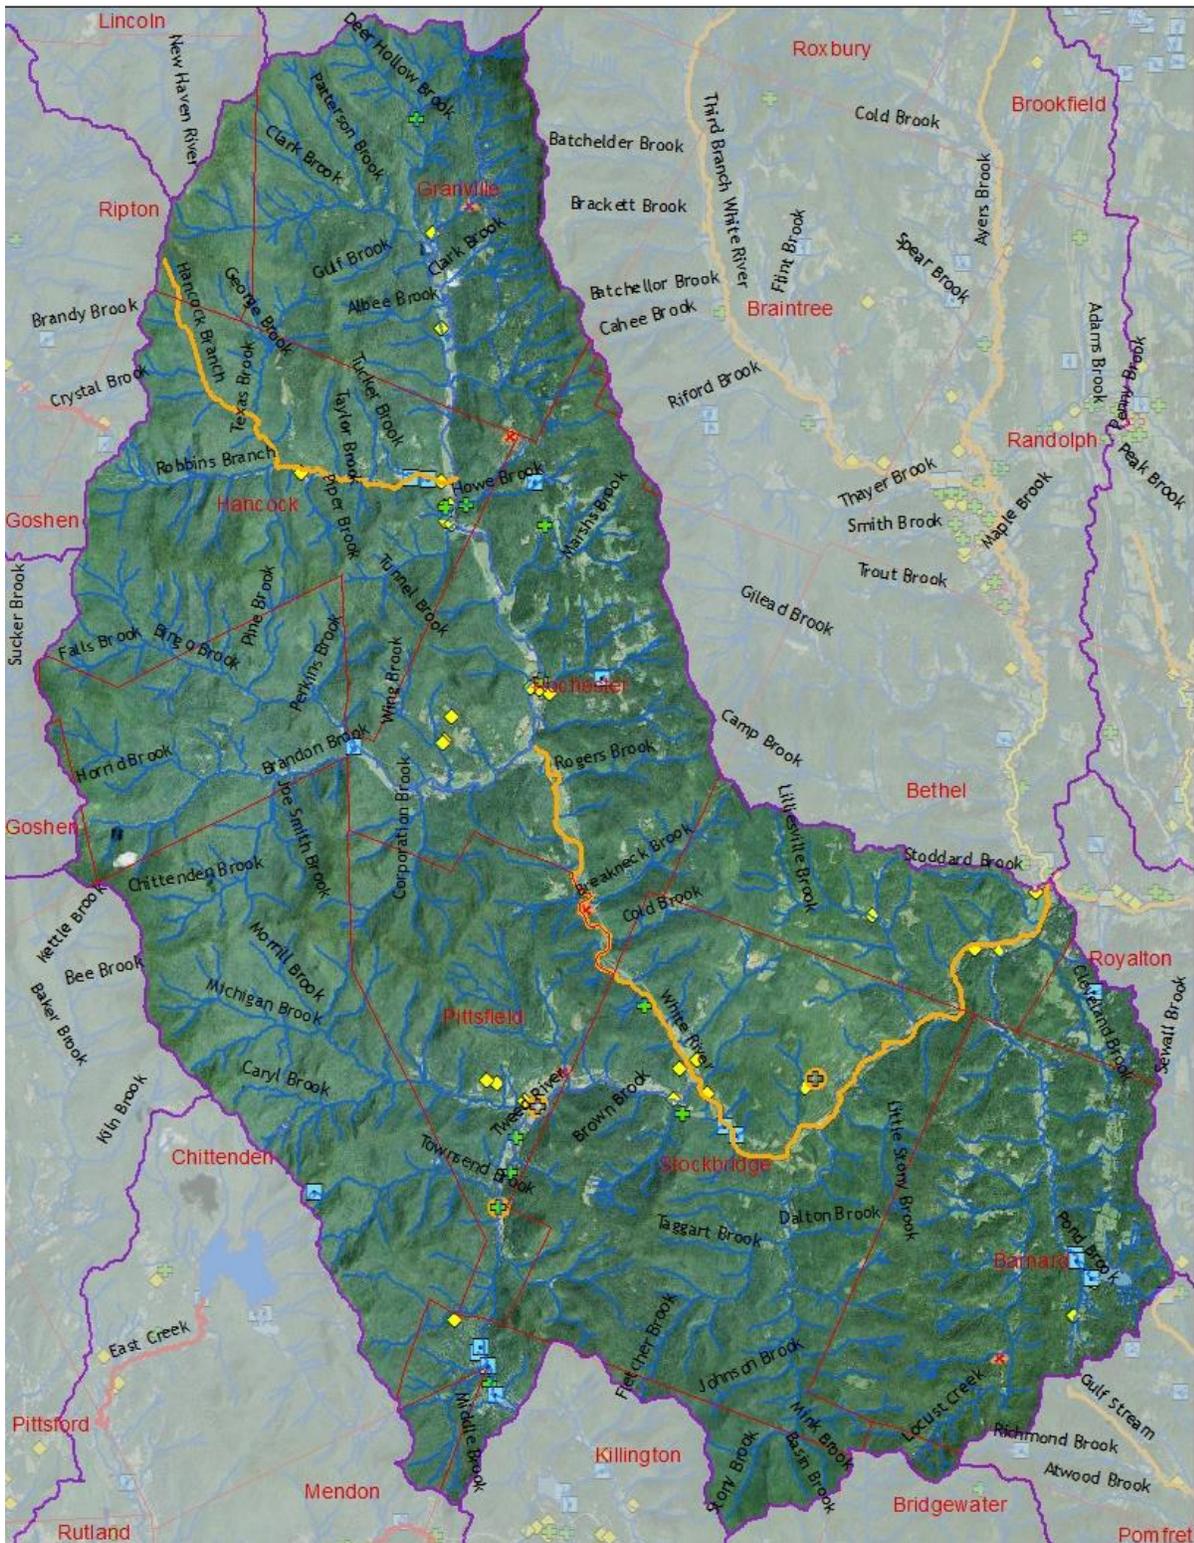
Figure 3. Upper White River Watershed showing the stressed reach (orange line), hazardous waste sites (yellow diamond), dams (turquoise squares), stormwater permits (green crosses), and landfills (brown with red x).

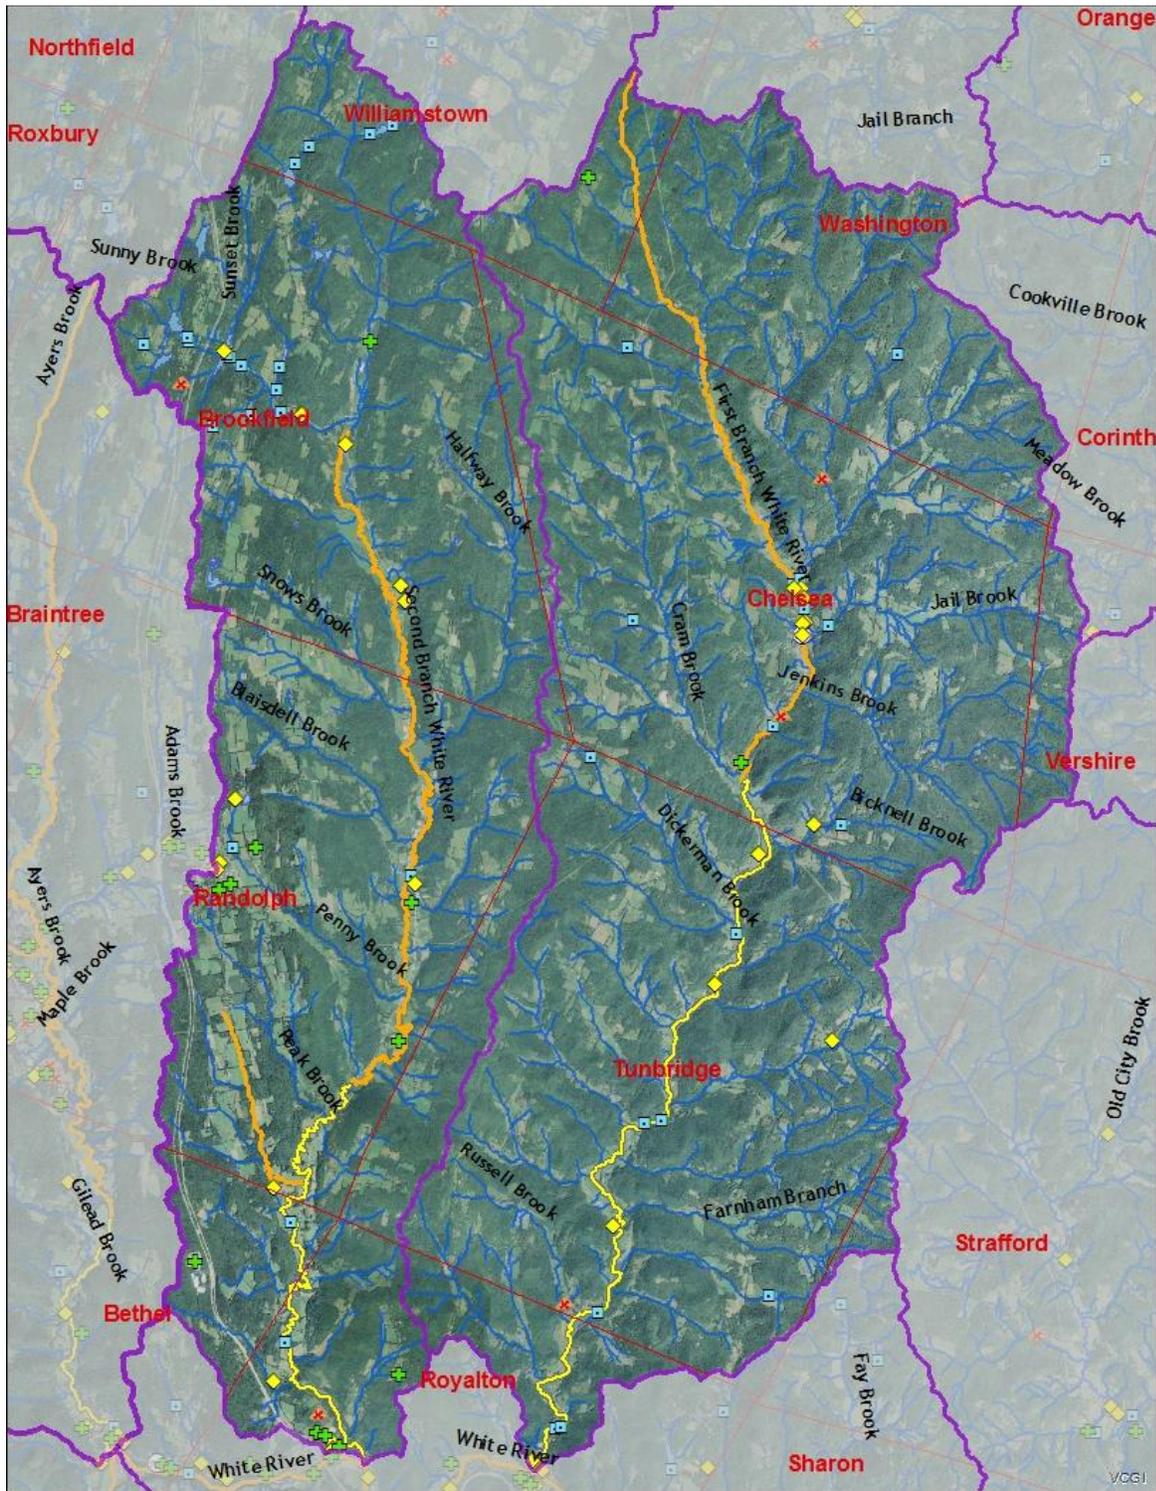
Figure 4. First and Second Branches White River showing the impaired reaches (yellow lines), stressed reaches (orange line), hazardous waste sites (yellow diamond), dams (turquoise squares), stormwater permits (green crosses), landfills (brown with red x).

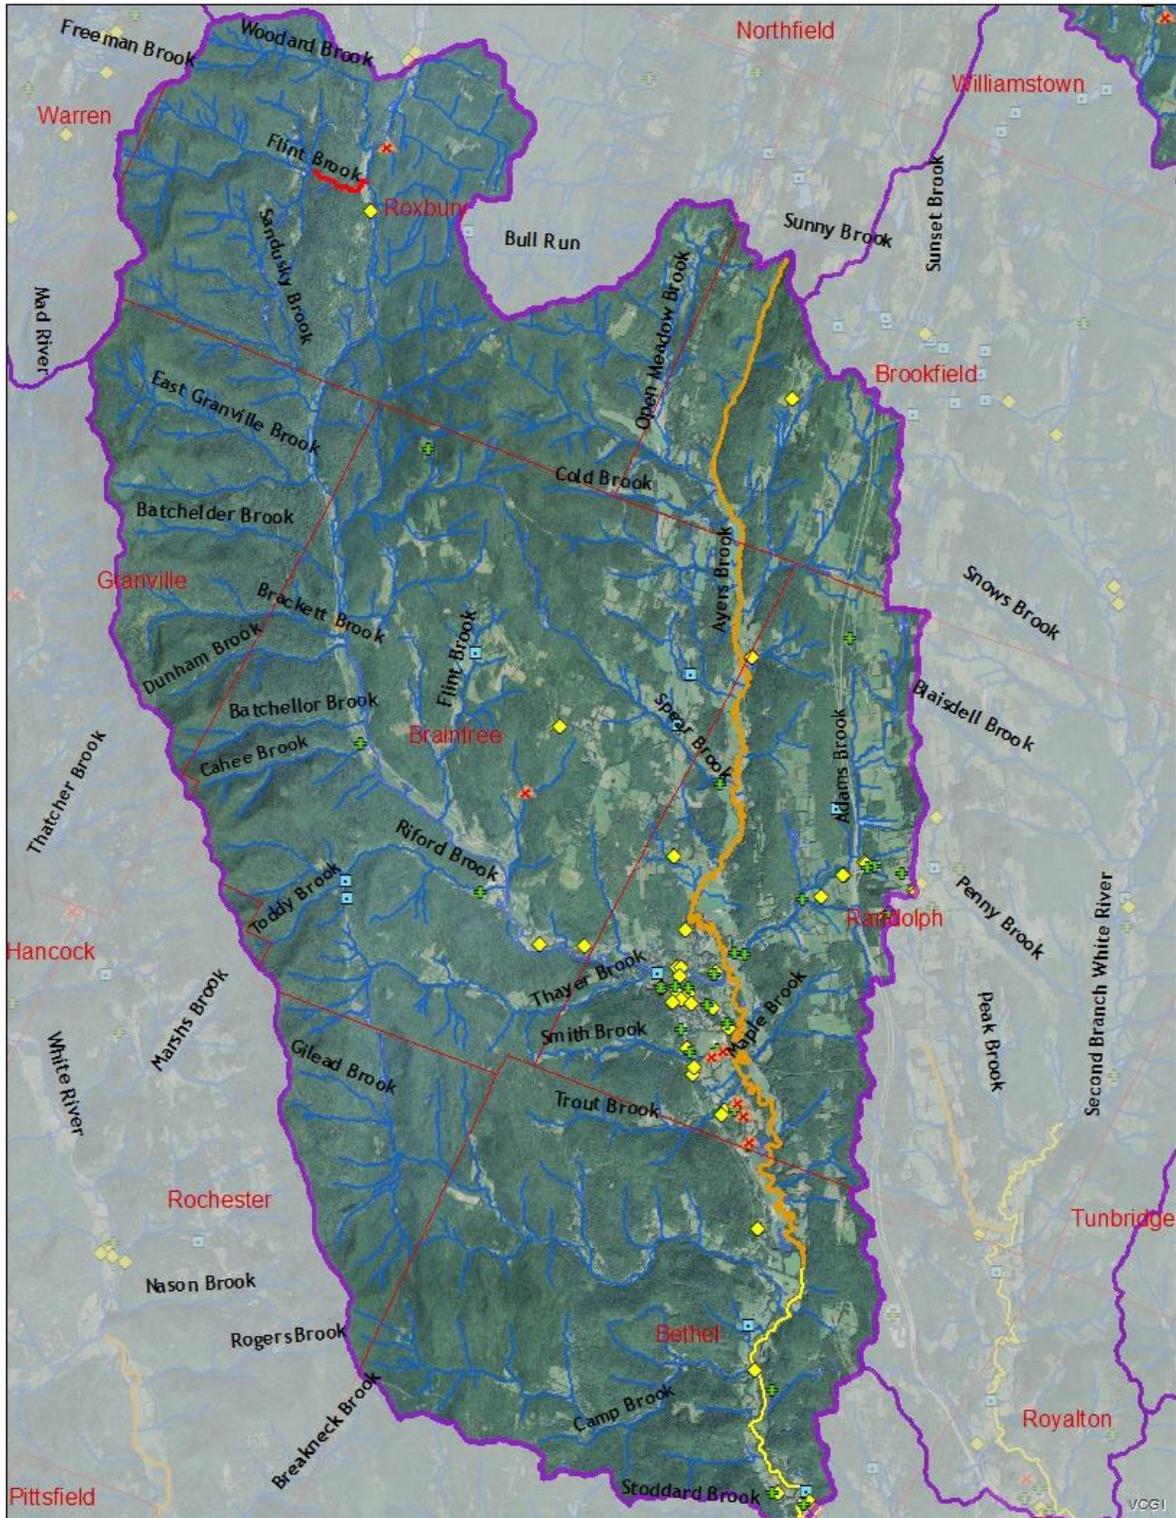
Figure 5. Third Branch White River showing the impaired reach (yellow line), stressed reach (orange line), hazardous waste sites (yellow diamond), dams (turquoise squares), stormwater permits (green crosses), landfills (brown with red x).
